## Six Mile Lane, Old Six Mile Lane and Airport Road, Glenugie

Existing stage road safety audit

TRF-PROJ-0024-01 ES RSA GLENUGIE REV 1

19/11/2019

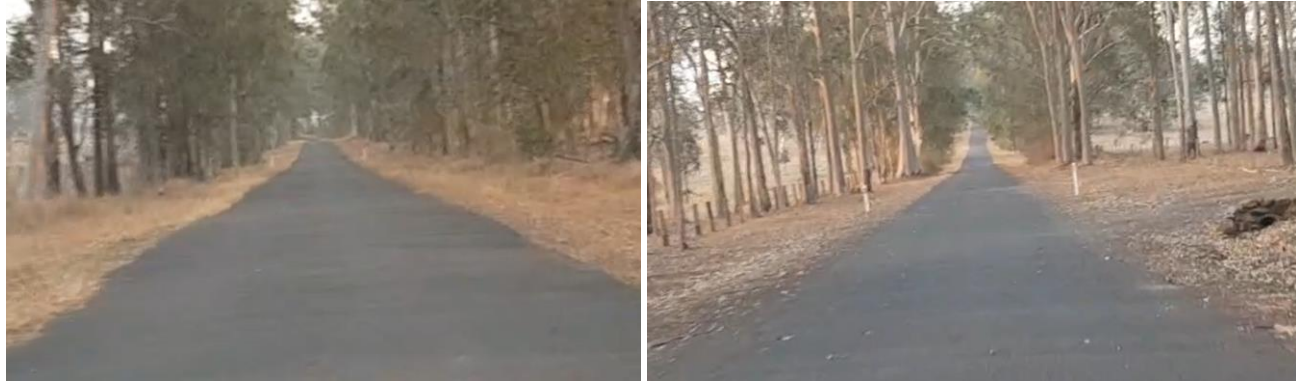
Ref	Location	Road safety audit finding – Aerodrome Road from Six Mile Lane to Eight Mile Lane.	Priority
7-1	Aerodrome Road, from Six Mile Lane to Eight Mile Lane.	<p>Overall, this road has a poorer layout compared with Six Mile Lane and Old Six Mile Lane North Deviation. This includes:</p> <ul style="list-style-type: none"> <li>▪ Narrow sealed width with limited passing clearance between opposing vehicles, and little recovery area in the form of sealed shoulders. This has associated risks of <i>head-on</i> and <i>run off road</i> crashes.</li> <li>▪ Further to the above, there are poor edge conditions including jagged edges, and grass encroachment onto the roadway. The jagged edges are structurally weak and susceptible to progressive damage due to wheel loading and possible under-mining of the sub-base with water ingress and root growth.</li> <li>▪ Rough pavement consisting of potholes and associated patchwork, and transverse corrugations which result in a poor ride quality, and which may destabilise vehicles including motorcyclists.</li> <li>▪ Clusters of non-frangible trees, fence posts and longitudinal culverts on each side of the road with limited clear zone, run out and recovery space in the event of a <i>loss of control</i> crash.</li> <li>▪ A high degree of leaf and gravel litter which compromises skid resistance.</li> </ul> <p>If this section of Aerodrome Road is to function as a key access route over the long term, consideration should be given to widening its sealed formation. Table 4.5 of the Austroads <i>Guide to Road Design Part 3</i> indicates that the minimum sealed width for a two-lane-two-way rural road (assuming that the traffic volume does not exceed 500 vehicles/day) is 7.2m. This is based on 2 x 3.1m lanes and 0.5m sealed shoulders either side. A 7.2m sealed width would vastly improve safety conditions on Aerodrome Road.</p> <div style="display: flex; justify-content: space-around;">

</div> <p><b>Above:</b> Examples photos showing the typical appearance of Aerodrome Road between Six Mile Lane and Eight Mile Lane.</p>	Medium

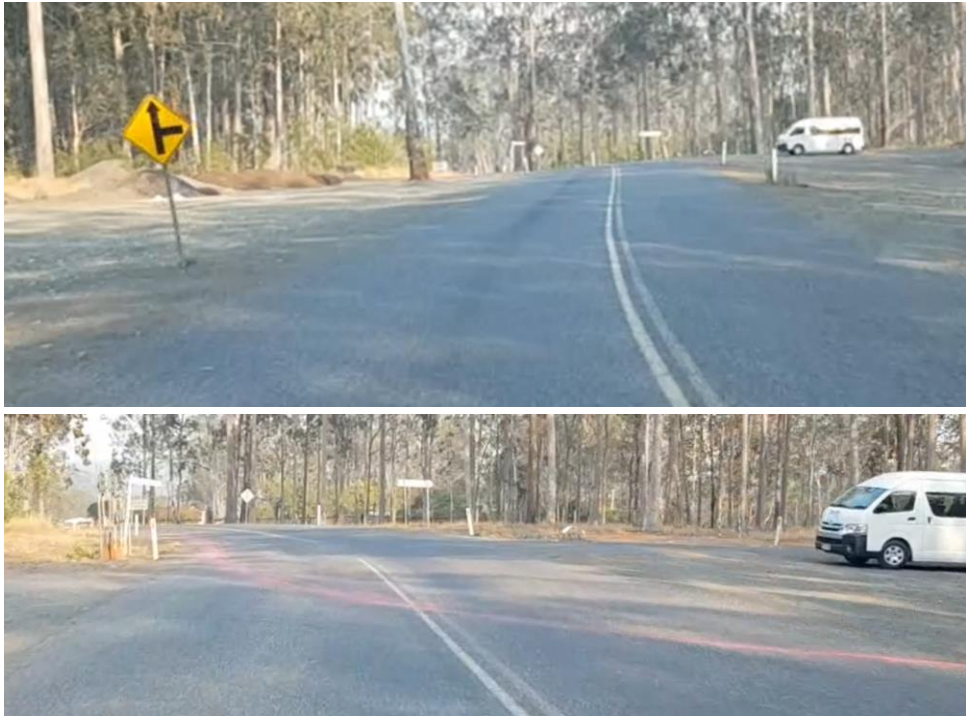
Ref	Location	Road safety audit finding – Aerodrome Road from Six Mile Lane to Eight Mile Lane.	Priority
7-2	Westbound travel direction on Eight Mile Lane in approach to Aerodrome Road.	<p>The Eight Mile Lane/ Aerodrome Road intersection is a T intersection configuration with Eight Mile Lane as the east-west major route and Aerodrome Road as the northern and terminating leg. Under current conditions, there are no passing facilities available for westbound drivers to use when there is a vehicle in the road ahead which has stopped or slowed down to turn right into Aerodrome Road. With the signage assembly currently in place on the southern side of the intersection, the shoulder has been rendered un-useable as a passing facility in the same manner as a basic right-turn (BAR) treatment.</p> <p>Consideration should be given to widening the shoulder and/ or shifting the entire signage assembly further south. This is especially since, from further upstream, the road appears to have a wide verge and shoulder. Furthermore, this verge area appears to be fully traversable. The photos below illustrate this further.</p>

<p><b>Top:</b> Looking westbound on Eight Mile Lane towards the Aerodrome Road side road leg (where the white van is located). The left-hand (southern) verge appears wide and fully traversable. Many drivers may falsely believe that this can be used as a passing facility if they encounter a stopped or slowed vehicle waiting to turn right into Aerodrome Road. <b>Bottom:</b> Further downstream and closer to the intersection, it becomes apparent that the shoulder and verge cannot be used as a passing facility since there is a signage assembly. If this signage assembly was simply shifted to the south and the ground made traversable, this could function as a shoulder and passing facility.</p>	Medium
