**Hazardous Materials Risk Assessment
Conrad Gargett Ancher Mortlock Woolley
Smalls Road Public School
Smalls Road, North Ryde NSW 2113**

Site Reference: 002

Our Reference : C120920 : J146932-02

Date: February 2017

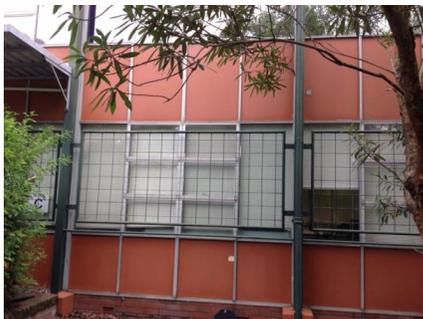
PHOTO NO.: J146932-02-002-PHOTO315
 RESULT: **ASBESTOS - POSITIVE**
 BUILDING/LEVEL: **B00C - ALL LEVELS**
 ROOM/LOCATION: **EXTERIOR - THROUGHOUT**
 FEATURE/MATERIAL: **INFILL PANELS - COMPRESSED CEMENT SHEETING**
 SAMPLE NO.: J146932-02-002-024

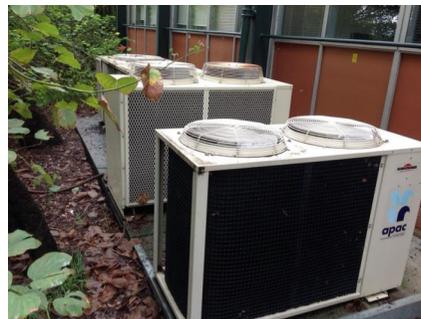
PHOTO NO.: J146932-02-002-PHOTO322
 RESULT: **ODS - POSITIVE**
 BUILDING/LEVEL: **B00C - GROUND LEVEL**
 ROOM/LOCATION: **EXTERIOR - EAST & WEST**
 FEATURE/MATERIAL: **A/C UNIT - R22 - CHLORODIFLUOROMETHANE**
 SAMPLE NO.: -

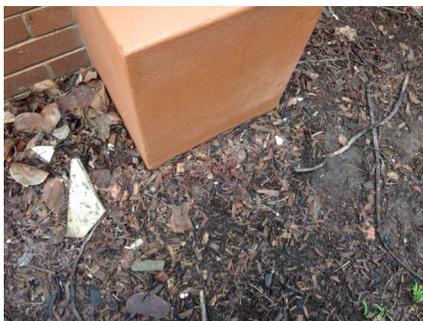
PHOTO NO.: J146932-02-002-PHOTO325
 RESULT: **ASBESTOS - POSITIVE**
 BUILDING/LEVEL: **B00C - GROUND LEVEL**
 ROOM/LOCATION: **EXTERIOR - WEST**
 FEATURE/MATERIAL: **DEBRIS - FIBRE CEMENT SHEETING**
 SAMPLE NO.: J146932-02-002-025

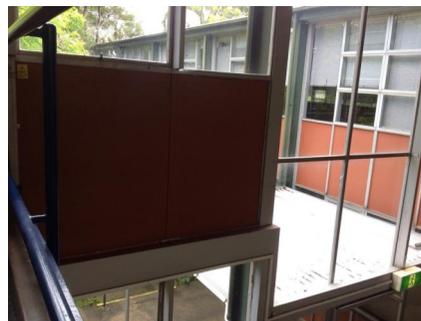
PHOTO NO.: J146932-02-002-PHOTO340
 RESULT: **ASBESTOS - PRESUMED POSITIVE**
 BUILDING/LEVEL: **B00C - GROUND LEVEL**
 ROOM/LOCATION: **CR0001 STAIRWELL - WEST**
 FEATURE/MATERIAL: **INFILL PANELS - HIGH LEVEL - COMPRESSED CEMENT SHEETING**
 SAMPLE NO.: SIMILAR TO: J146932-02-002-024

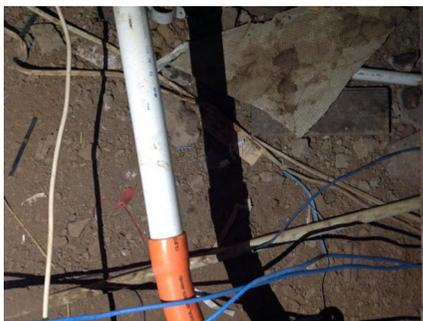
PHOTO NO.: J146932-02-002-PHOTO308
 RESULT: **ASBESTOS - POSITIVE**
 BUILDING/LEVEL: **B00C - GROUND LEVEL**
 ROOM/LOCATION: **CR0004 ELECTRICAL ROOM - VARIOUS THROUGHOUT**
 FEATURE/MATERIAL: **SUB FLOOR AREA - FIBRE CEMENT DEBRIS**
 SAMPLE NO.: J146932-02-002-022

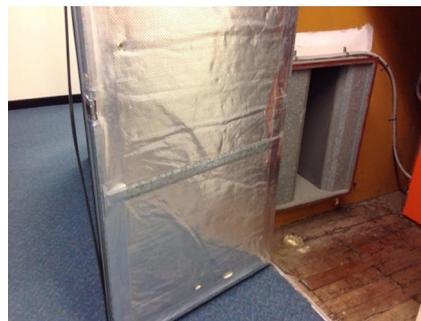
PHOTO NO.: J146932-02-002-PHOTO287
 RESULT: **SMF - POSITIVE**
 BUILDING/LEVEL: **B00C - GROUND LEVEL**
 ROOM/LOCATION: **CR0008 AIRCONDITIONING PLANT ROOM - SOUTH**
 FEATURE/MATERIAL: **LINING - SARKING INSULATION**
 SAMPLE NO.: -

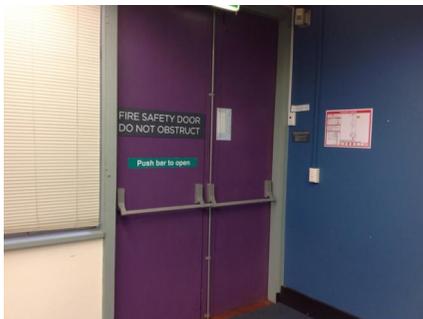
PHOTO NO.: J146932-02-002-PHOTO239
 RESULT: ASBESTOS - PRESUMED POSITIVE
 BUILDING/LEVEL: B00C - GROUND LEVEL
 ROOM/LOCATION: CR0013 OFFICE SPACE - SOUTHEAST
 FEATURE/MATERIAL: FIRE DOOR - DOUBLE - FIRE DOOR CORE
 SAMPLE NO.: NOT SAMPLED RESTRICTED ACCESS

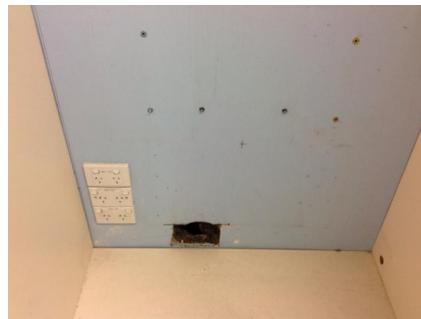
PHOTO NO.: J146932-02-002-PHOTO283
 RESULT: SMF - POSITIVE
 BUILDING/LEVEL: B00C - GROUND LEVEL
 ROOM/LOCATION: CR0019 HALLWAY - NORTH
 FEATURE/MATERIAL: LINING - INSULATION MATERIAL
 SAMPLE NO.: -

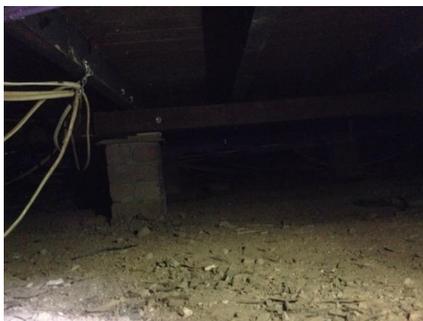
PHOTO NO.: J146932-02-002-PHOTO327
 RESULT: ASBESTOS - PRESUMED POSITIVE
 BUILDING/LEVEL: B00C - SUB-FLOOR
 ROOM/LOCATION: SUBFLOOR AREA - VARIOUS THROUGHOUT
 FEATURE/MATERIAL: COLUMN - PACKING
 SAMPLE NO.: NOT SAMPLED RESTRICTED ACCESS

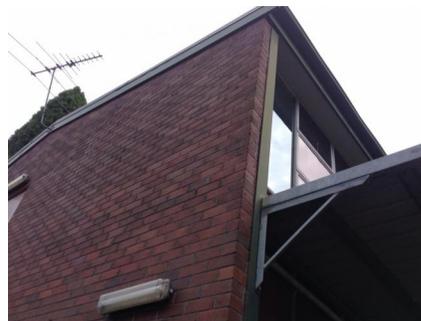
PHOTO NO.: J146932-02-002-PHOTO319
 RESULT: ASBESTOS - PRESUMED POSITIVE
 BUILDING/LEVEL: B00C - LEVEL ONE
 ROOM/LOCATION: EXTERIOR - EAST & WEST
 FEATURE/MATERIAL: EAVES - FIBRE CEMENT SHEETING
 SAMPLE NO.: NOT SAMPLED HEIGHT RESTRICTED

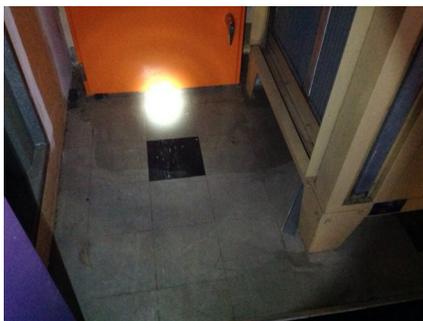
PHOTO NO.: J146932-02-002-PHOTO368
 RESULT: ASBESTOS - POSITIVE
 BUILDING/LEVEL: B00C - LEVEL ONE
 ROOM/LOCATION: CR1006 AIRCONDITIONING PLANT ROOM - THROUGHOUT
 FEATURE/MATERIAL: FLOOR COVERING - VINYL TILES & ADHESIVE
 SAMPLE NO.: J146932-02-002-029

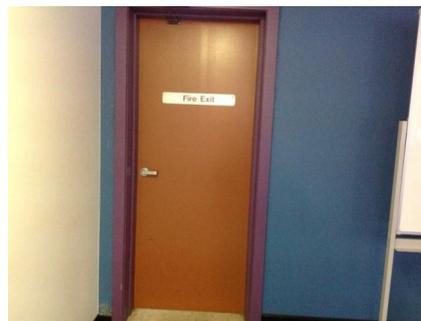
PHOTO NO.: J146932-02-002-PHOTO377
 RESULT: ASBESTOS - PRESUMED POSITIVE
 BUILDING/LEVEL: B00C - LEVEL ONE
 ROOM/LOCATION: CR1007 CLASSROOM - SOUTH
 FEATURE/MATERIAL: FIRE DOOR - FIRE DOOR CORE
 SAMPLE NO.: NOT SAMPLED RESTRICTED ACCESS

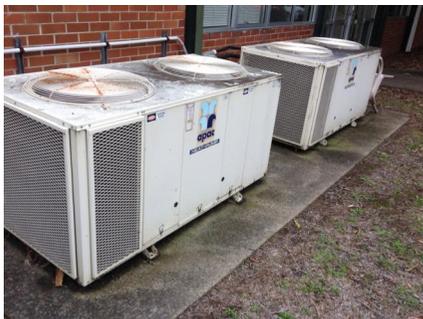
PHOTO NO.: J146932-02-002-PHOTO438
 RESULT: ODS - POSITIVE
 BUILDING/LEVEL: B00G - GROUND LEVEL
 ROOM/LOCATION: EXTERIOR - SOUTHEAST
 FEATURE/MATERIAL: A/C UNIT - R22 - CHLORODIFLUOROMETHANE
 SAMPLE NO.: -

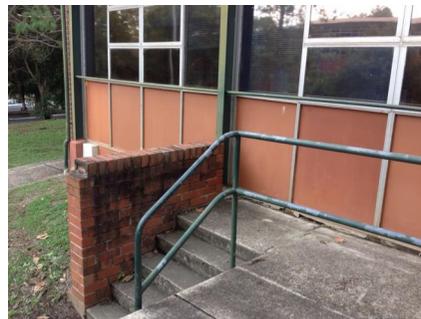
PHOTO NO.: J146932-02-002-PHOTO406
 RESULT: ASBESTOS - PRESUMED POSITIVE
 BUILDING/LEVEL: B00G - GROUND LEVEL
 ROOM/LOCATION: EXTERIOR - WEST
 FEATURE/MATERIAL: INFILL PANELS - COMPRESSED CEMENT SHEETING
 SAMPLE NO.: SIMILAR TO: J146932-02-002-024

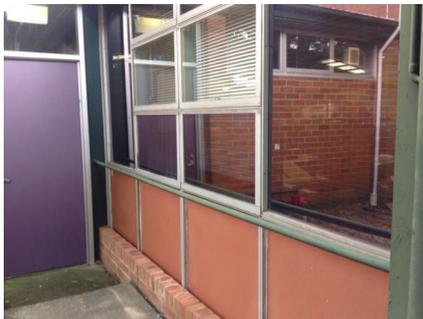
PHOTO NO.: J146932-02-002-PHOTO408
 RESULT: ASBESTOS - PRESUMED POSITIVE
 BUILDING/LEVEL: B00G - GROUND LEVEL
 ROOM/LOCATION: EXTERIOR - WEST
 FEATURE/MATERIAL: INFILL PANELS - COMPRESSED CEMENT SHEETING
 SAMPLE NO.: SIMILAR TO: J146932-02-002-024

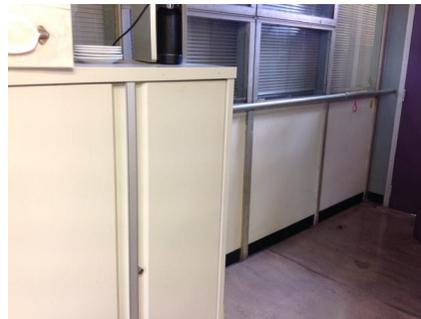
PHOTO NO.: J146932-02-002-PHOTO395
 RESULT: ASBESTOS - PRESUMED POSITIVE
 BUILDING/LEVEL: B00G - GROUND LEVEL
 ROOM/LOCATION: GR0001 DELIVERY/LOADING AREA - EAST
 FEATURE/MATERIAL: INFILL PANELS - COMPRESSED CEMENT SHEETING
 SAMPLE NO.: SIMILAR TO: J146932-02-002-024

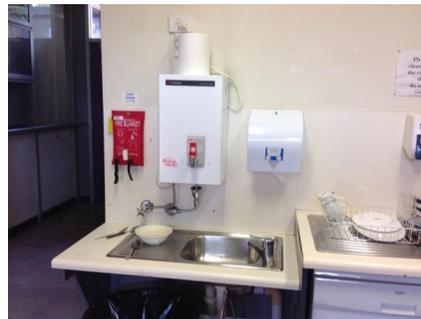
PHOTO NO.: J146932-02-002-PHOTO383
 RESULT: SMF - PRESUMED POSITIVE
 BUILDING/LEVEL: B00G - GROUND LEVEL
 ROOM/LOCATION: GR0004 KITCHENETTE - SOUTH
 FEATURE/MATERIAL: HOT WATER SERVICE INSULATION - INSULATION MATERIAL
 SAMPLE NO.: -

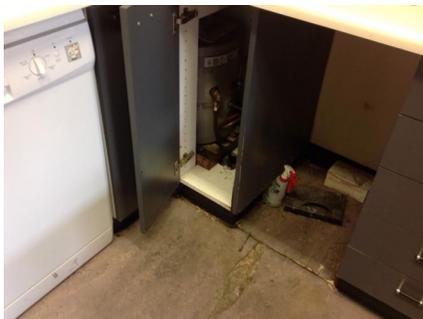
PHOTO NO.: J146932-02-002-PHOTO384
 RESULT: **SMF - PRESUMED POSITIVE**
 BUILDING/LEVEL: **B00G - GROUND LEVEL**
 ROOM/LOCATION: **GR0004 KITCHENETTE - SOUTH**
 FEATURE/MATERIAL: **HOT WATER SERVICE INSULATION - INSULATION MATERIAL**
 SAMPLE NO.: -

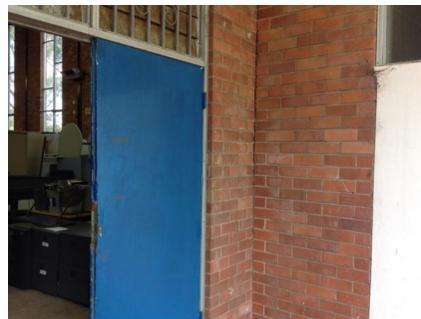
PHOTO NO.: J146932-02-002-PHOTO102
 RESULT: **ASBESTOS - POSITIVE**
 BUILDING/LEVEL: **B00H - ALL LEVELS**
 ROOM/LOCATION: **EXTERIOR - SOUTH**
 FEATURE/MATERIAL: **EXPANSION JOINT - CONSTRUCTION JOINT MASTIC**
 SAMPLE NO.: J146932-02-002-008

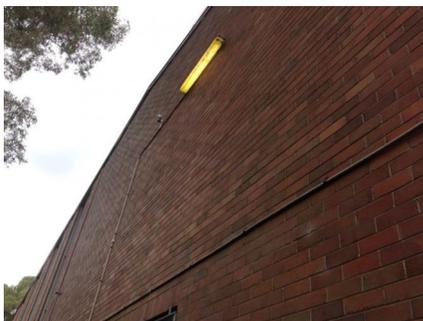
PHOTO NO.: J146932-02-002-PHOTO010
 RESULT: **PCB - PRESUMED POSITIVE**
 BUILDING/LEVEL: **B00H - ALL LEVELS**
 ROOM/LOCATION: **EXTERIOR - THROUGHOUT**
 FEATURE/MATERIAL: **FLUORESCENT LIGHT FITTING - CAPACITOR**
 SAMPLE NO.: -

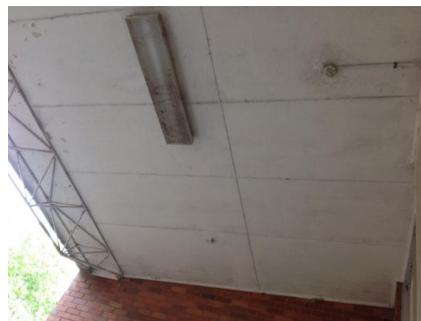
PHOTO NO.: J146932-02-002-PHOTO013
 RESULT: **ASBESTOS - PRESUMED POSITIVE**
 BUILDING/LEVEL: **B00H - GROUND LEVEL**
 ROOM/LOCATION: **EXTERIOR - SOUTH**
 FEATURE/MATERIAL: **CEILING - FIBRE CEMENT SHEETING**
 SAMPLE NO.: SIMILAR TO: J146932-02-002-002

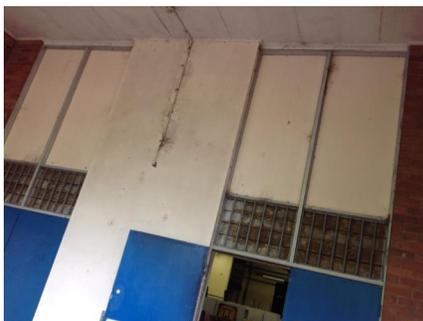
PHOTO NO.: J146932-02-002-PHOTO005
 RESULT: **ASBESTOS - PRESUMED POSITIVE**
 BUILDING/LEVEL: **B00H - GROUND LEVEL**
 ROOM/LOCATION: **EXTERIOR - SOUTH**
 FEATURE/MATERIAL: **INFILL PANELS - HIGH LEVEL - FIBRE CEMENT SHEETING**
 SAMPLE NO.: SIMILAR TO: J146932-02-002-003

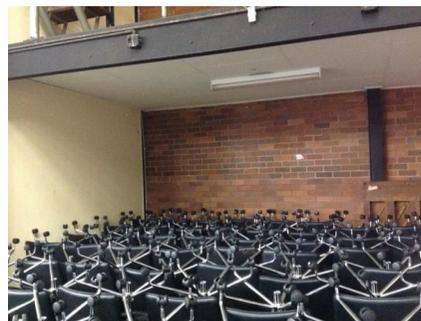
PHOTO NO.: J146932-02-002-PHOTO040
 RESULT: **ASBESTOS - PRESUMED POSITIVE**
 BUILDING/LEVEL: **B00H - GROUND LEVEL**
 ROOM/LOCATION: **HR00001 STAGE - EAST & WEST**
 FEATURE/MATERIAL: **CEILING LINING - FIBRE CEMENT SHEETING**
 SAMPLE NO.: SIMILAR TO: J146932-02-002-002

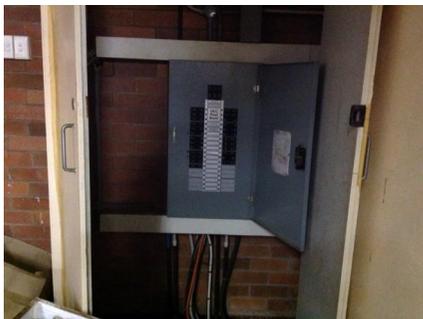
PHOTO NO.: J146932-02-002-PHOTO042
 RESULT: ASBESTOS - PRESUMED POSITIVE
 BUILDING/LEVEL: B00H - GROUND LEVEL
 ROOM/LOCATION: HR00001 STAGE - SOUTHEAST
 FEATURE/MATERIAL: ELECTRICAL - SWITCH BOARD - COMPRESSED BITUMINOUS ELECTRICAL PANEL
 SAMPLE NO.: NOT SAMPLED LIVE ELECTRICAL HAZARD

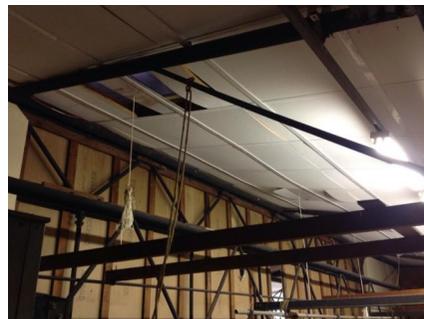
PHOTO NO.: J146932-02-002-PHOTO046
 RESULT: SMF - POSITIVE
 BUILDING/LEVEL: B00H - GROUND LEVEL
 ROOM/LOCATION: HR00001 STAGE - THROUGHOUT
 FEATURE/MATERIAL: CEILING TILES - INSULATION MATERIAL
 SAMPLE NO.: -

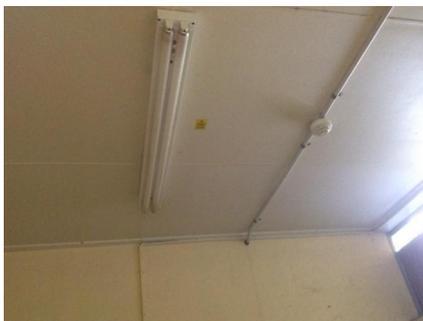
PHOTO NO.: J146932-02-002-PHOTO019
 RESULT: ASBESTOS - PRESUMED POSITIVE
 BUILDING/LEVEL: B00H - GROUND LEVEL
 ROOM/LOCATION: HR0004 KITCHEN - THROUGHOUT
 FEATURE/MATERIAL: CEILING - FIBRE CEMENT SHEETING
 SAMPLE NO.: SIMILAR TO: J146932-02-002-002

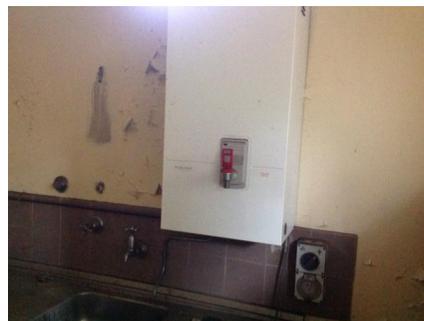
PHOTO NO.: J146932-02-002-PHOTO026
 RESULT: SMF - PRESUMED POSITIVE
 BUILDING/LEVEL: B00H - GROUND LEVEL
 ROOM/LOCATION: HR0004 KITCHEN - WEST
 FEATURE/MATERIAL: HOT WATER SERVICE INSULATION - INSULATION MATERIAL
 SAMPLE NO.: -

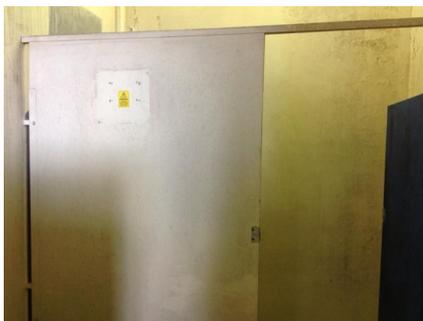
PHOTO NO.: J146932-02-002-PHOTO001
 RESULT: ASBESTOS - POSITIVE
 BUILDING/LEVEL: B00H - GROUND LEVEL
 ROOM/LOCATION: HR0005 MALE TOILET - CENTRAL
 FEATURE/MATERIAL: CUBICLE PARTITIONS - COMPRESSED CEMENT SHEET
 SAMPLE NO.: J146932-02-002-001

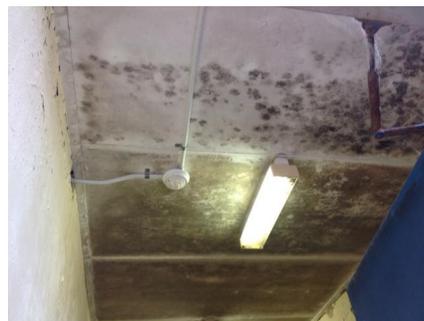
PHOTO NO.: J146932-02-002-PHOTO004
 RESULT: ASBESTOS - PRESUMED POSITIVE
 BUILDING/LEVEL: B00H - GROUND LEVEL
 ROOM/LOCATION: HR0005 MALE TOILET - THROUGHOUT
 FEATURE/MATERIAL: CEILING - FIBRE CEMENT SHEETING
 SAMPLE NO.: SIMILAR TO: J146932-02-002-002

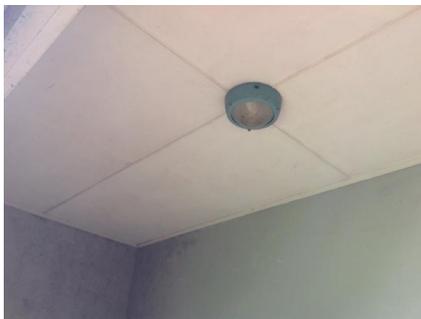
PHOTO NO.: J146932-02-002-PHOTO014
 RESULT: ASBESTOS - PRESUMED POSITIVE
 BUILDING/LEVEL: B00H - GROUND LEVEL
 ROOM/LOCATION: HR0006 STORAGE ROOM - THROUGHOUT
 FEATURE/MATERIAL: CEILING - FIBRE CEMENT SHEETING
 SAMPLE NO.: SIMILAR TO: J146932-02-002-002

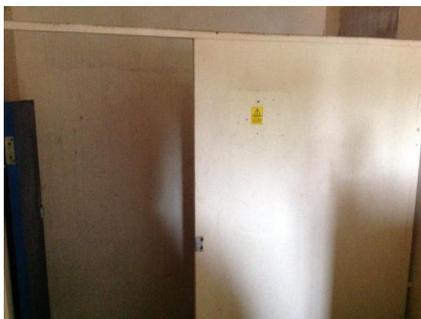
PHOTO NO.: J146932-02-002-PHOTO002
 RESULT: ASBESTOS - PRESUMED POSITIVE
 BUILDING/LEVEL: B00H - GROUND LEVEL
 ROOM/LOCATION: HR0008 FEMALE TOILET - CENTRAL
 FEATURE/MATERIAL: CUBICLE PARTITIONS - COMPRESSED CEMENT SHEET
 SAMPLE NO.: SIMILAR TO: J146932-02-002-001

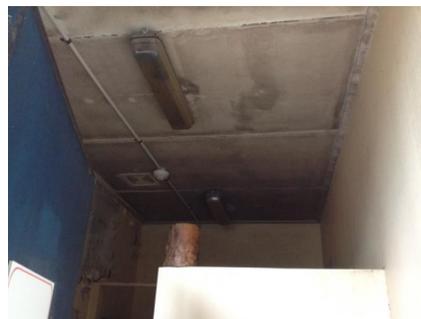
PHOTO NO.: J146932-02-002-PHOTO003
 RESULT: ASBESTOS - POSITIVE
 BUILDING/LEVEL: B00H - GROUND LEVEL
 ROOM/LOCATION: HR0008 FEMALE TOILET - THROUGHOUT
 FEATURE/MATERIAL: CEILING - FIBRE CEMENT SHEETING
 SAMPLE NO.: J146932-02-002-002

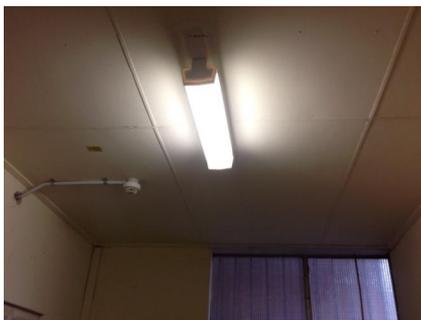
PHOTO NO.: J146932-02-002-PHOTO028
 RESULT: ASBESTOS - PRESUMED POSITIVE
 BUILDING/LEVEL: B00H - GROUND LEVEL
 ROOM/LOCATION: HR0009 STORAGE ROOM - THROUGHOUT
 FEATURE/MATERIAL: CEILING - FIBRE CEMENT SHEETING
 SAMPLE NO.: SIMILAR TO: J146932-02-002-002

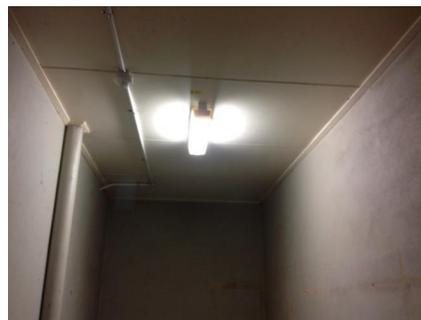
PHOTO NO.: J146932-02-002-PHOTO033
 RESULT: ASBESTOS - PRESUMED POSITIVE
 BUILDING/LEVEL: B00H - GROUND LEVEL
 ROOM/LOCATION: HR0010 STORAGE ROOM - THROUGHOUT
 FEATURE/MATERIAL: CEILING - FIBRE CEMENT SHEETING
 SAMPLE NO.: SIMILAR TO: J146932-02-002-002

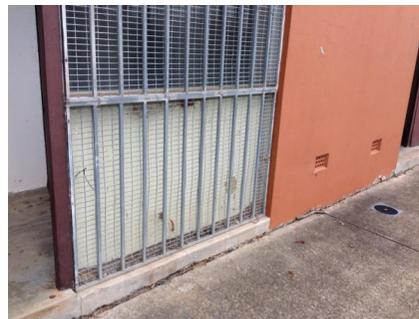
PHOTO NO.: J146932-02-002-PHOTO059
 RESULT: ASBESTOS - POSITIVE
 BUILDING/LEVEL: B00H - BASEMENT LEVEL
 ROOM/LOCATION: HR9008 CHANGE ROOM - NORTH
 FEATURE/MATERIAL: INFILL PANELS - COMPRESSED CEMENT SHEET
 SAMPLE NO.: J146932-02-002-003

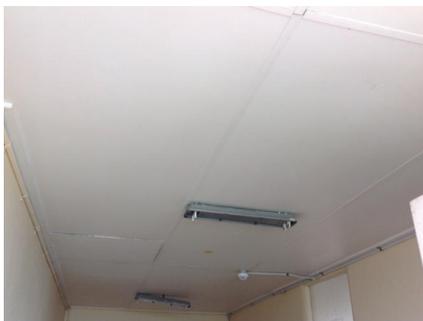
PHOTO NO.: J146932-02-002-PHOTO081
 RESULT: ASBESTOS - PRESUMED POSITIVE
 BUILDING/LEVEL: B00H - BASEMENT LEVEL
 ROOM/LOCATION: HR9001 CHANGE ROOM - THROUGHOUT
 FEATURE/MATERIAL: CEILING - FIBRE CEMENT SHEETING
 SAMPLE NO.: SIMILAR TO: J146932-02-002-002

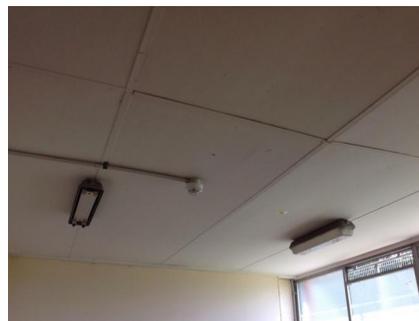
PHOTO NO.: J146932-02-002-PHOTO084
 RESULT: ASBESTOS - PRESUMED POSITIVE
 BUILDING/LEVEL: B00H - BASEMENT LEVEL
 ROOM/LOCATION: HR9002 TOILET/SHOWER - THROUGHOUT
 FEATURE/MATERIAL: CEILING - FIBRE CEMENT SHEETING
 SAMPLE NO.: SIMILAR TO: J146932-02-002-002

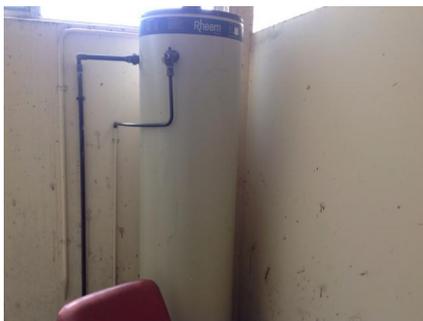
PHOTO NO.: J146932-02-002-PHOTO087
 RESULT: SMF - PRESUMED POSITIVE
 BUILDING/LEVEL: B00H - BASEMENT LEVEL
 ROOM/LOCATION: HR9002 TOILET/SHOWER - WEST
 FEATURE/MATERIAL: HOT WATER SERVICE INSULATION - INSULATION MATERIAL
 SAMPLE NO.: -

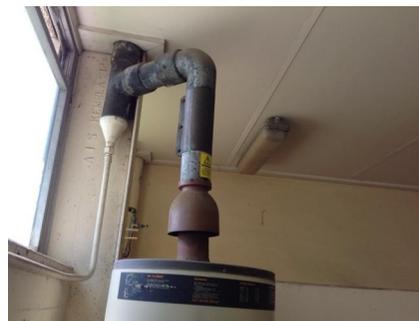
PHOTO NO.: J146932-02-002-PHOTO085
 RESULT: ASBESTOS - POSITIVE
 BUILDING/LEVEL: B00H - BASEMENT LEVEL
 ROOM/LOCATION: HR9002 TOILET/SHOWER - WEST
 FEATURE/MATERIAL: PIPEWORK - MOULDED FIBRE CEMENT
 SAMPLE NO.: J146932-02-002-005

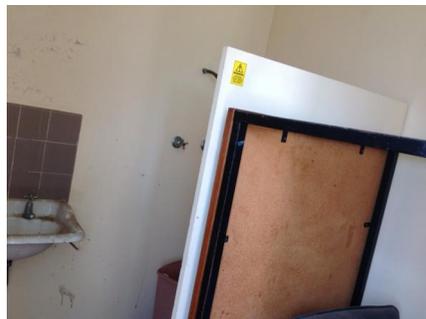
PHOTO NO.: J146932-02-002-PHOTO075
 RESULT: ASBESTOS - PRESUMED POSITIVE
 BUILDING/LEVEL: B00H - BASEMENT LEVEL
 ROOM/LOCATION: HR9003 SHOWER - CENTRAL
 FEATURE/MATERIAL: CUBICLE PARTITIONS - COMPRESSED CEMENT SHEET
 SAMPLE NO.: SIMILAR TO: J146932-02-002-001

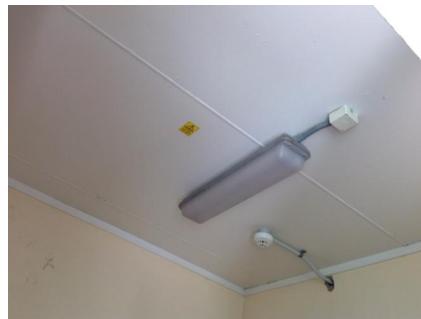
PHOTO NO.: J146932-02-002-PHOTO076
 RESULT: ASBESTOS - PRESUMED POSITIVE
 BUILDING/LEVEL: B00H - BASEMENT LEVEL
 ROOM/LOCATION: HR9003 SHOWER - THROUGHOUT
 FEATURE/MATERIAL: CEILING - FIBRE CEMENT SHEETING
 SAMPLE NO.: SIMILAR TO: J146932-02-002-002

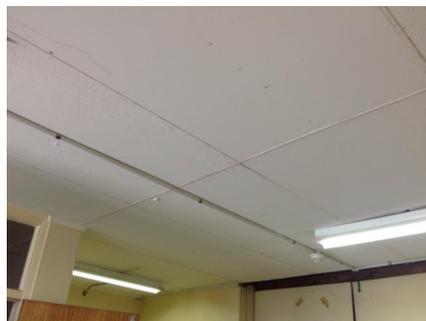
PHOTO NO.: J146932-02-002-PHOTO070
 RESULT: ASBESTOS - PRESUMED POSITIVE
 BUILDING/LEVEL: B00H - BASEMENT LEVEL
 ROOM/LOCATION: HR9005 LOADING AREA - THROUGHOUT
 FEATURE/MATERIAL: CEILING - FIBRE CEMENT SHEETING
 SAMPLE NO.: SIMILAR TO: J146932-02-002-002

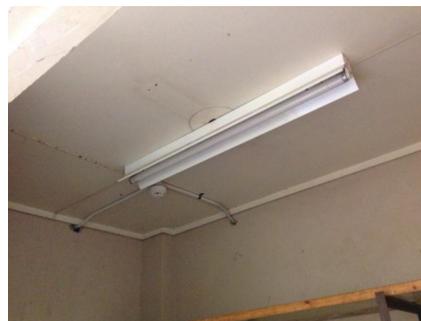
PHOTO NO.: J146932-02-002-PHOTO067
 RESULT: ASBESTOS - PRESUMED POSITIVE
 BUILDING/LEVEL: B00H - BASEMENT LEVEL
 ROOM/LOCATION: HR9006 STORAGE ROOM - THROUGHOUT
 FEATURE/MATERIAL: CEILING - FIBRE CEMENT SHEETING
 SAMPLE NO.: SIMILAR TO: J146932-02-002-002

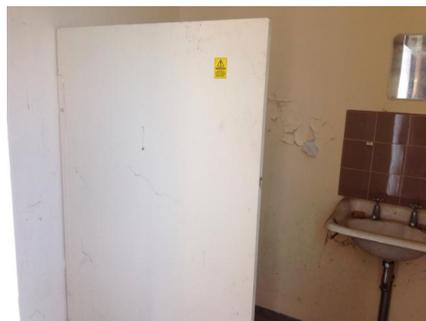
PHOTO NO.: J146932-02-002-PHOTO062
 RESULT: ASBESTOS - PRESUMED POSITIVE
 BUILDING/LEVEL: B00H - BASEMENT LEVEL
 ROOM/LOCATION: HR9007 SHOWER - CENTRAL
 FEATURE/MATERIAL: CUBICLE PARTITIONS - COMPRESSED CEMENT SHEET
 SAMPLE NO.: SIMILAR TO: J146932-02-002-001

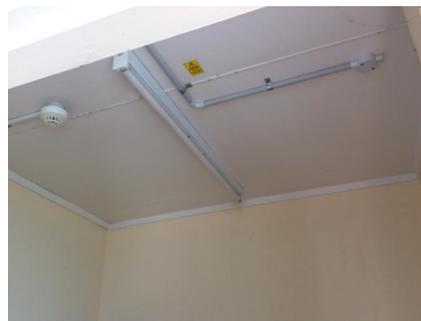
PHOTO NO.: J146932-02-002-PHOTO061
 RESULT: ASBESTOS - PRESUMED POSITIVE
 BUILDING/LEVEL: B00H - BASEMENT LEVEL
 ROOM/LOCATION: HR9007 SHOWER - THROUGHOUT
 FEATURE/MATERIAL: CEILING - FIBRE CEMENT SHEETING
 SAMPLE NO.: SIMILAR TO: J146932-02-002-002

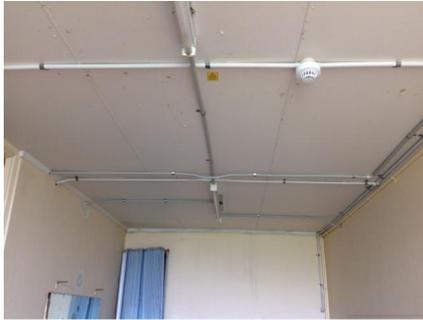
PHOTO NO.: J146932-02-002-PHOTO056
 RESULT: ASBESTOS - PRESUMED POSITIVE
 BUILDING/LEVEL: B00H - BASEMENT LEVEL
 ROOM/LOCATION: HR9008 CHANGE ROOM - THROUGHOUT
 FEATURE/MATERIAL: CEILING - FIBRE CEMENT SHEETING
 SAMPLE NO.: SIMILAR TO: J146932-02-002-002

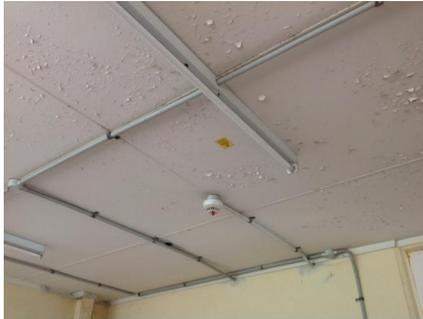
PHOTO NO.: J146932-02-002-PHOTO053
 RESULT: ASBESTOS - PRESUMED POSITIVE
 BUILDING/LEVEL: B00H - BASEMENT LEVEL
 ROOM/LOCATION: HR9009 TOILET/SHOWER - THROUGHOUT
 FEATURE/MATERIAL: CEILING - FIBRE CEMENT SHEETING
 SAMPLE NO.: SIMILAR TO: J146932-02-002-002

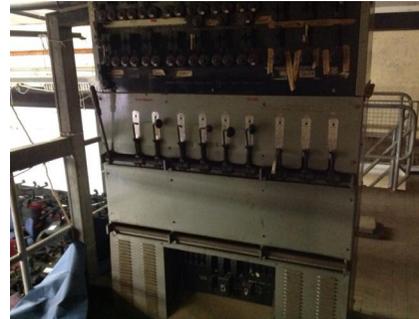
PHOTO NO.: J146932-02-002-PHOTO052
 RESULT: ASBESTOS - PRESUMED POSITIVE
 BUILDING/LEVEL: B00H - MEZZANINE LEVEL
 ROOM/LOCATION: HM0003 - CENTRAL
 FEATURE/MATERIAL: ELECTRICAL - SWITCH BOARD - COMPRESSED BITUMINOUS ELECTRICAL PANEL
 SAMPLE NO.: NOT SAMPLED LIVE ELECTRICAL HAZARD

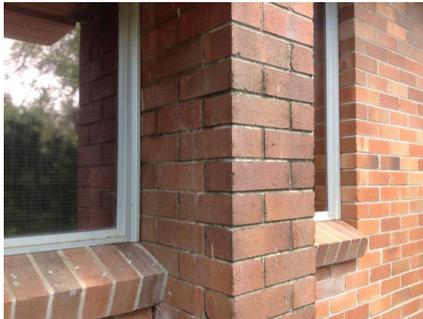
PHOTO NO.: J146932-02-002-PHOTO196
 RESULT: ASBESTOS - POSITIVE
 BUILDING/LEVEL: B00L - ALL LEVELS
 ROOM/LOCATION: EXTERIOR - VARIOUS THROUGHOUT
 FEATURE/MATERIAL: PACKER - MASTIC SEALANT
 SAMPLE NO.: J146932-02-002-016

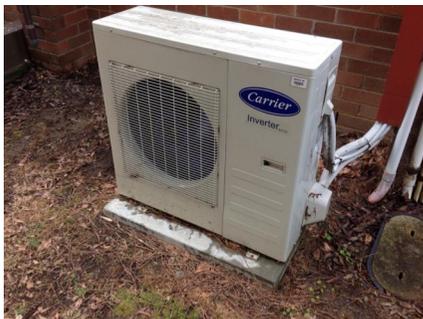
PHOTO NO.: J146932-02-002-PHOTO188
 RESULT: ODS - POSITIVE
 BUILDING/LEVEL: B00L - GROUND LEVEL
 ROOM/LOCATION: EXTERIOR - SOUTH
 FEATURE/MATERIAL: A/C UNIT - R410A - HFC BLEND
 SAMPLE NO.: -

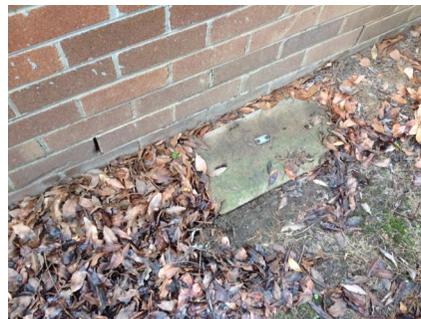
PHOTO NO.: J146932-02-002-PHOTO190
 RESULT: ASBESTOS - PRESUMED POSITIVE
 BUILDING/LEVEL: B00L - GROUND LEVEL
 ROOM/LOCATION: EXTERIOR - SOUTH
 FEATURE/MATERIAL: TELECOMMUNICATIONS PIT - COMPRESSED CEMENT SHEET
 SAMPLE NO.: NOT SAMPLED

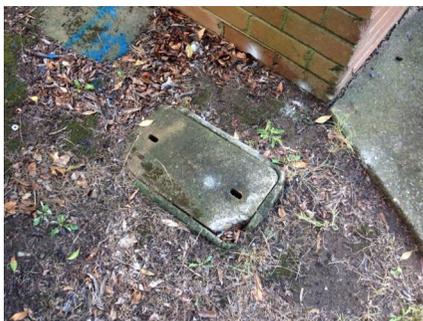
PHOTO NO.: J146932-02-002-PHOTO185
 RESULT: ASBESTOS - PRESUMED POSITIVE
 BUILDING/LEVEL: B00L - GROUND LEVEL
 ROOM/LOCATION: EXTERIOR - SOUTHEAST
 FEATURE/MATERIAL: TELECOMMUNICATIONS PIT - COMPRESSED CEMENT SHEET
 SAMPLE NO.: NOT SAMPLED
