**Re: Expert opinion on the potential impact on traffic safety at the Railway Crossing (LXM ID 349) located on Railway Street in Corrimal, NSW**

# **Railway Crossing (LXM ID 349) located on Railway Street in Corrimal, NSW**

## **Stage 5 (Existing road) Road Safety Audit**

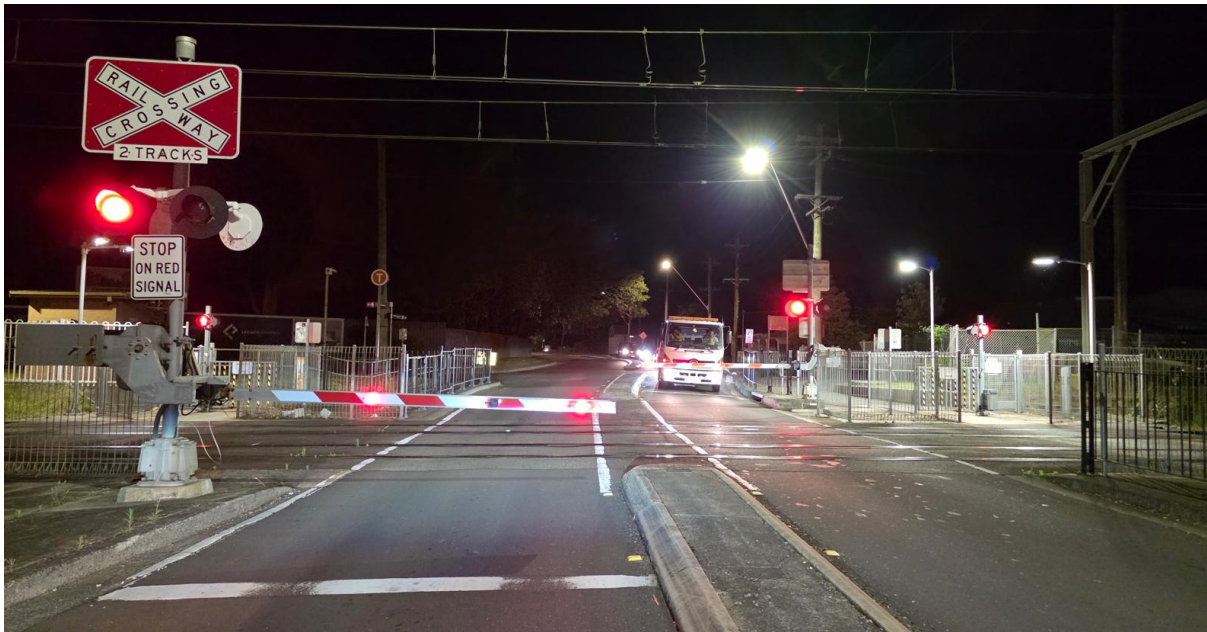
**Photo 1**

- The Railway Crossing is controlled by an RX-5 assembly and boom gates (refer to Photo 1), representing the highest level of control available for at-grade crossings under current standards.
- The pedestrian and cyclist crossing treatment includes active pedestrian controls on the western side of the crossing (refer to Photo 2), ensuring safe and regulated movement across the tracks.
- During the site inspections, it was observed that drivers, cyclists, and pedestrians were law-abiding, complying with the crossing controls and behaving predictably (refer to Photos 3 & 4).
- Regardless of the volume of vehicles, pedestrians, and cyclists approaching the crossing, it would be physically and visually implausible for a road user to overlook the need to stop. In other words, only those who intentionally disregard the controls could pose a risk, not due to design or visibility shortcomings.

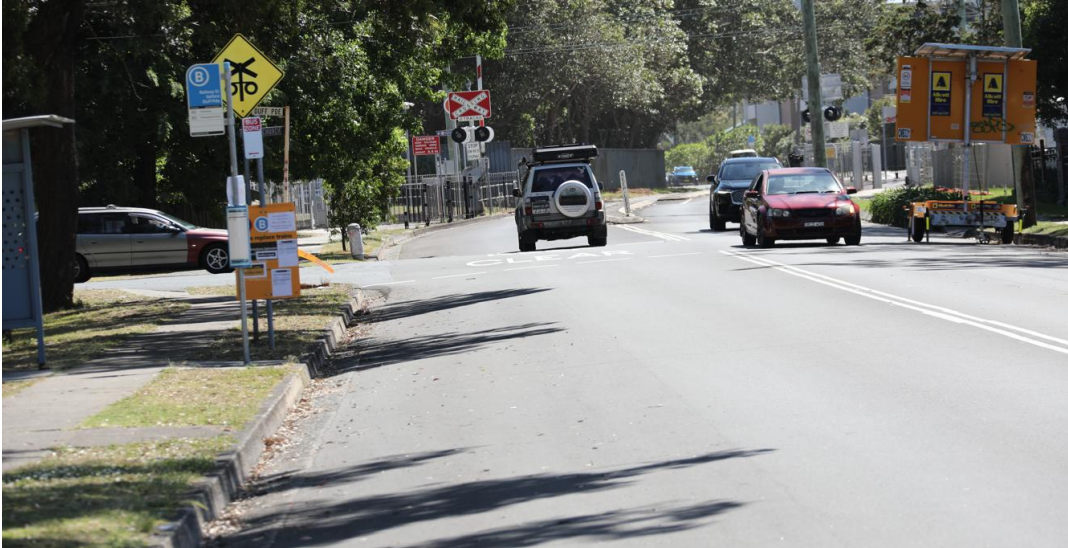
| No. | Approximate location | Description of findings | Risk rating (likelihood / consequence) |
|---|---|---|---|
| 1 | Railway Street, on the eastern approach to the Railway Crossing | <p>Railway Crossing Pavement Markings 'RAIL X' is missing on Railway Street, on the eastern approach to the Railway Crossing (refer to Photo 4.1, and Figure 4.1).</p> <p>The 'RAIL X' markings are a critical visual cue for drivers regarding the presence and location of the railway crossing.</p> <p>The lack of these markings could increase the chance of a driver being less alert to the presence of the Railway Crossing, thus increasing the chance for an accident to occur. The absence of these markings may reduce driver alertness, potentially increasing the risk of a collision, particularly under low visibility or high-speed conditions.</p> <p>However, due to the presence of other visual and environmental cues, it is considered highly unlikely that a driver would entirely overlook the existence of the Railway Crossing, despite the missing 'RAIL X' markings.</p> <p><b>Photo 4.1: 'RAIL X' markings are missing on Railway Street, on the eastern approach to the Railway Crossing</b><br/> (Photo: Traffic Engineering Centre Pty Ltd)</p> | <p><b>Medium</b><br/> (Negligible / Extreme)</p> |

| No. | Approximate location | Description of findings | Risk rating (likelihood / consequence) |
|---|---|---|---|
| 1<br>Cont'd | | <p><b>Figure 4.1</b><br/>(Source: AS1742.7:2016)</p> <p><b>Recommended mitigation measure:</b> The 'RAIL X' markings are to be painted on Railway Street, on the eastern approach to the Railway Crossing, in accordance with the AS1742.7:2016.</p> <p>This measure would eliminate the chance of an incident being caused by the lack of 'RAIL X' pavement marking.</p> | |

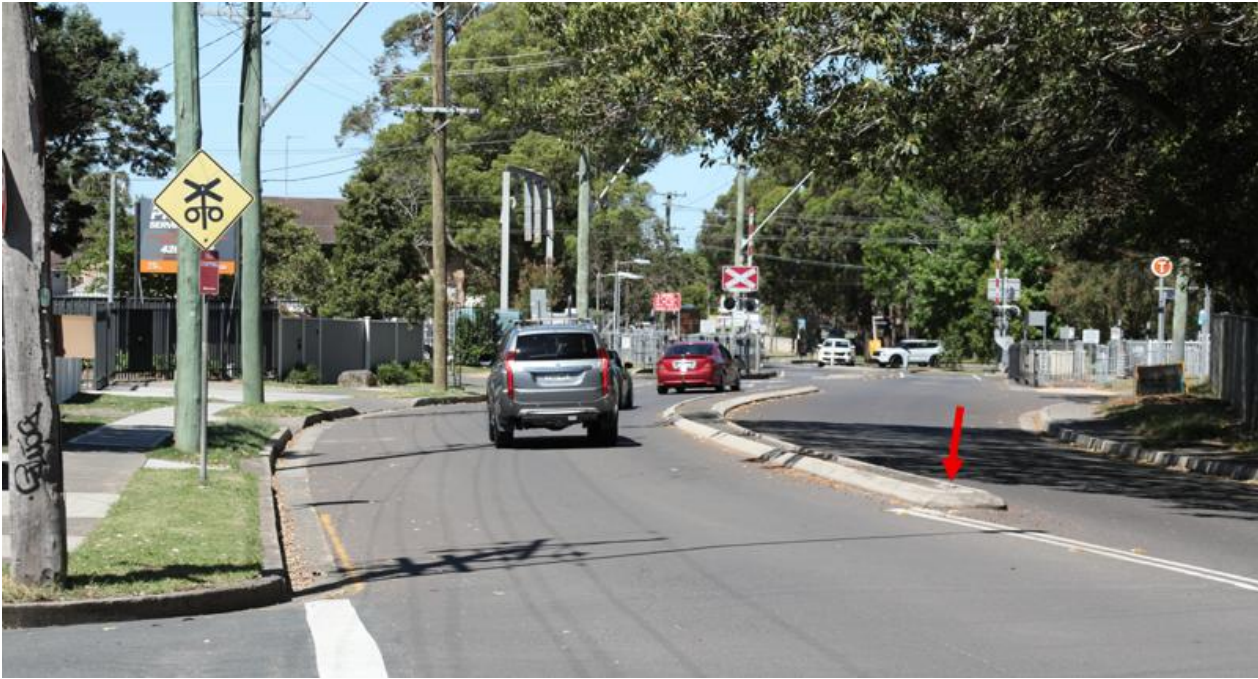
| No. | Approximate location | Description of findings | Risk rating (likelihood / consequence) |
|---|---|---|---|
| 2 | Raised medians on Railway Street, on both sides of the Railway Crossing | <p>'KEEP LEFT' (R2-3) signs are missing from the noses of the raised median islands (refer to Photos 4.2 to 4.6), despite the fact that traffic can physically pass on either side. However, it is essential that all approaching traffic passes to the left of these islands in accordance with standard road rules and design intent.</p> <p>In the absence of these regulatory signs—and without the kerb faces painted white, drivers may overlook the presence of the islands, even during daylight hours, and particularly under adverse lighting conditions (refer to Photos 4.5 &amp; 4.6). This increases the risk of a vehicle striking the island, potentially resulting in vehicle damage and injury to occupants.</p> <p><b>Photo 4.2: 'KEEP LEFT' sign is missing on the raised median on approach to the Railway Crossing</b><br/> (Photo: Traffic Engineering Centre Pty Ltd)</p> | <b>Negligible</b><br>(Medium / Negligible) |

| No. | Approximate location | Description of findings | Risk rating (likelihood / consequence) |
|---|---|---|---|
| 2<br>Cont'd | | <p><b>Photo 4.5: 'KEEP LEFT' sign is missing on the raised median on the approach to the Railway Crossing</b><br/>(Photo: Traffic Engineering Centre Pty Ltd)</p> <p><b>Photo 4.6: 'KEEP LEFT' sign is missing on the raised median on the approach to the Railway Crossing</b><br/>(Photo: Traffic Engineering Centre Pty Ltd)</p> <p><b>Recommended mitigation measure:</b> 'KEEP LEFT' (R2-3) signs to be installed on the raised medians' noses to minimise the risk of a vehicle striking the medians.</p> | |

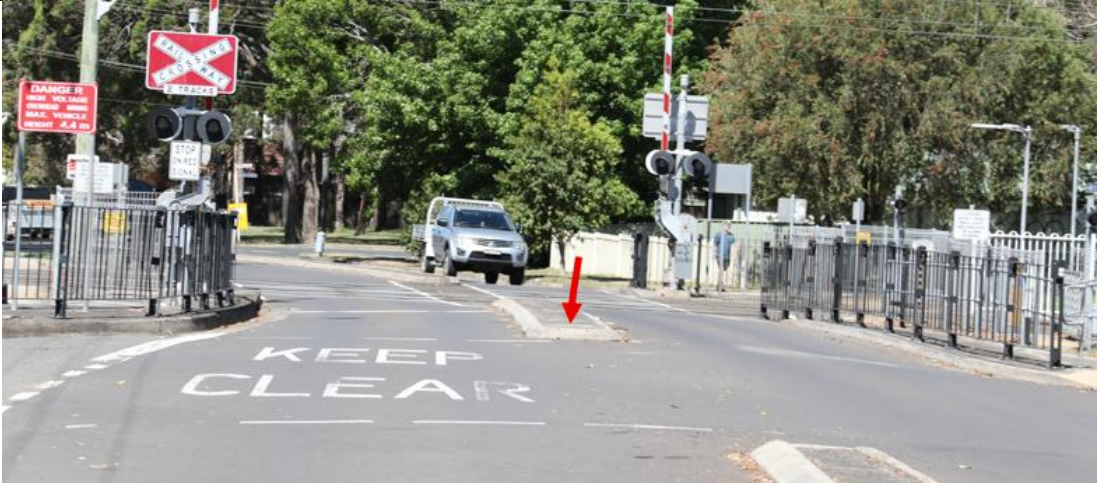
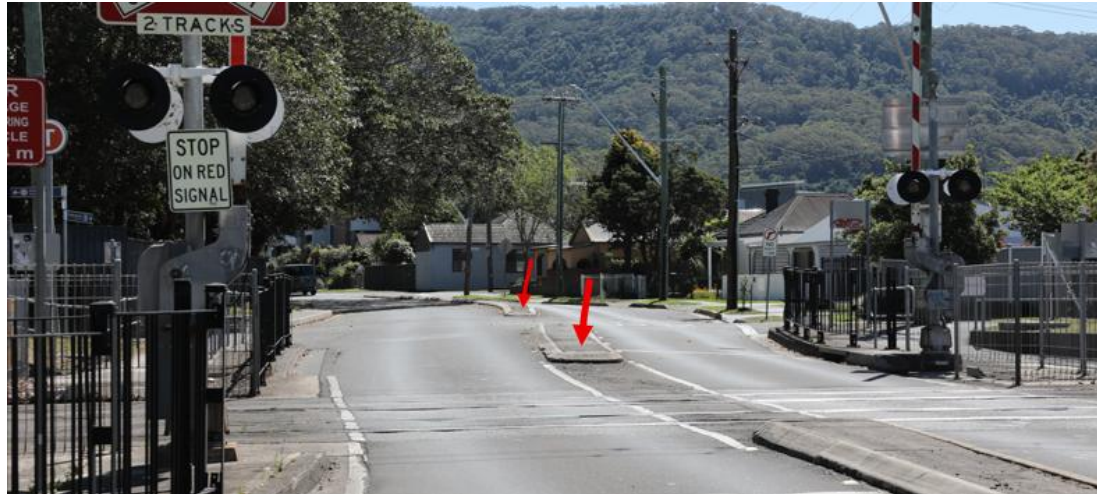
| No. | Approximate location | Description of findings | Risk rating<br>(likelihood / consequence) |
|---|---|---|---|
| 2<br>Cont'd | | <div data-bbox="611 264 1704 748"> <p><b>Photo 4.3: 'KEEP LEFT' sign is missing on the raised median on the approach to the Railway Crossing</b><br/>(Photo: Traffic Engineering Centre Pty Ltd)</p> </div> <div data-bbox="611 834 1704 1329"> <p><b>Photo 4.4: 'KEEP LEFT' sign is missing on the raised median on the approach to the Railway Crossing</b><br/>(Photo: Traffic Engineering Centre Pty Ltd)</p> </div> | |

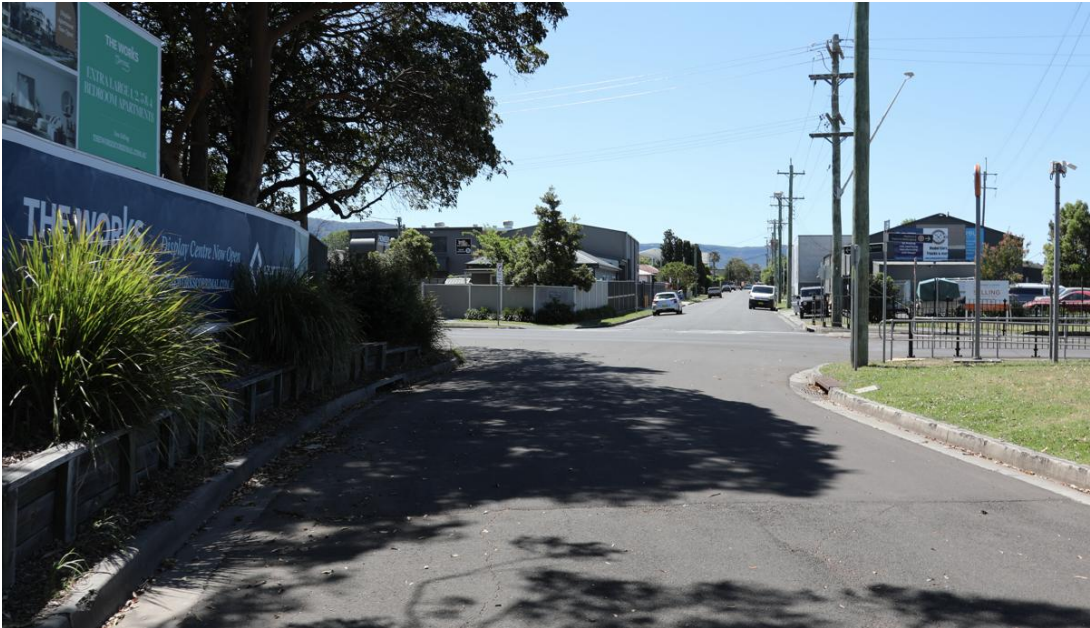
| No. | Approximate location | Description of findings | Risk rating<br>(likelihood / consequence) |
|---|---|---|---|
| 3 | Exit from the commuter car park at the intersection with Railway Street, some 20m to the west of the Railway Crossing | <p>The 'Give Way' (R1-2) sign and associated holding line are missing at the exit from the commuter car park onto Railway Street, approximately 20m west of the Railway Crossing (refer to Photo 4.7). In the absence of these regulatory controls, motorists exiting the car park may be unaware of the appropriate stopping point and their obligation to give way to through traffic on Railway Street.</p> <p><b>Photo 4.7: Exit from the car commuter park located off Railway Street, to the west of the Railway Crossing</b><br/>(Photo: Traffic Engineering Centre Pty Ltd)</p> <p>Furthermore, the intersection with Railway Street may not be clearly detectable to drivers on the final approach from within the car park. Due to its more prominent visual alignment, the driver's attention may be inadvertently drawn toward Ruddock Street, located beyond the intersection (refer to Photo 4.7). This could result in delayed decision-making or incorrect positioning, increasing the risk of conflict with vehicles on Railway Street.</p> | <p><b>Low</b><br/>(Low / Medium)</p> |

| No. | Approximate location | Description of findings | Risk rating (likelihood / consequence) |
|---|---|---|---|
| 3<br>Cont'd | | <p>This phenomenon is consistent with the 'see-through' effect commonly observed on minor roads.</p> <p>The Austroads Guide to Traffic Engineering Practice Series, Part 4: Treatment of Crash Locations, identifies the 'see-through' effect and the lack of evident intersection presence (at certain times of day) as the third and fifth most common contributing factors to right-angle collisions.</p> <p>As a result, some drivers may position their vehicles too far forward, with the front-end protruding into the traffic stream on Railway Street, significantly increasing the likelihood of severe crossing or turning collisions at this location.</p> <p><b>Recommended mitigation measure:</b> Install the 'Give Way' (R1-2) sign and paint the 'Give Way' line on the exit from the car park at the intersection with Railway Street.</p> | |

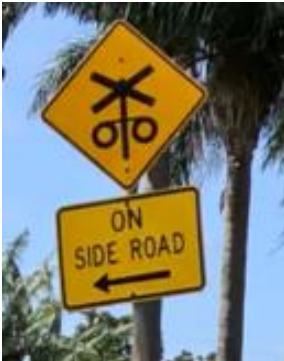
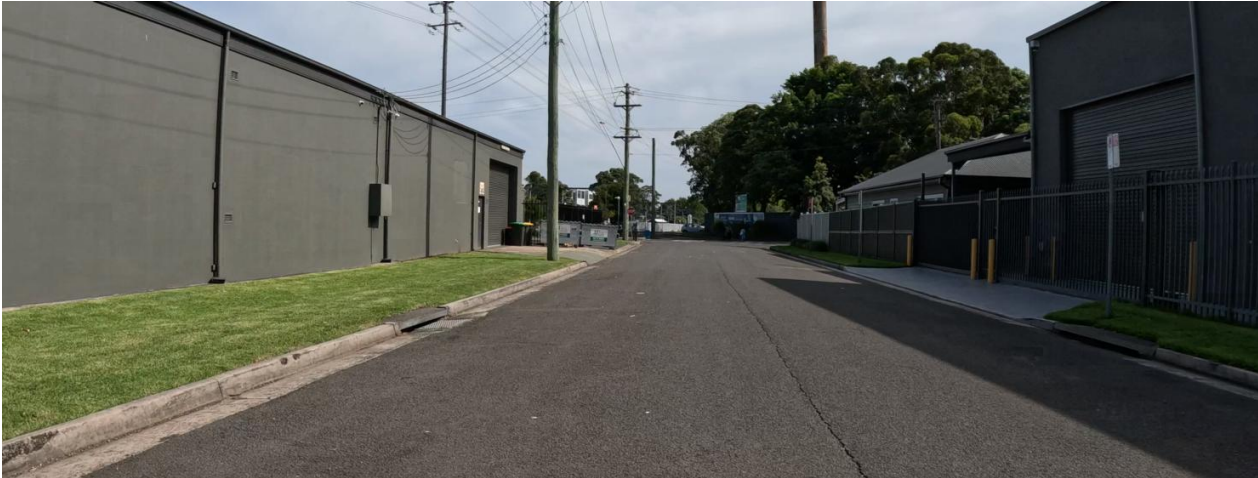
| No. | Approximate location | Description of findings | Risk rating (likelihood / consequence) |
|---|---|---|---|
| 4 | Ruddock Street; the access road to the commuter car park; & High Street, on their respective final approach to the intersection with Railway Street | <p>The 'Railway crossing flashing signal ahead on side road' (RX-7) assembly (comprising W7-4 sign and W8-3(L) or (R) supplementary sign - refer to Photo 4.8) is missing on: 1.Ruddock Street; 2. access to the railway station, and 3.High Street (refer to photos 4.9 to 4.11).</p> <p><b>Photo 4.8: 'Railway crossing flashing signal ahead on side road' (RX-7) assembly</b><br/>(Photo: Traffic Engineering Centre Pty Ltd)</p> <p><b>Photo 4.9: Ruddock Street on approach to the intersection with Railway Street, to the west of the Railway Crossing</b><br/>(Photo: Traffic Engineering Centre Pty Ltd)</p> | <p><b>Negligible</b><br/>(Negligible / Medium)</p> |

| No. | Approximate location | Description of findings | Risk rating<br>(likelihood / consequence) |
|---|---|---|---|
| 4<br>Cont'd | | <p>Without the RX-7 assembly in place, there is nothing to give advance warning on a through road of a crossing which is controlled by flashing signals and located on the side road (Railway Street) too close to the intersection to provide the appropriate distance required for the erection of the W7-4 sign on the side road.</p> <p>Consequently, this increases the chance of an incident occurring on Railway Street.</p> <p><b>Figure 4.1</b><br/>(Source: AS1742.7:2016)</p> <p><b>Recommended mitigation measure:</b> Install the 'Railway crossing flashing signal ahead on side road' (RX-7) assembly on 1. Ruddock Street, 2. the access road to the commuter car park; and 3. High Street on their respective final approach to the intersection with Railway Street.</p> | |

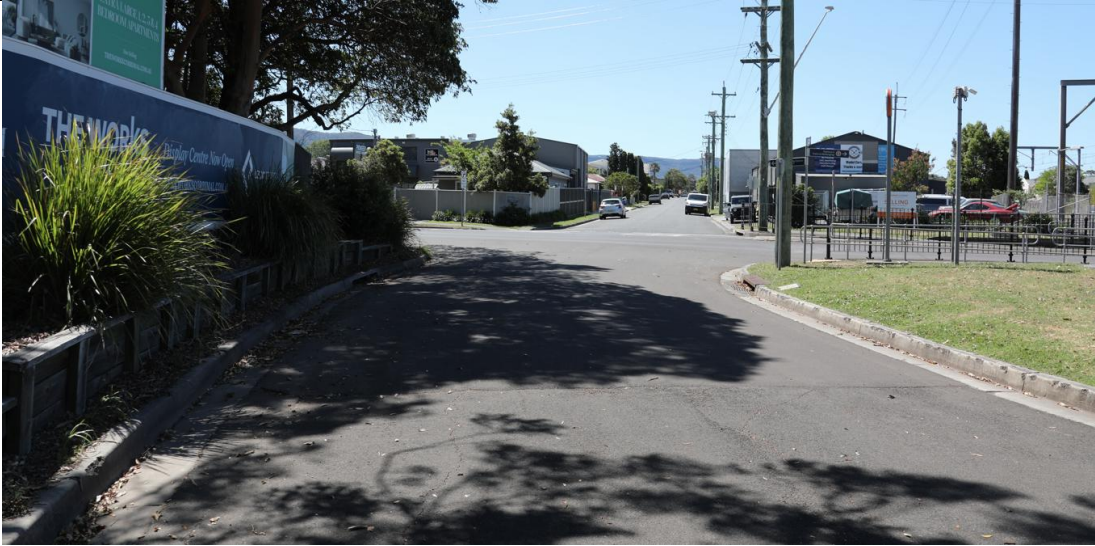
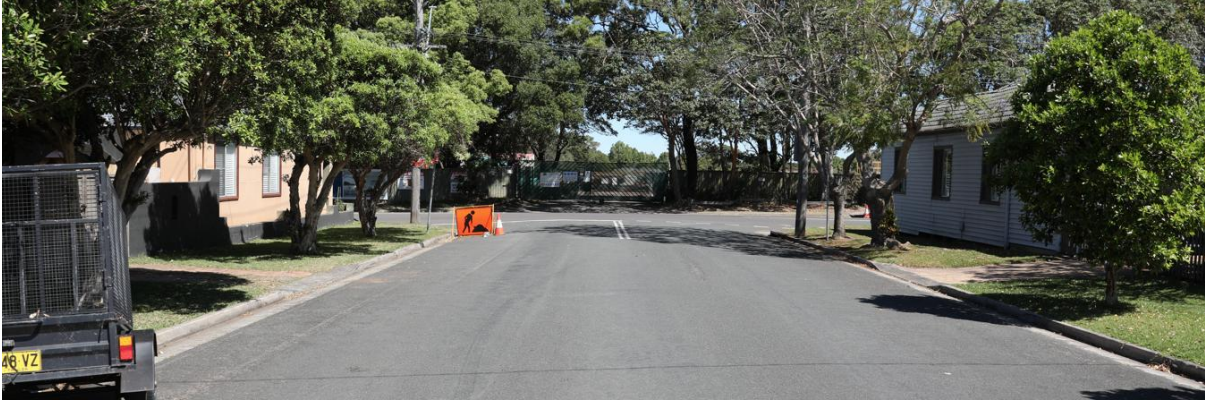
| No. | Approximate location | Description of findings | Risk rating (likelihood / consequence) |
|---|---|---|---|
| 4<br>Cont'd | | <p><b>Photo 4.10: Access road to the commuter car park on approach to the intersection with Railway Street, to the west of the Railway Crossing</b><br/>(Photo: Traffic Engineering Centre Pty Ltd)</p> <p><b>Photo 4.11: High Street on approach to the intersection with Railway Street, to the west of the Railway Crossing</b><br/>(Photo: Traffic Engineering Centre Pty Ltd)</p> | |

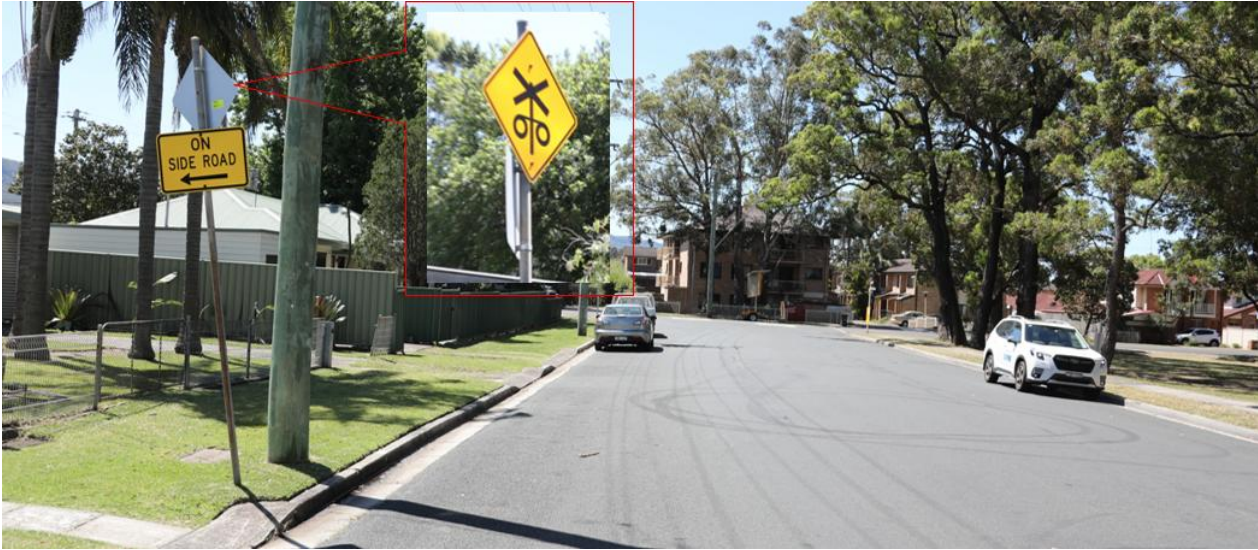
| No. | Approximate location | Description of findings | Risk rating<br>(likelihood / consequence) |
|---|---|---|---|
| 5 | Duff Parade | <p>The 'W7-4' sign within the 'Railway Crossing Flashing Signal Ahead on Side Road' (RX-7) assembly (comprising the W7-4 sign and W8-3(L) supplementary sign), is incorrectly oriented. It is currently facing drivers travelling away from the Railway Crossing, rather than toward it as intended (refer to Photo 4.12).</p> <p><b>Photo 4.12: Duff Parade looking toward the intersection with Railway Street</b><br/>(Photo: Traffic Engineering Centre Pty Ltd)</p> <p>This misalignment compromises the effectiveness of the warning assembly, as it fails to alert approaching drivers to the presence of the railway crossing and its associated flashing signals. Correct orientation is critical to ensure advanced driver awareness, particularly in environments where sight distance or approach geometry may limit early detection of the crossing.</p> <p><b>Recommended mitigation measure:</b> Reorient the 'W7-4' sign within the 'Railway Crossing Flashing Signal Ahead on Side Road' (RX-7) assembly to face approaching traffic, ensuring it provides appropriate advance warning to drivers travelling toward the Railway Crossing.</p> | <p><b>Negligible</b><br/>(Negligible / Medium)</p> |
