**Hazardous Building Materials (HAZMAT)
Report**

**UNSW Barker Street On-Campus Student
Accommodation**

39 Barker Street, Kensington NSW

**Project 227492.10
2 December 2025
Revision 2**

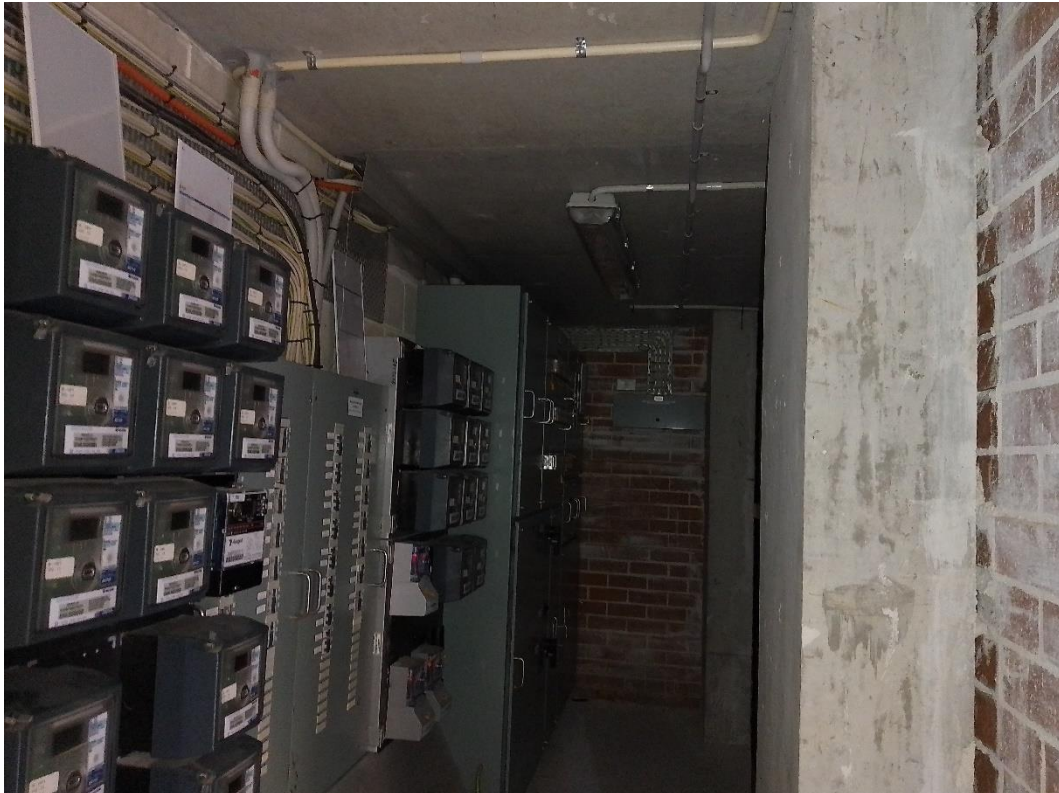
Photo 1: East wing, Main switch board room.

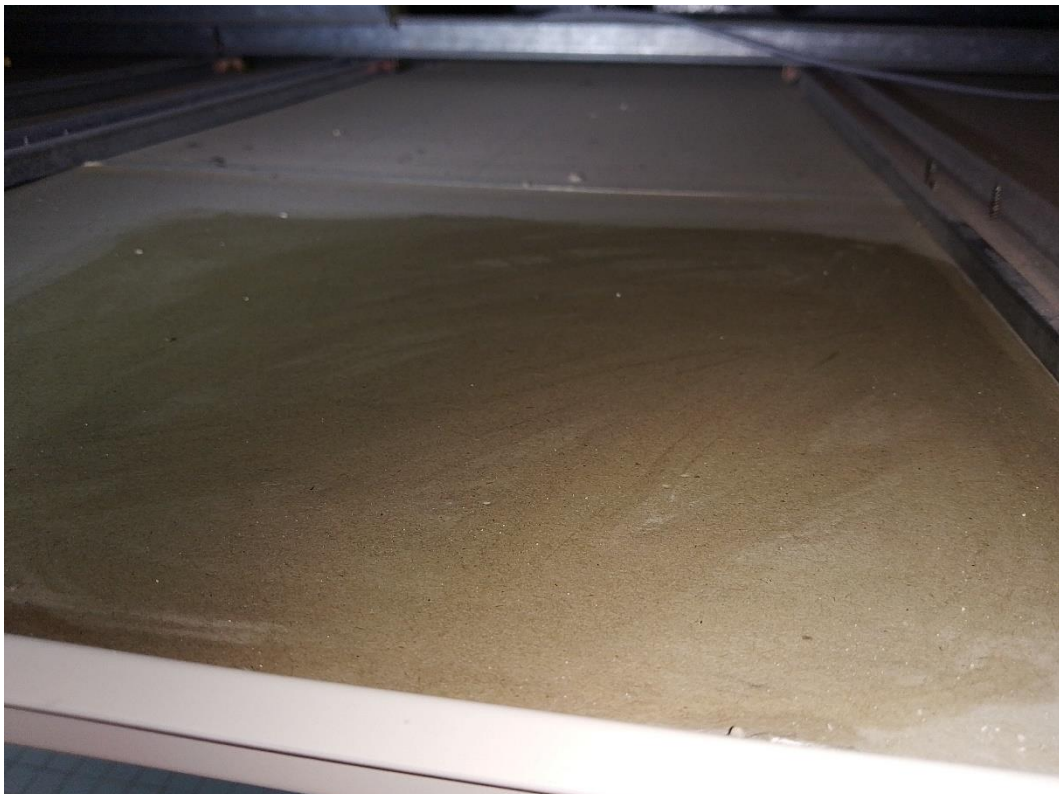
Photo 2: East wing, garbage room, above false ceiling, dust, lead detected.

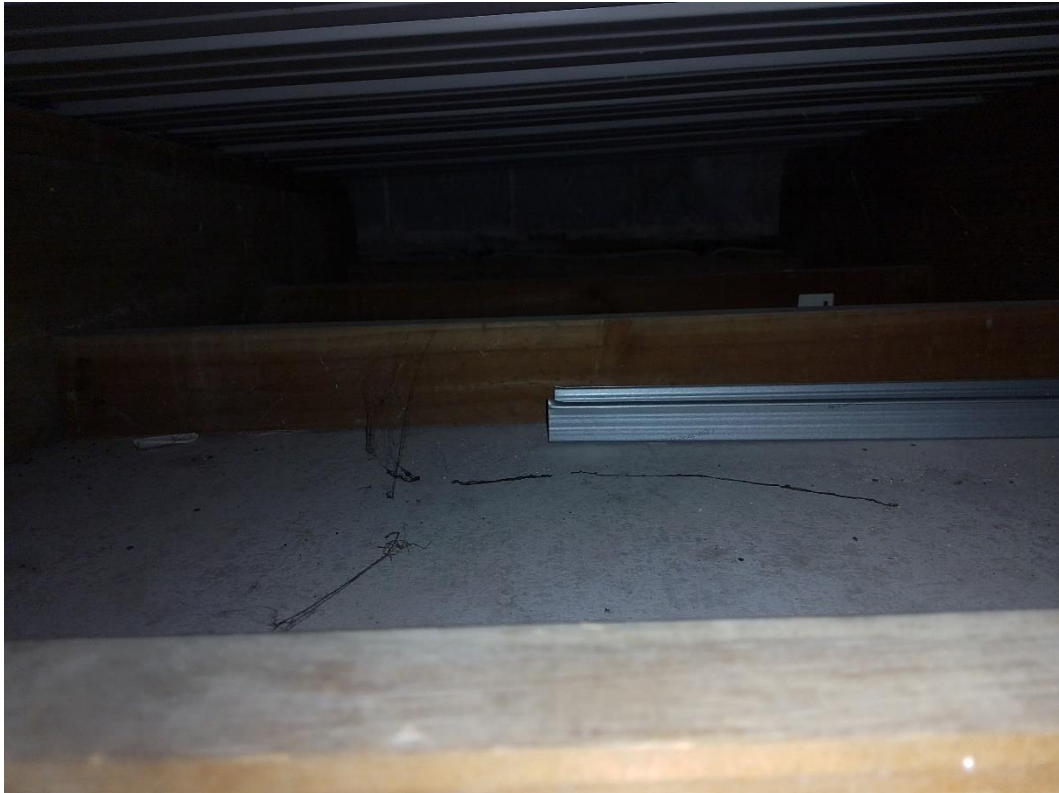
Building	Room / Area	Material Location	Material Type	Sample No.	Result (mg/m ²)	Material Status	Photo No.	Summary Comment/Recommendation
West wing	Central laundry	Above false ceiling	settled dust /debris	LD5	0.6	lead detected	3	<p>Ensure access to building cavity(s) is adequately restricted and entry is only made under controlled conditions.</p> <p>Remove lead contamination if reasonably practicable to do so and prior to any substantive disturbance.</p> <p>Implement appropriate controls to prevent exposure and dispersal including during building work (e.g. maintenance, refurbishment and demolition).</p>
West wing	West laundry	Above false ceiling	settled dust /debris	LD6	0.5	lead detected	N/A	<p>Ensure access to building cavity(s) is adequately restricted and entry is only made under controlled conditions.</p> <p>Remove lead contamination if reasonably practicable to do so and prior to any substantive disturbance.</p> <p>Implement appropriate controls to prevent exposure and dispersal including during building work (e.g. maintenance, refurbishment and demolition).</p>

Photo 3: West wing, central laundry, above false ceiling, dust, lead detected.

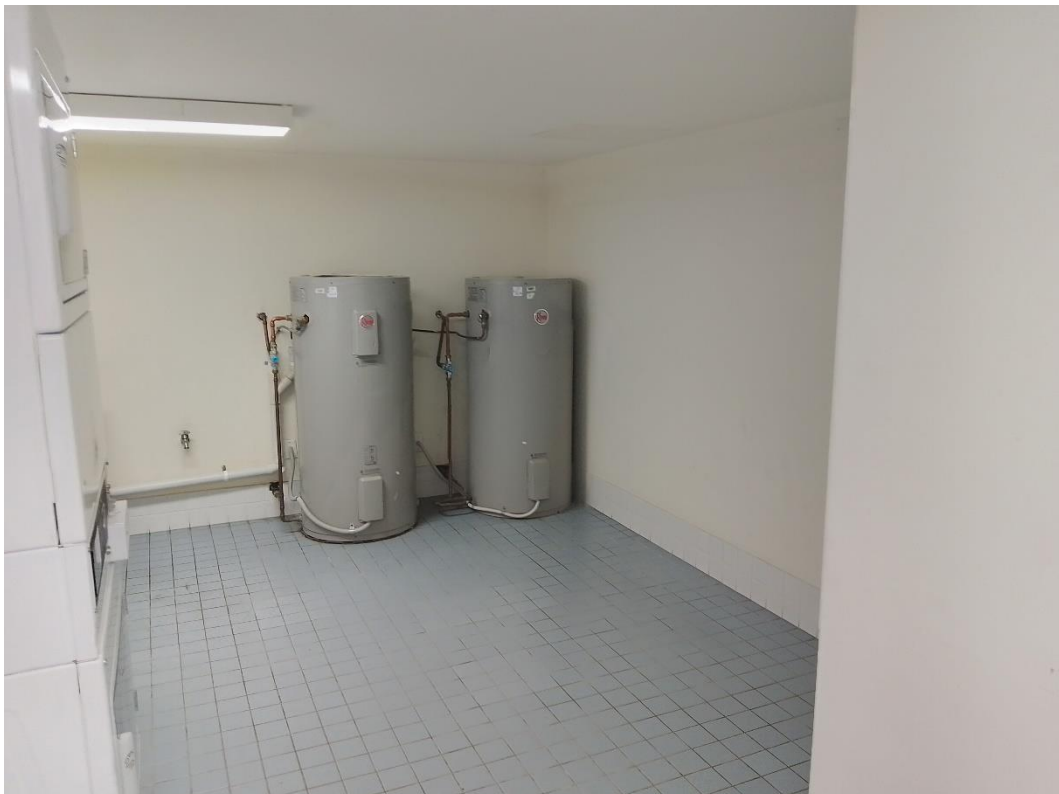
Building	Room / Area	Material Location	Material Type	Sample No.	Material Status	Photo No.	Summary Comment/Recommendation
East wing	Common laundry 1	Hot water units	Internal insulation	N/A	SMF (suspected)	4	<p>SMF suspected. Conduct further investigation(s) as required to confirm the status of the material prior to any disturbance.</p> <p>Classify material for disposal in accordance with the NSW EPA Waste Classification Guidelines and segregate material, if required, for disposal.</p> <p>Minimise disturbance and implement controls to prevent exposure and dispersal during any abatement activity and any building work (e.g. maintenance, refurbishment and demolition).</p>

Photo 4: East wing, Common laundry 1, hot water units, internal insulation, SMF (suspected).

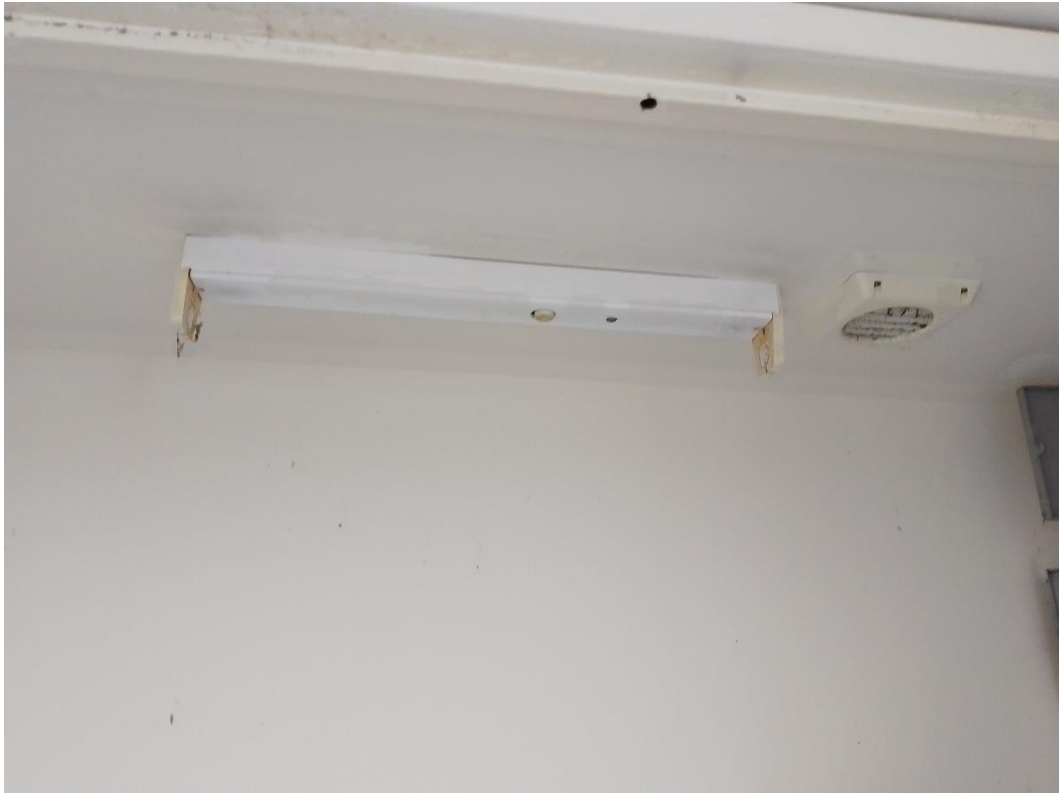
Building	Room / Area	Material Location	Material Type	Sample No.	Material Status	Photo No.	Summary Comment/Recommendation
East wing	Garbage room	Ceiling	Fluorescent lighting fixtures, internal components	N/A	nil PCB (suspected)	5	Nil PCB suspected since historical imagery available on the NSW Spatial Services website indicates these buildings were constructed circa 1996-1998. Consider confirming presence/absence of PCB by further inspection and/or sampling and analysis when safe access is available and prior to any disturbance.
East wing	internal / external	ceiling	Fluorescent lighting fixtures, internal components	N/A	nil PCB (suspected)	N/A	Nil PCB suspected since historical imagery available on the NSW Spatial Services website indicates these buildings were constructed circa 1996-1998. Consider confirming presence/absence of PCB by further inspection and/or sampling and analysis when safe access is available and prior to any disturbance.

Photo 5: East wing, Garbage room, ceiling, fluorescent lighting fixtures, nil PCB (suspected).
