**SY214006**

# **Post–Construction Dilapidation Report**

**Council Assets**

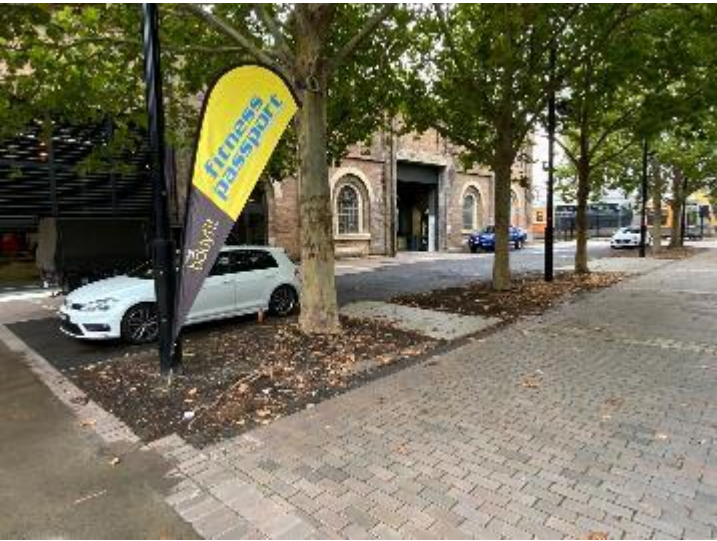
| | <p><b>Photograph 1.EW.5 - Rev.B</b></p> <p><u>East Walkway</u><br/><u>General Photograph</u></p> <p>General photograph of the new bitumen patching at the north half of the east walkway.</p> <p>Photographed looking north-west.</p> |

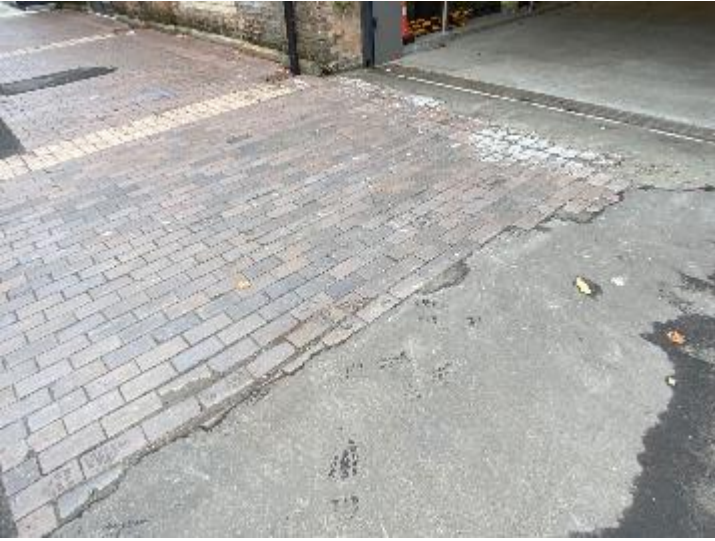
| | <p><b>Photograph 2.EW.8</b></p> <p><u>East Walkway</u><br/><u>Minor</u></p> <p>Movement of the pavers with chipped and missing pavers evident in front of the loading bay door at the north end of workshop 1.</p> <p>Photographed looking south-west.</p> |

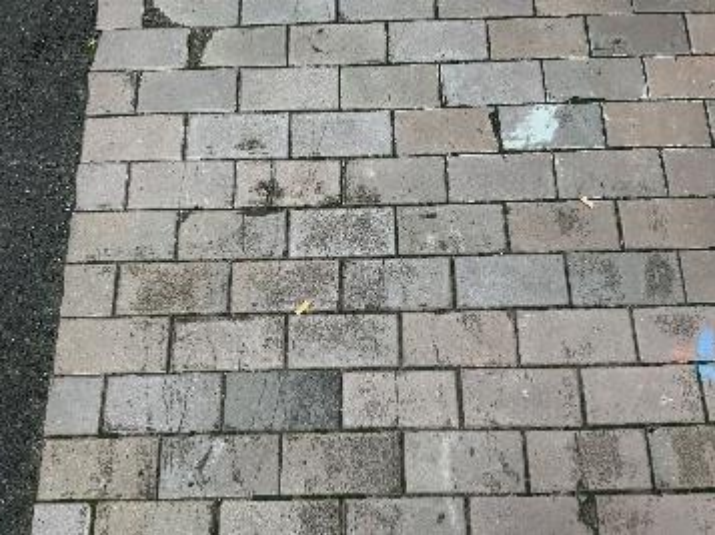
| | <p><b>Photograph 2.EW.9</b></p> <p><u>East Walkway</u><br/><u>Minor</u></p> <p>Various cracks approximately max. 100mm long x max. 0.5mm wide located in the pavers at the south end of the loading bay door, typical in the pavers.</p> <p>Photographed looking south.</p> |

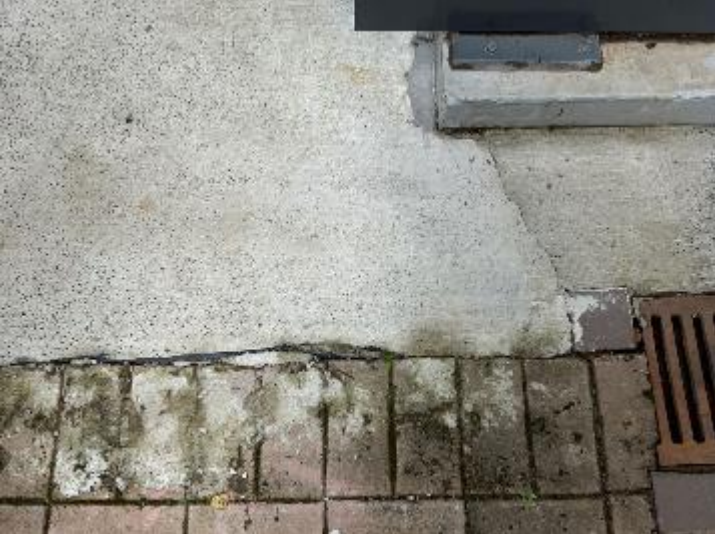
| | <p><b>Photograph 2.EW.10</b></p> <p><u>East Walkway</u><br/><u>Minor</u></p> <p>Crack approximately 300mm long x 0.6mm wide running in the north-south direction in the concrete located south of the north door, chipping evident.</p> <p>Photographed looking south.</p> |

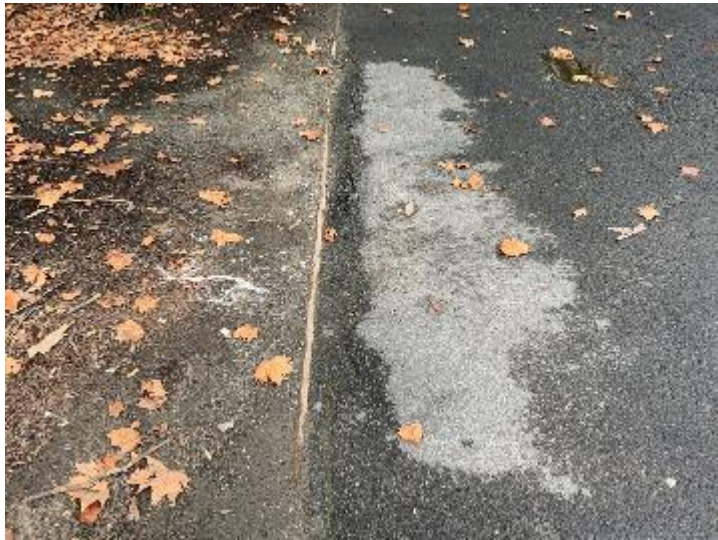
| | <p><b>Photograph 2.EW.11</b></p> <p><u>East Walkway</u><br/><u>Minor</u></p> <p>Various cracks approximately max. 3500mm long x max. 10mm wide located at the east end of the bitumen opposite the third north window.</p> <p>Photographed looking south.</p> |

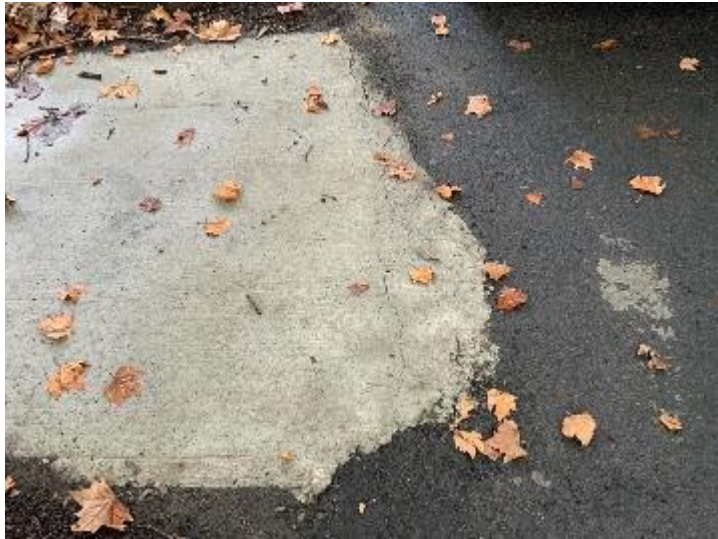
| | <p><b>Photograph 2.EW.12</b></p> <p><u>East Walkway</u><br/><u>Minor</u></p> <p>Various cracks approximately max. 1600mm long x max. 1.3mm wide located in the concrete at the trees near the north door.</p> <p>Photographed looking south.</p> |

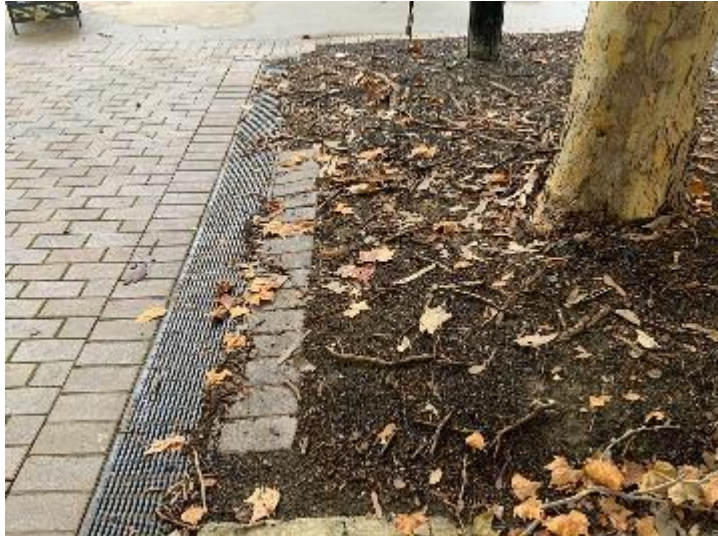
| | <p><b>Photograph 2.EW.13</b></p> <p><u>East Walkway</u><br/><u>Minor</u></p> <p>Upheaval of the pavers and missing pavers evident at the south-east corner of the trees in front of the north door.</p> <p>Photographed looking south.</p> |

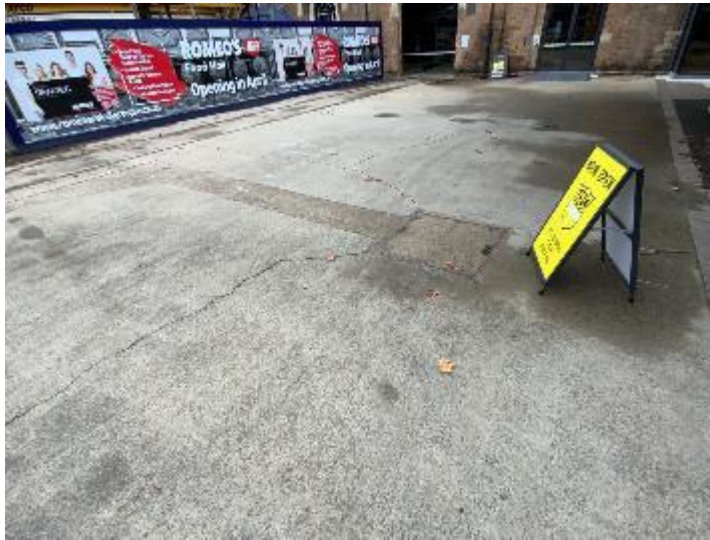
| | <p><b>Photograph 2.EW.14</b></p> <p><u>East Walkway</u><br/><u>Minor</u></p> <p>Various cracks approximately max. 5200mm long x max. 3mm wide located in the concrete outside the central doors to workshop 1, chipping of the cracks evident.</p> <p>Photographed looking south-west.</p> |

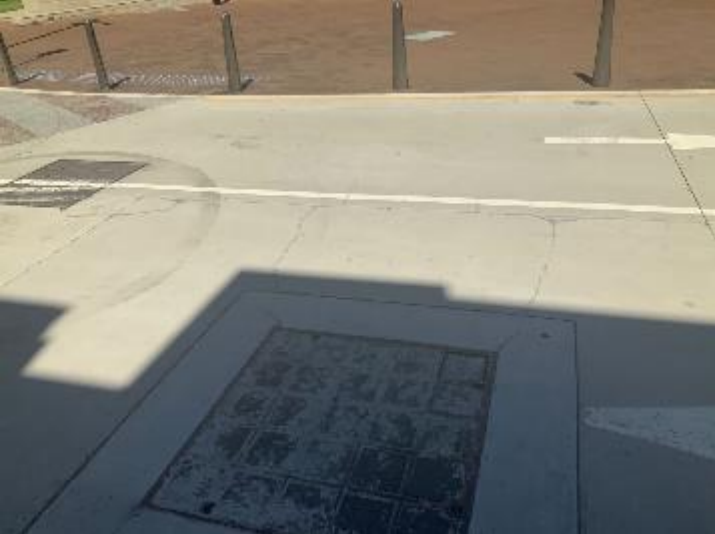
| | <p><b>Photograph 2.L.82</b></p> <p><u>Locomotive Street - Outside Workshop 1</u><br/><u>Minor</u></p> <p>Various cracks approximately max. 2000mm long x max. 2mm wide located in the road in front of bay 1 near the central service pit, typical.</p> <p>Photographed looking south.</p> |

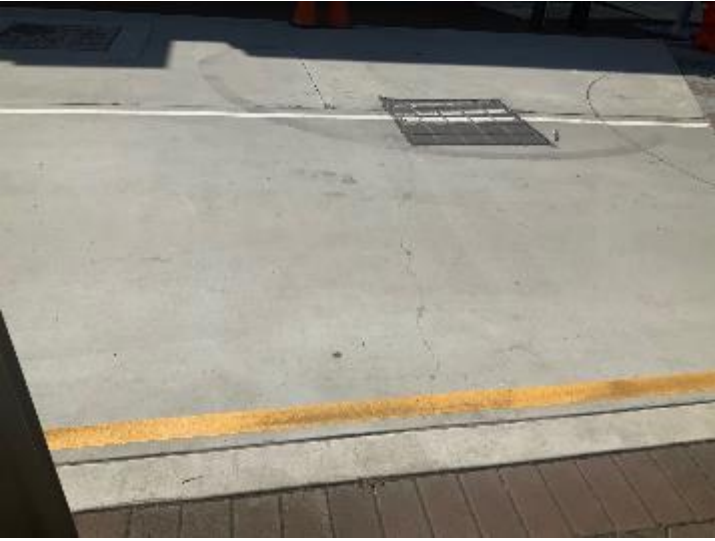
| | <p><b>Photograph 2.L.83</b></p> <p><u>Locomotive Street - Outside Workshop 1</u><br/><u>Minor</u></p> <p>Various cracks approximately max. 2000mm long x max. 2mm wide located in the road near the east service pit.</p> <p>Photographed looking south.</p> |

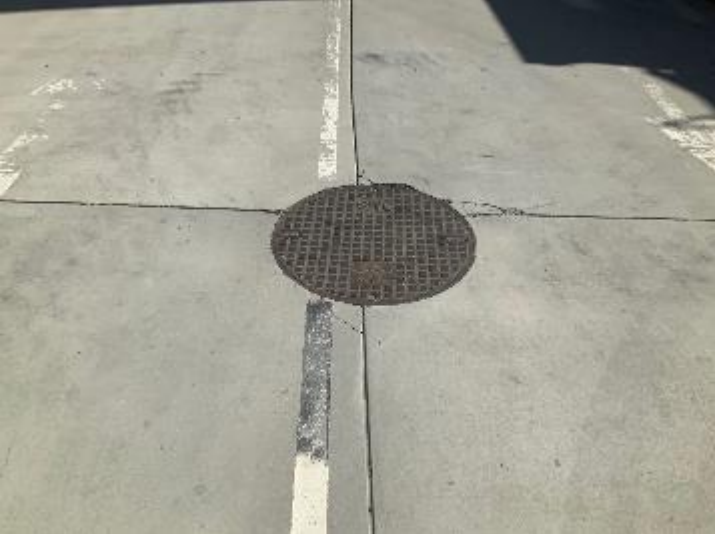
| | <p><b>Photograph 1.L.75 - Rev.B</b></p> <p><u>Locomotive Street - Outside Workshop 2</u><br/><u>Minor</u></p> <p>General photograph of the service pit located in front of workshop 2, various chips and cracks located around the perimeter of the pit.</p> <p>Photographed looking west.</p> |

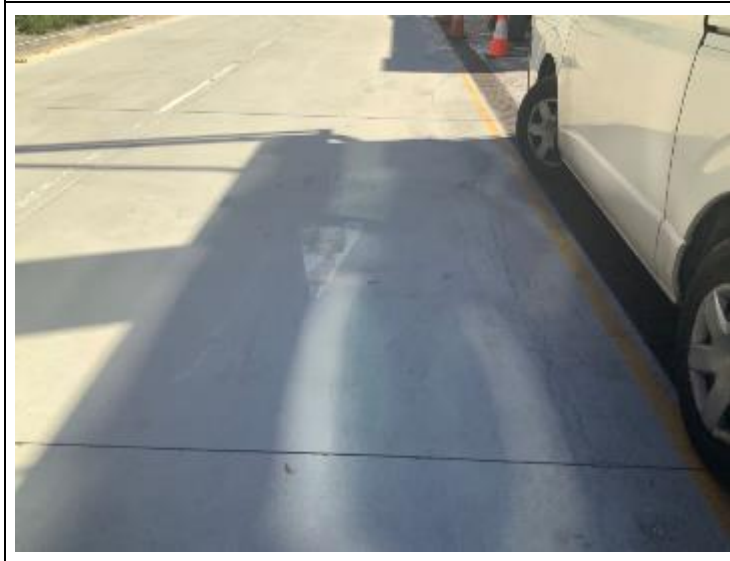
| | <p><b>Photograph 2.L.85</b></p> <p><u>Locomotive Street - Outside Workshop 2</u><br/><u>Minor</u></p> <p>Various cracks approximately max. 2000mm long x max. 1mm wide located in the north lane in front of workshop 2.</p> <p>Photographed looking west.</p> |

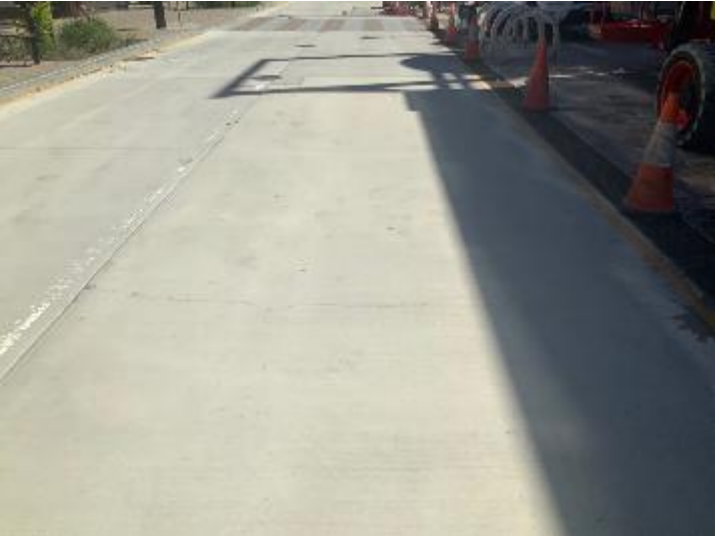
| | <p><b>Photograph 2.L.86</b></p> <p><u>Locomotive Street - Outside Workshop 3</u><br/><u>Minor</u></p> <p>Horizontal crack approximately 2500mm long x 1mm wide located in the north lane of the road.</p> <p>Photographed looking west.</p> |

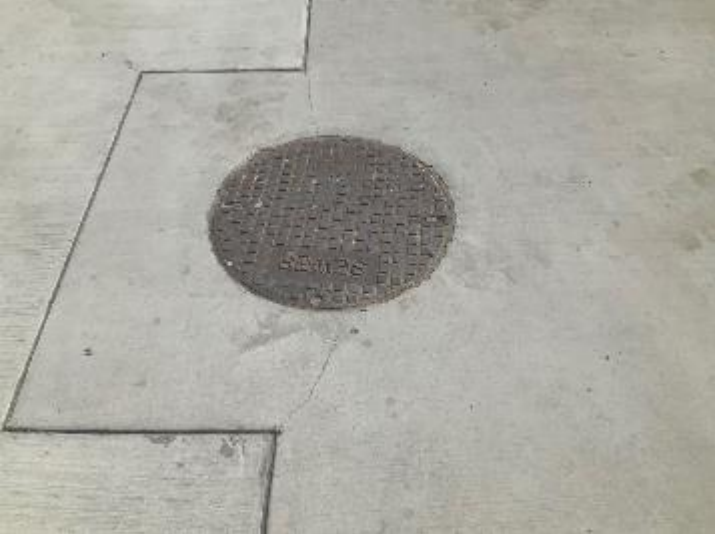
| | <p><b>Photograph 2.L.88</b></p> <p><u>Locomotive Street - Outside Workshop 4A<br/>(Formerly Workshop 5)</u><br/><u>Minor</u></p> <p>Various horizontal cracks approximately max. 500mm long x max. 1mm wide located near the sewer pit in the road.</p> <p>Photographed looking west.</p> |

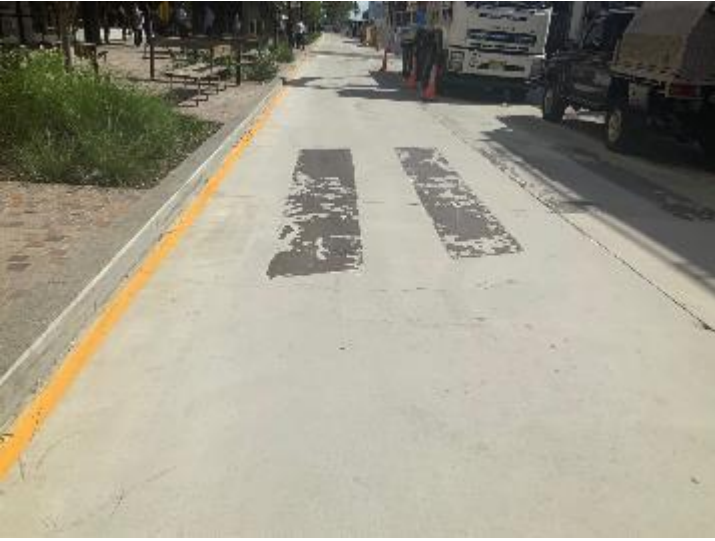
| | <p><b>Photograph 2.L.90</b></p> <p><u>Locomotive Street - Outside Workshop 5 (Formerly Workshop 6)</u></p> <p><u>Minor</u></p> <p>Various cracks approximately max. 2500mm long x max. 1mm wide located in the road near the south lane outside workshop 5.</p> <p>Photographed looking west.</p> |

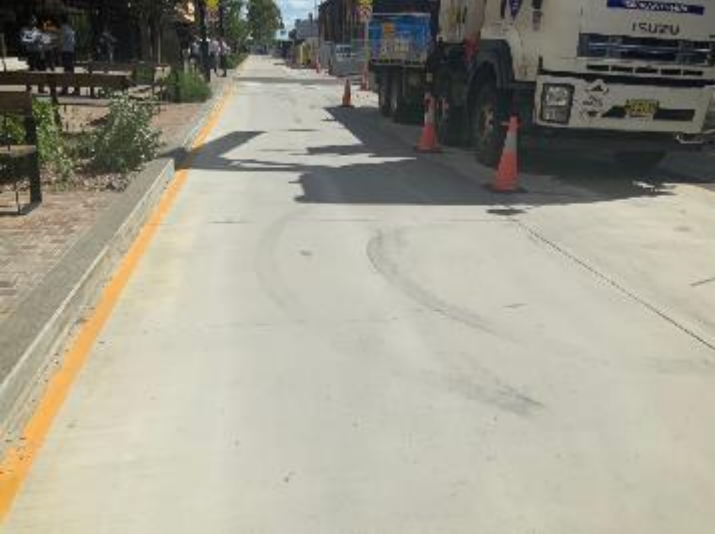
| | <p><b>Photograph 2.L.91</b></p> <p><u>Locomotive Street - Outside Workshop 6 (Formerly Workshop 7)</u></p> <p><u>Minor</u></p> <p>Various cracks approximately max. 2200mm long x max. 2mm wide located in the road in front of workshop 6.</p> <p>Photographed looking west.</p> |

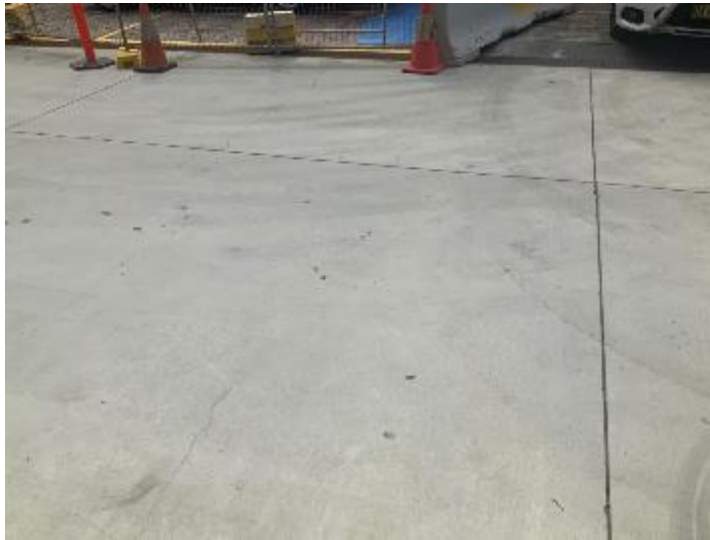
| | <p><b>Photograph 2.L.92</b></p> <p><u>Locomotive Street - Outside Workshop 8 (Formerly Workshop 9)</u></p> <p><u>Minor</u></p> <p>Various cracks approximately max. 2500mm long x max. 2mm wide located in the road, typical.</p> <p>Photographed looking north.</p> |

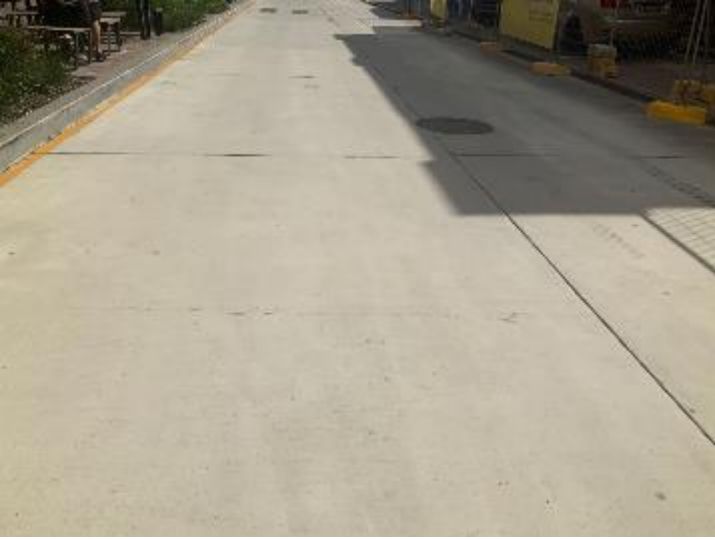
| | <p><b>Photograph 2.L.93</b></p> <p><u>Locomotive Street - Outside Workshop 9 (Formerly Workshop 10)</u><br/><u>Minor</u></p> <p>Various cracks approximately max. 2500mm long x max. 2mm wide located in the road, typical.</p> <p>Photographed looking west.</p> |

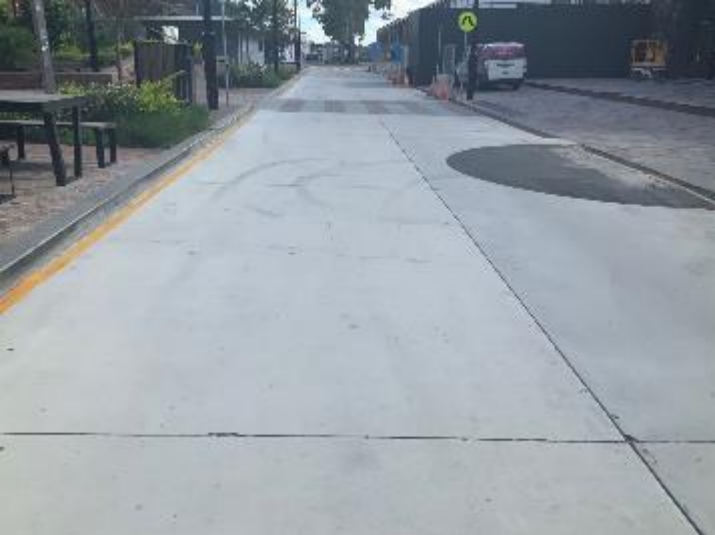
| | <p><b>Photograph 2.L.96</b></p> <p><u>Locomotive Street - Outside Workshop 12</u><br/><u>(Formerly Workshop 13)</u><br/><u>Minor</u></p> <p>Various cracks approximately max. 2500mm long x max. 2mm wide located in the road.</p> <p>Photographed looking west.</p> |

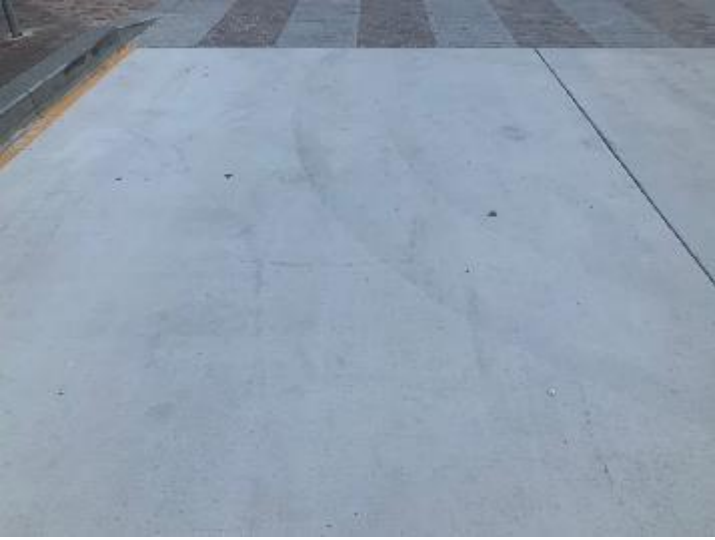
| | <p><b>Photograph 2.L.97</b></p> <p><u>Locomotive Street - Outside Workshop 13 (Formerly Workshop 14)</u><br/><u>Minor</u></p> <p>Various cracks approximately max. 1500mm long x max. 1mm wide located in the slab near the pedestrian crossing.</p> <p>Photographed looking west.</p> |

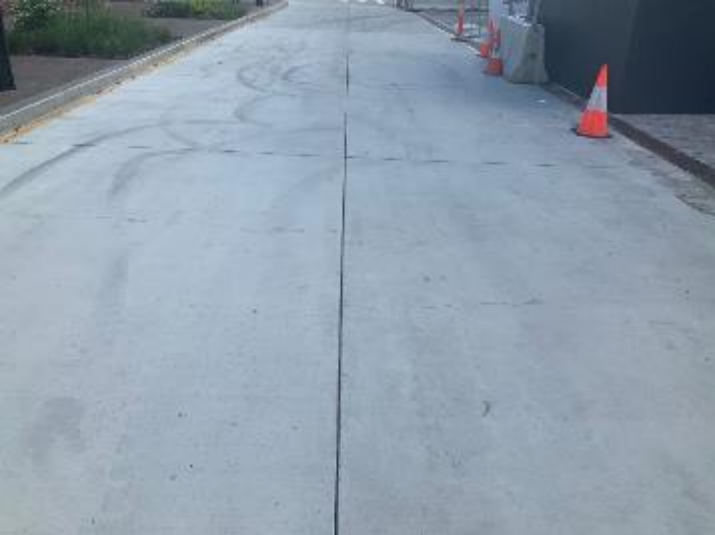
| | <p><b>Photograph 2.L.98</b></p> <p><u>Locomotive Street - Outside Workshop 14 (Formerly Workshop 15)</u><br/><u>Minor</u></p> <p>Various cracks approximately max. 3000mm long x max. 1mm wide located in the road, typical.</p> <p>Photographed looking west.</p> |

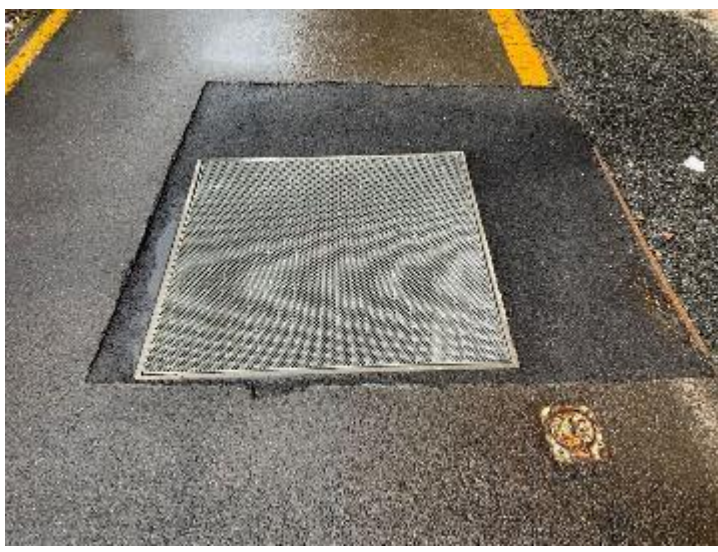
| | <p><b>Photograph 2.NW.31</b></p> <p><u>North Walkway - Workshop 15</u><br/><u>(Formerly Workshop 16)</u></p> <p><u>Minor</u></p> <p>General photograph of the new drain and bitumen patching, settlement of the new bitumen patching.</p> <p>Photographed looking east.</p> |

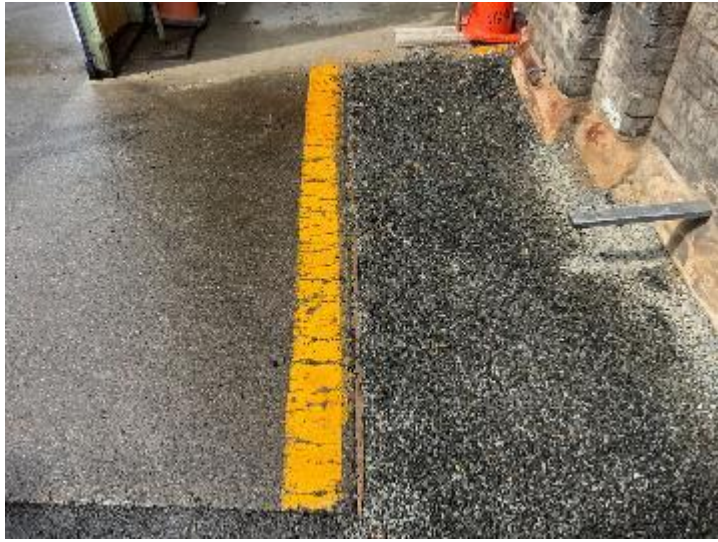
| | <p><b>Photograph 2.NW.32</b></p> <p><u>North Walkway - Workshop 15</u><br/><u>(Formerly Workshop 16)</u></p> <p><u>Minor</u></p> <p>Various cracks approximately max. 150mm long x max. 0.5mm wide located in the south side of the pathway, typical on the walkway paint lines.</p> <p>Photographed looking east.</p> |

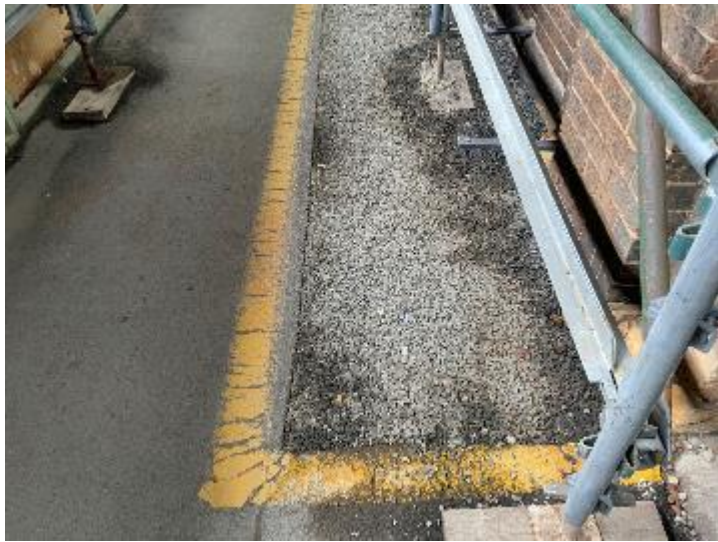
| | <p><b>Photograph 2.NW.33</b></p> <p><u>North Walkway - Workshop 14</u><br/><u>(Formerly Workshop 15)</u></p> <p><u>Minor</u></p> <p>Various cracks approximately max. 150mm long x max. 0.5mm wide located in the south side of the pathway, typical on the walkway paint lines.</p> <p>Photographed looking east.</p> |

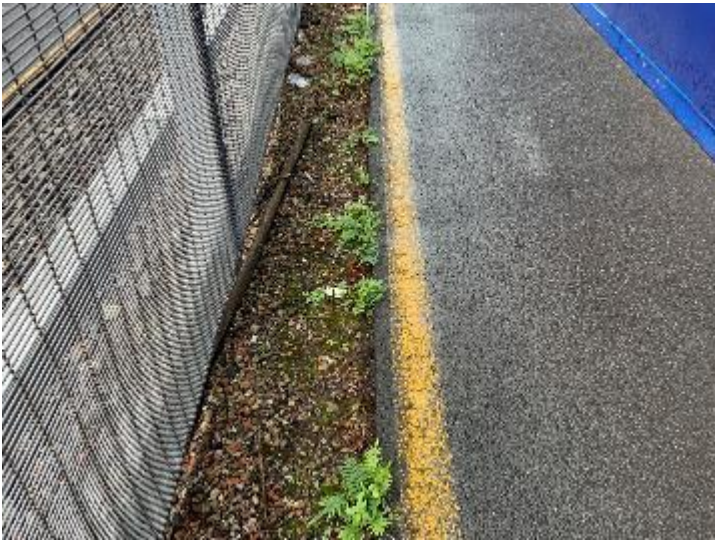
| | <p><b>Photograph 2.NW.34</b></p> <p><u>North Walkway - Workshop 14</u><br/><u>(Formerly Workshop 15)</u></p> <p><u>Minor</u></p> <p>Timber skirting has torn away from the footpath on the north side opposite the doorway.</p> <p>Photographed looking east.</p> |

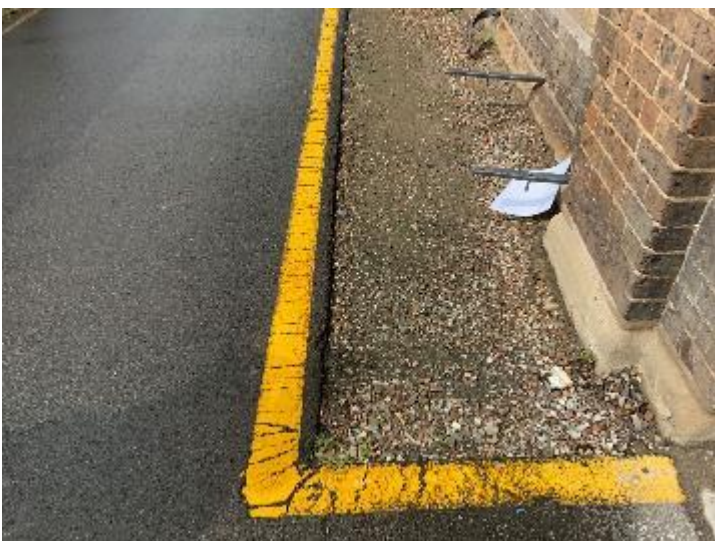
| | <p><b>Photograph 2.NW.36</b></p> <p><u>North Walkway - Workshop 11</u><br/><u>(Formerly Workshop 12)</u></p> <p><u>Minor</u></p> <p>Various cracks approximately max. 150mm long x max. 0.5mm wide located in the south side of the pathway, typical on the walkway paint lines.</p> <p>Photographed looking east.</p> |

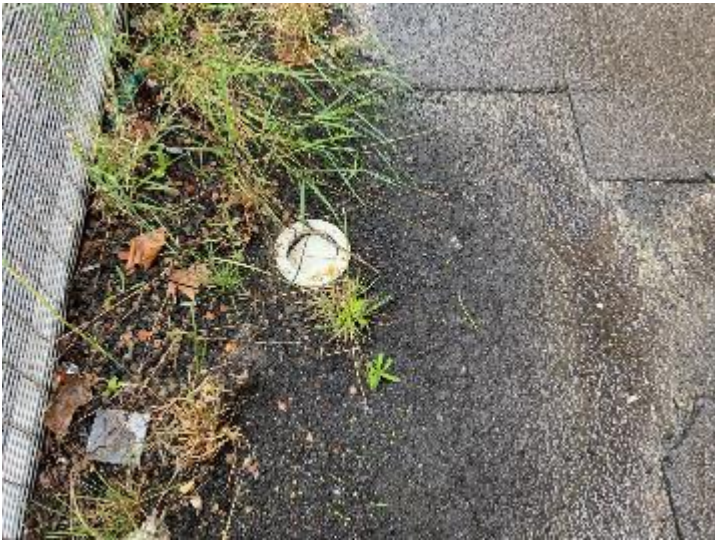
| | <p><b>Photograph 2.NW.37</b></p> <p><u>North Walkway - Workshop 8</u><br/> <u>(Formerly Workshop 9)</u><br/> <u>Minor</u></p> <p>Damaged service pit cover opposite the doorway to workshop 8.</p> <p>Photographed looking east.</p> |

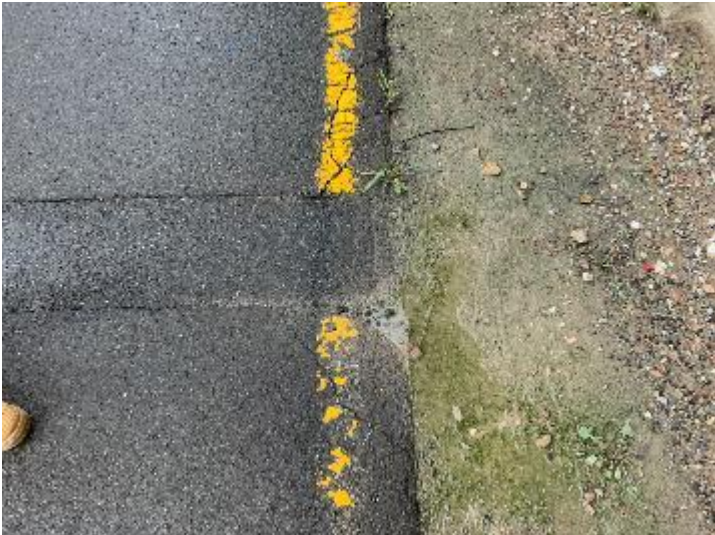
| | <p><b>Photograph 2.NW.38</b></p> <p><u>North Walkway - Workshop 8</u><br/> <u>(Formerly Workshop 9)</u><br/> <u>Minor</u></p> <p>Various cracks approximately max. 600mm long x max. 3mm wide located at the south end of the bitumen trench outside workshop 8.</p> <p>Photographed looking east.</p> |

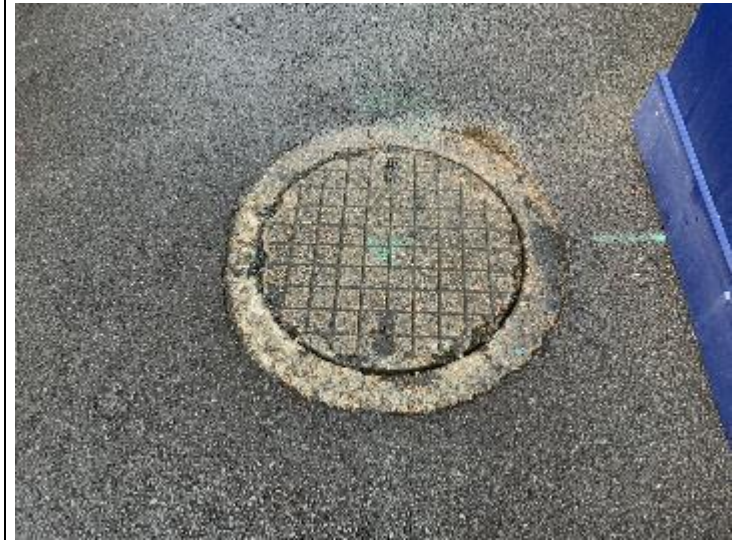
| | <p><b>Photograph 2.NW.40</b></p> <p><u>North Walkway - Workshop 7</u><br/><u>(Formerly Workshop 8)</u><br/><u>Minor</u></p> <p>Various chips around the perimeter of the pit located between workshops 6 and 7.</p> <p>Photographed looking east.</p> |

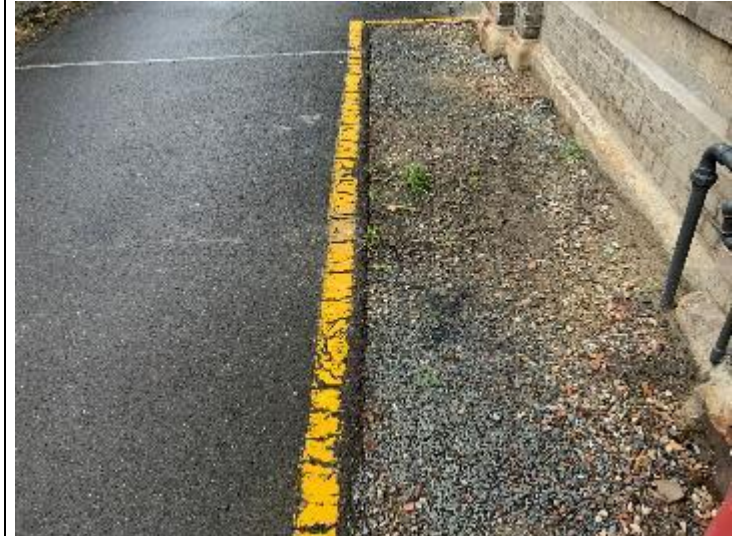
| | <p><b>Photograph 2.NW.42</b></p> <p><u>North Walkway - Workshop 6</u><br/><u>(Formerly Workshop 7)</u><br/><u>Minor</u></p> <p>Various cracks approximately max. 150mm long x max. 0.5mm wide located in the south side of the pathway, typical on the walkway paint lines.</p> <p>Photographed looking east.</p> |

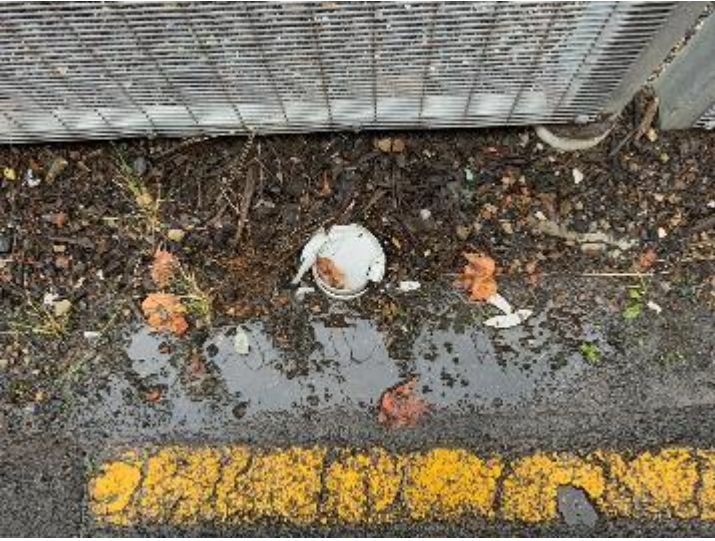
| | <p><b>Photograph 2.NW.43</b></p> <p><u>North Walkway - Workshop 6</u><br/><u>(Formerly Workshop 7)</u><br/><u>Minor</u></p> <p>Damaged service pit cover at the north-west end of workshop 6.</p> <p>Photographed looking north.</p> |

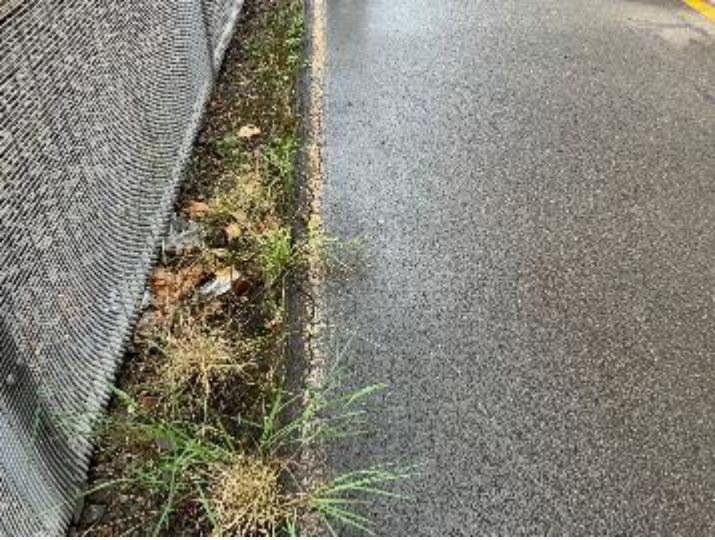
| | <p><b>Photograph 2.NW.44</b></p> <p><u>North Walkway - Workshop 8</u><br/><u>(Formerly Workshop 9)</u><br/><u>Minor</u></p> <p>Crack approximately 3200mm long x 4mm wide located in the north side of the walkway opposite the door to workshop 8.</p> <p>Photographed looking east.</p> |

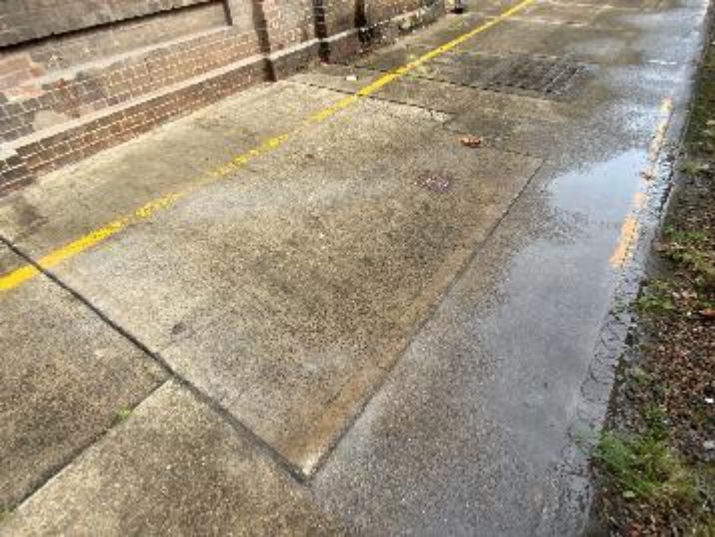
| | <p><b>Photograph 2.NW.47</b></p> <p><u>North Walkway - Workshop 4A</u><br/> <u>(Formerly Workshop 5)</u><br/> <u>Minor</u></p> <p>Various cracks in the walkway at the west section of workshop 4A.</p> <p>Photographed looking south-west.</p> |

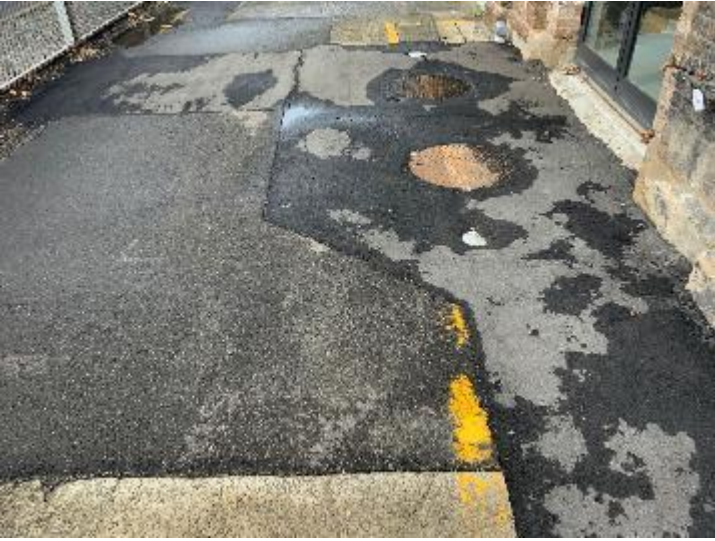
| | <p><b>Photograph 2.NW.49</b></p> <p><u>North Walkway - Workshop 4</u><br/><u>Minor</u></p> <p>General photograph of the bitumen patch outside the west door of workshop 4, uneven surface evident.</p> <p>Photographed looking east.</p> |

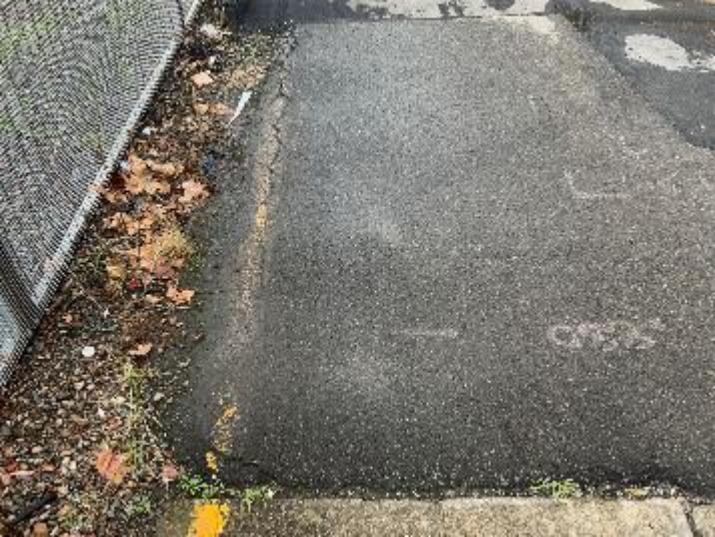
| | <p><b>Photograph 2.NW.50</b></p> <p><u>North Walkway - Workshop 4</u><br/><u>Minor</u></p> <p>Various cracks approximately max. 2500mm long x max. 10mm wide located at the north end of the walkway opposite the west door of workshop 4.</p> <p>Photographed looking east.</p> |

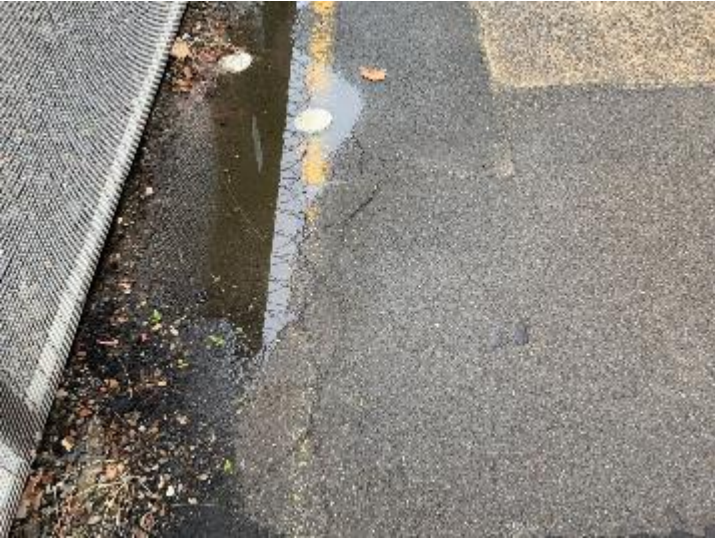
| | <p><b>Photograph 2.NW.52</b></p> <p><u>North Walkway - Workshop 4</u><br/><u>Minor</u></p> <p>Various cracks approximately max. 1400mm long x max. 7mm wide located at the north side of the walkway opposite the east door for workshop 4.</p> <p>Photographed looking east.</p> |

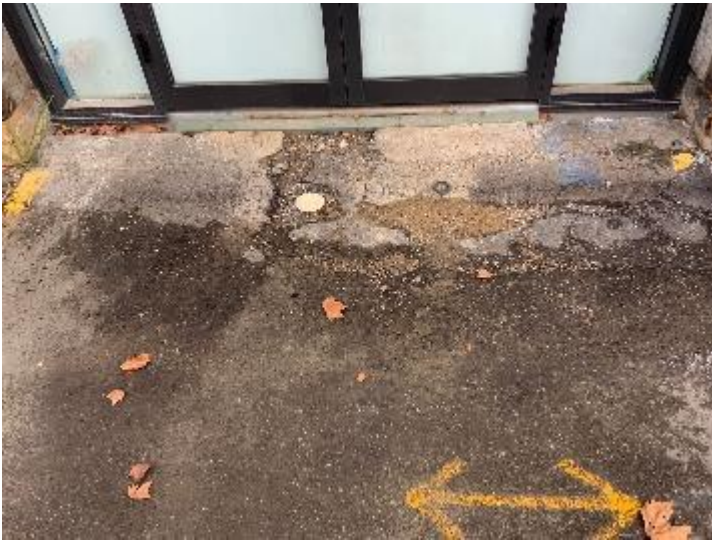
| | <p><b>Photograph 2.NW.55</b></p> <p><u>North Walkway - Workshop 1</u><br/><u>Minor</u></p> <p>Chipping and spalling of the walkway in front of the doorway to workshop 1.</p> <p>Photographed looking south.</p> |

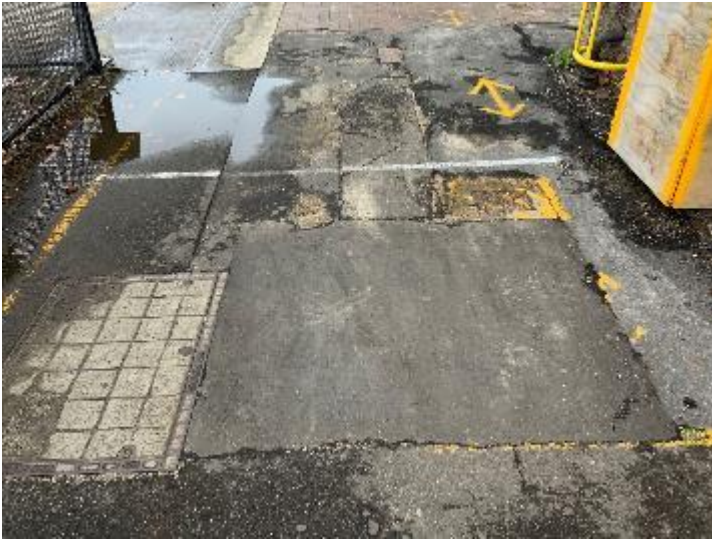
| | <p><b>Photograph 2.NW.56</b></p> <p><u>North Walkway - Workshop 1</u><br/><u>Minor</u></p> <p>General photograph of the bitumen patching at the east end of workshop 1, uneven surface evident.</p> <p>Photographed looking east.</p> |

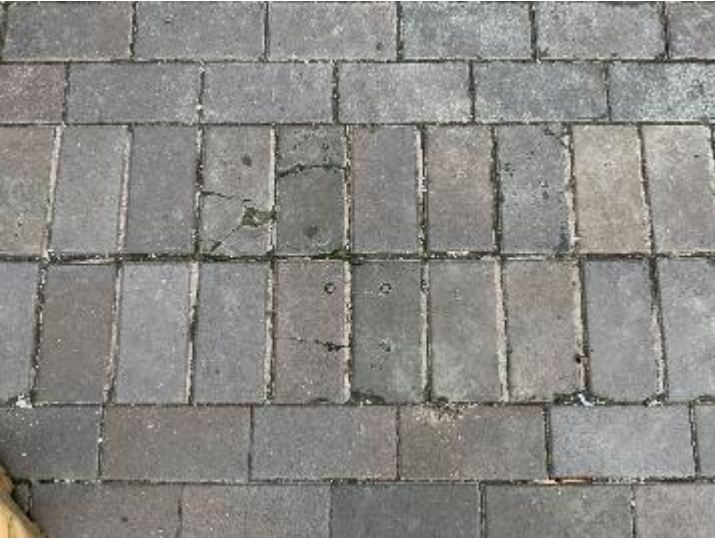
| | <p><b>Photograph 2.NW.58</b></p> <p><u>North Walkway - Workshop 1</u><br/><u>Minor</u></p> <p>Various cracks approximately max. 100mm long x max. 0.7mm wide located in the pavers near the north-east corner of workshop 1 with chipping at the cracks, typical in the pavers.</p> <p>Photographed looking south.</p> |

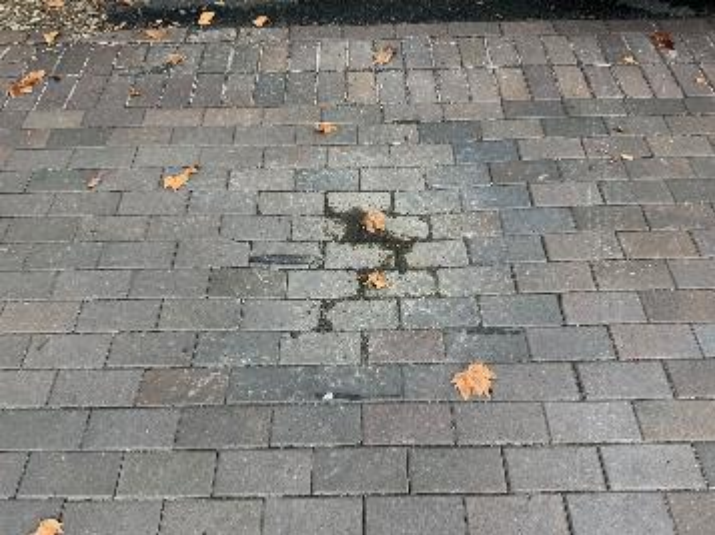
| | <p><b>Photograph 2.NW.59</b></p> <p><u>North Walkway - Workshop 1</u><br/><u>Minor</u></p> <p>Settlement of the pavers between the light pole and workshop 1.</p> <p>Photographed looking south.</p> |
