**SY214006**

# **Post–Construction Dilapidation Report**

**Council Assets**

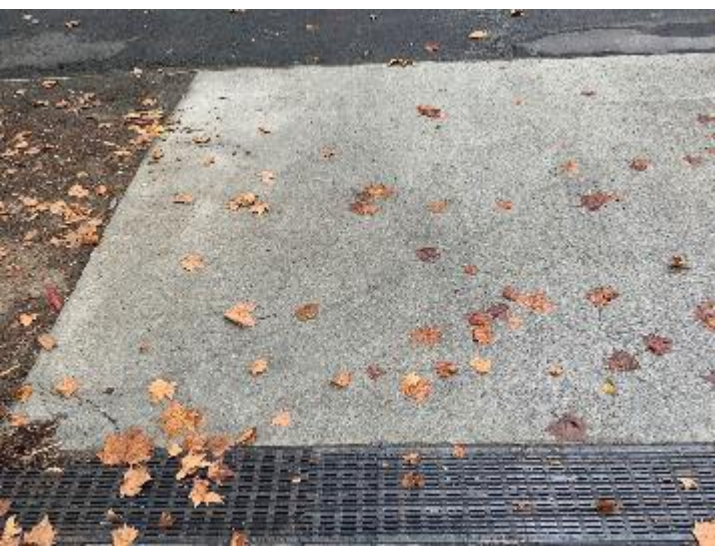
<p><b>Photograph 2.EW.6</b></p> <p><u>East Walkway</u> <u>Minor</u></p> <p>Various cracks approximately max. 3000mm long x max. 1.2mm wide located at the south end of the concrete in front of the loading bay door at the north end of workshop 1.</p> <p>Photographed looking west.</p>

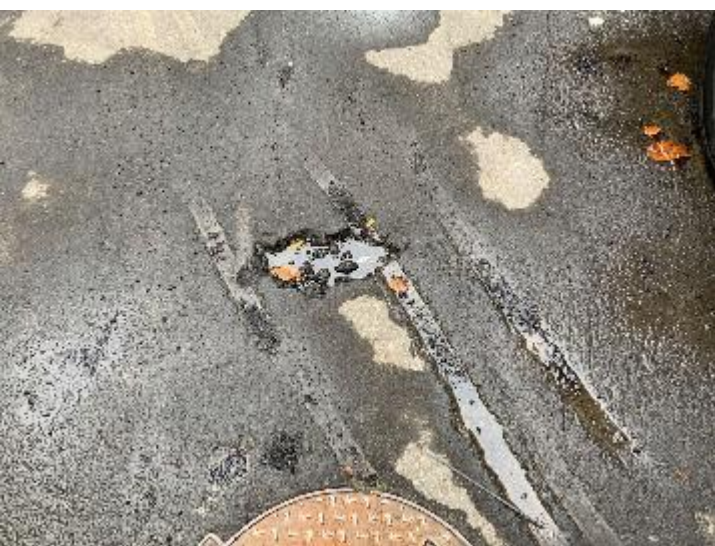
<p><b>Photograph 2.EW.7</b></p> <p><u>East Walkway</u> <u>Minor</u></p> <p>Pothole in the bitumen next to the second north window.</p> <p>Photographed looking south.</p>

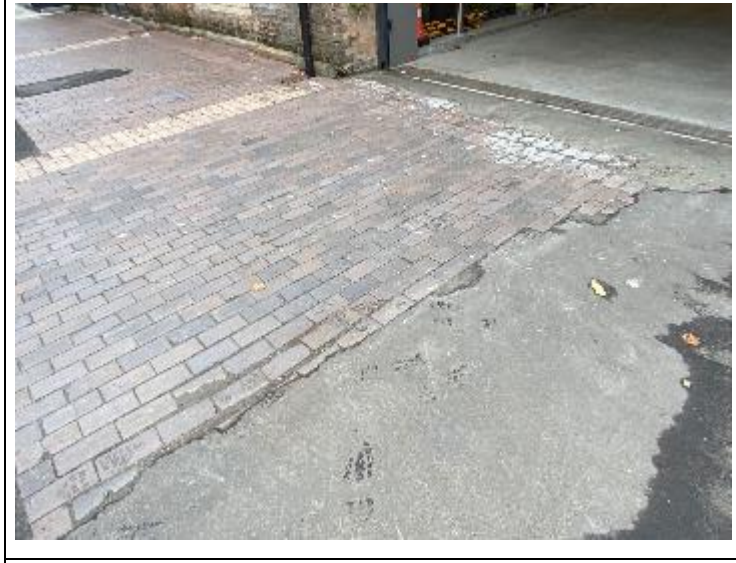
<p><b>Photograph 2.EW.8</b></p> <p><u>East Walkway</u> <u>Minor</u></p> <p>Movement of the pavers with chipped and missing pavers evident in front of the loading bay door at the north end of workshop 1.</p> <p>Photographed looking south-west.</p>

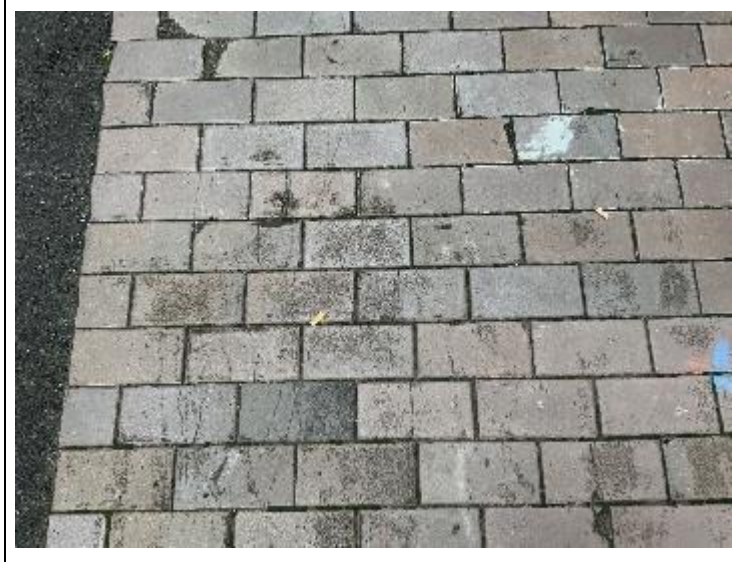
<p><b>Photograph 2.EW.9</b></p> <p><u>East Walkway</u> <u>Minor</u></p> <p>Various cracks approximately max. 100mm long x max. 0.5mm wide located in the pavers at the south end of the loading bay door, typical in the pavers.</p> <p>Photographed looking south.</p>

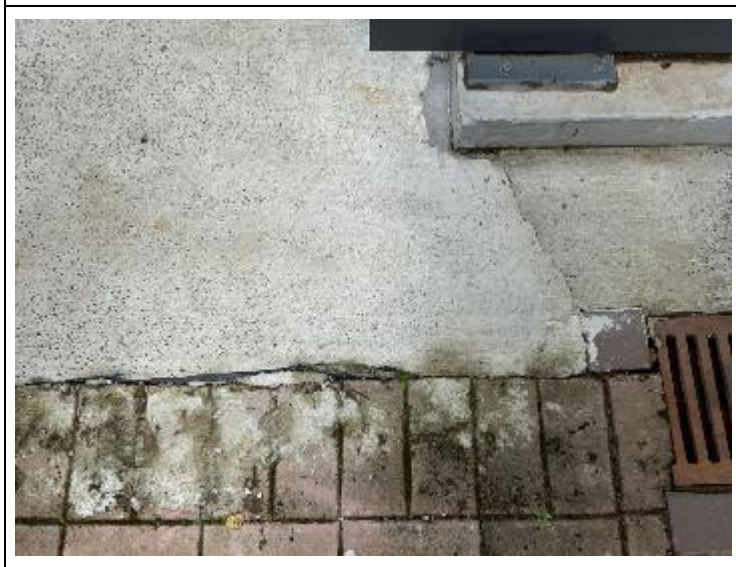
<p><b>Photograph 2.EW.10</b></p> <p><u>East Walkway</u> <u>Minor</u></p> <p>Crack approximately 300mm long x 0.6mm wide running in the north-south direction in the concrete located south of the north door, chipping evident.</p> <p>Photographed looking south.</p>

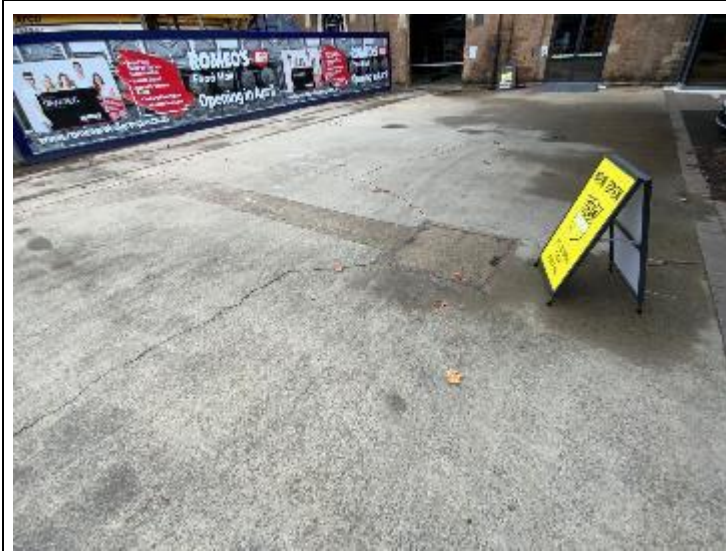
**Photograph 2.EW.14**

Various cracks approximately max. 5200mm long x max. 3mm wide located in the concrete outside the central doors to workshop 1, chipping of the cracks evident.

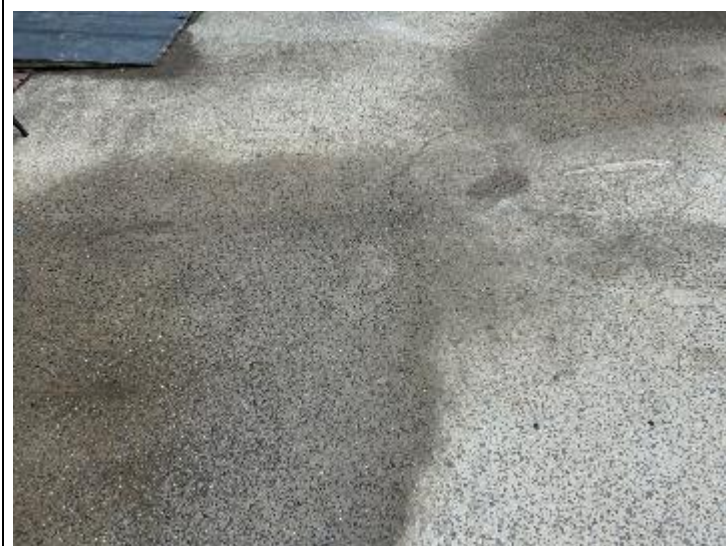
**Photograph 2.EW.15**

Various cracks approximately max. 4500mm long x max. 1.4mm wide located in the concrete between the central doors.

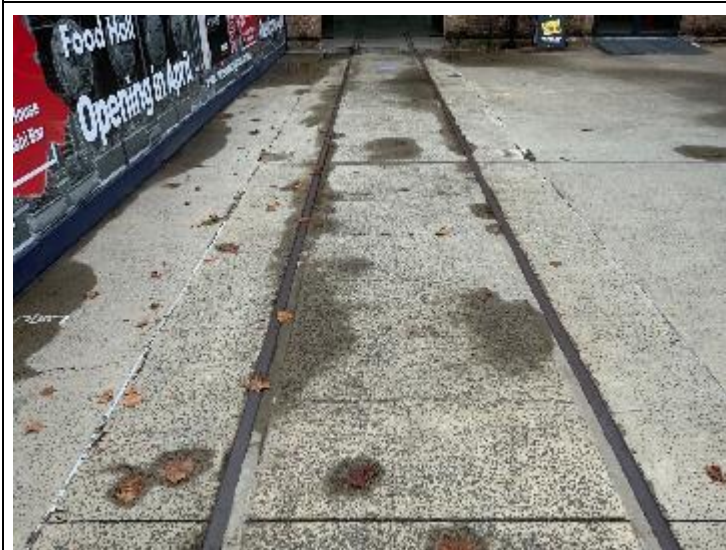
**Photograph 2.EW.16**

Various cracks approximately max. 1400mm long x max. 1.8mm wide located in the concrete around the tracks in front of the main entry door to workshop 1, chipping of the concrete at the slab joints.

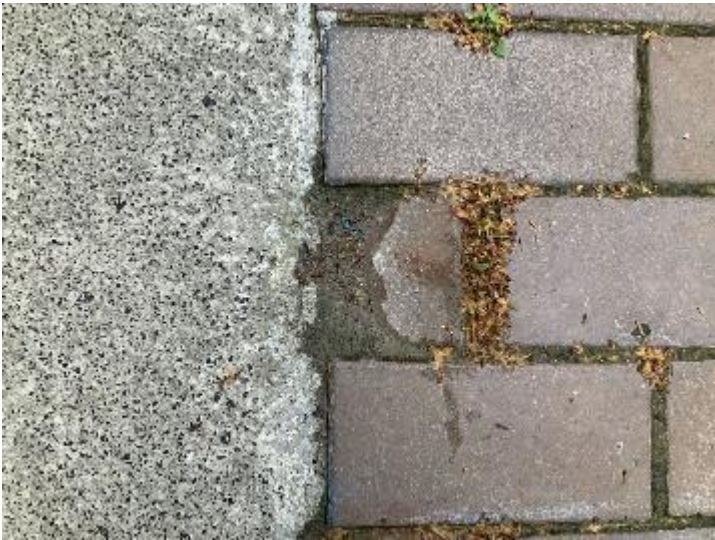
<p><b>Photograph 2.EW.20</b></p> <p><u>East Walkway</u> <u>Minor</u></p> <p>Settlement of brick in walkway. Typical along the south end of the east walkway.</p> <p>Photographed looking north.</p>
 	<p><b>Photograph 2.EW.21</b></p> <p><u>East Walkway</u> <u>Minor</u></p> <p>Various cracks approximately max. 1500mm long x max. 1mm wide located in the concrete slab at the south end of the east walkway.</p> <p>Photographed looking west.</p>

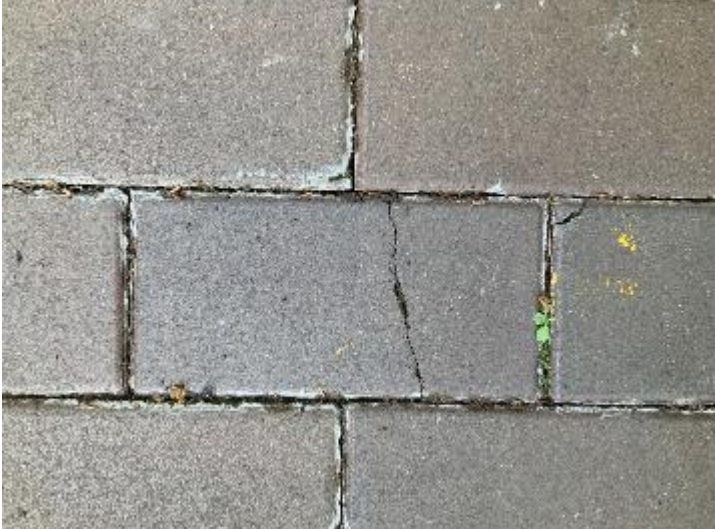
<p><b>Photograph 2.EW.22</b></p> <p><u>East Walkway</u> <u>Minor</u></p> <p>Various cracks approximately max. 100mm long x max. 0.1mm wide located in the brick paving at the south end of the east walkway. Chipping and spalling of bricks at the edges evident, typical across all paving.</p> <p>Photographed looking north.</p>

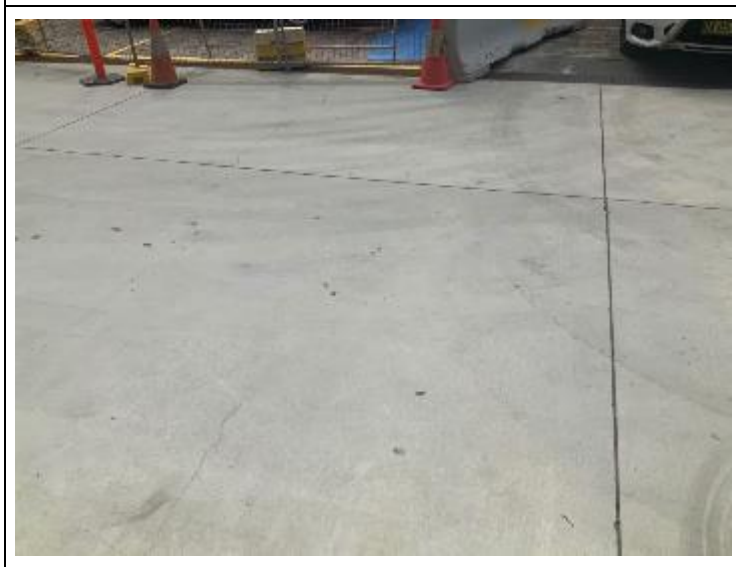
<p><b>Photograph 2.L.92</b></p> <p><u>Locomotive Street - Outside Workshop 8 (Formerly Workshop 9)</u> <u>Minor</u></p> <p>Various cracks approximately max. 2500mm long x max. 2mm wide located in the road, typical.</p> <p>Photographed looking north.</p>

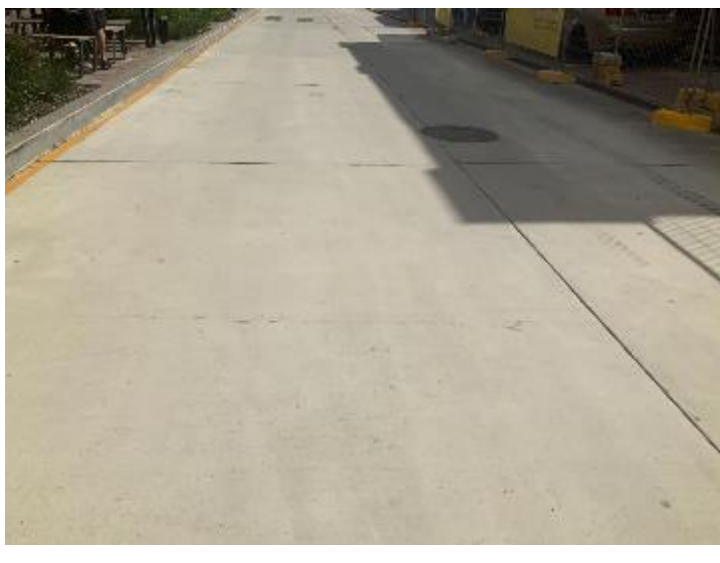
<p><b>Photograph 2.L.93</b></p> <p><u>Locomotive Street - Outside Workshop 9 (Formerly Workshop 10)</u> <u>Minor</u></p> <p>Various cracks approximately max. 2500mm long x max. 2mm wide located in the road, typical.</p> <p>Photographed looking west.</p>

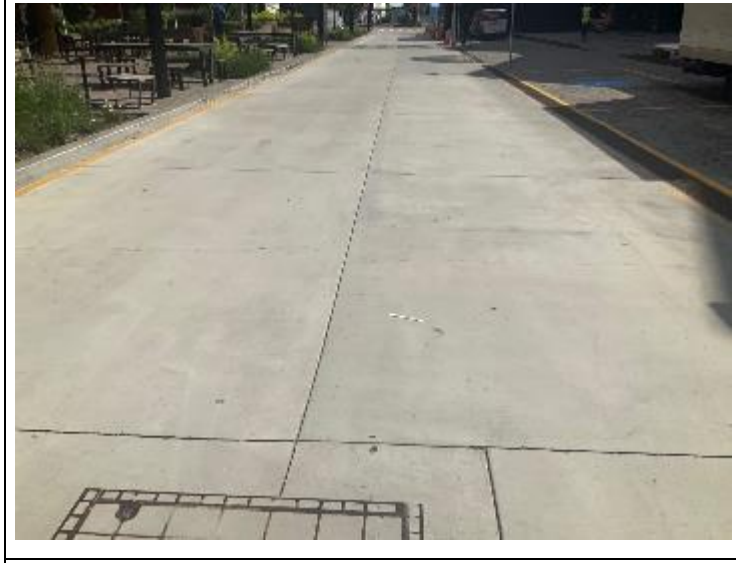
<p><b>Photograph 2.L.95</b></p> <p><u>Locomotive Street - Outside Workshop 10</u> <u>(Formerly Workshop 11)</u></p> <p><u>Minor</u></p> <p>Various cracks approximately max. 3000mm long x max. 1mm wide located in the road, typical.</p> <p>Photographed looking west.</p>

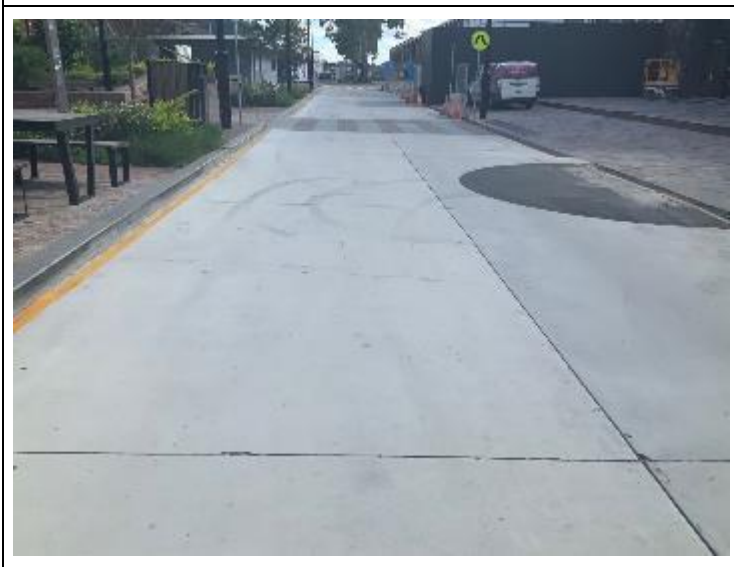
<p><b>Photograph 2.L.96</b></p> <p><u>Locomotive Street - Outside Workshop 12 (Formerly Workshop 13)</u> <u>Minor</u></p> <p>Various cracks approximately max. 2500mm long x max. 2mm wide located in the road.</p> <p>Photographed looking west.</p>

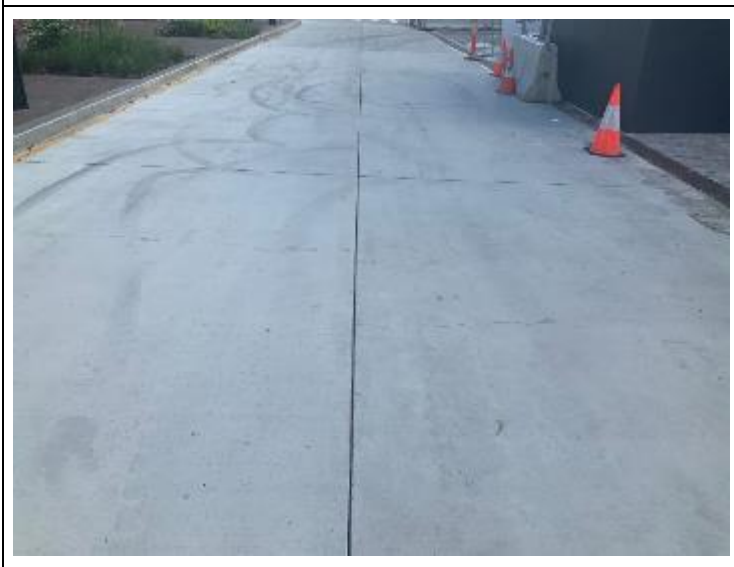
<p><b>Photograph 2.L.98</b></p> <p><u>Locomotive Street - Outside Workshop 14</u>  <u>(Formerly Workshop 15)</u>  <u>Minor</u></p> <p>Various cracks approximately max. 3000mm long x max. 1mm wide located in the road, typical.</p> <p>Photographed looking west.</p>

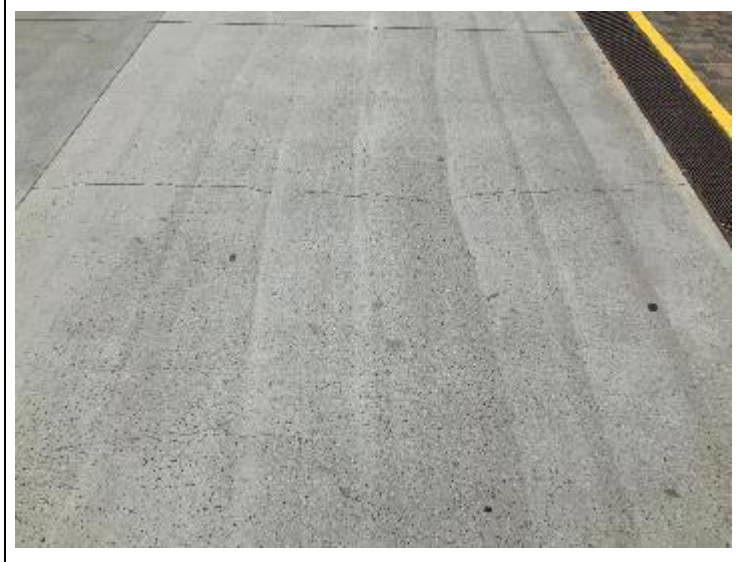
<p><b>Photograph 2.L.109</b></p> <p><u>Outside Workshop 8</u> <u>(Formerly Workshop 9)</u> <u>Minor</u></p> <p>Crack approximately 1500mm long x 0.5mm wide located in the north lane outside workshop 8.</p> <p>Photographed looking west.</p>

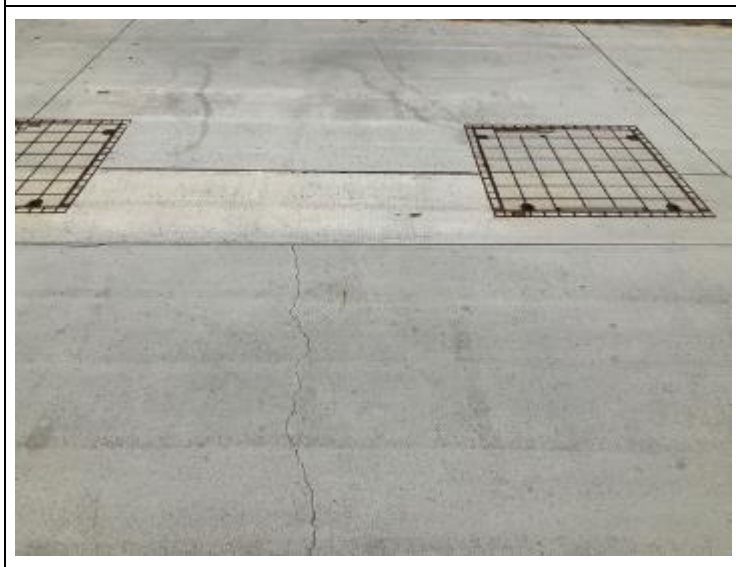
<p><b>Photograph 2.L.116</b></p> <p><u>Outside Workshop 10</u> <u>(Formerly Workshop 11)</u> <u>Minor</u></p> <p>Various cracks approximately max. 1500mm long x max. 0.5mm wide located in the north lane and south lanes outside workshop 10.</p> <p>Photographed looking west.</p>

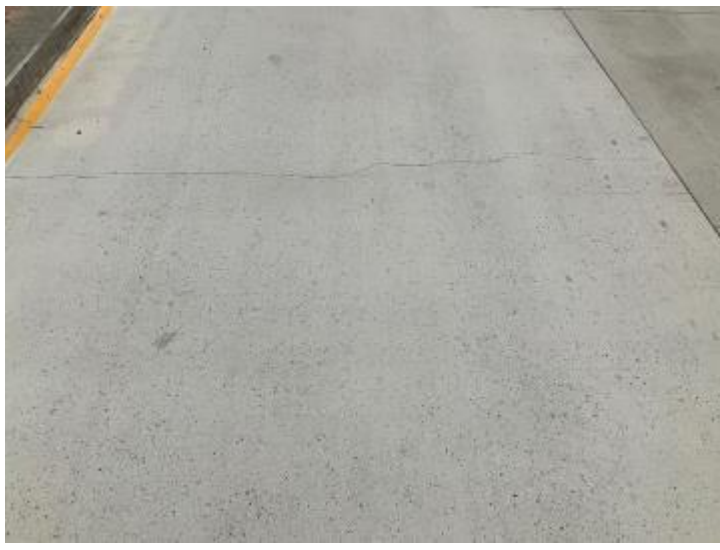
<p><b>Photograph 2.L.120</b></p> <p><u>Outside Workshop 5</u> <u>(Formerly Workshop 6)</u> <u>Minor</u></p> <p>Various cracks approximately max. 1500mm long x max. 0.5mm wide located in the road lanes.</p> <p>Photographed looking west.</p>

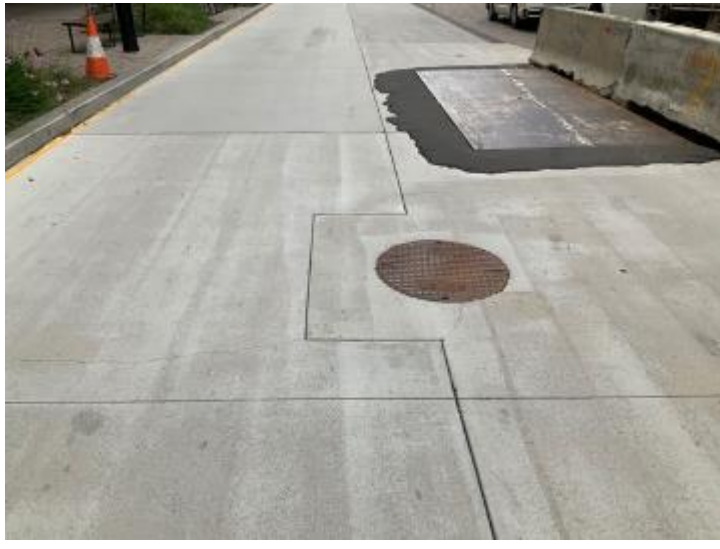
<p><b>Photograph 2.L.122</b></p> <p><u>Outside Workshop 4a</u> <u>(Formerly Workshop 5)</u> <u>Minor</u></p> <p>Various cracks approximately max. 1500mm long x max. 0.2mm wide located in the road lanes. Bitumen patching, temporary steel cover and concrete barriers evident. Service pit evident.</p> <p>Photographed looking west.</p>

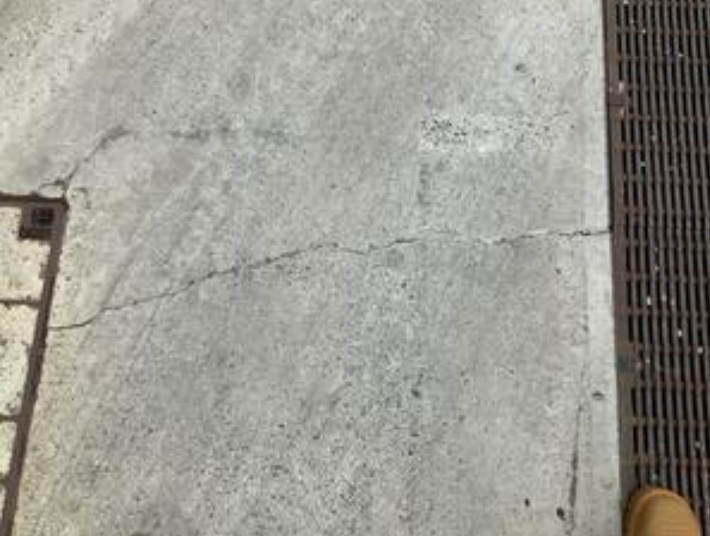
<p><b>Photograph 2.L.126</b></p> <p><u>Outside Workshop 4</u> <u>Minor</u></p> <p>Various cracks approximately max. 500mm long x max. 0.2mm wide located in the north road lane.</p> <p>Photographed looking west.</p>

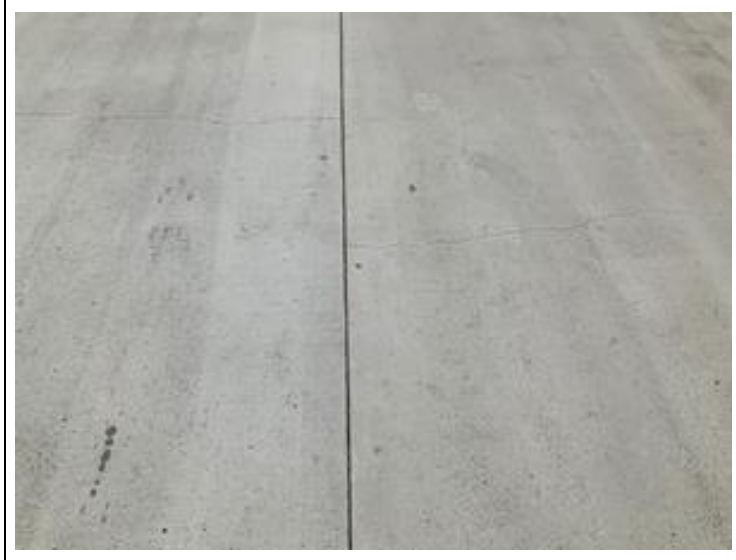
<p><b>Photograph 2.L.131</b></p> <p><u>Outside Workshop 13</u>  <u>(Formerly Workshop 14)</u>  <u>Minor</u></p> <p>Various cracks approximately max. 1500mm long x max. 0.5mm wide located in the north and south road lanes.</p> <p>Photographed looking west.</p>

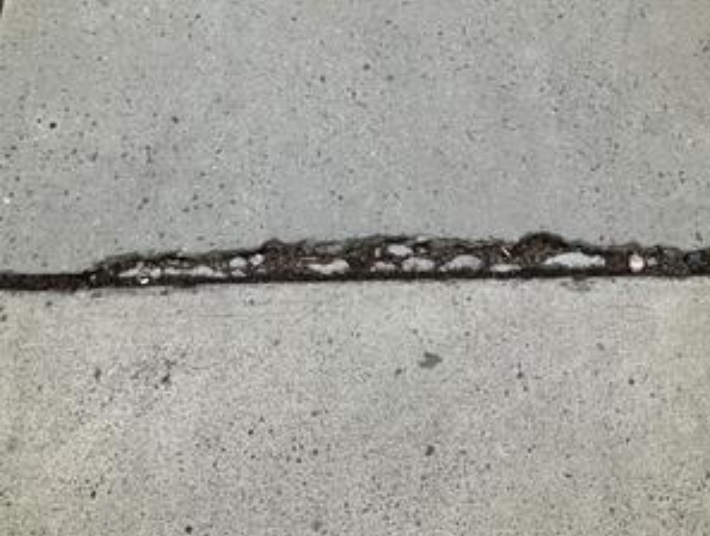
<p><b>Photograph 2.L.135</b></p> <p><u>Outside Workshop 14</u> <u>(Formerly Workshop 15)</u> <u>Minor</u></p> <p>Chipping and spalling of concrete at the joint between the slabs of the road.</p> <p>Photographed looking west.</p>

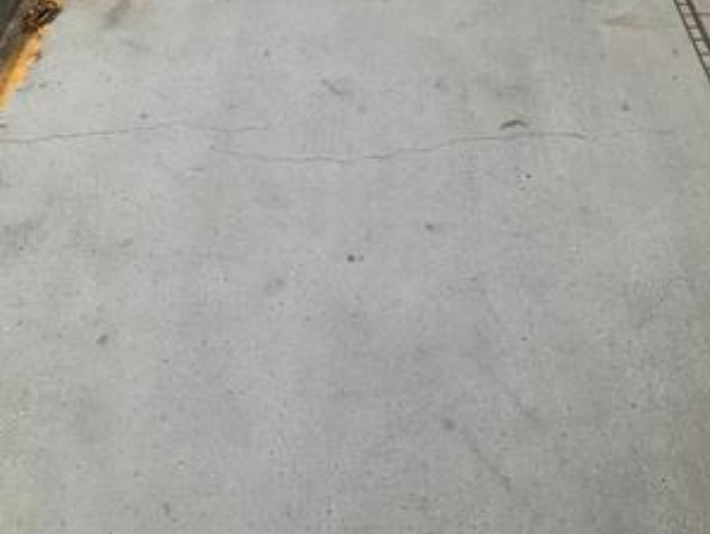
<p><b>Photograph 2.L.137</b></p> <p><u>Outside Workshop 15</u> <u>(Formerly Workshop 16)</u> <u>Minor</u></p> <p>Various cracks approximately max. 1500mm long x max. 0.5mm wide located in the north and south road lanes.</p> <p>Photographed looking west.</p>

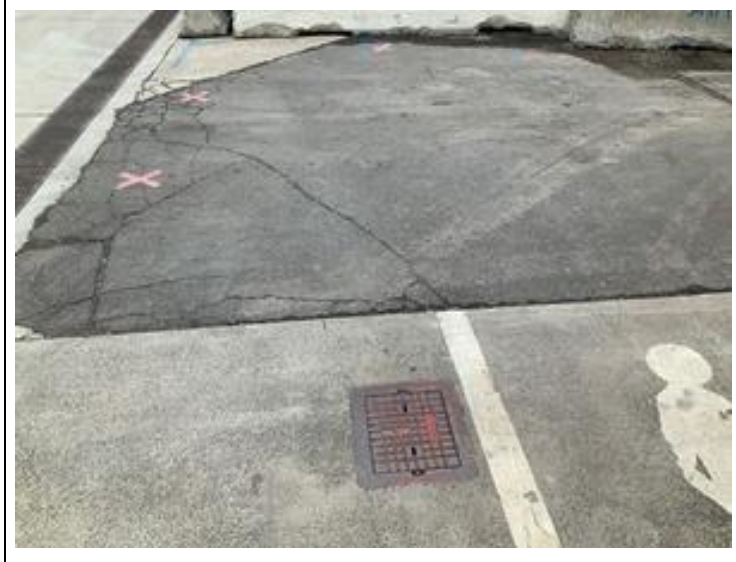
<p><b>Photograph 2.L.139</b></p> <p><u>Outside Workshop 15</u> <u>(Formerly Workshop 16)</u> <u>Minor</u></p> <p>Various cracks approximately max. 3000mm long x max. 1mm wide located in the bitumen road patching and concrete footpath. Chipping and spalling of bitumen patching evident.</p> <p>Photographed looking west.</p>

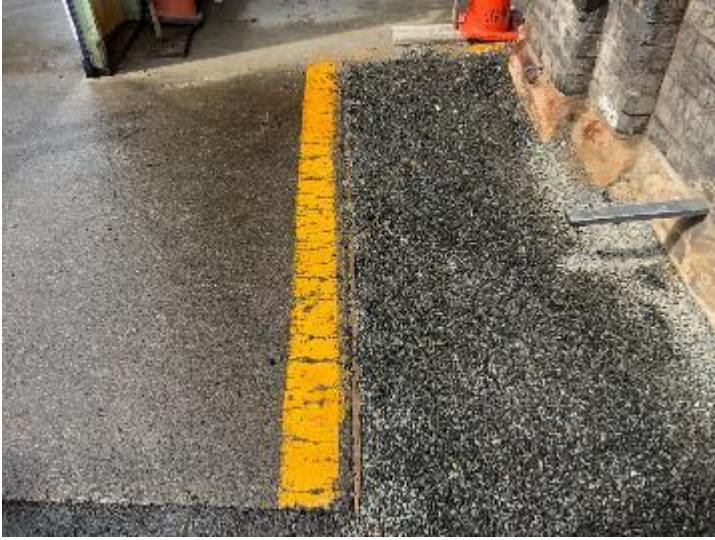
<p><b>Photograph 2.NW.32</b></p> <p><u>North Walkway - Workshop 15</u> <u>(Formerly Workshop 16)</u></p> <p><u>Minor</u></p> <p>Various cracks approximately max. 150mm long x max. 0.5mm wide located in the south side of the pathway, typical on the walkway paint lines.</p> <p>Photographed looking east.</p>

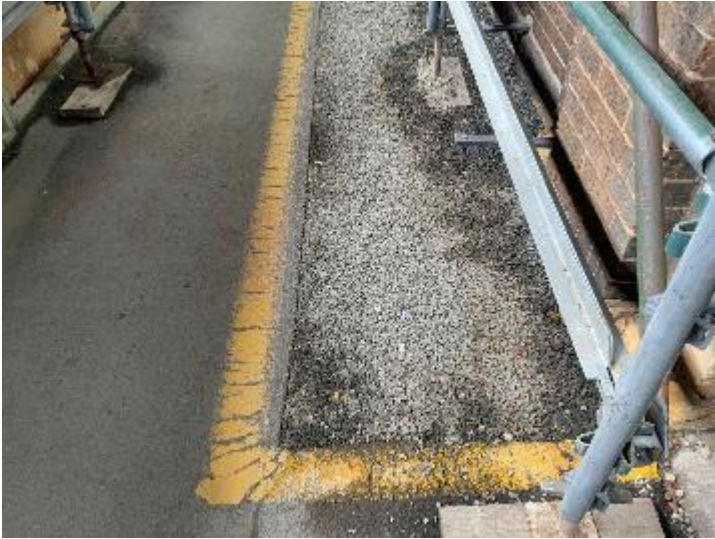
<p><b>Photograph 2.NW.33</b></p> <p><u>North Walkway - Workshop 14</u> <u>(Formerly Workshop 15)</u></p> <p><u>Minor</u></p> <p>Various cracks approximately max. 150mm long x max. 0.5mm wide located in the south side of the pathway, typical on the walkway paint lines.</p> <p>Photographed looking east.</p>

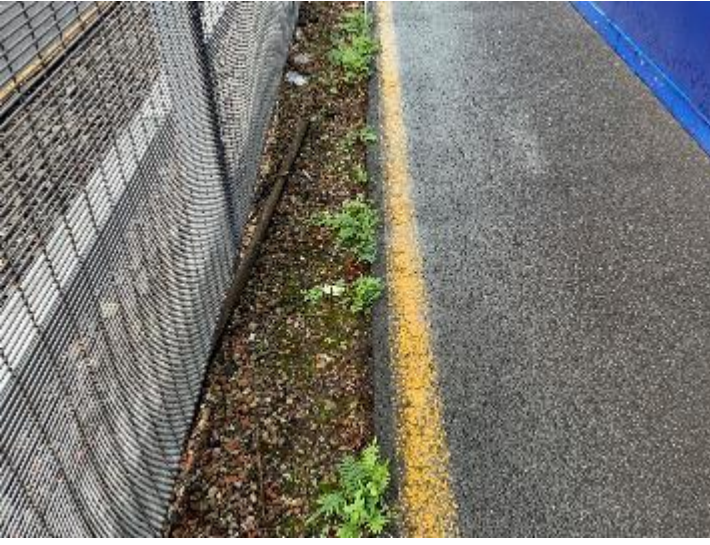
<p><b>Photograph 2.NW.34</b></p> <p><u>North Walkway - Workshop 14</u> <u>(Formerly Workshop 15)</u></p> <p><u>Minor</u></p> <p>Timber skirting has torn away from the footpath on the north side opposite the doorway.</p> <p>Photographed looking east.</p>

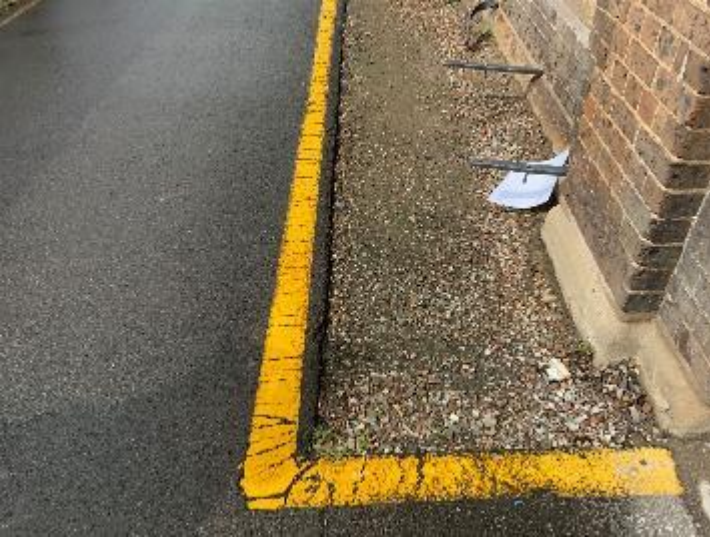
<p><b>Photograph 2.NW.36</b></p> <p><u>North Walkway - Workshop 11</u> <u>(Formerly Workshop 12)</u></p> <p><u>Minor</u></p> <p>Various cracks approximately max. 150mm long x max. 0.5mm wide located in the south side of the pathway, typical on the walkway paint lines.</p> <p>Photographed looking east.</p>

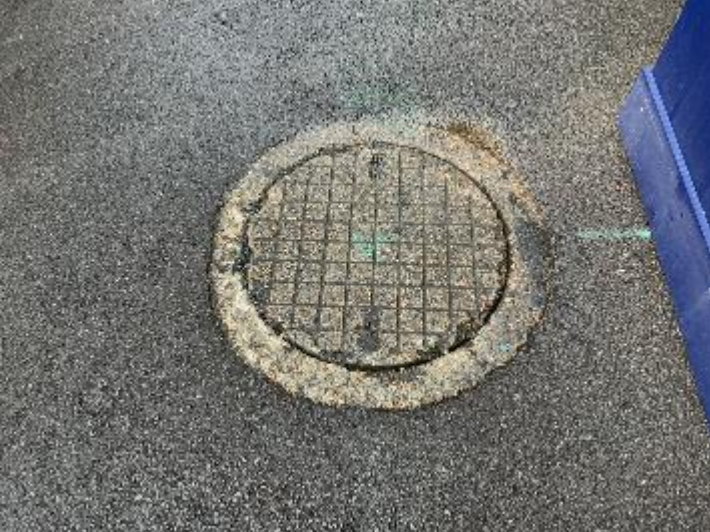
<p><b>Photograph 2.NW.40</b></p> <p><u>North Walkway - Workshop 7</u> <u>(Formerly Workshop 8)</u> <u>Minor</u></p> <p>Various chips around the perimeter of the pit located between workshops 6 and 7.</p> <p>Photographed looking east.</p>

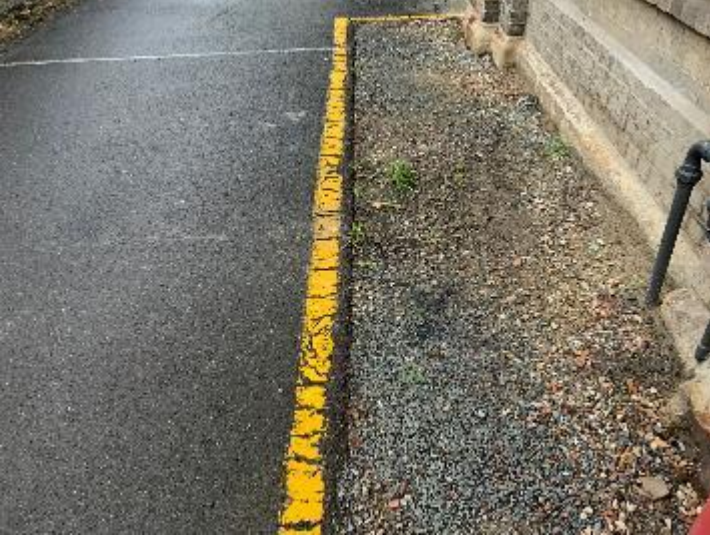
<p><b>Photograph 2.NW.42</b></p> <p><u>North Walkway - Workshop 6</u> <u>(Formerly Workshop 7)</u> <u>Minor</u></p> <p>Various cracks approximately max. 150mm long x max. 0.5mm wide located in the south side of the pathway, typical on the walkway paint lines.</p> <p>Photographed looking east.</p>

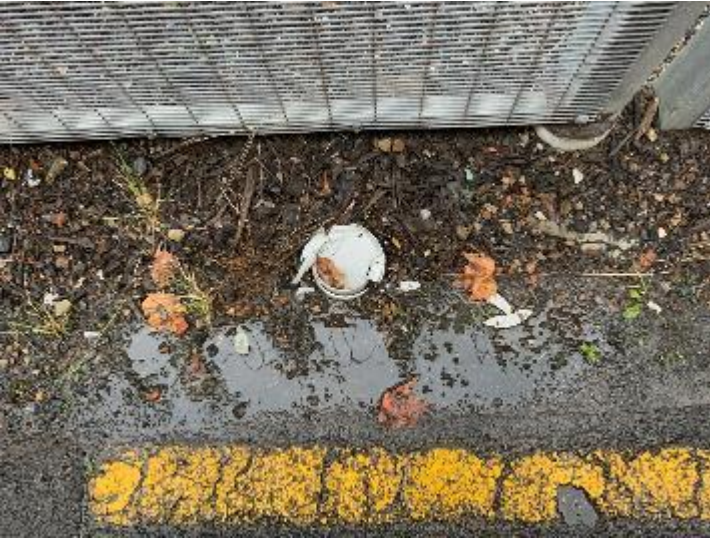
<p><b>Photograph 2.NW.43</b></p> <p><u>North Walkway - Workshop 6</u> <u>(Formerly Workshop 7)</u> <u>Minor</u></p> <p>Damaged service pit cover at the north-west end of workshop 6.</p> <p>Photographed looking north.</p>

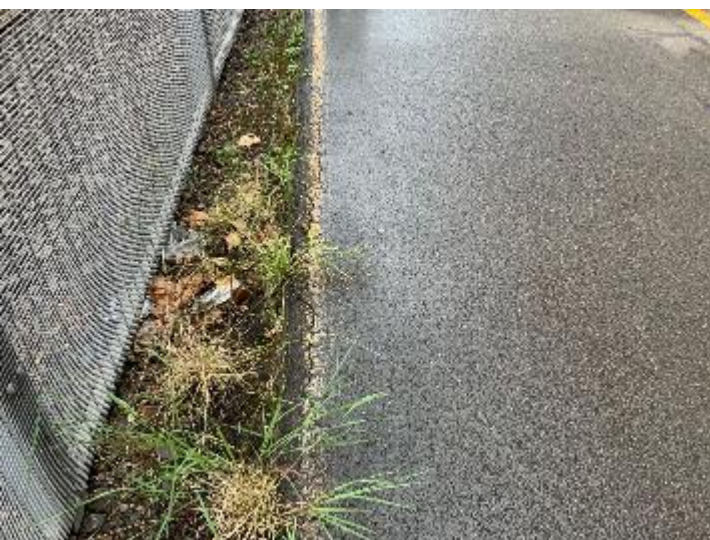
<p><b>Photograph 2.NW.44</b></p> <p><u>North Walkway - Workshop 8</u> <u>(Formerly Workshop 9)</u> <u>Minor</u></p> <p>Crack approximately 3200mm long x 4mm wide located in the north side of the walkway opposite the door to workshop 8.</p> <p>Photographed looking east.</p>

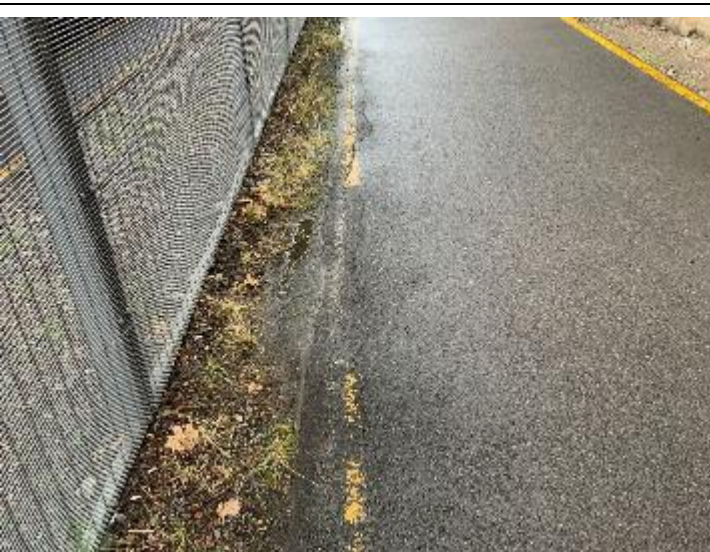
<p><b>Photograph 2.NW.45</b></p> <p><u>North Walkway - Workshop 6</u> <u>(Formerly Workshop 7)</u> <u>Minor</u></p> <p>Various cracks approximately max. 3000mm long x max. 8mm wide located in the north side of the walkway opposite the door to workshop 6.</p> <p>Photographed looking east.</p>

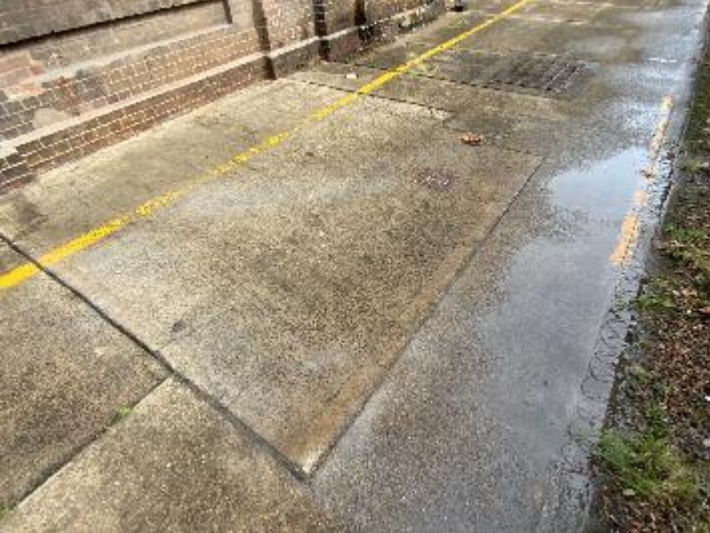
<p><b>Photograph 2.NW.47</b></p> <p><u>North Walkway - Workshop 4A</u> (Formerly Workshop 5) <u>Minor</u></p> <p>Various cracks in the walkway at the west section of workshop 4A.</p> <p>Photographed looking south-west.</p>

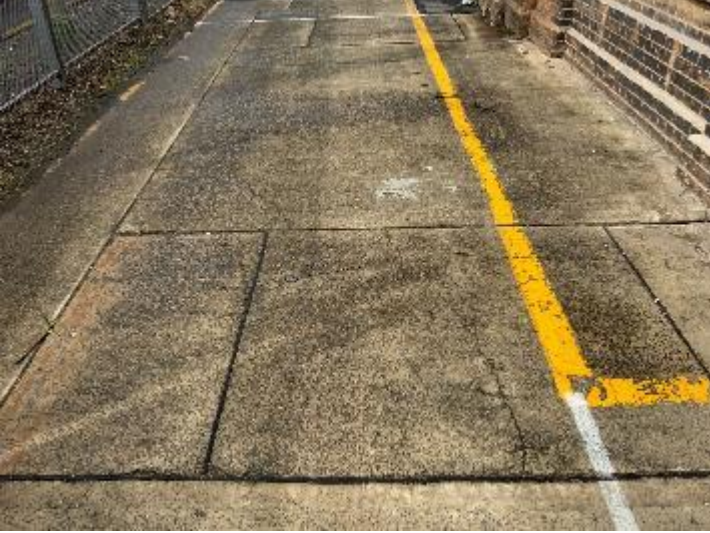
<p><b>Photograph 2.NW.48</b></p> <p><u>North Walkway - Workshop 4A</u> (Formerly Workshop 5) <u>Minor</u></p> <p>Various cracks in the walkway at the east section of workshop 4A.</p> <p>Photographed looking south-west.</p>

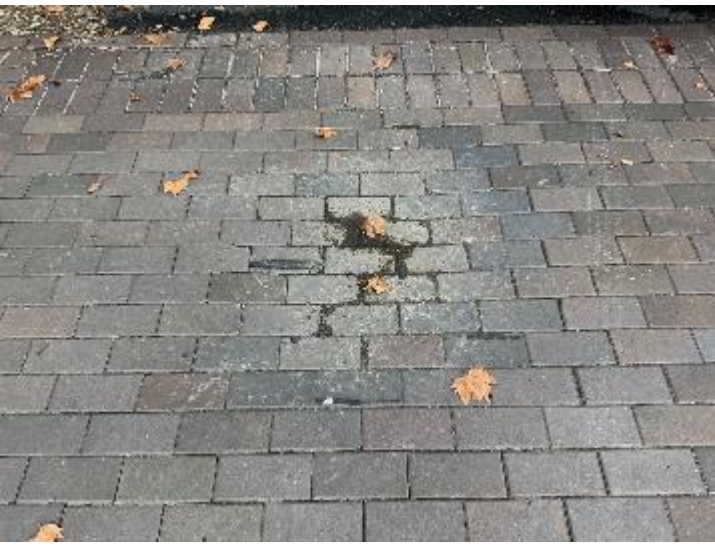
Stain mark on asphalt.
