Mirvac Projects Pty Ltd  
Hazardous Materials Survey  
Locomotive Workshop Building  
Australian Technology Park

2 Locomotive Street  
Eveleigh, NSW

9 August 2017

51142-110236 (Rev A)  
JBS&G Australia Pty Ltd

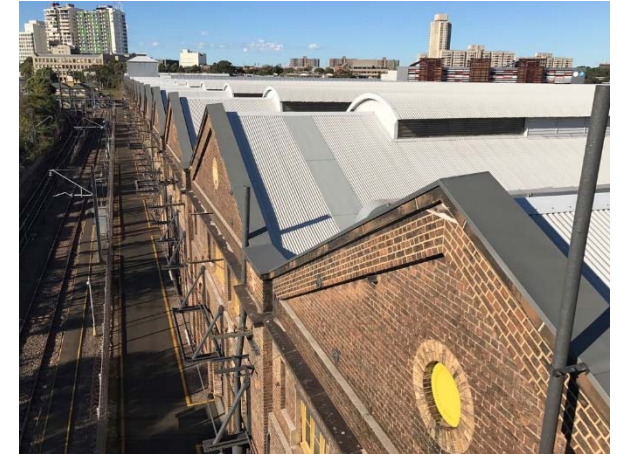
Photo 3: Locomotive Workshop – North aspect, looking east

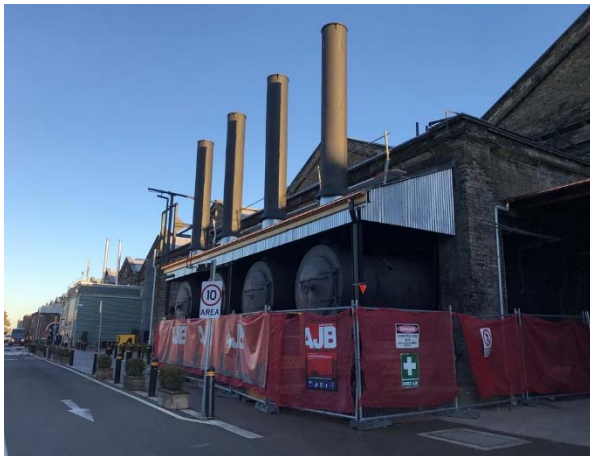
Photo 4: Exterior – Boiler House

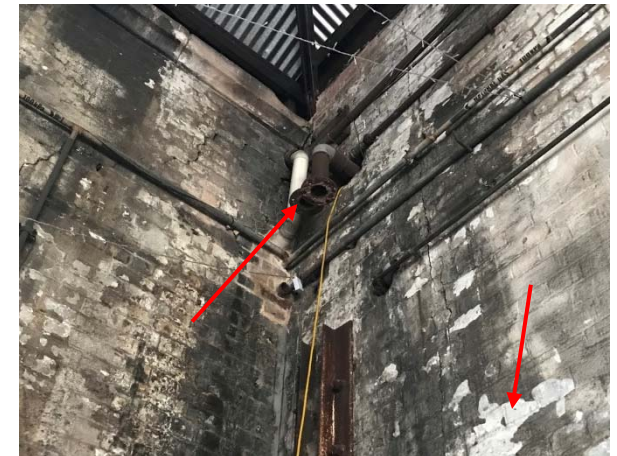
Photo 6: Exterior – SE Annex, suspected asbestos containing gaskets and potential lead based paint

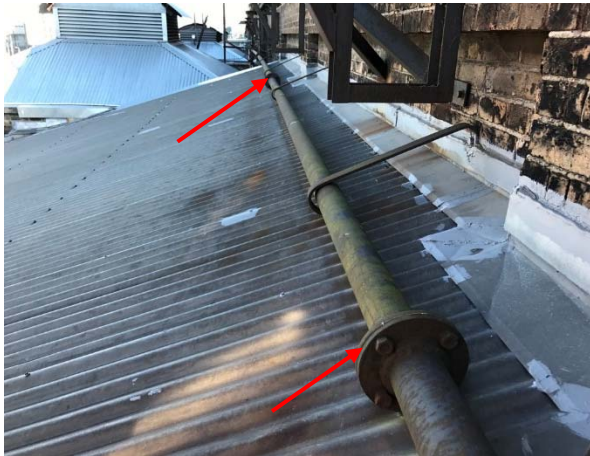
Photo 7: Exterior, SE Annex - Non-rubberised gaskets associated with the water pipe traversing the awning are assumed to contain asbestos.

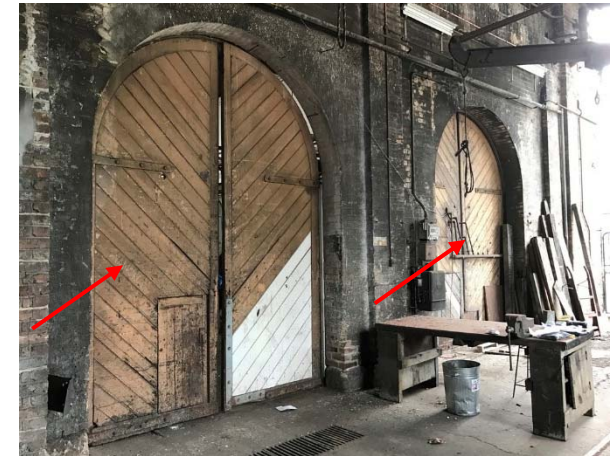
- Analysis and XRF screening of the mustard coloured double doors to the external south of Bay 1 identified lead paint (Ext-LP01), this paint is deteriorating and flaking.

Photo 9: Exterior – SE Annex, mustard coloured timber double arched door at south of Bay 1 contain lead based paint. Flaking paint should be removed and managed.

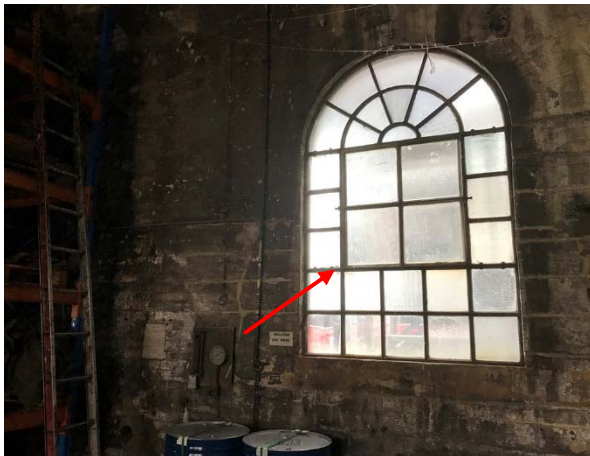
Photo 10: Exterior – SE Annex, arched heritage window frame on west wall contains lead based paint. Flaking paint should be removed and managed.

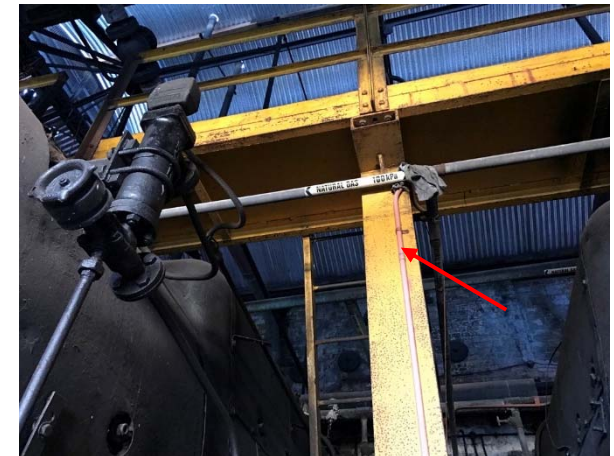
Photo 12: Exterior – Boiler house, XRF screening of the yellow steel boiler gantry identified lead based paint

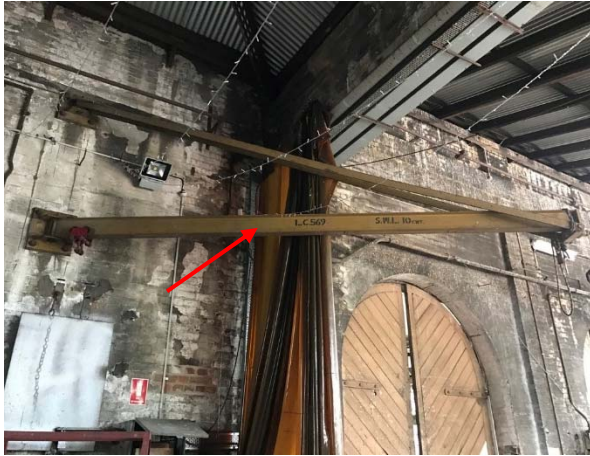
Photo 13: Exterior – SE Annex, XRF screening of the grey and yellow jib cranes identified lead based paint

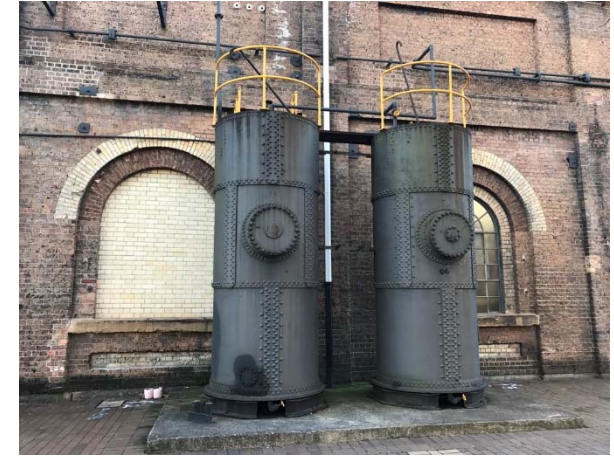
- A sample of the gasket material between valves fitting on top of the two cylindrical water vessels adjacent the eastern wall, south end of the building, was found to contain non-friable asbestos (Ext-A05). Other gaskets of identical material were noted on the vessels.

Photo 15: Exterior - Non-rubberised gaskets associated with the pressure vessels at the SE corner of the building contain asbestos

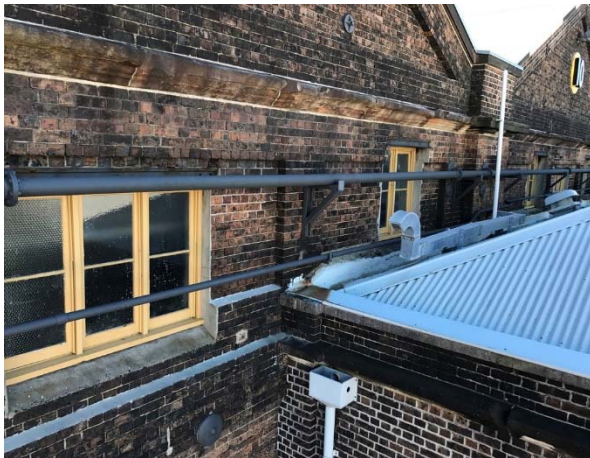
Photo 16: Exterior – XRF screening of the mustard coloured timber rectangular windows in the upper north, south and west walls identified lead based paint

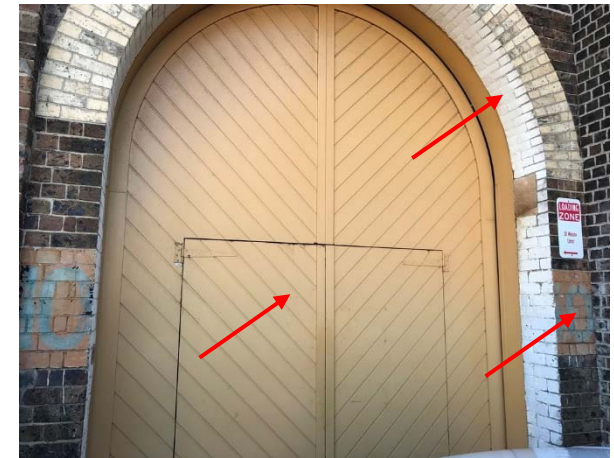
Photo 18: Exterior – XRF screening of 'original' mustard coloured timber double arched doors identified lead based paint. Newer western red cedar replacement doors do not contain lead based paint.

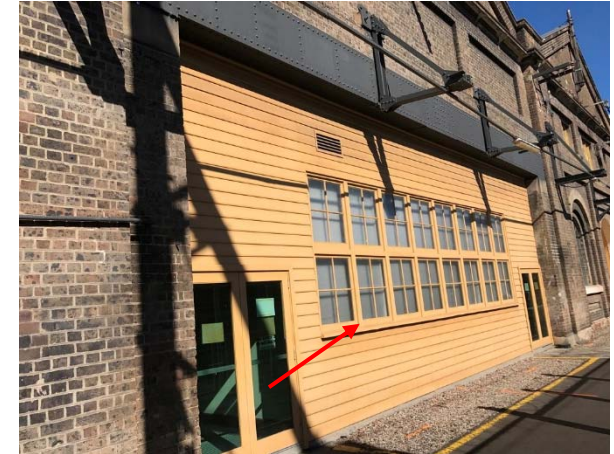
Photo 21: Exterior – Bay 8 north, XRF screening of the older mustard coloured timber window frames identified lead based paint. XRF screening of newer timber panelling did not identify lead based paint

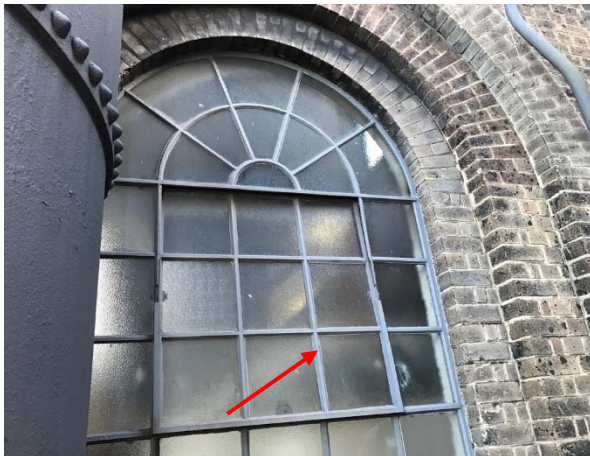
Photo 22: Exterior – Bay 4 south, XRF screening of the heritage arched window identified lead based paint

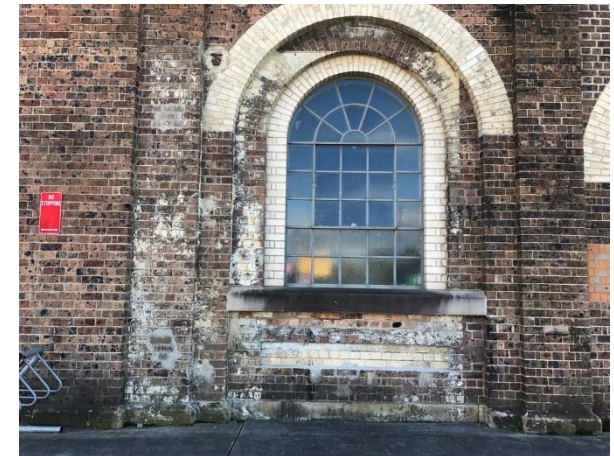
Photo 24: Exterior – Bay 13 south, XRF screening of the residual paint on the brickwork around the window identified lead based paint

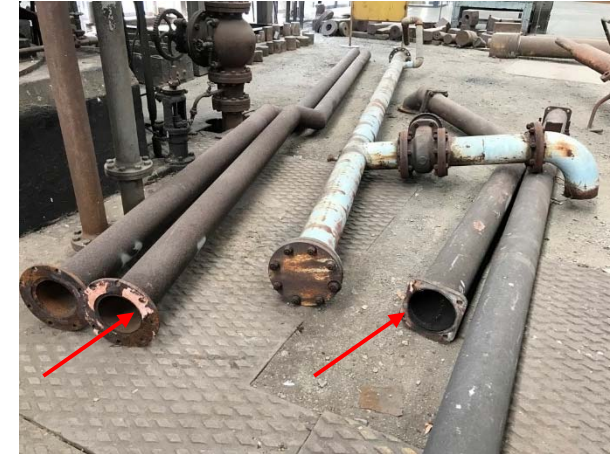
Photo 27: Bay 1 north - Residual gaskets on old pipes on the floor of the Davy display contain asbestos. Several of these gaskets are in poor condition and should be removed.

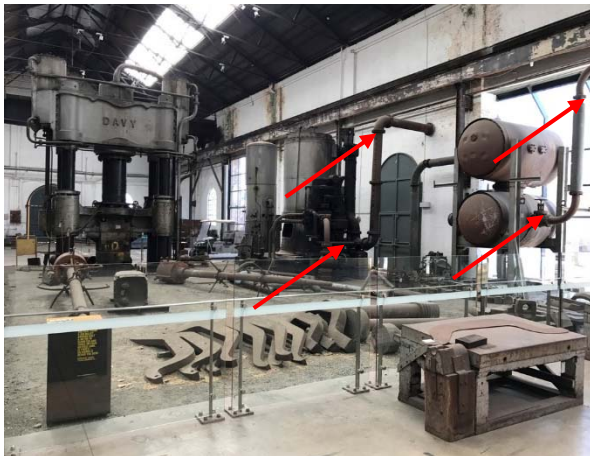
Photo 28: Bay 1 - Non-rubberised gaskets associated with the old steam plant throughout Bays 1 and 2 are suspected to contain asbestos

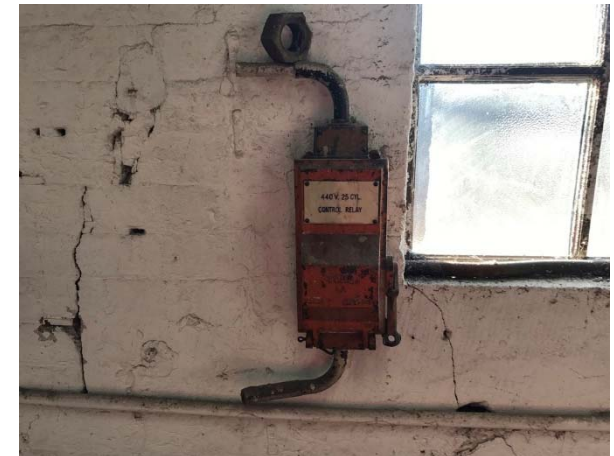
Photo 30: Bay 1 north - Control relay box compartments on north wall contain asbestos paper linings (friable)

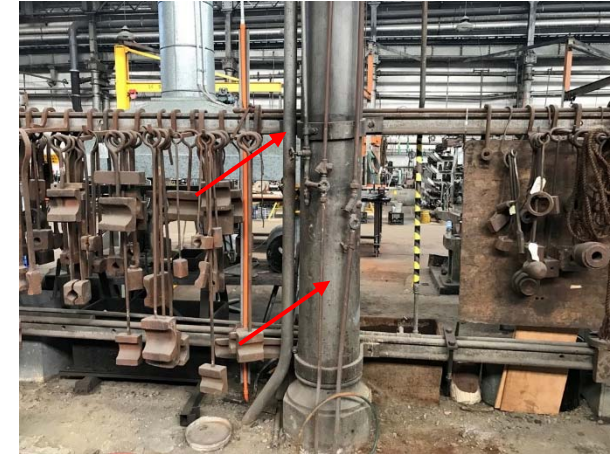
Photo 33: Bay 1 - Silver heritage columns throughout the bay contain lead based paint

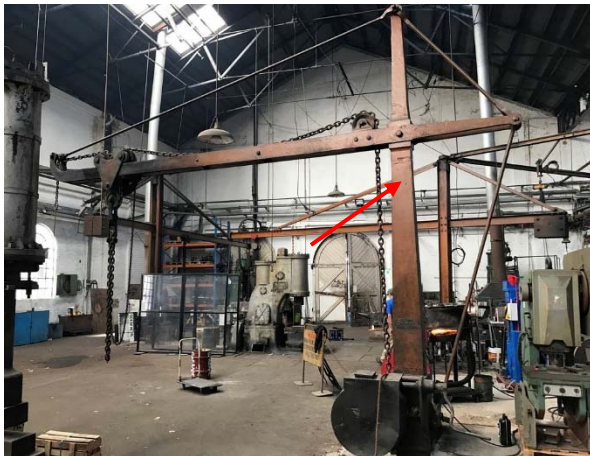
Photo 34: Bay 1 south - The orange 7 CWT Jib Crane contains lead based paint

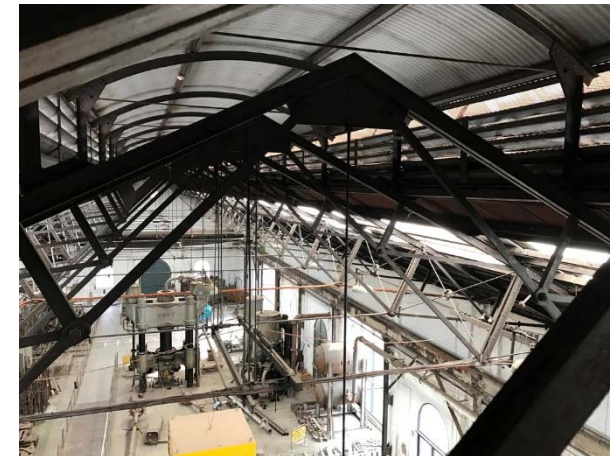
Photo 36: Bay 1 - XRF screening of heritage structural steel columns, capitals, beams, downpipes, purlins, crane rails and roof trusses throughout the bay identified lead based paint

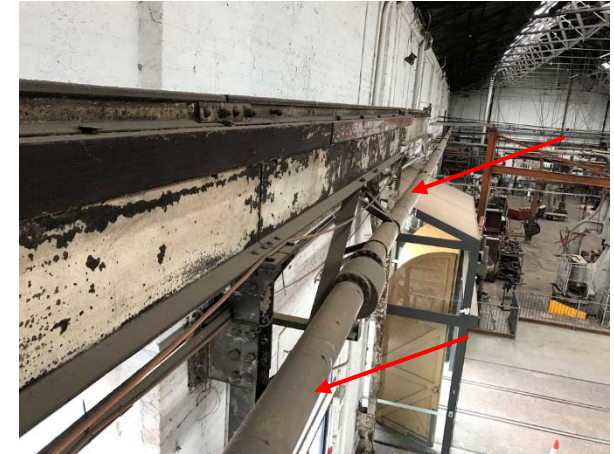
Photo 39: Bay 1 – Old pipework associated with the former steam plant may contain asbestos gaskets. Old and new pipework traversing the upper walls of the bay is insulated with SMF

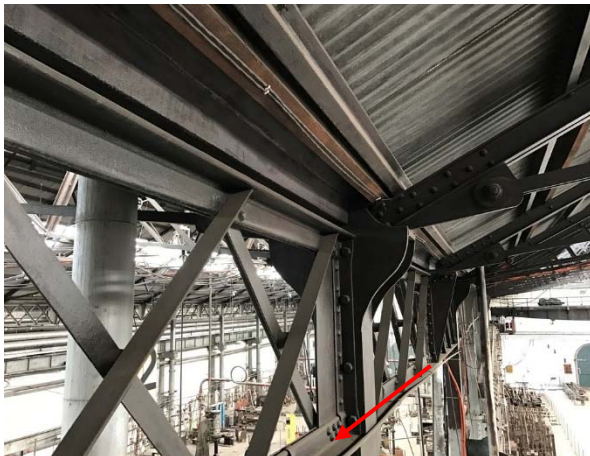
Photo 40: Bay 1 south – A lead dust sample collected from the top of a roof beam in the NW corner of Bay 1 south identified lead contaminated dusts. It is noted that minimal settled dust was present in this sampling location.

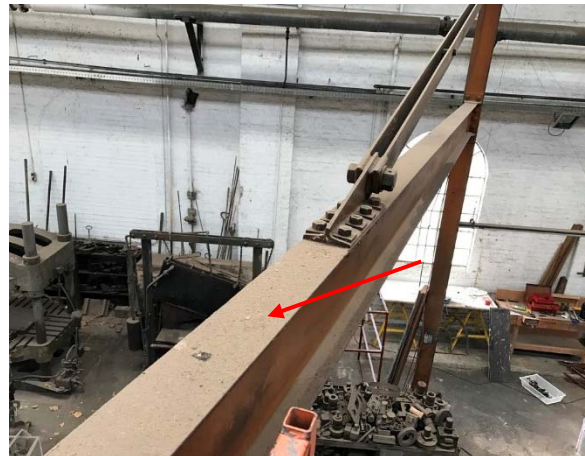
Photo 41: Bay 1 south – A lead dust sample collected from the top of the northernmost Jib Crane identified lead contaminated dust.

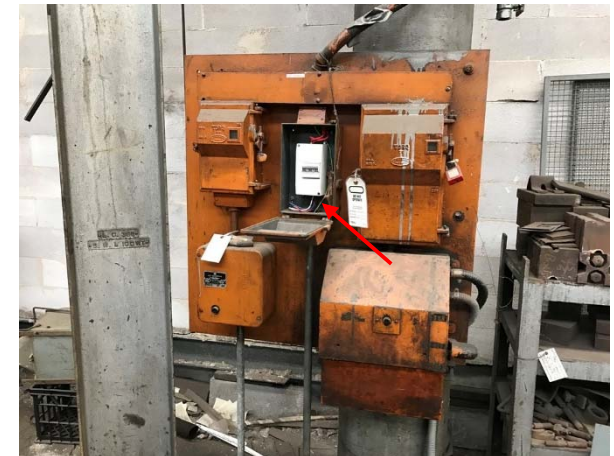
Photo 42: Bay 2 south - Electrical box compartments on west wall contain asbestos paper linings (friable)

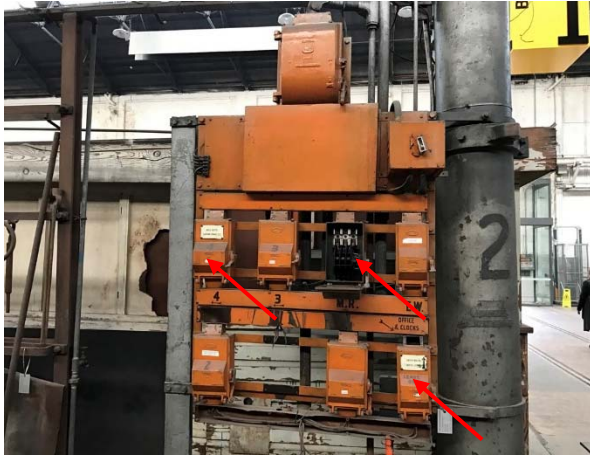
Photo 43: Bay 2 north - Fuse box compartments in the SE of Bay 2 south contain asbestos paper linings (friable)

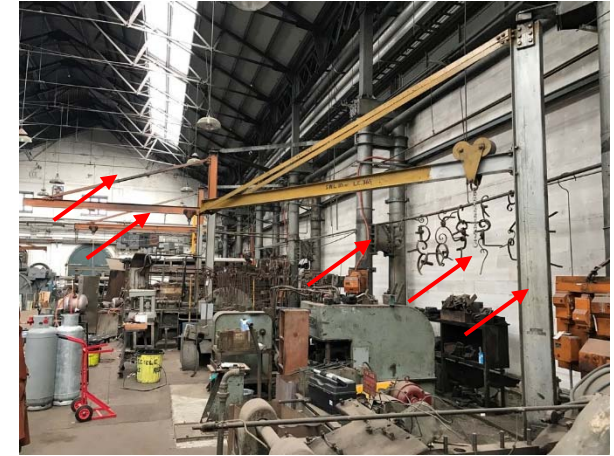
Photo 45: Bay 2 - XRF screening of the jib cranes and electrical boxes identified lead based paint. Lead based undercoat paints may be present beneath the white perimeter walls of Bay 2.

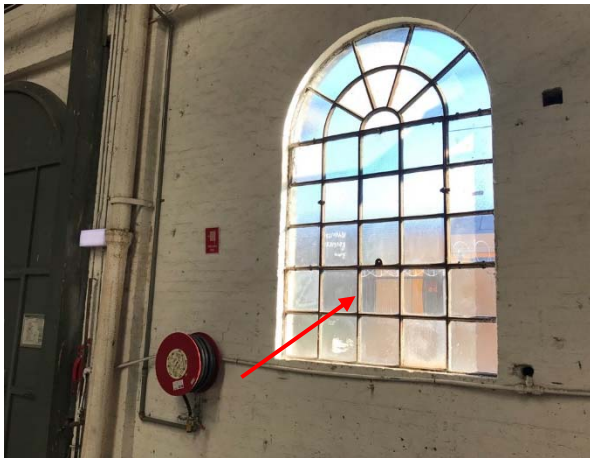
Photo 46: Bay 2 north - XRF screening of the heritage arched window frame on the northern wall identified lead based paint

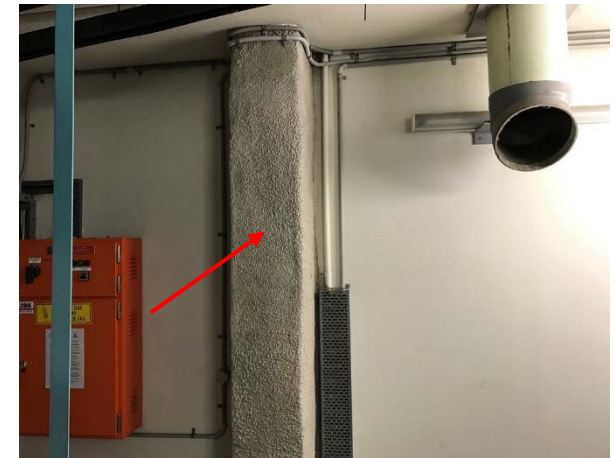
Photo 48: Bay 3 north - The vermiculite fire-rating insulation in the northern Level 2 plant room does not contain asbestos

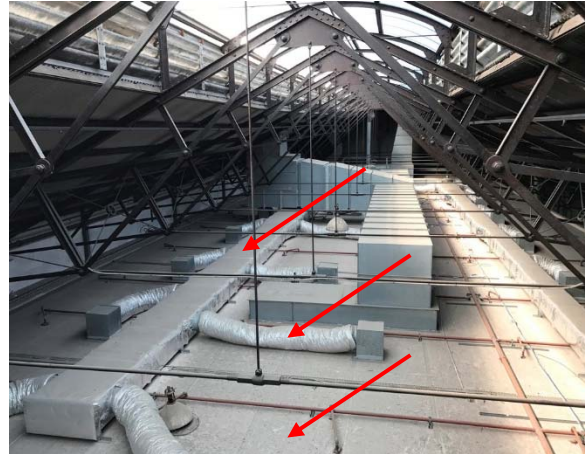
Photo 50: Bay 3 south – A lead dust sample collected from the top of the southern function centre identified lead contaminated dusts. Fixed and flexible air-conditioning ductwork is insulated with SMF.

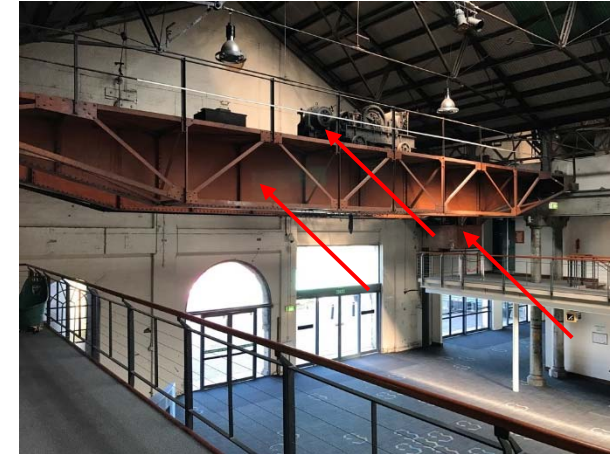
Photo 51: Bay 4 south - XRF screening of both overhead travelling cranes in the bay identified lead based paints. Electrical boards in the operators cabins and brake pads associated with the crane winch gear are presumed to contain asbestos.

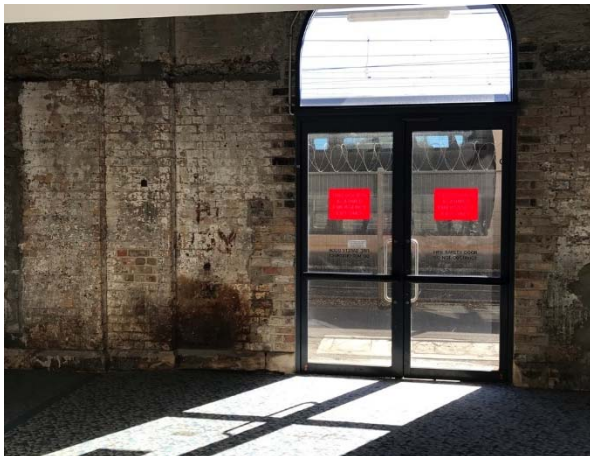
Photo 52: Bay 4 north – Residual paints on the northern wall of the bay are lead based paint. Lead based undercoat paints may be present beneath the white perimeter walls in other areas.

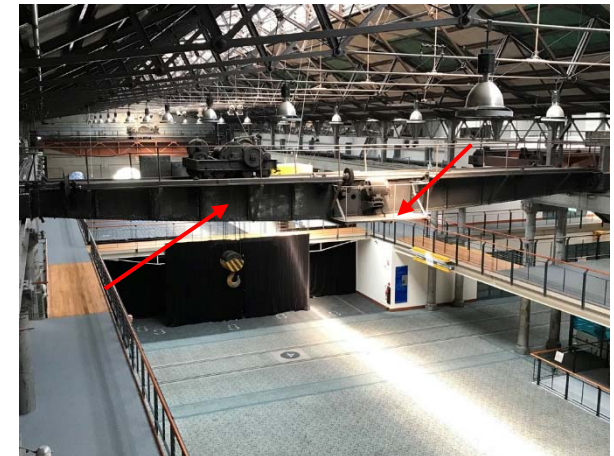
Photo 54: Bay 4 north – A lead dust sample collected from the timber platform of the northern travelling crane identified lead contaminated dusts. As per description for Photo 51, lead based paints and asbestos materials are associated with the northern crane.

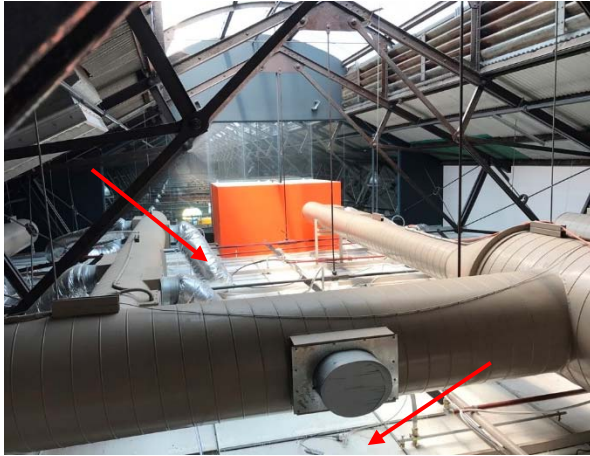
Photo 55: Bay 4 north – Fixed and flexible air-conditioning ductwork within office ceiling cavities is insulated with SMF. Lead impacted settled dusts may be present on the ductwork and ceiling tiles in Level 2 ceiling locations that are directly below exposed roof trusses.

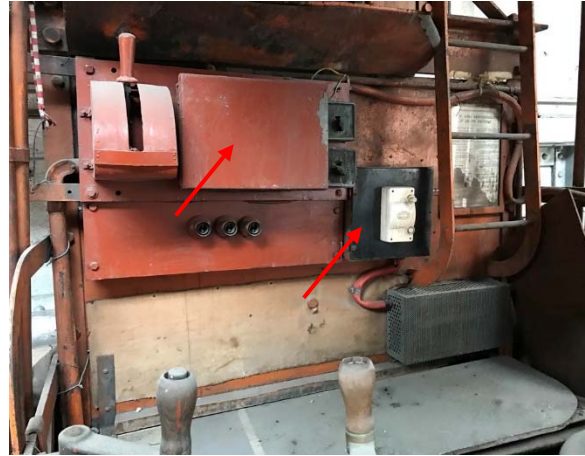
Photo 56: Bay 5 - Electrical boards in the operators cabin overhead crane are presumed to contain asbestos.

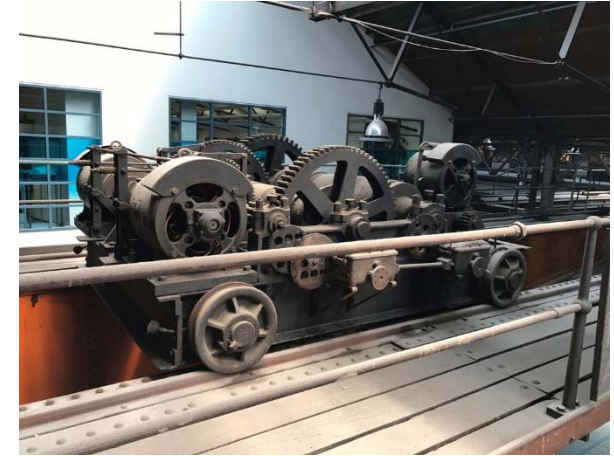
Photo 57: Bay 5 - Brake pads associated with the crane winch gear are presumed to contain asbestos.

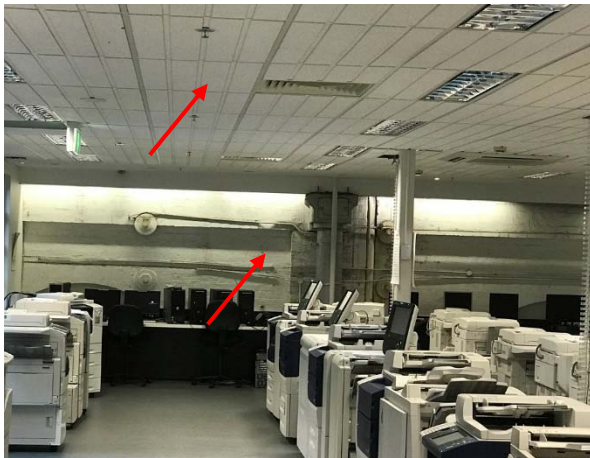
Photo 58: Bay 5 – All walls, older patchy undercoats concealed beneath the white surface coat may contain lead based paint. Ceiling tiles contain SMF.

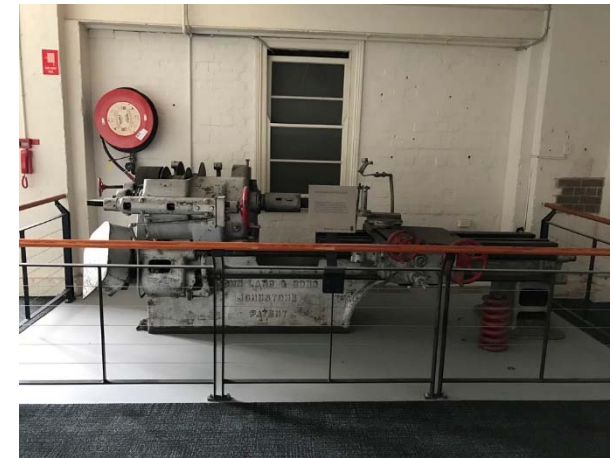
Photo 60: Bay 5 - XRF screening of the silver Johnston Spring Coiler identified lead based paint

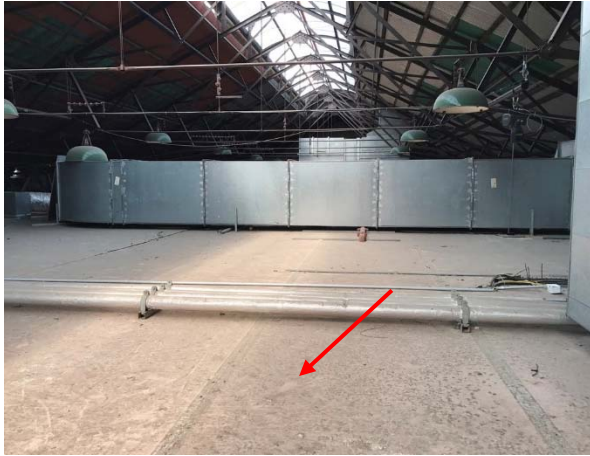
Photo 61: Bay 5 south – A lead dust sample collected from the top of the southern theatre identified lead contaminated dusts. Fixed and flexible air-conditioning ductwork is insulated with SMF.

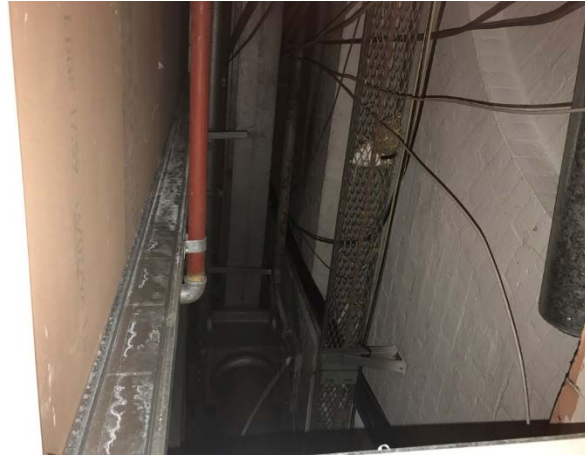
Photo 62: Bay 5 south – Dusts concealed in wall cavities / plenums of Bay 5 and Bay 6 south may be lead impacted. These areas should be assessed prior to demolition.

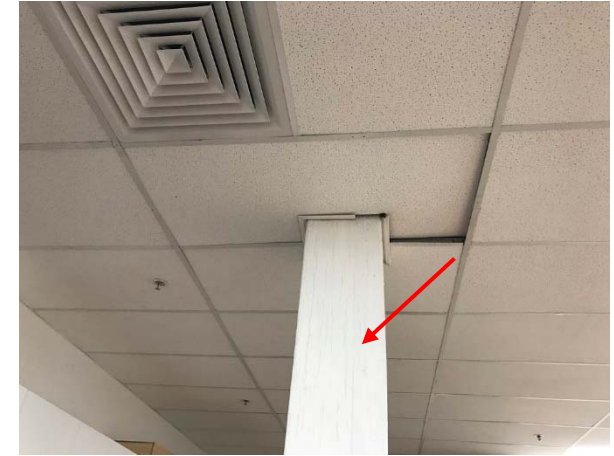
Photo 63: Bay 6 south - XRF screening of the square timber columns and beams in the working space and ceiling cavity identified lead based paint

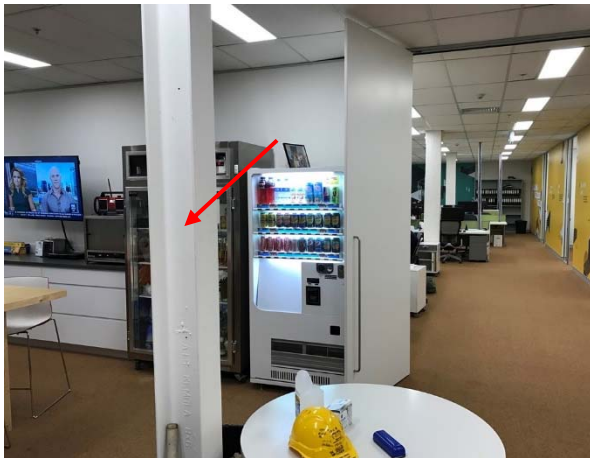
Photo 64: Bay 6 south - XRF screening of the white RSJ columns and beams in the working space and ceiling cavity identified lead based paint

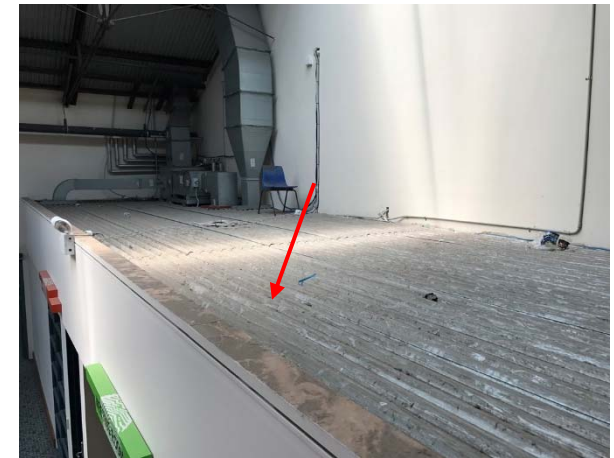
Photo 66: Bay 6 – Lead dust samples collected from the top of the roof of the southern an northern office blocks identified lead contaminated dusts.

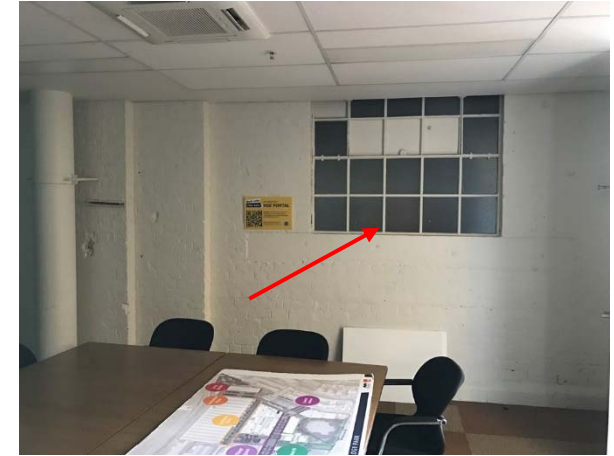
Photo 69: Bay 7 – XRF screening of the off-white heritage arched window on the southern wall identified lead based paint

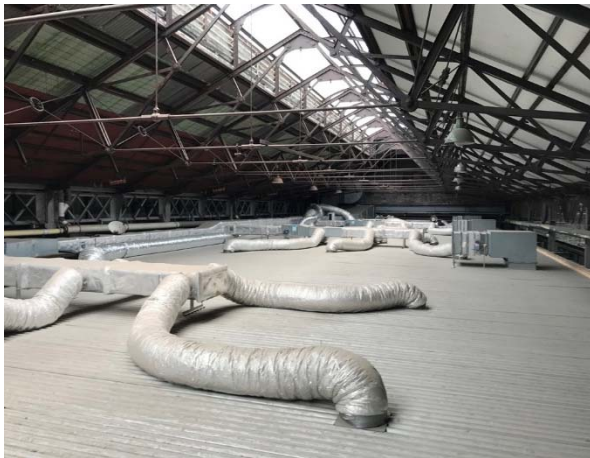
Photo 70: Bay 7 – Lead dust samples collected from the top of the roof of the southern office block identified lead contaminated dusts.

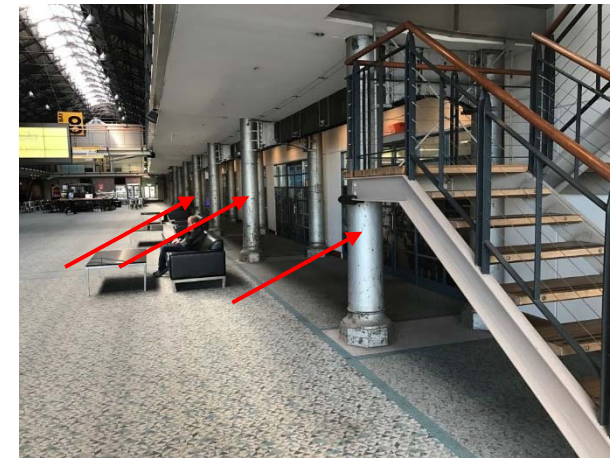
Photo 72: Bay 8 - XRF screening of heritage structural steel columns, capitals, beams, downpipes, purlins, crane rails and roof trusses throughout the bay identified lead based paint

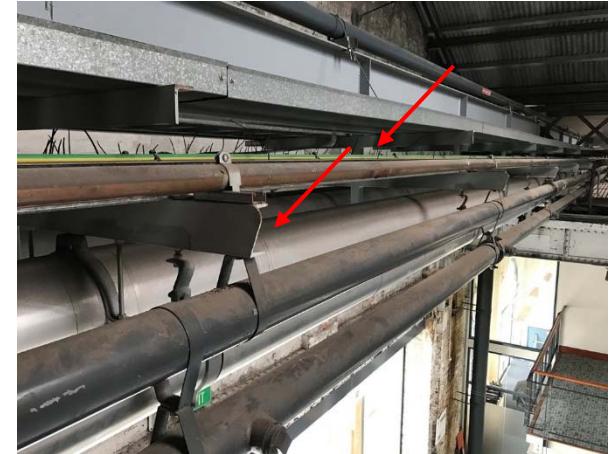
Photo 75: Bay 8 – Lead dust samples collected from the top of the cable tray above the southern entry doors identified lead contaminated dusts. Pipework traversing the upper north and south walls are insulated with SMF.

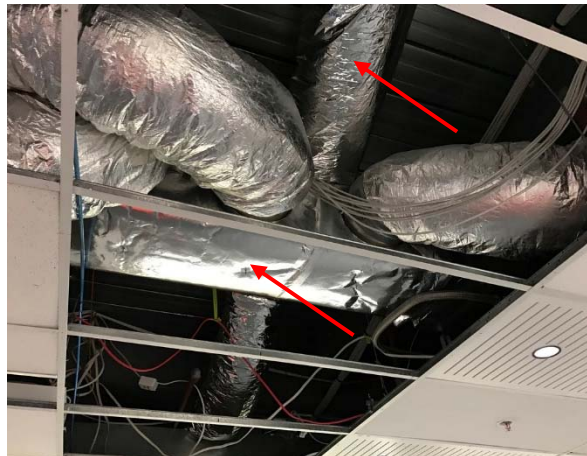
Photo 77: Bay 9 – Fixed and flexible air-conditioning ductwork within office ceiling cavities is insulated with SMF.

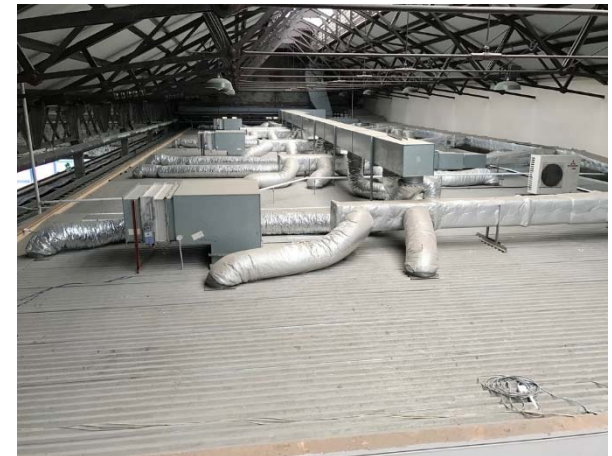
Photo 78: Bay 9 – Lead dust samples collected from the top of the roof of the southern office block identified lead contaminated dusts. Fixed and flexible air-conditioning ductwork on the Level 1 office roof is insulated with SMF.

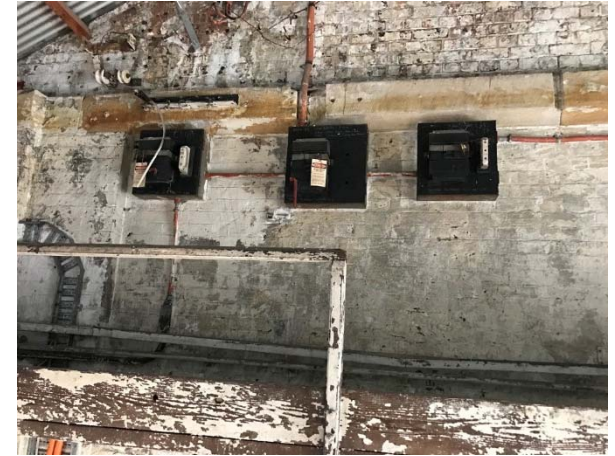
Photo 81: Bay 10 north - Three black electrical boards on the upper north wall of Bay 10 are presumed to contain asbestos

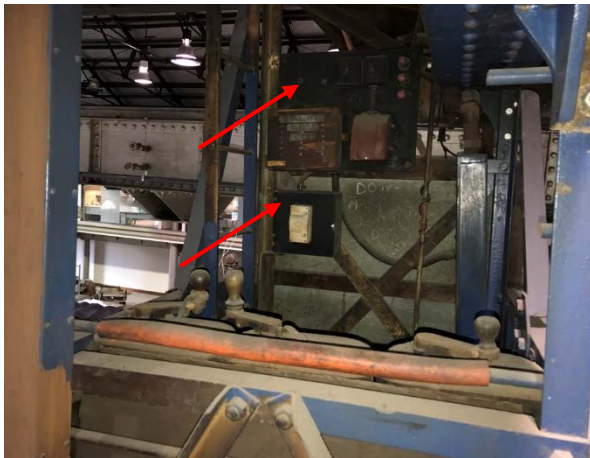
Photo 82: Bays 10 - 14 - Black electrical boards in the operators cabins of the overhead travelling cranes are presumed to contain asbestos

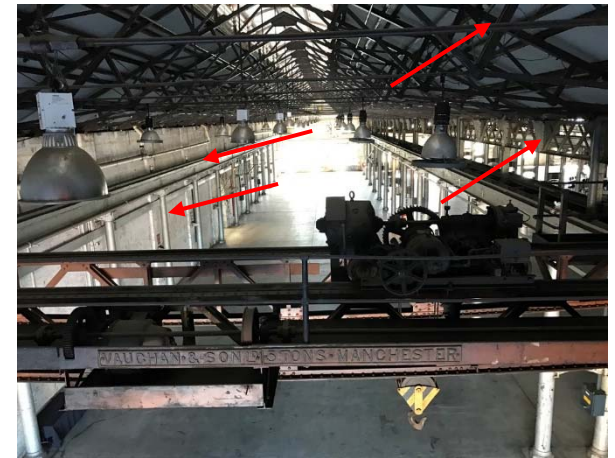
Photo 84: Bays 10 - 14 – XRF screening of heritage structural steel columns, capitals, beams, downpipes, purlins, crane rails and roof trusses throughout the bay identified lead based paints

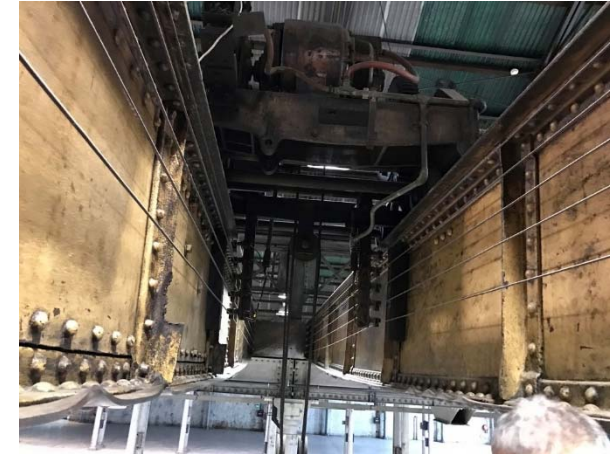
Photo 87: Bays 10 - 14 – XRF screening of overhead travelling cranes located in the bays identified lead based paints

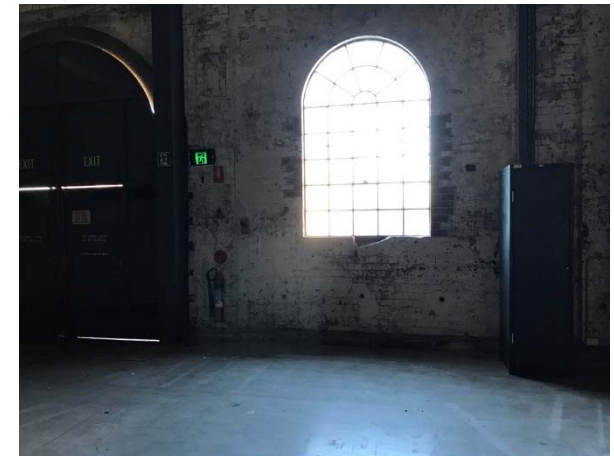
Photo 90: Bay 14 – Analysis and XRF screening of the off-white arched heritage window frame on the northern wall of Bay 14 identified lead based paints

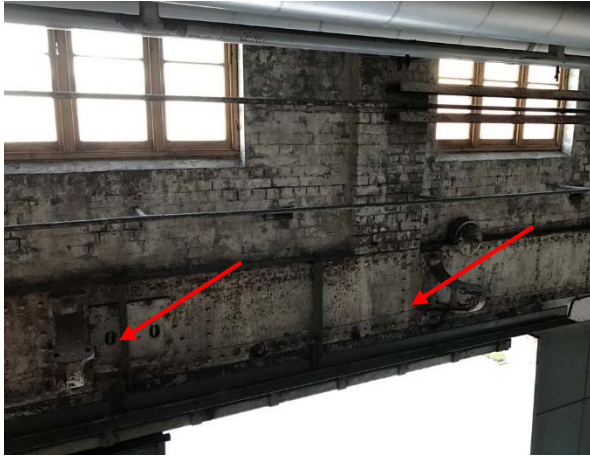
Photo 91: Bay 14 –XRF screening of the off-white paint on the steel lintel beam spanning the southern entry to Bay 14 identified lead based paints. This beam is also present on the northern wall and is deteriorated and flaking.

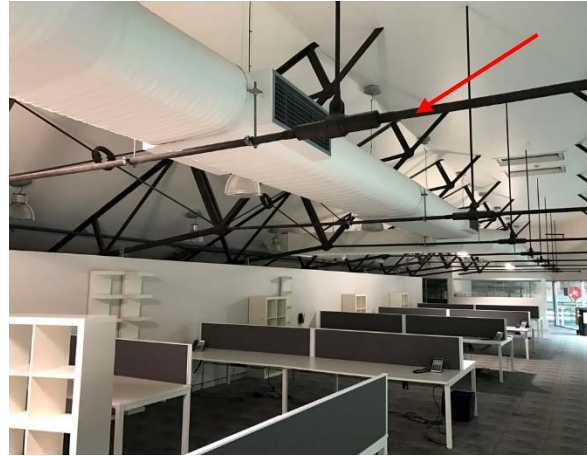
Photo 92: Bay 15 – XRF screening of heritage structural steel columns, capitals, beams, downpipes, purlins, crane rails and roof trusses throughout the bay identified lead based paints. Columns, beams, crane rails and trusses penetrate the office spaces on this level.

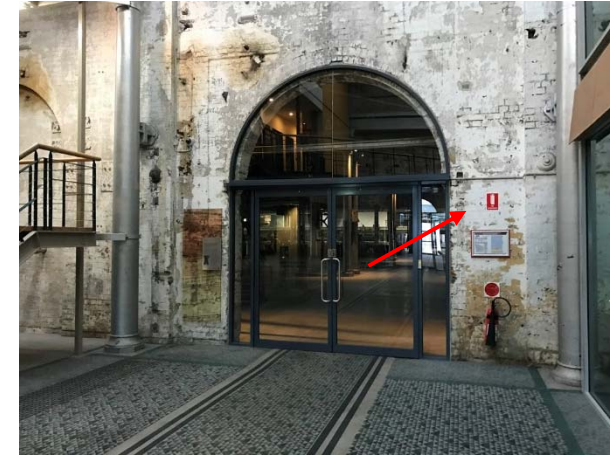
Photo 93: Bay 15 – XRF screening of off-white paint on the eastern wall adjacent the Central Road access door identified lead based paints. A black undercoat was observed in this location.

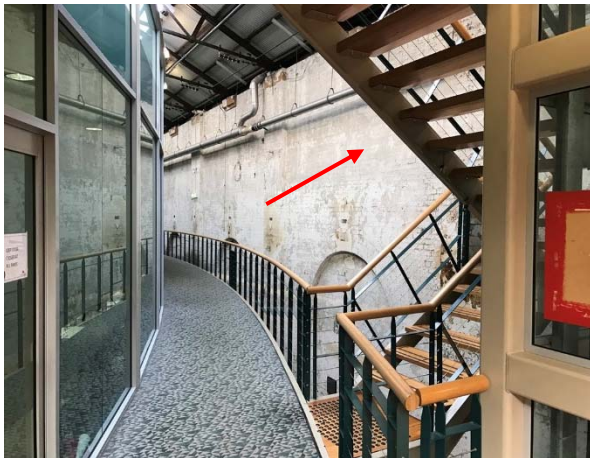
Photo 94: Bay 15 – All walls, older patchy undercoats concealed beneath the white surface coat may contain lead based paint.

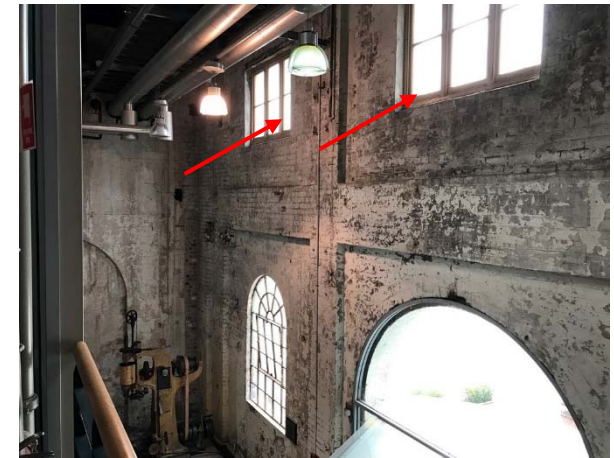
Photo 96: Bay 15 – XRF screening of the mustard rectangular timber windows located on the upper north and south walls of the building have identified lead based paints.

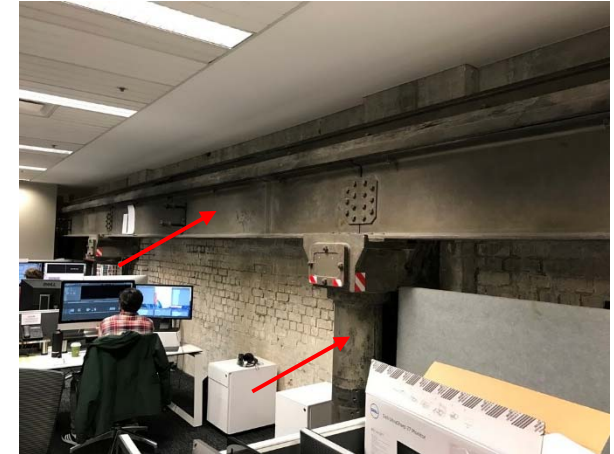
Photo 99: Bay 16 – XRF screening of the heritage structural steel columns, capitals, beams, downpipes, purlins, crane rails and roof trusses throughout the bay identified lead based paints

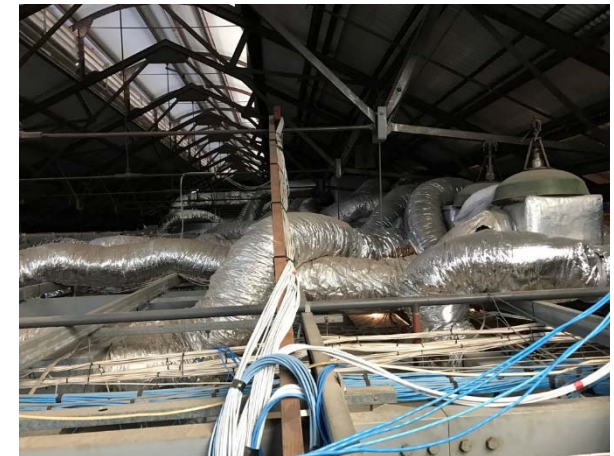
Photo 102: Bay 16 – Lead dust samples collected from the flat roofs of the northern and southern office blocks identified lead contaminated dusts. Fixed and flexible air-conditioning ductwork on the Level 1 office roof is insulated with SMF.
