**Date** 7/08/2018  
**To** Chris Callaghan  
**From** Nicholas Sheldrake  
**Copy to** Zac Langford, John Chalmers, Belinda Aspinall  
**Subject** Locomotive Workshop, Australian Technology Park (ATP) – Existing Slab on Grade at Entry to Proposed Loading Dock at Bay 1

Revision 2 –  
07/8/18

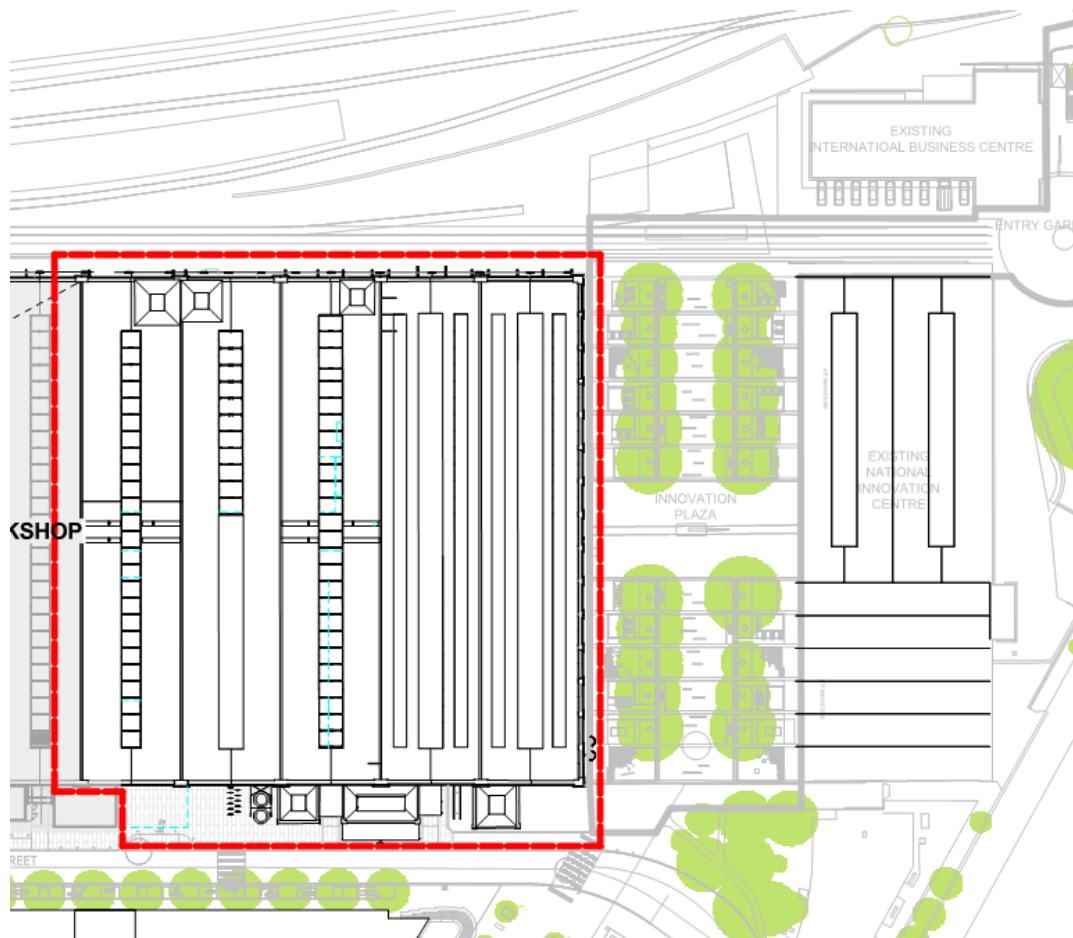
This memorandum summarises the findings of a site inspection carried out on 23<sup>rd</sup> January 2018 of the condition and capacity of the existing slab on grade, adjacent to the entry of Locomotive Workshop's loading dock entry at Bay 1 of the site, within Innovation Plaza as illustrated in Figure 1 below.

**Figure 1: Loading dock entry to Locomotive Workshop and slab on grade reference location**

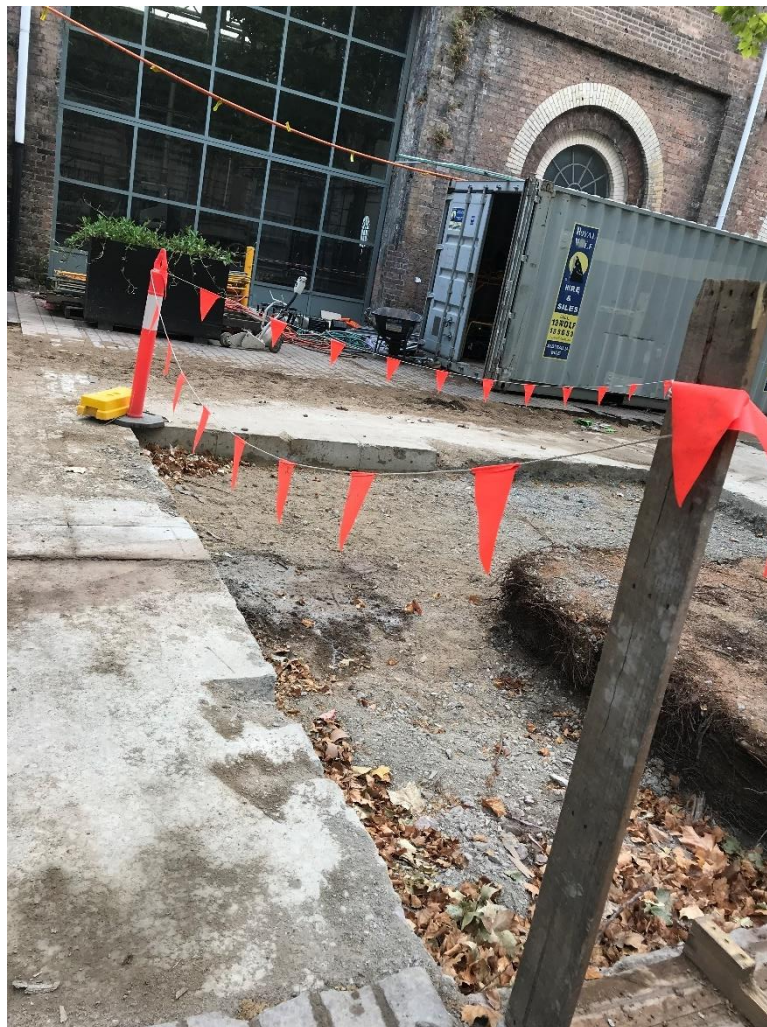
The existing slab on grade consists of reinforced concrete construction, with minimum depth of 200mm varying up to 300mm in some locations. Associated public domain construction works such as tree planter modification and minor replacement of pavers are currently underway within Innovation Plaza, and has exposed the existing slab on grade in some areas enabling a visual inspection to take place. The existing slab is generally in good condition supported on compacted material, and is capable of withstanding trafficable loads up to AS 2890 definition of Heavy Rigid Vehicle (HRV) classification, typically up to 12 tonnes Gross Vehicle Mass (GVM).

This existing slab on grade has also been subject to construction vehicular traffic, including small excavators and trucks of up to 10 tonnes, and no signs of distress have been reported to date. The existing pavers are in good condition and appear to be of similar masonry form to match the Locomotive Workshop and Innovation Centre façade construction.

**Figure 2: Existing reinforced concrete slab on grade**

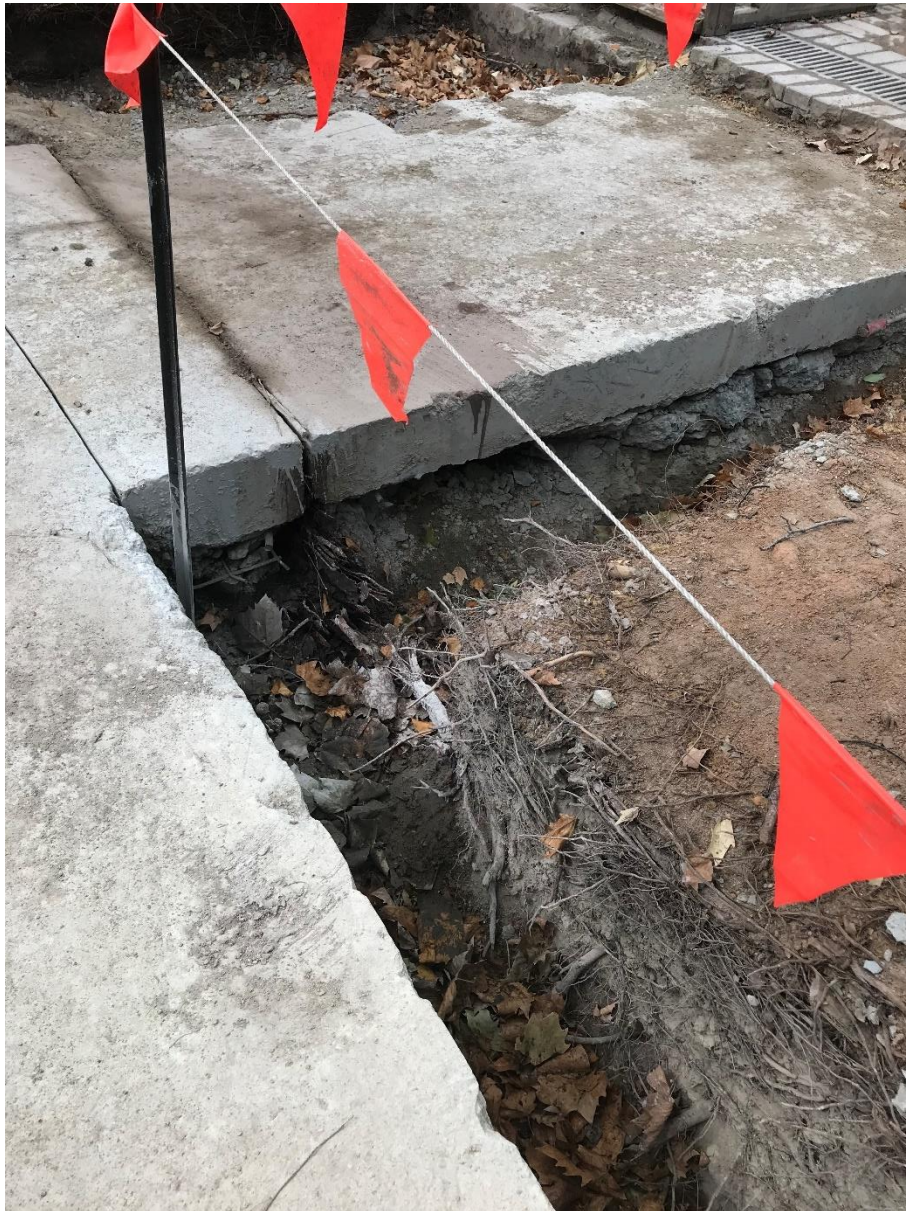
***Figure 3: Existing reinforced concrete slab on grade***

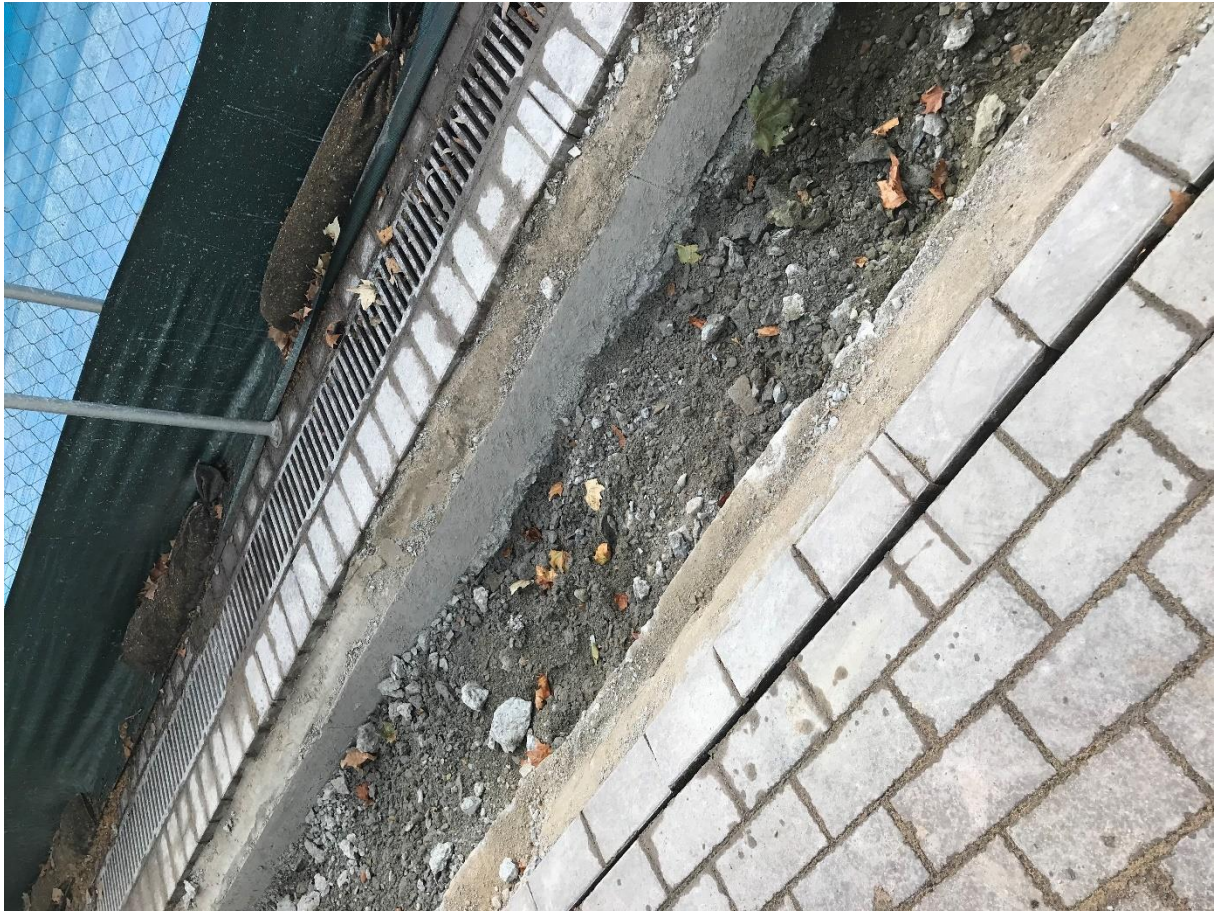
***Figure 4: Existing slab on grade and paver construction***
