# Hazardous Materials Survey

72-88 Water Street, Strathfield South NSW

**Report No:** Hazardous Materials Survey E26573.E10.002\_Rev1

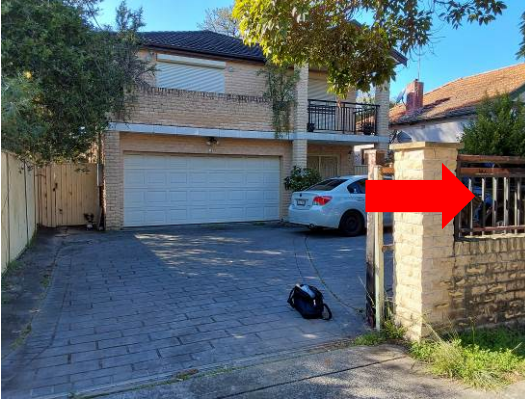
| External, western wall, metal gate and fencing | Black Paint | Non-friable | 72Pb-1 | 0.001% w/w | N/A | N/A | N/A | N/A | N/A | |

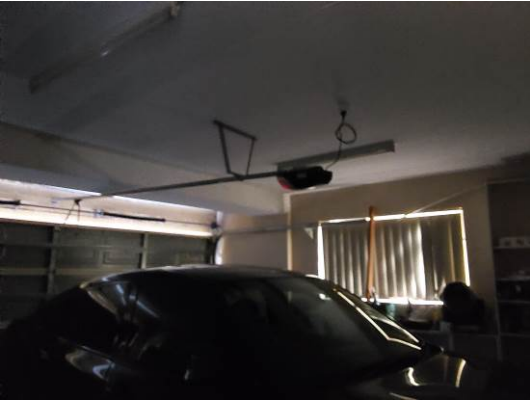
| Internal, garage, ceilings, fluorescent light fittings | PCB-containing single-tube fluorescent light fitting capacitors (assumed) | N/A | Visual inspection - electrical hazard | - | 2 x fittings | Good / Maintenance only | Priority 4 - Negligible Risk Level | 25/7/2025 | Remove prior to demolition works.<br>Avoid damage to capacitors. | |

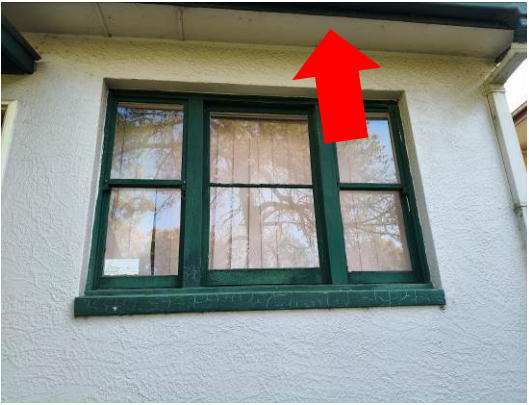
| External, eaves throughout | ACM (assumed) | Non-friable | Visual inspection - height restriction | - | Approximately 30m <sup>2</sup> | Good / Maintenance only | Priority 4 - Negligible Risk Level | 25/7/2025 | Remove during initial stage of demolition works | |

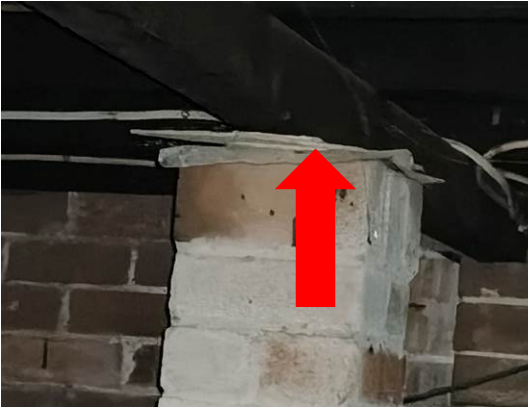
| Subfloor area, packers in between brick pylons and timber floor joists | ACM (assumed) | Non-friable | Visual inspection - height restriction | - | 1-5m <sup>2</sup> | Poor / Maintenance only | Priority 3 - Low Risk Level | 25/7/2025 | Remove under controlled demolition conditions | |

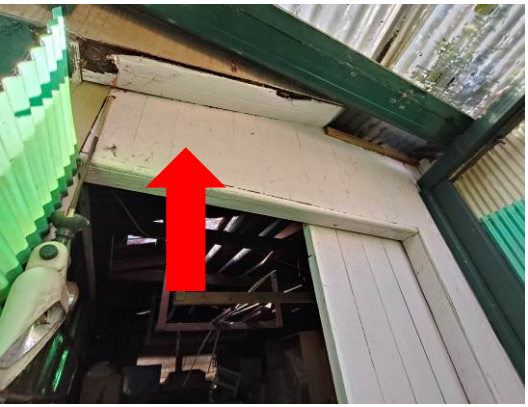
| External, laundry shed, northern wall | ACM<br>(assumed) | Non-friable | Visual inspection | - | Approximately 2m <sup>2</sup> | Good / Maintenance only | Priority 4 - Negligible Risk Level | 25/7/2025 | Remove during initial stage of demolition works | |

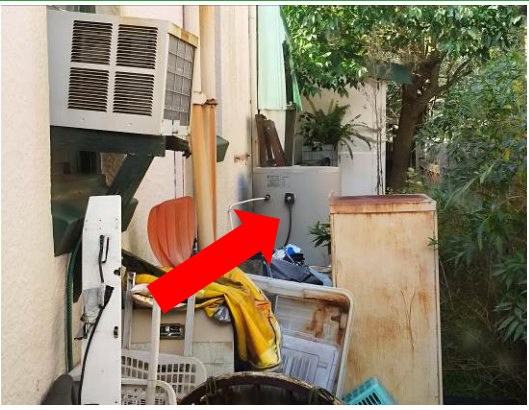
| External, northern wall, hot water heater | SMF-lined insulation<br>(assumed) | Sealed | Visual inspection - electrical hazard | - | 1 x unit | Good / Maintenance only | Priority 4 - Negligible Risk Level | 25/7/2025 | Remove during initial stage of demolition works | |

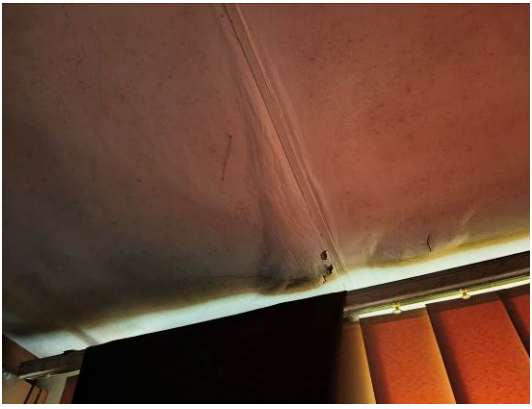
| Interior, southern room, ceiling | White LBP | Non-friable | LBP74-1 | 0.11% w/w | Approximately 10m <sup>2</sup> | Fair / Maintenance only | Priority 4 - Negligible Risk Level | 25/7/2025 | Remove grossly peeling paint. Stabilise remaining membrane. Minimise abrasive works that will disturb paint during demolition. | |

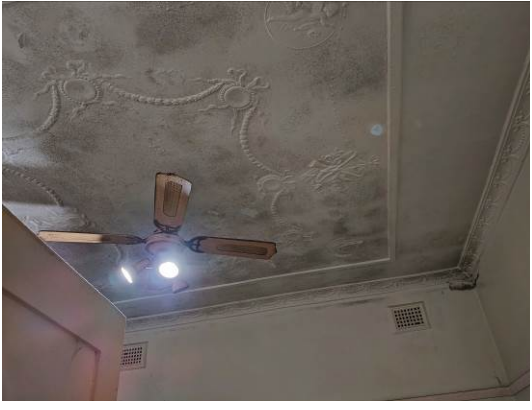
| Internal, south east room, ceiling | White LBP | Non-friable | LBP74-2 | 8.9% w/w | Approximately 10m <sup>2</sup> | Good / Maintenance only | Priority 4 - Negligible Risk Level | 25/7/2025 | Remove grossly peeling paint. Stabilise remaining membrane. Minimise abrasive works that will disturb paint during demolition. | |

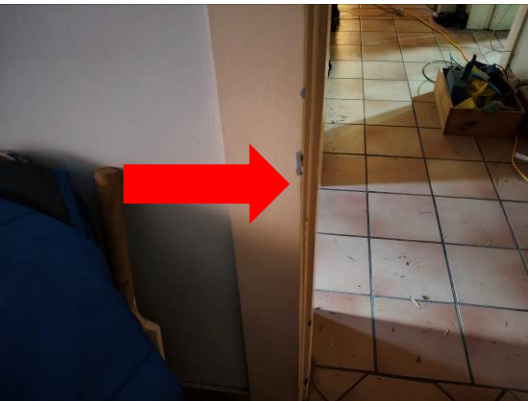
| Internal, south east room, door frame | Cream LBP | Non-friable | LBP74-3 | 0.11% w/w | 5x door frames | Fair / Maintenance only | Priority 4 - Negligible Risk Level | 25/7/2025 | Remove grossly peeling paint. Stabilise remaining membrane. Minimise abrasive works that will disturb paint during demolition. | |

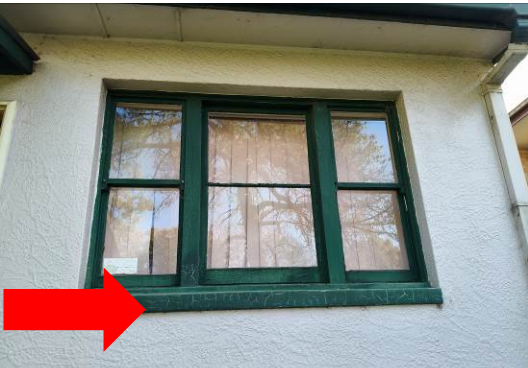
| External, window frames throughout | Green LBP | Non-friable | LBP74-4 | 0.12% w/w | 4x windows | Fair / Maintenance only | Priority 4 - Negligible Risk Level | 25/7/2025 | Remove grossly peeling paint. Stabilise remaining membrane. Minimise abrasive works that will disturb paint during demolition. | |

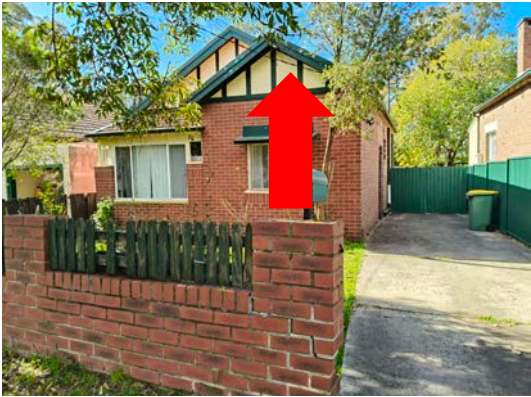
| External, main dwelling, western gables | ACM (assumed) | Non-friable | Visual inspection | - | Approximately 25m <sup>2</sup> | Good / Maintenance only | Priority 4 - Negligible Risk Level | 25/7/2025 | Remove during initial stage of demolition works | |

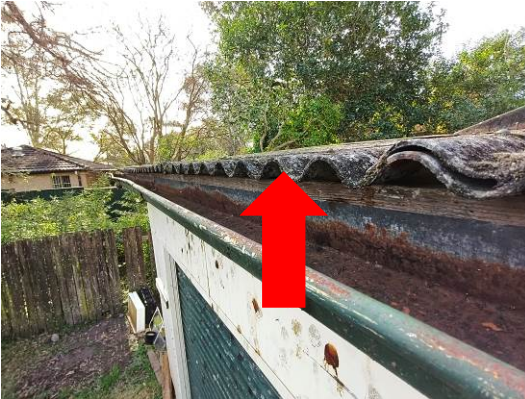
All identified hazardous building materials were ranked **Priority 3 or Priority 4** (i.e. stable and posing low to negligible health risk under present conditions), excluding the corrugated ACM roofing and the potential fibrous residue within the gutter and down-pipe systems of the detached garage at 76 Water Street, which is ranked **Priority 2 - Elevated Risk**.

| External, detached garage, corrugated roof | ACM | Non-friable | ASB76-02 and ASB76-03 | Chrysotile and Amosite Asbestos Detected | Approximately 30m <sup>2</sup> | Fair / Maintenance only | Priority 3 - Low Risk Level | 25/7/2025 | Remove during initial stage of demolition works | |

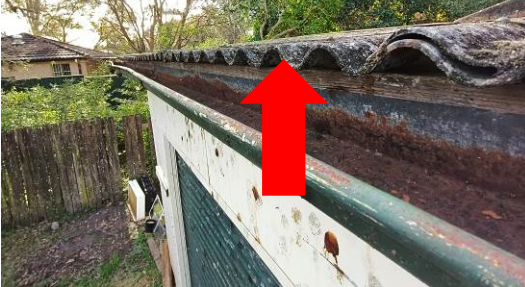
| External, detached garage, gutters and downpipes, fibrous residue | ACM (assumed) | Friable | Visual inspection | - | ND | Poor / Maintenance only | Priority 2 - Elevated Risk Level | 1/7/2025 | Fibrous residue associated with runoff from asbestos cement roof<br>Clean gutters and downpipes, prior to demolition | |

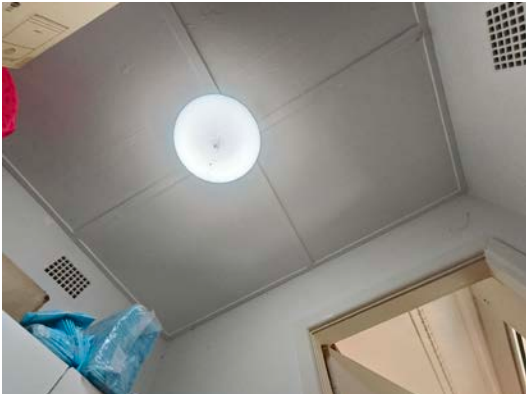
| Internal, main dwelling, bathroom, ceiling | ACM (assumed) | Non-friable | Visual inspection - height restriction | - | Approximately 5m <sup>2</sup> | Good / Maintenance only | Priority 4 - Negligible Risk Level | 25/7/2025 | Remove during initial stage of demolition works | |

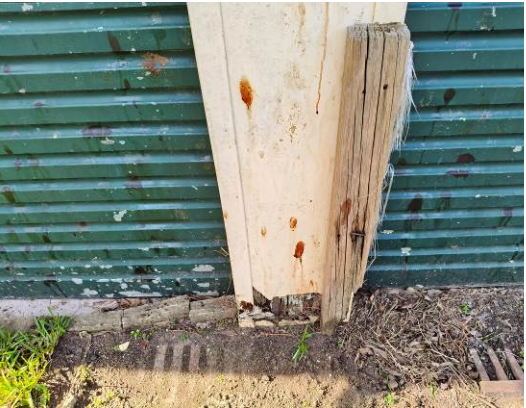
| External, detached garage, eastern wall | FCS | Non-friable | ASB76-01 | No Asbestos Detected | N/A | N/A | N/A | N/A | N/A | |

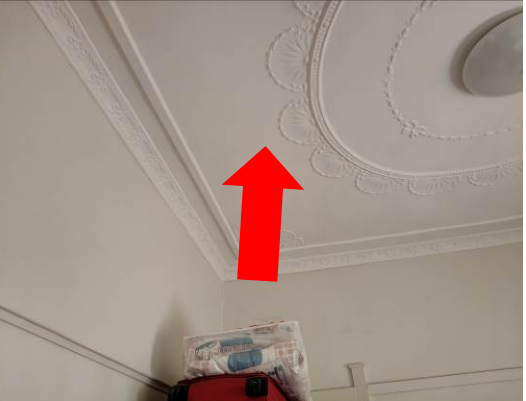
| Internal, main dwelling, ceilings throughout | White LBP | Non-friable | LBP76-01 | 0.23% w/w | Approximately 70m <sup>2</sup> | Good / Maintenance only | Priority 4 - Negligible Risk Level | 25/7/2025 | Remove grossly peeling paint. Stabilise remaining membrane. Minimise abrasive works that will disturb paint during demolition. | |

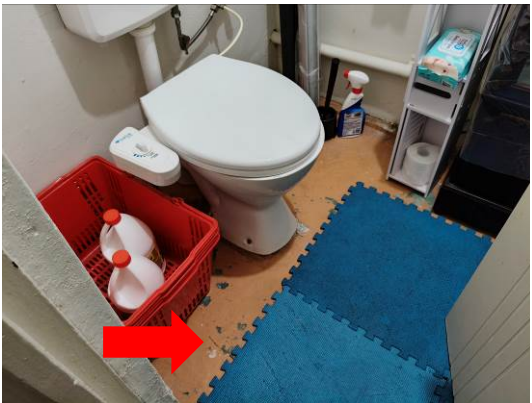
| Internal, main dwelling, eastern corner room, floor | Orange LBP | Non-friable | LBP76-03 | 0.21% w/w | Approximately 20m <sup>2</sup> | Good / Maintenance only | Priority 4 - Negligible Risk Level | 25/7/2025 | Remove grossly peeling paint. Stabilise remaining membrane. Minimise abrasive works that will disturb paint during demolition. | |

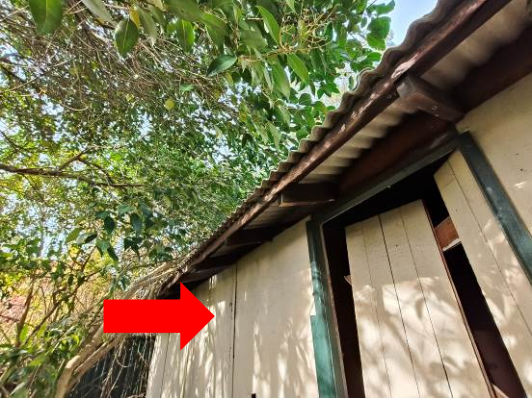
| External, detached shed, eastern wall | Cream Paint | Non-friable | LBP76-02 | 0.023% w/w | N/A | N/A | N/A | 25/7/2025 | N/A | |

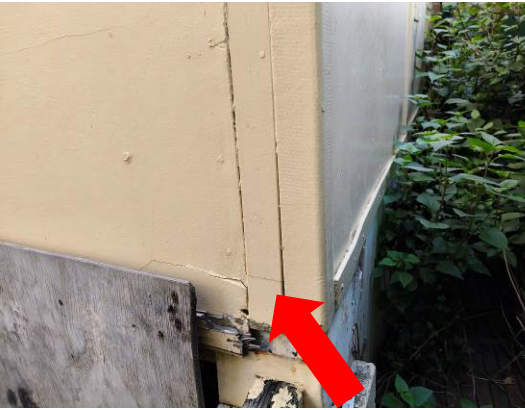
| External, north-eastern wall, corner trimming | ACM | Non-friable | ASB78-01 | Chrysotile and Amosite Asbestos Detected | Approximately 5m <sup>2</sup> | Good / Maintenance only | Priority 4 - Negligible Risk Level | 25/07/2025 | Remove during initial stage of demolition works | |

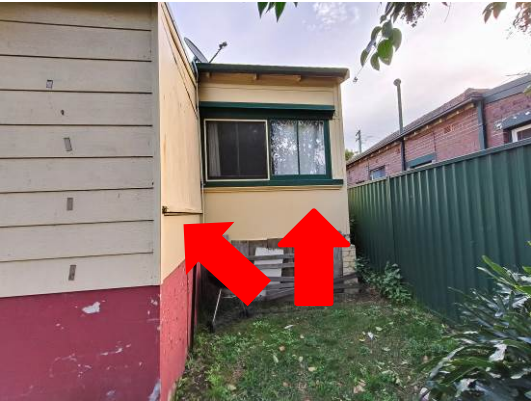
| External, north-eastern walls | ACM (assumed) | Non-friable | Visual inspection - similar to ASB78-01 | - | Approximately 25m <sup>2</sup> | Good / Maintenance only | | 25/07/2025 | Remove during initial stage of demolition works | |

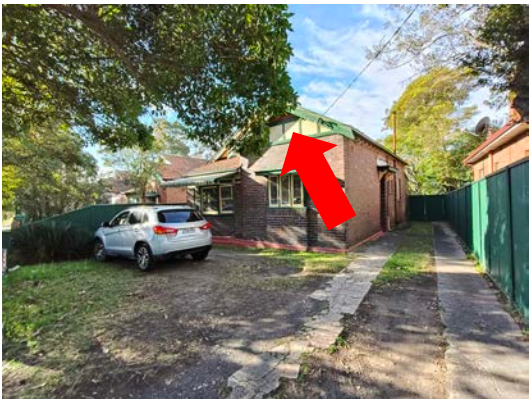
| External, gables | ACM<br>(assumed) | Non-friable | Visual inspection - similar to ASB78-01 | - | Approximately 20m <sup>2</sup> | Good / Maintenance only | Priority 4 - Negligible Risk Level | 25/07/2025 | Remove during initial stage of demolition works | |

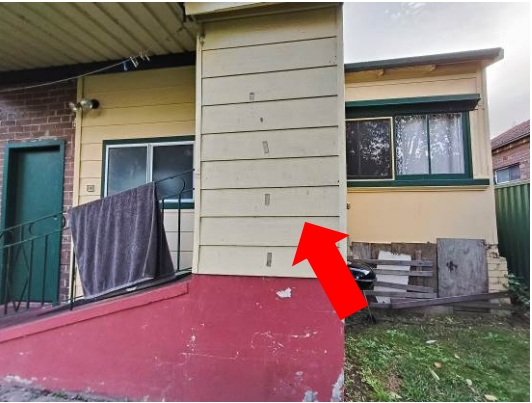
| External, eastern wall cladding | FCS | Non-friable | ASB78-02 | No Asbestos Detected<br>Organic Fibres Detected | N/A | N/A | N/A | N/A | N/A | |

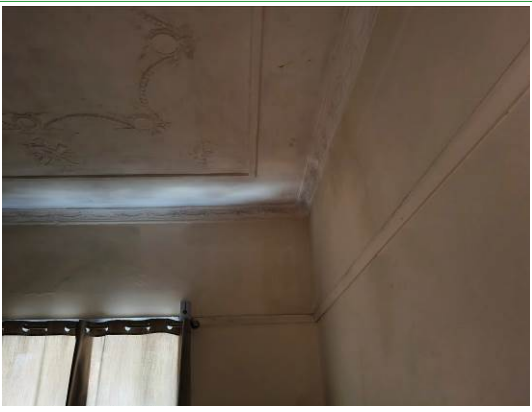
| Internal, central room, ceiling | White LBP | Non-friable | LBP78-1 | 2.2% w/w | Approximately 50m <sup>2</sup> | Good / Occasional | Priority 4 - Negligible Risk Level | 25/7/2025 | Remove grossly peeling paint. Stabilise remaining membrane. Minimise abrasive works that will disturb paint during demolition. | |

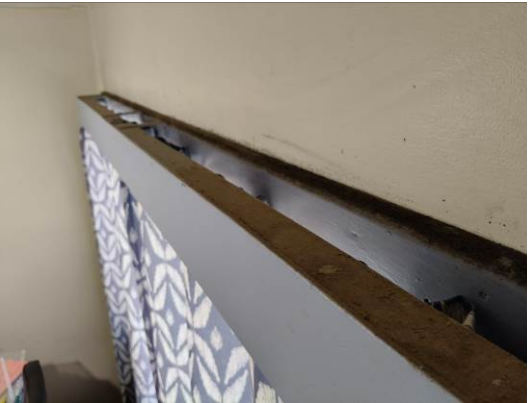
| Internal, eastern room, window sill | Grey Paint | Non-friable | LBP78-2 | 0.020% w/w | N/A | N/A | N/A | N/A | N/A |

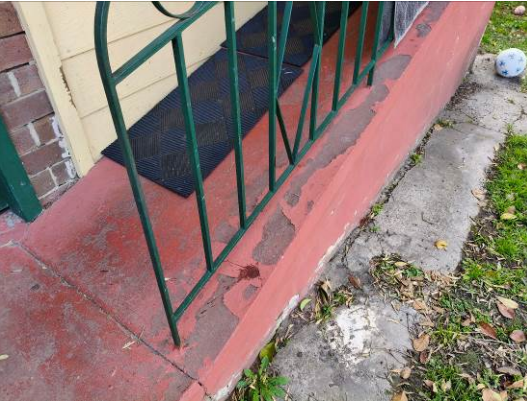
| External, eastern ramp, concrete floor | Red Paint | Non-friable | LBP78-3 | 0.085% w/w | N/A | N/A | N/A | N/A | N/A |

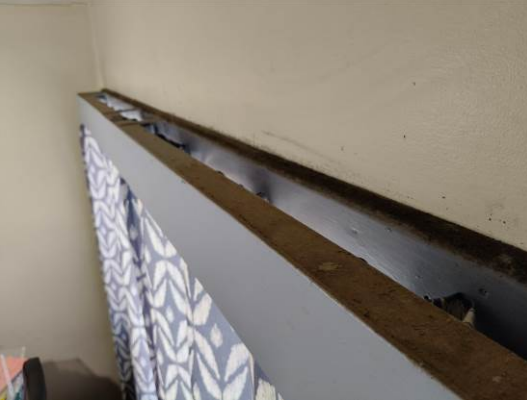
| Internal, eastern room, window sill | Dust / debris | Friable | LCD78-01 | 120 mg/kg | Low load | N/A | N/A | N/A | Review levels as part of a risk assessment for management, and remediate dust under controlled conditions prior to demolition works. |

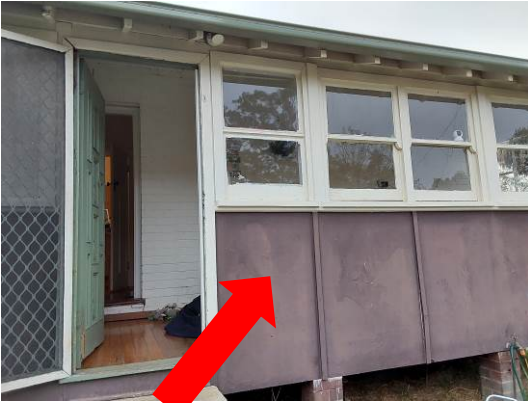
| External, eastern walls | ACM | Non-friable | 82Asb-1 | Chrysotile, Amosite and Crocidolite Asbestos Detected | Approximately 20m <sup>2</sup> | Good / Occasional | Priority 4 - Negligible Risk Level | 25/7/2025 | Remove during initial stage of demolition works | |

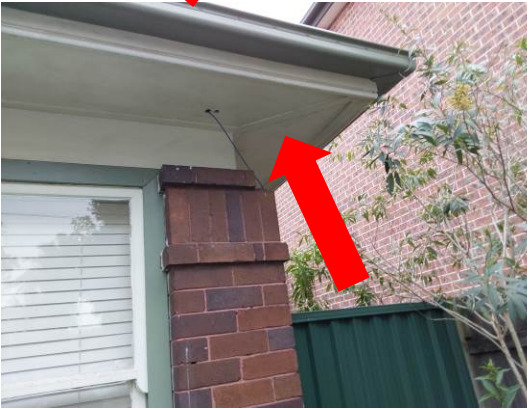
| External, eaves throughout | ACM (assumed) | Non-friable | Visual inspection - height restriction | - | Approximately 20m <sup>2</sup> | Good / Maintenance only | Priority 3 - Low Risk Level | 25/7/2025 | Remove during initial stage of demolition works | |

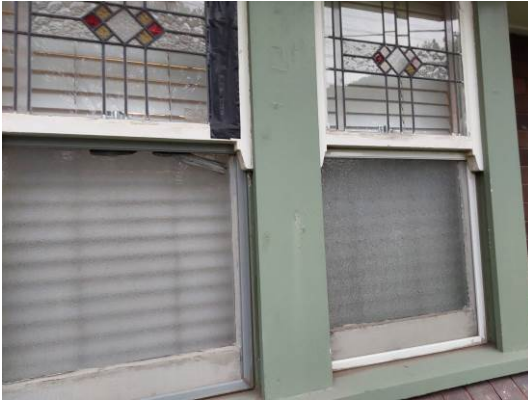
| External, western wall, window sill | Green Paint | Non-friable | 82Pb-1 | 0.099% w/w | N/A | N/A | N/A | N/A | N/A | |

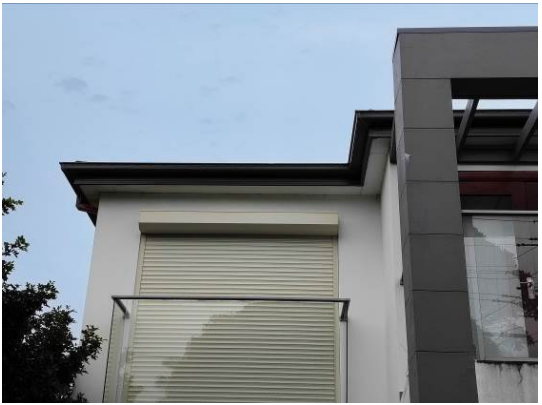
| External, eaves throughout | FCS (assumed) | Non-friable | Visual inspection – height restriction | - | N/A | N/A | N/A | N/A | Building was constructed circa 2010 and therefore the eaves were not assumed to be ACM | |

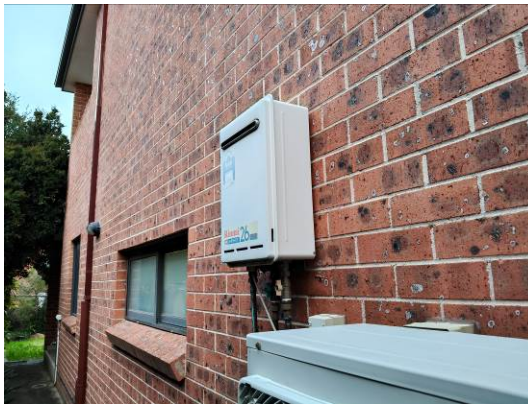
| External, northern wall, gas unit | SMF-lined insulation (assumed) | Sealed | Visual inspection | - | 1 x unit | Good / Maintenance only | Priority 4 - Negligible Risk Level | 25/7/2025 | Remove during initial stage of demolition works | |

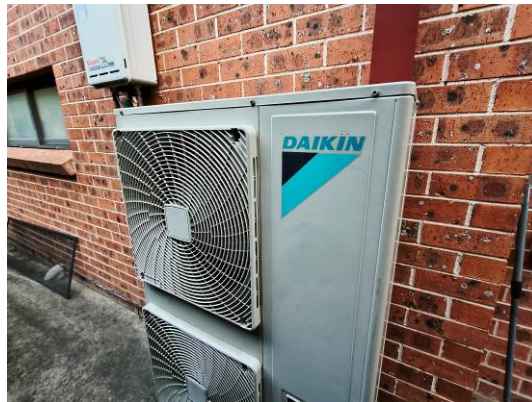
| External, northern wall, air conditioning units | SMF-lined insulation (assumed) | Sealed | Visual inspection - height restriction | - | 2 x units | Good / Maintenance only | | 25/7/2025 | Remove during initial stage of demolition works | |

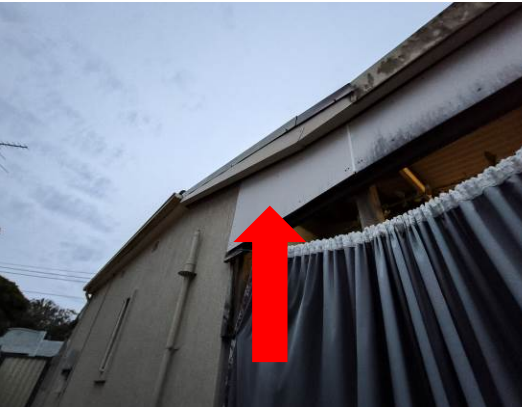
| External, detached shed, upper panel | ACM (assumed) | Non-friable | Visual inspection - height restriction | - | Approximately 5m <sup>2</sup> | Good / Maintenance only | Priority 4 - Negligible Risk Level | 25/7/2025 | Remove during initial stage of demolition works | |

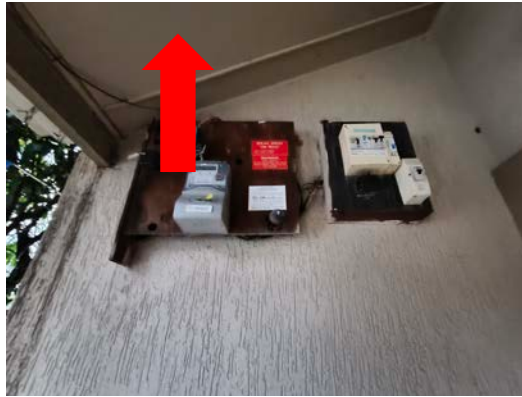
| External, main dwelling, western patio, soffit | ACM (assumed) | Non-friable | Visual inspection - height restriction | - | Approximately 20m <sup>2</sup> | Good / Maintenance only | | 25/7/2025 | Remove during initial stage of demolition works | |

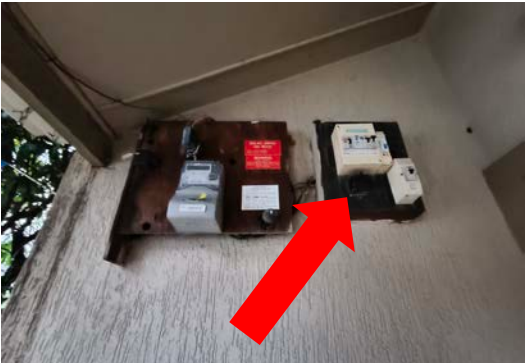
| External, main dwelling, western patio, electrical distribution box | ACM (assumed) | Non-friable | Visual inspection - electrical hazard | - | 1x unit | Good / Maintenance only | Priority 4 - Negligible Risk Level | 25/7/2025 | Remove during initial stage of demolition works | |

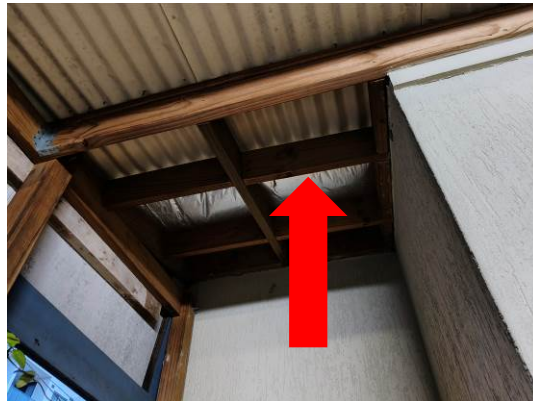
| External, detached shed, eastern roofing, sarking | SMF-lined insulation (assumed) | Sealed | Visual inspection - height restriction | - | Approximately 10m <sup>2</sup> | Good / Maintenance only | Priority 4 - Negligible Risk Level | 25/7/2025 | Remove during initial stage of demolition works | |

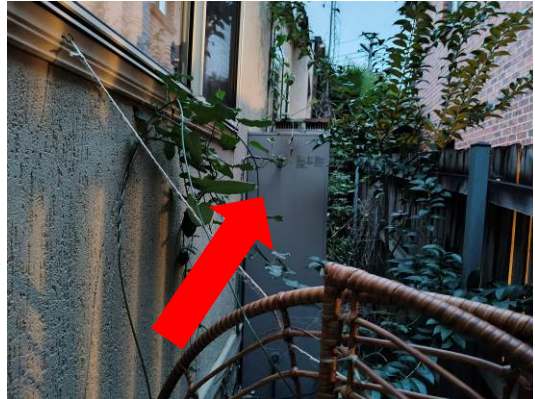
| External, main dwelling, northern wall, hot water heater | SMF-lined insulation (assumed) | Sealed | Visual inspection - electrical hazard | - | 1 x unit | Good / Maintenance only | Priority 4 - Negligible Risk Level | 25/7/2025 | Remove during initial stage of demolition works | |

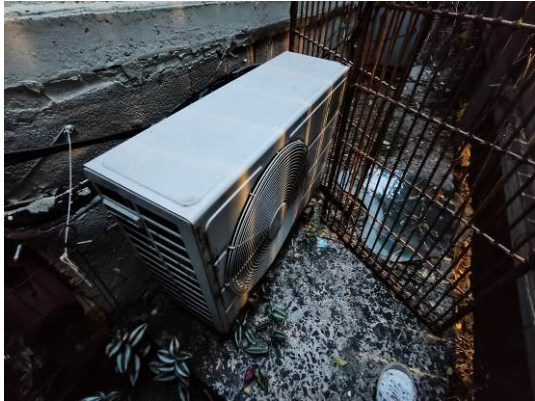
| External, northern wall, air conditioning unit | SMF-lined insulation (assumed) | Sealed | Visual inspection - electrical hazard | - | 1 x unit | Good / Maintenance only | Priority 4 - Negligible Risk Level | 25/7/2025 | Remove during initial stage of demolition works | |

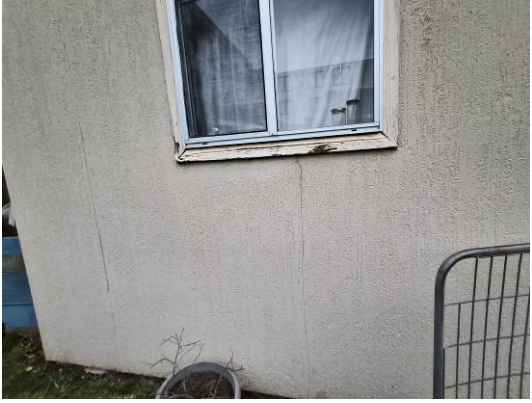
| External, detached shed, eastern window sill | White Paint | Non-friable | LBP86-01 | 0.002% w/w | N/A | N/A | N/A | N/A | N/A | |

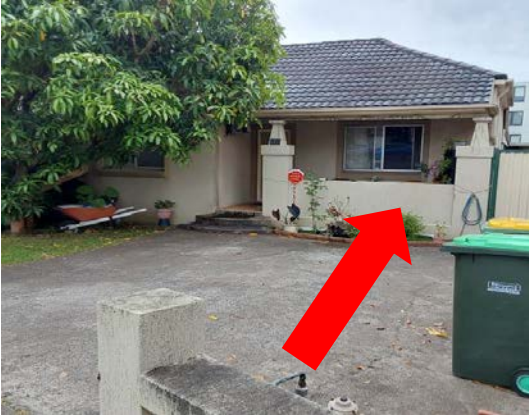
| External, main dwelling, walls throughout | Grey Paint | Non-friable | LBP86-02 | <0.001% w/w | N/A | N/A | N/A | N/A | N/A | |

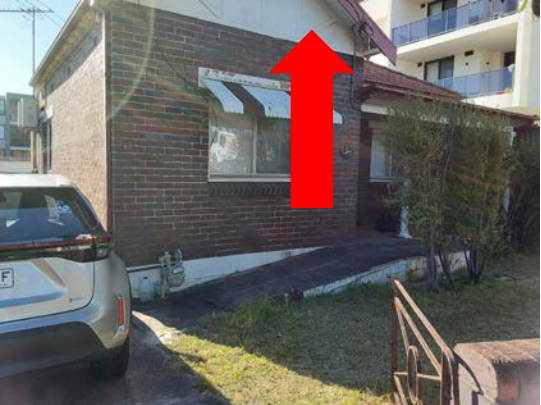
| Hazardous Materials Register<br>72-88 Water Street, Belfield NSW | | | | | | | | | | 88 Water Street |
|---|---|---|---|---|---|---|---|---|---|---|
| External, western gable | ACM (assumed) | Non-friable | Visual inspection – height restriction | - | Approximately 5m <sup>2</sup> | Good / Maintenance only | Priority 4 - Negligible Risk Level | 25/07/2025 | Remove during initial stage of demolition works | |

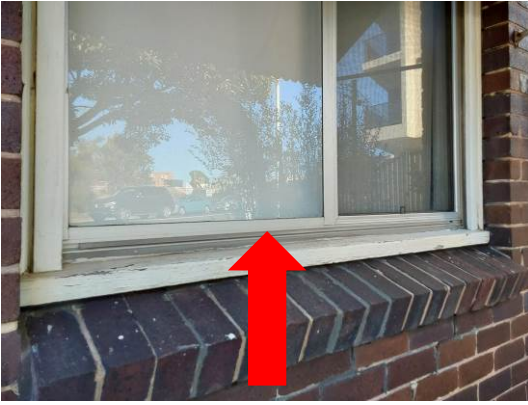
| External, window sills throughout | White LBP | Non-friable | 88Pb-1 | 4.6% w/w | 4 x windows | Fair / Maintenance only | Priority 4 - Negligible Risk Level | 25/7/2025 | Remove grossly peeling paint. Stabilise remaining membrane. Minimise abrasive works that will disturb paint during demolition. | |

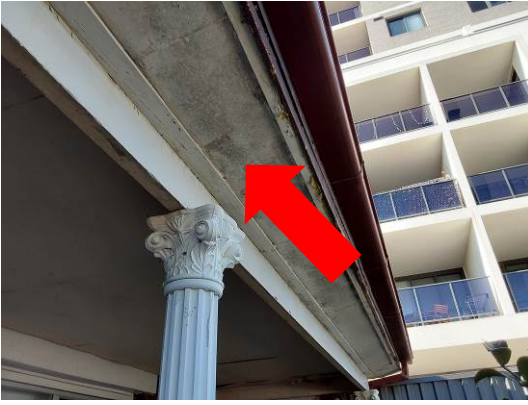
| External, western balcony, eaves | White LBP | Non-friable | 88Pb-2 | 0.23% w/w | 15-30m² | Good / Maintenance only | Priority 4 - Negligible Risk Level | 25/7/2025 | Remove grossly peeling paint. Stabilise remaining membrane. Minimise abrasive works that will disturb paint during demolition. | |

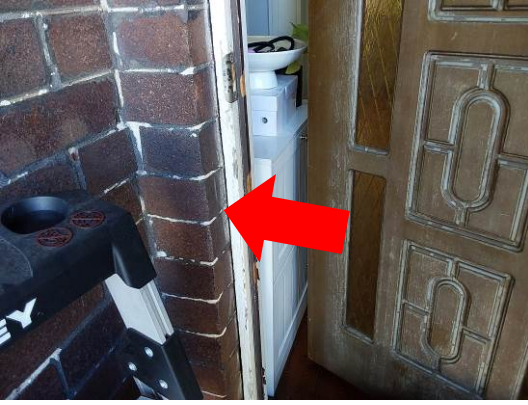
| External, western entrance, door frame | White LBP | Non-friable | 88Pb-3 | 4.0% w/w | Approximately 2m² | Good / Maintenance only | Priority 4 - Negligible Risk Level | 25/7/2025 | Remove grossly peeling paint. Stabilise remaining membrane. Minimise abrasive works that will disturb paint during demolition. | |

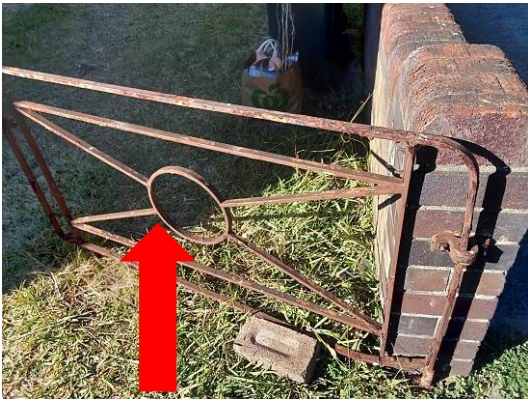
| External, western yard, metal gate | Yellow LBP | Non-friable | 88Pb-4 | 0.56% w/w | 1 x gate | Good / Regular | Priority 4 - Negligible Risk Level | 25/7/2025 | Remove grossly peeling paint. Stabilise remaining membrane. Minimise abrasive works that will disturb paint during demolition. | |

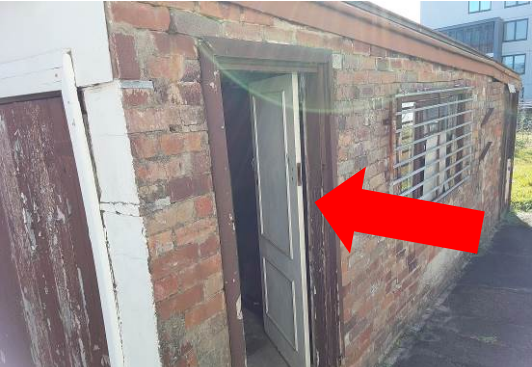
| External, garage, door frame | Brown LBP | Non-friable | 88Pb-5 | 3.3% w/w | 1x door frame | Fair / Occasional | Priority 4 - Negligible Risk Level | 25/7/2025 | Remove grossly peeling paint. Stabilise remaining membrane. Minimise abrasive works that will disturb paint during demolition. | |

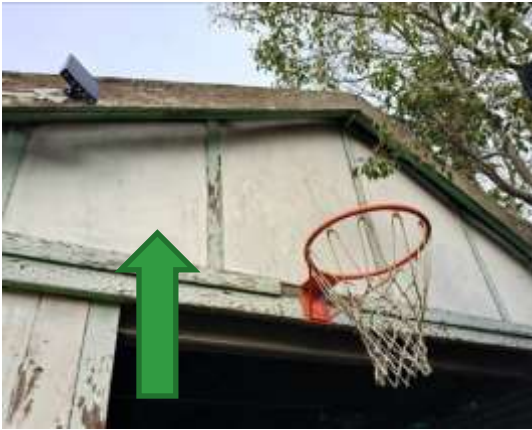
| External, detached garage, southern wall, gable infill panel | ACM | Non-friable | ASB80-1 | Chrysotile Asbestos Detected | Approximately 10m <sup>2</sup> | Good / Maintenance only | Priority 4 - Negligible Risk Level | 25/07/2025 | Remove during initial stage of demolition works | |

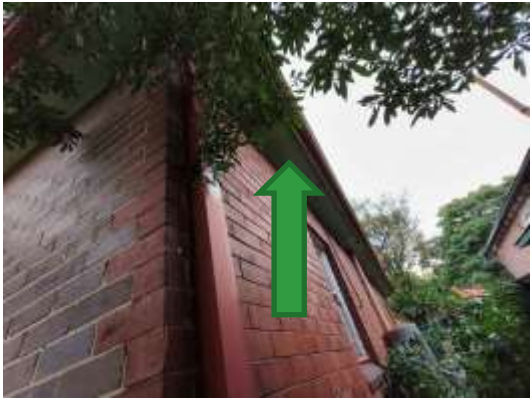
| External, eaves throughout | ACM (assumed) | Non-friable | Visual inspection – height restriction | - | Approximately 30m <sup>2</sup> | Good / Maintenance only | Priority 4 - Negligible Risk Level | 25/07/2025 | Remove during initial stage of demolition works | |

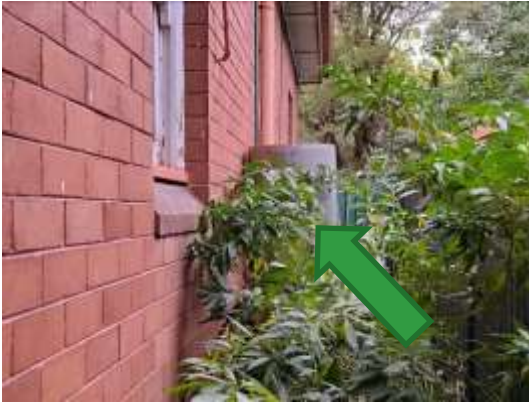
| External, main dwelling, northern wall, hot water heater | SMF-lined insulation (assumed) | Sealed | Visual inspection - electrical hazard | - | 1 x unit | Good / Maintenance only | Priority 4 - Negligible Risk Level | 25/07/2025 | Remove during initial stage of demolition works | |

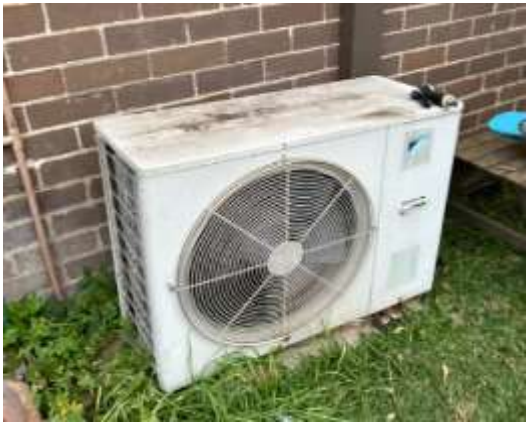
| External, main dwelling, north eastern wall, AC unit | SMF-lined insulation | Sealed | Visual inspection - electrical hazard | - | 1 x unit | Good / Maintenance only | Priority 4 - Negligible Risk Level | 25/07/2025 | Remove during initial stage of demolition works | |

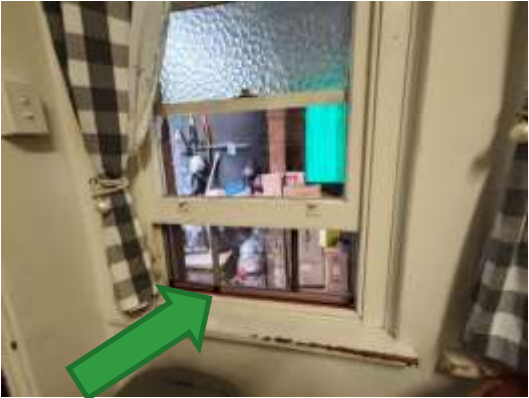
| Internal, main dwelling, western room, kitchen, window frame | White LBP | Non-friable | LBP80-01 | 14% w/w | Approximately 5m² | Good / Maintenance only | Priority 4 - Negligible Risk Level | 25/07/2025 | Remove grossly peeling paint. Stabilise remaining membrane. Minimise abrasive works that will disturb paint during demolition. | |

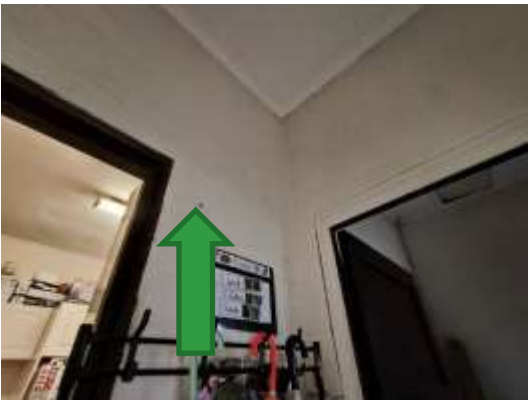
| Internal, main dwelling, north western room, walls throughout | White LBP | Non-friable | LBP80-02 | 0.20% w/w | Approximately 70m² | Good / Maintenance only | Priority 4 - Negligible Risk Level | 25/07/2025 | Remove grossly peeling paint. Stabilise remaining membrane. Minimise abrasive works that will disturb paint during demolition. | |

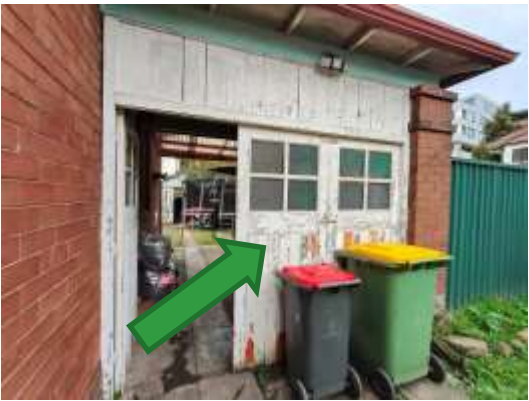
| External, main dwelling, southern wall adjacent yard entrance | White LBP | Non-friable | LBP80-03 | 4.6% w/w | Approximately 10m² | Fair / Occasional | Priority 4 - Negligible Risk Level | 25/07/2025 | Remove grossly peeling paint.<br>Stabilise remaining membrane.<br>Minimise abrasive works that will disturb paint during demolition. | |

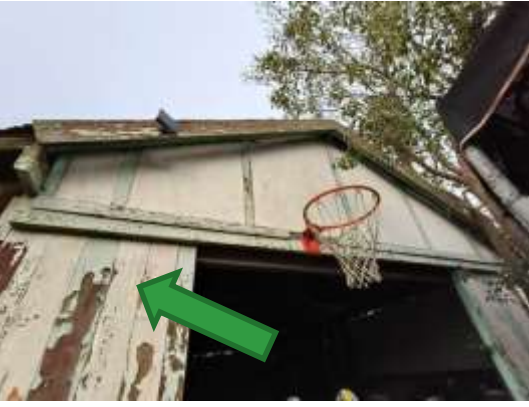
| External, detached garage, southern wall | White LBP | Non-friable | LBP80-04 | 12% w/w | 10-30m² | Poor / Occasional | Priority 3 - Low Risk Level | 25/07/2025 | Remove grossly peeling paint.<br>Stabilise remaining membrane.<br>Minimise abrasive works that will disturb paint during demolition. | |
