## **Review of Existing Documentation in relation to the SEARS 24 Requirements for the State Significant Development Application for 601 Pacific Highway, St Leonards NSW 2065**

# **Hazardous Building Materials Re-inspection Assessment<sup>1</sup>**

**601 Pacific Highway, St Leonards NSW 2065**

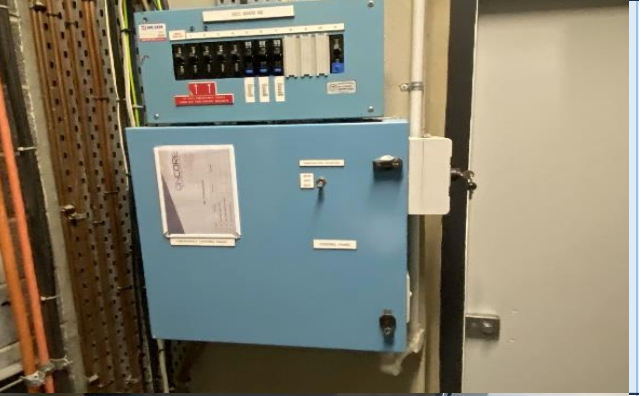
| Client: Stockland | | | | Site Address: 601 Pacific Highway, St Leonards NSW 2065 | | | | Client No: S0003 | | | | Job No: 115528S | | | | Consultant: TAI | | | |
|---|---|---|---|---|---|---|---|---|---|---|---|---|---|---|---|---|---|---|---|
| 12 | Internal - Level 12 | Electrical and communication s cupboard | Fuseboard | Fuses | Asbestos | Assumed Positive | Not sampled: live electrics | Friable | — | None under normal occupation and use | Low | Good | Low | UQ | P3 | Confirm Status, label as containing asbestos and maintain in current condition if to remain in-situ, remove under controlled friable asbestos removal conditions prior to refurbishment or demolition works by a Class A (friable) licensed asbestos removal contractor. | 16-02-2024 | 16-02-2029 | |

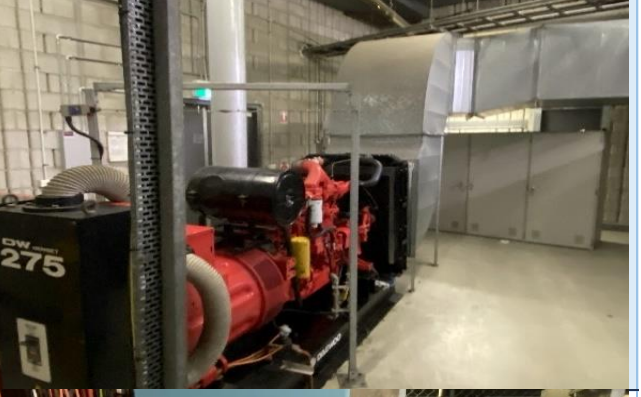
| Client: Stockland | | | | Site Address: 601 Pacific Highway, St Leonards NSW 2065 | | | | Client No: S0003 | | | | Job No: 115528S | | | | Consultant: TAI | | | |
|---|---|---|---|---|---|---|---|---|---|---|---|---|---|---|---|---|---|---|---|
| 20 | Internal - Service Level | Generator Room | Daewoo Diesel Generator | Gasket Material | Asbestos | Assumed Positive | Not sampled: live plant | Non-friable | — | None under normal occupation and use | Low | Good | Low | 1 Unit | P4 | Confirm Status, label as containing asbestos and maintain in current condition if to remain in-situ, remove under controlled bonded asbestos removal conditions prior to refurbishment or demolition works by a Class A (friable & non-friable) or Class B (non-friable) licensed asbestos removal contractor. | 16-02-2024 | 16-02-2029 | |

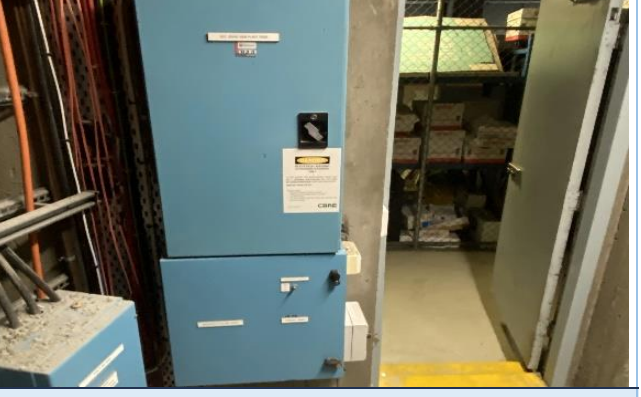
| Client: Stockland | | | | Site Address: 601 Pacific Highway, St Leonards NSW 2065 | | | | Client No: S0003 | | | | Job No: 115528S | | | | Consultant: TAI | | | |
|---|---|---|---|---|---|---|---|---|---|---|---|---|---|---|---|---|---|---|---|
| 21 | Internal - Service Level | Electrical Services Telecoms Room | Distribution board | Bituminous backing board | Asbestos | Assumed Positive | Not sampled: live electrics | Non-friable | — | None under normal occupation and use | Low | Good | Low | 1 Unit | P4 | Confirm Status, label as containing asbestos and maintain in current condition if to remain in-situ, remove under controlled bonded asbestos removal conditions prior to refurbishment or demolition works by a Class A (friable & non-friable) or Class B (non-friable) licensed asbestos removal contractor. | 16-02-2024 | 16-02-2029 | |

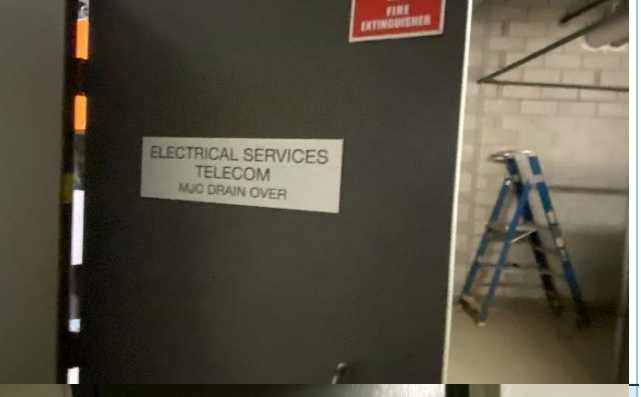
| Client: Stockland | | | | Site Address: 601 Pacific Highway, St Leonards NSW 2065 | | | | Client No: S0003 | | | | Job No: 115528S | | | | Consultant: TAI | | | |
|---|---|---|---|---|---|---|---|---|---|---|---|---|---|---|---|---|---|---|---|
| 26 | Internal—Basement Level 1 | Electrical Services Telecoms Room | Fuseboard | Fuses | Asbestos | Assumed Positive | Not sampled: electrical risk | Friable | — | None under normal occupation and use | Low | Good | Low | 5 Units | - | Item not sighted during 2024 Assessment, assumed to have been removed. No clearance certificate provided. | — | — | |

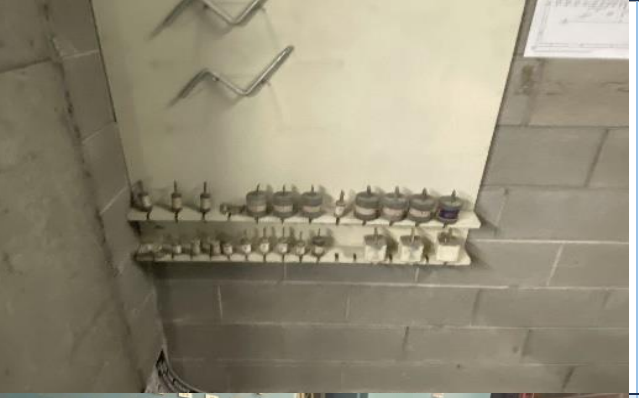
| Client: Stockland | | | Site Address: 601 Pacific Highway, St Leonards NSW 2065 | | | | | | | | | | Client No: S0003 | | | Job No: 115528S | | | Consultant: TAI |
|---|---|---|---|---|---|---|---|---|---|---|---|---|---|---|---|---|---|---|---|
| 35 | Internal - Basement Level 1 | Main Switchroom, North elevation | Stored Items | Fuses | Asbestos | Assumed Positive | Not sampled: electrical risk | Friable | — | None under normal occupation and use | Low | Good | Low | 26 Units | P3 | Confirm Status and maintain in current condition if to remain in-situ, remove under controlled friable asbestos removal conditions prior to refurbishment or demolition works by a Class A (friable) licensed asbestos removal contractor. | 16-02-2024 | 16-02-2029 | |

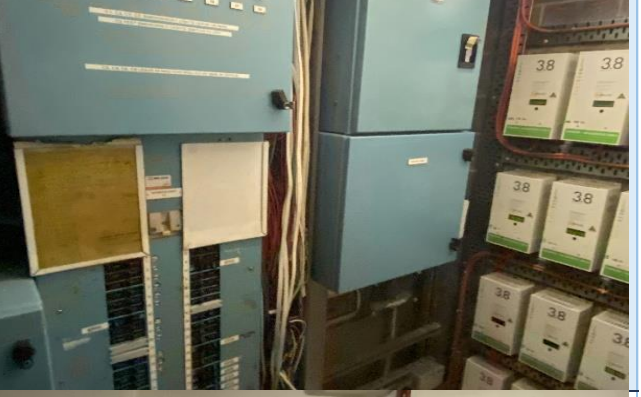
| Client: Stockland | | | Site Address: 601 Pacific Highway, St Leonards NSW 2065 | | | | | | | | | | Client No: S0003 | | | Job No: 115528S | | | Consultant: TAI |
|---|---|---|---|---|---|---|---|---|---|---|---|---|---|---|---|---|---|---|---|
| 37 | Internal - Basement Level 2 | Electrical Services Telecoms Room | Fuseboard | Fuses | Asbestos | Assumed Positive | Not sampled: electrical risk | Friable | — | None under normal occupation and use | Low | Good | Low | UQ | P3 | Confirm Status, label as containing asbestos and maintain in current condition if to remain in-situ, remove under controlled friable asbestos removal conditions prior to refurbishment or demolition works by a Class A (friable) licensed asbestos removal contractor. | 16-02-2024 | 16-02-2029 | |

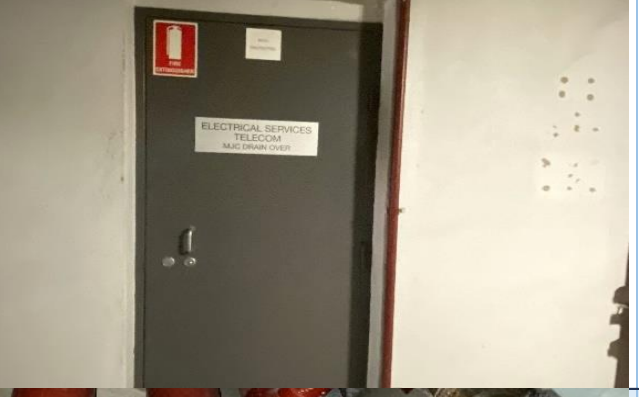
| Client: Stockland | | | Site Address: 601 Pacific Highway, St Leonards NSW 2065 | | | | | | | | | | Client No: S0003 | | | Job No: 115528S | | | Consultant: TAI |
|---|---|---|---|---|---|---|---|---|---|---|---|---|---|---|---|---|---|---|---|
| 40 | Internal - Basement Level 3 | Electrical Services Telecoms Room | Fuseboard | Fuses | Asbestos | Assumed Positive | Not sampled: live electrics | Friable | — | None under normal occupation and use | Low | Good | Low | UQ | P3 | Confirm Status, label as containing asbestos and maintain in current condition if to remain in-situ, remove under controlled friable asbestos removal conditions prior to refurbishment or demolition works by a Class A (friable) licensed asbestos removal contractor. | 16-02-2024 | 16-02-2029 | |

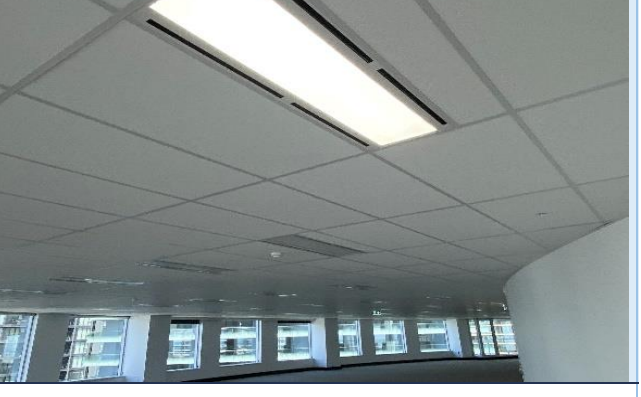
| Client: Stockland | | | Site Address: 601 Pacific Highway, St Leonards NSW 2065 | | | | | | | | | | Client No: S0003 | | | Job No: 115528S | | | Consultant: TAI |
|---|---|---|---|---|---|---|---|---|---|---|---|---|---|---|---|---|---|---|---|
| 49 | Internal - Level 13 to Level 1 | Throughout Tenancies | Ceiling | Compressed ceiling tiles | Synthetic Mineral Fibre | Suspected Positive | — | Bonded | — | — | Low | Good | Low | 200 m² | — | Maintain in current condition if to remain in-situ. Remove under controlled SMF conditions as per Code of Practice for the Safe Use of Synthetic Mineral Fibres [NOHSC: 2006 (1990)]. | — | — | |

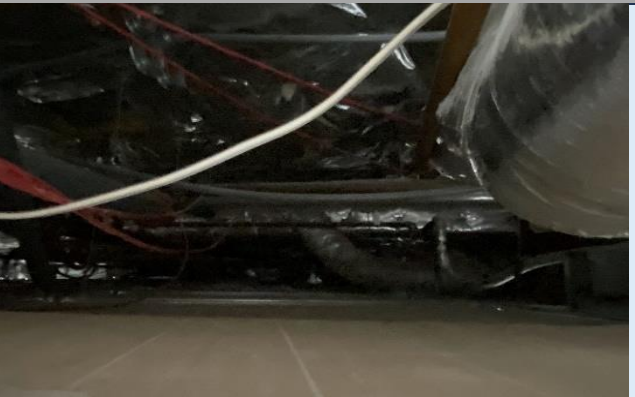
| Client: Stockland | | | | Site Address: 601 Pacific Highway, St Leonards NSW 2065 | | | | Client No: S0003 | | | | Job No: 115528S | | | | Consultant: TAI | | | |
|---|---|---|---|---|---|---|---|---|---|---|---|---|---|---|---|---|---|---|---|
| 53 | Internal - Level 13 to Level 1 | Throughout lift lobbies and communal areas | Flexible ductwork | Insulation material | Synthetic Mineral Fibre | Suspected Positive | — | Bonded | — | — | Low | Good | Low | 250 Lm | — | Maintain in current condition if to remain in-situ. Remove under controlled SMF conditions as per Code of Practice for the Safe Use of Synthetic Mineral Fibres [NOHSC: 2006 (1990)]. | — | — | |

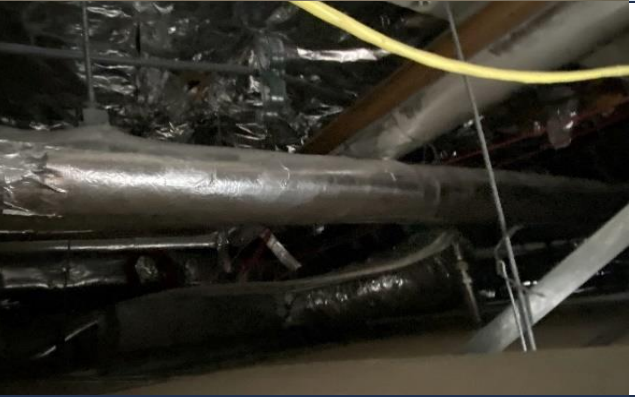
| Client: Stockland | | | | Site Address: 601 Pacific Highway, St Leonards NSW 2065 | | | | Client No: S0003 | | | | Job No: 115528S | | | | Consultant: TAI | | | |
|---|---|---|---|---|---|---|---|---|---|---|---|---|---|---|---|---|---|---|---|
| 54 | Internal - Level 13 to Level 1 | Throughout lift lobbies and communal areas | Duct | Insulation material - external | Synthetic Mineral Fibre | Suspected Positive | — | Bonded | — | — | Low | Good | Low | 250 Lm | — | Maintain in current condition if to remain in-situ. Remove under controlled SMF conditions as per Code of Practice for the Safe Use of Synthetic Mineral Fibres [NOHSC: 2006 (1990)]. | — | — | |

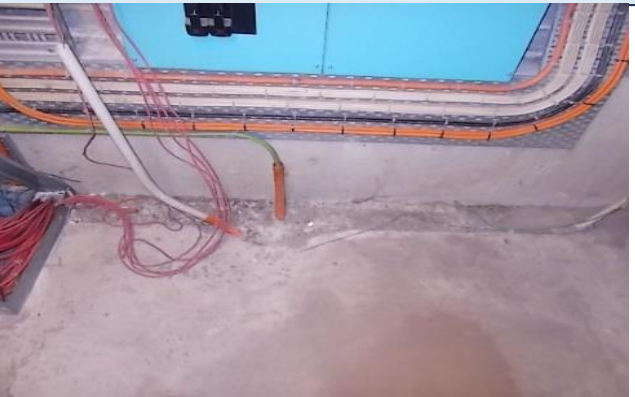
| Client: Stockland | | | | Site Address: 601 Pacific Highway, St Leonards NSW 2065 | | | | Client No: S0003 | | | | Job No: 115528S | | | | Consultant: TAI | | | |
|---|---|---|---|---|---|---|---|---|---|---|---|---|---|---|---|---|---|---|---|
| 58 | Internal - Service Level | Electrical Services Telecoms Room | Floor and ceiling penetrations throughout | Pillow Insulation | Synthetic Mineral Fibre | Suspected Positive | — | Unbonded | — | — | Low | Good | Low | 2 m² | — | Maintain in current condition if to remain in-situ. Remove under controlled SMF conditions as per Code of Practice for the Safe Use of Synthetic Mineral Fibres [NOHSC: 2006 (1990)]. | — | — | |

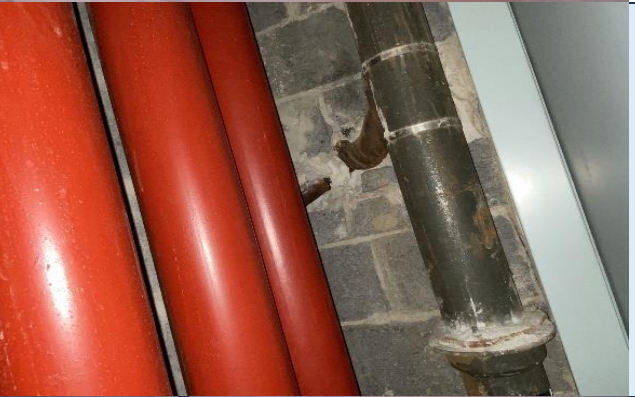
| Client: Stockland | | | | Site Address: 601 Pacific Highway, St Leonards NSW 2065 | | | | Client No: S0003 | | | | Job No: 115528S | | | | Consultant: TAI | | | |
|---|---|---|---|---|---|---|---|---|---|---|---|---|---|---|---|---|---|---|---|
| 60 | Internal - Basement Level 1 to Basement Level 3 | Hydraulic Cupboard | Penetrations | Packing | Synthetic Mineral Fibre | Suspected Positive | — | Bonded | — | — | Low | Good | Low | 1 m² | — | Maintain in current condition if to remain in-situ. Remove under controlled SMF conditions as per Code of Practice for the Safe Use of Synthetic Mineral Fibres [NOHSC: 2006 (1990)]. | — | — | |

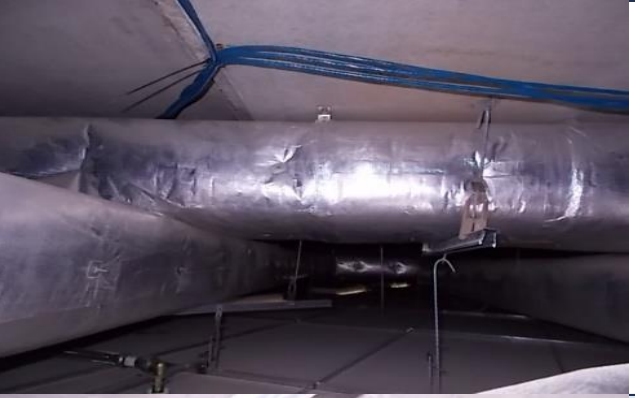
| Client: Stockland | | | | Site Address: 601 Pacific Highway, St Leonards NSW 2065 | | | | Client No: S0003 | | | | Job No: 115528S | | | | Consultant: TAI | | | |
|---|---|---|---|---|---|---|---|---|---|---|---|---|---|---|---|---|---|---|---|
| 61 | Internal - Basement Level 1 to Basement Level 3 | Male WC, within ceiling space | Flexible ductwork | Insulation material | Synthetic Mineral Fibre | Suspected Positive | — | Bonded | — | — | Low | Good | Low | 10 Lm | — | Maintain in current condition if to remain in-situ. Remove under controlled SMF conditions as per Code of Practice for the Safe Use of Synthetic Mineral Fibres [NOHSC: 2006 (1990)]. | — | — | |

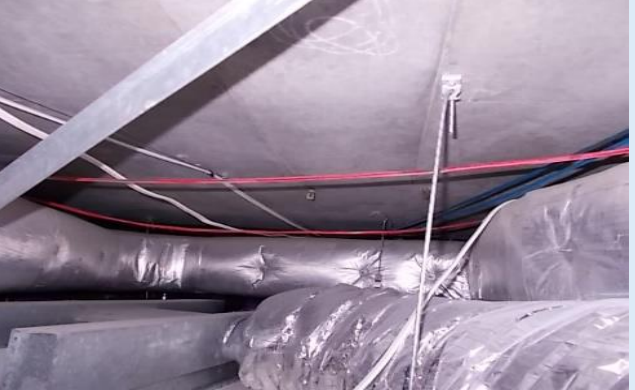
| Client: Stockland | | | | Site Address: 601 Pacific Highway, St Leonards NSW 2065 | | | | Client No: S0003 | | | | Job No: 115528S | | | | Consultant: TAI | | | |
|---|---|---|---|---|---|---|---|---|---|---|---|---|---|---|---|---|---|---|---|
| 62 | Internal - Basement Level 1 to Basement Level 3 | Female WC, within ceiling space | Flexible ductwork | Insulation material | Synthetic Mineral Fibre | Suspected Positive | — | Bonded | — | — | Low | Good | Low | 10 Lm | — | Maintain in current condition if to remain in-situ. Remove under controlled SMF conditions as per Code of Practice for the Safe Use of Synthetic Mineral Fibres [NOHSC: 2006 (1990)]. | — | — | |

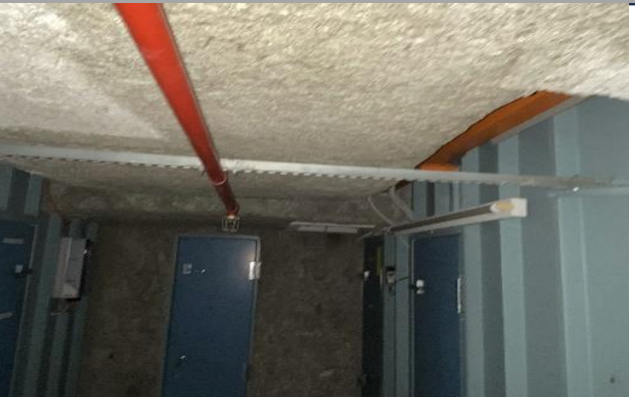
| Client: Stockland | | | Site Address: 601 Pacific Highway, St Leonards NSW 2065 | | | | | | | | | | Client No: S0003 | | | Job No: 115528S | | | Consultant: TAI |
|---|---|---|---|---|---|---|---|---|---|---|---|---|---|---|---|---|---|---|---|
| 63 | Internal - Basement Level 1 to Basement Level 3 | Electrical Services Telecoms Room | Floor and ceiling penetrations throughout | Vermiculite | Synthetic Mineral Fibre | Suspected Positive | — | Bonded | — | — | Low | Good | Low | 2 m² | — | Maintain in current condition if to remain in-situ. Remove under controlled SMF conditions as per Code of Practice for the Safe Use of Synthetic Mineral Fibres [NOHSC: 2006 (1990)]. | — | — | |

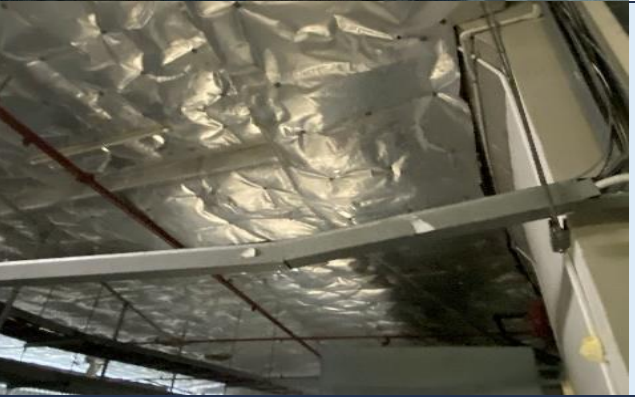
| Client: Stockland | | | Site Address: 601 Pacific Highway, St Leonards NSW 2065 | | | | | | | | | | Client No: S0003 | | | Job No: 115528S | | | Consultant: TAI |
|---|---|---|---|---|---|---|---|---|---|---|---|---|---|---|---|---|---|---|---|
| 64 | Internal - Basement Level 1 to Basement Level 3 | Electrical Services Telecoms Room | Floor and ceiling penetrations throughout | Pillow Insulation | Synthetic Mineral Fibre | Suspected Positive | — | Unbonded | — | — | Low | Good | Low | 2 m² | — | Maintain in current condition if to remain in-situ. Remove under controlled SMF conditions as per Code of Practice for the Safe Use of Synthetic Mineral Fibres [NOHSC: 2006 (1990)]. | — | — | |

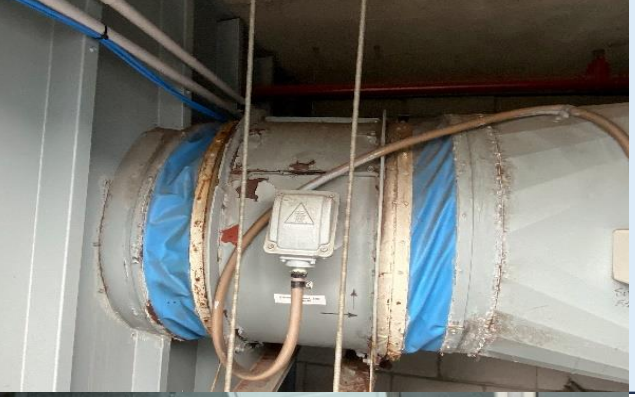
| Client: Stockland | | | Site Address: 601 Pacific Highway, St Leonards NSW 2065 | | | | | | | | | | Client No: S0003 | | | Job No: 115528S | | | Consultant: TAI |
|---|---|---|---|---|---|---|---|---|---|---|---|---|---|---|---|---|---|---|---|
| 67 | Internal - Level 15 | Kitchen Exhaust Fan Room | Kitchen Exhaust Fan | Grey - upper coloured paint system | Lead Paint - Chip | Suspected Positive | Similar to previously sampled: 58911-094-LCP002 | — | — | — | Low | Fair | Low | 200 m² | — | Suspected 0.2% lead content, remove flaking sections and paint over with a lead-free paint. Remove under controlled conditions in accordance with AS 4361.2:2017 Guide to hazardous lead paint management prior to renovation or demolition works. | — | — | |

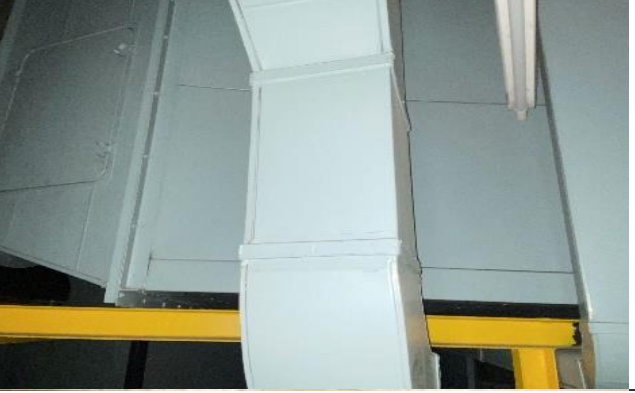
| Client: Stockland | | | Site Address: 601 Pacific Highway, St Leonards NSW 2065 | | | | | | | | | | Client No: S0003 | | | Job No: 115528S | | | Consultant: TAI |
|---|---|---|---|---|---|---|---|---|---|---|---|---|---|---|---|---|---|---|---|
| 68 | Internal - Service Level | Throughout | Duct | Grey - upper coloured paint system | Lead Paint - Chip | Positive | Previously sampled: 58911-094-LCP002 | — | — | — | Low | Fair | Low | 200 m² | — | 0.2% lead content, remove flaking sections and paint over with a lead-free paint. Remove under controlled conditions in accordance with AS 4361.2:2017 Guide to hazardous lead paint management prior to renovation or demolition works. | — | — | |
