Concept Design Road Safety Audit

**Hurlstone Agricultural High
School (Hawkesbury)
Campus Drive and Blacktown
Road**

Prepared for NSW Department of Education c/o Mace Australia Pty Ltd / 10 August
2018

161108 TAAE

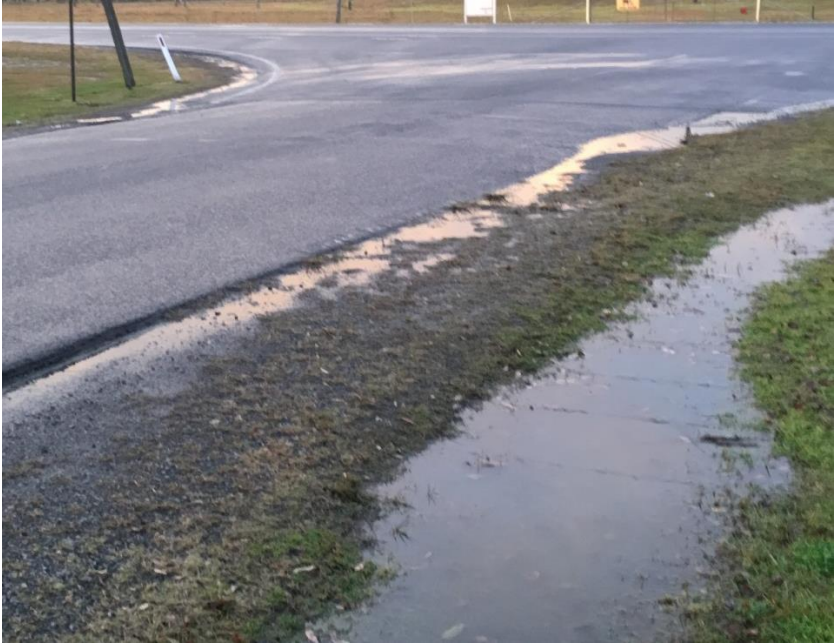
Item	Location	Identified Risks	Photographic Record	Frequency Severity Risk	Accept / Reject	Corrective Actions
INTERSECTION OF CAMPUS DRIVE/BLACKTOWN ROAD						
14	Campus Drive	Limited drainage infrastructure has been provided adjacent to Campus Drive. There is a risk that ponding water adjacent to the roadway may encroach travel lanes and result in vehicles aquaplaning and losing control. There is also a risk that drivers may swerve to avoid driving through water. These risks could lead to side impact or rear end collisions.

Improbable Minor Low	A	<i>Severe aquaplane risks are not considered to be evident at this location.</i> <i>Existing issue is unlikely to be worsened by additional traffic.</i> <i>Operation is considered satisfactory.</i> No further action.
15	Campus Drive	No centre line has been line marked on Campus Drive. There is a risk that vehicles may encroach into the oncoming travelling lane which may lead to head on collisions. This risk is further exacerbated by the road alignment of Campus Drive which includes reverse curves on approach to the intersection with Blacktown Road which may encourage straight line driving and increased speeds.

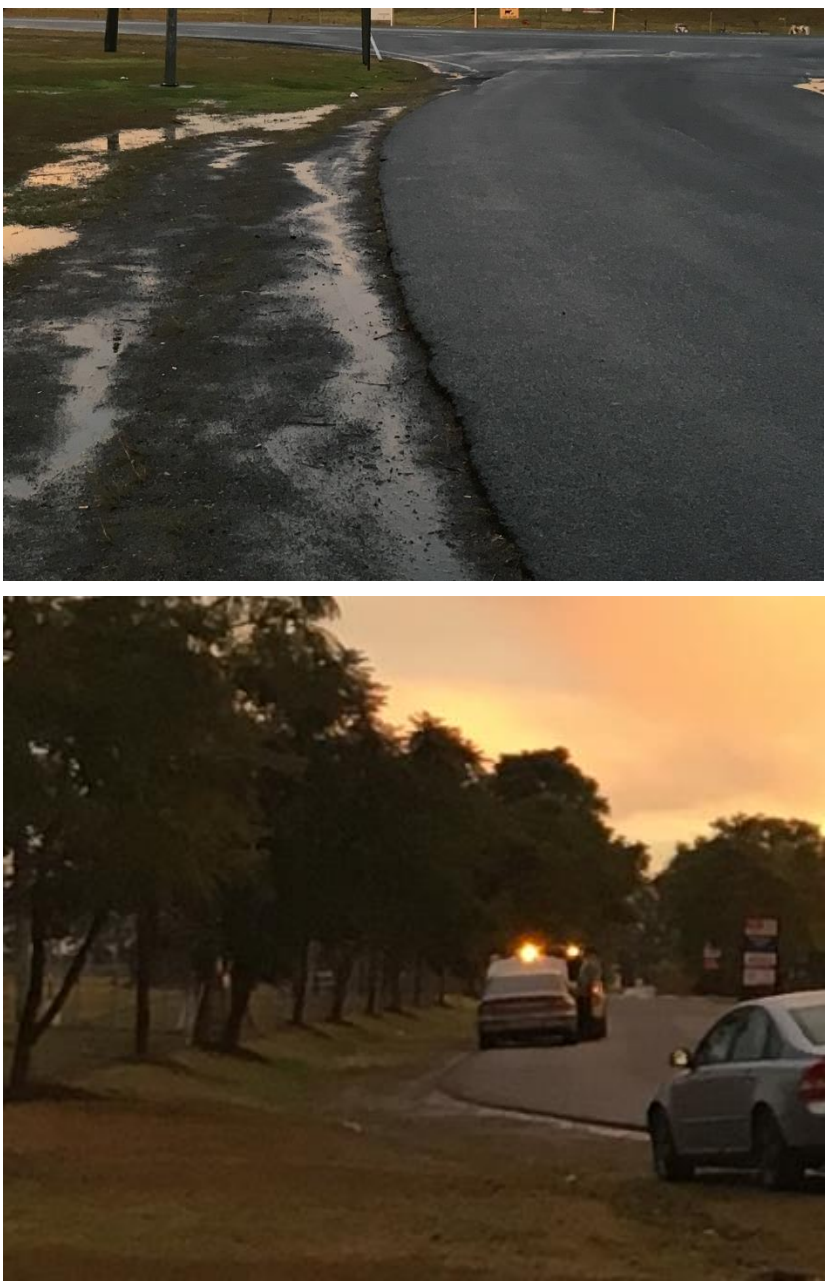
Item	Location	Identified Risks	Photographic Record	Frequency Severity Risk	Accept / Reject	Corrective Actions
16	Campus Drive	No edge line or kerb has been installed on Campus Drive providing no clear delineation of the edge of the roadway. This may result in drivers travelling close to the edge of the pavement and potentially overrunning into the grassed area. This has the potential to result in vehicle damage from collisions with roadside objects.

Improbable Minor Low	A	<i>Edge line to be added to detailed design. (Action by Civil Engineer)</i>

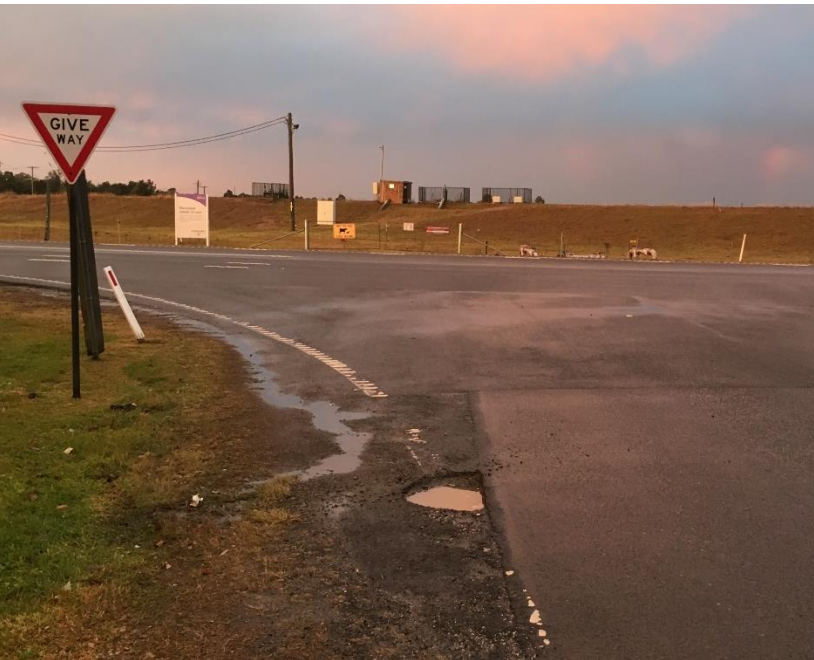
Item	Location	Identified Risks	Photographic Record	Frequency Severity Risk	Accept / Reject	Corrective Actions
17	Campus Drive	<p>No give way line marking has been provided on the Campus Drive approach to the intersection with Blacktown Road. Drivers approaching the intersection may encroach into the travelling lane on Blacktown Road which may result in front end or side impact collisions.</p>

Occasional Serious High	A	<p><i>Hold line to be added to detailed design. Associated changes to Give Way signage to be reviewed if necessary. (Action by Civil Engineer)</i></p>
18	Campus Drive	<p>Street signage for Campus Drive is difficult to read due to poor maintenance and the sign is located approximately 15m from the intersection with Blacktown Road. There is a risk that the street signage may not be sighted by a passing motorist until late resulting in sudden deceleration and possible rear end collisions.</p> <p>It is noted that there is advance warning signage for the turn for the "Richmond College of TAFE" which may reduce the incidence of events.</p>

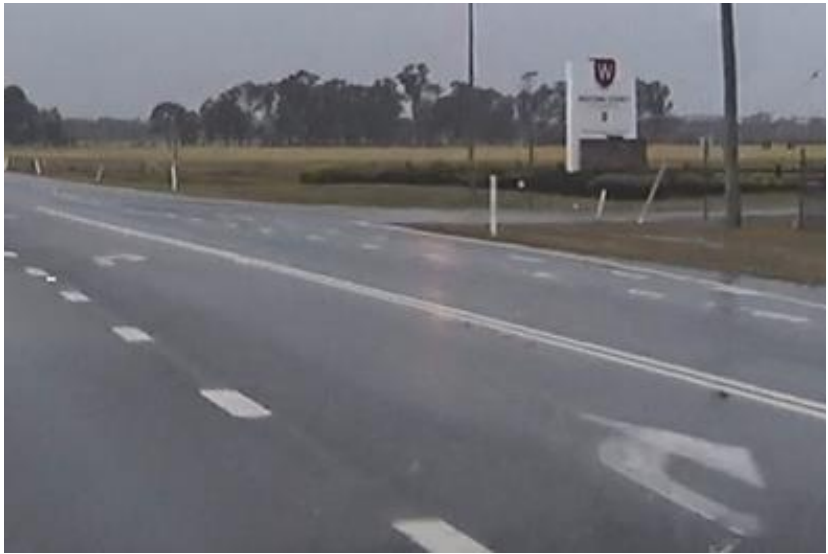
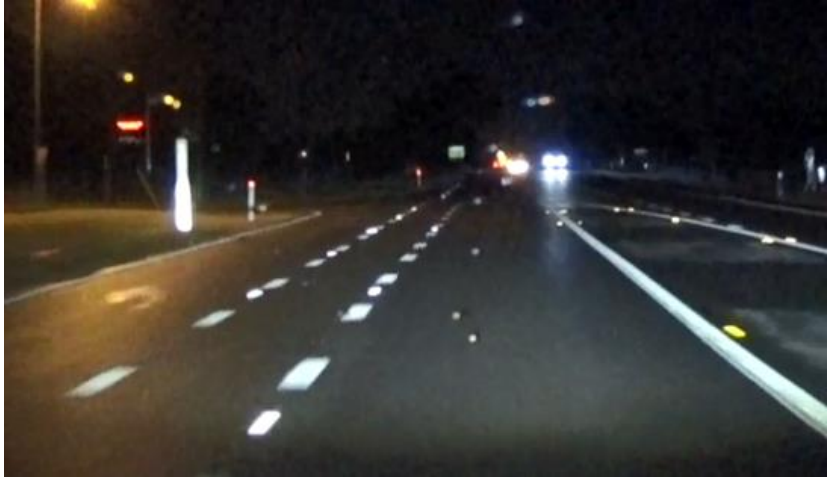
Item	Location	Identified Risks	Photographic Record	Frequency Severity Risk	Accept / Reject	Corrective Actions
19	Blacktown Road	Line markings of turning arrows and chevrons are faded on Blacktown Road. During night or adverse weather conditions turning arrows may be difficult to identify. There is a risk that drivers may not be aware of the turning bays and may brake suddenly to enter these bays or cross the bays to turn into Campus Drive. This could result in a rear end collision.

Occasional Serious High	A	<p><i>Line marking can be renewed as part of line marking works at Campus Drive intersection.</i></p> <p><i>To be investigated with RMS during detailed design and approval process. (Action by Civil Engineer)</i></p>

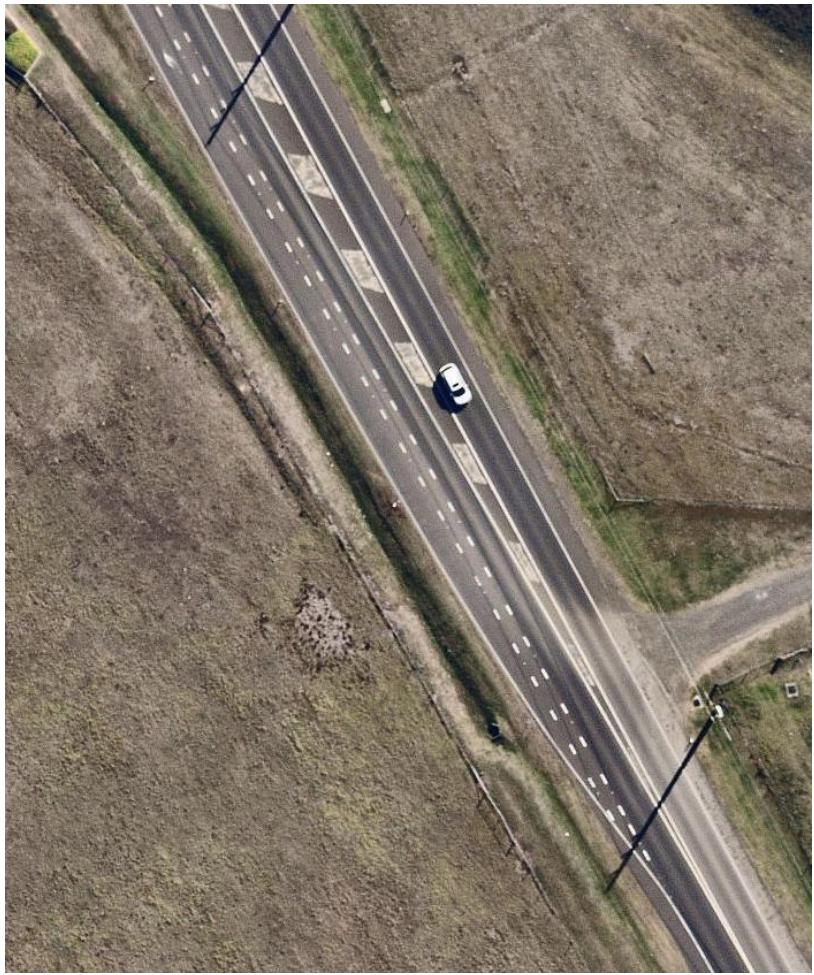
Item	Location	Identified Risks	Photographic Record	Frequency Severity Risk	Accept / Reject	Corrective Actions
20	Blacktown Road	<p>On Blacktown Road, cyclists are permitted to ride within the shoulder on the western edge. On approach to Campus Drive there is a left turn bay and these cyclists are expected to continue riding a straight path adjacent to this turning bay. While the continuation of the cycle path has been indicated by line marking, no bicycle symbols, coloured pavement or signage are provided within this cycle lane.</p> <p>There is a risk that drivers may be confused about which line marking applies to them and their vehicles may encroach into the bicycle lane. This may lead to vehicle-bicycle collisions. This risk is further exacerbated by the faded left turn arrow line marking.</p> <p>There is also a risk that cyclists may be confused about which alignment to travel through the intersection which may lead to vehicle-bicycle collisions.</p>

Improbable Serious Medium	A	<p><i>Line marking can be renewed as part of line marking works at Campus Drive intersection.</i></p> <p><i>To be investigated with RMS during detailed design and approval process. (Action by Civil Engineer)</i></p>

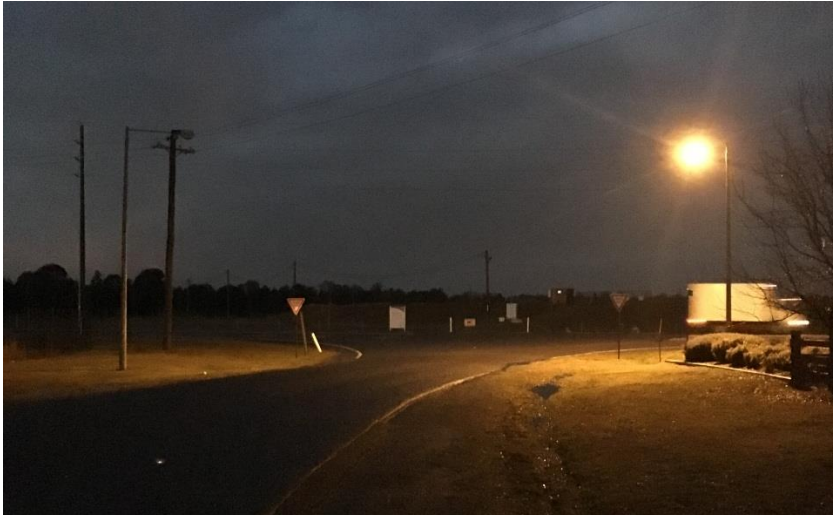
21	Campus Drive	<p>During night conditions there is one light pole not functioning near to the intersection with Blacktown Road. There is a risk that vehicles, pedestrians and/or cyclists on Campus Drive may be difficult to see during night conditions. This could lead to collisions.</p>

Improbable Serious Medium	A	<p><i>Maintenance to be referred to WSU as part of regular procedures. (Action by Client)</i></p>

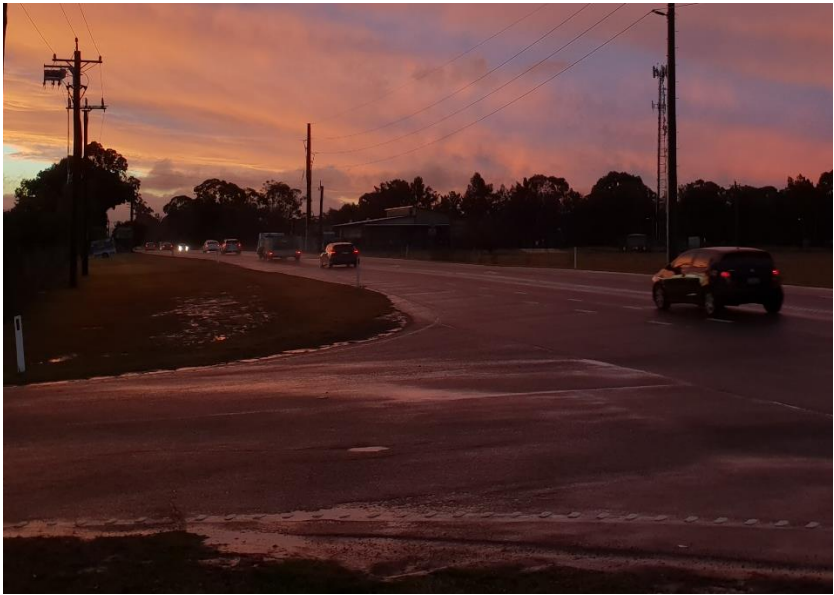
Item	Location	Identified Risks	Photographic Record	Frequency Severity Risk	Accept / Reject	Corrective Actions
22	Campus Drive	No reflectors are provided on Campus Drive which results in the location of travel lanes being difficult to determine during night or adverse weather conditions. This could lead to vehicles overrunning the paved roadway. This is further exacerbated by the poor lighting of Campus Drive and the lack of line marking.

Improbable Limited Low	A	<p><i>Reflectors can be renewed as part of line marking works at Campus Drive intersection.</i></p> <p><i>To be investigated with RMS during detailed design and approval process. (Action by Civil Engineer)</i></p>
