HAZARDOUS BUILDING MATERIALS ASSESSMENT

PROPOSED HOSPITAL REDEVELOPMENT

**GOULBURN BASE HOSPITAL,
130 GOLDSMITH STREET, GOULBURN, NSW**

22 SEPTEMBER 2017

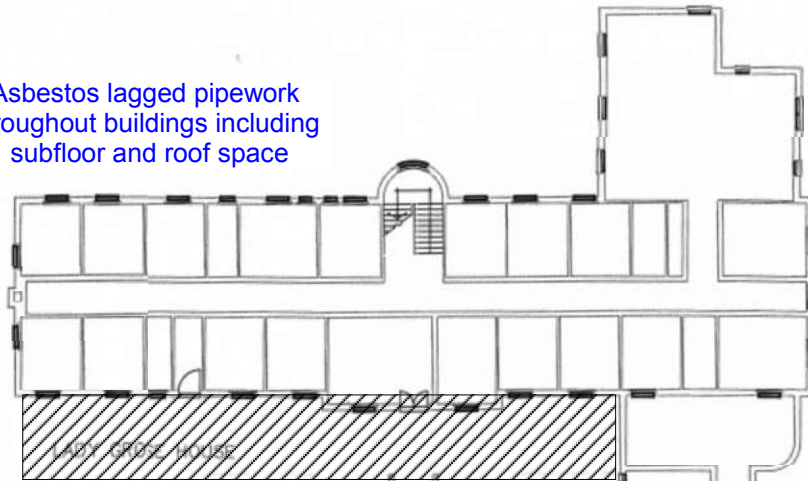
LADY GROSE HOUSE
GROUND FLOOR PLAN

Asbestos lagged pipework throughout buildings including subfloor and roof space

Asbestos millboard in metal water tank in roof space

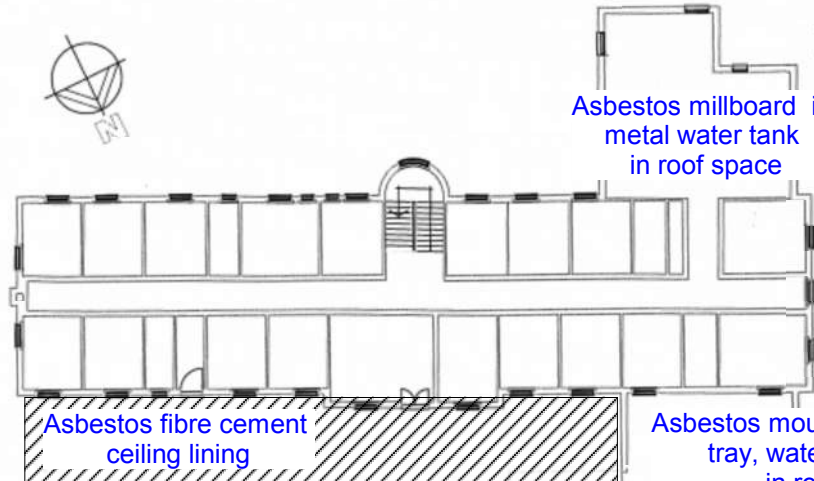
FIRST FLOOR PLAN

Asbestos fibre cement ceiling lining

Asbestos moulded fibre cement tray, water tank and lid in roof space

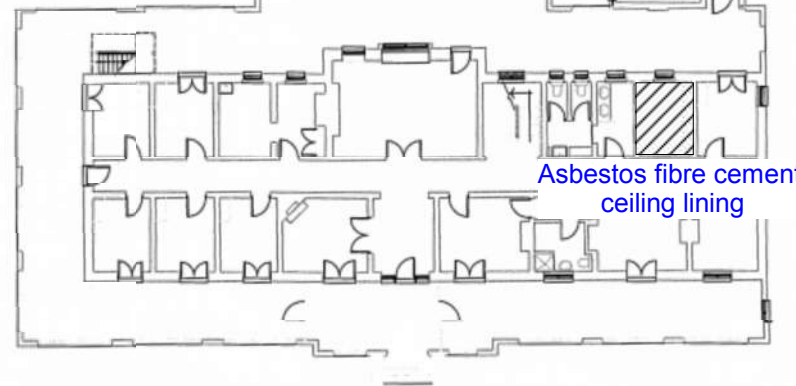
Asbestos fibre cement ceiling lining

Asbestos fibre cement wall lining

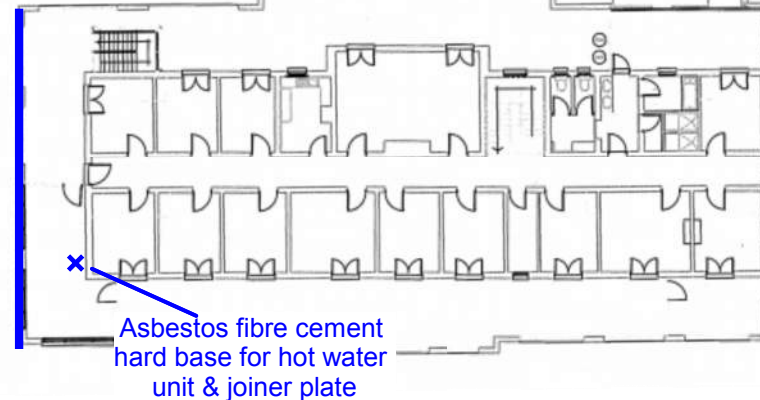
Asbestos fibre cement hard base for hot water unit & joiner plate

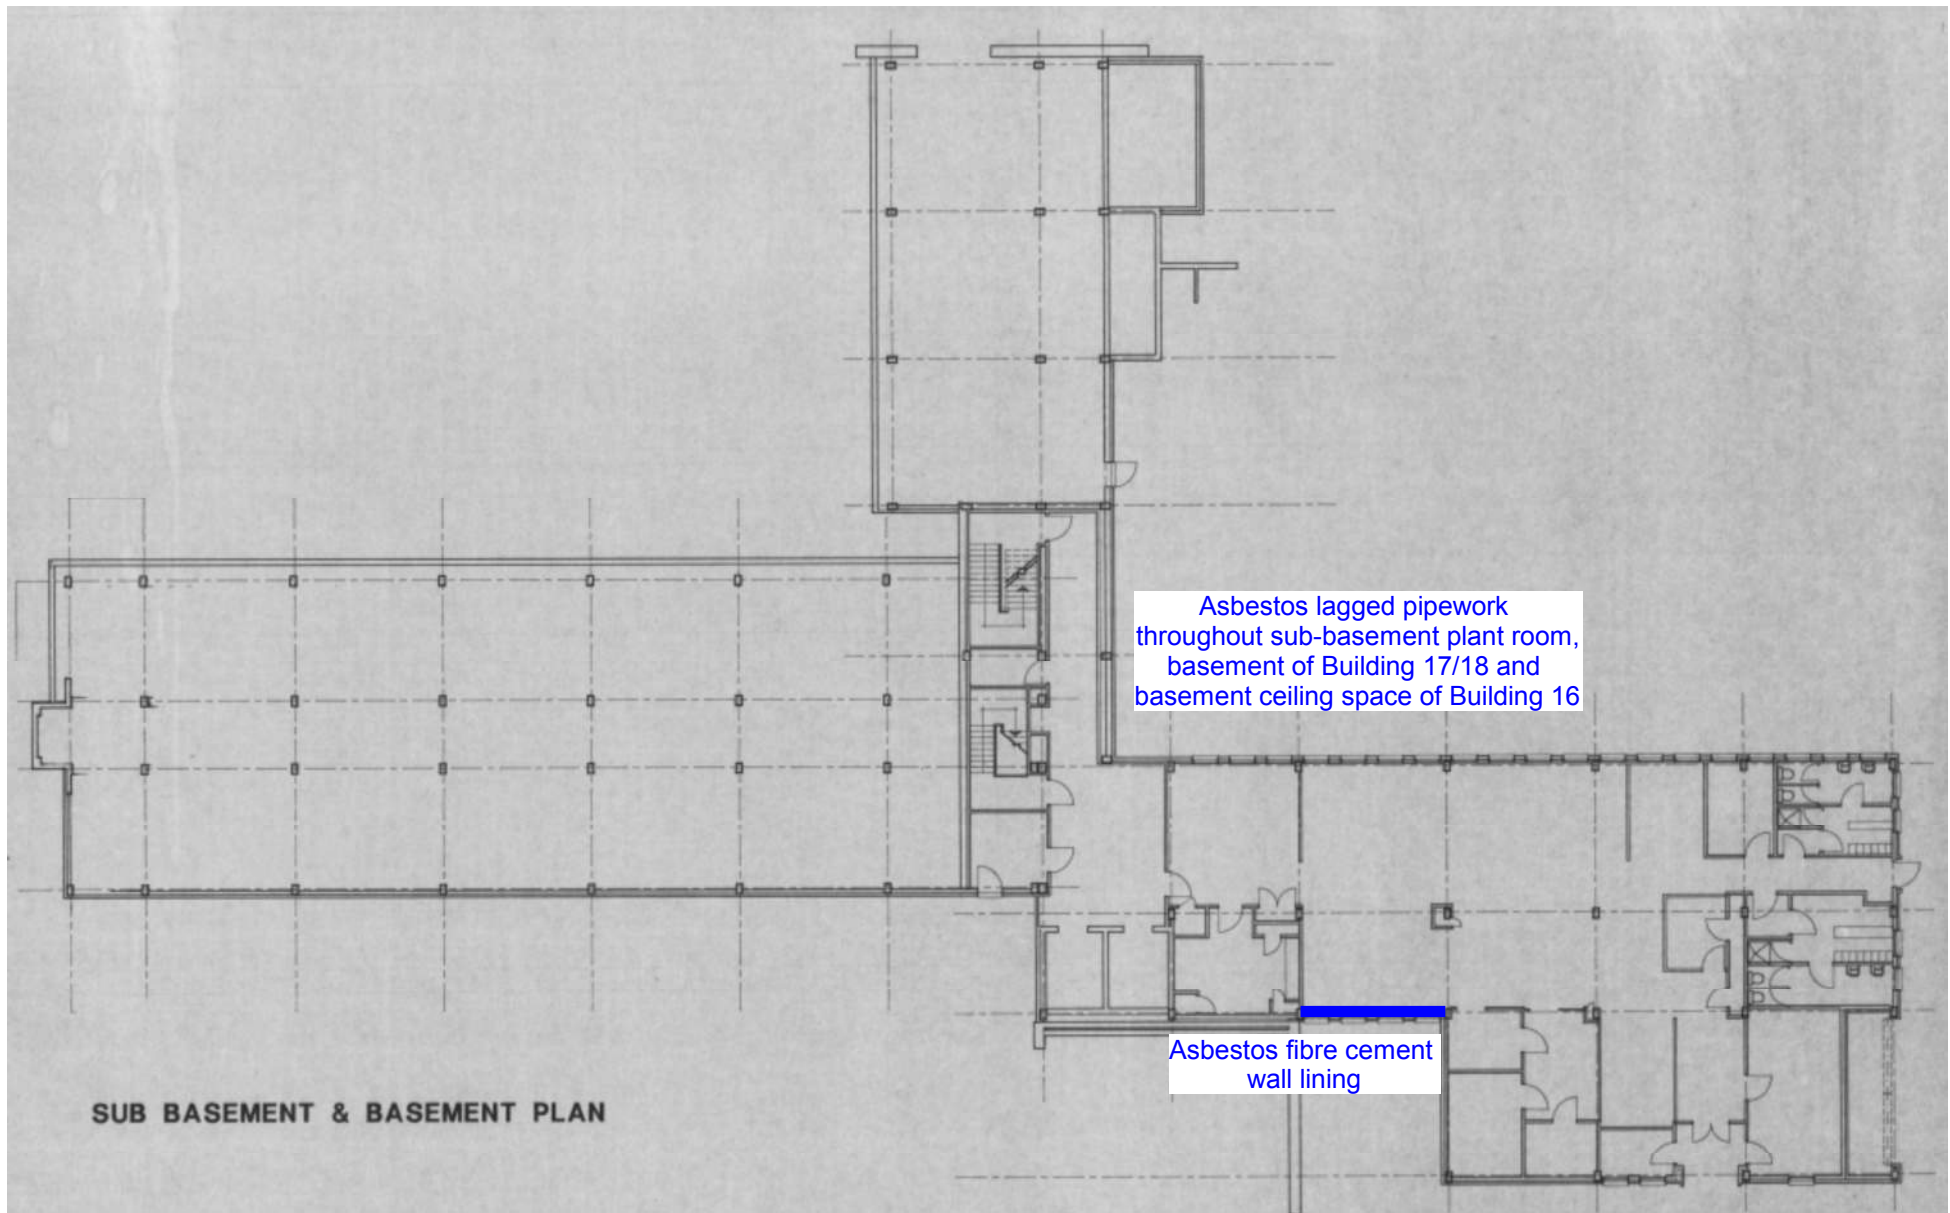
SUB BASEMENT & BASEMENT PLAN

Asbestos lagged pipework
throughout sub-basement plant room,
basement of Building 17/18 and
basement ceiling space of Building 16

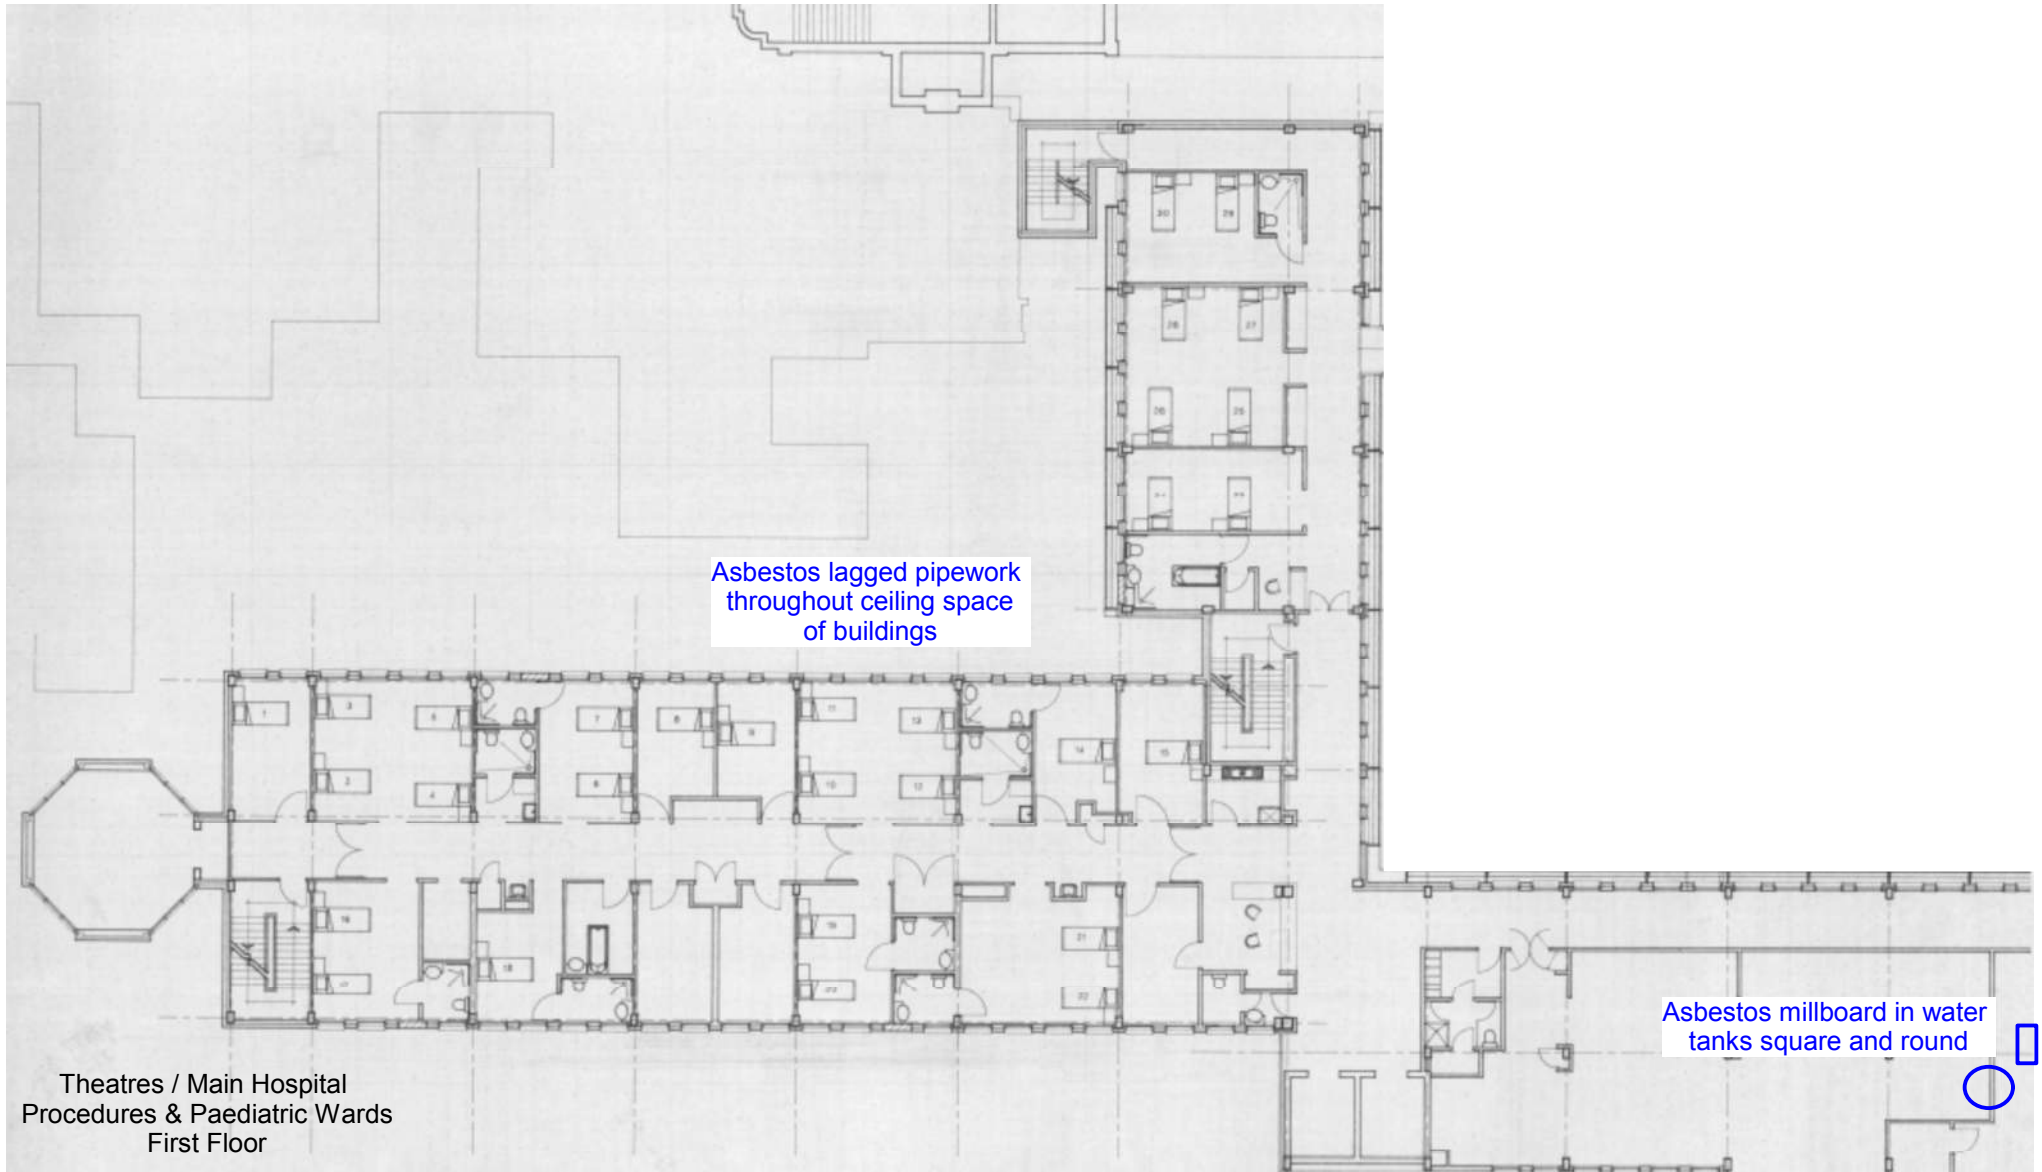
Theatres / Main Hospital
 Procedures & Paediatric Wards
 First Floor

Asbestos lagged pipework
 throughout ceiling space
 of buildings

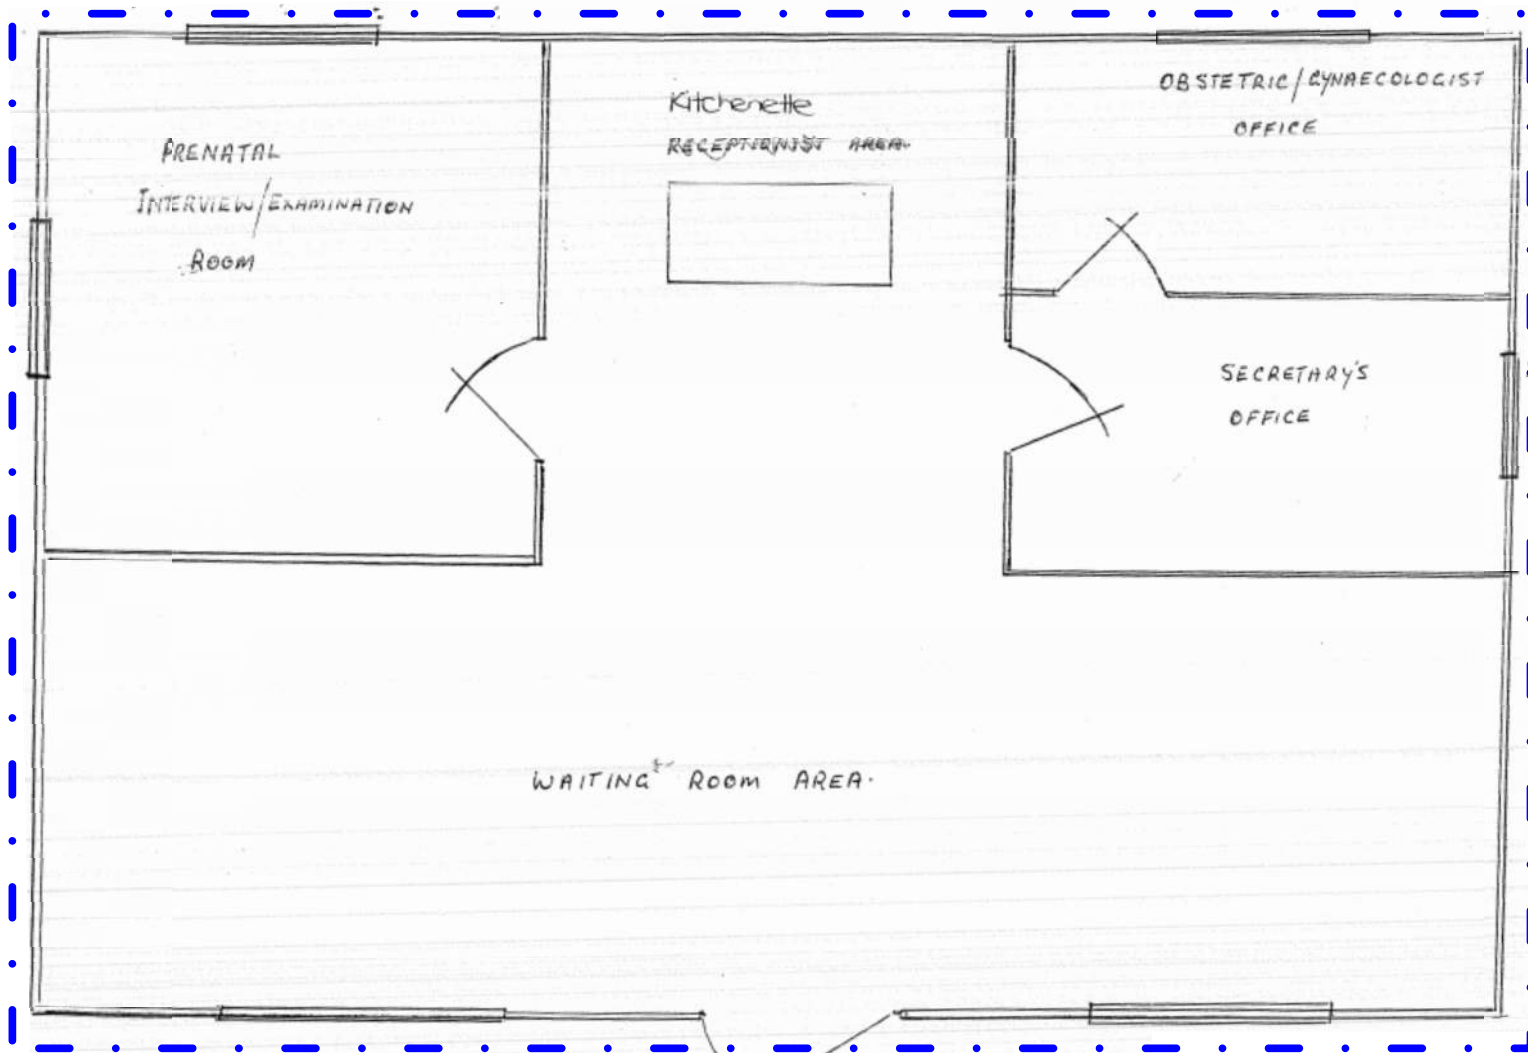
Asbestos fibre cement
eave lining

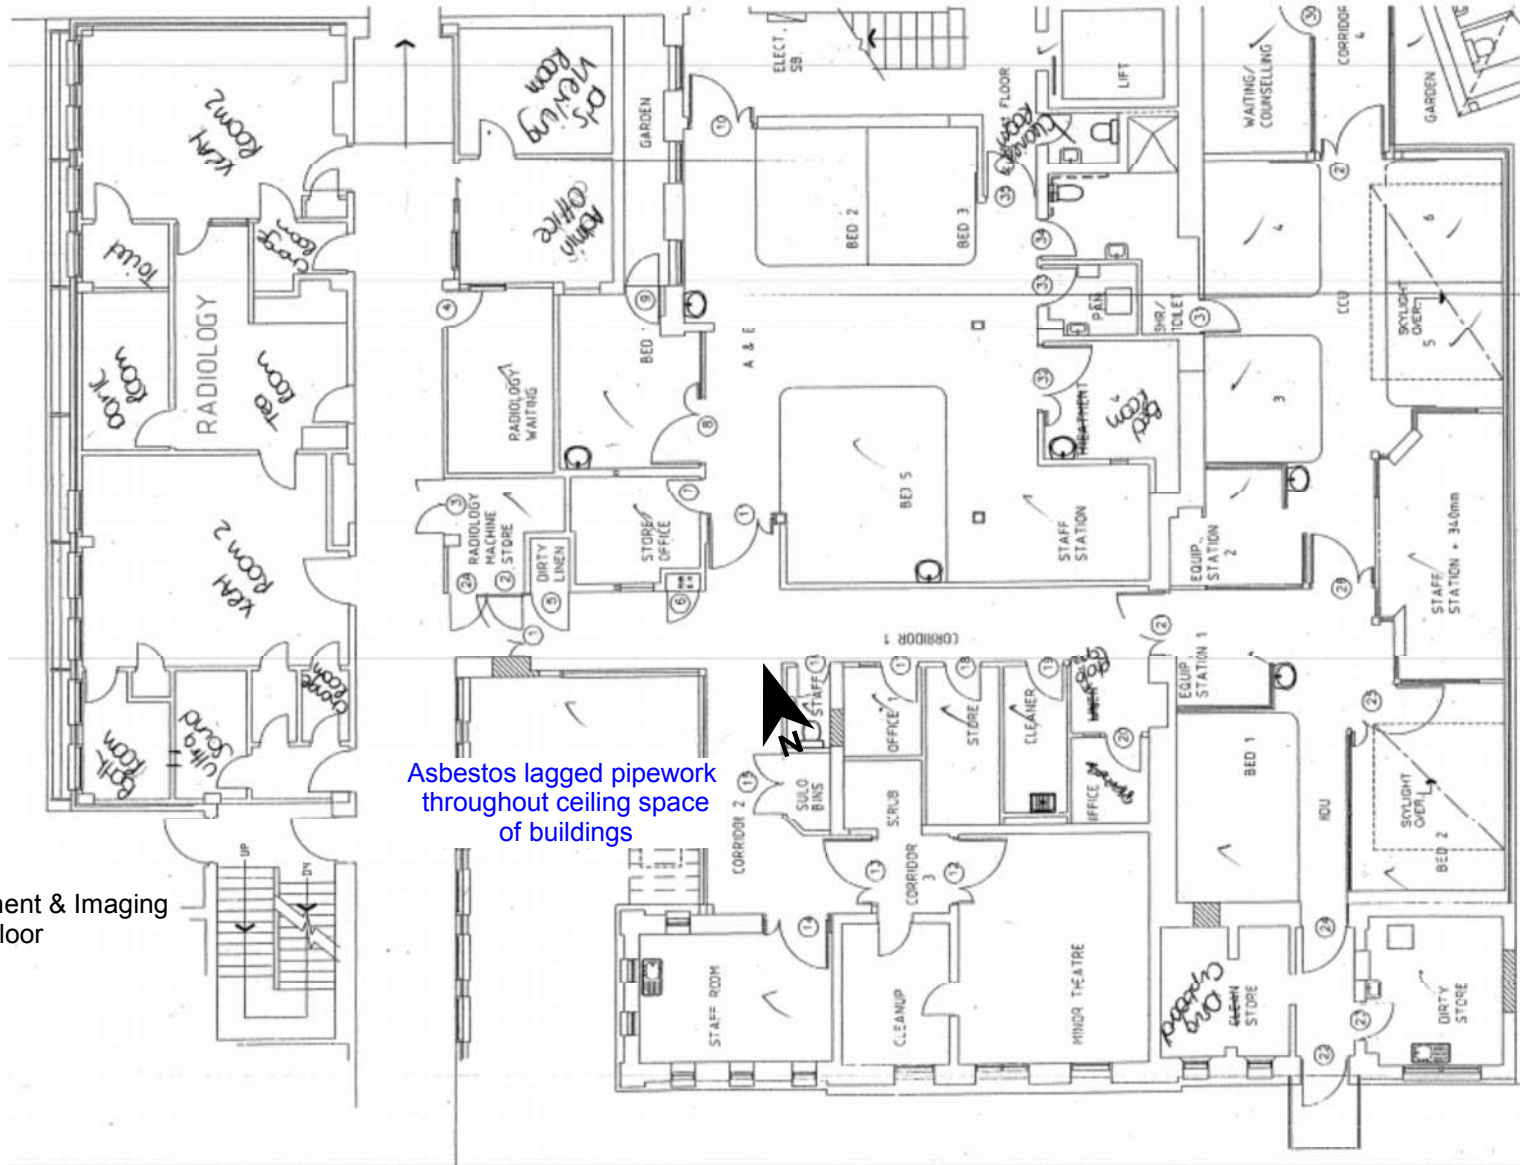
Emergency Department & Imaging
Ground Floor

Asbestos lagged pipework
throughout ceiling
space of buildings

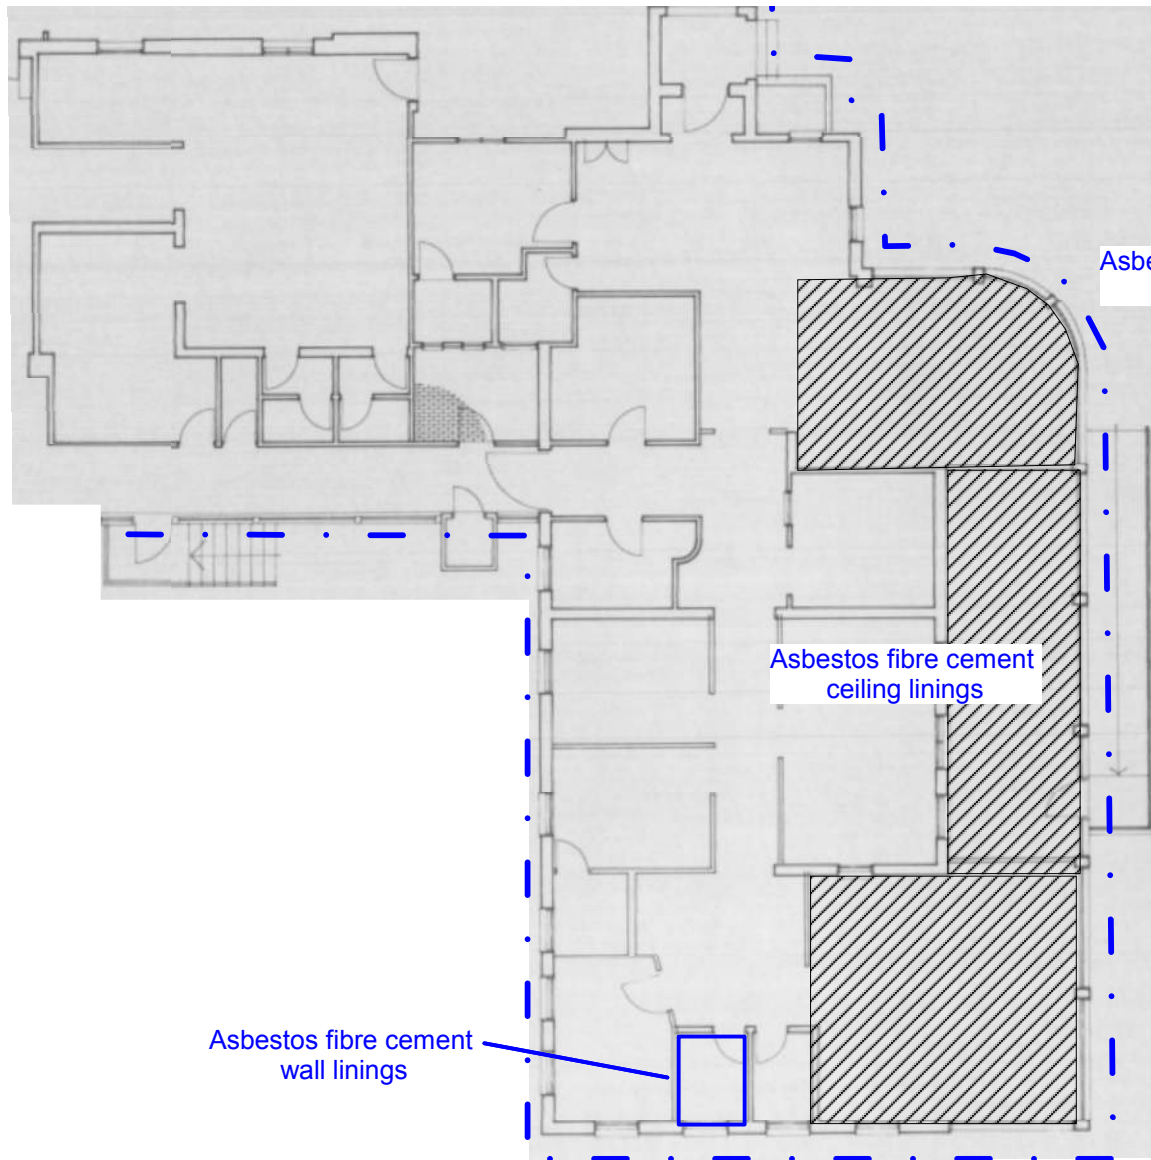
Asbestos lagged pipework
throughout ceiling space
of buildings

Asbestos fibre cement
eave linings

Asbestos fibre cement
ceiling linings
