**Goulburn Base Hospital, 130 Goldsmith Street, Goulburn, NSW
 Hazardous Building Materials Register - September 2017**

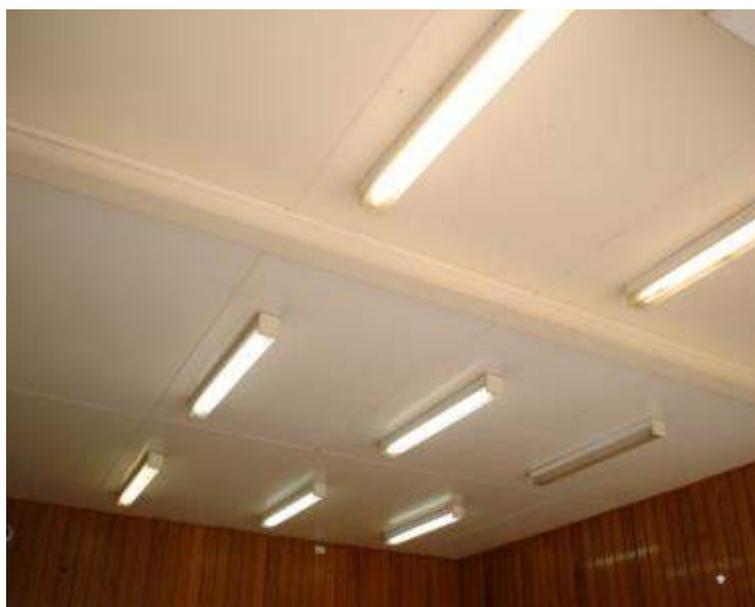
Flat fibre cement sheet – S33

Building:	Building 0 – Ambulance Bay
Location:	External, ceiling lining
Material Type:	Flat asbestos fibre cement sheet
Friable / non-friable	Non-friable
Condition:	Generally intact
Extent:	~30m ²
Risk Assessment / Recommendation:	Low risk, leave and maintain in current condition
Reinspection / Removal Date:	Remove prior to refurbishment / demolition works or reinspect in 5 years

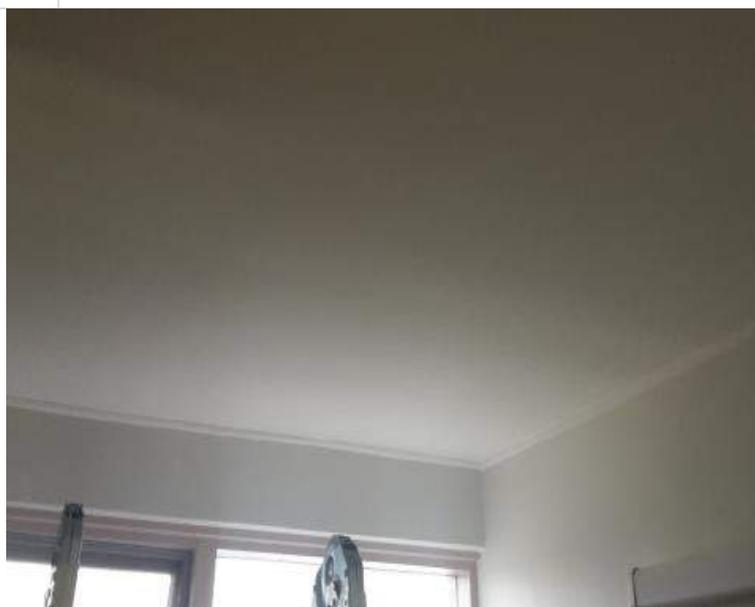
Flat fibre cement sheet – S19

Building:	Building 1 – Community Health
Location:	Internal, first floor, toilet ceiling lining
Material Type:	Flat asbestos fibre cement sheet
Friable / non-friable	Non-friable
Condition:	Generally intact
Extent:	~9m ²
Risk Assessment / Recommendation:	Low risk, leave and maintain in current condition
Reinspection / Removal Date:	Remove prior to refurbishment / demolition works or reinspect in 5 years

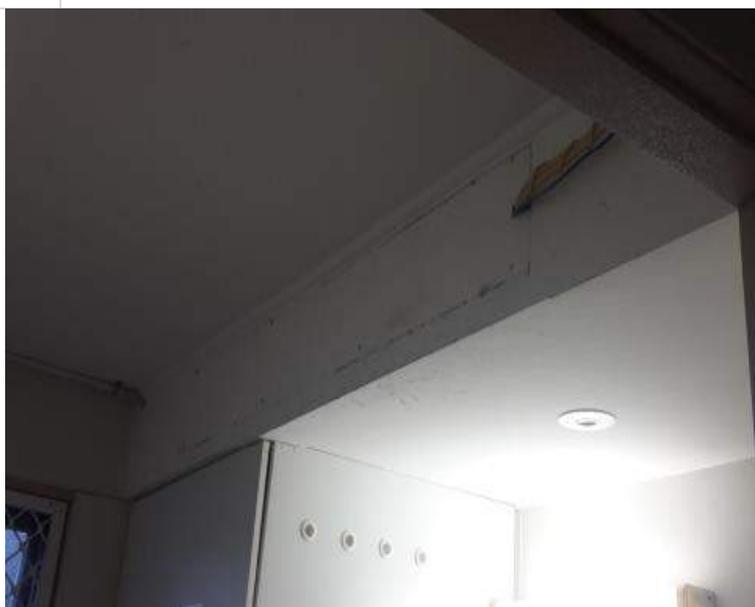
Flat fibre cement sheet – S21

Building:	Building 1 – Community Health
Location:	Internal, ground floor toilet, cable tray box lining
Material Type:	Flat asbestos fibre cement sheet
Friable / non-friable	Non-friable
Condition:	Generally intact
Extent:	~6m ²
Risk Assessment / Recommendation:	Low risk, leave and maintain in current condition
Reinspection / Removal Date:	Remove prior to refurbishment / demolition works or reinspect in 5 years

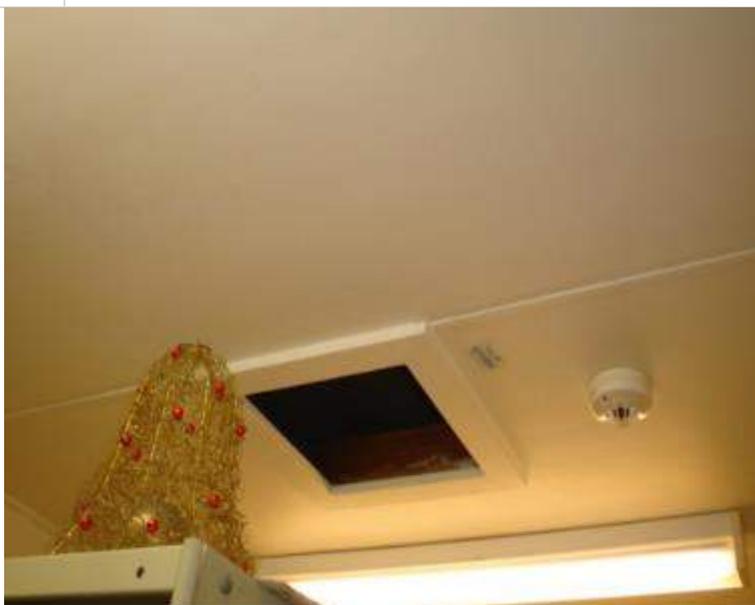
Flat fibre cement sheet – S10

Building:	Building 2 & 3 - Springfield House / Lady Grose Home / George Gerathy Wing
Location:	Springfield House, internal, ground floor, staff showers and storeroom ceiling lining
Material Type:	Flat asbestos fibre cement sheet
Friable / non-friable	Non-friable
Condition:	Generally intact
Extent:	~8m ²
Risk Assessment / Recommendation:	Low risk, leave and maintain in current condition
Reinspection / Removal Date:	Remove prior to refurbishment / demolition works or reinspect in 5 years

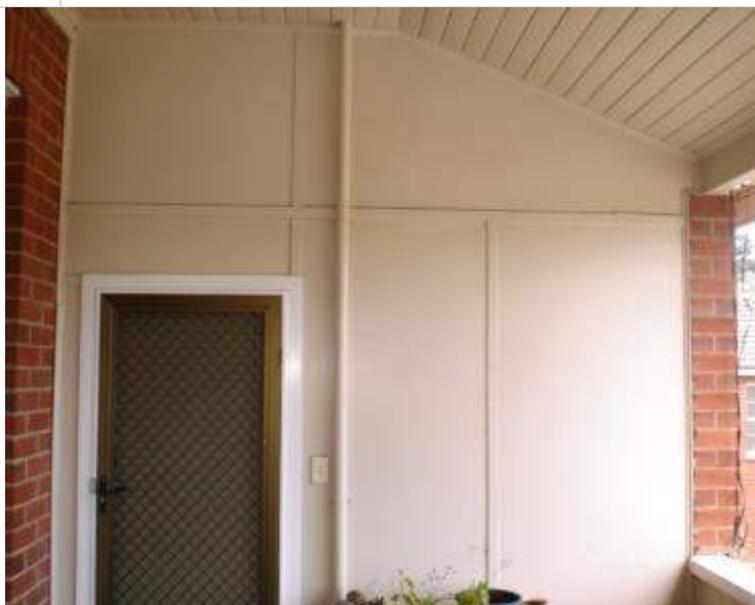
**Flat fibre cement sheet – Visually inspected
(limit damage due to room being occupied)**

Building:	Building 2 & 3 - Springfield House / Lady Grose Home / George Gerathy Wing
Location:	Springfield House, Level 1, wall lining at end of the veranda
Material Type:	Flat asbestos fibre cement sheet
Friable / non-friable	Non-friable
Condition:	Generally intact
Extent:	~20m ²
Risk Assessment / Recommendation:	Low risk, leave and maintain in current condition
Reinspection / Removal Date:	Remove prior to refurbishment / demolition works or reinspect in 5 years

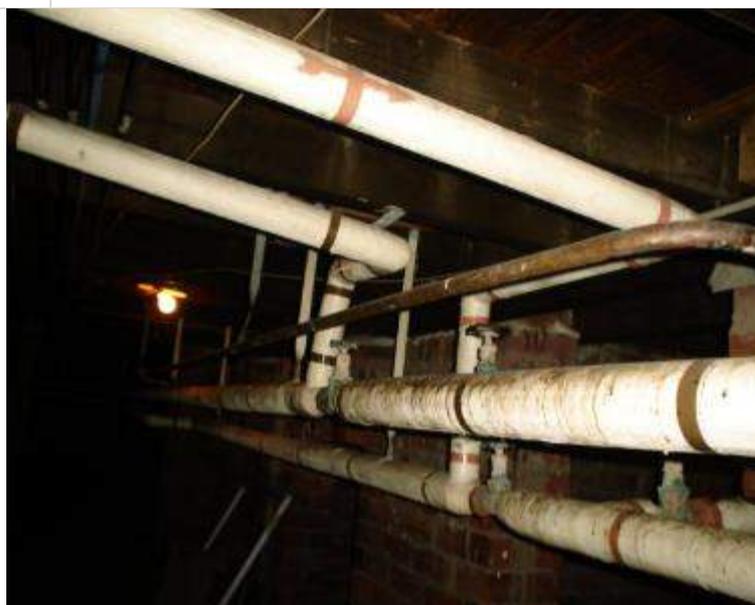
Wrapped asbestos lagging – S13

Building:	Building 2 & 3 - Springfield House / Lady Grose Home / George Gerathy Wing
Location:	Springfield House, internal, subfloor, pipework
Material Type:	Wrapped asbestos lagging
Friable / non-friable	Friable
Condition:	Generally intact
Extent:	Unknown
Risk Assessment / Recommendation:	High risk, material should be removed as soon as reasonably practicable
Reinspection / Removal Date:	Remove material as soon as reasonably practicable and prior to refurbishment and/or demolition works

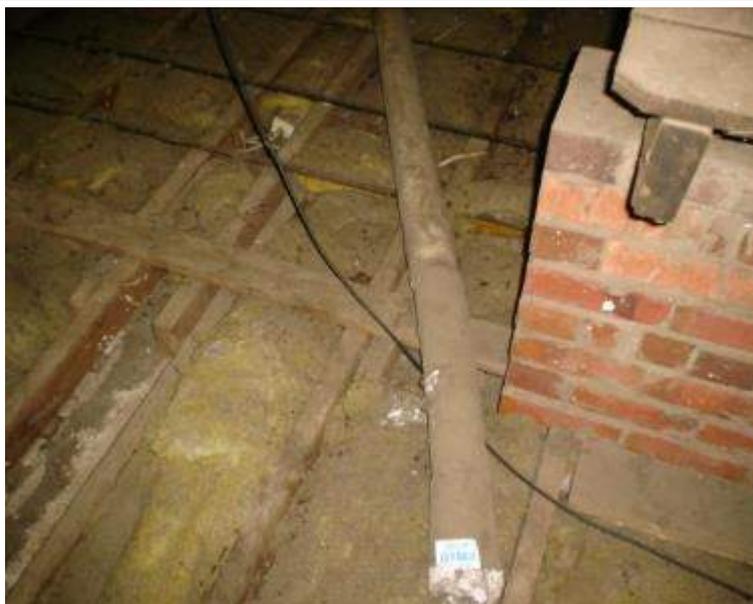
Wrapped asbestos lagging and associated debris – S14

Building:	Building 2 & 3 - Springfield House / Lady Grose Home / George Gerathy Wing
Location:	Lady Grouse Home and George Gerathy Wing, internal roof space, hot water pipework
Material Type:	Wrapped asbestos lagging and associated debris
Friable / non-friable	Friable
Condition:	Generally intact
Extent:	~ 2 linear metres
Risk Assessment / Recommendation:	High risk, material should be removed as soon as reasonably practicable
Reinspection / Removal Date:	Remove material as soon as reasonably practicable and prior to refurbishment and/or demolition works

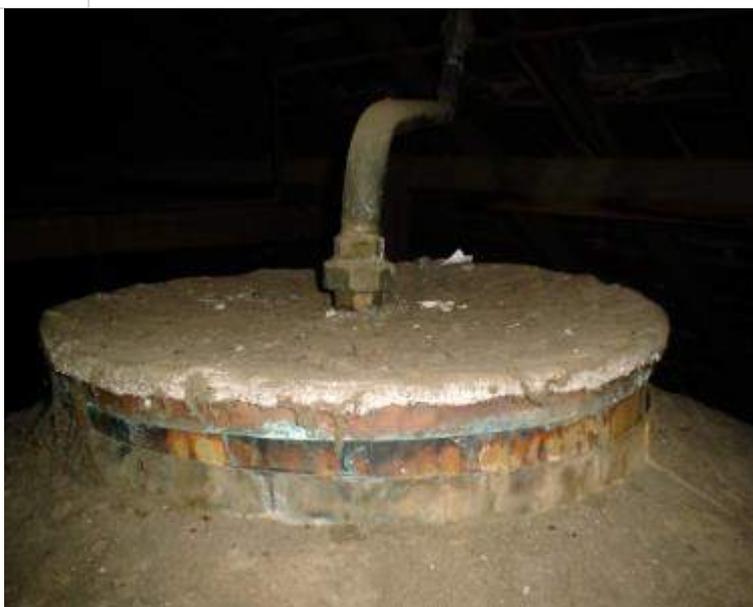
Asbestos Millboard – S15

Building:	Building 2 & 3 - Springfield House / Lady Grose Home / George Gerathy Wing
Location:	Lady Grose Home and George Gerathy Wing, internal roof space, hot water pipework
Material Type:	Millboard (black bituminous material)
Friable / non-friable	Friable
Condition:	Generally intact
Extent:	~1m ²
Risk Assessment / Recommendation:	High risk, material should be removed as soon as reasonably practicable
Reinspection / Removal Date:	Remove material as soon as reasonably practicable and prior to refurbishment and/or demolition works

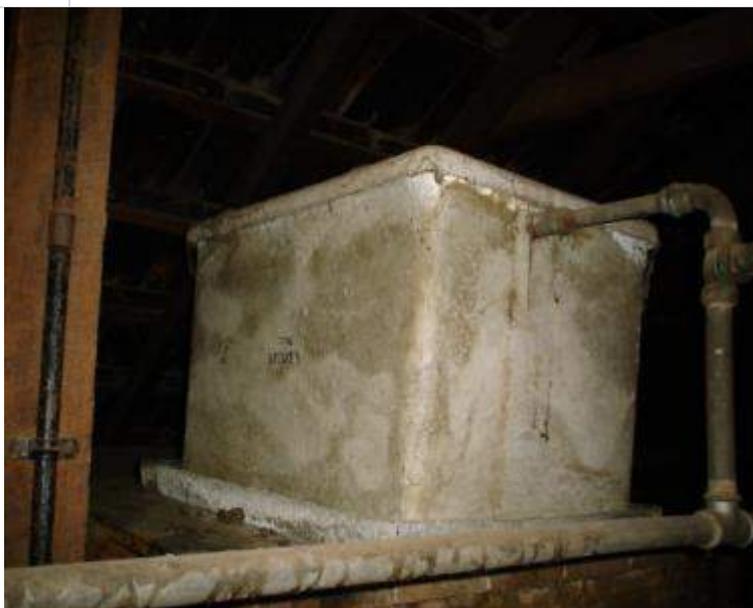
Moulded fibre cement sheet – S16

Building:	Building 2 & 3 - Springfield House / Lady Grouse Home / George Gerathy Wing
Location:	Lady Grouse Home and George Gerathy Wing, internal, roof space, tray tank and lid of small Sydney Water Tanks
Material Type:	Moulded asbestos fibre cement sheet
Friable / non-friable	Non-friable
Condition:	Generally intact
Extent:	~3m ²
Risk Assessment / Recommendation:	Low risk, leave and maintain in current condition
Reinspection / Removal Date:	Remove prior to refurbishment / demolition works or reinspect in 5 years

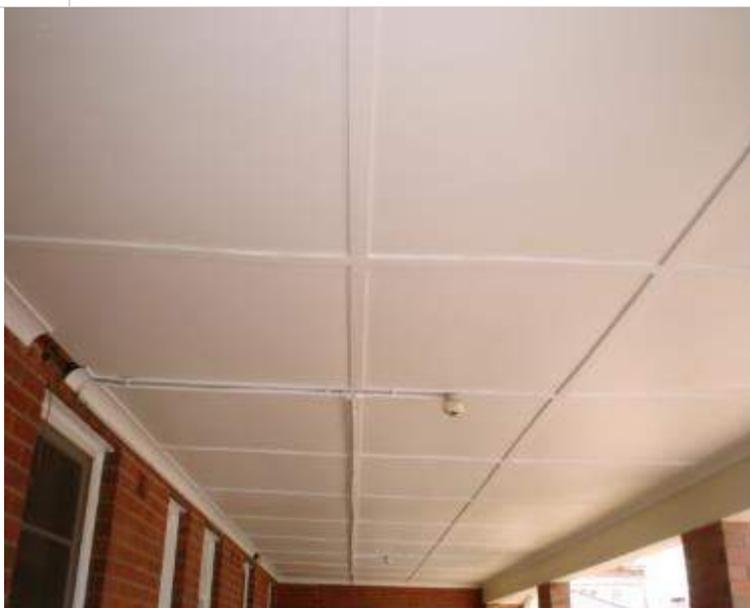
Flat fibre cement sheet – S17

Building:	Building 2 & 3 - Springfield House / Lady Grouse Home / George Gerathy Wing
Location:	Lady Grouse Home and George Gerathy Wing, Level1 external, verandah ceiling lining
Material Type:	Flat asbestos fibre cement sheet
Friable / non-friable	Non-friable
Condition:	Generally intact
Extent:	~40m ²
Risk Assessment / Recommendation:	Low risk, leave and maintain in current condition
Reinspection / Removal Date:	Remove prior to refurbishment / demolition works or reinspect in 5 years

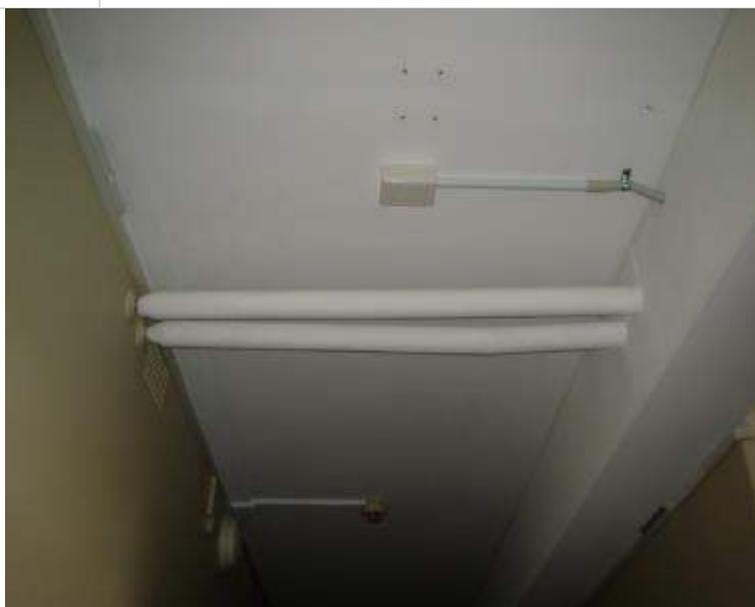
Wrapped asbestos lagging and associated debris – Similar to S14

Building:	Building 2 & 3 - Springfield House / Lady Grose Home / George Gerathy Wing
Location:	Lady Grouse Home and George Gerathy Wing, internal ground floor, pipework in main hallways
Material Type:	Wrapped asbestos lagging and associated debris
Friable / non-friable	Friable
Condition:	Generally intact
Extent:	~ 2 linear metres
Risk Assessment / Recommendation:	High risk, material should be removed as soon as reasonably practicable
Reinspection / Removal Date:	Remove material as soon as reasonably practicable and prior to refurbishment and/or demolition works

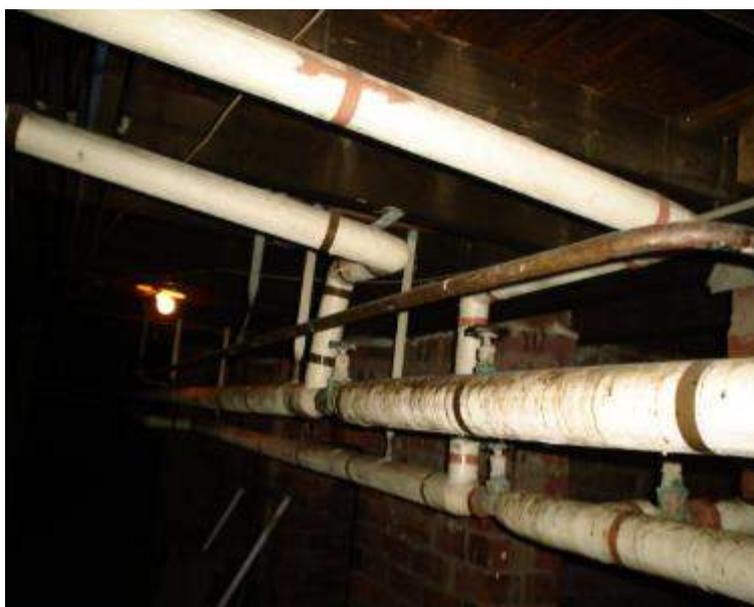
Wrapped asbestos lagging and associated debris –S18

Building:	Building 2 & 3 - Springfield House / Lady Grose Home / George Gerathy Wing
Location:	Lady Grouse Home and George Gerathy Wing, internal, sub-floor, hot water pipework
Material Type:	Wrapped asbestos lagging and associated debris
Friable / non-friable	Friable
Condition:	Generally intact
Extent:	~ 2 linear metres
Risk Assessment / Recommendation:	High risk, material should be removed as soon as reasonably practicable
Reinspection / Removal Date:	Remove material as soon as reasonably practicable and prior to refurbishment and/or demolition works

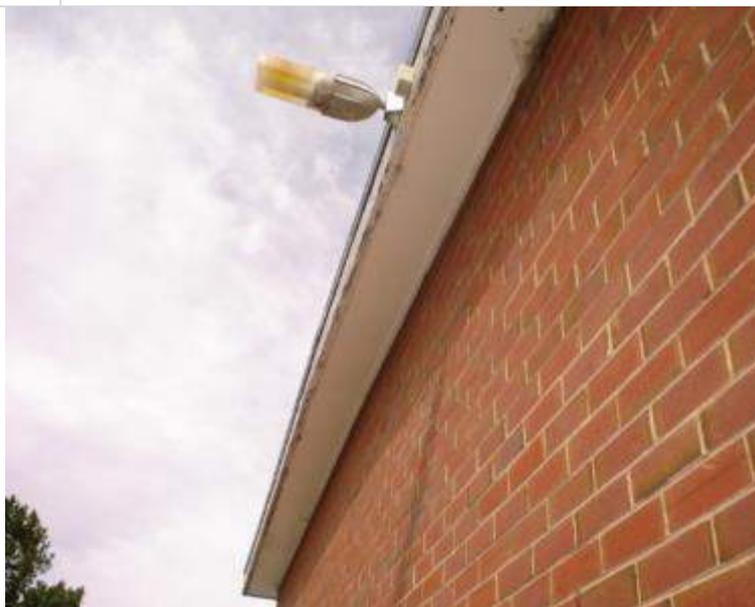
Flat fibre cement sheet – S1

Building:	Building 7 - Workshop
Location:	External, eave linings
Material Type:	Flat asbestos fibre cement sheet
Friable / non-friable	Non-friable
Condition:	Generally intact
Extent:	~40m ²
Risk Assessment / Recommendation:	Low risk, leave and maintain in current condition
Reinspection / Removal Date:	Remove prior to refurbishment / demolition works or reinspect in 5 years

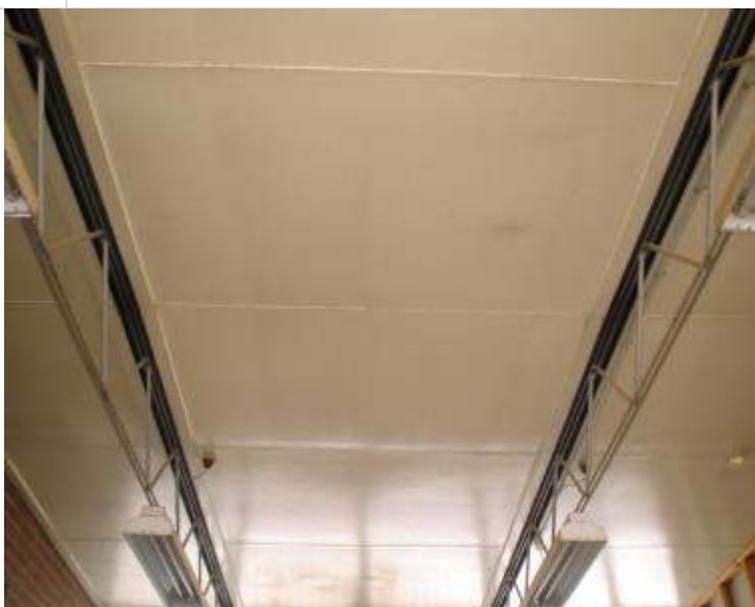
Flat fibre cement sheet – Similar to S1

Building:	Building 7 – Workshop
Location:	Internal, ceiling linings
Material Type:	Flat asbestos fibre cement sheet
Friable / non-friable	Non-friable
Condition:	Generally intact
Extent:	~40m ²
Risk Assessment / Recommendation:	Low risk, leave and maintain in current condition
Reinspection / Removal Date:	Remove prior to refurbishment / demolition works or reinspect in 5 years

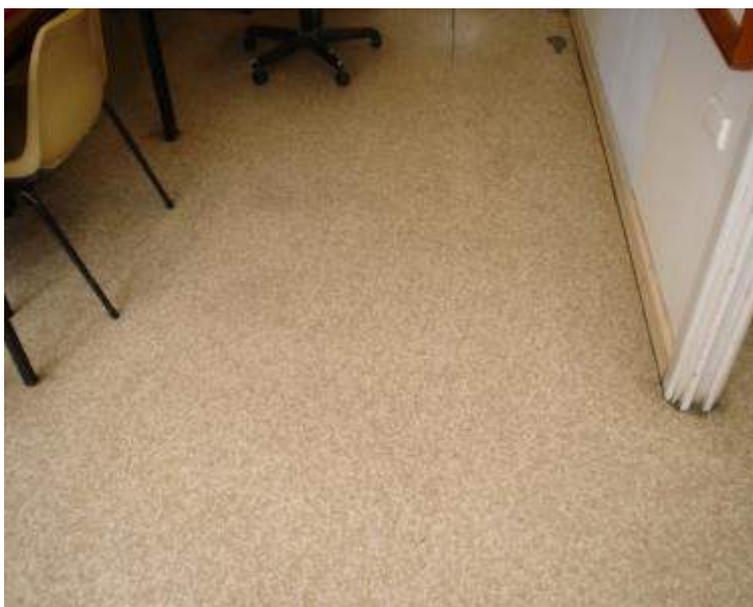
Vinyl Sheeting – S5

Building:	Building 7 – Workshop
Location:	Internal, lunchroom, locker room and kitchen floor covering (mottled cream)
Material Type:	Vinyl sheeting
Friable / non-friable	Non-friable
Condition:	Generally intact
Extent:	~20m ²
Risk Assessment / Recommendation:	Low risk, leave and maintain in current condition
Reinspection / Removal Date:	Remove prior to refurbishment / demolition works or reinspect in 5 years

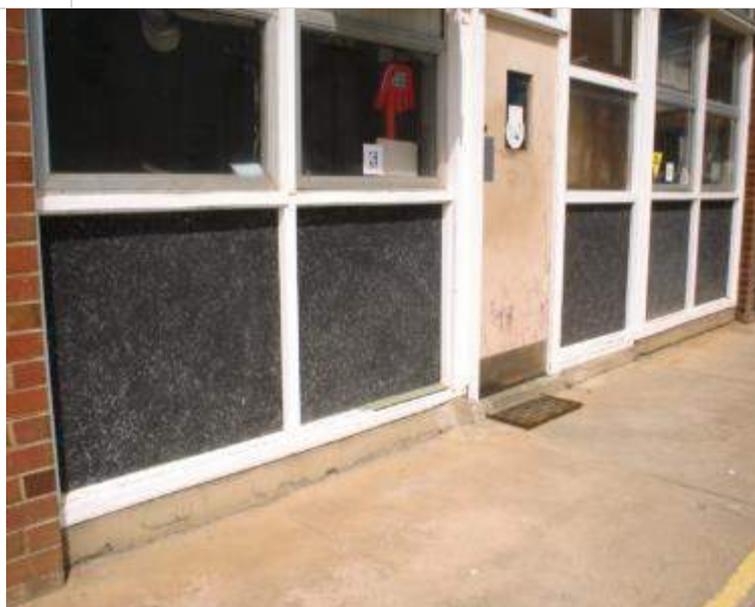
Flat fibre cement sheet – S6

Building:	Building 7 – Workshop
Location:	External, infill panels beneath windows
Material Type:	Flat asbestos fibre cement sheet
Friable / non-friable	Non-friable
Condition:	Generally intact
Extent:	~5m ²
Risk Assessment / Recommendation:	Low risk, leave and maintain in current condition
Reinspection / Removal Date:	Remove prior to refurbishment / demolition works or reinspect in 5 years

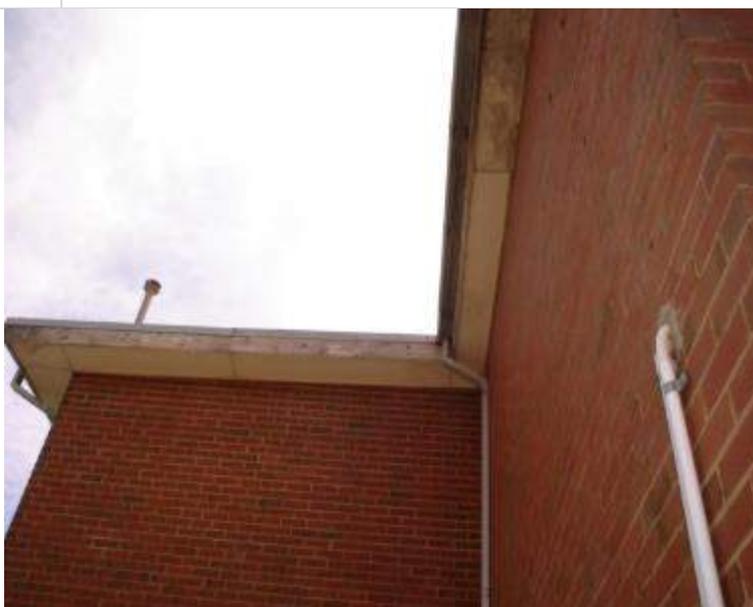
Flat fibre cement sheet – Visually inspected (height restriction)

Building:	Building 8 – Asset Management
Location:	External, eave linings
Material Type:	Flat asbestos fibre cement sheet
Friable / non-friable	Non-friable
Condition:	Generally intact
Extent:	~40m ²
Risk Assessment / Recommendation:	Low risk, leave and maintain in current condition
Reinspection / Removal Date:	Remove prior to refurbishment / demolition works or reinspect in 5 years

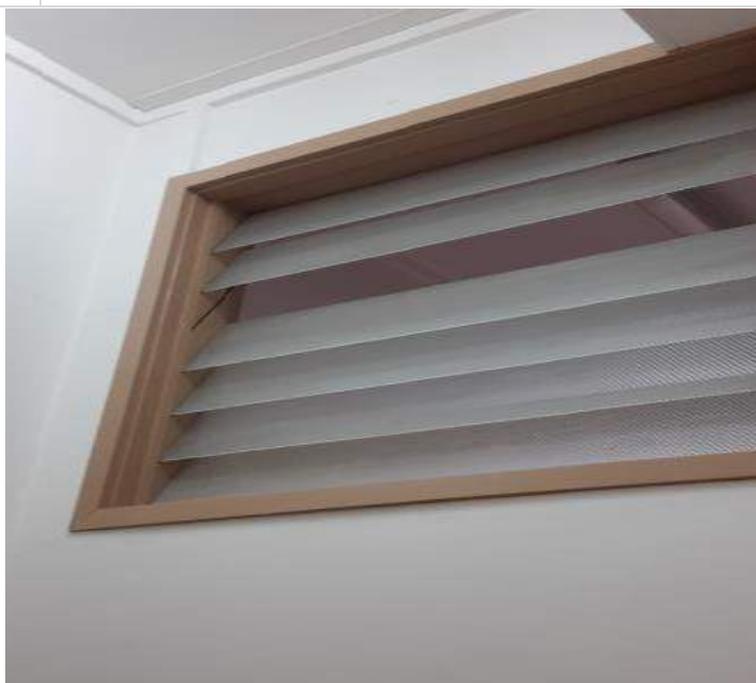
Flat asbestos fibre cement sheet –S11

Building:	Building 13 - Physio
Location:	Internal, infill panels in staff toilets
Material Type:	Flat asbestos fibre cement sheet
Friable / non-friable	Non-friable
Condition:	Generally intact
Extent:	~1m ²
Risk Assessment / Recommendation:	Low risk, leave and maintain in current condition
Reinspection / Removal Date:	Remove prior to refurbishment / demolition works or reinspect in 5 years

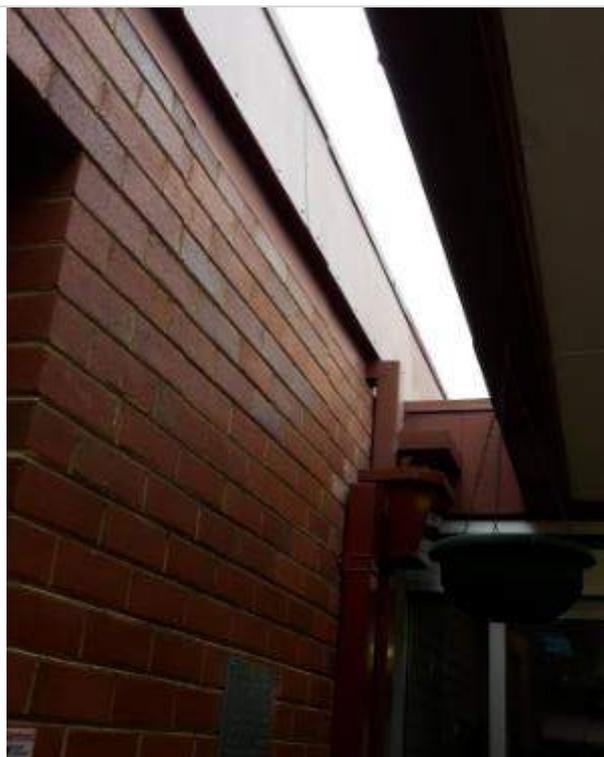
Flat asbestos fibre cement sheet –S12

Building:	Building 13 - Physio
Location:	External, bulkhead panels
Material Type:	Flat asbestos fibre cement sheet
Friable / non-friable	Non-friable
Condition:	Generally intact
Extent:	~120m ²
Risk Assessment / Recommendation:	Low risk, leave and maintain in current condition
Reinspection / Removal Date:	Remove prior to refurbishment / demolition works or reinspect in 5 years

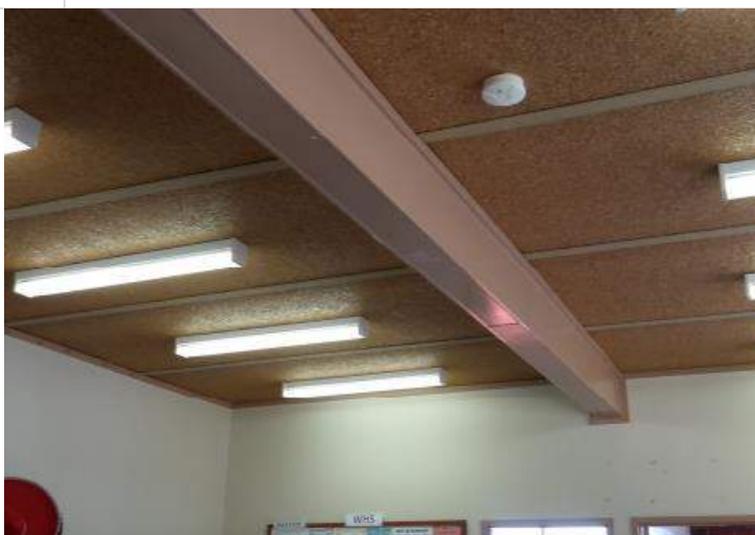
Flat asbestos fibre cement sheet –S41

Building:	Building 13 - Physio
Location:	Internal, lining to ceiling beams
Material Type:	Flat asbestos fibre cement sheet
Friable / non-friable	Non-friable
Condition:	Generally intact
Extent:	~100m ²
Risk Assessment / Recommendation:	Low risk, leave and maintain in current condition
Reinspection / Removal Date:	Remove prior to refurbishment / demolition works or reinspect in 5 years

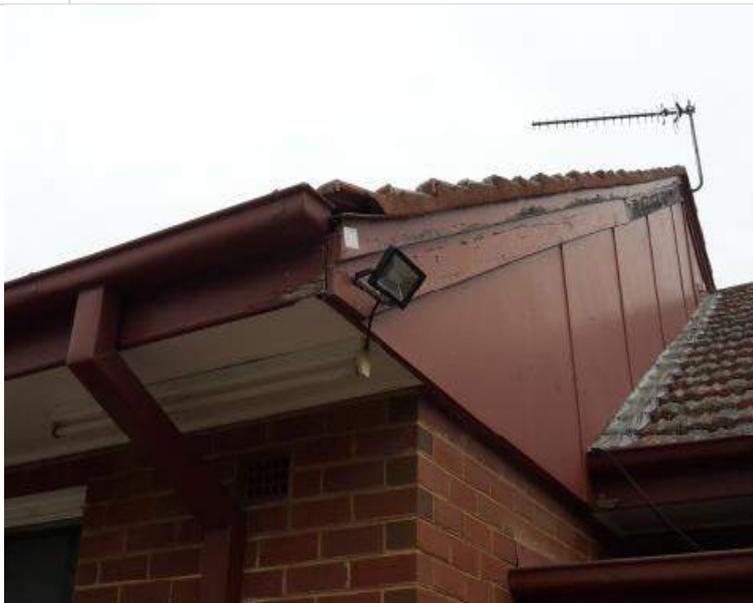
Flat asbestos fibre cement sheet –S04

Building:	Building 14 – Renal Unit
Location:	External, tile edge support
Material Type:	Flat asbestos fibre cement sheet
Friable / non-friable	Non-friable
Condition:	Generally intact
Extent:	~10m ²
Risk Assessment / Recommendation:	Low risk, leave and maintain in current condition
Reinspection / Removal Date:	Remove prior to refurbishment / demolition works or reinspect in 5 years

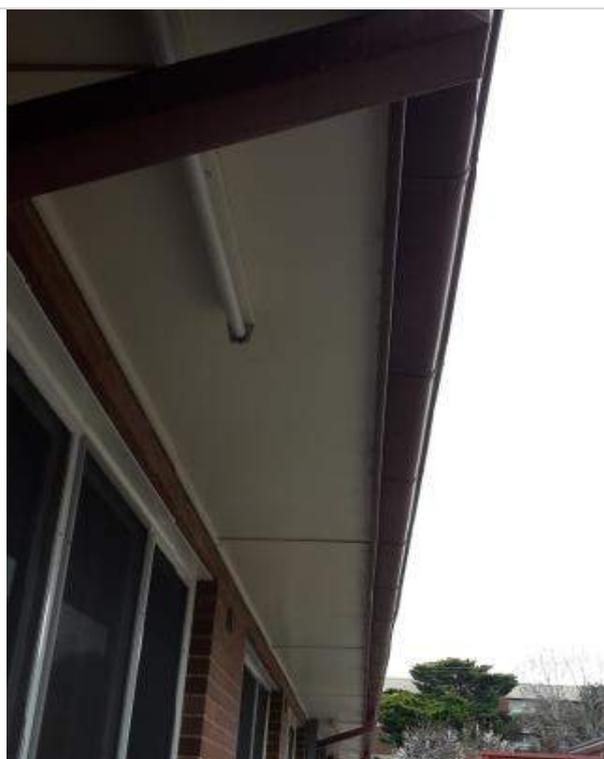
Flat asbestos fibre cement sheet –S05

Building:	Building 14 – Renal Unit
Location:	External, eave linings
Material Type:	Flat asbestos fibre cement sheet
Friable / non-friable	Non-friable
Condition:	Generally intact
Extent:	~80m ²
Risk Assessment / Recommendation:	Low risk, leave and maintain in current condition
Reinspection / Removal Date:	Remove prior to refurbishment / demolition works or reinspect in 5 years

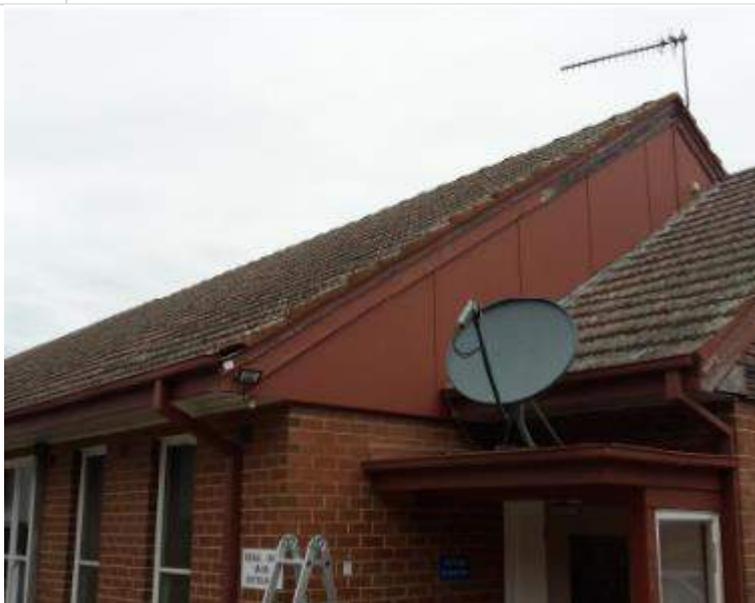
Flat asbestos fibre cement sheet –Similar to S05

Building:	Building 14 – Renal Unit
Location:	External, gable ends
Material Type:	Flat asbestos fibre cement sheet
Friable / non-friable	Non-friable
Condition:	Generally intact
Extent:	~30m ²
Risk Assessment / Recommendation:	Low risk, leave and maintain in current condition
Reinspection / Removal Date:	Remove prior to refurbishment / demolition works or reinspect in 5 years

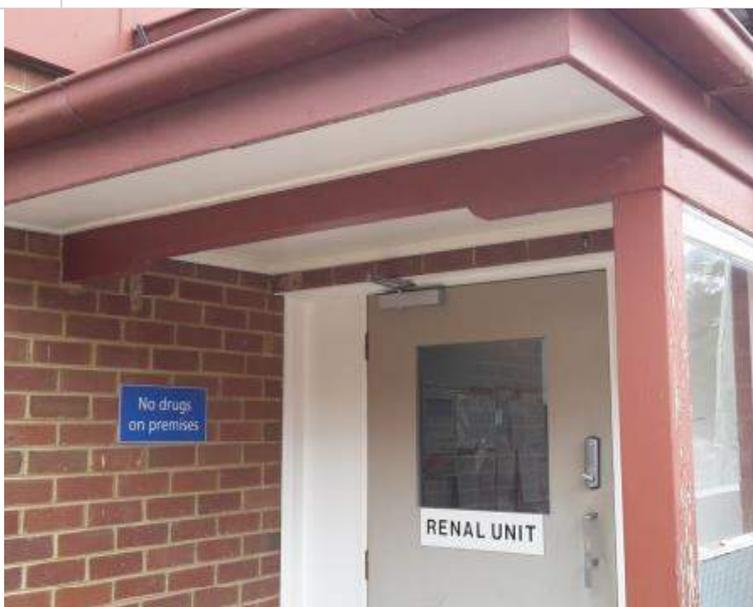
Flat asbestos fibre cement sheet –Similar to S05

Building:	Building 14 – Renal Unit
Location:	External, surrounds to door and awning
Material Type:	Flat asbestos fibre cement sheet
Friable / non-friable	Non-friable
Condition:	Generally intact
Extent:	~20m ²
Risk Assessment / Recommendation:	Low risk, leave and maintain in current condition
Reinspection / Removal Date:	Remove prior to refurbishment / demolition works or reinspect in 5 years

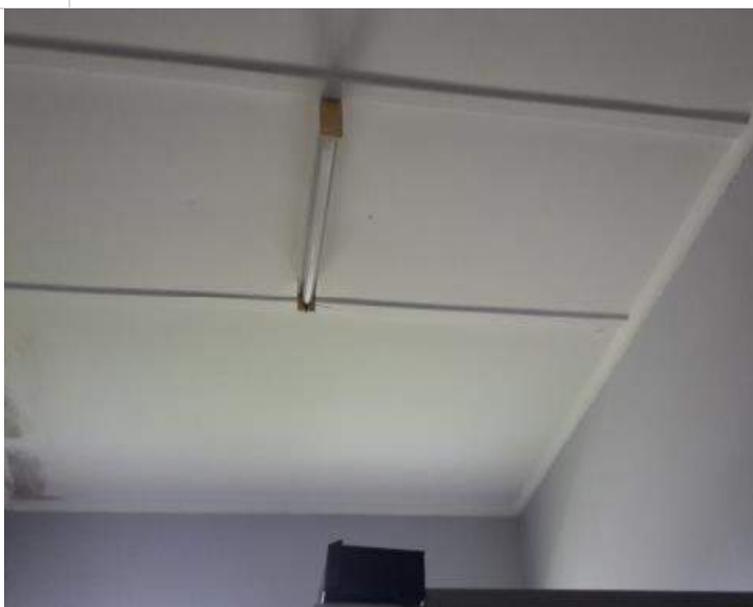
Flat asbestos fibre cement sheet –S10

Building:	Building 14 – Renal Unit
Location:	Internal, cleaners store outside Occupational Therapy, ceiling lining
Material Type:	Flat asbestos fibre cement sheet
Friable / non-friable	Non-friable
Condition:	Generally intact
Extent:	~18m ²
Risk Assessment / Recommendation:	Low risk, leave and maintain in current condition
Reinspection / Removal Date:	Remove prior to refurbishment / demolition works or reinspect in 5 years

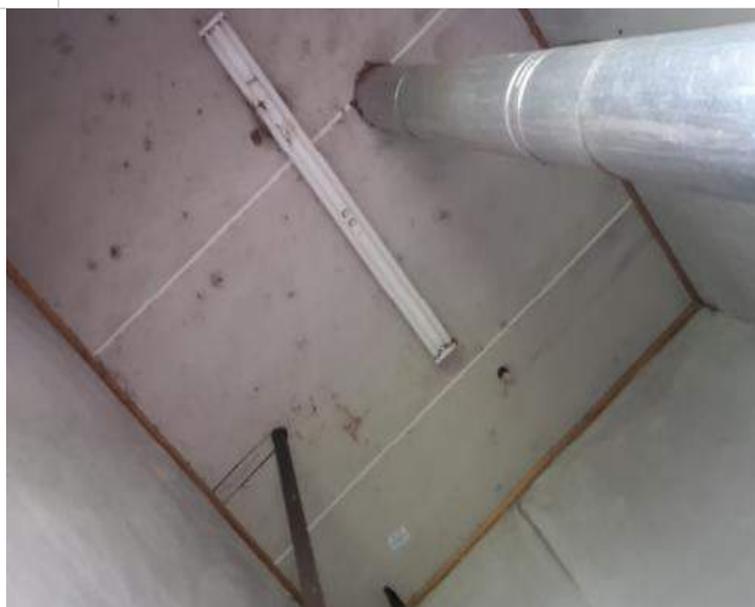
Flat asbestos fibre cement sheet – Similar to S10

Building:	Building 14 – Renal Unit
Location:	Internal, plant room ceiling lining
Material Type:	Flat asbestos fibre cement sheet
Friable / non-friable	Non-friable
Condition:	Generally intact
Extent:	~9m ²
Risk Assessment / Recommendation:	Low risk, leave and maintain in current condition
Reinspection / Removal Date:	Remove prior to refurbishment / demolition works or reinspect in 5 years

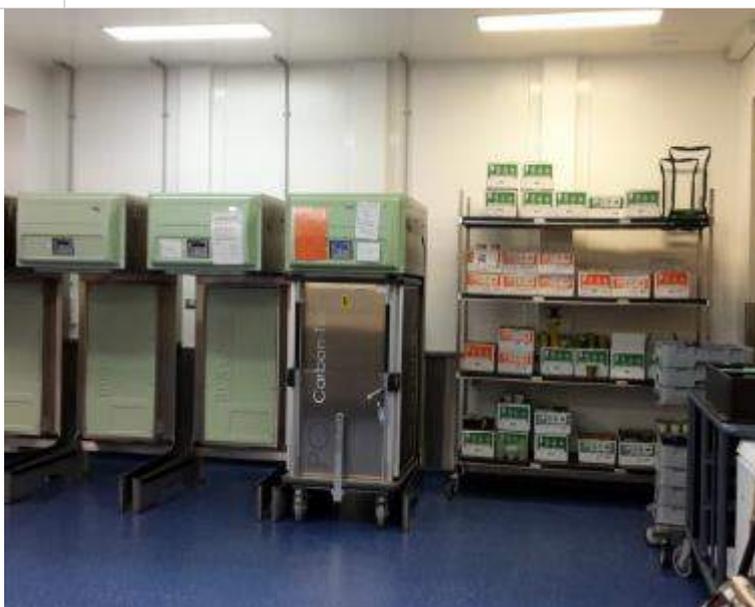
Flat asbestos fibre cement sheet –S77

Building:	Building 16 – Main Hospital / Theatres
Location:	Internal, catering kitchen, west wall, wall lining
Material Type:	Flat asbestos fibre cement sheet
Friable / non-friable	Non-friable
Condition:	Generally intact
Extent:	~30m ²
Risk Assessment / Recommendation:	Low risk, leave and maintain in current condition
Reinspection / Removal Date:	Remove prior to refurbishment / demolition works or reinspect in 5 years

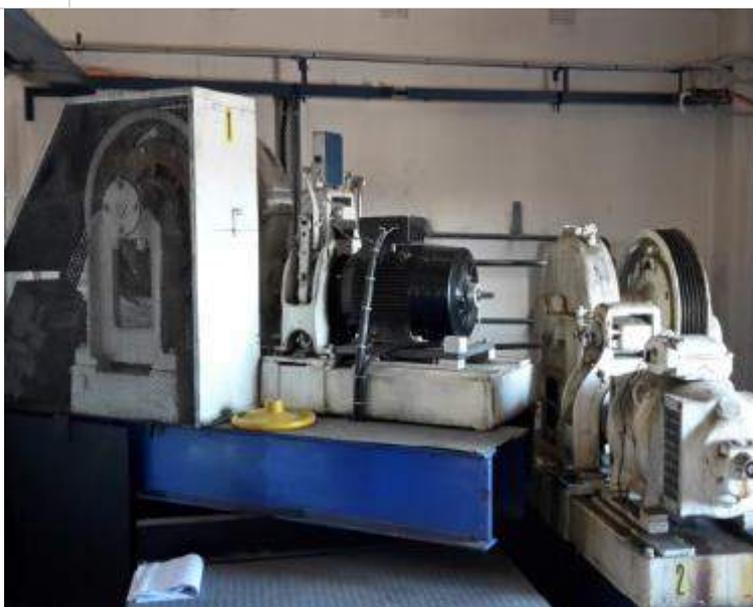
Lift brake equipment including brake shoes – Not sampled (electrical hazard)

Building:	Building 16 – Main Hospital / Theatres
Location:	Internal, third floor lift motor room
Material Type:	Lift equipment including brake shoes
Friable / non-friable	NA
Condition:	NA
Extent:	NA
Risk Assessment / Recommendation:	Low risk, leave and maintain in current condition
Reinspection / Removal Date:	Remove prior to refurbishment / demolition works or reinspect in 5 years

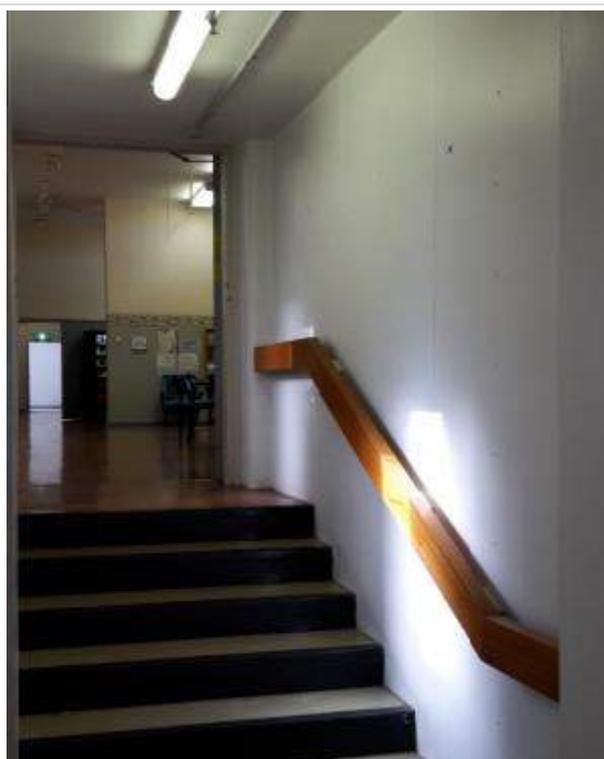
Flat asbestos fibre cement sheet –S79

Building:	Building 16 – Main Hospital / Theatres
Location:	Internal, wall linings to corridor from Building 29 to Building 16
Material Type:	Flat asbestos fibre cement sheet
Friable / non-friable	Non-friable
Condition:	Generally intact
Extent:	~30m ²
Risk Assessment / Recommendation:	Low risk, leave and maintain in current condition
Reinspection / Removal Date:	Remove prior to refurbishment / demolition works or reinspect in 5 years

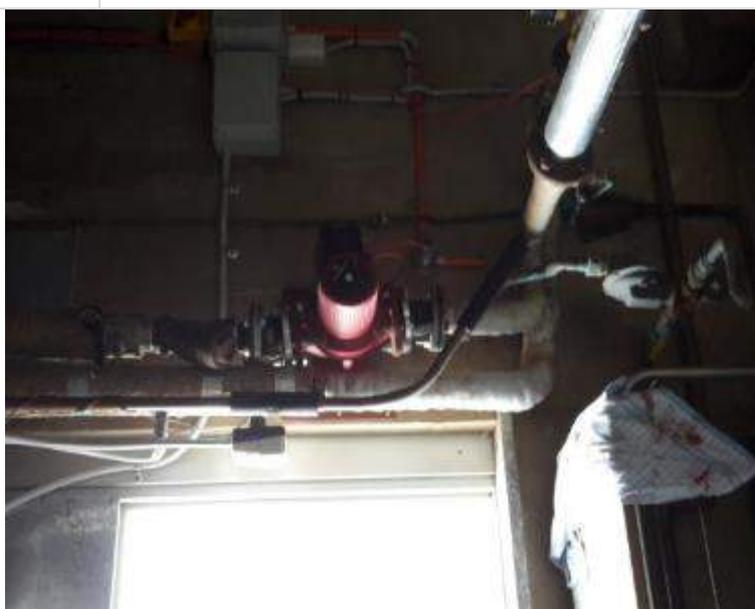
Wrapped asbestos lagging – Similar to S14

Building:	Building 16 – Main Hospital / Theatres
Location:	Internal, first floor plant room, pipework
Material Type:	Wrapped asbestos lagging
Friable / non-friable	Friable
Condition:	Generally intact
Extent:	Throughout plant room, ceiling space and service ducts on first floor
Risk Assessment / Recommendation:	High risk, material should be removed as soon as reasonably practicable
Reinspection / Removal Date:	Remove material as soon as reasonably practicable and prior to refurbishment and/or demolition works

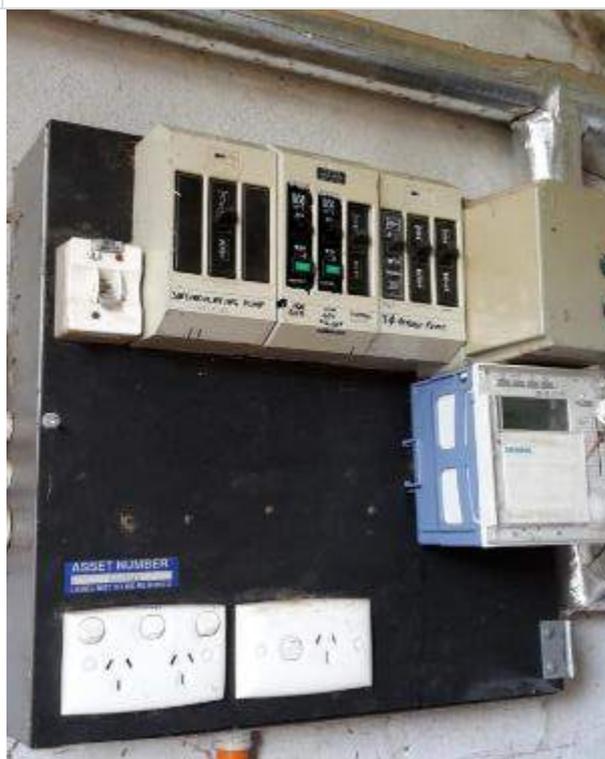
Electrical backing board – Not sampled (electrical hazard)

Building:	Building 16 – Main Hospital / Theatres
Location:	Internal, first floor plant room
Material Type:	Electrical backing board
Friable / non-friable	Non-friable
Condition:	Generally intact
Extent:	~1m ²
Risk Assessment / Recommendation:	Low risk, leave and maintain in current condition
Reinspection / Removal Date:	Remove prior to refurbishment / demolition works or reinspect in 5 years

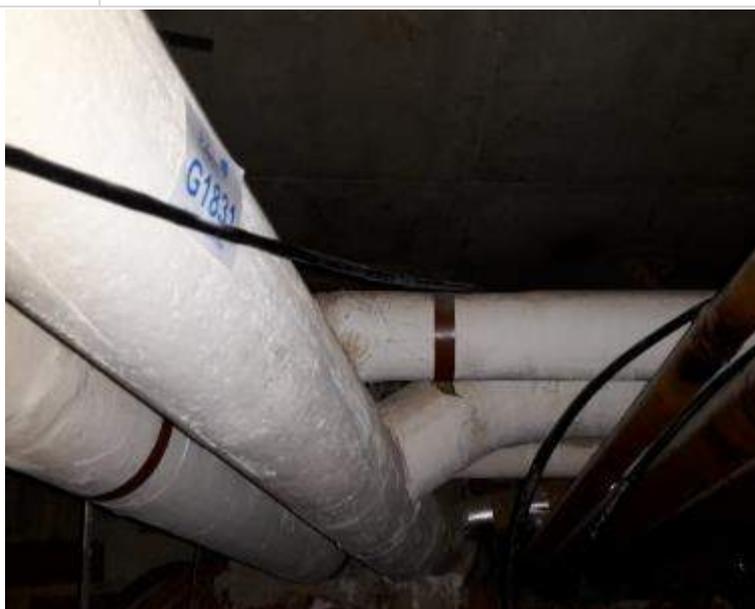
Wrapped asbestos lagging – Similar to S14

Building:	Building 16 – Main Hospital / Theatres
Location:	Internal, ground floor ceiling space, pipework
Material Type:	Wrapped asbestos lagging
Friable / non-friable	Friable
Condition:	Generally intact
Extent:	Throughout ceiling space and service ducts on ground floor
Risk Assessment / Recommendation:	High risk, material should be removed as soon as reasonably practicable
Reinspection / Removal Date:	Remove material as soon as reasonably practicable and prior to refurbishment and/or demolition works

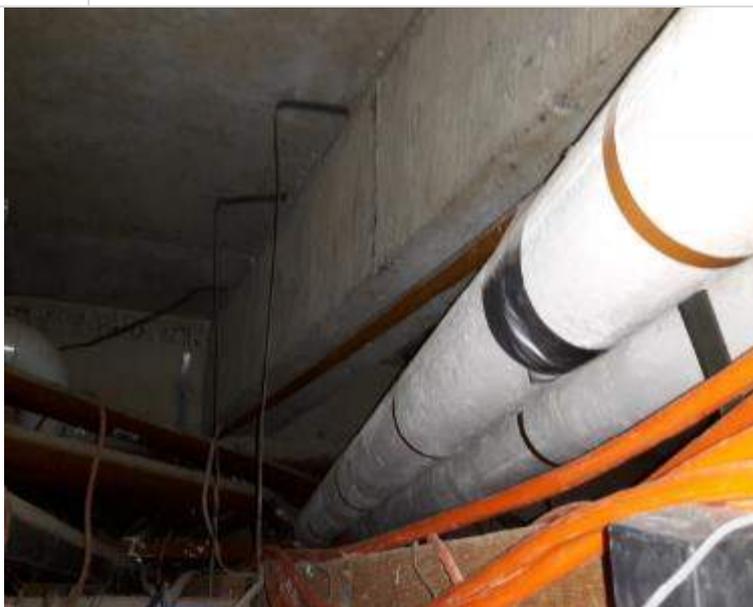
Wrapped asbestos lagging – Similar to S14

Building:	Building 16 – Main Hospital / Theatres
Location:	Internal, basement ceiling space, pipework
Material Type:	Wrapped asbestos lagging
Friable / non-friable	Friable
Condition:	Generally intact
Extent:	Throughout ceiling space and service ducts on basement level
Risk Assessment / Recommendation:	High risk, material should be removed as soon as reasonably practicable
Reinspection / Removal Date:	Remove material as soon as reasonably practicable and prior to refurbishment and/or demolition works

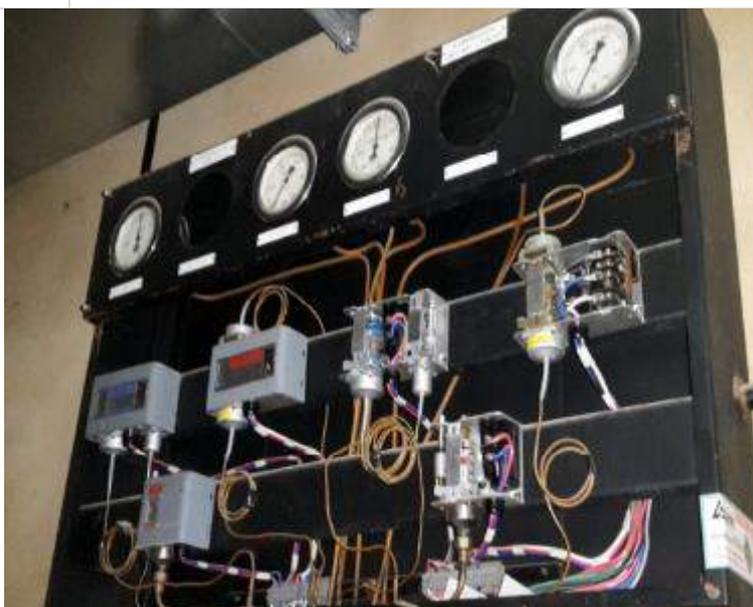
Electrical backing board – S83

Building:	Building 16 – Main Hospital / Theatres
Location:	Internal, lower basement level
Material Type:	Asbestos electrical backing board
Friable / non-friable	Non-friable
Condition:	Generally intact
Extent:	~1m ²
Risk Assessment / Recommendation:	Low risk, leave and maintain in current condition
Reinspection / Removal Date:	Remove prior to refurbishment / demolition works or reinspect in 5 years

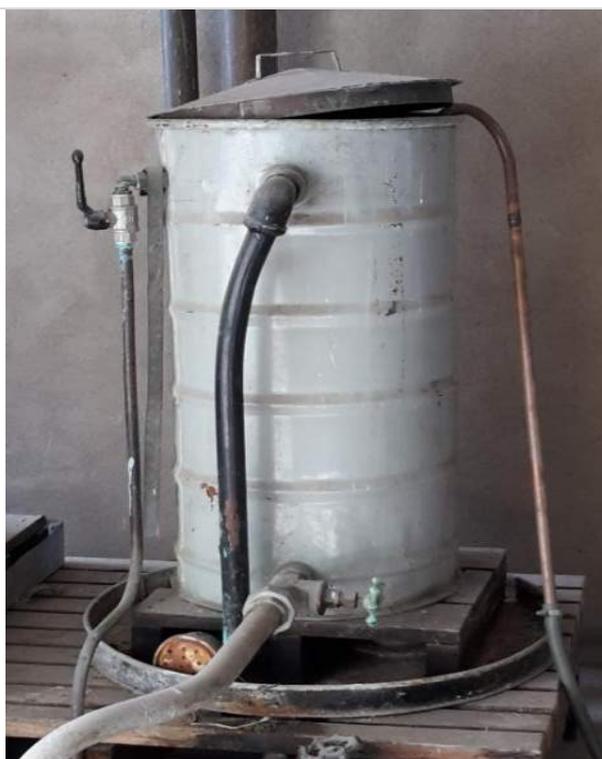
Millboard – Similar to S15

Building:	Building 16 – Theatres / Main Hospital
Location:	Internal, fourth floor, water tank (small round)
Material Type:	Millboard
Friable / non-friable	Friable
Condition:	Generally contained
Extent:	1 unit
Risk Assessment / Recommendation:	High risk, material should be removed as soon as reasonably practicable
Reinspection / Removal Date:	Remove material as soon as reasonably practicable and prior to refurbishment and/or demolition works

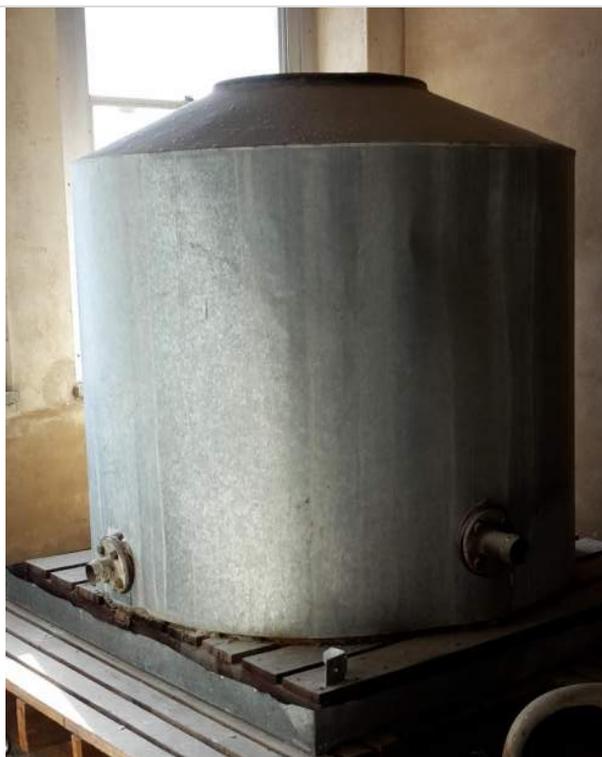
Millboard – Similar to S15

Building:	Building 16 – Theatres / Main Hospital
Location:	Internal, fourth floor, water tank (larger round)
Material Type:	Millboard
Friable / non-friable	Friable
Condition:	Generally contained
Extent:	1 unit
Risk Assessment / Recommendation:	High risk, material should be removed as soon as reasonably practicable
Reinspection / Removal Date:	Remove material as soon as reasonably practicable and prior to refurbishment and/or demolition works

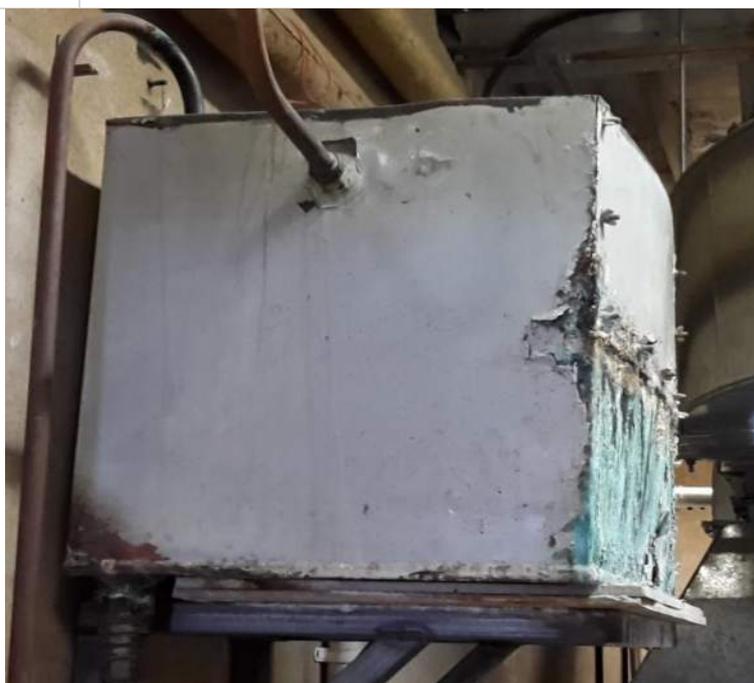
Millboard – Similar to S15

Building:	Building 16 – Theatres / Main Hospital
Location:	Internal, first floor, plant room, water tank (square)
Material Type:	Millboard
Friable / non-friable	Friable
Condition:	Generally contained
Extent:	1 unit
Risk Assessment / Recommendation:	High risk, material should be removed as soon as reasonably practicable
Reinspection / Removal Date:	Remove material as soon as reasonably practicable and prior to refurbishment and/or demolition works

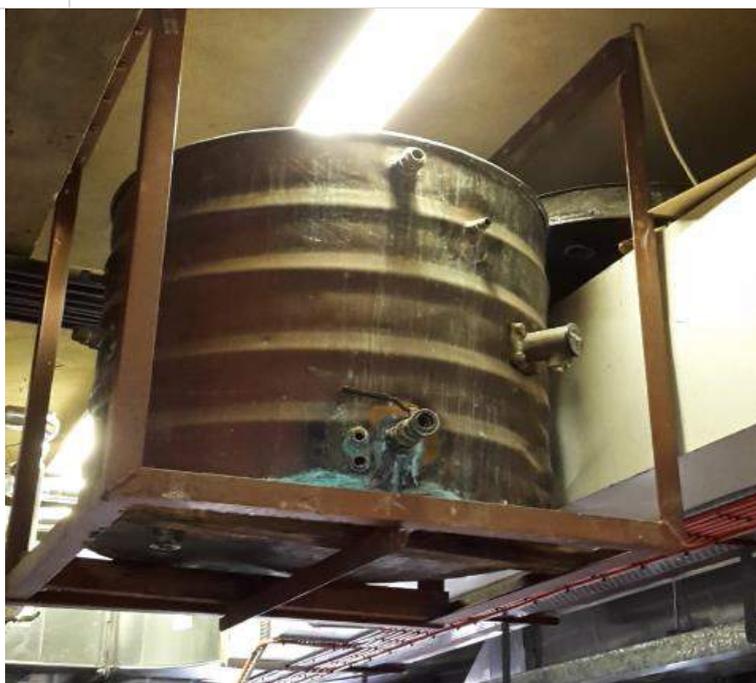
Millboard – Similar to S15

Building:	Building 16 – Theatres / Main Hospital
Location:	Internal, first floor, water tank (metal round)
Material Type:	Millboard
Friable / non-friable	Friable
Condition:	Generally contained
Extent:	1 unit
Risk Assessment / Recommendation:	High risk, material should be removed as soon as reasonably practicable
Reinspection / Removal Date:	Remove material as soon as reasonably practicable and prior to refurbishment and/or demolition works
