**Goulburn Base Hospital, 130 Goldsmith Street, Goulburn, NSW
 Hazardous Building Materials Register - September 2017**

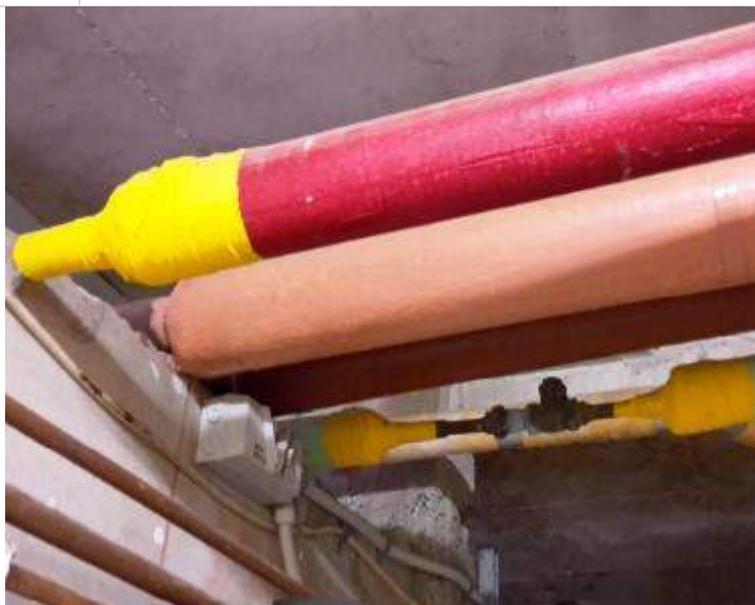
Wrapped asbestos lagging – Similar to S14

Building:	Building 17 / 18 - Procedure & Paediatric Units / Wards
Location:	External, under floor areas, pipework
Material Type:	Wrapped asbestos lagging
Friable / non-friable	Friable
Condition:	Generally intact
Extent:	Throughout underfloor area and assumed to extend throughout building
Risk Assessment / Recommendation:	High risk, material should be removed as soon as reasonably practicable
Reinspection / Removal Date:	Remove material as soon as reasonably practicable and prior to refurbishment and/or demolition works

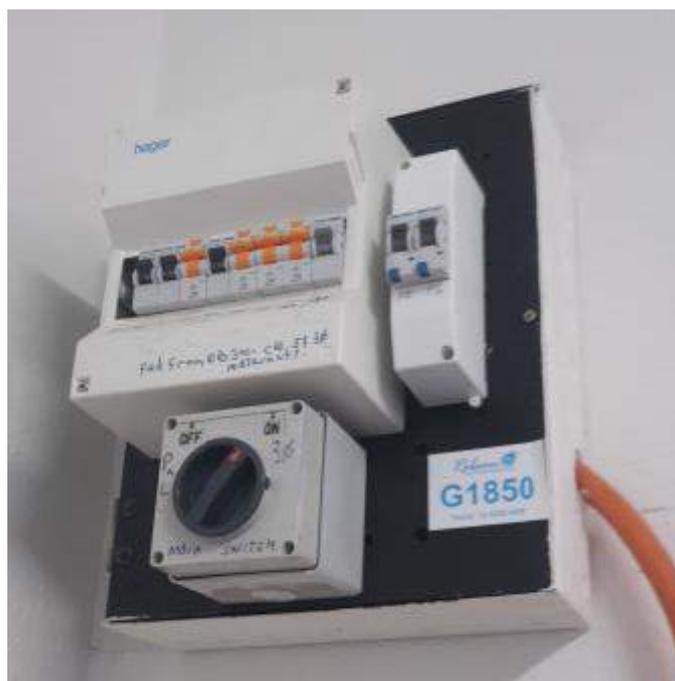
Electrical backing board – S15

Building:	Building 19 - Education
Location:	Internal, 'treatment' room
Material Type:	Asbestos electrical backing board
Friable / non-friable	Non-friable
Condition:	Generally intact
Extent:	~1m ²
Risk Assessment / Recommendation:	Low risk, leave and maintain in current condition
Reinspection / Removal Date:	Remove prior to refurbishment / demolition works or reinspect in 5 years

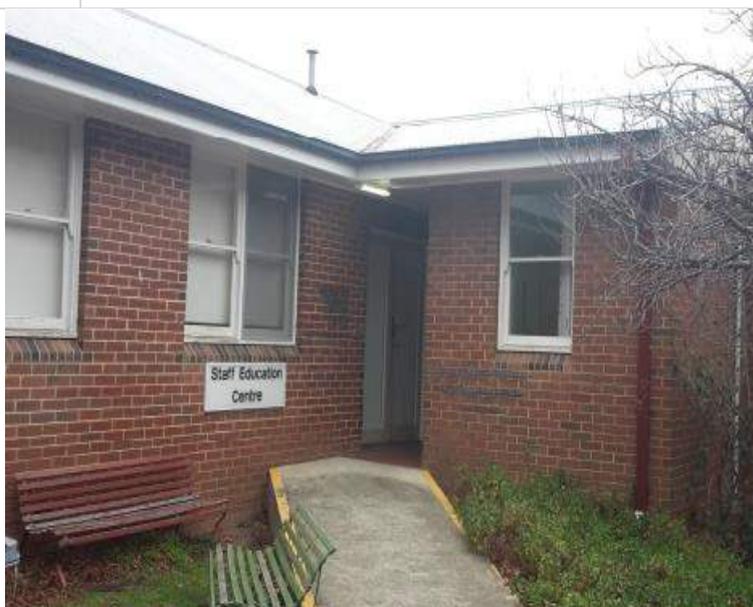
Flat asbestos fibre cement sheet –S16

Building:	Building 19 - Education
Location:	External, eave linings
Material Type:	Flat asbestos fibre cement sheet
Friable / non-friable	Non-friable
Condition:	Generally intact
Extent:	~60m ²
Risk Assessment / Recommendation:	Low risk, leave and maintain in current condition
Reinspection / Removal Date:	Remove prior to refurbishment / demolition works or reinspect in 5 years

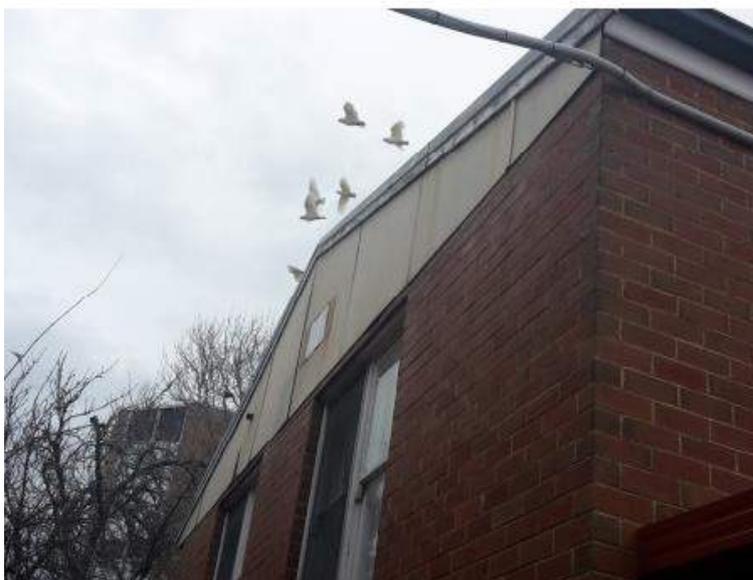
Flat asbestos fibre cement sheet –S17

Building:	Building 19 - Education
Location:	External, gable ends and joining strips
Material Type:	Flat asbestos fibre cement sheet
Friable / non-friable	Non-friable
Condition:	Generally intact
Extent:	~80m ²
Risk Assessment / Recommendation:	Low risk, leave and maintain in current condition
Reinspection / Removal Date:	Remove prior to refurbishment / demolition works or reinspect in 5 years

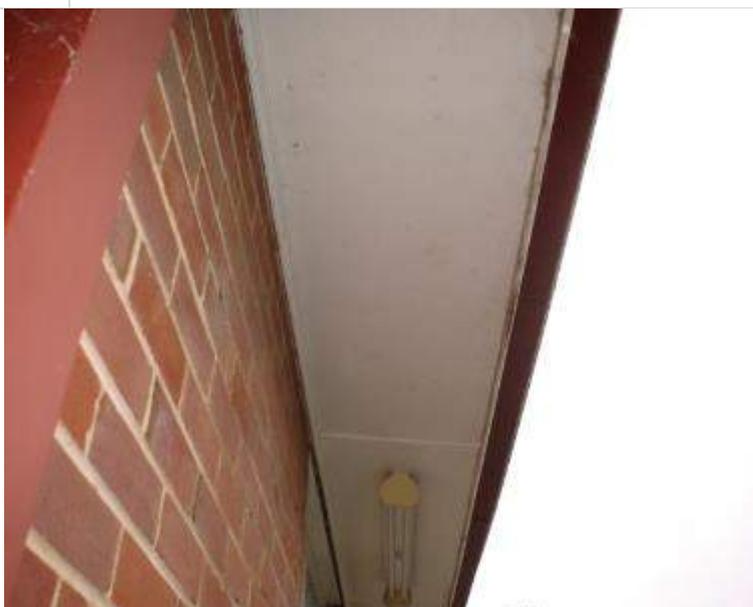
Flat asbestos fibre cement sheet –Similar to S33

Building:	Building 20 - Antenatal
Location:	External, eave linings
Material Type:	Flat asbestos fibre cement sheet
Friable / non-friable	Non-friable
Condition:	Generally intact
Extent:	~20m ²
Risk Assessment / Recommendation:	Low risk, leave and maintain in current condition
Reinspection / Removal Date:	Remove prior to refurbishment / demolition works or reinspect in 5 years

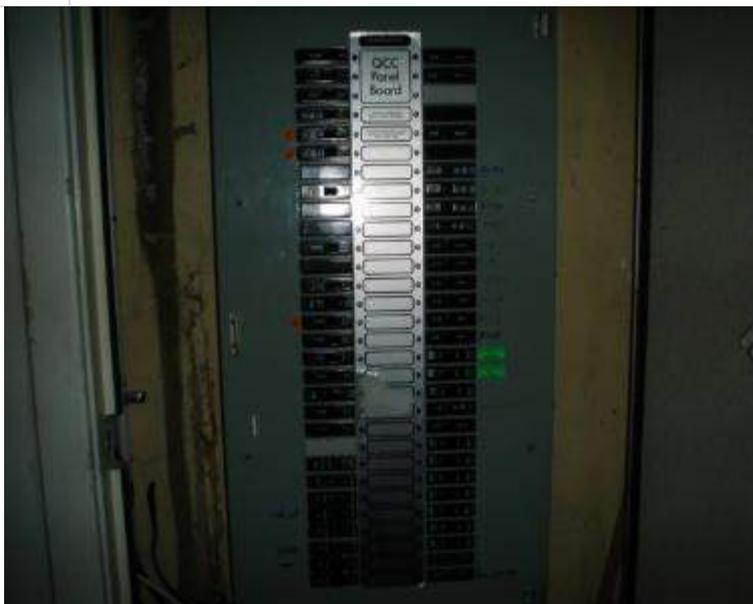
Distribution Board – Visually inspected (metal cover)

Building:	Building 21 - Maternity
Location:	Internal corridor north and south electrical cupboards, distribution boards
Material Type:	Distribution board
Friable / non-friable	Non-friable
Condition:	Generally intact
Extent:	~1m ²
Risk Assessment / Recommendation:	Low risk, leave and maintain in current condition
Reinspection / Removal Date:	Remove prior to refurbishment / demolition works or reinspect in 5 years

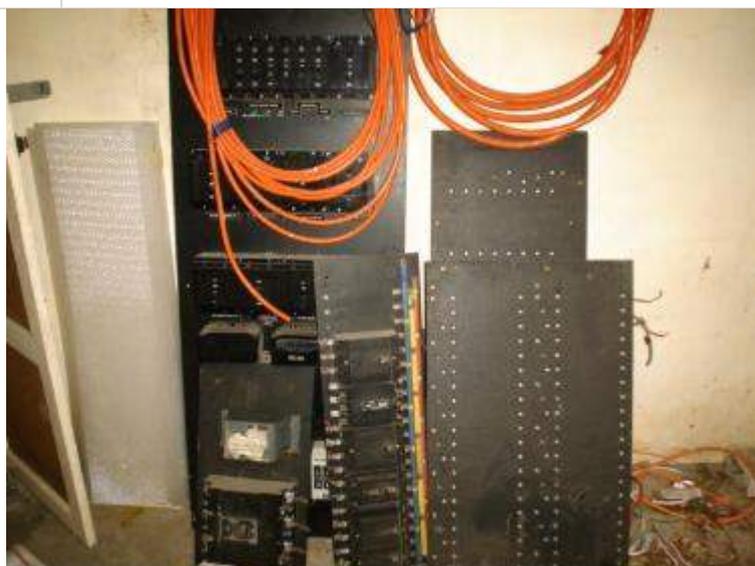
Electrical Backing Boards (disused) – S23

Building:	Building 21 - Maternity
Location:	Internal sub floor boiler room
Material Type:	Electrical backing boards (disused)
Friable / non-friable	Non-friable
Condition:	Generally intact
Extent:	~2m ²
Risk Assessment / Recommendation:	Low risk, leave and maintain in current condition
Reinspection / Removal Date:	Remove prior to refurbishment / demolition works or reinspect in 5 years

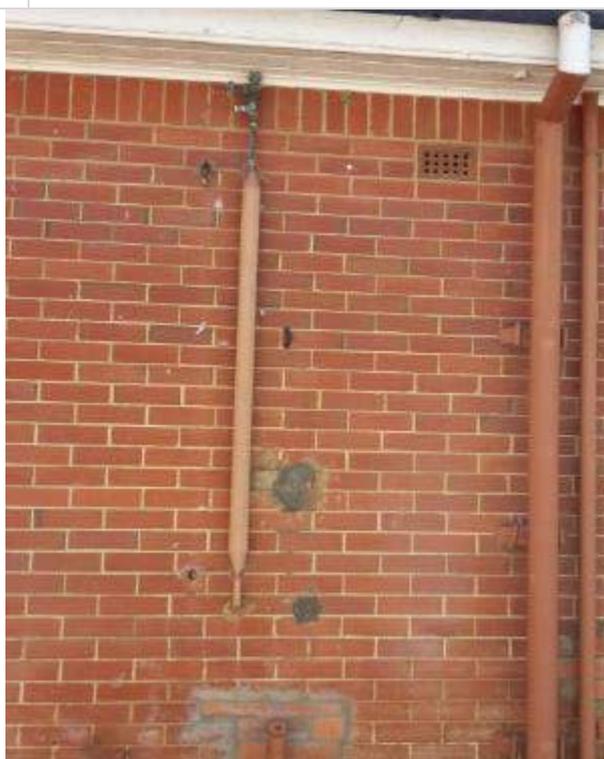
Asbestos lagged pipework– Similar to S14

Building:	Building 22 – West Wing / Office / Clinical Library
Location:	External, walls of domestic services end of building, pipework
Material Type:	Wrapped asbestos lagging
Friable / non-friable	Friable
Condition:	Generally intact
Extent:	~8 linear metres
Risk Assessment / Recommendation:	High risk, material should be removed as soon as reasonably practicable
Reinspection / Removal Date:	Remove material as soon as reasonably practicable and prior to refurbishment and/or demolition works

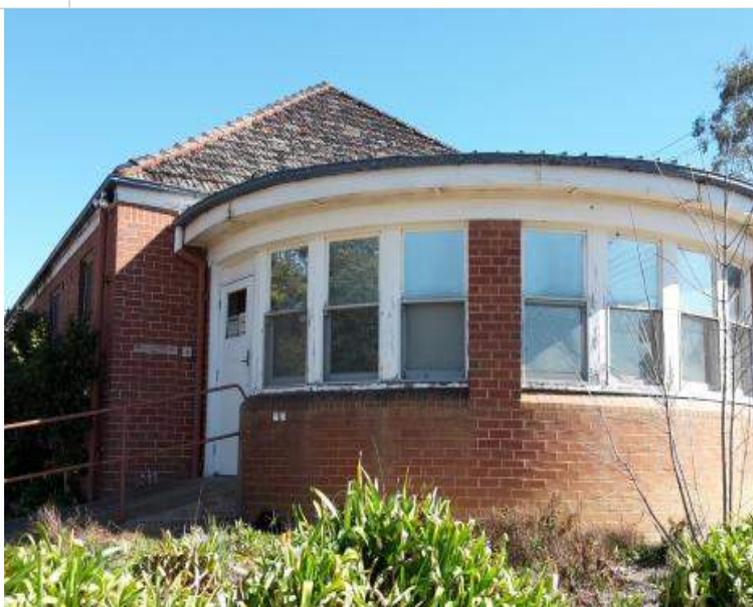
Flat asbestos fibre cement sheet –S42

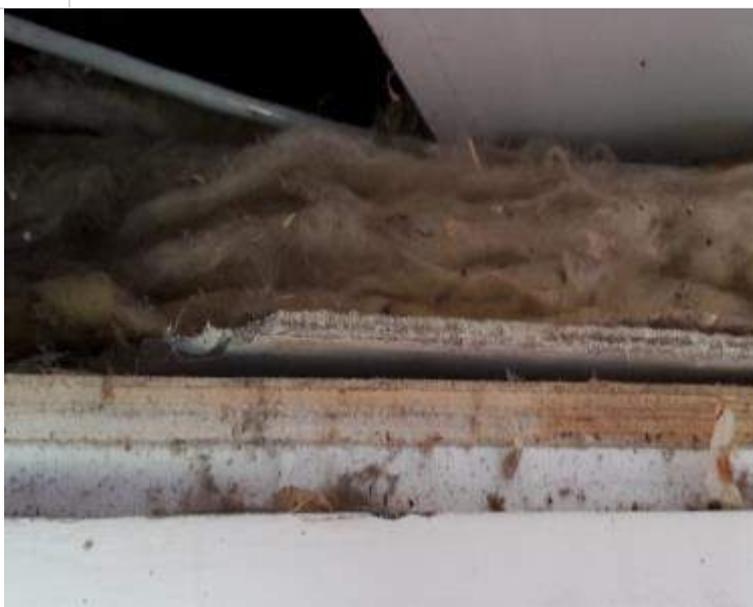
Flat asbestos fibre cement sheet –S63

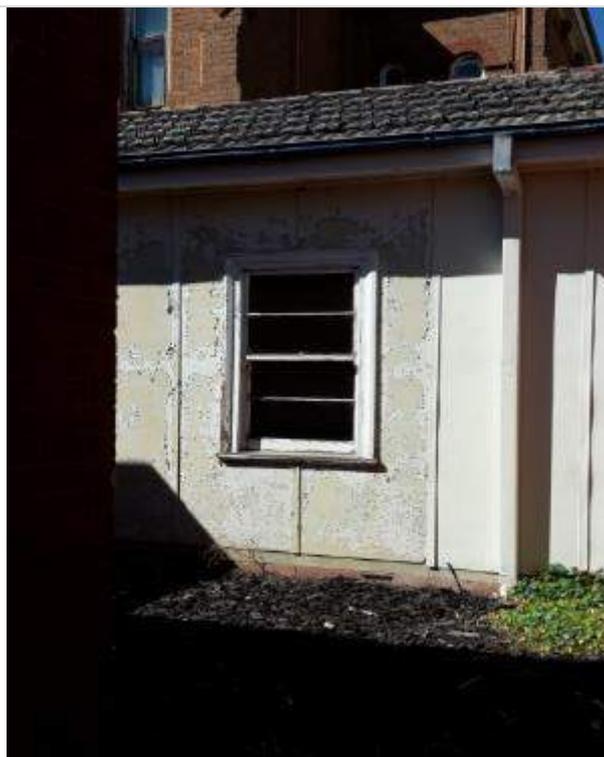
Flat asbestos fibre cement sheet –S69

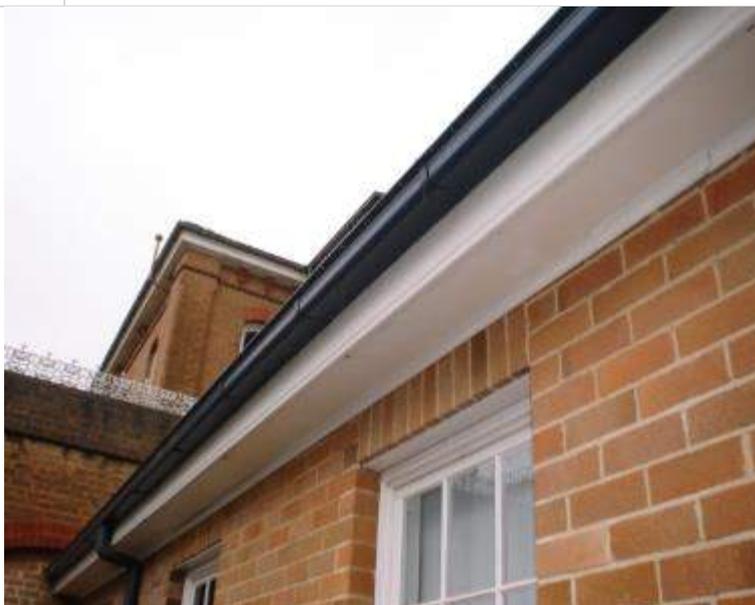
Flat asbestos fibre cement sheet –Similar to S33

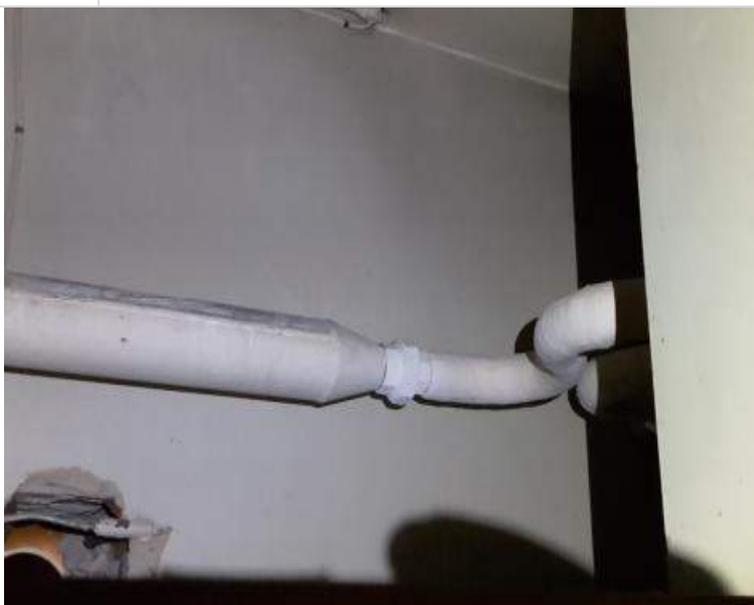
Asbestos lagged pipework– Similar to S31

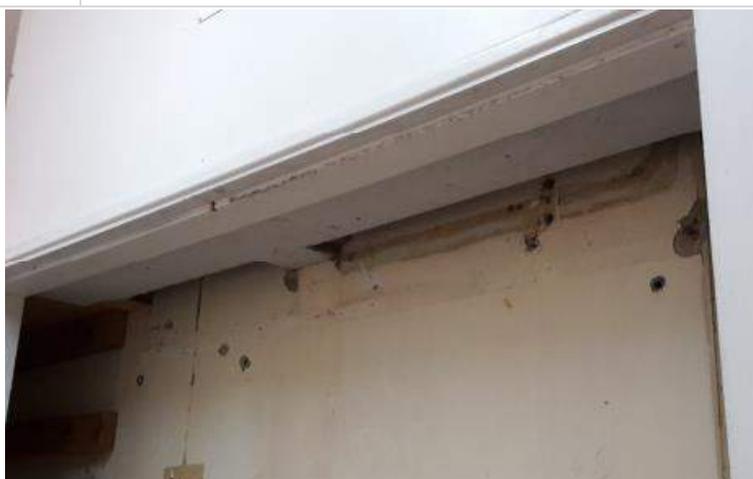
Flat asbestos fibre cement sheet –S32

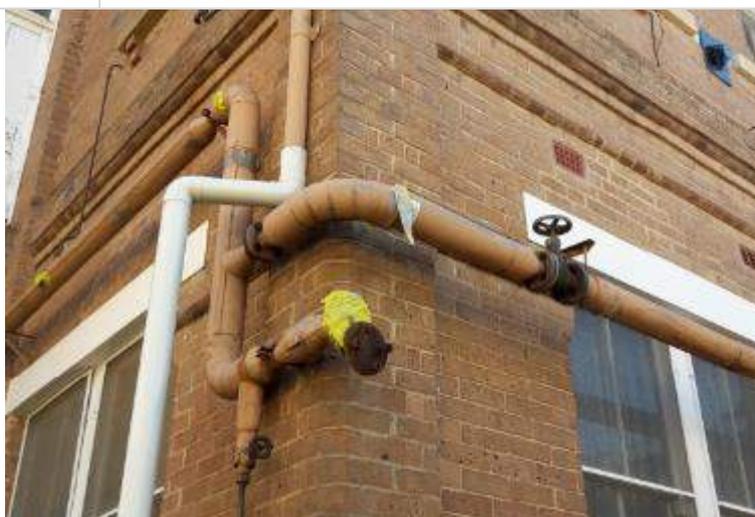
Asbestos lagged pipework– Similar to S14

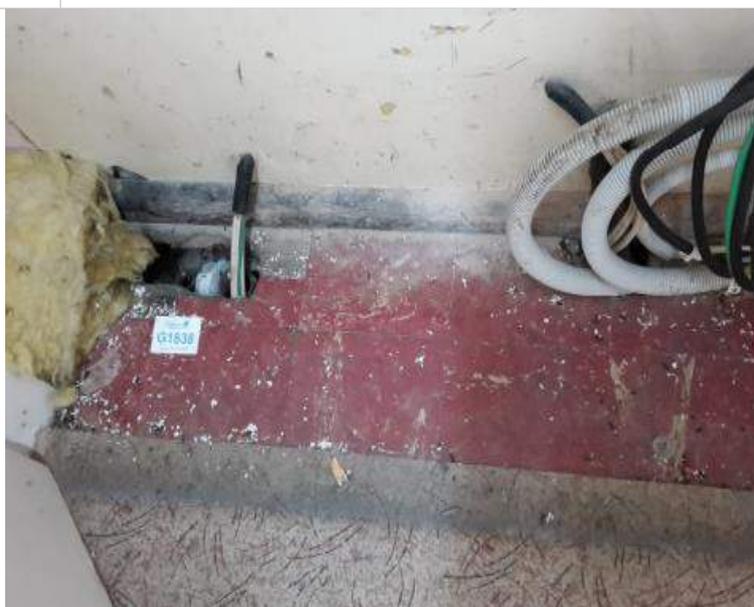
Asbestos containing vinyl floor tiles –S33

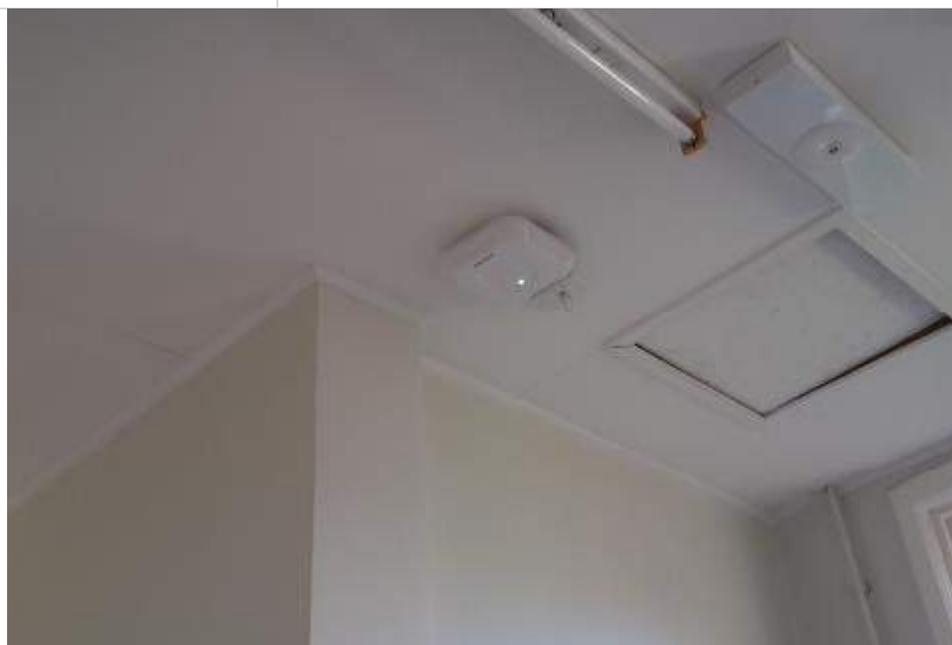
Flat asbestos fibre cement sheet –S36

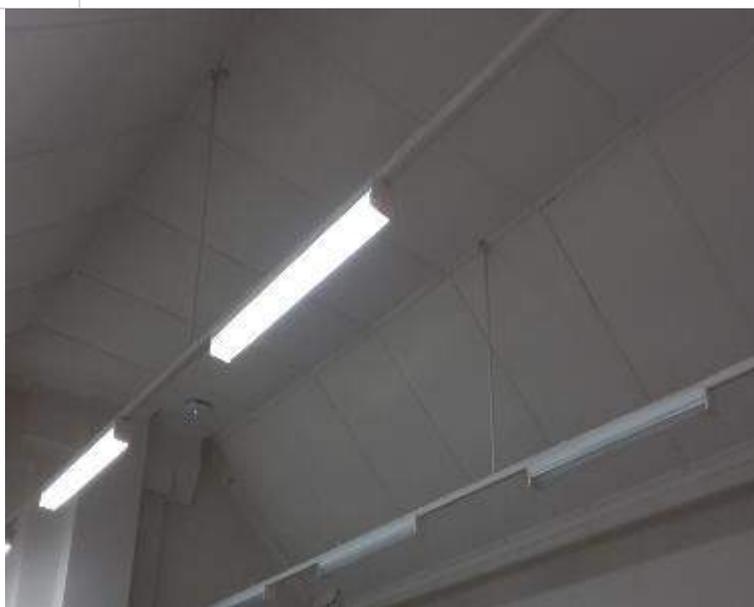
Flat fibre cement sheet –Not sampled (height restriction)

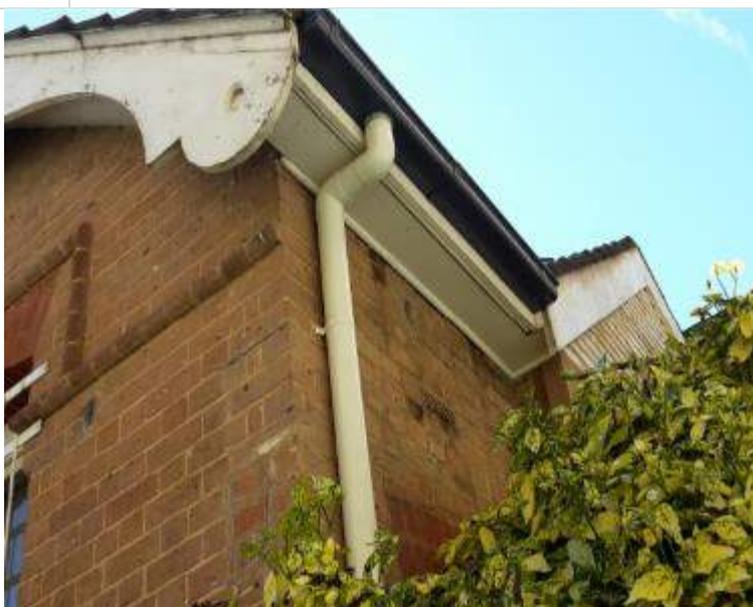
Flat asbestos fibre cement sheet – S75

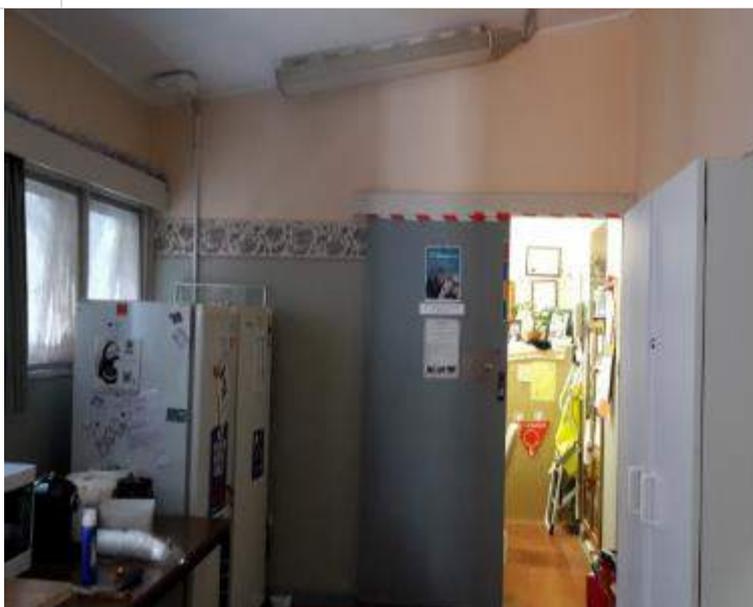
Flat asbestos fibre cement sheet –S59

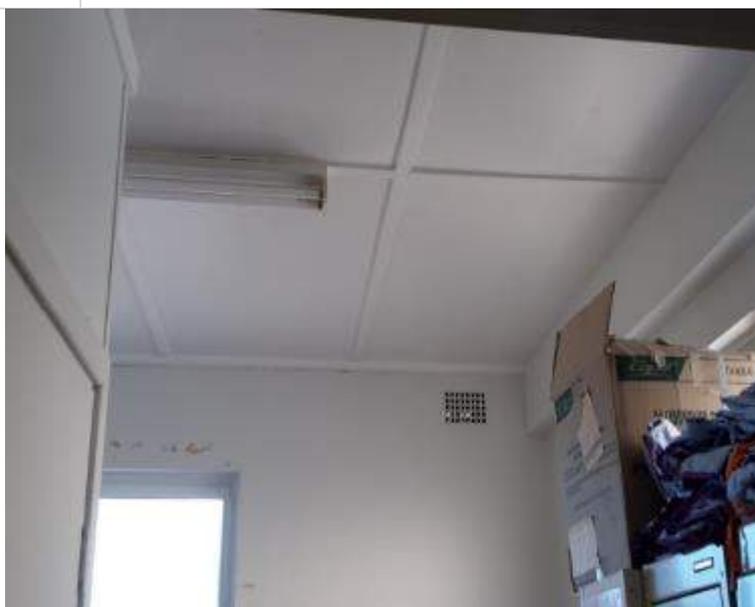
Flat asbestos fibre cement sheet –S60

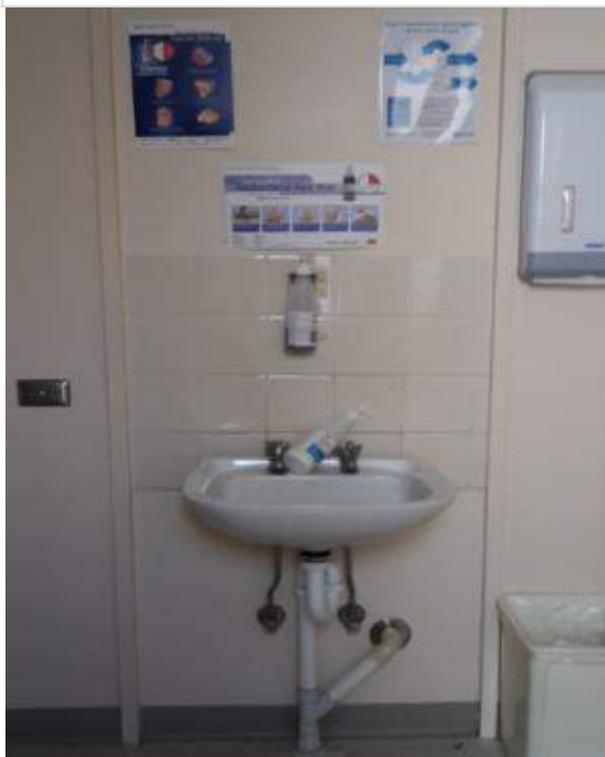
Flat asbestos fibre cement sheet – Similar to S59

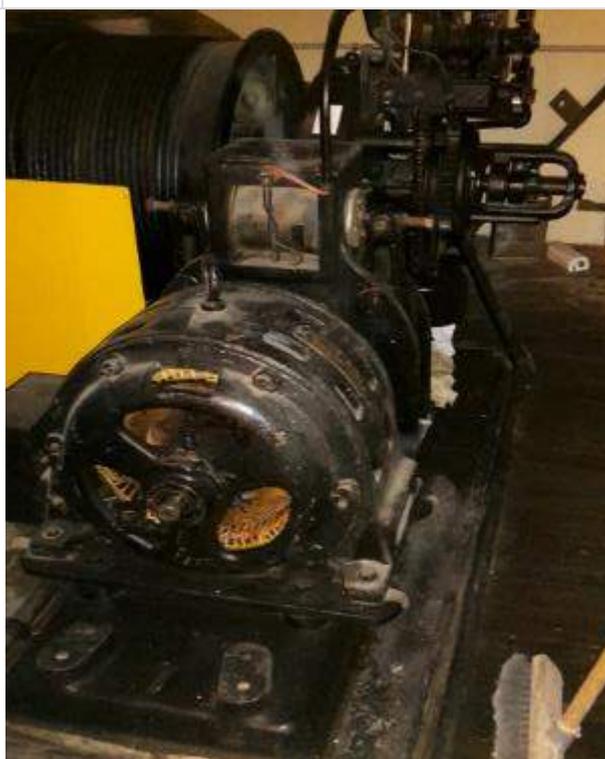
Lift brake equipment including brake shoes – Not sampled (electrical hazard)

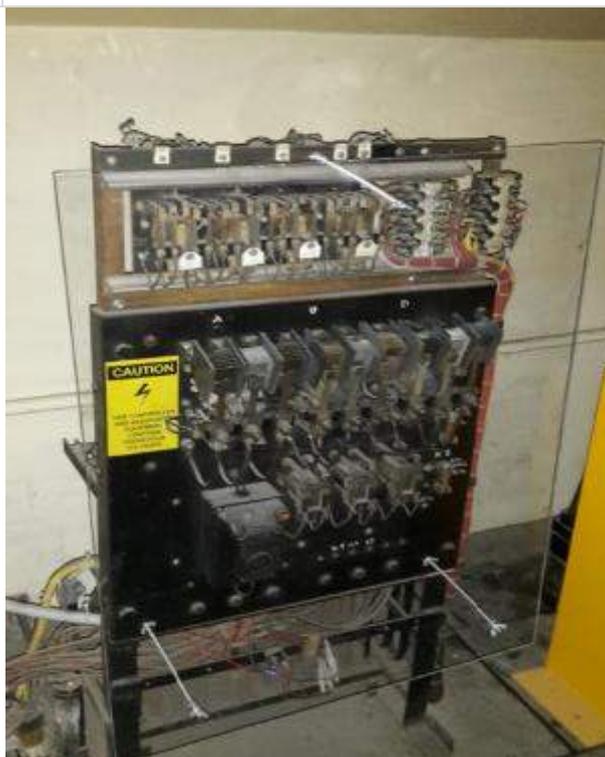
Electrical Backing Boards – Not sampled (electrical hazard)

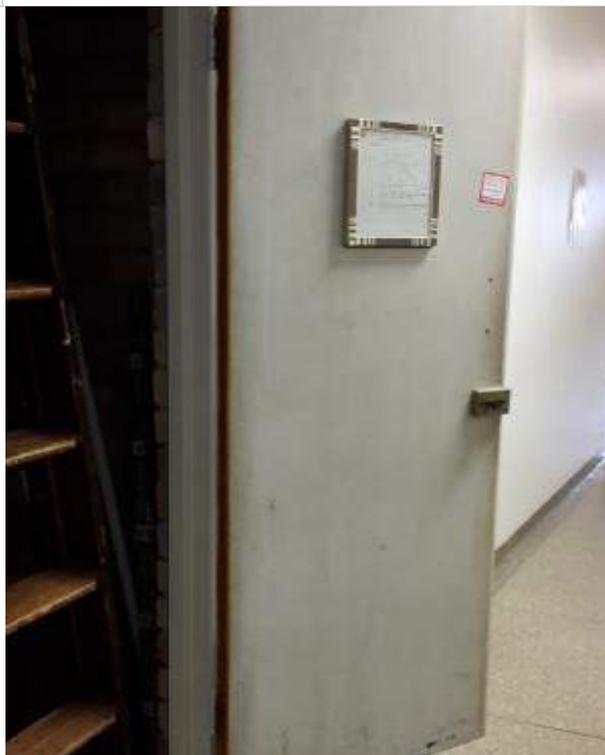
Flat asbestos fibre cement sheet – S27

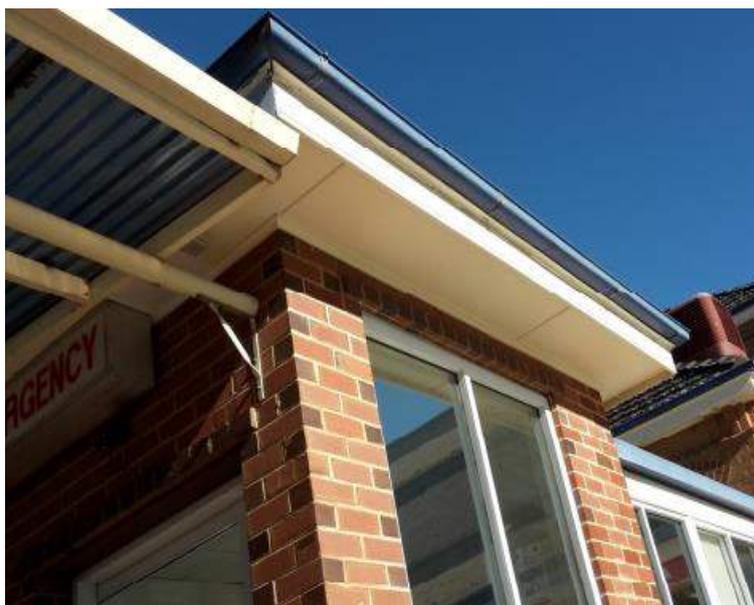
Flat asbestos fibre cement sheet – Similar to S46

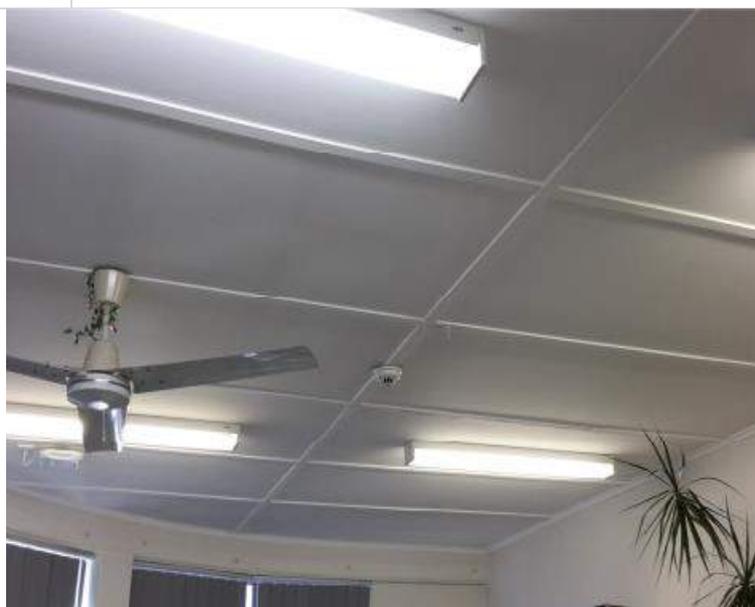
Flat asbestos fibre cement sheet – Similar to S45

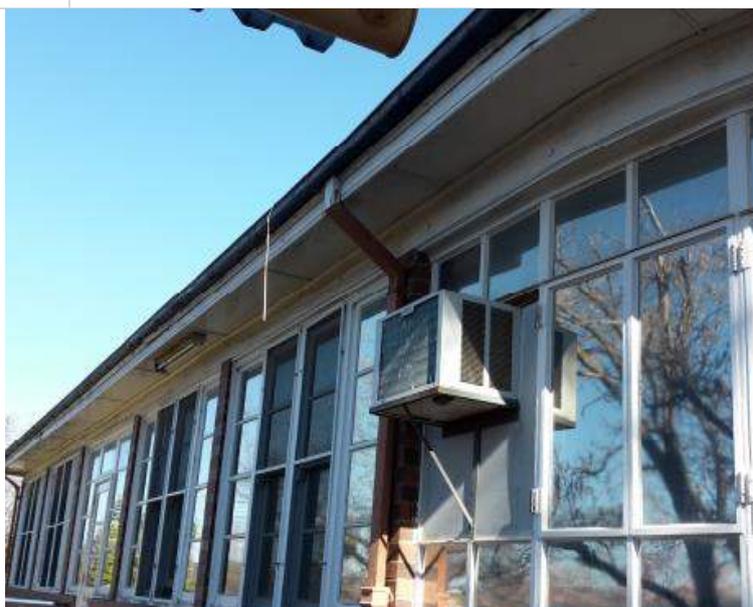
Flat asbestos fibre cement sheet – S26

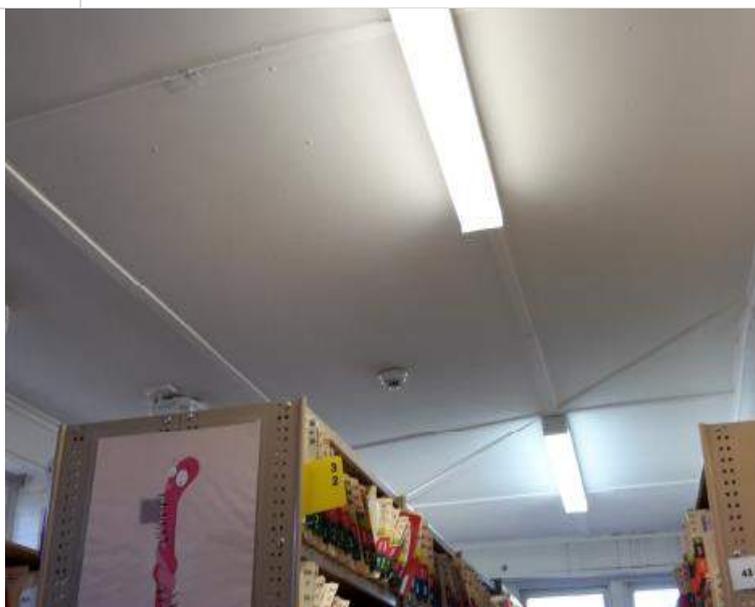
Flat asbestos fibre cement sheet – Similar to S45

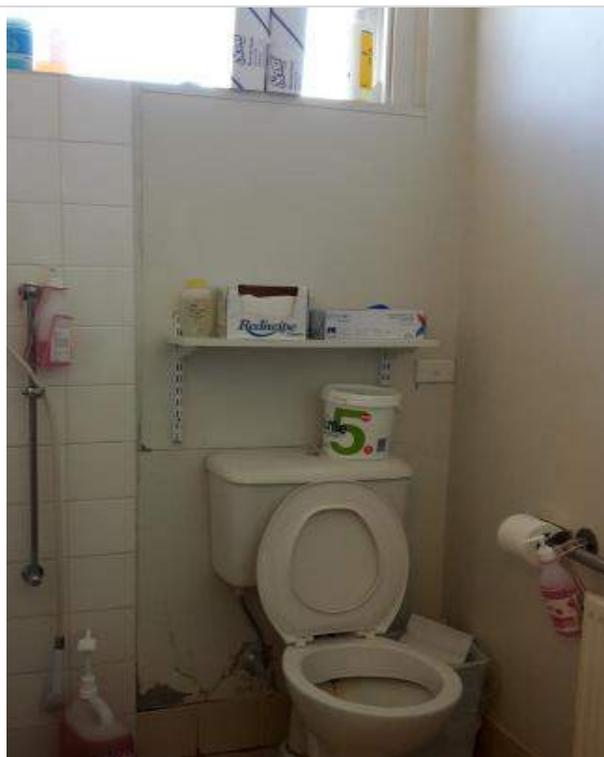
Flat asbestos fibre cement sheet – S44

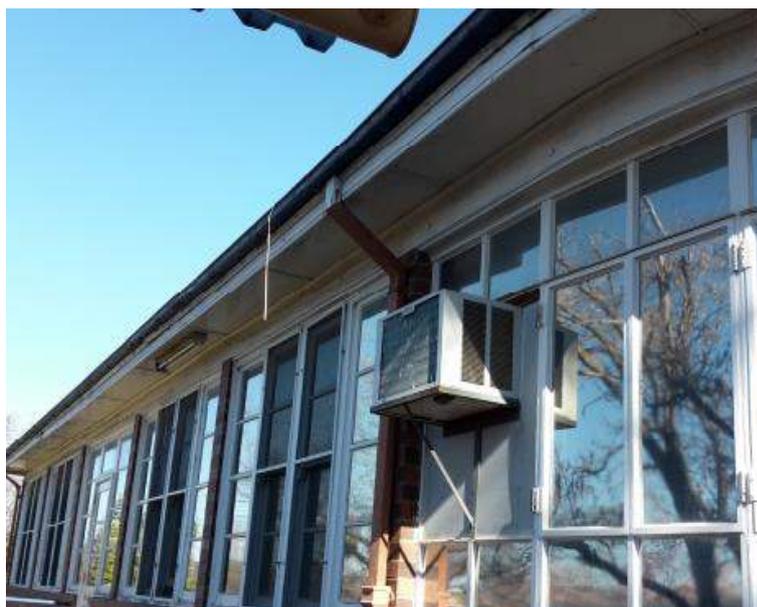
Flat asbestos fibre cement sheet –S46

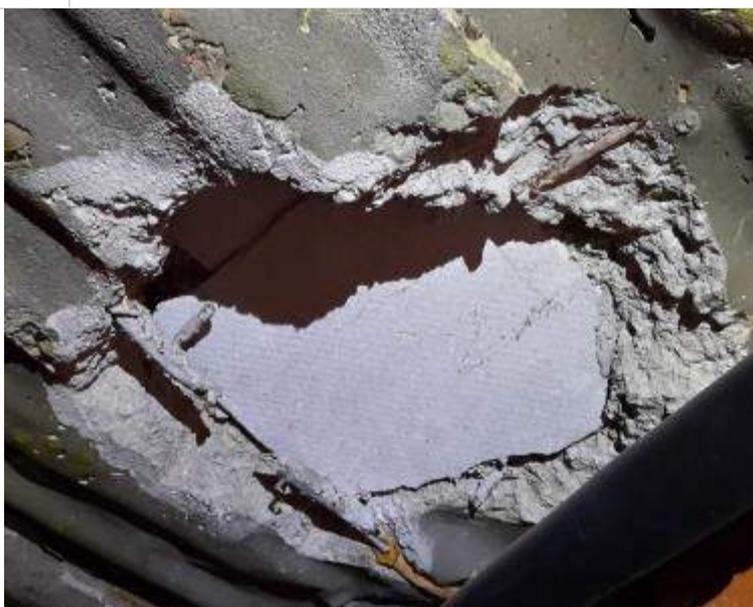
Flat asbestos fibre cement sheet –S86
