**119-129 Princes Highway, Kogarah NSW 2217**

**Arboricultural Impact Assessment**

**Prepared for Akalan**

| <b>Project Number</b> | AIA18/07/2025 |

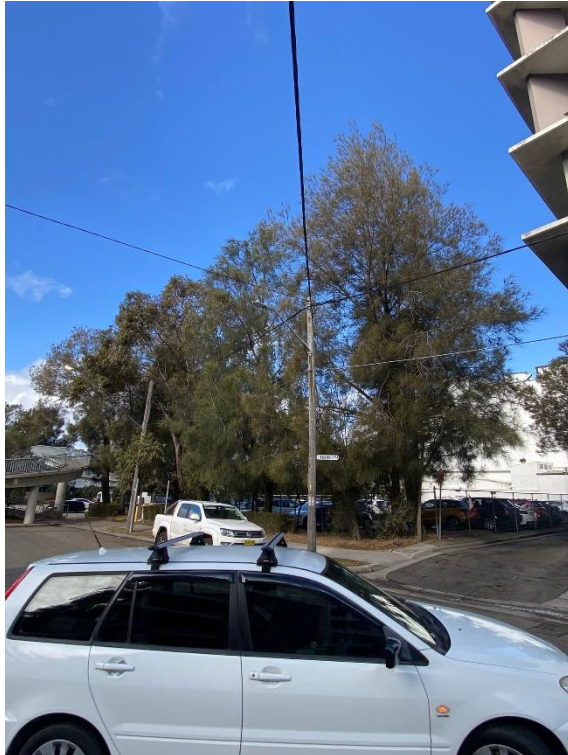
Photo 1: Trees 1-11

| Tree # | Botanical Name<br>(Common Name) | Height<br>(m) | Canopy<br>(m) | DBH<br>(mm) | DAB<br>(mm) | TPZ<br>(m) | SRZ<br>(m) | TPZ<br>Encroachment | SULE | Retention<br>Value | Action | Notes |
|---|---|---|---|---|---|---|---|---|---|---|---|---|
| 1 | <i>Allocasuarina verticillata</i><br>(Drooping She-Oak) | 6 | 4 | 130 | 140 | 2.00 | 1.50 | 100% - Located within the footprint | 3D | Low | Remove | Fair heath and structural condition |
| 2 | <i>Allocasuarina verticillata</i><br>(Drooping She-Oak) | 12 | 7 | 400 | 420 | 4.80 | 2.30 | 100% - Located within the footprint | 2D | Moderate | Remove | Fair heath and structural condition |
| 3 | <i>Allocasuarina verticillata</i><br>(Drooping She-Oak) | 7 | 4 | 182 | 250 | 2.20 | 1.85 | 100% - Located within the footprint | 3D | Low | Remove | Fair heath and structural condition, multi stem (combined DBH) |
| 4 | <i>Allocasuarina verticillata</i><br>(Drooping She-Oak) | 13 | 6 | 410 | 420 | 4.92 | 2.30 | 100% - Located within the footprint | 2D | Moderate | Remove | Fair heath and structural condition |
| 5 | <i>Allocasuarina verticillata</i><br>(Drooping She-Oak) | 7 | 3 | 100 | 110 | 2.00 | 1.50 | 100% - Located within the footprint | 3D | Low | Remove | Fair heath and structural condition |
| 6 | <i>Allocasuarina verticillata</i><br>(Drooping She-Oak) | 7 | 3 | 110 | 120 | 2.00 | 1.50 | 100% - Located within the footprint | 3D | Low | Remove | Fair heath and structural condition |
| 7 | <i>Allocasuarina verticillata</i><br>(Drooping She-Oak) | 7 | 3 | 130 | 140 | 2.00 | 1.50 | 100% - Located within the footprint | 3D | Moderate | Remove | Fair heath and structural condition |
| 8 | <i>Eucalyptus saligna</i> (Sydney Blue Gum) | 13 | 6 | 610 | 620 | 7.32 | 2.71 | 100% - Located within the footprint | 2D | Low | Remove | Fair heath and structural condition |
| 9 | <i>Eucalyptus saligna</i> (Sydney Blue Gum) | 10 | 5 | 326 | 360 | 3.90 | 2.15 | 100% - Located within the footprint | 4B | Moderate | Remove | Poor health or structural condition, broken branches, multi stem (combined DBH) |
| 10 | <i>Allocasuarina verticillata</i> | 11 | 5 | 410 | 420 | 4.92 | 2.30 | 100% - Located within the footprint | 2D | Moderate | Remove | Fair heath and structural condition |

| Tree # | Botanical Name<br>(Common Name) | Height<br>(m) | Canopy<br>(m) | DBH<br>(mm) | DAB<br>(mm) | TPZ<br>(m) | SRZ<br>(m) | TPZ<br>Encroachment | SULE | Retention<br>Value | Action | Notes |
|---|---|---|---|---|---|---|---|---|---|---|---|---|
| 11 | <i>Allocasuarina verticillata</i><br>(Drooping She-Oak) | 11 | 5 | 470 | 480 | 5.64 | 2.43 | 100% - Located within the footprint | 2D | Moderate | Remove | Fair heath and structural condition |

Accordingly, removal is recommended to facilitate the development, with consideration given to implementing suitable replacement planting to offset the loss of canopy cover in accordance with council policy.

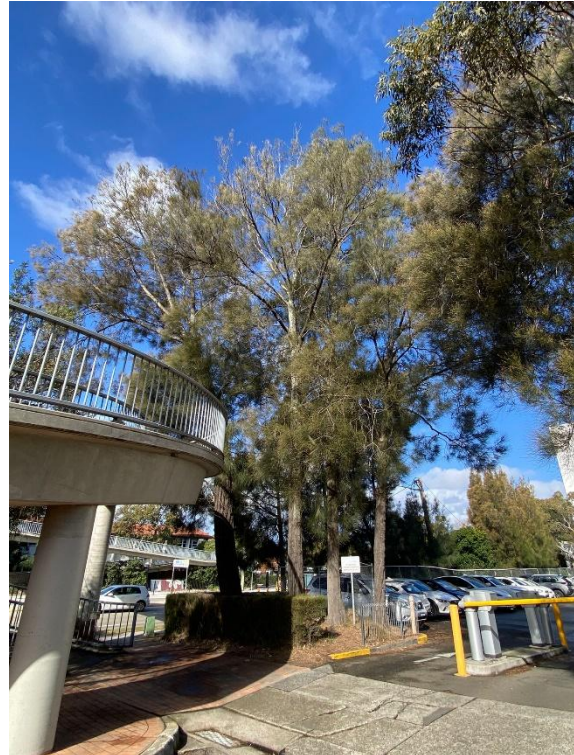
Photo 2: Trees 12-15

| Tree # | Botanical Name<br>(Common Name) | Height<br>(m) | Canopy<br>(m) | DBH<br>(mm) | DAB<br>(mm) | TPZ<br>(m) | SRZ<br>(m) | TPZ<br>Encroachment | SULE | Retention<br>Value | Action | Notes |
|---|---|---|---|---|---|---|---|---|---|---|---|---|
| 12 | <i>Allocasuarina verticillata</i><br>(Drooping She-Oak) | 11 | 6 | 300 | 310 | 3.60 | 2.02 | 100% - Located within the footprint | 2D | Moderate | Remove | Fair heath and structural condition |
| 13 | <i>Allocasuarina verticillata</i><br>(Drooping She-Oak) | 11 | 5 | 430 | 440 | 5.16 | 2.34 | 100% - Located within the footprint | 2D | Moderate | Remove | Fair heath and structural condition |
| 14 | <i>Allocasuarina verticillata</i><br>(Drooping She-Oak) | 15 | 5 | 510 | 520 | 6.12 | 2.51 | 100% - Located within the footprint | 2D | Moderate | Remove | Fair heath and structural condition |
| 15 | <i>Allocasuarina verticillata</i><br>(Drooping She-Oak) | 12 | 7 | 860 | 870 | 10.32 | 3.12 | 100% - Located within the footprint | 2D | Moderate | Remove | Fair heath and structural condition |

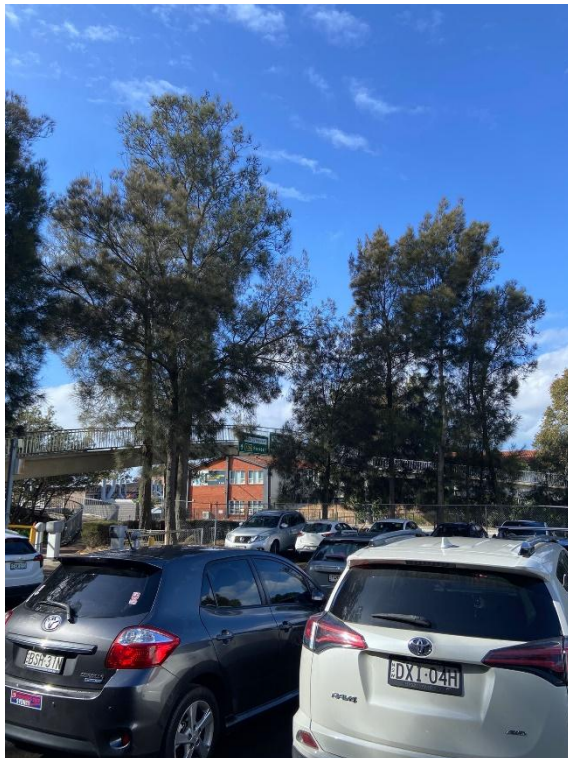
Photo 3: Trees 16-20

| Tree # | Botanical Name<br>(Common Name) | Height<br>(m) | Canopy<br>(m) | DBH<br>(mm) | DAB<br>(mm) | TPZ<br>(m) | SRZ<br>(m) | TPZ<br>Encroachment | SULE | Retention<br>Value | Action | Notes |
|---|---|---|---|---|---|---|---|---|---|---|---|---|
| 16 | <i>Allocasuarina verticillata</i><br>(Drooping She-Oak) | 6 | 4 | 280 | 290 | 3.36 | 1.97 | 100% - Located within the footprint | 2D | Moderate | Remove | Fair heath and structural condition |
| 17 | <i>Allocasuarina verticillata</i><br>(Drooping She-Oak) | 12 | 5 | 280 | 290 | 3.36 | 1.97 | 100% - Located within the footprint | 2D | Moderate | Remove | Fair heath and structural condition |
| 18 | <i>Allocasuarina verticillata</i><br>(Drooping She-Oak) | 10 | 4 | 260 | 270 | 3.12 | 1.91 | 100% - Located within the footprint | 2D | Moderate | Remove | Fair heath and structural condition |
| 19 | <i>Allocasuarina verticillata</i><br>(Drooping She-Oak) | 11 | 4 | 164 | 200 | 2.00 | 1.68 | 100% - Located within the footprint | 2D | Low | Remove | Fair heath and structural condition, multi stem (combined DBH) |
| 20 | <i>Allocasuarina verticillata</i><br>(Drooping She-Oak) | 12 | 5 | 290 | 300 | 3.48 | 2.00 | 100% - Located within the footprint | 2D | Moderate | Remove | Fair heath and structural condition |

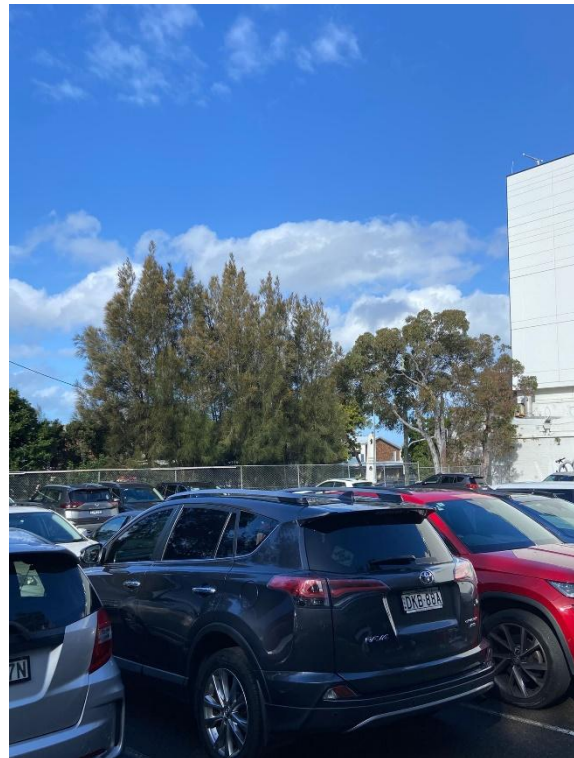
Photo 4: Trees 21-25

| Tree # | Botanical Name<br>(Common Name) | Height<br>(m) | Canopy<br>(m) | DBH<br>(mm) | DAB<br>(mm) | TPZ<br>(m) | SRZ<br>(m) | TPZ<br>Encroachment | SULE | Retention<br>Value | Action | Notes |
|---|---|---|---|---|---|---|---|---|---|---|---|---|
| 21 | <i>Allocasuarina verticillata</i><br>(Drooping She-Oak) | 7 | 4 | 227 | 300 | 2.70 | 2.00 | 100% - Located within the footprint | 2D | Low | Remove | Fair heath and structural condition, multi stem (combined DBH) |
| 22 | <i>Allocasuarina verticillata</i><br>(Drooping She-Oak) | 8 | 4 | 300 | 320 | 3.60 | 2.05 | 100% - Located within the footprint | 2D | Moderate | Remove | Fair heath and structural condition |
| 23 | <i>Allocasuarina verticillata</i><br>(Drooping She-Oak) | 7 | 4 | 299 | 300 | 3.60 | 2.00 | 100% - Located within the footprint | 2D | Low | Remove | Fair heath and structural condition, multi stem (combined DBH) |
| 24 | <i>Corymbia maculata</i><br>(Spotted Gum) | 9 | 5 | 730 | 740 | 8.76 | 2.92 | 100% - Located within the footprint | 2D | High | Remove | Fair heath and structural condition, wound |
| 25 | <i>Corymbia maculata</i><br>(Spotted Gum) | 6 | 4 | 480 | 500 | 5.76 | 2.47 | 100% - Located within the footprint | 2D | Moderate | Remove | Fair heath and structural condition, wound |

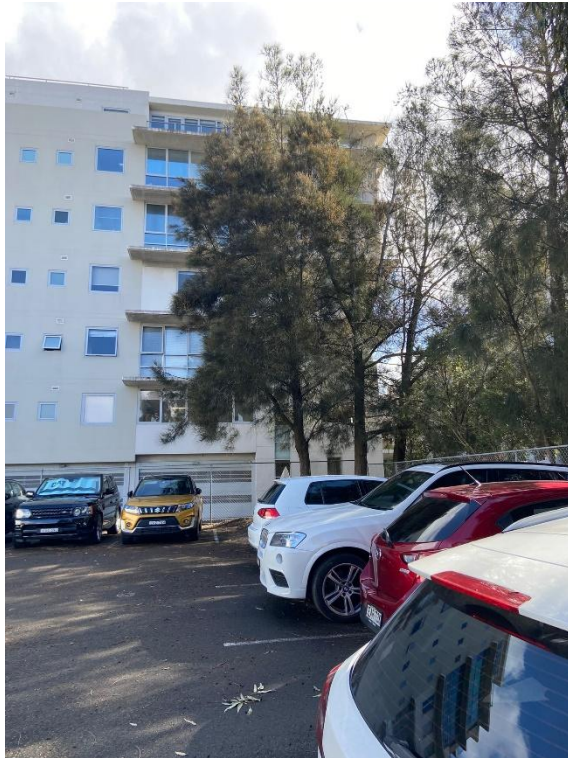
Photo 5: Trees 26 & 27

| Tree # | Botanical Name<br>(Common Name) | Height<br>(m) | Canopy<br>(m) | DBH<br>(mm) | DAB<br>(mm) | TPZ<br>(m) | SRZ<br>(m) | TPZ<br>Encroachment | SULE | Retention<br>Value | Action | Notes |
|---|---|---|---|---|---|---|---|---|---|---|---|---|
| 26 | <i>Allocasuarina verticillata</i><br>(Drooping She-Oak) | 12 | 5 | 350 | 360 | 4.20 | 2.15 | 100% - Located within the footprint | 2D | Moderate | Remove | Fair heath and structural condition |
| 27 | <i>Allocasuarina verticillata</i><br>(Drooping She-Oak) | 12 | 6 | 320 | 330 | 3.84 | 2.08 | 100% - Located within the footprint | 2D | Moderate | Remove | Fair heath and structural condition |

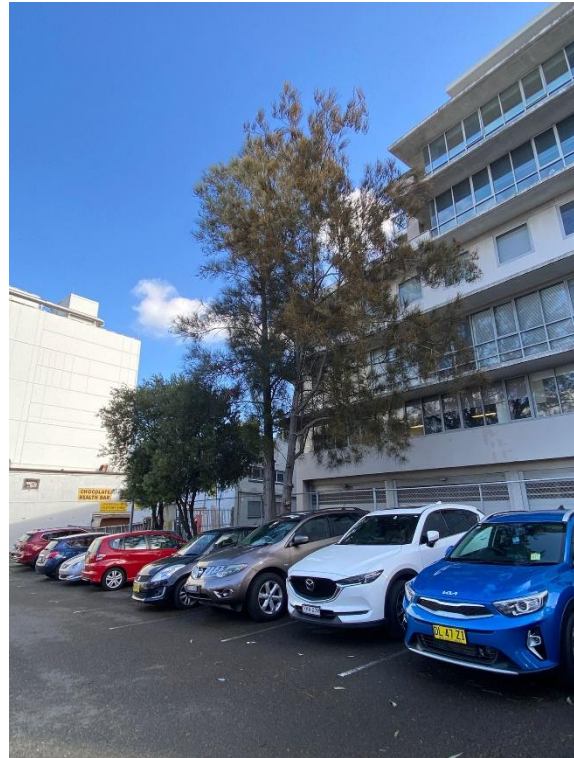
Photo 6: Trees 28-30

| Tree # | Botanical Name<br>(Common Name) | Height<br>(m) | Canopy<br>(m) | DBH<br>(mm) | DAB<br>(mm) | TPZ<br>(m) | SRZ<br>(m) | TPZ<br>Encroachment | SULE | Retention<br>Value | Action | Notes |
|---|---|---|---|---|---|---|---|---|---|---|---|---|
| 28 | <i>Allocasuarina verticillata</i><br>(Drooping She-Oak) | 13 | 8 | 516 | 780 | 6.20 | 2.98 | 100% - Located within the footprint | 2D | Moderate | Remove | Fair heath and structural condition, multi stem (combined DBH) |
| 29 | <i>Melaleuca viminalis</i><br>(Weeping Bottlebrush) | 7 | 5 | 241 | 300 | 2.90 | 2.00 | 100% - Located within the footprint | 3A | Low | Remove | Fair heath and structural condition, multi stem (combined DBH) |
| 30 | <i>Melaleuca viminalis</i><br>(Weeping Bottlebrush) | 7 | 5 | 325 | 320 | 3.90 | 2.05 | 100% - Located within the footprint | 3A | Low | Remove | Fair heath and structural condition, multi stem (combined DBH) |
