# **REPORT: HAZARDOUS MATERIALS SURVEY UPDATE**

Job Number: **J50944**

**ST GEORGE PRIVATE HOSPITAL**

**1 SOUTH STREET, KOGARAH, NSW**

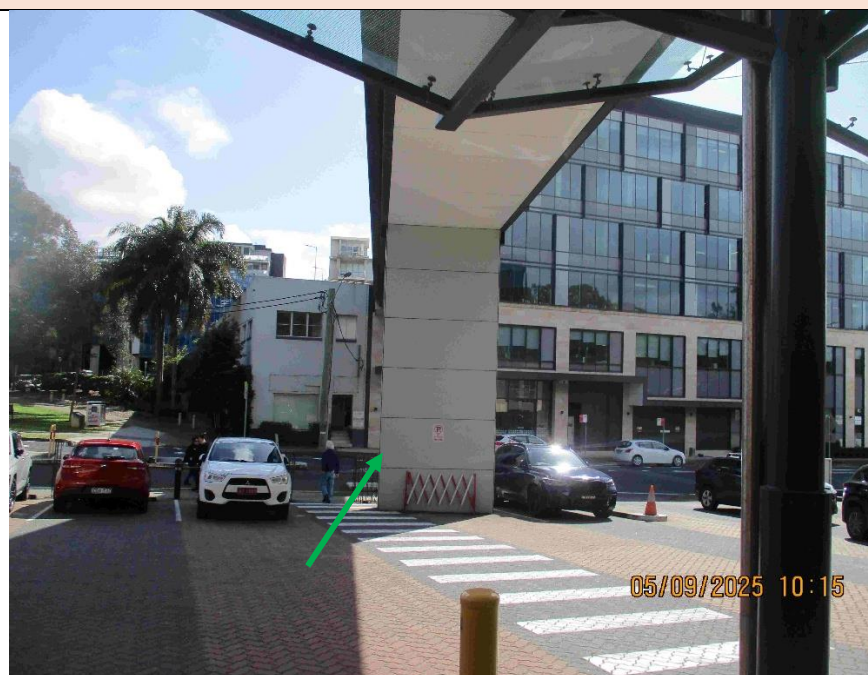
**Photo 2**  
Northside column to overhead walkway, compressed fibro cement cladding.  
ESP Sample E89676. No asbestos detected.

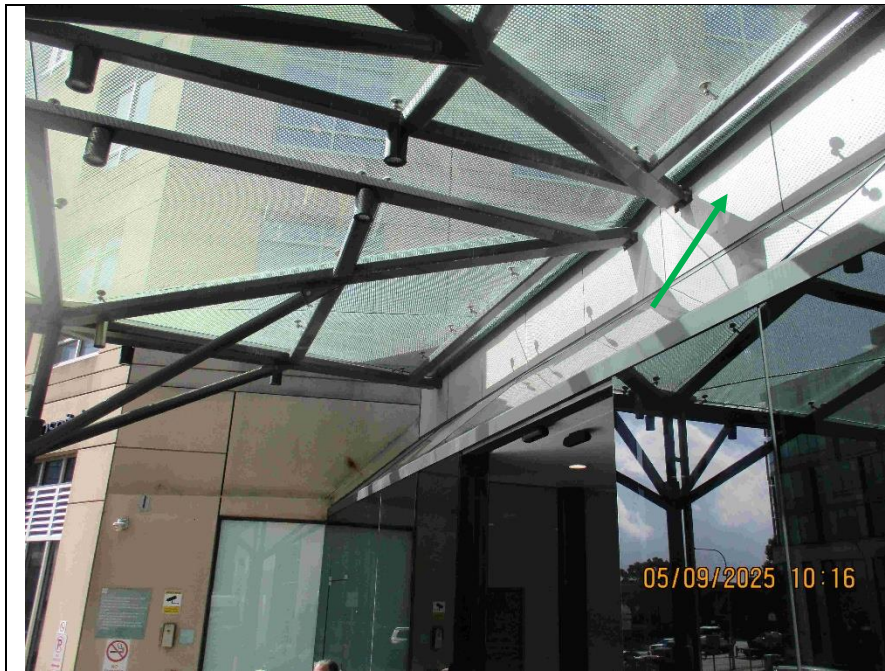
**Photo 3**  
Northside entry bulkhead, compressed fibro cement cladding.  
Refer ESP Sample E89676. No asbestos detected.

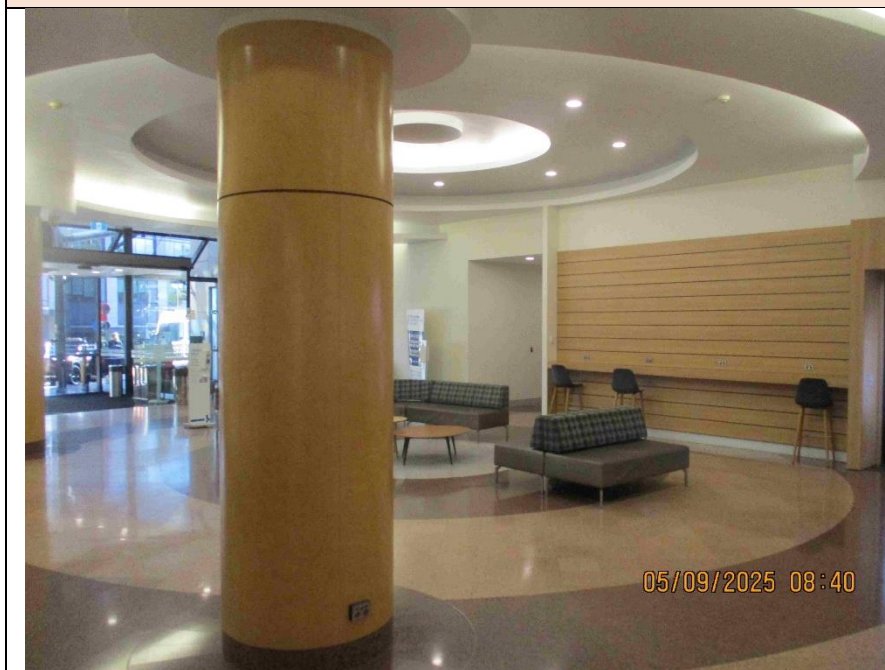
**Photo 4**  
Entry foyer. No asbestos materials identified.

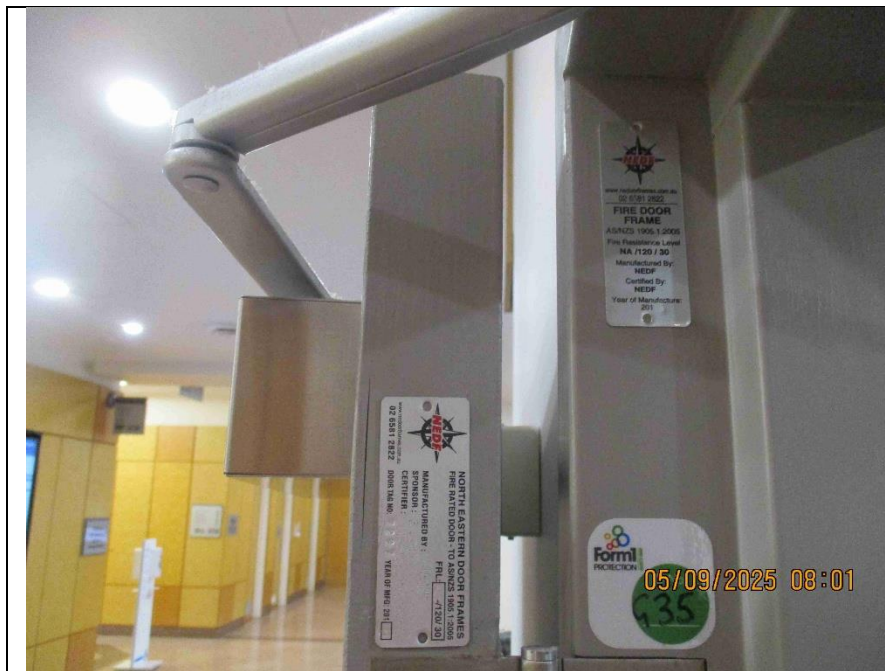
**Photo 5**  
Foyer area near lifts, Fire Door G35. Tag dated “2015” year of manufacture.

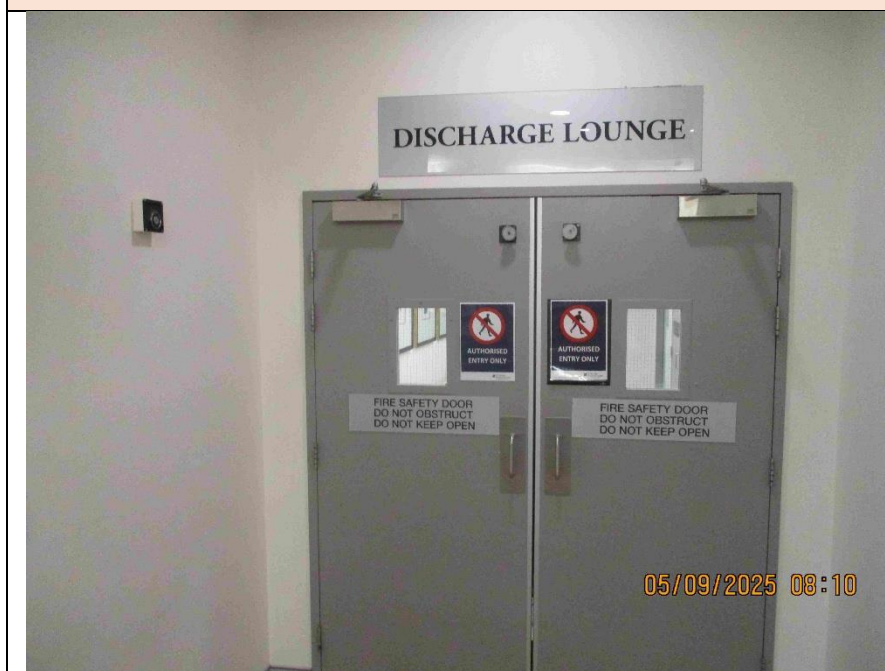
**Photo 6**  
Fire Doors to Discharge Lounge (off Foyer).  
Tag dated “2015” year of manufacture

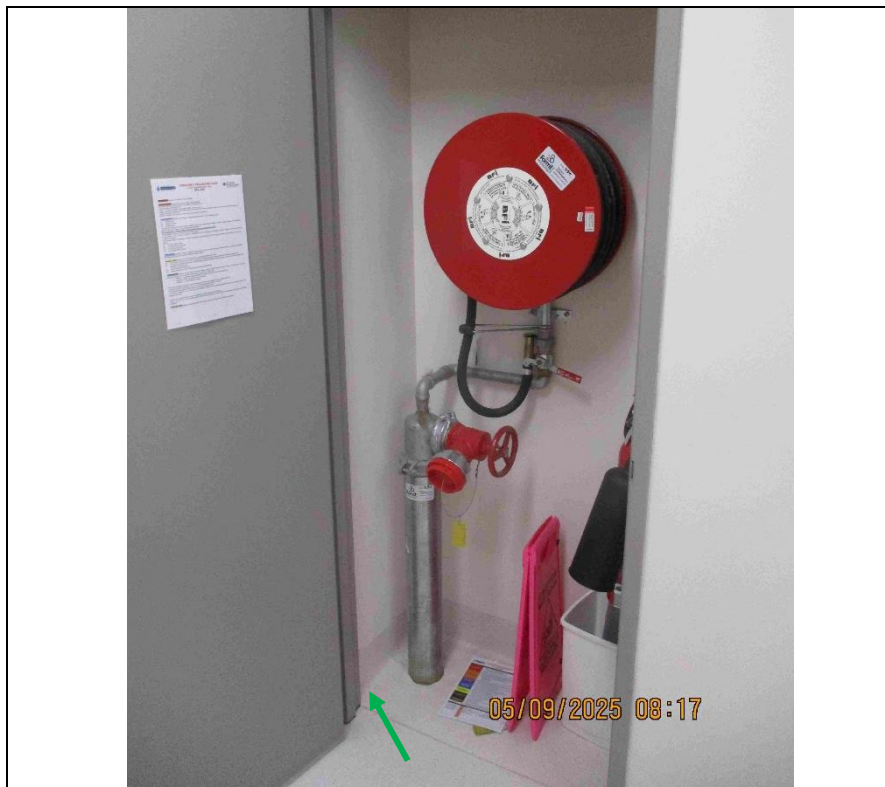
**Photo 7**  
**Fire Hose Reel cupboard at corridor to Discharge Lounge.**  
**Floor, vinyl sheet. ESP Sample E89673. No asbestos detected.**

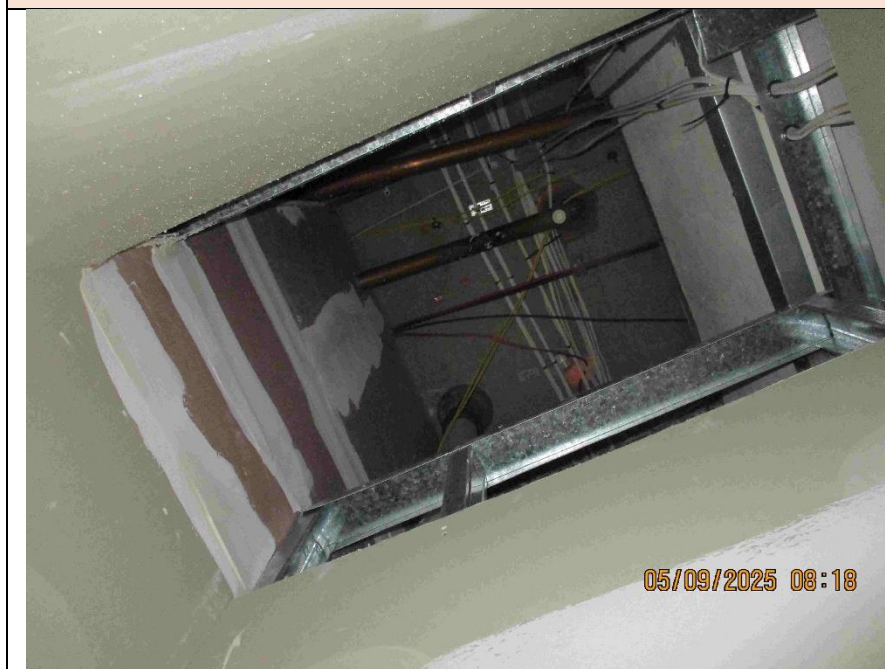
**Photo 8**  
**Fire Hose Reel cupboard at corridor to Discharge Lounge.**  
**Walls, plasterboard. Ceiling, concrete slab floor above.**

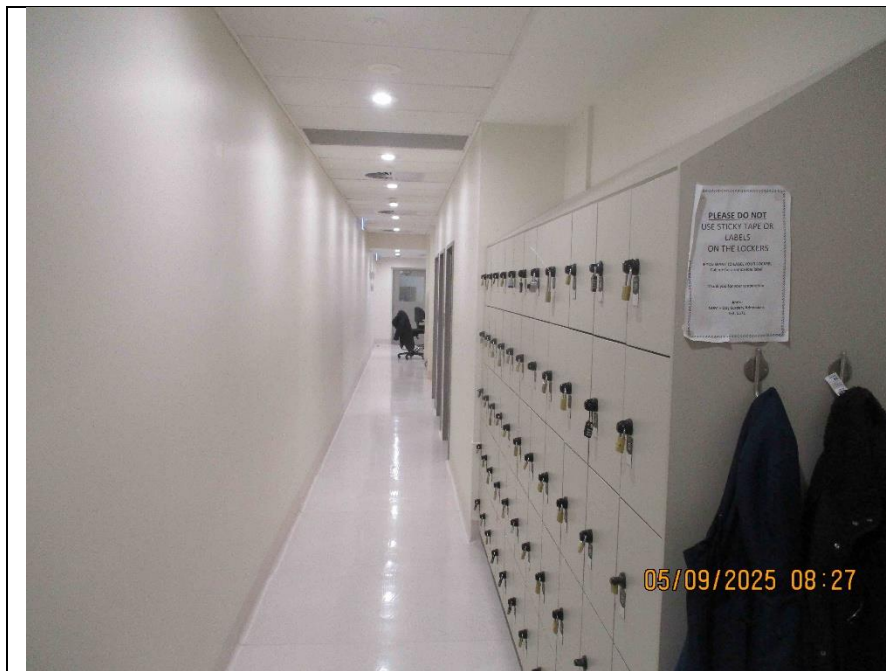
| REGISTER OF HAZARDOUS MATERIALS | | | | | | | | | | |
|---|---|---|---|---|---|---|---|---|---|---|
| 9, 10, 11 | - | Offices, Corridors | Ceilings | Acoustic Tiles | Synthetic Mineral Fibre | - | - | Low | Refer to 8.0 Recommendations | - |

**Photo 9**  
Corridor behind Reception area. No asbestos materials identified.  
Floor, vinyl. Walls, plasterboard. Ceiling, plasterboard & SMF acoustic tiles.

During maintenance, refurbishment or demolition, any works involving SMF should comply with the National Occupational Health and Safety Commission (1990) Synthetic Mineral Fibres; National Standard for SMF; and the National Code of Practice for the Safe Use of SMFs. All contractors working in areas where SMH is identified and may be impacted should wear appropriate Personal Protective Equipment (PPE) as outlined in the above NOHSC Code.

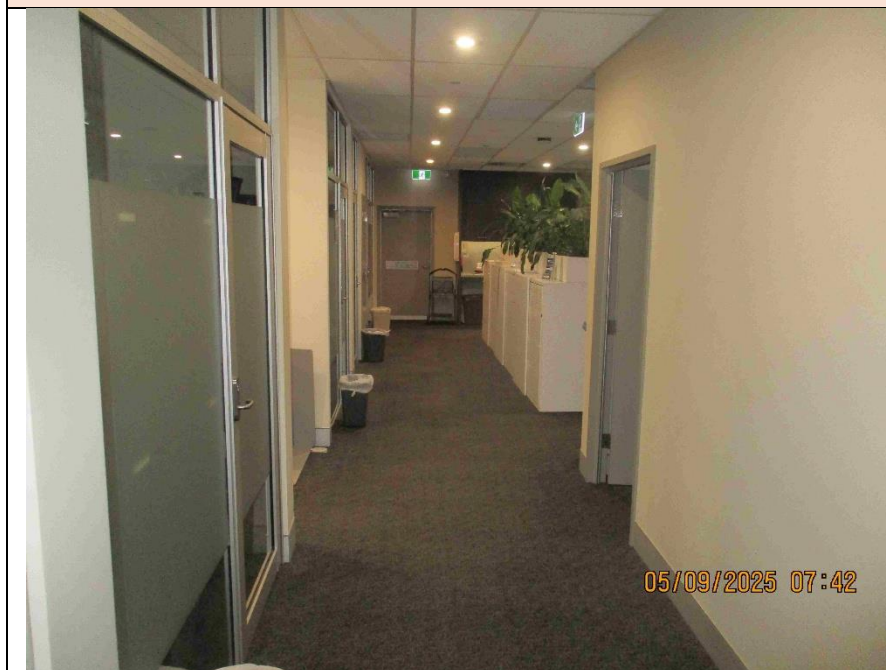
**Photo 10**  
Typical Executive office area. No asbestos materials identified.  
Floor, carpet. Walls, plasterboard. Ceiling, SMF acoustic tiles.

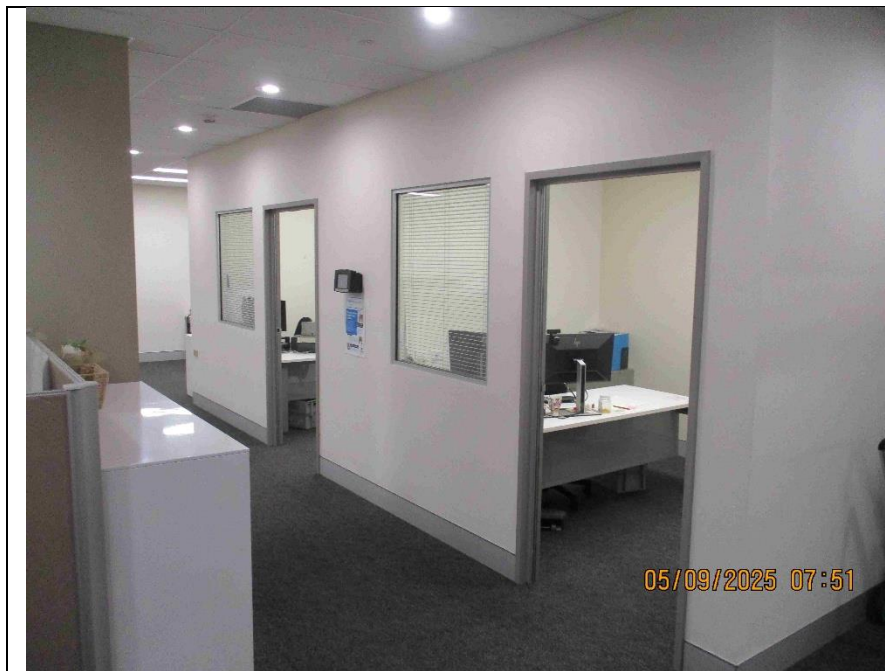
**Photo 11**  
**Typical Admin office area. No asbestos materials identified.**  
**Floor, carpet. Walls, plasterboard. Ceiling, SMF acoustic tiles.**

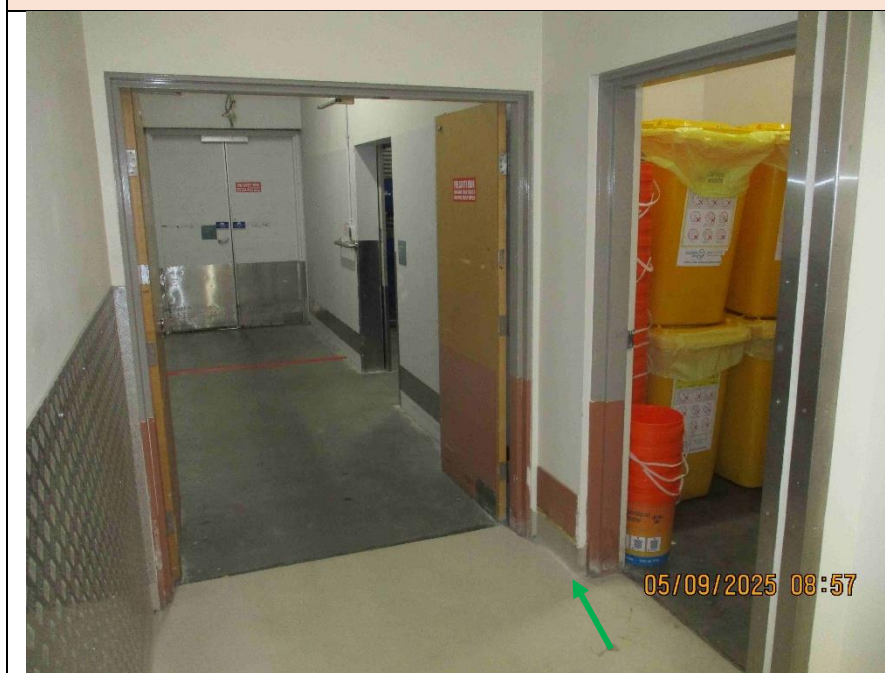
**Photo 12**  
**Corridor at Waste Bin Rooms.**  
**Floor, vinyl sheet. ESP Sample E89675. No asbestos detected.**

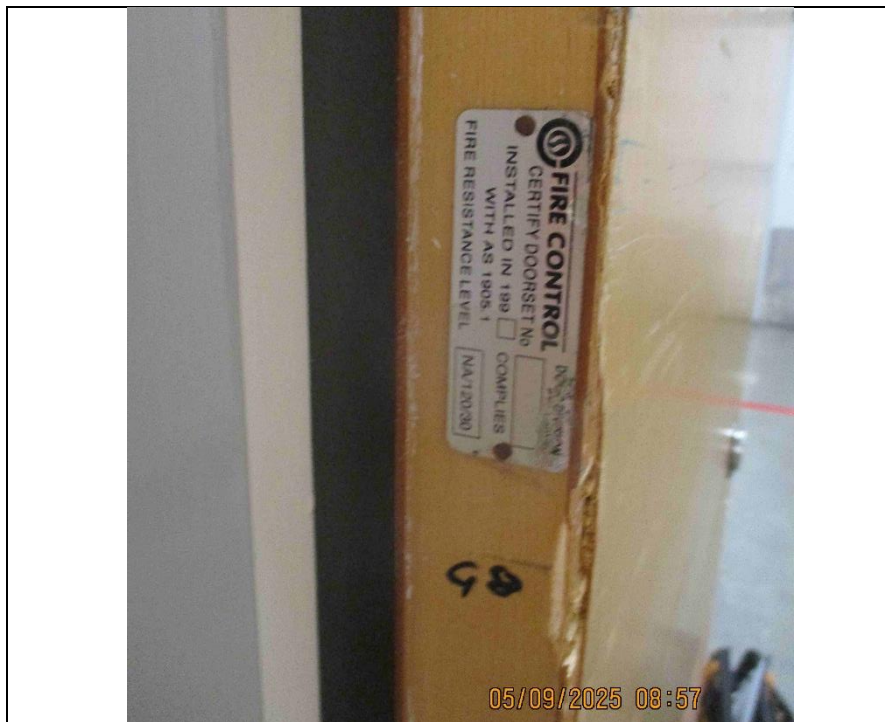
**Photo 13**  
Corridor at Waste Bin Rooms.  
Fire Door G8. Tag dated "199\_" year of manufacture.

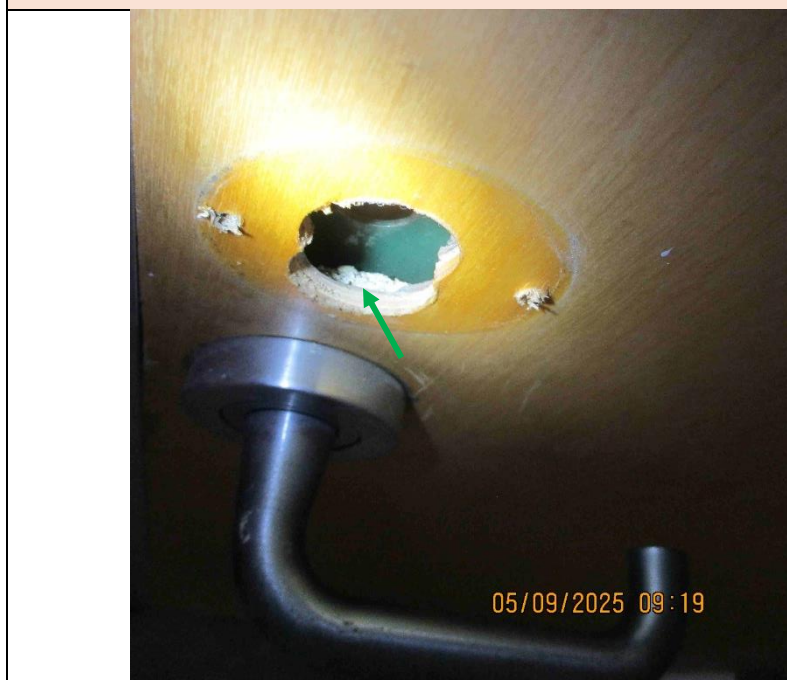
**Photo 14**  
Corridor at Waste Bin Rooms.  
Fire Door G8, inner core material. ESP Sample E89674. No asbestos detected.

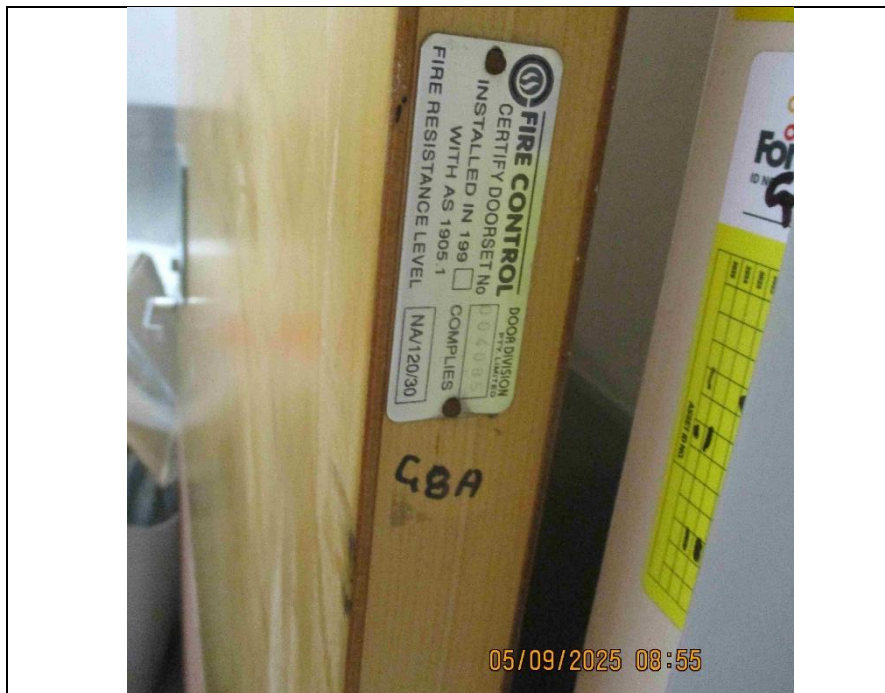
**Photo 15**  
**Clean Bin Store.**  
**Fire Door G8A. Tag dated "199\_" year of manufacture.**

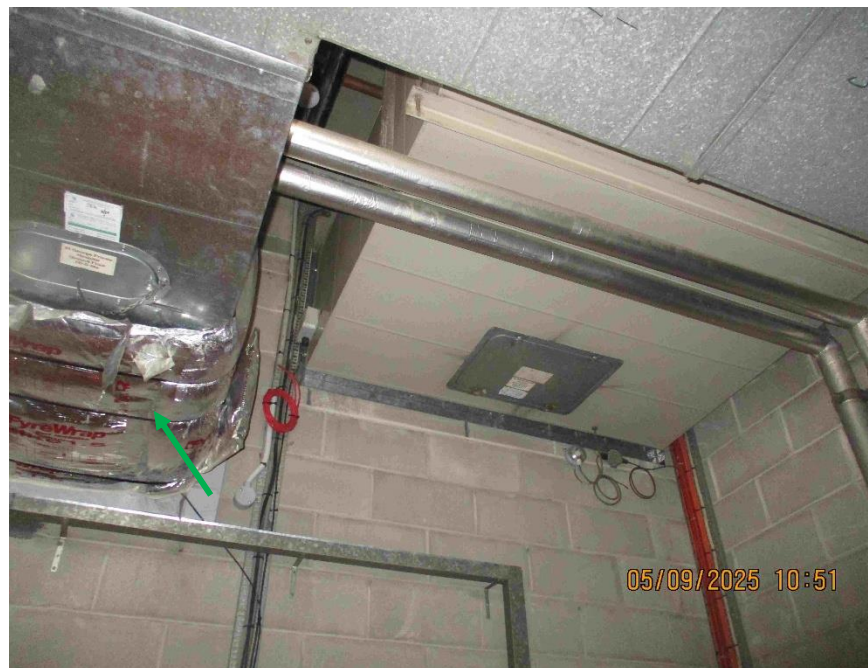
Synthetic Mineral Fibre (SMF) was visually identified in suspended acoustic ceiling tiles, and insulation to ductwork in the plant room area. Refer to 8.0 Recommendations.

| REGISTER OF HAZARDOUS MATERIALS | | | | | | | | | | |
|---|---|---|---|---|---|---|---|---|---|---|
| 16 | - | Plant Room AH Units G1, G2 | Ductwork | Insulation | Synthetic Mineral Fibre | - | Good | Low | Refer to 8.0 Recommendations | - |

**Photo 16**  
**Plant Room, Air Handling Unit, G1, G2.**  
**FyreWrap duct insulation. Synthetic Mineral Fibre (SMF).**
