REPORT

HAMMOND CARE PTY LTD

PRELIMINARY GEOTECHNICAL ASSESSMENT

**97 TO 115 RIVER ROAD, GREENWICH HOSPITAL,
GREENWICH, NSW**

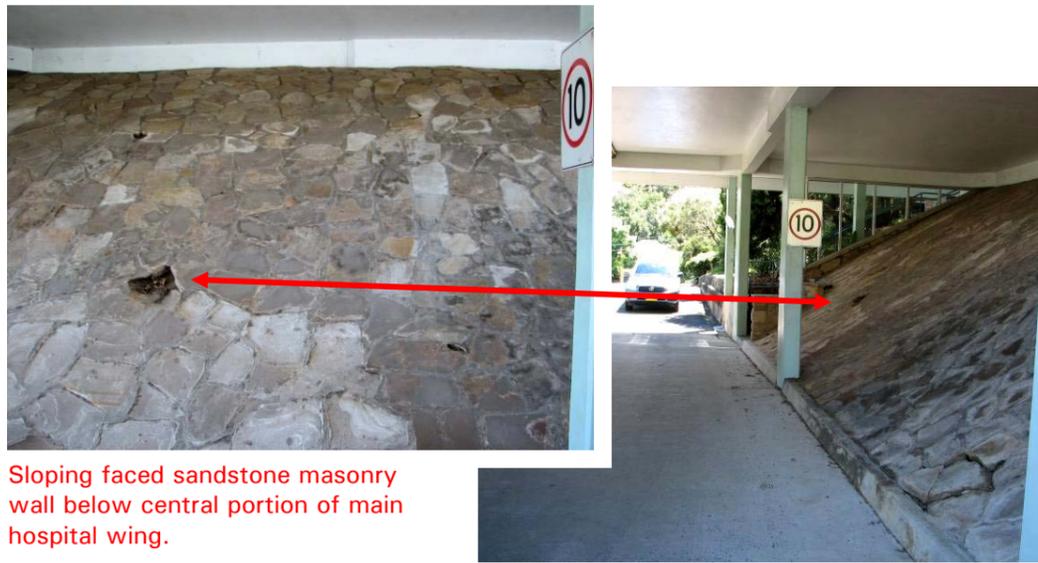
- Sandstone masonry walls of maximum 3.5m and 3m heights which supported areas lining the eastern side of the driveway (below the Main Hospital Wing – Extension) and the north-western and western side of Pallister House, respectively and had faces sloping at about 35° to 40°. The walls were generally in reasonably good condition with the exception of occasional missing or displaced blocks (below the Main Hospital Wing – Extension). However our observations were limited as significant lengths of the walls were overgrown. See Plate 1.

Sloping faced sandstone masonry wall below central portion of main hospital wing.

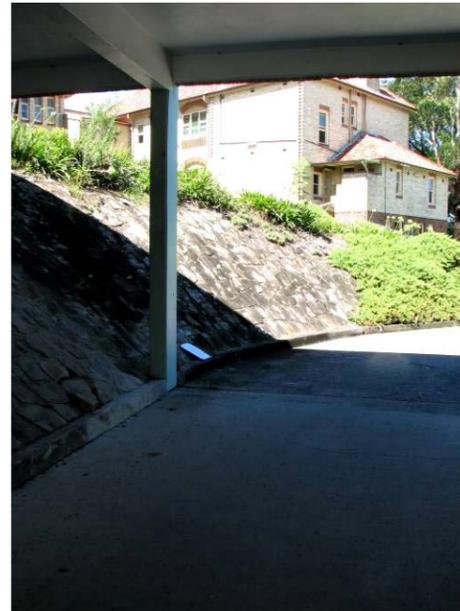
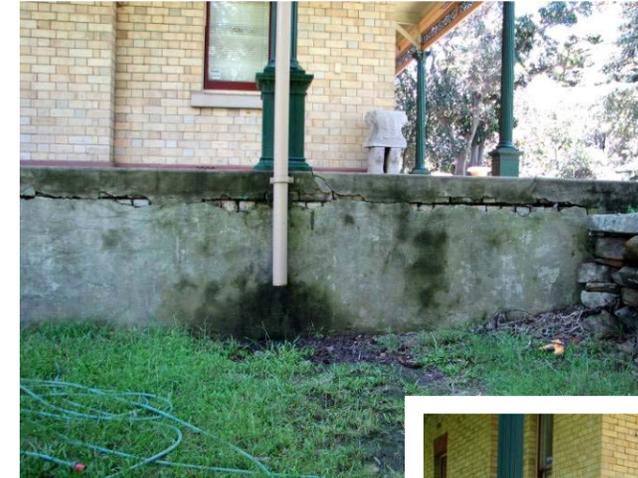
South-western corner of Pallister House

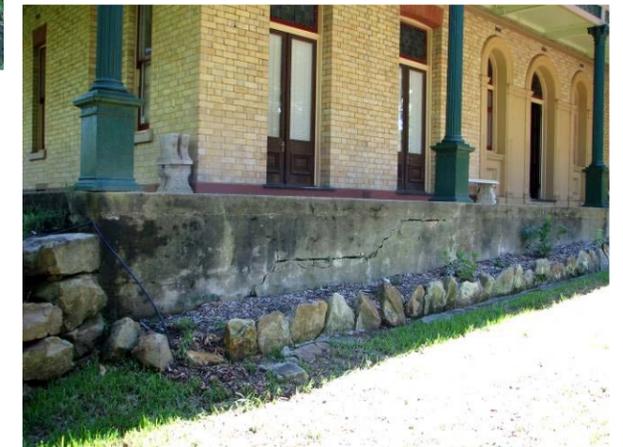
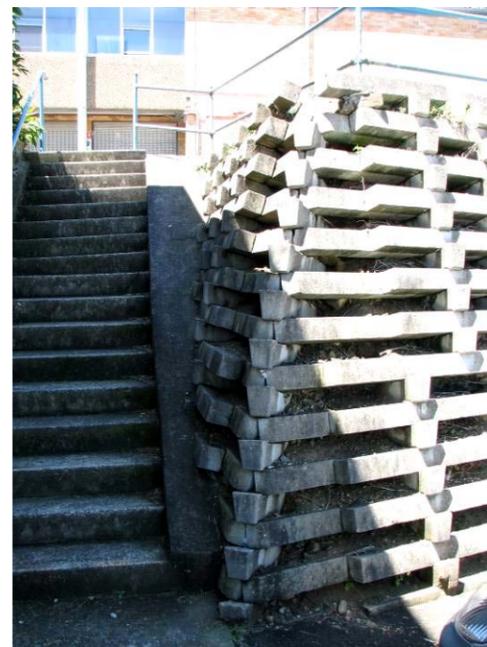
- A concrete crib wall supporting the western side of the car park adjacent to the Service Wing which was a maximum of about 2.6m high and with a face that sloped down to the west at about 70°. The wall appeared to be in reasonably good condition with some erosion of the sand backfill (which included gravel to small cobble sized inclusions of brick, sandstone and asbestos sheeting). See Plate 1.

Crib wall supporting western side of car park lining western side of service wing.

- The concrete crib wall supporting the western side of the car park adjacent to the Service Wing.
- Unless repaired in accordance with the advice provided in Section 6.3, below:

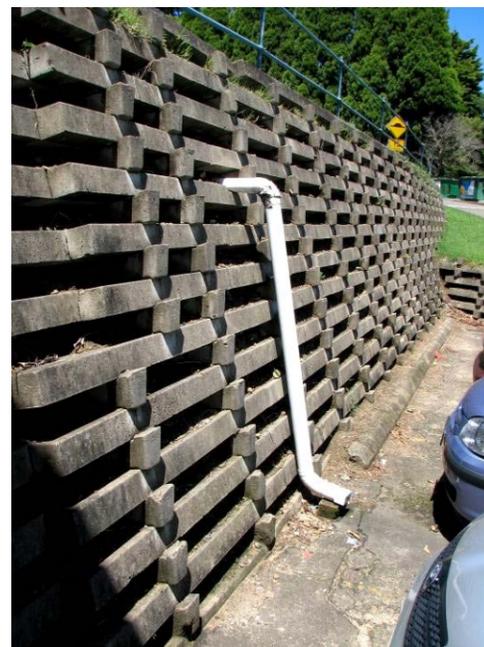
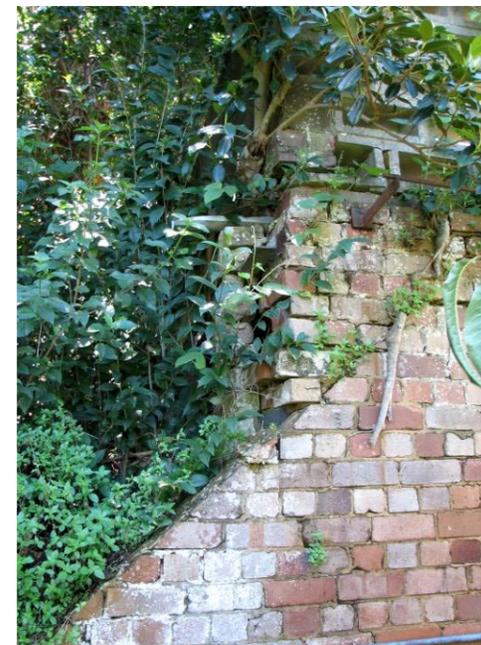
western end of the southern site boundary was lined by an abandoned pool. The southern and western sides of the pool area were supported by brick walls of about 1.5m maximum height. The south-western corner of the wall was in poor condition; what appeared to be a previously collapsed section of wall (about 0.5m wide and 1m high) was evident. See Plate 1.

Brick wall supporting south-western corner of abandoned pool.

The poor condition brick wall supporting the south-western corner of the abandoned pool area should be strengthened, re-constructed or removed. Further advice should be sought from a structural engineer and any wall strengthening or re-construction should be completed in accordance with the advice provided in Section 7.3.2.

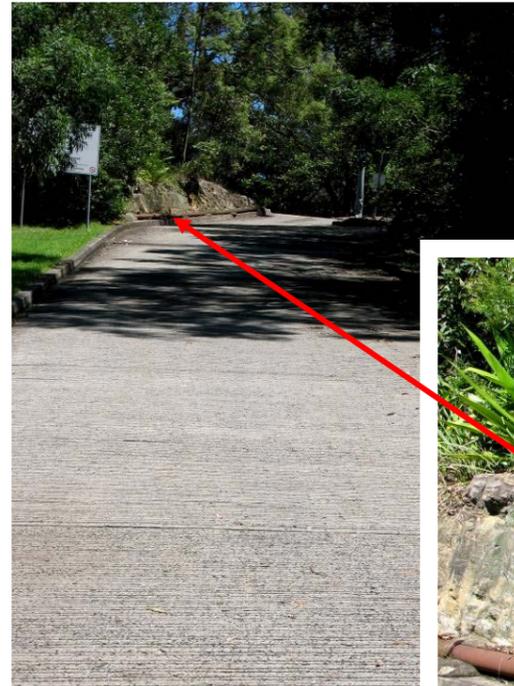
Driveway leading down to St Vincents Road.

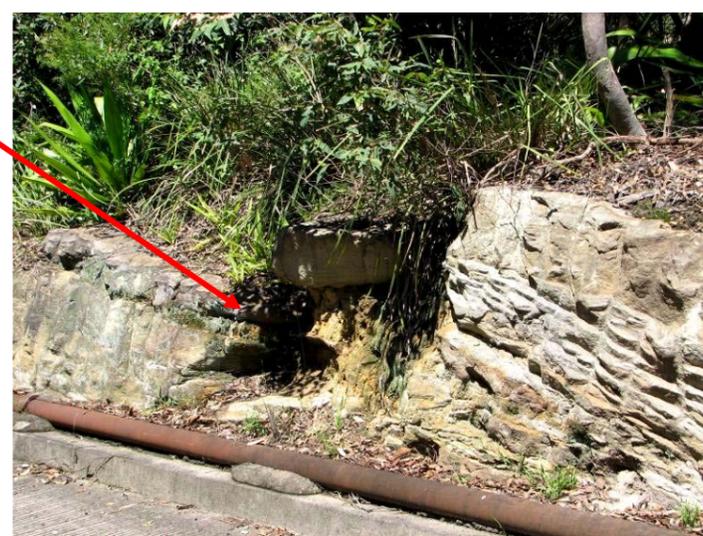
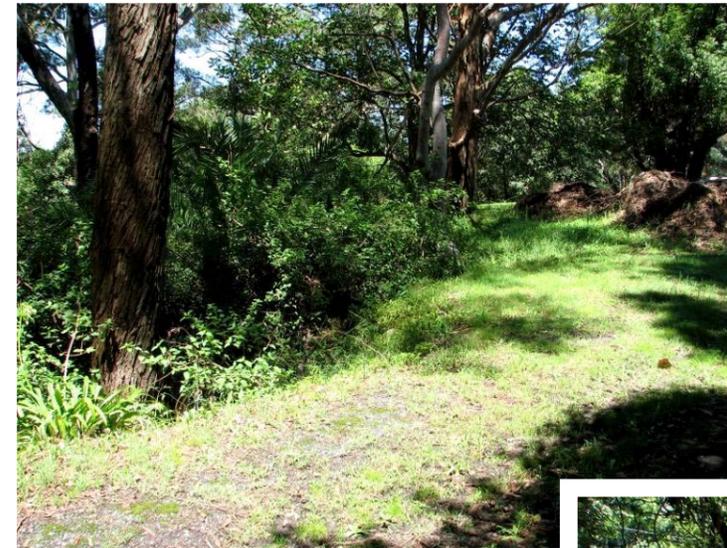
Crest of fill slope.

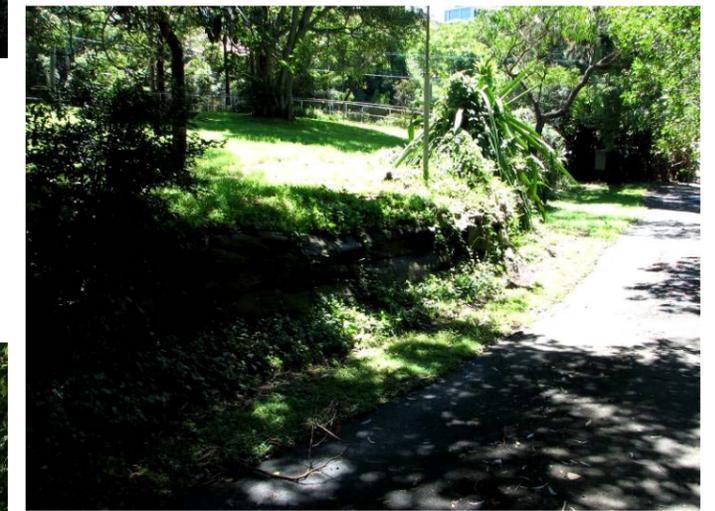
Sandstone outcrop and stacked sandstone wall lining pathway over north-eastern corner of the site.

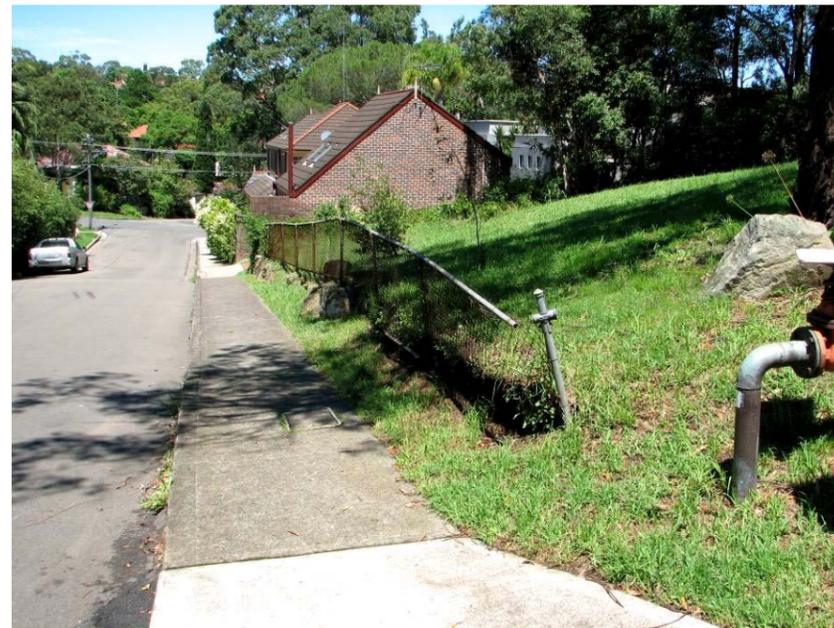
South-eastern corner of site (St Vincents Road).

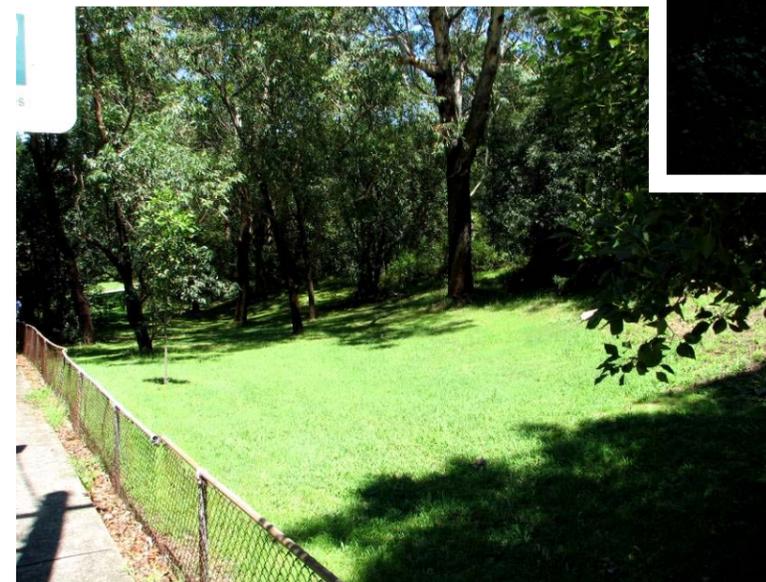
Looking south from north-eastern corner of site boundary (St Vincents Road).

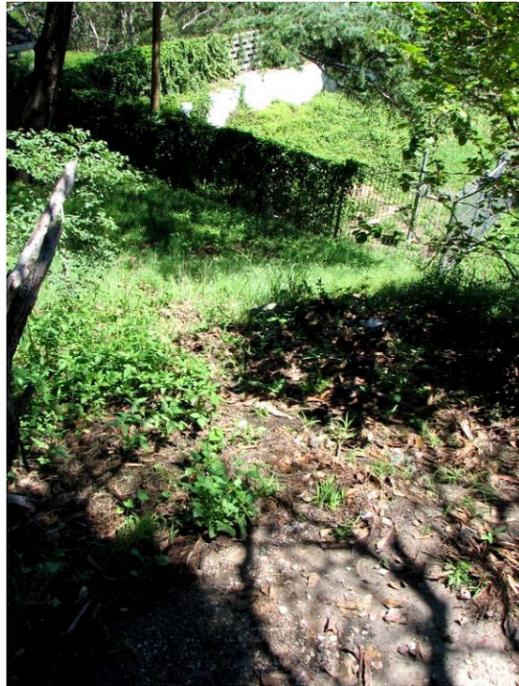
Abandoned inground pool south-western corner of the site.

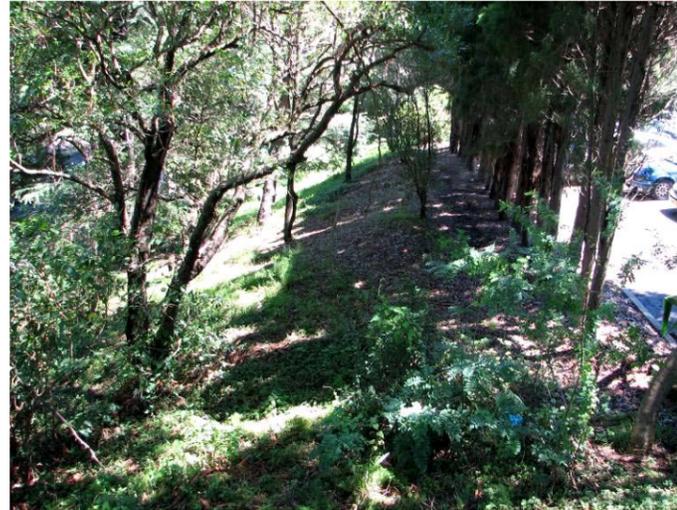
Fill batter lining southern side of car park to south of service wing.

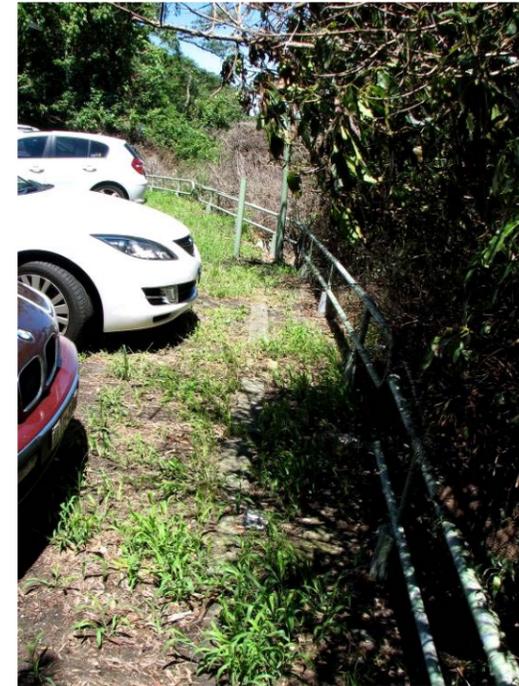
slopes. The steeper batter slopes (up to 45°) typically had uneven faces and the trees on the batter slopes generally had curved bases and/or the trunks leaned 'back'. No tension cracks were noted along the crest areas of the fill batters. However, a section of the fence line at the crest of the fill batter to the west of the Main Hospital Wing was misaligned and leaning and the crest of the fill batter over the eastern side of the site contained a number of arcuate features which may well represent localised areas of previous instability. We note that our observations were limited by thick vegetation and tree cover. See Plates 2 and 3.

Leaning fence at crest of fill batter to west of main hospital wing.

- The crest areas of the fill batter slopes adjacent to the car parks over the western and south-western portions of the site. The inspection should check for signs of tension cracking within the car park paved surface, leaning trees or fences and/or areas of disturbed fill batter slope surface.

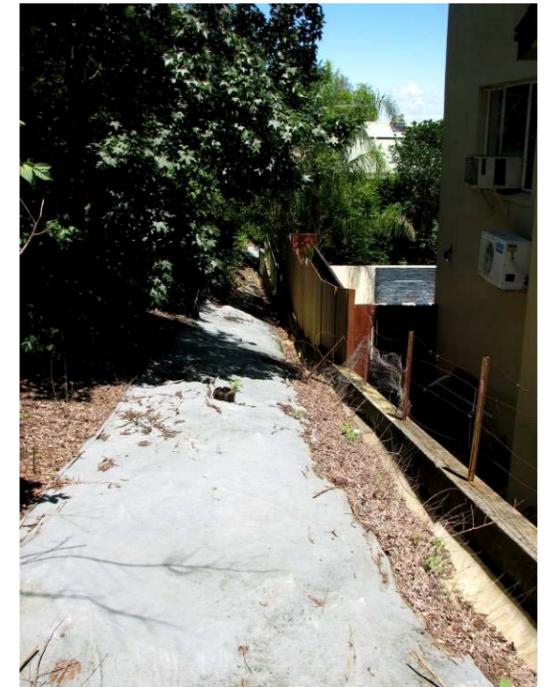
Toe of fill batter lining northern portion of western site boundary.

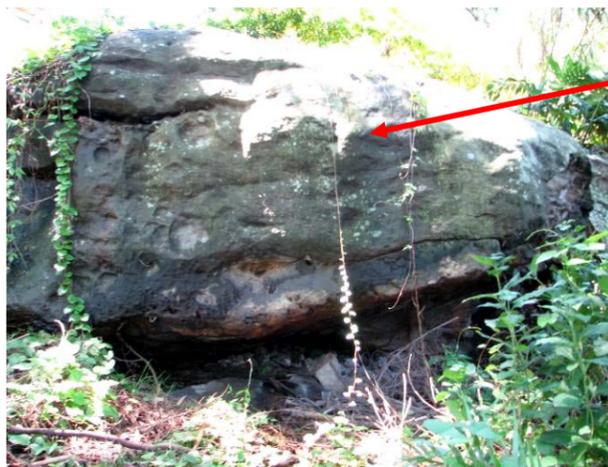
Sandstone outcrop below south-western corner of Pallister House.

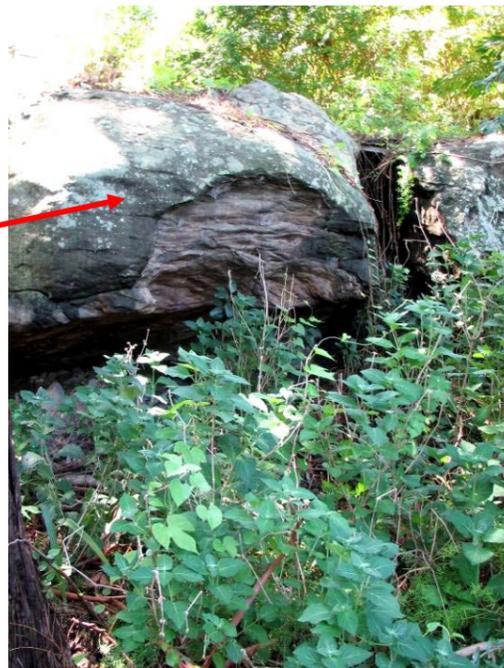
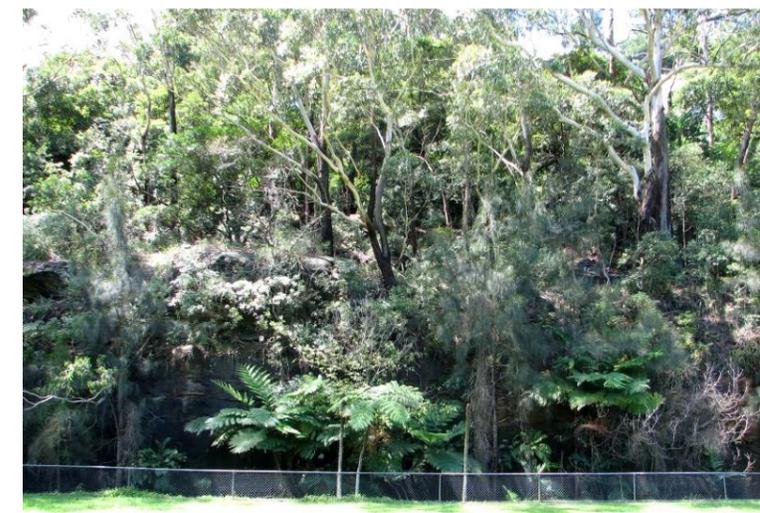
- The northern and central portion of the western site boundary was lined by yard and pool areas of residences; the toe of one of the above mentioned fill batter slopes extended to this portion of the western site boundary. Two and three level rendered and timber houses were set-back at least 1m from the site boundary; the northern end of the western site boundary was lined by a concrete wall (maximum height about 1.5m) which supported the subject site. Based on a cursory inspection from within the site the neighbouring buildings and structures appeared to be in good external condition. The southern portion of the western site boundary was lined by a sub-vertical cliff face (estimated to be about 25m high) which was thickly vegetated and appeared to have a stepped face profile. The toe of the cliff face was lined by Gore Creek which flowed north to south adjacent to the flat grass surfaced Gore Creek Reserve. The crest of the cliff face comprised a flat bench; the toe of the fill batter which extended down from the south-western portion of the site was typically set-back between about 1m and 3m from the crest of the cliff face. However, access restrictions, thick vegetation and safety considerations prevented further inspection of the cliff face crest. See Plate 3.

Vegetated cliff face below south-western portion of the site.
