Report on
Desktop Geotechnical Assessment

Proposed Residential Development
Ivanhoe Estate, Macquarie Park

Prepared for
Frasers Property Australia Pty Ltd

Project 86043.00
November 2017

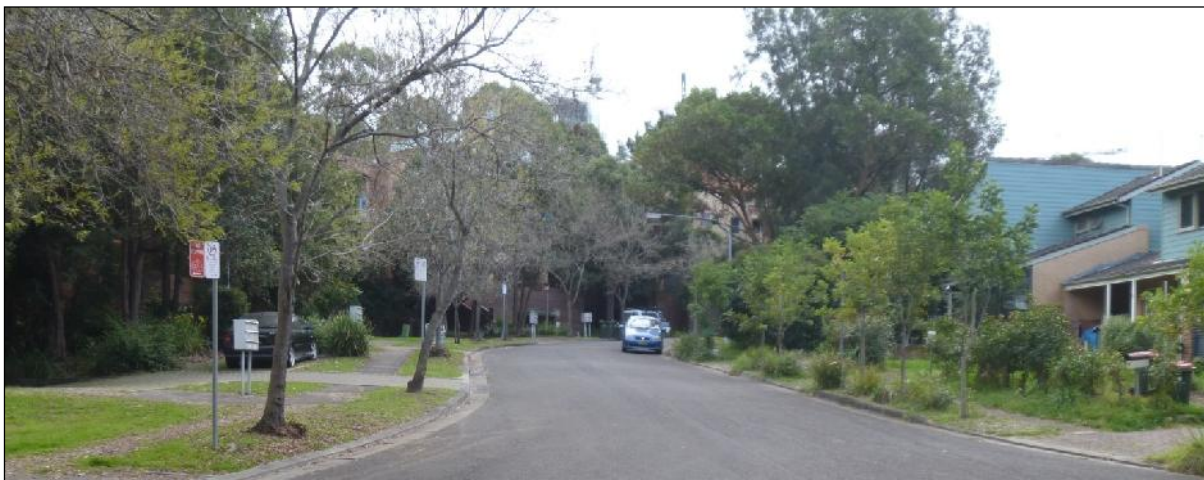
Figure 2: Facing uphill from the cul-de-sac of Ivanhoe Place. Note townhouses at right. Medium-rise residential flats are obscured by trees at left hand side.

The existing structures were generally in poor to reasonable condition, although some cracks were present in the brickwork of buildings and retaining walls, possibly indicating differential movement of foundations.

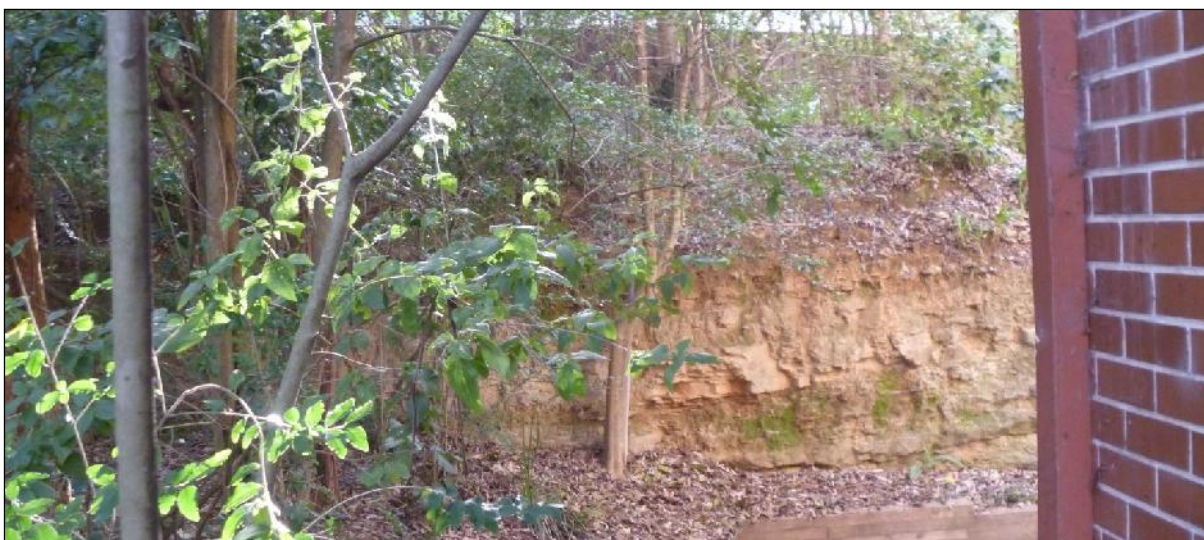
Construction of the existing residential buildings has included cut and fill activities, including cuts into bedrock in the western part of the site. Exposed rock was visible in several locations at the rear of residences west of Ivanhoe Place, at the locations shown in Drawing 1, in Appendix B. The rock faces were generally not accessible for close inspection, but appeared to generally comprise sandstone, sometimes thinly bedded. Shale and siltstone were also considered to be present, particularly towards the upper (north-western) end of the site, based on the apparent bedding thickness and weathering of the rock, although this may also be due to the presence of weaker sandstone.

Figure 3: Exposed rock face at rear of 10 Ivanhoe Place.

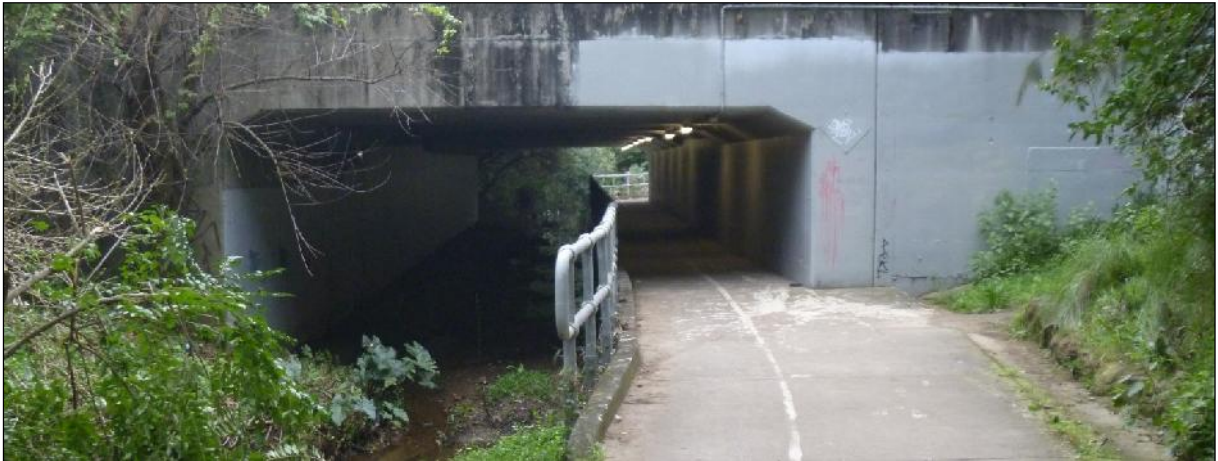
A medium strength sandstone outcrop was also visible at the southern corner of the site, near Shrimptons Creek (refer feature "G" in Drawing 1).

Figure 4: Epping Road Culvert for Shrimptons Creek, facing south. Note low sandstone outcrop (Feature "G") at right hand side of path.

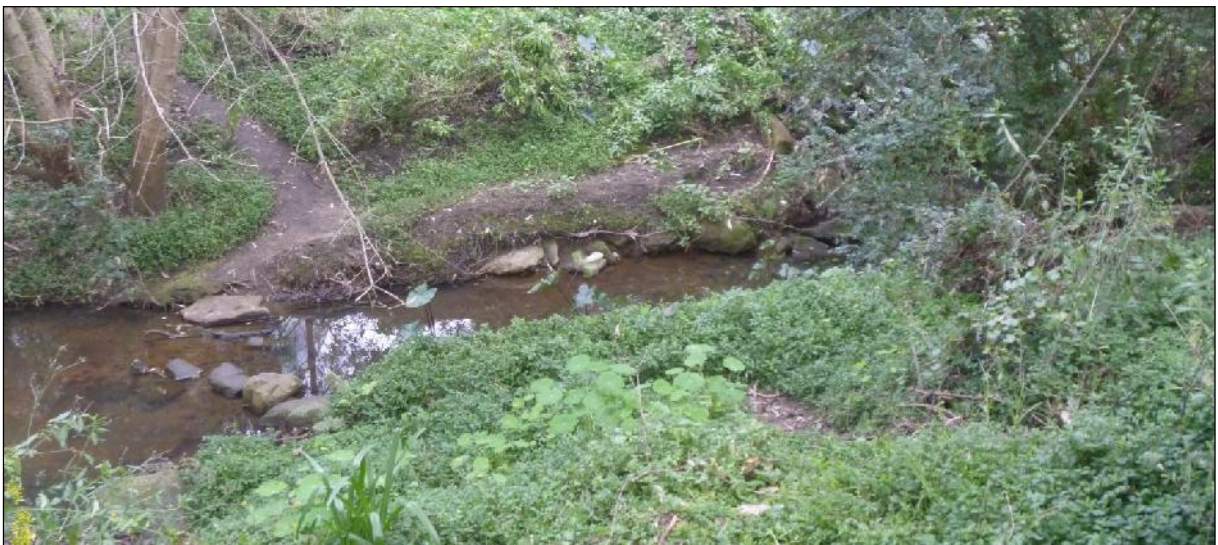
The banks of Shrimptons Creek slope were gently to moderately steep, and were generally vegetated or comprised exposed filling. Numerous sandstone boulders were present in the banks and creek bed (refer feature "F" in Drawing 1). It is considered probable that the boulders were used to stabilise the slope against erosion, although this appear largely ineffective in their current alignment. Some sandstone boulder headwalls are present near stormwater outlets, and appear to be in better condition.

Figure 5: Shrimptons Creek, facing south-east near centre of south-eastern boundary. Note presence of sandstone boulders in creek bank and floor of creek.

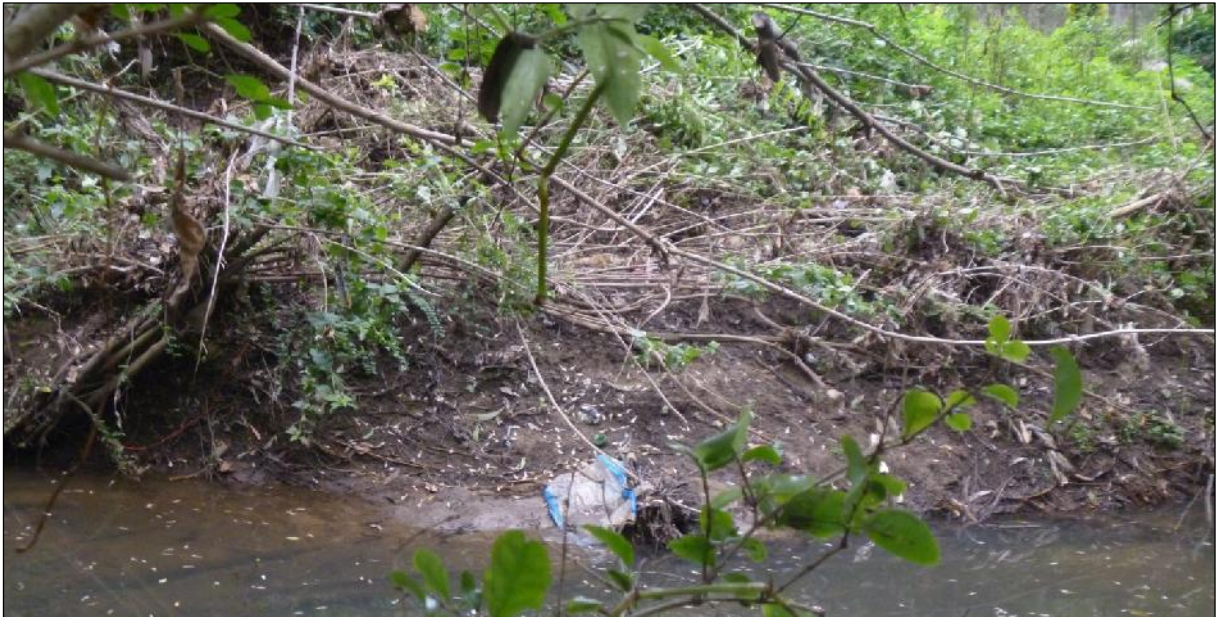
Figure 6: Shrimptons Creek, facing north-west near centre of south-eastern boundary. Possible outcrop or boulder at toe of slope.

Signage at Shrimptons Creek indicates that the creek is subject to flooding.

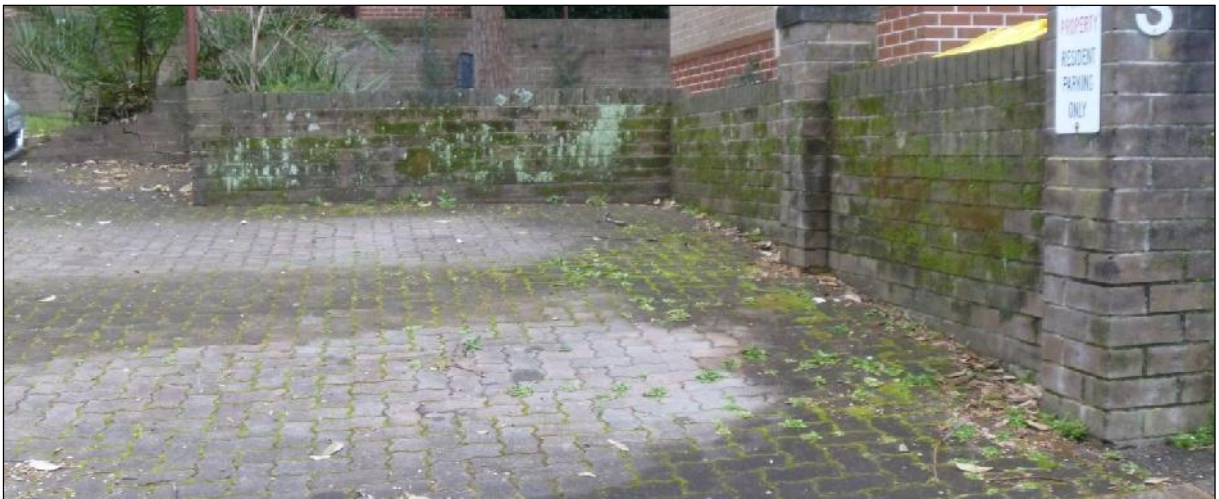
Groundwater seepage was not observed at cuts or creek banks. Throughout the site, however, mossy growth was observed between pavers and on walls, suggesting that the existing soils are poorly drained. Some of these areas are shown in Drawing 1 (Appendix B) and are denoted by the letter "D".

Figure 7: Moss growth on pavers and walls; 3 Wilcannia Way

Moss growth was observed on roads and retaining walls in several areas on the site, suggesting that existing soil moisture levels are relatively high. Control of subsurface moisture by the use of appropriate drainage, will be critical to the performance of any pavements.

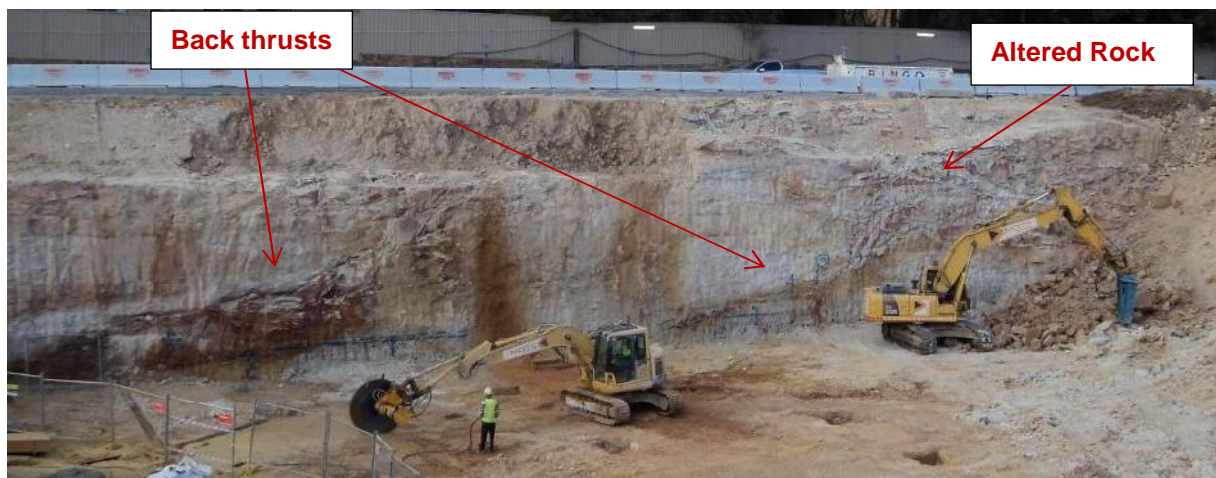
-) Thrust faulting, often associated with dykes, has been identified at a nearby site to the north-west of the subject site. A photograph showing the subsurface profile exposed by bulk excavation on this site is included in Figure 13.
-) Groundwater monitoring at discrete time intervals upslope of the site identified water levels within the sandstone, at depths of between 2 m and 12 m, although only very minor seepage occurred into the resulting (3 basement level) excavation.

Figure 13: Back thrusts in an excavation wall at a nearby site

Thrust faults are often associated with dykes, though may affect a larger area. Thrust faults may vary significantly between sites, and their presence may relatively abruptly discontinue within a site. Their impact may include a band of fractured rock (e.g. the thrust fault, or back thrust), to thick zones (to several metres depth) of altered sandstone affected by iron-cementation and bleaching, as seen in Figure 13.

The presence of dykes or thrust faulting may result in locally poorer rock conditions, which may lead to additional support being required in some areas of the site (or over a short distance). Detailed investigation and/or careful monitoring and inspection of ground conditions during excavation (including for soldier piles) would generally be appropriate to ensure that support is taken down to an appropriate depth in any affected areas.

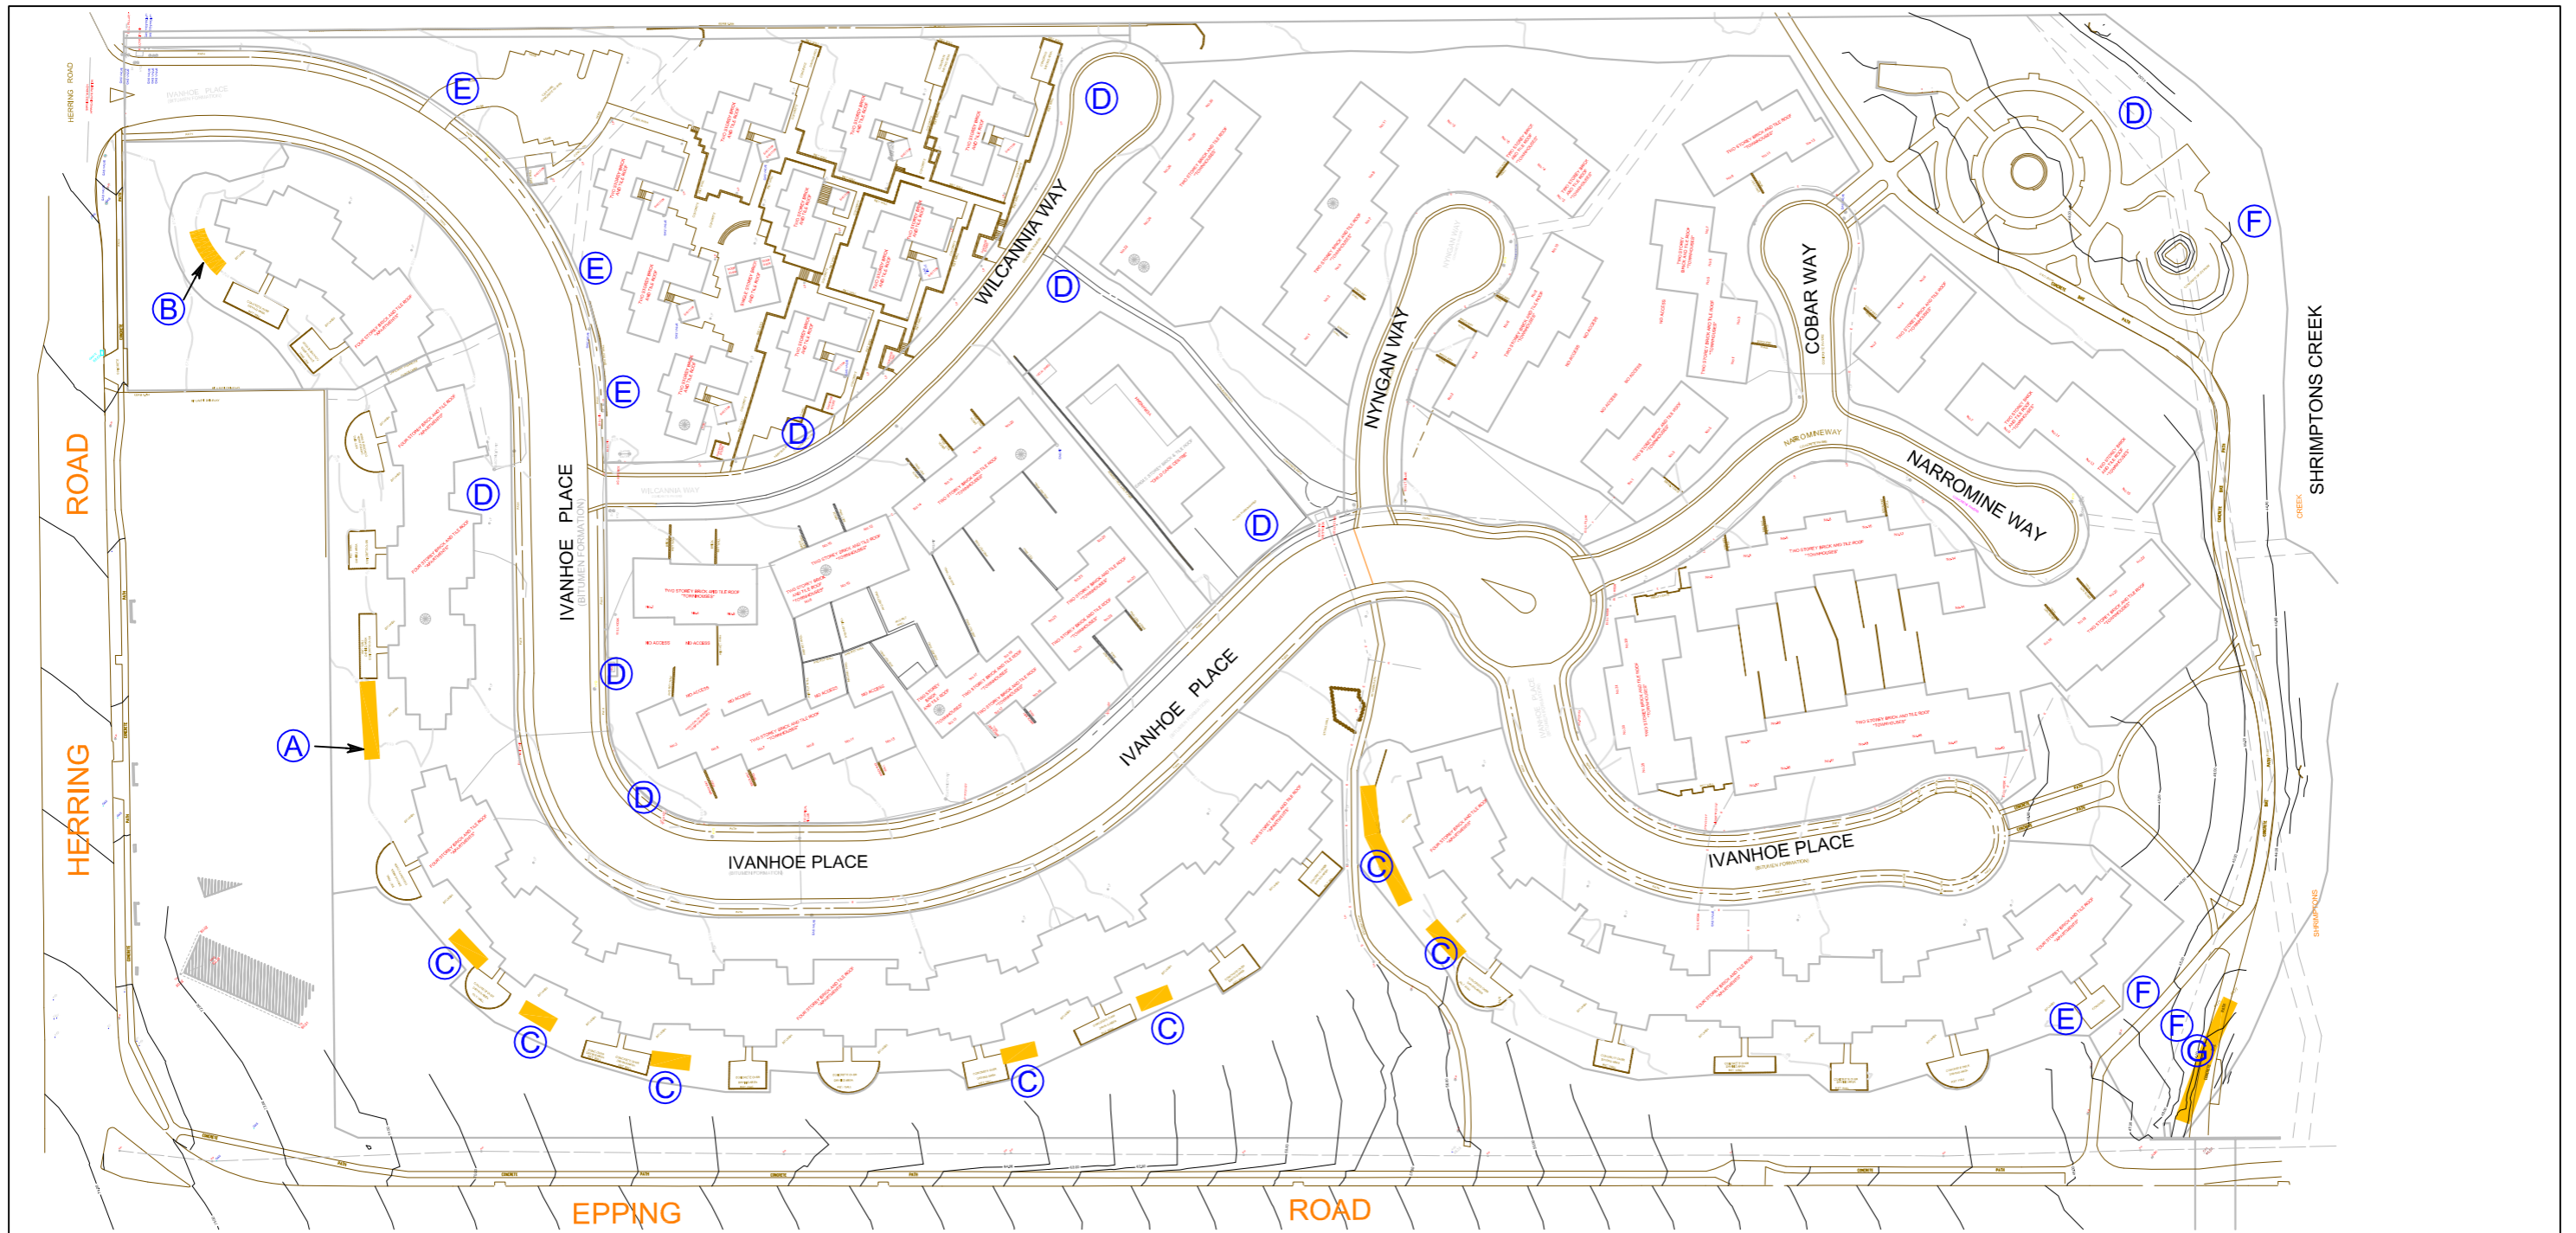
- (A)** Rock Cut. Following strata observed.
Soil to ~ R.L. 66.8
Very low to low strength shale to ~ R.L. 66.5
Low to medium and high strength laminated shale and siltstone to ~ R.L. 65.5
Medium strength, fine grained sandstone to ~ R.L. 65
- (B)** Extremely weathered shale and medium strength sandstone
(Inaccessible for inspection)
- (C)** Very low, low and medium strength sandstone
(Inaccessible for inspection)
- (D)** Mossy growth/moist ground
- (E)** Fill batter
- (F)** Disturbed ground and sandstone boulders
- (G)** Medium strength sandstone
- Rock outcrop/exposure

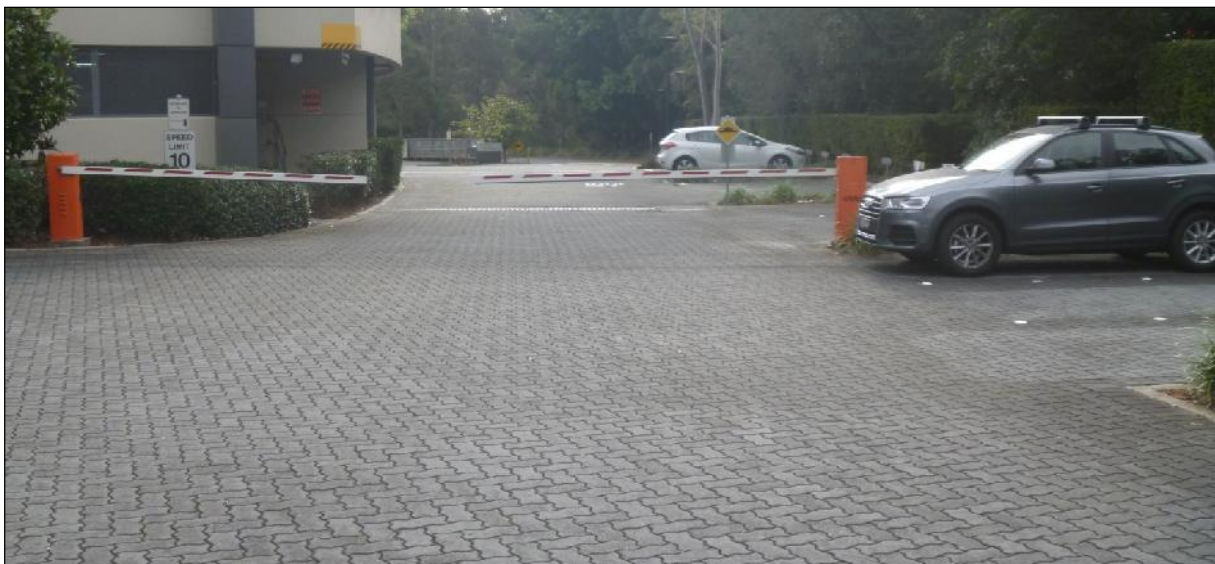
Figure 1: Subject new road alignment, facing west from Lyon Park Road

The existing pavement comprises interlocking segmental paving blocks and is generally in good condition. Pavement levels within the subject development area slope gently down from approximately RL 49 at Lyon Park Road towards Shrimptons Creek at approximately 1° to 2°.

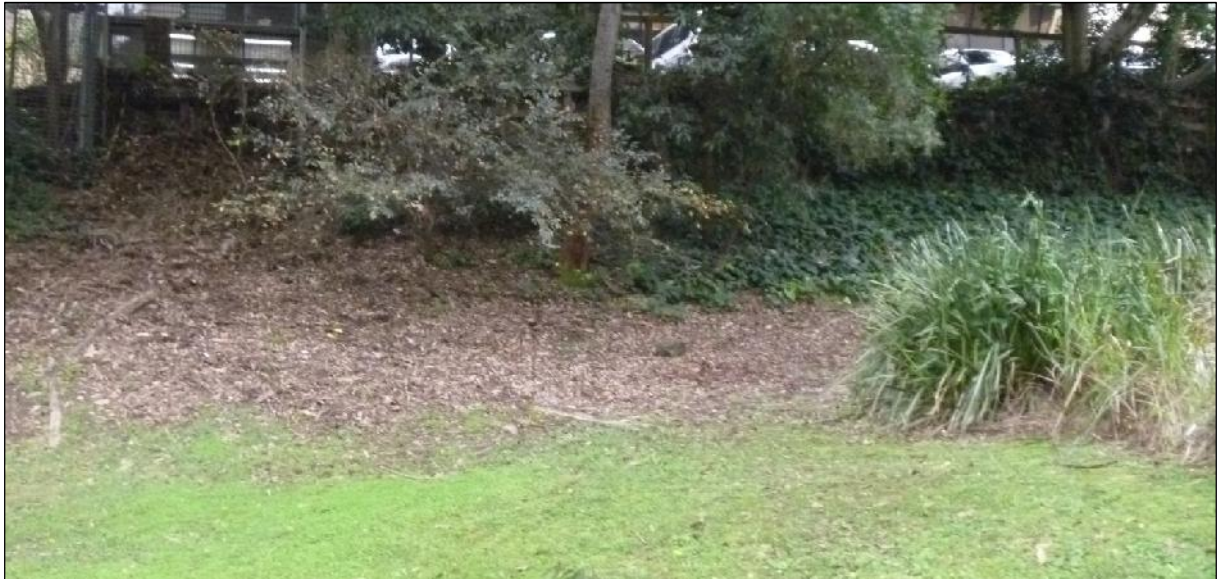
Higher ground levels on the adjoining site at 6 Lyon Park Road (for pavement areas, at approximately RL 49) are supported by crib walls on the common site boundary and, in some parts of the site, by batters within the proposed road corridor. The difference in level between the sites increases towards Shrimptons Creek and at the rear half of the site, mulched and vegetated batters rise along the proposed corridor towards the toe of the crib walls. The batters are up to 2 m high, and support crib walls of typical heights of 1.5 m to 2 m (see Figure 2)

Figure 2: Mulched batter slope and crib wall at rear boundary between 2-4 and 6 Lyon Park Road

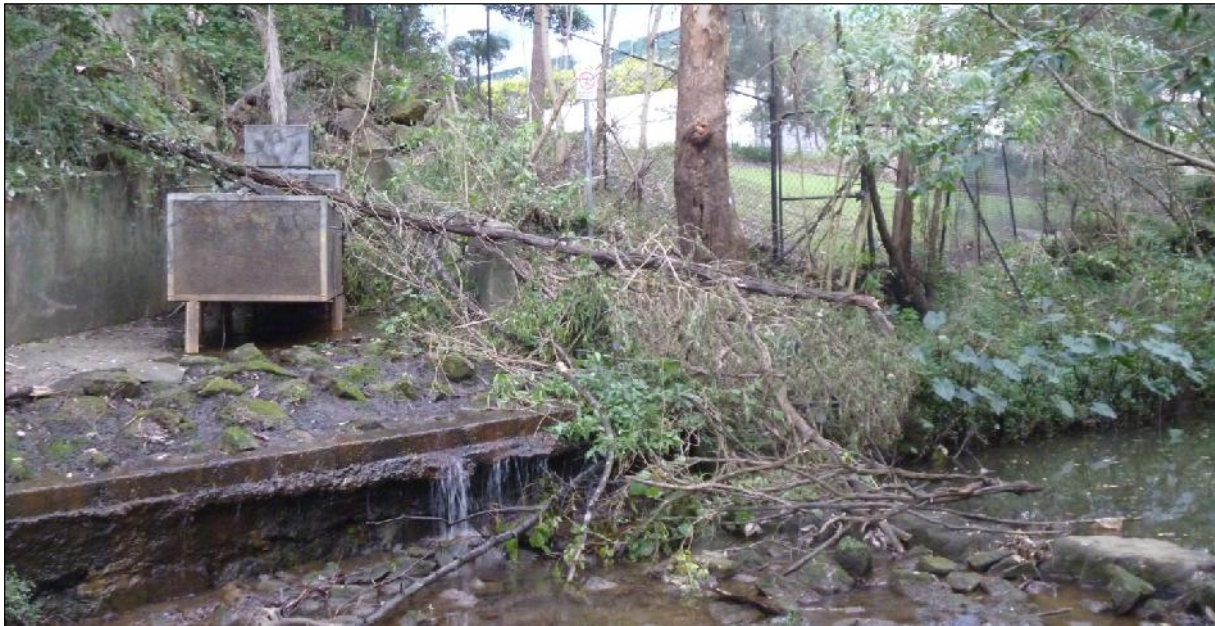
At the rear of the proposed road corridor, a stormwater outlet drains to Shrimptons Creek. The outlet has steep sandstone boulder headwalls and concrete sidewalls, built into the steeper batter in this area. The concrete and sandstone apron may possibly be constructed on sandstone blocks or outcrop, but was not accessible for safe inspection during the site visit.

Figure 3: Stormwater outlet at Shrimptons Creek, with concrete sidewalls and sandstone boulder headwall, as viewed from north-western bank.
