## **Hazardous Materials Survey**

13-15 Oxford Street, 17 Oxford Street & 2 Verona Street,  
Paddington NSW

**Report No:** E25559.E10\_Rev0

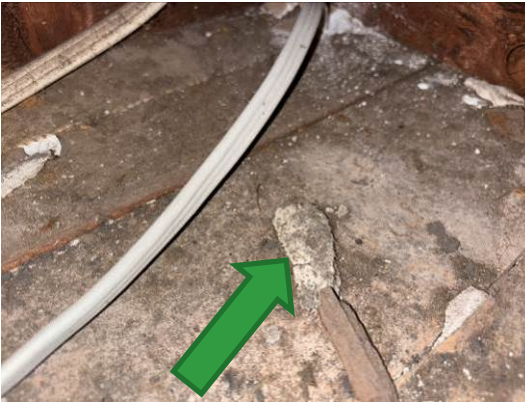
| Ceiling cavity, 1 <sup>st</sup> floor, northern side above lunch room / bathroom, debris | ACM | Non-friable | Asb-07 | Chrysotile Asbestos Detected | ND | Poor / Maintenance only | Priority 2 - Elevated Risk Level | 3/10/2025 | Dust within the ceiling cavity should be HEPA vacuumed prior to demolition<br><br>Remove during initial stage of demolition works | |

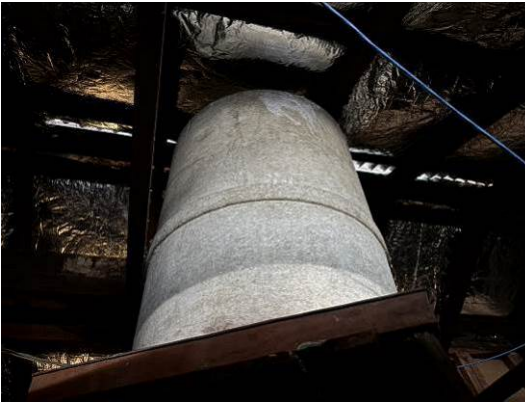
| Ceiling cavity, 1 <sup>st</sup> floor, above southern offices, tank/pipe | ACM (assumed) | Non-friable | Visual inspection – similar to Asb-07 | - | Approximately 2m <sup>2</sup> | Fair / Maintenance only | Priority 3 - Low Risk Level | 3/10/2025 | Remove during initial stage of demolition works | |

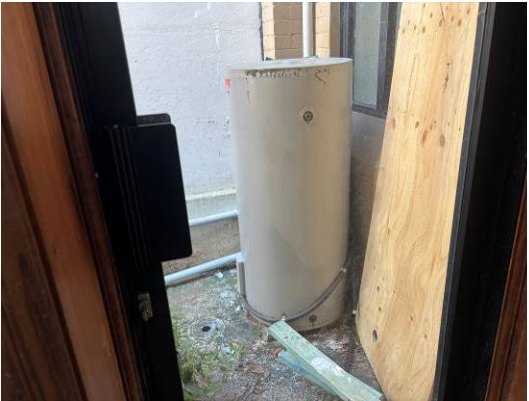
| Location | Material | Friability | Sample | Analysis Result | Quantity | Condition / Accessibility | Priority | Date of Identification | Recommendations / Comments | Photograph |
|---|---|---|---|---|---|---|---|---|---|---|
| External, ground floor, northern side, hot water heater | SMF-lined insulation (assumed) | Sealed | Visual inspection - electrical hazard | - | 1 x unit | Good / Maintenance only | Priority 4 - Negligible Risk Level | 3/10/2025 | Remove during initial stage of demolition works | |

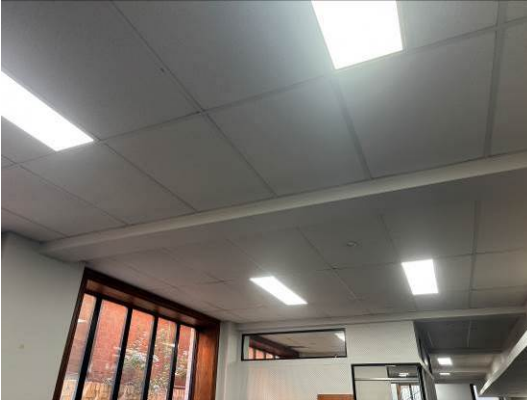
| Location | Material | Friability | Sample | Analysis Result | Quantity | Condition / Accessibility | Priority | Date of Identification | Recommendations / Comments | Photograph |
|---|---|---|---|---|---|---|---|---|---|---|
| Internal, ground floor, offices, perforated ceiling tiles throughout | SMF (assumed) | Sealed | Visual inspection | - | 150-200m <sup>2</sup> | Good / Maintenance only | Priority 4 - Negligible Risk Level | 3/10/2025 | Remove during initial stage of demolition works | |

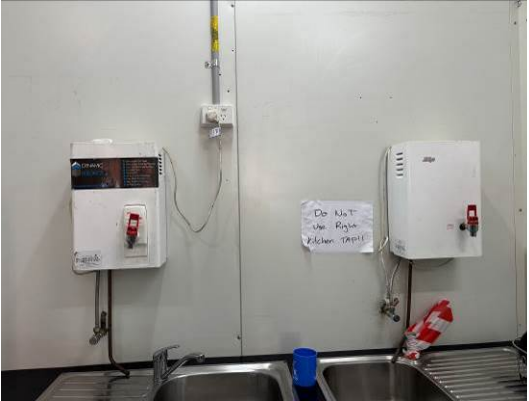
| Location | Material | Friability | Sample | Analysis Result | Quantity | Condition / Accessibility | Priority | Date of Identification | Recommendations / Comments | Photograph |
|---|---|---|---|---|---|---|---|---|---|---|
| Internal, 1 <sup>st</sup> floor, lunchroom, kitchen, zip hot water heaters | SMF-lined insulation (assumed) | Sealed | Visual inspection - electrical hazard | - | 2 x units | Good / Maintenance only | Priority 4 - Negligible Risk Level | 3/10/2025 | Remove during initial stage of demolition works | |

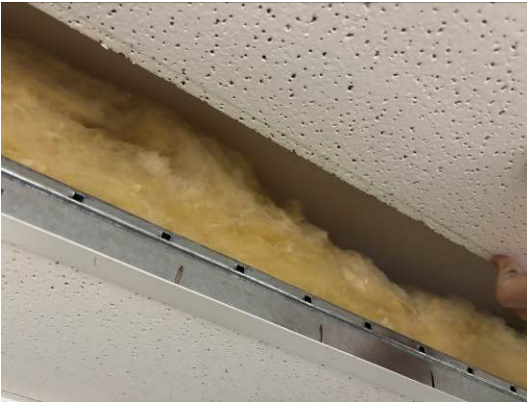
| Hazardous Materials Register<br>13-15 Oxford Street, 17 Oxford Street & 2 Verona Street, Paddington NSW | | | | | | | | | | 2 Verona Street – Commercial Building |
|---|---|---|---|---|---|---|---|---|---|---|
| Ceiling cavity, ground floor, insulation throughout | SMF (assumed) | Sealed | Visual inspection | - | Approximately 400m <sup>2</sup> | Good / Maintenance only | Priority 4 - Negligible Risk Level | 3/10/2025 | Remove during initial stage of demolition works | |

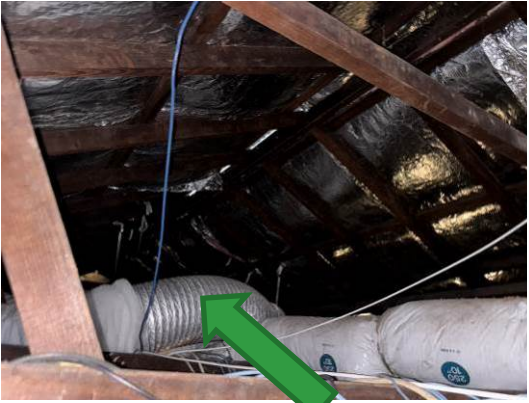
| Hazardous Materials Register<br>13-15 Oxford Street, 17 Oxford Street & 2 Verona Street, Paddington NSW | | | | | | | | | | 2 Verona Street – Commercial Building |
|---|---|---|---|---|---|---|---|---|---|---|
| Ceiling cavity, ducting throughout | SMF-lined insulation (assumed) | Sealed | Visual inspection - height restriction | - | ND | Good / Maintenance only | Priority 4 - Negligible Risk Level | 3/10/2025 | Remove during initial stage of demolition works | |

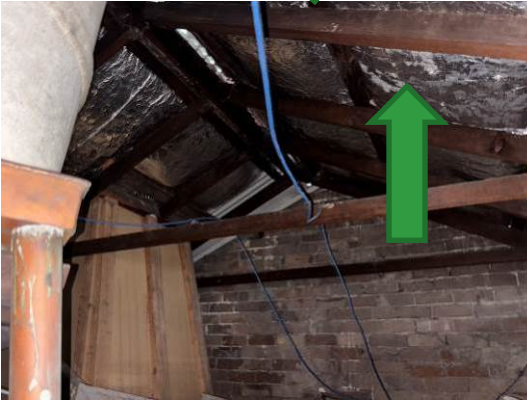
| Hazardous Materials Register<br>13-15 Oxford Street, 17 Oxford Street & 2 Verona Street, Paddington NSW | | | | | | | | | | 2 Verona Street – Commercial Building |
|---|---|---|---|---|---|---|---|---|---|---|
| Ceiling cavity, 1 <sup>st</sup> floor, roof sarking insulation | SMF-lined insulation (assumed) | Sealed | Visual inspection - height restriction | - | Approximately 400m <sup>2</sup> | Good / Maintenance only | Priority 4 - Negligible Risk Level | 3/10/2025 | Remove during initial stage of demolition works | |

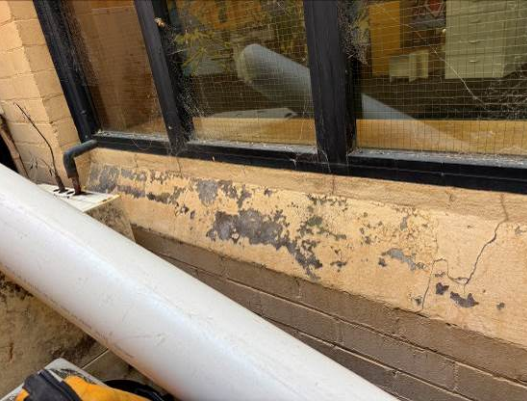
| Hazardous Materials Register<br>13-15 Oxford Street, 17 Oxford Street & 2 Verona Street, Paddington NSW | | | | | | | | | | 2 Verona Street – Commercial Building |
|---|---|---|---|---|---|---|---|---|---|---|
| External, western walls | Yellow LBP | Friable | LBP-04 | 2.1% w/w | Approximately 100m <sup>2</sup> | Fair / Maintenance only | Priority 3 - Low Risk Level | 3/10/2025 | Remove grossly peeling paint. Stabilise remaining membrane. Minimise abrasive works that will disturb paint during demolition. | |

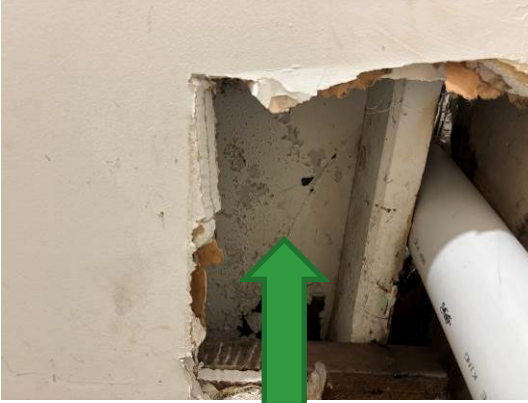
| Hazardous Materials Register<br>13-15 Oxford Street, 17 Oxford Street & 2 Verona Street, Paddington NSW | | | | | | | | | | 2 Verona Street – Commercial Building |
|---|---|---|---|---|---|---|---|---|---|---|
| Ceiling cavity, 1 <sup>st</sup> floor, offices, above eastern bathroom, upper ceiling | White LBP | Friable | LBP-06 | 0.11% w/w | ND | Fair / Maintenance only | Priority 4 - Negligible Risk Level | 3/10/2025 | Remove during initial stage of demolition works | |

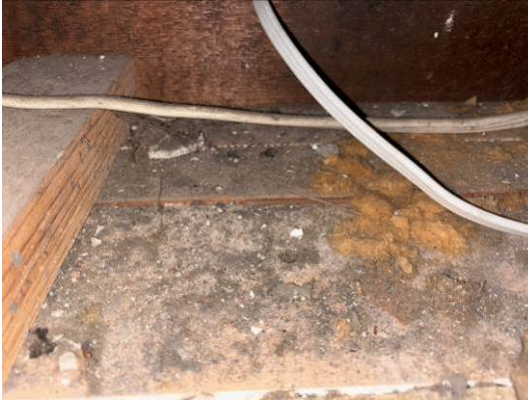
| Location | Material | Friability | Sample | Analysis Result | Quantity | Condition / Accessibility | Priority | Date of Identification | Recommendations / Comments | Photograph |
|---|---|---|---|---|---|---|---|---|---|---|
| Ceiling cavity, 1 <sup>st</sup> floor, northern side (above lunch room / bathroom), dust | Dust / debris | Friable | LD-01 | 1,100 mg/kg | Low Load | N/A | N/A | N/A | Review levels as part of a risk assessment for management, and remediate dust under controlled conditions prior to demolition works. | |

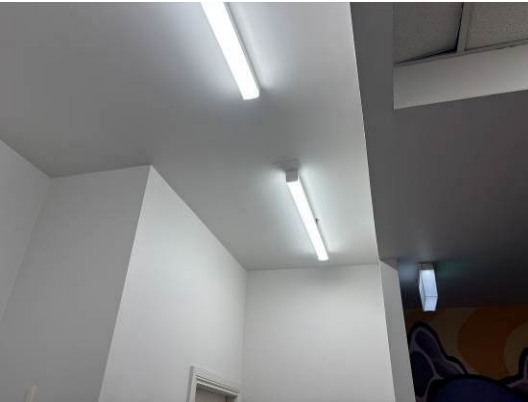
| Location | Material | Friability | Sample | Analysis Result | Quantity | Condition / Accessibility | Priority | Date of Identification | Recommendations / Comments | Photograph |
|---|---|---|---|---|---|---|---|---|---|---|
| Internal, ground floor, kitchen, ceiling, fluorescent light fittings | PCB-containing single-tube fluorescent light fitting capacitors (assumed) | N/A | Visual inspection - electrical hazard | - | 2 x fittings | Good / Maintenance only | Priority 4 - Negligible Risk Level | 3/10/2025 | Remove prior to demolition works.<br>Avoid damage to capacitors. | |

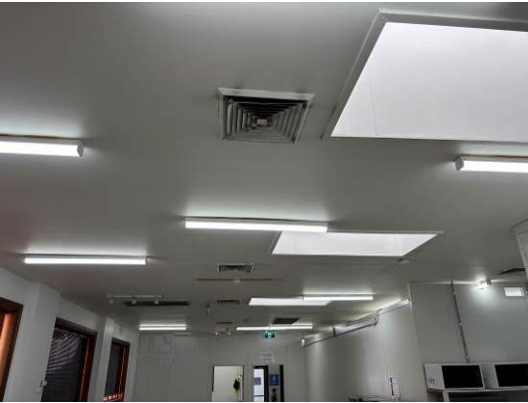
| Location | Material | Friability | Sample | Analysis Result | Quantity | Condition / Accessibility | Priority | Date of Identification | Recommendations / Comments | Photograph |
|---|---|---|---|---|---|---|---|---|---|---|
| Internal, 1 <sup>st</sup> floor, ceiling, fluorescent light fittings | PCB-containing single-tube fluorescent light fitting capacitors (assumed) | N/A | Visual inspection - electrical hazard | - | 19 x fittings | Good / Maintenance only | Priority 4 - Negligible Risk Level | 3/10/2025 | Remove prior to demolition works.<br>Avoid damage to capacitors. | |

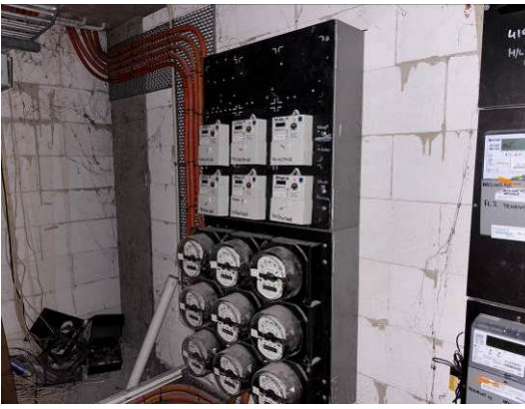
| Internal, basement, switch room, electrical distribution boards | ACM (assumed) | Non-friable | Visual inspection – electrical hazard | - | 8 x boards | Good / Maintenance only | Priority 4 - Negligible Risk Level | 3/10/2025 | Remove during initial stage of demolition works | |

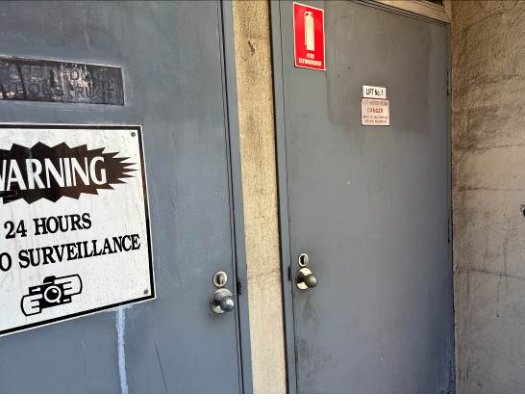
| External / internal, basement and ground floor, fire doors throughout, internal lining | ACM (assumed) | Friable | Visual inspection – inaccessible | - | ND | Good / Maintenance only | Priority 3 - Low Risk Level | 3/10/2025 | Many fire doors were not accessible during the inspection and are assumed to contain friable asbestos insulation. See Section 6.1.2 for recommendations.<br><br>Remove during initial stage of demolition works | |

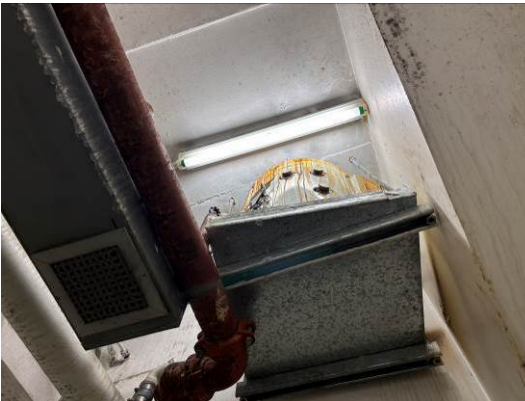
| Internal, basement, male bathroom, hot water heater | SMF-lined insulation (assumed) | Sealed | Visual inspection - electrical hazard | - | 1 x unit | Good / Maintenance only | Priority 4 - Negligible Risk Level | 3/10/2025 | Remove during initial stage of demolition works | |

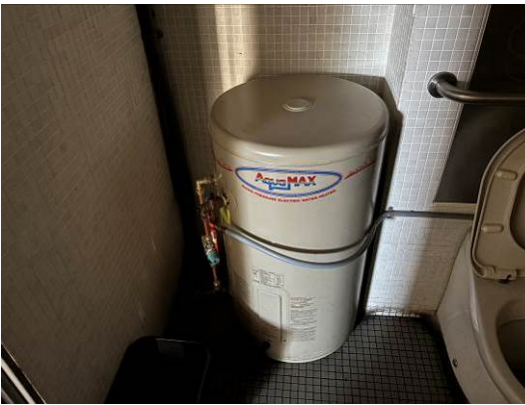
| Internal, 1 <sup>st</sup> floor, bathroom, hot water heater | SMF-lined insulation (assumed) | Sealed | Visual inspection - electrical hazard | - | 1 x unit | Good / Maintenance only | Priority 4 - Negligible Risk Level | 3/10/2025 | Remove during initial stage of demolition works | |

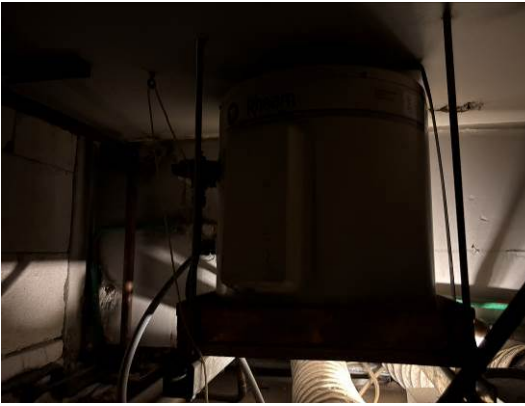
| Ceiling cavity, 1 <sup>st</sup> floor, above male bathroom, hot water heater | SMF-lined insulation (assumed) | Sealed | Visual inspection - electrical hazard | - | 1 x unit | Good / Maintenance only | Priority 4 - Negligible Risk Level | 3/10/2025 | Remove during initial stage of demolition works | |

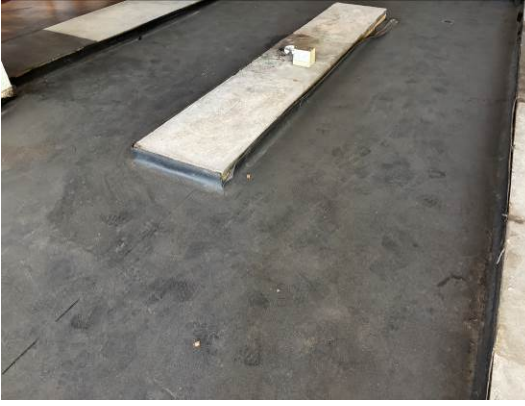
| Internal, 1 <sup>st</sup> floor, main cinema lobby, central portion, black vinyl floor sheeting | SMF | Non-friable | Asb-11 | No Asbestos Detected<br>Synthetic Mineral Fibres Detected | Approximately 15m <sup>2</sup> | Fair / Maintenance only | Priority 4 - Negligible Risk Level | 3/10/2025 | Remove during initial stages of demolition works | |

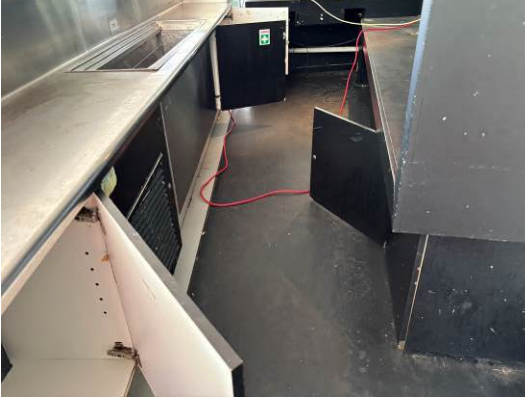
| Internal, 2 <sup>nd</sup> floor, bar, black vinyl floor sheeting | SMF (assumed) | Non-friable | Visual inspection – similar to Asb-11 | - | Approximately 10m <sup>2</sup> | Fair / Maintenance only | Priority 4 - Negligible Risk Level | 3/10/2025 | Remove during initial stages of demolition works | |

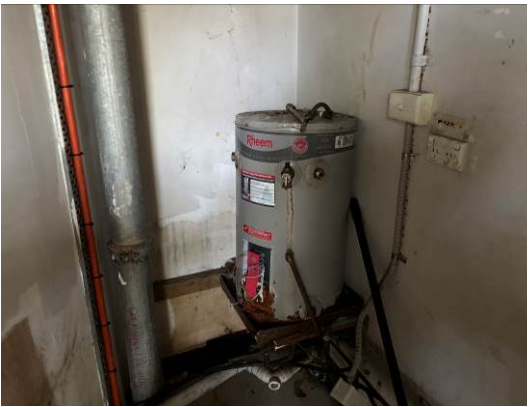
| Internal, 2 <sup>nd</sup> floor, bar store room, hot water heater | SMF-lined insulation (assumed) | Sealed | Visual inspection - electrical hazard | - | 1 x unit | Good / Maintenance only | Priority 4 - Negligible Risk Level | 3/10/2025 | Remove during initial stage of demolition works | |

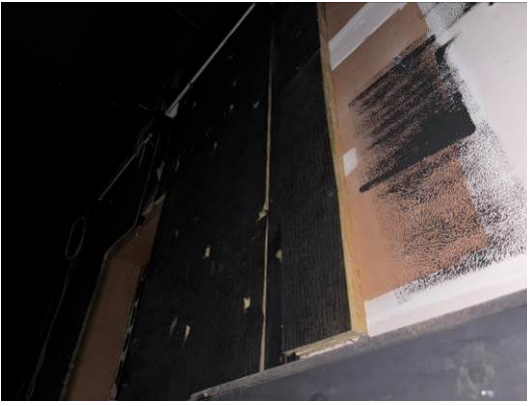
| Internal, 2 <sup>nd</sup> floor, cinema rooms, walls throughout, insulation | SMF-lined insulation (assumed) | Sealed | Visual inspection | - | ND | Good / Maintenance only | Priority 4 - Negligible Risk Level | 3/10/2025 | Remove during initial stage of demolition works | |

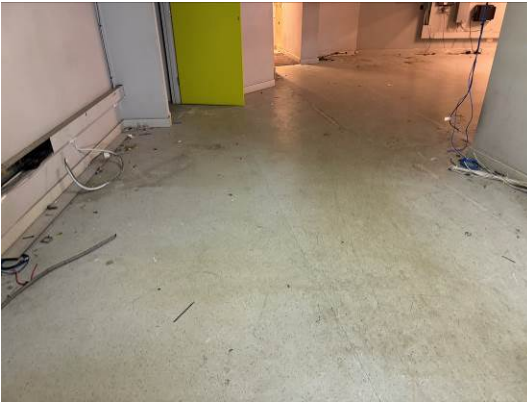
| Internal, 3 <sup>rd</sup> floor, white vinyl floor sheeting with fibrous backing | SMF | Non-friable | Asb-15 | No Asbestos Detected<br>Organic Fibres Detected<br>Synthetic Mineral Fibres Detected | Approximately 50m <sup>2</sup> | Fair / Maintenance only | Priority 4 - Negligible Risk Level | 3/10/2025 | Remove during initial stages of demolition works | |

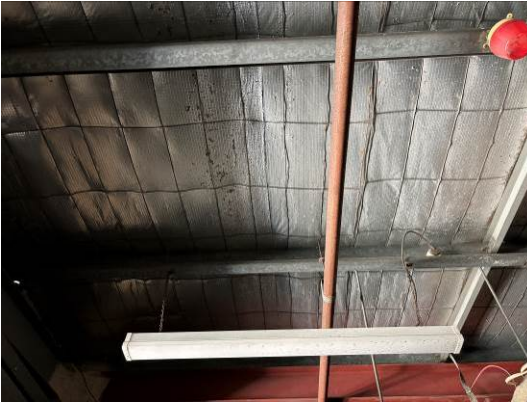
| Internal, 3 <sup>rd</sup> floor, plant room, roof sarking insulation | SMF-lined insulation (assumed) | Sealed | Visual inspection | - | ND | Good / Maintenance only | Priority 4 - Negligible Risk Level | 3/10/2025 | Remove during initial stage of demolition works | |

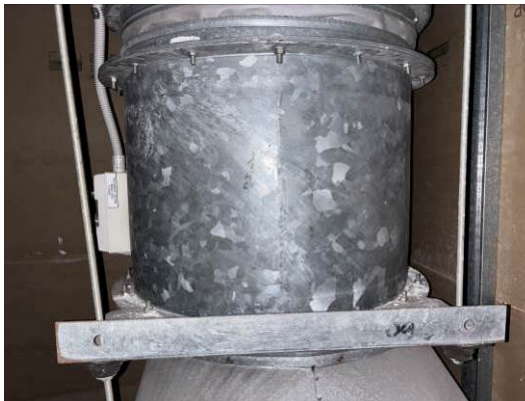
| Hazardous Materials Register<br>13-15 Oxford Street, 17 Oxford Street & 2 Verona Street, Paddington NSW | | | | | | | 17 Oxford Street – Commercial Building | | | |
|---|---|---|---|---|---|---|---|---|---|---|
| Ceiling cavity / plant room, ducting throughout | SMF-lined insulation (assumed) | Sealed | Visual inspection - height restriction | - | ND | Good / Maintenance only | Priority 4 - Negligible Risk Level | 3/10/2025 | Remove during initial stage of demolition works | |

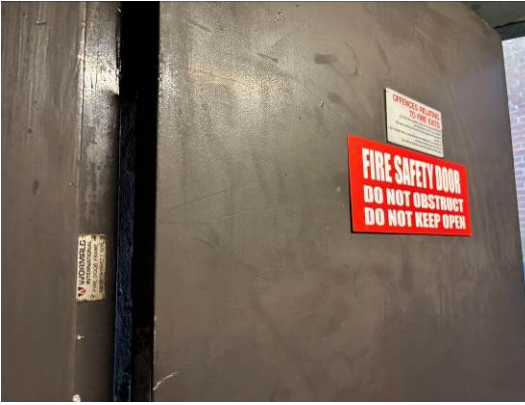
| Internal, basement 1, fire doors throughout | ACM (assumed) | Friable | Visual inspection – inaccessible | - | 5 x doors | Good / Maintenance only | Priority 3 - Low Risk Level | 3/10/2025 | Identification plaque lists date of manufacture as ‘unknown’.<br><br>See Section 6.1.2 for recommendations.<br><br>Remove during initial stage of demolition works | |

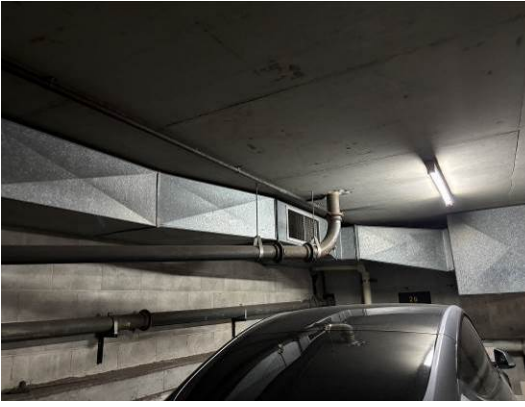
| Internal, basement, ducting throughout | SMF-lined insulation (assumed) | Sealed | Visual inspection - height restriction | - | ND | Good / Maintenance only | Priority 4 - Negligible Risk Level | 3/10/2025 | Remove during initial stage of demolition works | |

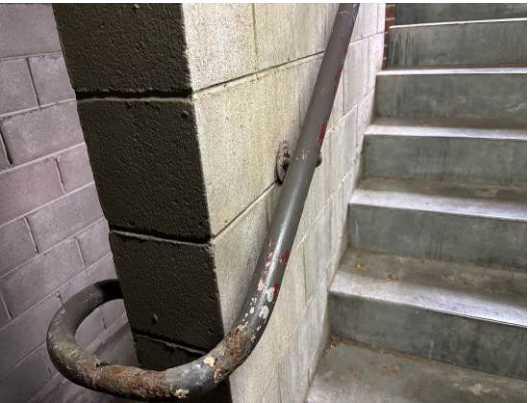
| Internal, basement 1, southern stairwell, hand rails | Grey LBP | Non-friable | LBP-25 | 0.14% w/w | Approximately 30m <sup>2</sup> | Fair / Occasional | Priority 3 - Low Risk Level | 3/10/2025 | Remove grossly peeling paint. Stabilise remaining membrane. Minimise abrasive works that will disturb paint during demolition. | |
