## **Preliminary Hazardous Materials Assessment Rev 1**

251-257 Maroubra Road and 133 & 135 Garden Street, Maroubra  
NSW

BWSLD Maroubra Pty Ltd

March 2026

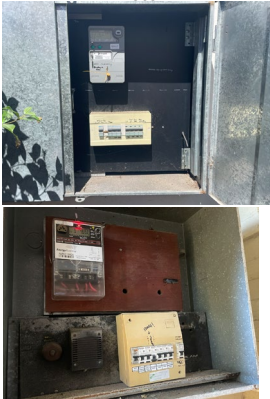
Photo 1

| Sample | Location | Surface | Material/<br>Condition | Result | Priority | Friable/ Non-<br>Friable | Accessibility | Comment | Approx<br>Qty |
|---|---|---|---|---|---|---|---|---|---|
| NS1 | All buildings/ residences. | Switch board<br>backing.<br>Auxiliary power<br>boards. | Bituminous panels.<br>Good Condition | All bituminous panels are<br>assumed to contain<br>asbestos. | Medium | Non-Friable | Not accessible<br>while power is<br>connected and<br>active. | Sample analysis to be undertaken prior to<br>any works commencing in this location | 9 |

NS1: All buildings/ residences.  
Bituminous switch board backing.  
Auxiliary power boards.  
Example Photos

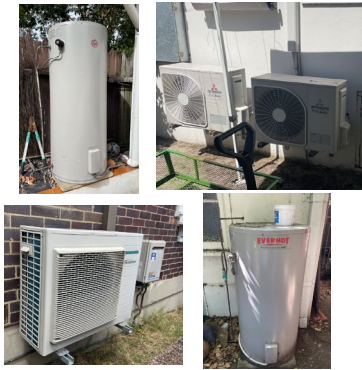
Photo 2

| Sample | Location | Surface | Material/<br>Condition | Result | Priority | Friable/ Non-<br>Friable | Accessibility | Comment | Approx<br>Qty |
|---|---|---|---|---|---|---|---|---|---|
| NS2 | All buildings/ residences. | Hot water / AC<br>systems & piping | Insulation.<br>Unknown | Material assessed and<br>SMF expected present<br>within systems. | Low | N/A | Not accessible<br>without<br>specialised<br>equipment. | Removal under controlled conditions<br>prior to renovation or demolition works | N/A |

NS2: All buildings/ residences.  
Hot water / AC systems & piping.  
Example Photos

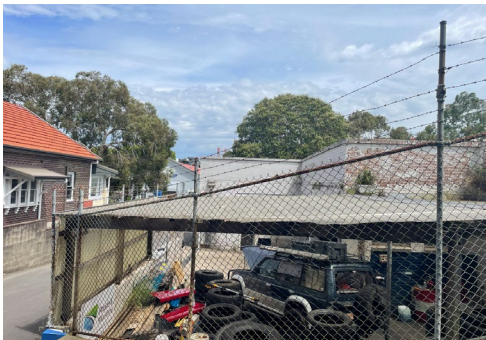
Photo 3

| NS6 | 251-253 Maroubra Road<br>ground floor exterior | Rear awning wall<br>and roof | Corrugated fibreglass<br>Fair Condition | <b>Material assessed and<br/>SMF expected present<br/>within systems.</b> | Low | N/A | Accessible | Removal under controlled conditions<br>prior to renovation or demolition works | 10m <sup>2</sup> |

NS6: 251-253 Maroubra Road ground floor exterior  
Rear awning wall and roof

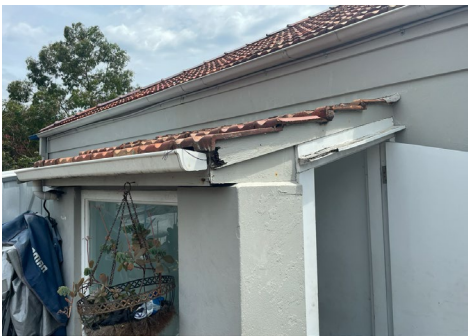
Photo 4

| NS7 | 251-253 Maroubra Road<br>second floor exterior | Extension wall<br>panels | Fibrous cement<br>sheeting.<br>Good condition | <b>Material assessed and<br/>expected to contain<br/>asbestos</b> | Medium | Non-Friable | Accessible | Licensed removal under controlled<br>conditions prior to renovation or<br>demolition works | <5m <sup>2</sup> |

NS7: 251-253 Maroubra Road second floor  
exterior  
Extension wall panels

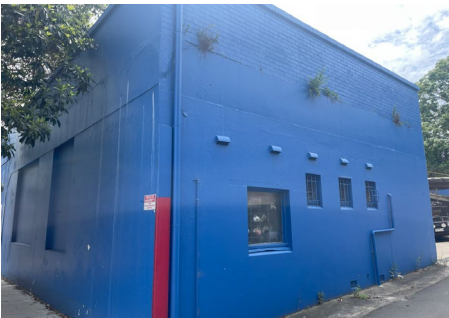
Photo 5

| LS3 | 251-253 Maroubra Road<br>ground floor exterior | External walls.<br>Blue/white | Paint multi layered<br>Fair condition | <b>Lead in paint detected.<br/>(&gt;0.1%)</b> | Medium | N/A | Accessible | <b>Management/ removal by a certified<br/>lead abatement contractor.</b> | N/A |

LS3: 251-253 Maroubra Road ground floor exterior  
External walls.

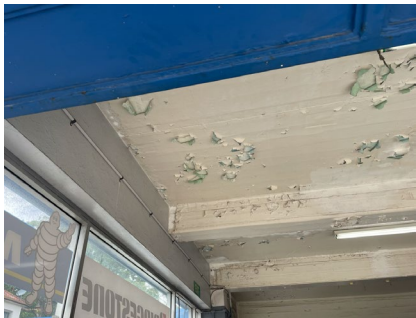
Photo 6

| NS8 | 251-253 Maroubra Road<br>ground floor interior | Internal ceiling.<br>Cream/green | Paint multi layered<br>Fair condition | <b>Material assessed and<br/>expected to contain<br/>&gt;0.1% lead in paint.</b> | Medium | N/A | Not accessible<br>without<br>equipment | <b>Management/ removal by a certified<br/>lead abatement contractor.</b> | N/A |

NS8: 251-253 Maroubra Road ground floor interior  
Internal ceiling.

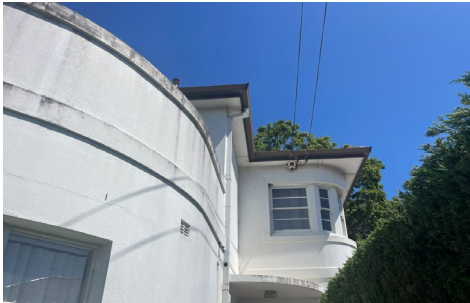
Photo 7

| NS9 | 255 Maroubra Road<br>Exterior | Eaves | Fibrous cement<br>sheeting.<br>Good condition | <b>Material assessed and<br/>expected to contain<br/>asbestos</b> | Medium | Non-Friable | Accessible | Confirmative destructive sampling once<br>building is vacant is advised. Licensed<br>removal under controlled conditions<br>prior to renovation or demolition works | 10m <sup>2</sup> |

NS9: 255 Maroubra Road Exterior  
Eaves

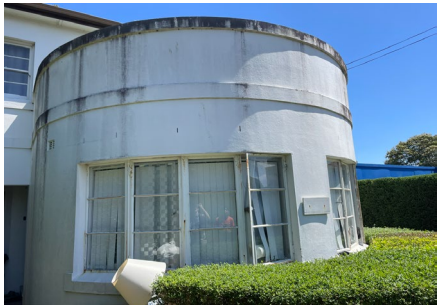
Photo 9

| LS4 | 255 Maroubra Road<br>Exterior | Metal windowsill.<br>White | Paint multi layered<br>Fair condition | <b>Lead in paint detected.<br/>(&gt;0.1%)</b> | Medium | N/A | Accessible | <b>Management/ removal by a certified<br/>lead abatement contractor.</b> | N/A |

LS4: 255 Maroubra Road Exterior  
Metal windowsill.

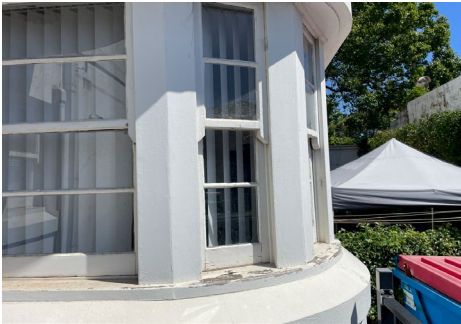
Photo 10

| LS5 | 255 Maroubra Road<br>Exterior | Wooden<br>windowsill.<br>White | Paint multi layered<br>Fair condition | <b>Lead in paint detected.<br/>(&gt;0.1%)</b> | Medium | N/A | Accessible | <b>Management/ removal by a certified<br/>lead abatement contractor.</b> | N/A |

LS5: 255 Maroubra Road Exterior  
Wooden windowsill.

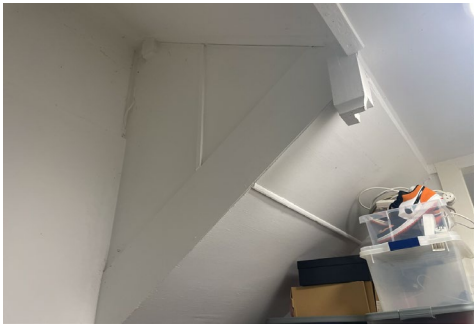
Photo 11

| NS11 | 255 Maroubra Road<br>Interior | Staircase base<br>panels | Fibrous cement<br>sheeting.<br>Good condition | <b>Material assessed and<br/>expected to contain<br/>asbestos</b> | Medium | Non-Friable | Accessible | Confirmative destructive sampling once<br>building is vacant is advised. Licensed<br>removal under controlled conditions<br>prior to renovation or demolition works | N/A |

NS11: 255 Maroubra Road Interior  
Staircase base panels

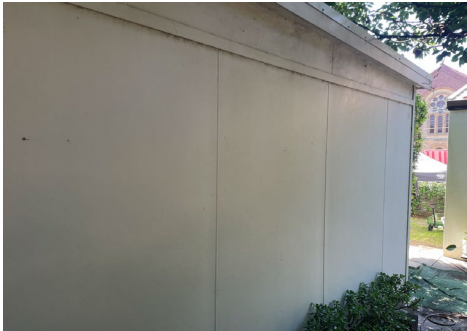
Photo 12

| AS1 | 255 Maroubra Road<br>Exterior garage | External garage<br>walls | Fibrous cement<br>sheeting.<br>Good condition | <b>No Asbestos Detected</b> | N/A | N/A | Accessible | No control action required | N/A |

AS1: 255 Maroubra Road Exterior garage  
External garage walls

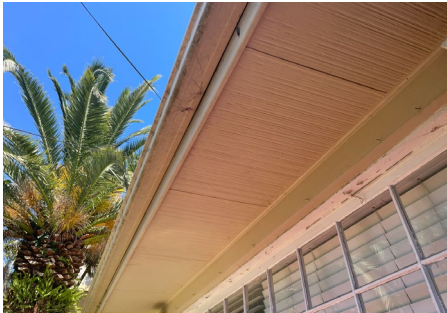
**Photo 14**

| NS14 | 257 Maroubra Road<br>Exterior | Veranda ceiling | Fibrous cement<br>sheeting.<br>Good condition | <b>Material assessed and<br/>expected to contain<br/>asbestos</b> | Medium | Non-Friable | Accessible | Confirmative destructive sampling once<br>building is vacant is advised. Licensed<br>removal under controlled conditions<br>prior to renovation or demolition works | 10m <sup>2</sup> |

NS14: 257 Maroubra Road Exterior  
Veranda ceiling

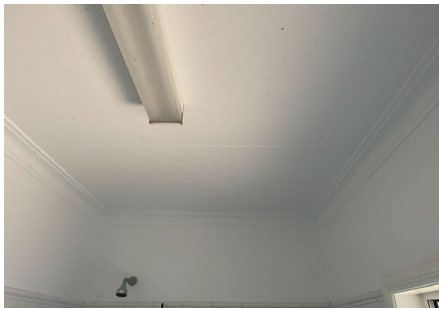
**Photo 15**

| NS15 | 257 Maroubra Road<br>Interior rear extension | Bathroom walls<br>and ceiling | Fibrous cement<br>sheeting.<br>Good condition | <b>Material assessed and<br/>expected to contain<br/>asbestos</b> | Medium | Non-Friable | Accessible | Confirmative destructive sampling once<br>building is vacant is advised. Licensed<br>removal under controlled conditions<br>prior to renovation or demolition works | 50m <sup>2</sup> |

NS15: 257 Maroubra Road  
Interior rear extension  
Bathroom walls and ceiling

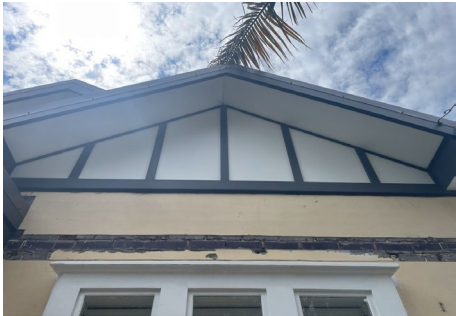
**Photo 18**

| NS17 | 133 Garden Street front exterior | Facia panels | Fibrous cement sheeting.<br>Good condition | <b>Material assessed and expected to contain asbestos</b> | Medium | Non-Friable | Accessible | Confirmative destructive sampling once building is vacant is advised. Licensed removal under controlled conditions prior to renovation or demolition works | 10m <sup>2</sup> |

NS17: 133 Garden Street front exterior  
Facia panels

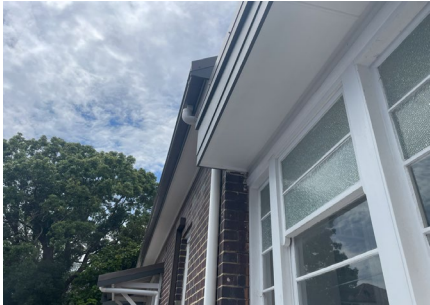
**Photo 19**

| NS18 | 133 Garden Street front exterior | eves | Fibrous cement sheeting.<br>Good condition | <b>Material assessed and expected to contain asbestos</b> | Medium | Non-Friable | Accessible | Confirmative destructive sampling once building is vacant is advised. Licensed removal under controlled conditions prior to renovation or demolition works | 10m <sup>2</sup> |

NS18: 133 Garden Street front exterior  
Eaves

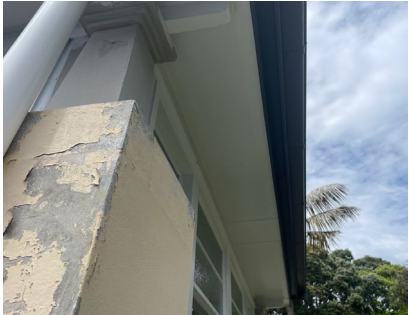
**Photo 20**

| NS19 | 133 Garden Street front veranda extension | Eves/ceiling | Fibrous cement sheeting.<br>Good condition | <b>Material assessed and expected to contain asbestos</b> | Medium | Non-Friable | Accessible | Confirmative destructive sampling once building is vacant is advised. Licensed removal under controlled conditions prior to renovation or demolition works | 20m <sup>2</sup> |

NS19: 133 Garden Street front veranda extension  
Eaves/ceiling

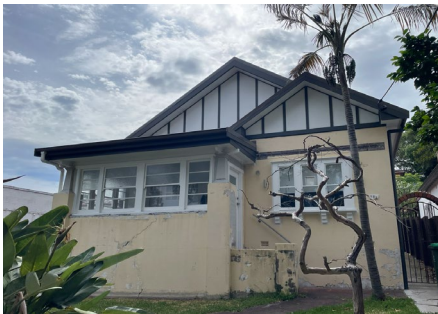
**Photo 21**

| LS2 | 133 Garden Street exterior | Exterior walls | Paint multi layered<br>Fair condition | <b>Lead in paint detected. (&gt;0.1%)</b> | Medium | N/A | Accessible | <b>Management/ removal by a certified lead abatement contractor.</b> | N/A |

LS2: 133 Garden Street exterior  
Exterior walls

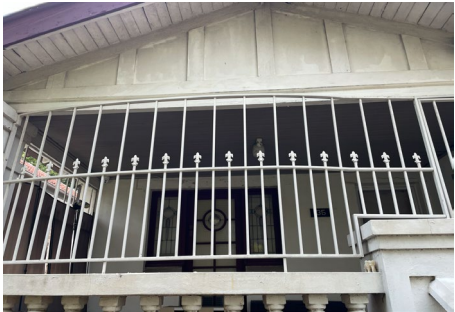
**Photo 22**

| NS20 | 135 Garden Street front exterior | Facia panels | Fibrous cement sheeting.<br>Good condition | Material assessed and expected to contain asbestos | Medium | Non-Friable | Accessible | Confirmative destructive sampling once building is vacant is advised. Licensed removal under controlled conditions prior to renovation or demolition works | 10m <sup>2</sup> |

NS20: 135 Garden Street front exterior  
Facia panels

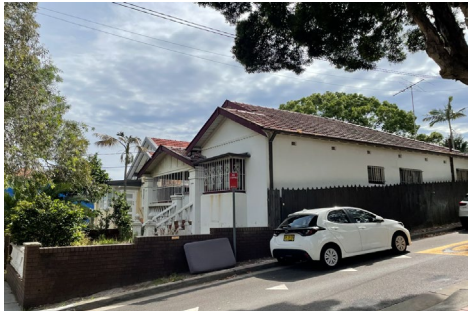
**Photo 23**

| LS1 | 135 Garden Street exterior | Exterior walls | Paint multi layered<br>Fair condition | Lead in paint detected. (>0.1%) | Medium | N/A | Accessible | Management/ removal by a certified lead abatement contractor. | N/A |

LS1: 135 Garden Street exterior  
Exterior walls
