Our ref: SYDEN233503-IA04

**Interim Audit Advice 04 – Completion of Stage 1 Remediation
Development of Parramatta West Public School, Crimea Street, Parramatta NSW**

Site Inspection at Completion of Remediation, 27 April 2020

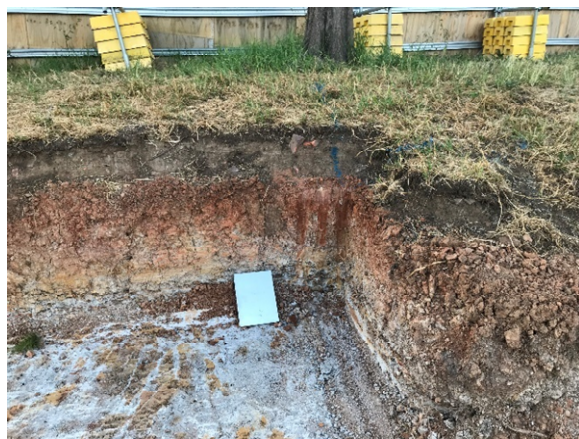
Photograph 1: Subsurface soil profile exposed by excavation in the northeast corner of the site. The soil layers shown from top to bottom are:

- Topsoil with grass
- Historical imported fill material (grey)
- Residual clayey soil derived from natural weathering of shale (red-orange grading to light brown)
- Weathered shale bedrock (light grey)

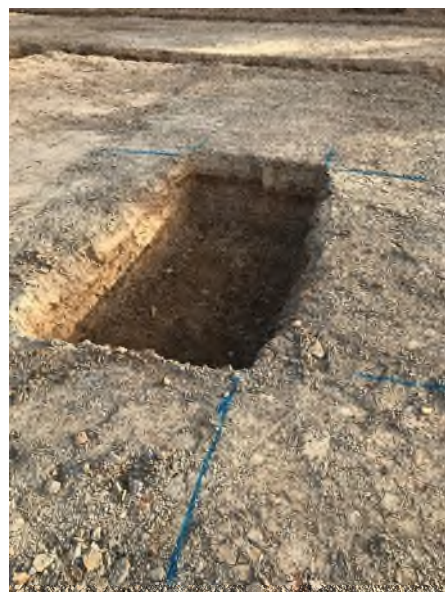
Photograph 5: Typical excavation for installation of a building footing.

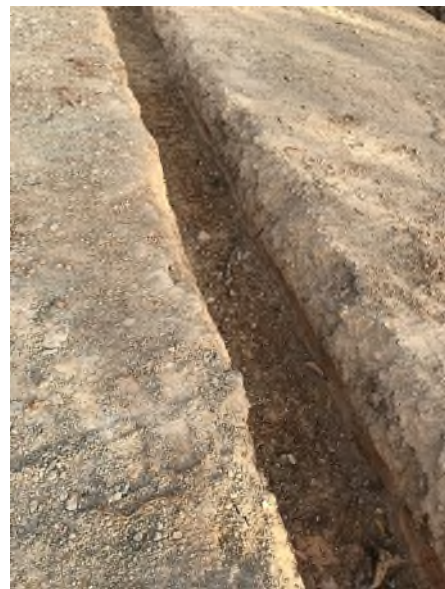
Photograph 6: Typical excavation for installation of a building edge beam.
