HAZARDOUS MATERIALS MANAGEMENT SURVEY HAZMAT SURVEYS - AUSTRAL

Job Number: JN00090
Issued date: 6 April 2018
Prepared for: Alliance Geotechnical
Client Address: 10 Welder Road, Seven Hills NSW 2147
Report by: Mr Alex Thompson, Mr Jim Batty & Mr Aaron McElvogue, Hazmat Consultants
Approved by: Faz Jalali
Total No of pages: 33

Hazmat Surveys - Austral

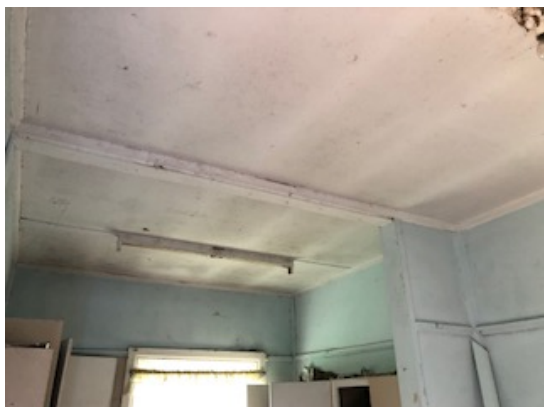
Photograph number: 1

Item Found: 135 Tenth Avenue - Kitchen walls & ceiling

- Medium risk asbestos was detected and identified in the Kitchen walls and shed walls to rear of the property. Remove prior to refurbishment if likely to be disturbed by a licensed asbestos removalist.

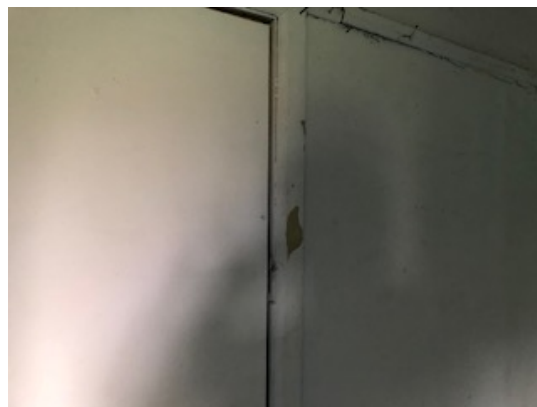
Photograph number: 2

Item Found: 135 Tenth Avenue - To walls, doors and door frames throughout

- Lead paint observed to walls, doors and door frames throughout the building. Some damage and flaking observed. Repair damage paint. Remove under controlled condition by a competent person if likely to be disturbed.

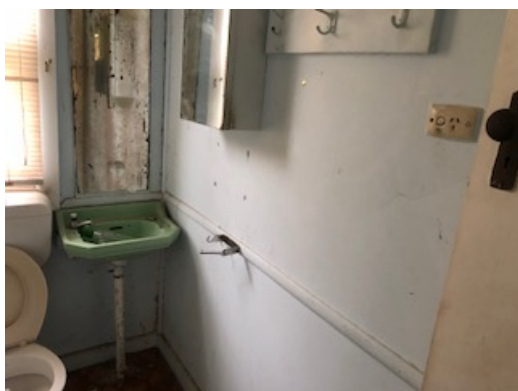
Photograph number: 3

Internal	Bathroom Walls	Refer to ASB 1	A, CH	30 m ²	NF	L	Remove under controlled conditions If disturbed as part of planned works

Item Found: 135 Tenth Avenue – Bathroom Wall

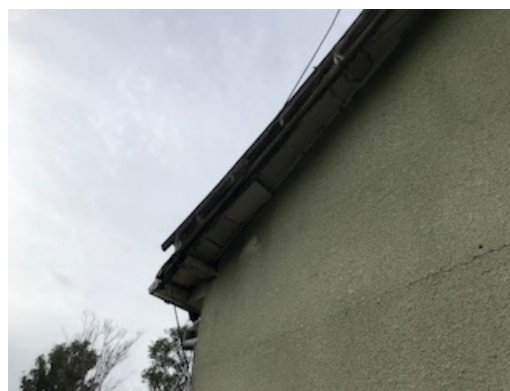
Photograph number: 4

Item Found: 135 Tenth Avenue – External Walls & Eaves

- High risk asbestos was detected and identified in the external wall linings and debris to the ground surrounding the house. It is recommended these are remediated by a Class B Removalist.

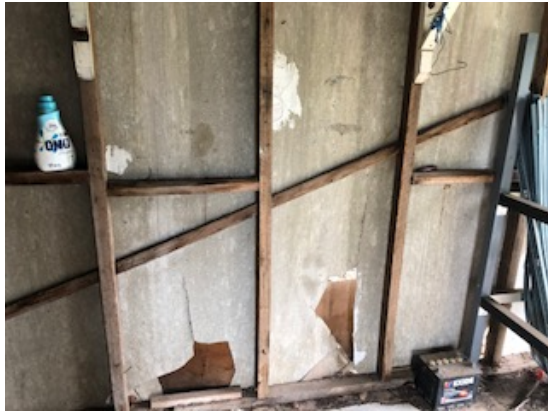
Photograph number: 5

Shed 1	Shed walls to rear of property	Refer to ASB 1	A, CH	50 m ²	NF	M	Observed to be in Poor Condition, Recommend removal by a Class B Removalists

Item Found: 135 Tenth Avenue – Shed walls to rear of property

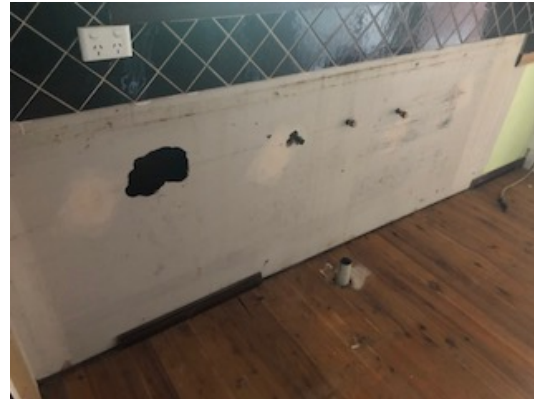
Photograph number: 6

Item Found: 160 Eleventh Avenue - Kitchen wall below window at rear of property

- Medium risk asbestos was detected and identified in the kitchen wall below window at rear of property. Remove prior to refurbishment if likely to be disturbed by a licensed asbestos removalist.

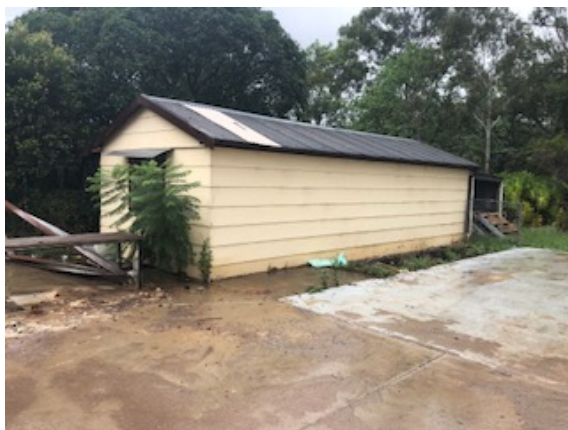
Photograph number: 7

Item Found: 160 Eleventh Avenue – Rear Shed

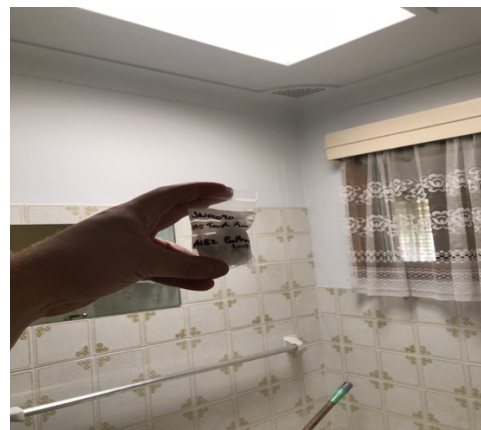
Photograph number: 8

Item Found: 145 Tenth Avenue – Internal Bathroom wall lining

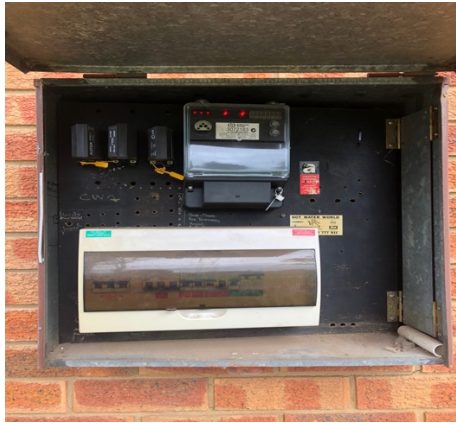
Photograph number: 9

Item Found: 145 Tenth Avenue – External Electrical board

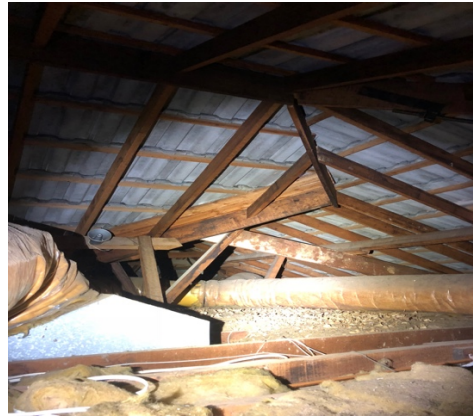
Photograph number: 10

Item Found: 145 Tenth Avenue – Internal roof cavity Insulation batts

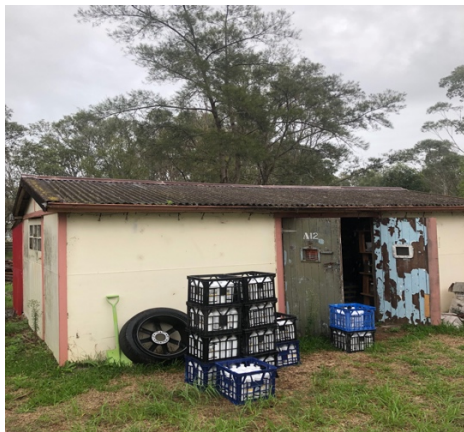
Photograph number: 11

Item Found: 155 tenth avenue – External Storage Shed
