FISH MARKET – EARLY WORKS

Hazardous Materials Management Plan

Infrastructure NSW
Pre-Demolition Hazardous Building Materials Survey

New Sydney Fish Markets,
1A to 1C Bridge Road,
Glebe, NSW

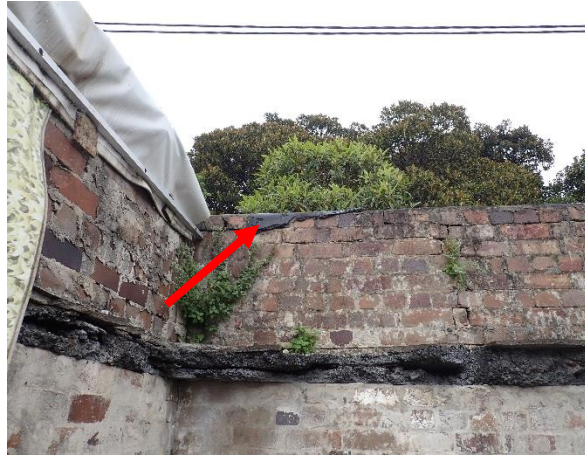
Photo 2: Lot 3, asbestos containing bituminous membrane on top of the brick wall adjacent the shower room

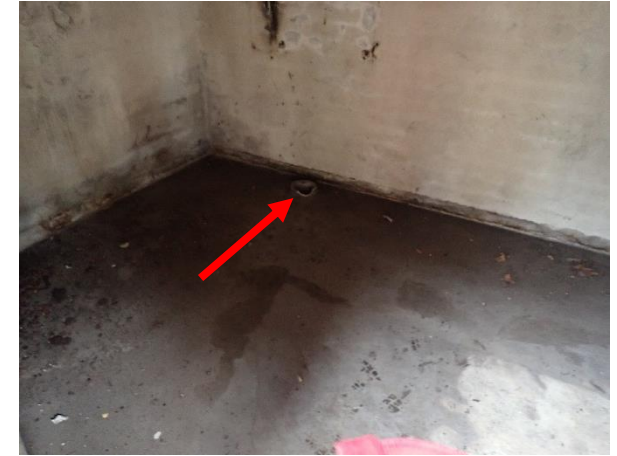
Photo 3: Lot 3, asbestos containing fibre cement conduit penetrating the floor of the store room

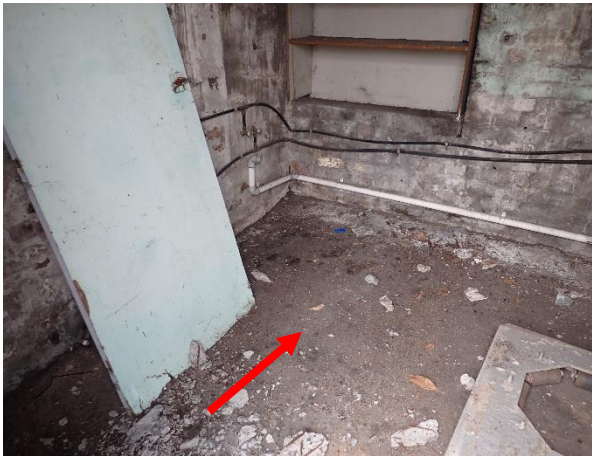
Photo 4: Lot 3, lead containing dust to the floor of the shower room

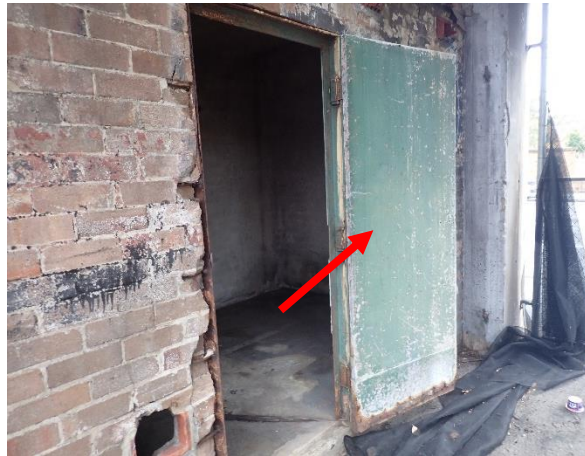
Photo 5: Lot 3, lead based green paint to the store room door

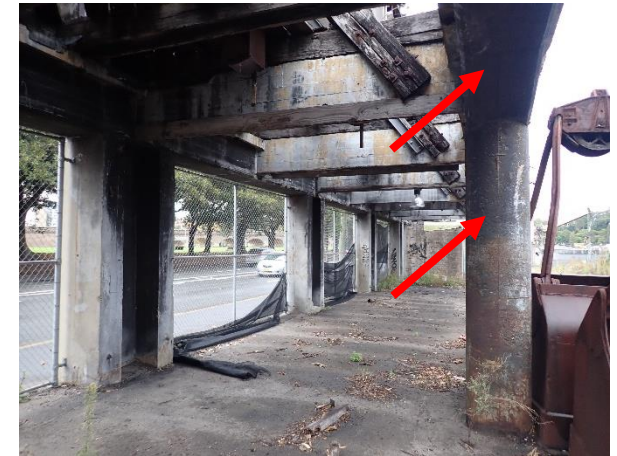
Photo 6: Lot 3, lead based black paint to the columns and beams of the timber structure

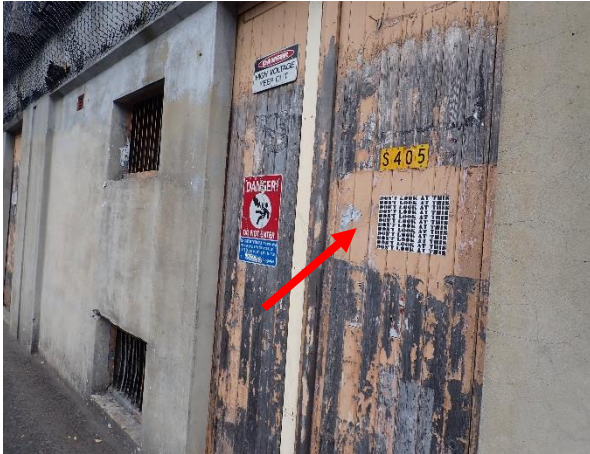
Photo 7: Lot 3, lead based yellow paint to the substation timber doors

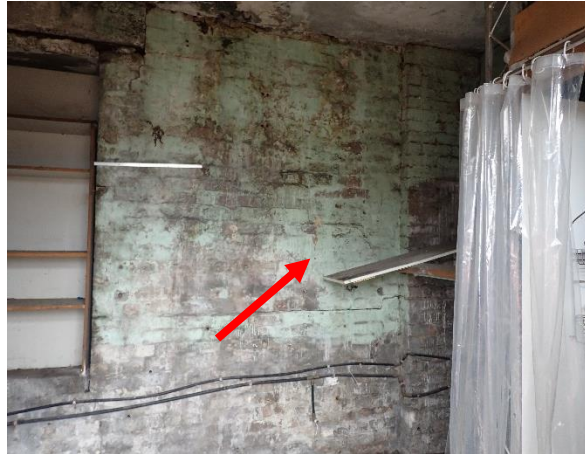
Photo 8: Lot 3, lead based blue paint to the shower room walls

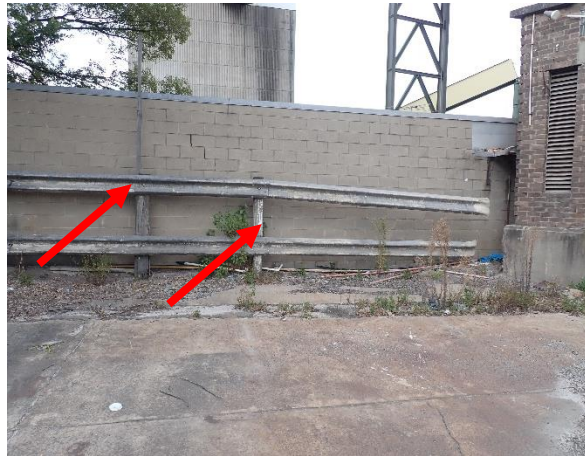
Photo 11: Lot 4, lead based white paint to the metal and timber barrier at the SW end of the lot

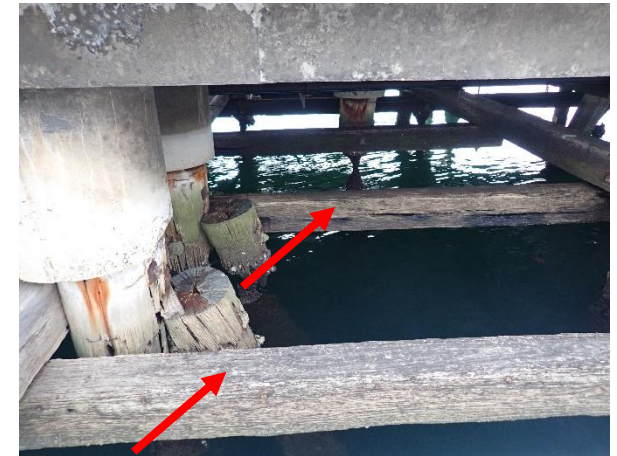
Photo 12: Lot 4, lead based white paint to the timber beams of the pier

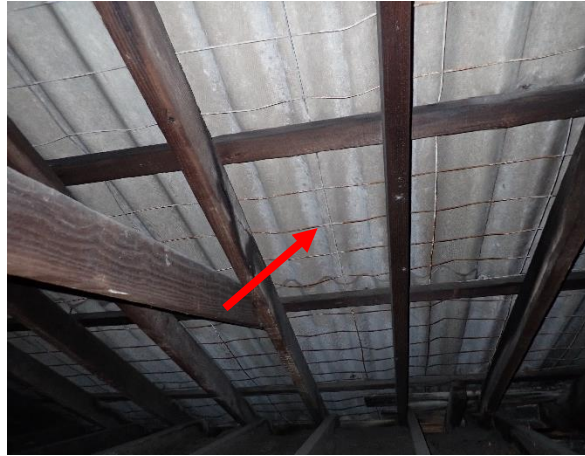
Photo 14: Lot 4, Old Office Building, asbestos containing corrugated fibre cement roof (internal surface)

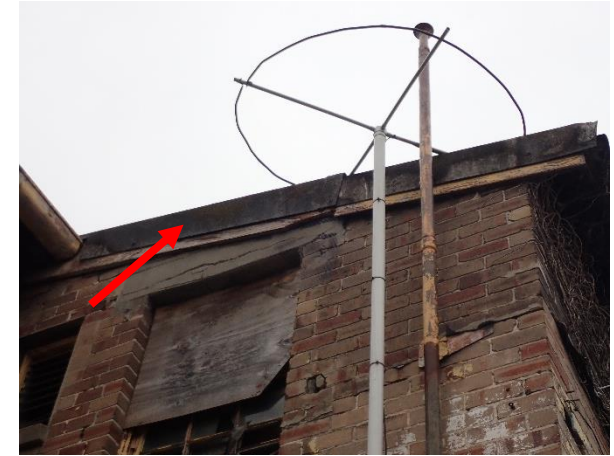
Photo 15: Lot 4, Old Office Building, asbestos containing fibre cement roof barge capping

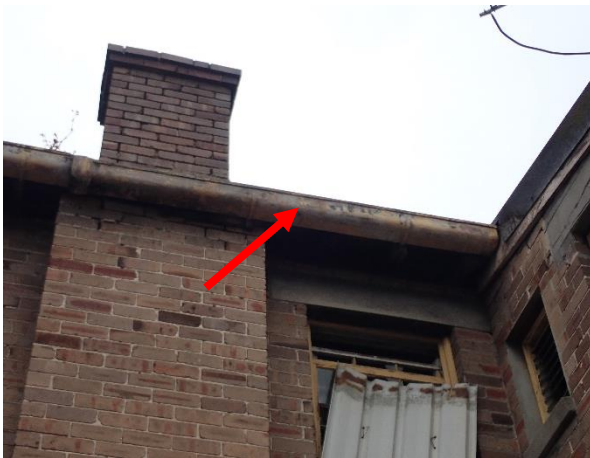
Photo 16: Lot 4, Old Office Building, assumed asbestos containing fibre cement gutters

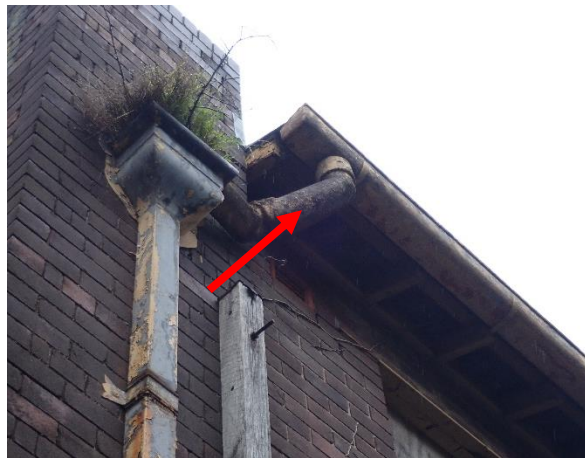
Photo 17: Lot 4, Old Office Building, assumed asbestos containing fibre cement downpipe

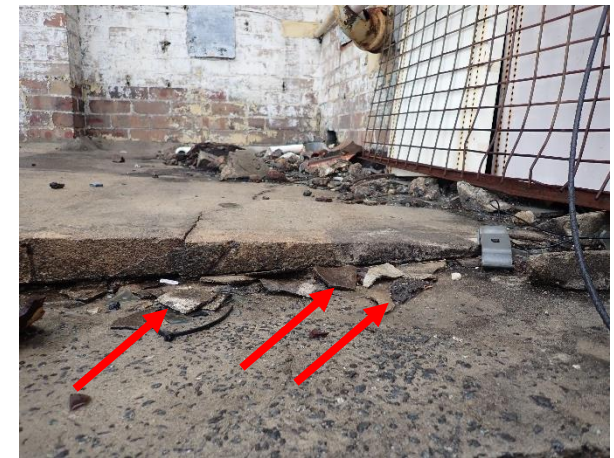
Photo 18: Lot 4, Old Office Building, asbestos containing mixed fibre cement debris on top of the concrete roof to the north store room

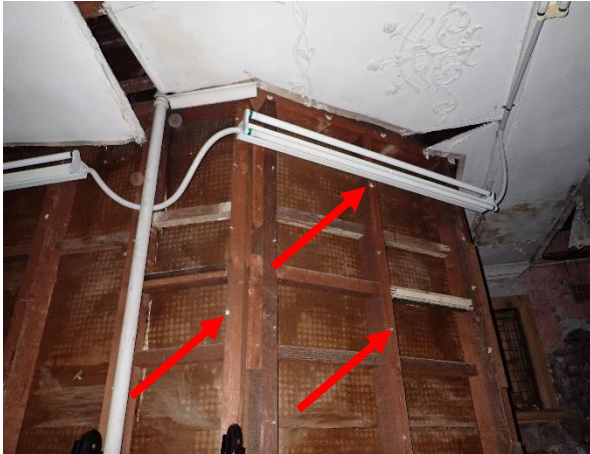
Photo 19: Lot 4, Old Office Building, asbestos containing fibre cement fragments to the timber studs and behind nails on the south wall of the main room (ground floor)

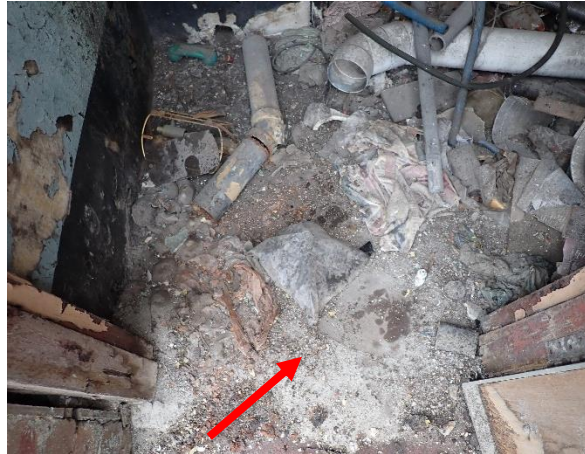
Photo 20: Lot 4, Old Office Building, asbestos containing and lead containing settled dust to the floor of the ground floor toilets

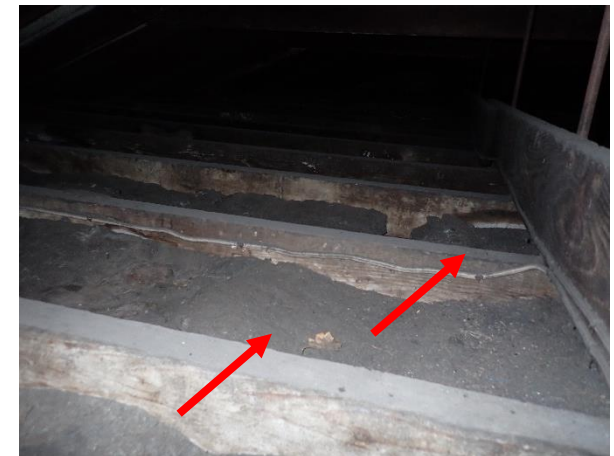
Photo 24: Lot 4, Old Office Building, lead containing dust and SMF insulation throughout the roof void

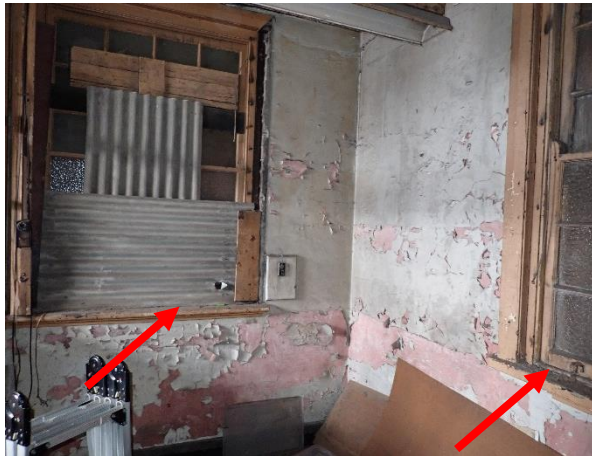
Photo 25: Lot 4, Old Office Building, lead containing dust to the ground floor window sills

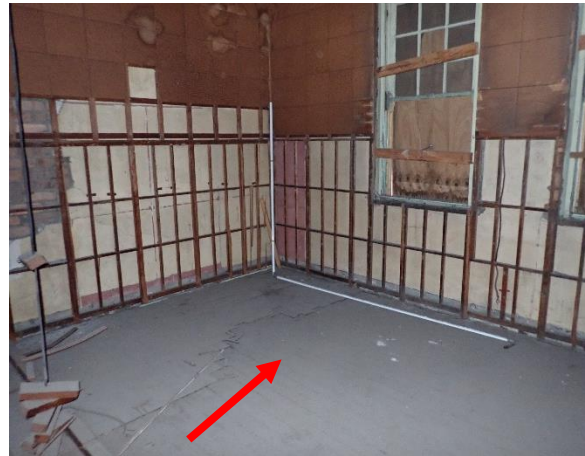
Photo 26: Lot 4, Old Office Building, lead containing dust throughout the first floor

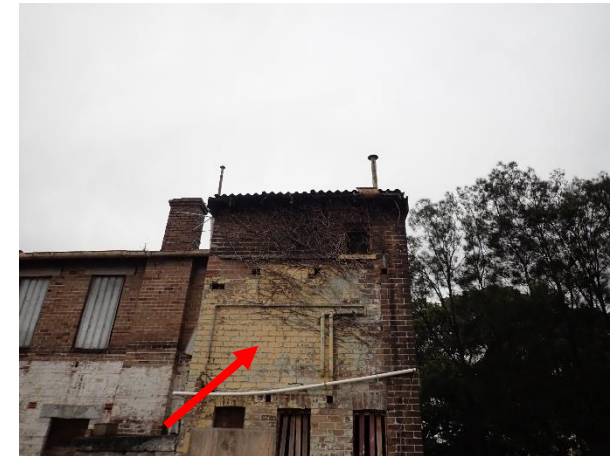
Photo 27: Lot 4, Old Office Building, lead based cream paint to the external north wall

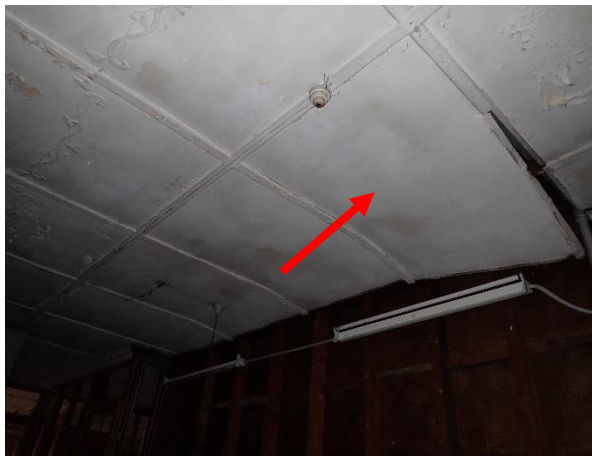
Photo 28: Lot 4, Old Office Building, lead based white paint to the ground floor ceiling

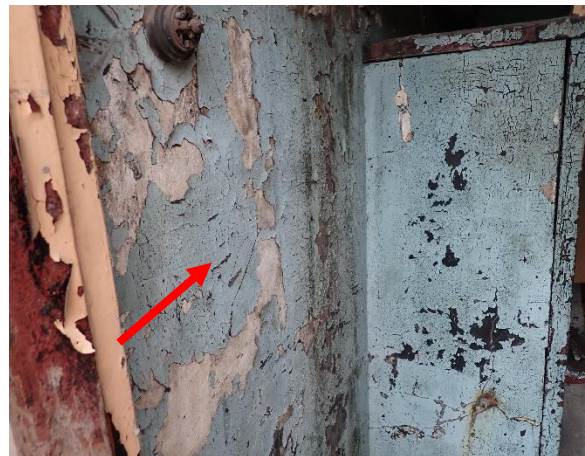
Photo 29: Lot 4, Old Office Building, lead based blue paint to the ground floor toilet walls

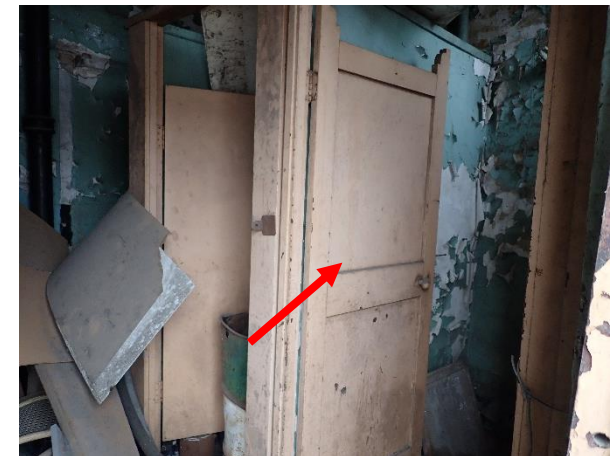
Photo 30: Lot 4, Old Office Building, lead based yellow/orange paint to the ground floor toilet timber doors and frames

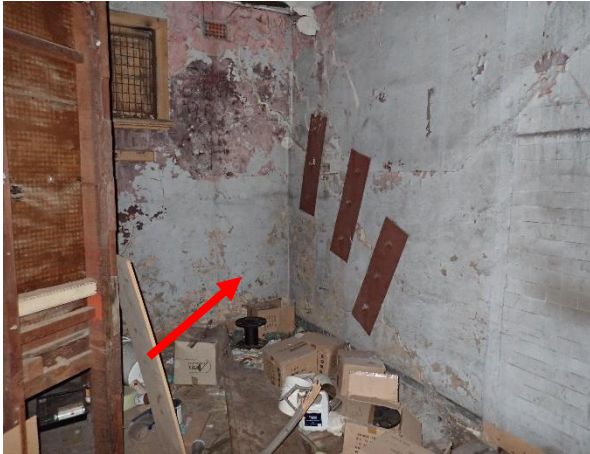
Photo 31: Lot 4, Old Office Building, lead based white paint to the ground floor internal brick walls

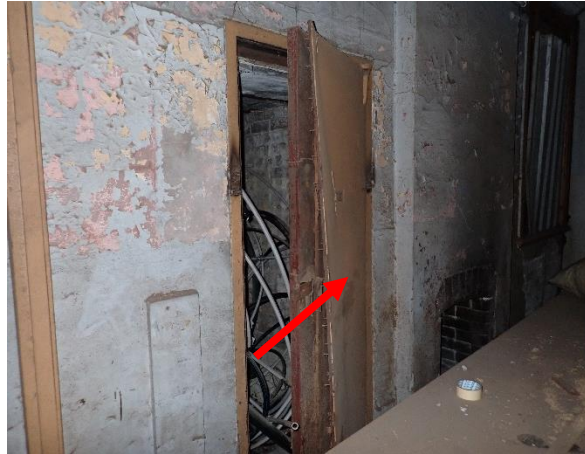
Photo 32: Lot 4, Old Office Building, lead based brown paint to the north store room door

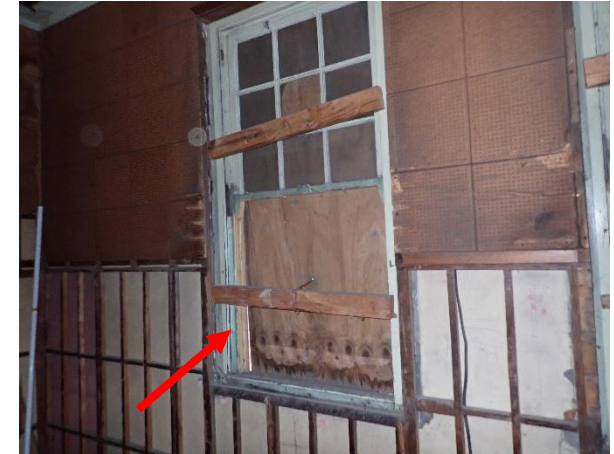
Photo 33: Lot 4, Old Office Building, lead based green paint for the first floor east room windows

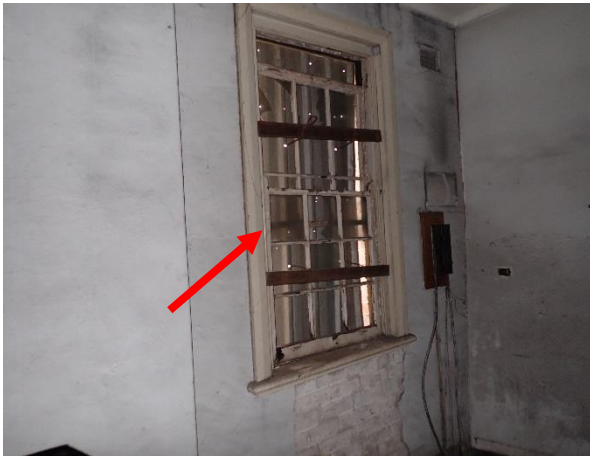
Photo 34: Lot 4, Old Office Building, lead based white paint to the first floor main room windows

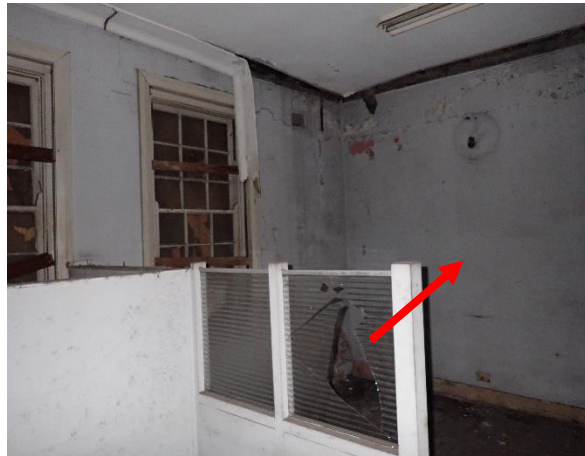
Photo 35: Lot 4, Old Office Building, lead based blue paint to the first floor main room walls

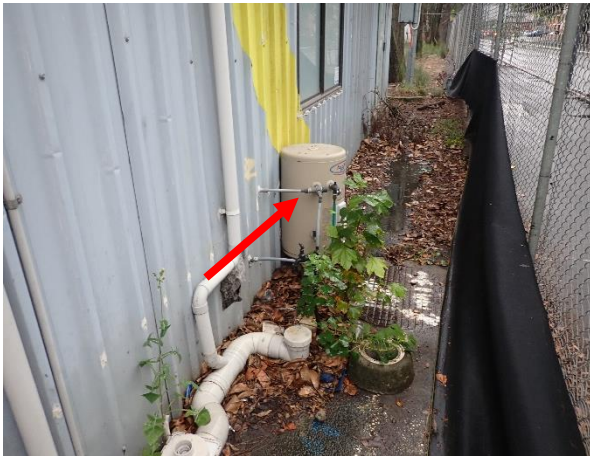
Photo 40: Lot 4, Site Office, assumed SMF insulation to the hot water system

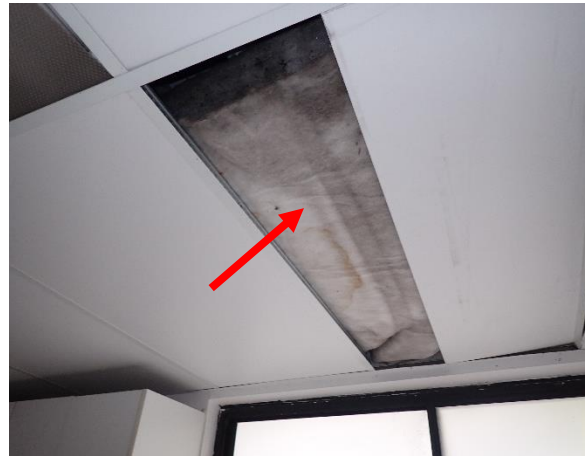
Photo 41: Lot 4, Site Office, assumed SMF insulation throughout the roof void
