## COMPLIANCE HAZARDOUS MATERIAL INSPECTION AND RISK ASSESSMENT

JULY 2023

J053229

40 Stewart St  
Ermington NSW (P027)  
2115

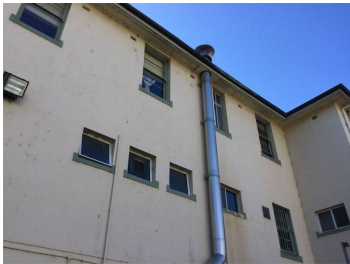
| Location | P027-H01 - External - Ground Level - All Areas - Eaves - Throughout - Fibre Cement Sheeting | | | | |
| Hazard Type | Asbestos | Material Assessment | | Disturbance Assessment | |

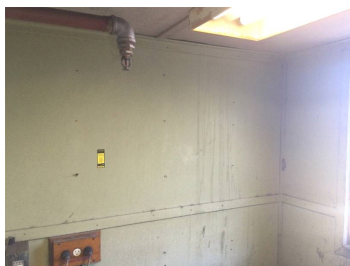
| Location | | P027-H01 - 2nd Floor - Ceiling Space - Wall Lining - Old Comms Room - Throughout - Fibre Cement Sheeting | | | | | | | | |
| Hazard Type | | Asbestos | | Material Assessment | | | Disturbance Assessment | | | |
| | | | | Priority Score | | 9 | Low | | | |

| Item No. | Hazard Type | Item Location and Description | Recommendations |
|---|---|---|---|
| Item 6 | Asbestos | P027-H01, 2nd Floor, Ceiling Space, Wall Lining - Old Comms Room - Throughout, Fibre Cement Sheeting | Encapsulate / Repair & Manage In Situ |

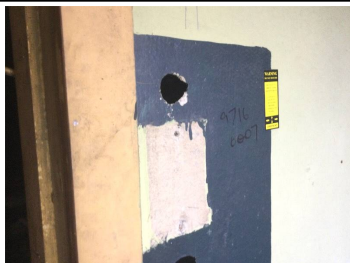
| Location | | P027-H01 - 2nd Floor - Ceiling Space - Ceiling Lining - Old Comms Room - Throughout - Fibre Cement Sheeting | | | |
| Hazard Type | | Asbestos | | Material Assessment | |

| Item No. | Hazard Type | Item Location and Description | Recommendations |
|---|---|---|---|
| Item 7 | Asbestos | P027-H01, 2nd Floor, Ceiling Space, Ceiling Lining - Old Comms Room - Throughout , Fibre Cement Sheeting | Encapsulate / Repair & Manage In Situ |

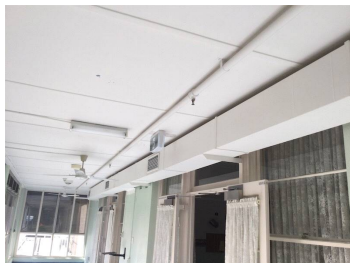
| Location | | P027-H01 - 2nd Floor - Western Verandah - Adjacent Dining - Ceiling Lining - Throughout - Fibre Cement Sheeting | | | | | | |
| Hazard Type | | Asbestos | | Material Assessment | | | Disturbance Assessment | |

| Item No. | Hazard Type | Item Location and Description | Recommendations |
|---|---|---|---|
| Item 25 | Asbestos | P027-H01, 2nd Floor, Western Verandah - Adjacent Dining, Ceiling Lining - Throughout, Fibre Cement Sheeting | Encapsulate / Repair & Manage In Situ |

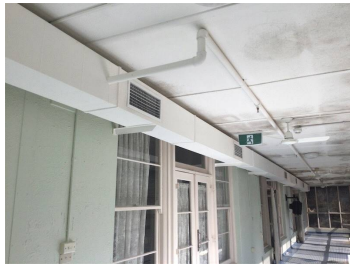
| Location | | P027-H01 - 2nd Floor - Western Verandah - Adjacent Dining - Ceiling Lining - Central - Paint Systems - White | | | | |
| Hazard Type | | Lead Paint | Material Assessment | | Disturbance Assessment | |

| Item No. | Hazard Type | Item Location and Description | Recommendations |
|---|---|---|---|
| Item 27 | Lead Paint | P027-H01, 2nd Floor, Western Verandah - Adjacent Dining, Ceiling Lining - Central , Paint Systems - White (1.6% w/w) | Encapsulate / Repair & Manage In Situ |

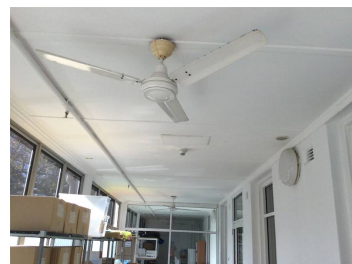
| Location | P027-H01 - 2nd Floor - Training Centre - Verandah - Ceiling Lining - Central - Paint Systems - White | | |
| Hazard Type | Lead Paint | Material Assessment | Disturbance Assessment |

| Item No. | Hazard Type | Item Location and Description | Recommendations |
|---|---|---|---|
| Item 95 | Lead Paint | P027-H01, 2nd Floor, Training Centre - Verandah, Ceiling Lining - Central , Paint Systems - White (1.6% w/w) | Encapsulate / Repair & Manage In Situ |

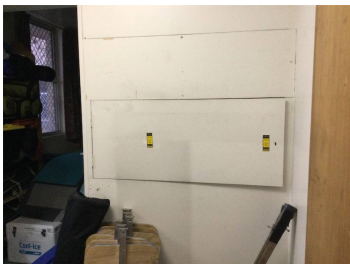
| Location P027-H01 - 1st Floor - Therapy Unit - Occ Therapy - Riser Cupboard - Pipework - throughout - Lagging - (Not Sampled to prevent disturbance) | | | | |
| Hazard Type | Asbestos | Material Assessment | Disturbance Assessment | |
| | | | | Medium |

| Item No. | Hazard Type | Item Location and Description | Recommendations |
|---|---|---|---|
| Item 54 | Asbestos | P027-H01, 1st Floor, Therapy Unit - Occ Therapy - Riser Cupboard, Pipework - throughout, Lagging - (Not Sampled to prevent disturbance) | Restrict Access & Remove Under Suitably Controlled Conditions |

- | Immediately restrict access to riser cupboard within 1<sup>st</sup> Floor (possibly ground floor on site plans) – Therapy unit – Occ Therapy – Riser Cupboard - Pipework lagging suspected of containing friable asbestos is in poor condition. Organise removal through Class A Licenced Asbestos Removal Contractor (LARC) or repair and encapsulate.

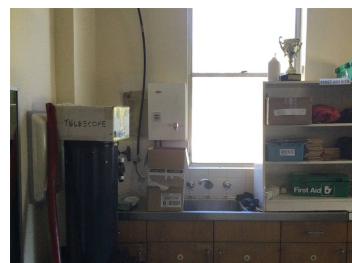
| Location | | P027-H01 - 1st Floor - Therapy Unit - Kitchen - Access hatch - North - Fibre Cement Sheeting | | | |
| | | Priority Score | 10 | Low | |

| Item No. | Hazard Type | Item Location and Description | Recommendations |
|---|---|---|---|
| Item 58 | Asbestos | P027-H01, 1st Floor, Therapy Unit - Kitchen, Access hatch - North, Fibre Cement Sheeting | Remove Under Suitably Controlled Conditions |

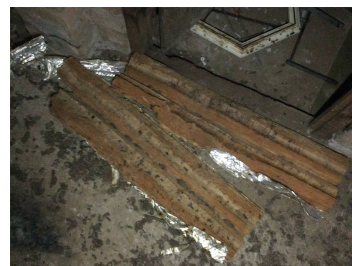
| Location P027-H01 - Subfloor - Pbax - Packers - Between Brickwork - Throughout - Fibre Cement Sheeting | | | |
| | | Priority Score | 6 Very Low |

- | It is recommended to signpost all subfloor areas at the access points to warn of asbestos-containing materials within (such as packers to piers).
- | It is recommended keep access restricted to the ceiling cavity about the Main kitchen - This area is suspected of containing non-friable asbestos-cement sheeting debris.

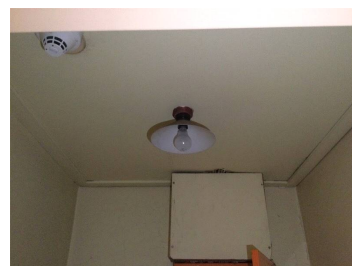
| Location P027-H01 - Ground Floor - Electrical Switchboard - Ceiling Lining - Throughout - Fibre Cement Sheeting | | | |
| | | Priority Score | 8 Very Low |

| Item No. | Hazard Type | Item Location and Description | Recommendations |
|---|---|---|---|
| Item 71 | Asbestos | P027-H01, Ground Floor, Electrical Switchboard, | Encapsulate / Repair & Manage In Situ |

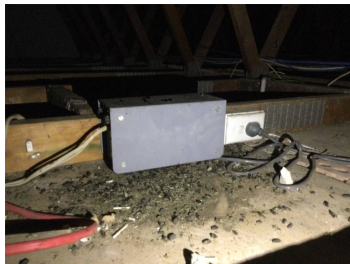
| Location | | P027-S01 - Ground Floor - Ceiling Space - North-Eastern Room, on top of ceiling - throughout - Lead dust (1,100mg/kg) | | |
| Hazard Type | Lead Dust | Material Assessment | Disturbance Assessment | |

| Item 85 | Lead Dust | P027-S01, Ground Floor, Ceiling Space, North-Eastern Room, on top of ceiling - throughout, Lead dust (1,100mg/kg) | Remove Under Suitably Controlled Conditions 1100mg/kg |

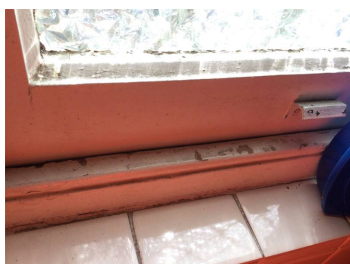
| Location | | P027-S01 - Ground Floor - North Bathroom - Window frame - West - Paint System, white (3.5% w/w) | | |
| Hazard Type | Lead Paint | Material Assessment | Disturbance Assessment | |

| Item 87 | Lead Paint | P027-S01, Ground Floor, North Bathroom, Window frame - West, Paint System, white (3.5% w/w) | Encapsulate / Repair & Manage In Situ 3.5% w/w |
