### ASN Structural Timbers and related steel collars stored at White Bay

Based on a visual inspection on 3 March 2016, the following items are located at White Bay Power Station as follows:

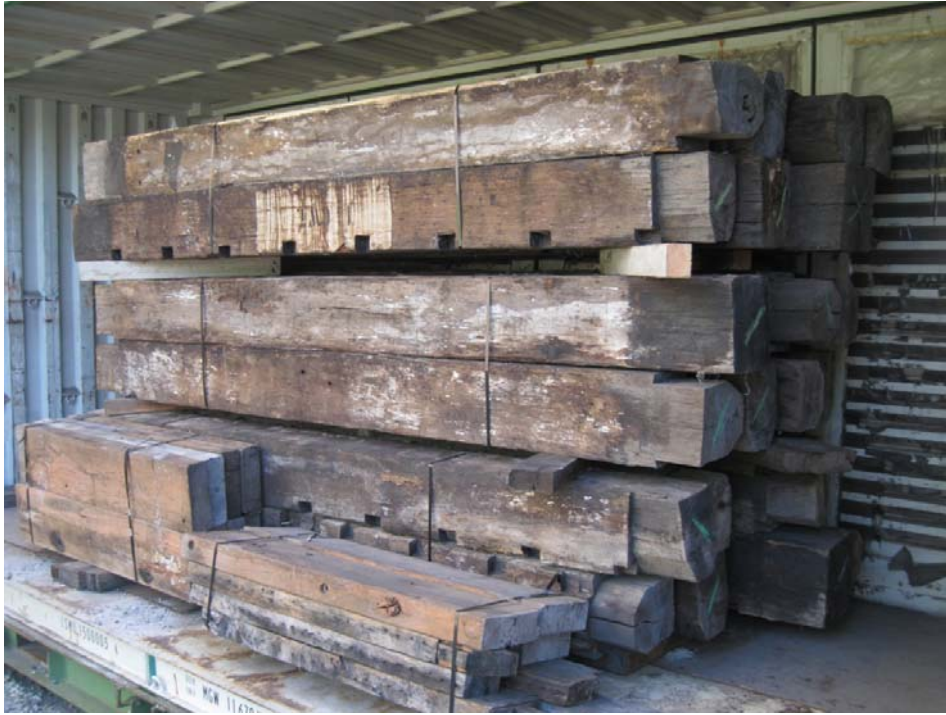
1. Timber beams stored in NW container. The timber beams are a combination of shaped and square ends.

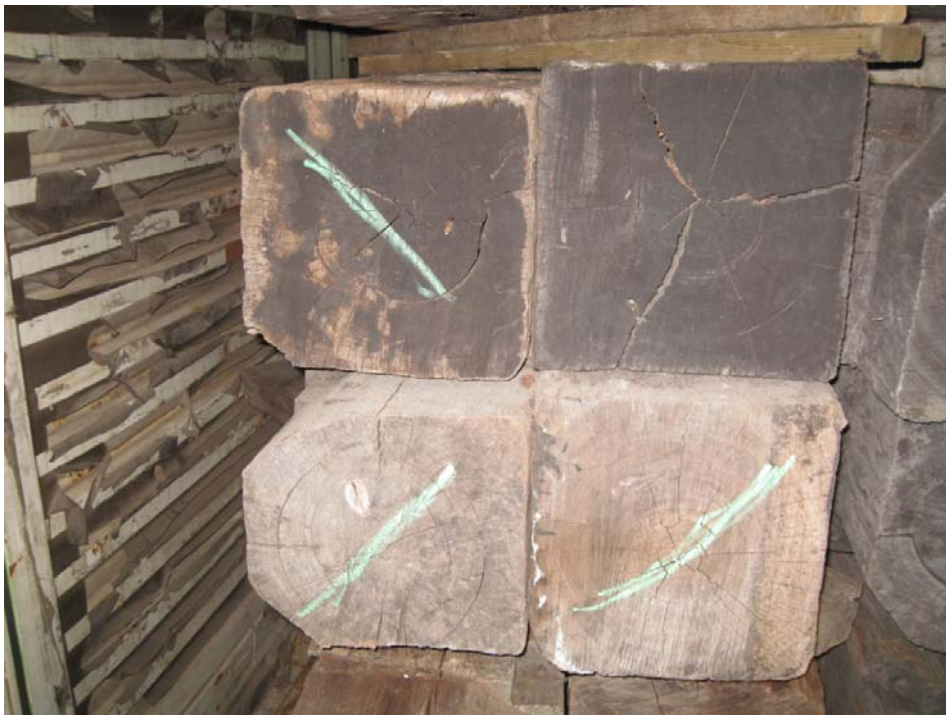
2. The shaped ends will be constructed into the steel collars and the square ends into the side walls of the building. Beams shaped at both ends are noted above as Centre Beams, and beams shaped at one end but square at the other end are noted above as End Beams.

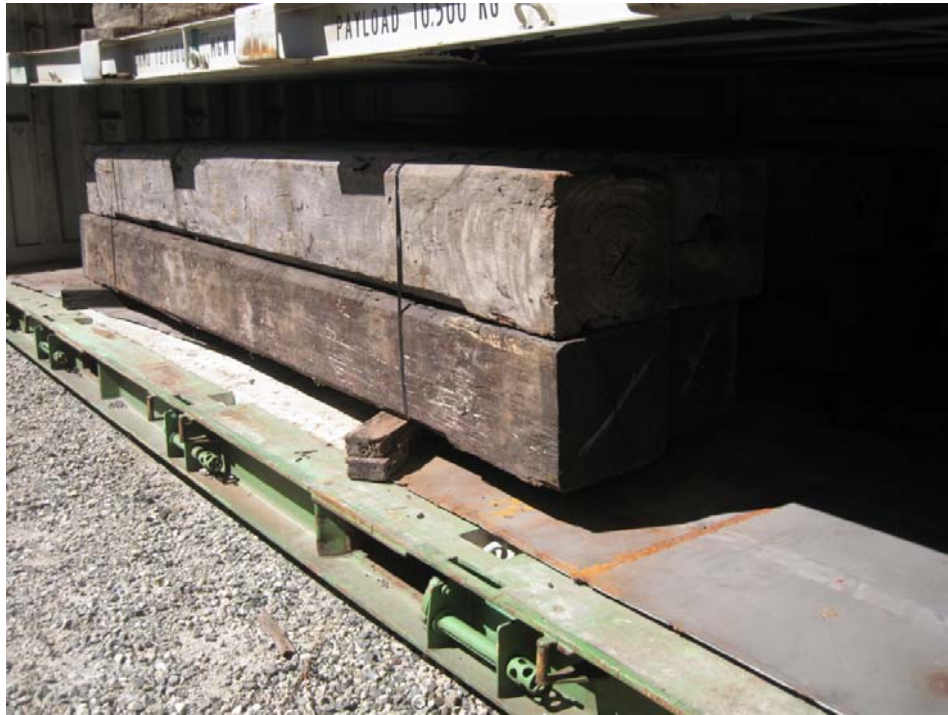
3. Timber columns stored in SW container on lower shelf. Upper shelf is non related items.

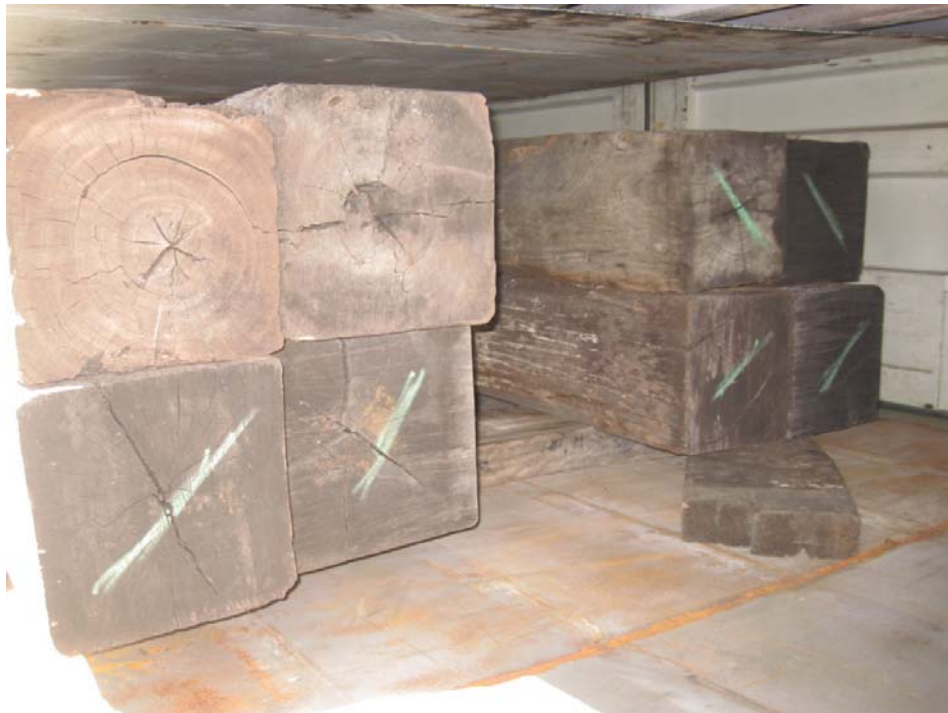
4. Timber columns stored in SW container in two packs of four columns.

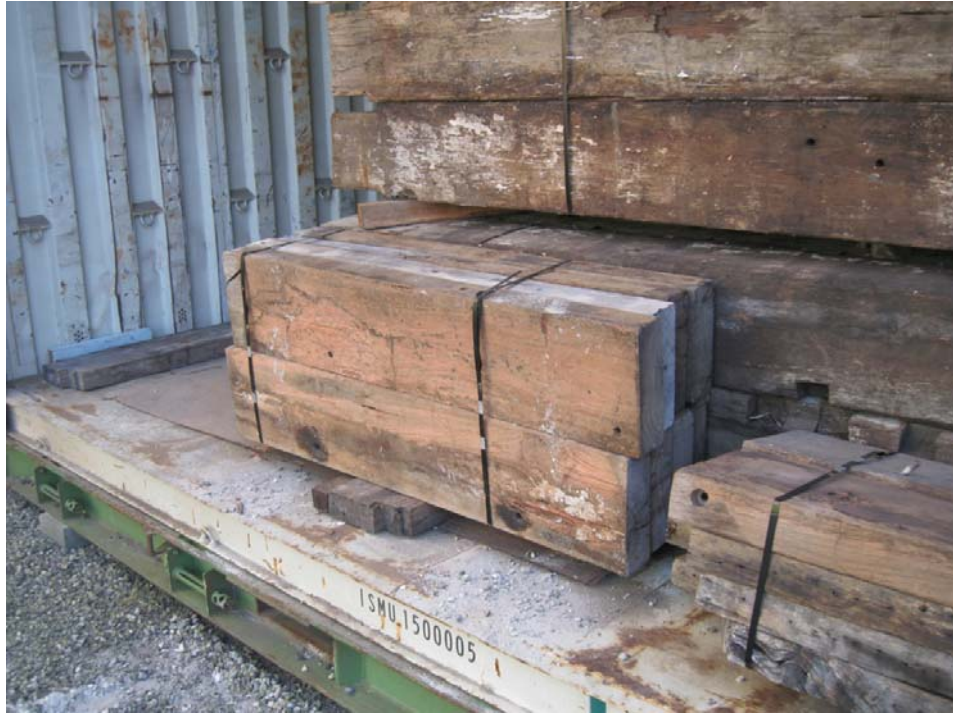
5. Suspected sections of timber joists cut into shorter segments. Stored in NW container.

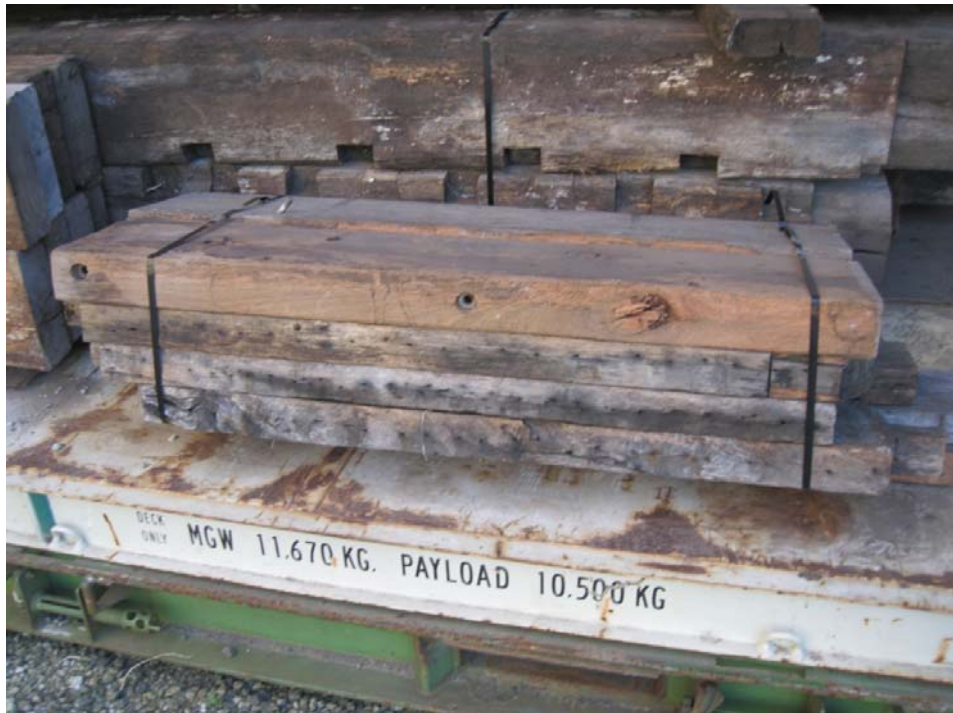
6. 5. Suspected sections of timber joists cut into shorter segments. Stored in NW container.

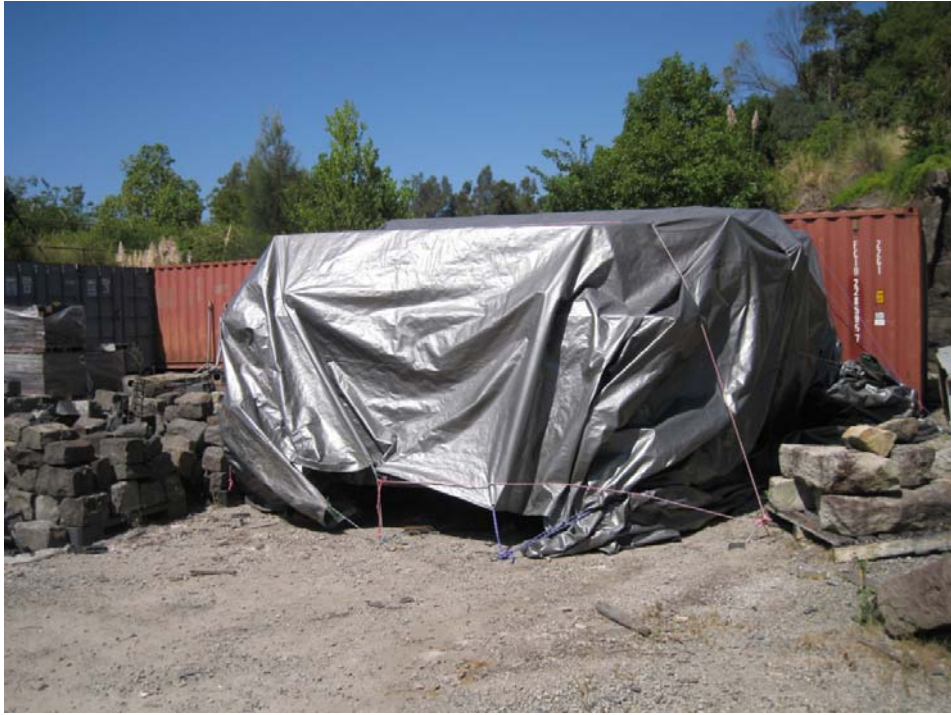
7. Tarpaulin covering packs of timber joists at southern end of building yard.

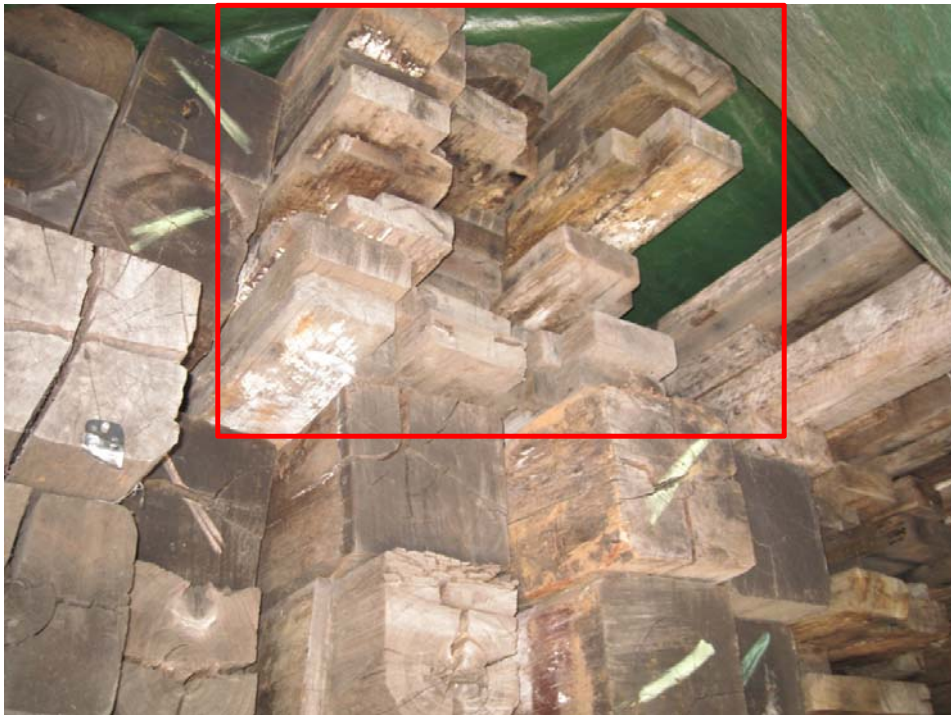
8. Packs of timber joists (shown in red box) located under tarpaulin. The other larger section timbers shown are additional beams or columns of various condition as noted in the summary above.

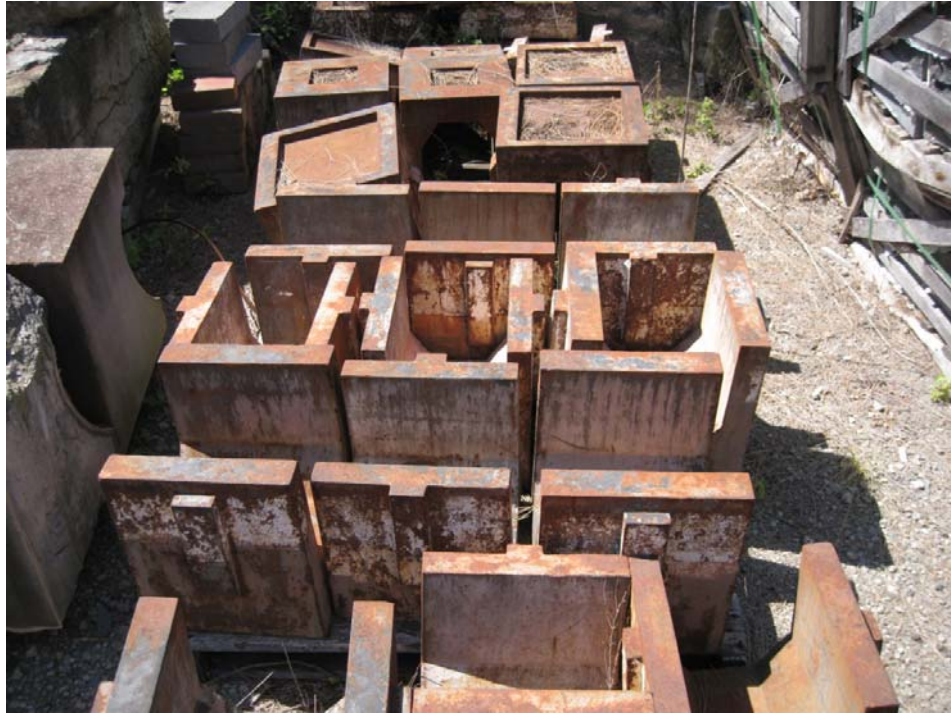
- 36 top pieces and 34 bottom pieces
- All generally good condition. Some treatment to surface rust required.

9. Steel collars located towards eastern boundary of southern building yard. The steel collars are in two pieces: bottom pieces and top pieces. Photo (9) shows top pieces only – in the lower part of the photo the pieces are stored upside-down, in the upper part of the photo the pieces are stored upright.

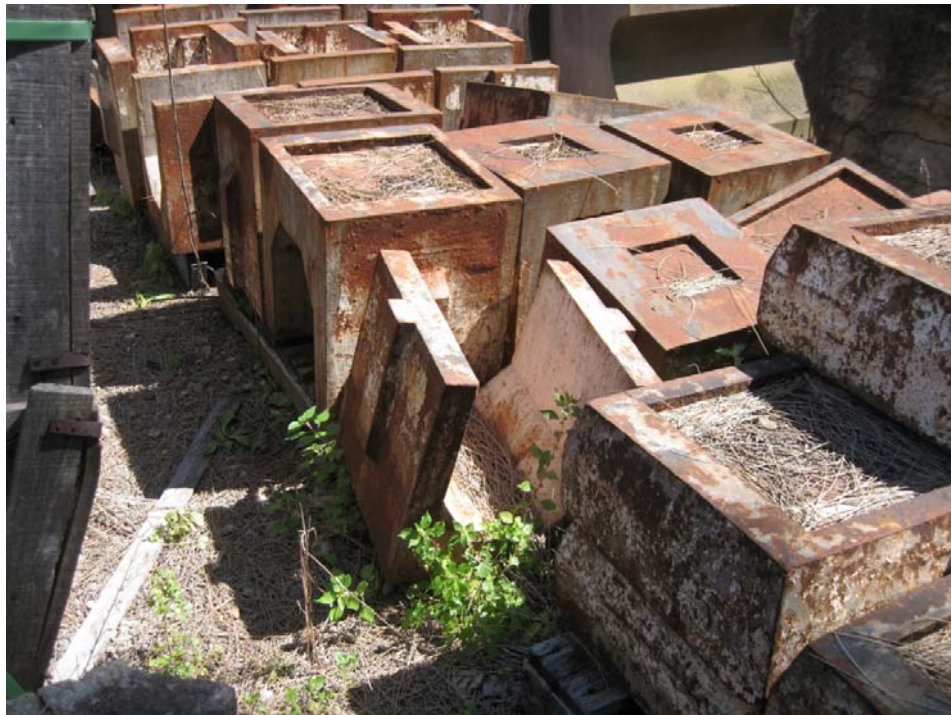
10. Steel collar top pieces (centre of photograph). Note the various scale of the collars and the indents in the top surface. The smaller indents indicate the collars to the upper structural level of the building.

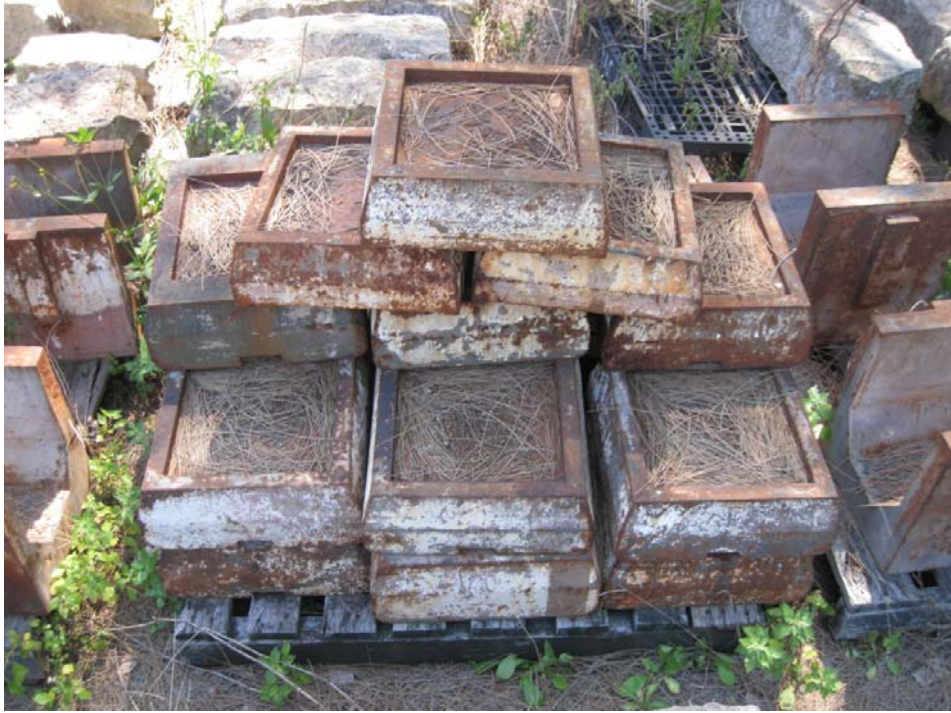
11. Steel collar bottom pieces. Note: stacked upside-down.

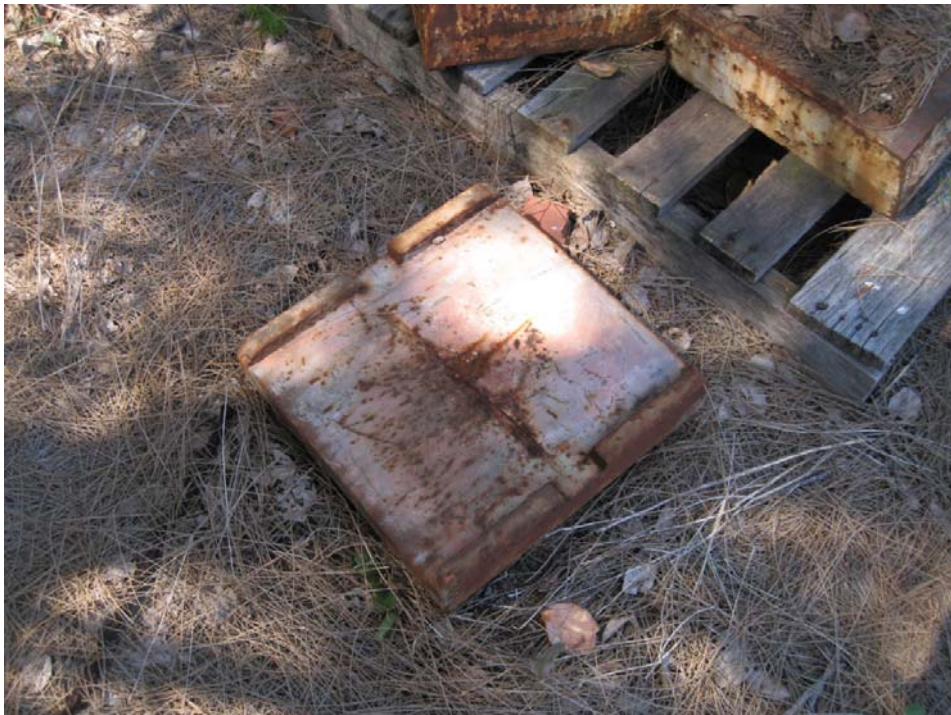
12. Steel collar bottom piece shown upright.

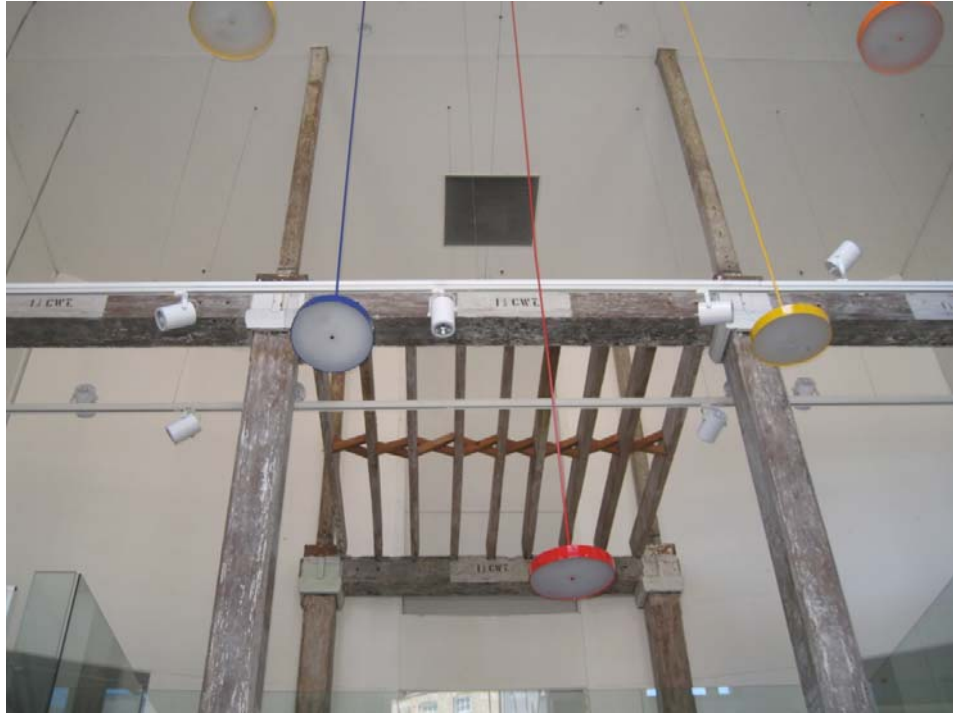
13. Example timber construction remaining insitu at 5 Hickson Road, The Rocks. Level 3 and 4.

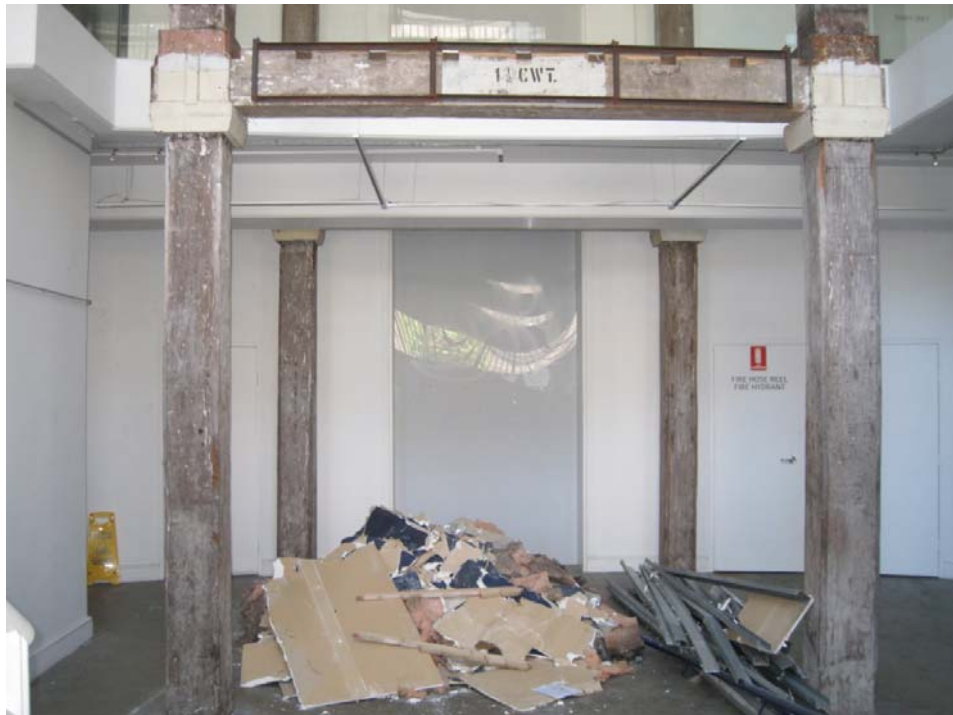
14. Example timber construction remaining insitu at 5 Hickson Road, The Rocks. Level 2.

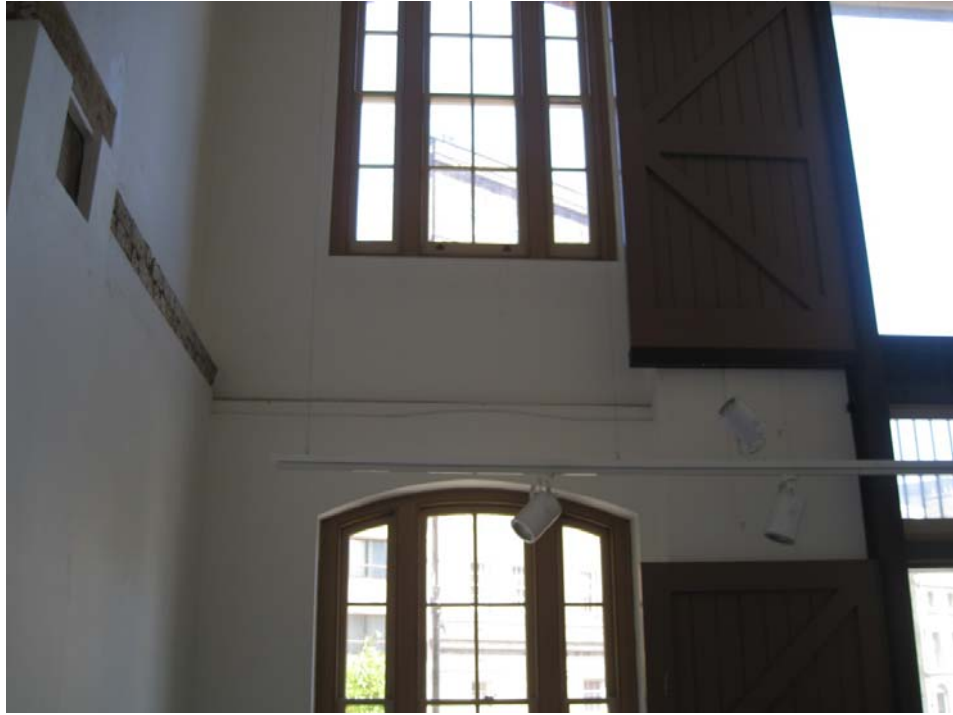
15. Example of space at 5 Hickson Road to be reconstructed. South western corner to Level 4 floor level. Note: square recess on side wall for location of end beam connection, and stepped ledge on end wall located between the windows to support ends of joists.

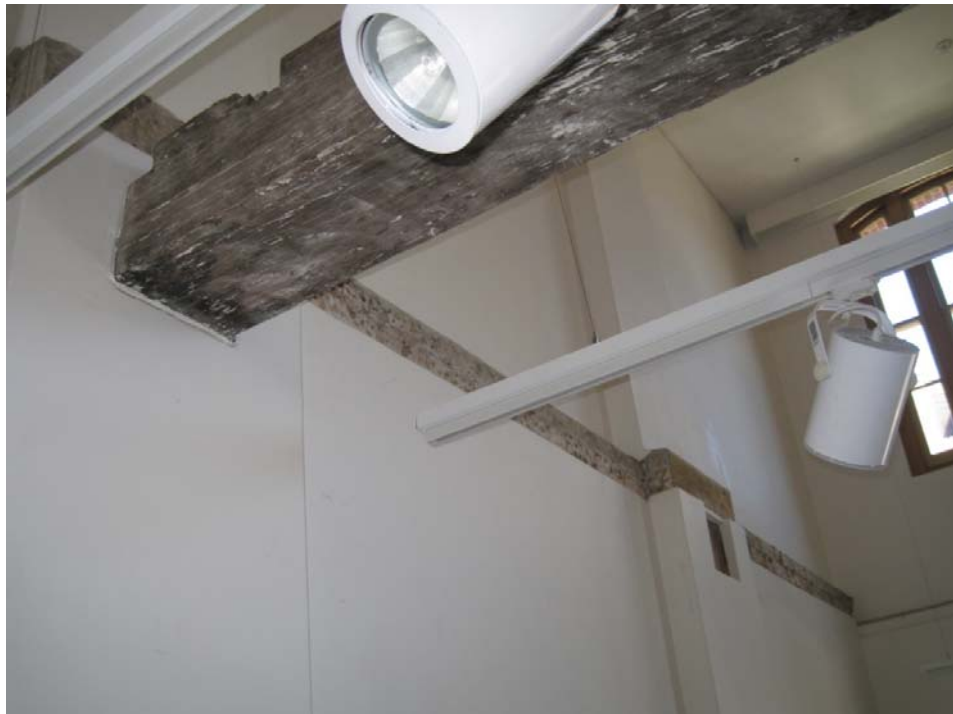
16. Example of end beam connecting to side wall at 5 Hickson Road.

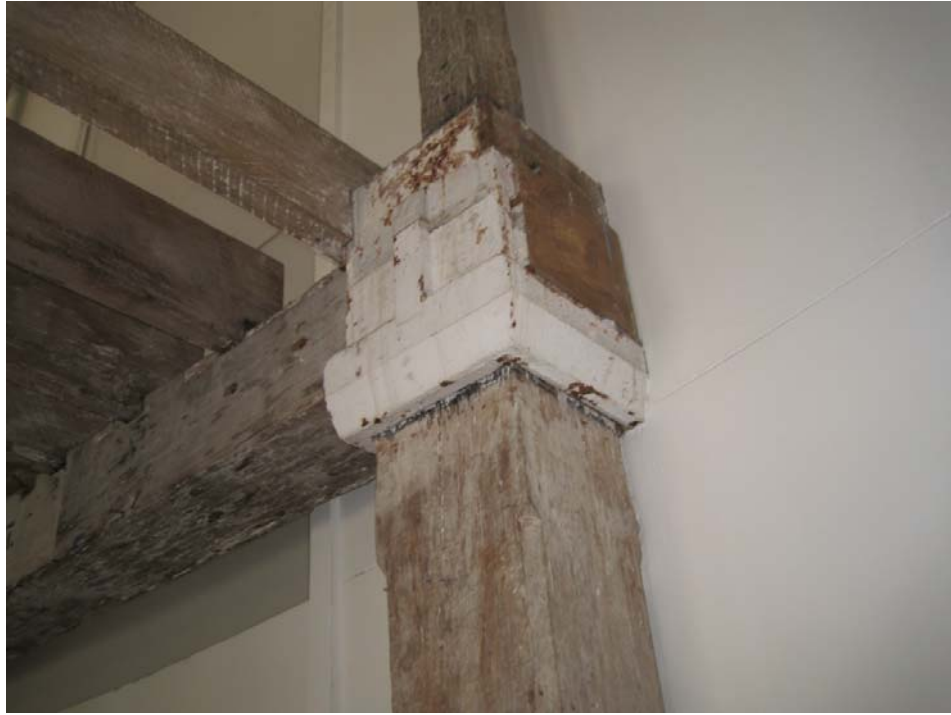
17. Example of timber construction detail at 5 Hickson Road. Note: a timber beam will be reconstructed into the right hand side of the collar as part of the proposed works.

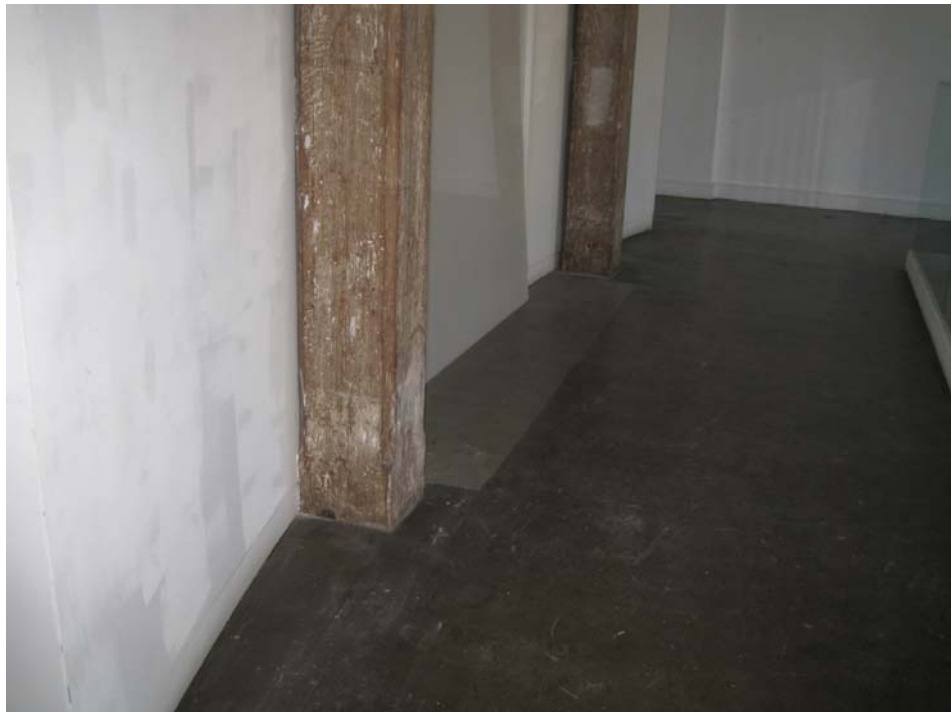
18. Example of timber columns extending through the later concrete floors at Level 3. The timber structure is connected to the timber columns and steel collar detail in Level 2 below. The concrete floor will be demolished and the timber floor structure reconstructed as part of the proposed works.

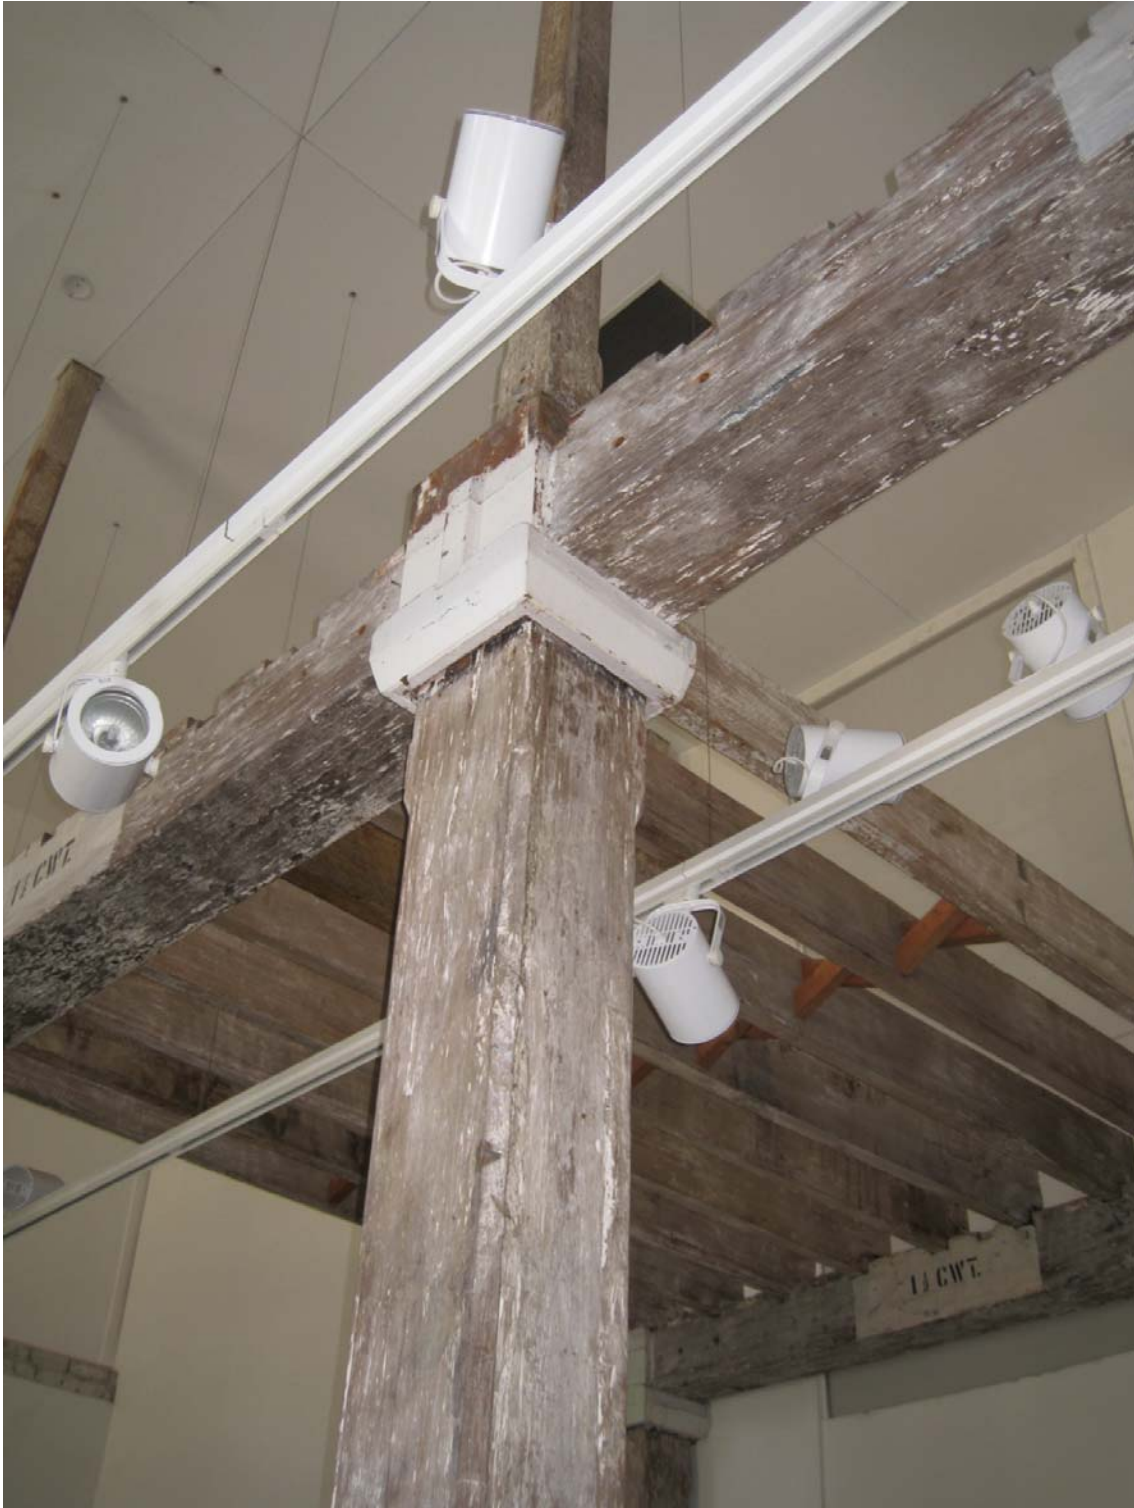
19. Example of timber construction detail remaining insitu at 5 Hickson Road, The Rocks.
