# Hazardous Materials Inspection

| <b>Prepared for:</b> | Loreto Normanhurst |
| <b>Site:</b> | <b>4 Mount Pleasant Ave, Normanhurst<br/>NSW 2076</b> |
| <b>Date:</b> | Monday, 7 December 2020 |

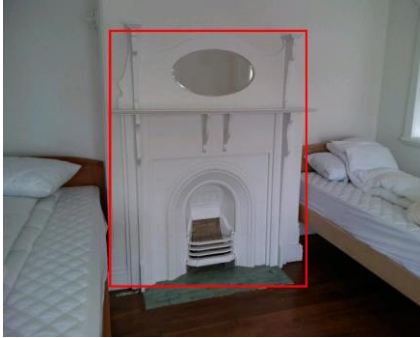
Photo No: 200928-103437  
Result: Asbestos - Presumed Positive  
Location-Level: Interior - Ground Floor  
Room-Location: Living room, dining room and Room: Riverina & Dubbo - chimney  
Feature-Material: Internal insulation

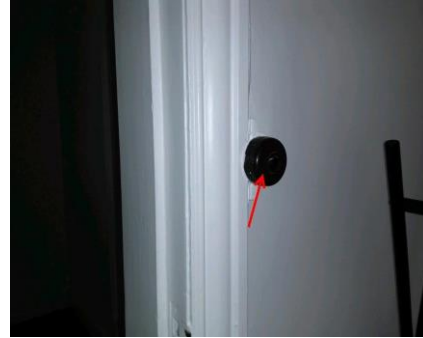
Photo No: 200928-105727  
Result: Asbestos - Presumed Positive  
Location-Level: Interior - Ground Floor  
Room-Location: Room: Riverina and living room - power switch  
Feature-Material: Internal wire insulation

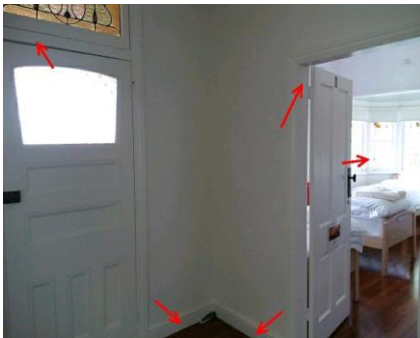
Photo No: 200928-105942  
Result: Lead in Paint - Positive  
Location-Level: Interior - Ground Floor  
Room-Location: Door and window frame and walls skirt throughout  
Feature-Material: Lower colour paint system

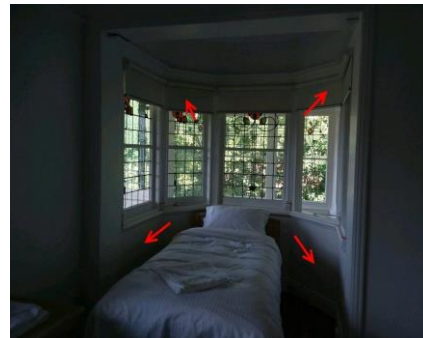
Photo No: 200928-113844  
Result: Asbestos - Positive  
Location-Level: Interior - Ground Floor  
Room-Location: Southern end of room: Dubbo - infill panels below & above windows  
Feature-Material: FC sheeting

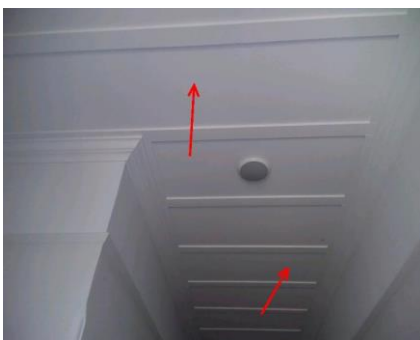
Photo No: 200928-112113  
Result: Asbestos - Positive  
Location-Level: Interior - Ground Floor  
Room-Location: Corridor - ceiling  
Feature-Material: FC sheeting

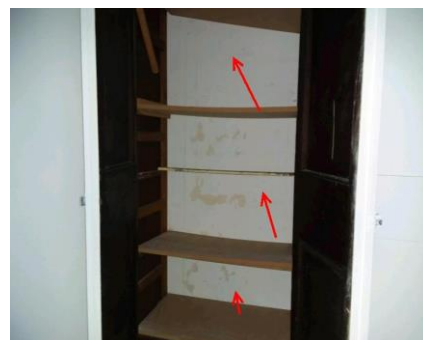
Photo No: 200928-112636  
Result: Lead in Paint - Positive  
Location-Level: Interior - Ground Floor  
Room-Location: Internal wardrobe in Room: Narrabri - paint faint  
Feature-Material: Lower colour paint system

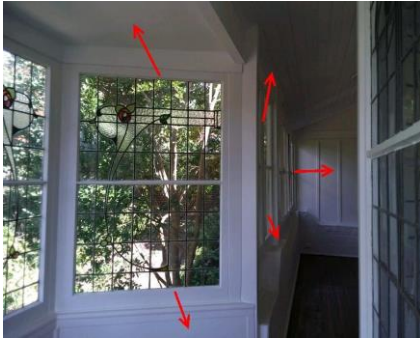
Photo No: 200928-114114  
Result: Asbestos - Positive  
Location-Level: Interior - Ground Floor  
Room-Location: Southern balcony - infill panels and ceiling  
Feature-Material: FC sheeting

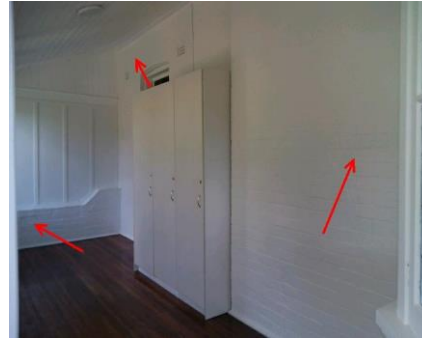
Photo No: 200928-114747  
Result: Lead in Paint - Positive  
Location-Level: Interior - Ground Floor  
Room-Location: Paint on brick walls  
Feature-Material: Lower colour paint system

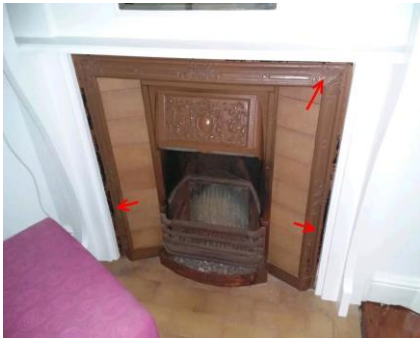
Photo No: 200928-115857  
Result: Lead in Paint - Positive  
Location-Level: Interior - Ground Floor  
Room-Location: Room: Dubbo and living room - fireplace frames  
Feature-Material: Lower colour paint system

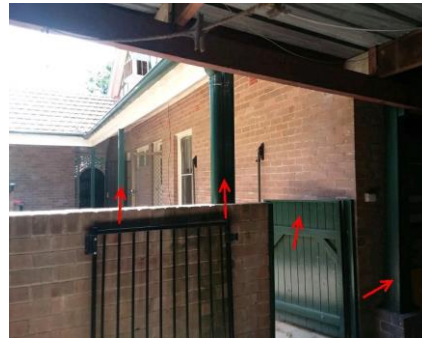
Photo No: 200928-120226  
Result: Lead in Paint - Positive  
Location-Level: Exterior - Ground Floor  
Room-Location: All elevation of the house -  
Feature-Material: Lower colour paint system

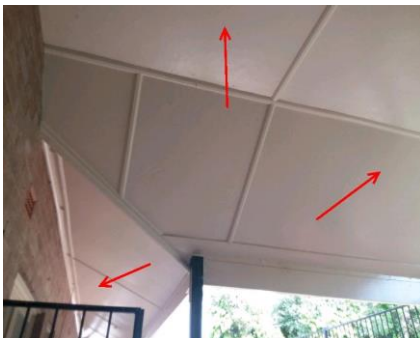
Photo No: 200928-120756  
Result: Asbestos - Positive  
Location-Level: Exterior - Ground Floor  
Room-Location: Rear entrance - eaves  
Feature-Material: FC sheeting

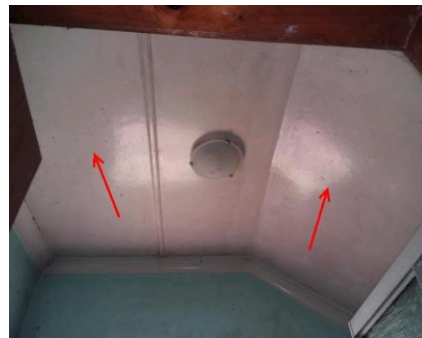
Photo No: 200928-121639  
Result: Lead in Paint - Positive  
Location-Level: Exterior - Ground Floor  
Room-Location: Bathroom - ceiling  
Feature-Material: Lower colour paint system

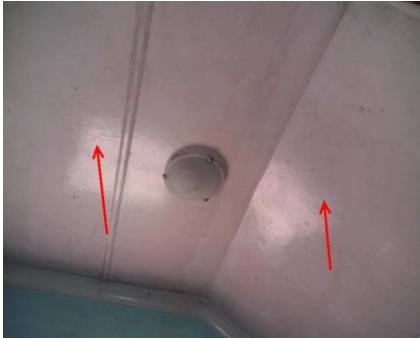
Photo No: 200928-121743  
Result: Asbestos - Positive  
Location-Level: Exterior - Ground Floor  
Room-Location: Bathroom - ceiling  
Feature-Material: FC sheeting

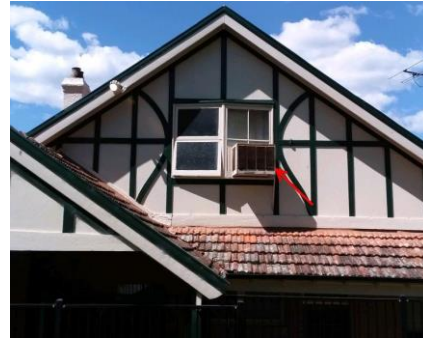
Photo No: 200928-125901  
Result: ODS - Presumed Positive  
Location-Level: Exterior - 1st Floor  
Room-Location: Western elevation of the house - AC unit  
Feature-Material: Unknown label

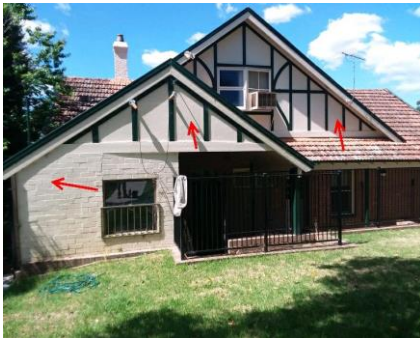
Photo No: 200928-122524  
Result: Lead in Paint - Positive  
Location-Level: Exterior - Ground Floor  
Room-Location: All elevation of the house - external walls  
Feature-Material: Lower colour paint system

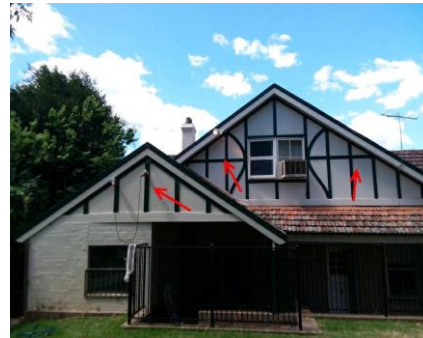
Photo No: 200928-123022  
Result: Asbestos - Positive  
Location-Level: Exterior - Ground Floor  
Room-Location: Eastern and western elevation of the house - gable  
Feature-Material: FC sheeting

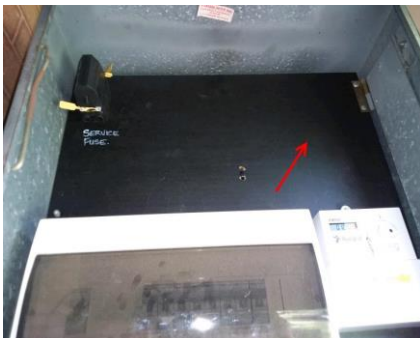
| Item | Location | Level | Room-Specific Location | Hazard Type | Item description | Sample Reference | Sample Status | Photo No | Extent | Condition | Friability | Disturbance Potential | Risk Rating | Current Label | Control Priority | Control Recommendation |
|---|---|---|---|---|---|---|---|---|---|---|---|---|---|---|---|--|
| 29 | Exterior | Ground Floor | Electrical meter board | Asbestos | backing board | Nil - energised | Presumed Positive | 200928-124950 | 1 | Good | Non-Friable | Low | Low | No | P4 | <p>P4 - No short term remediation works required. Review periodically and manage as part of an AMP</p> |

Photo No: 200928-124950  
Result: Asbestos - Presumed Positive  
Location-Level: Exterior - Ground Floor  
Room-Location: Electrical meter board  
Feature-Material: backing board

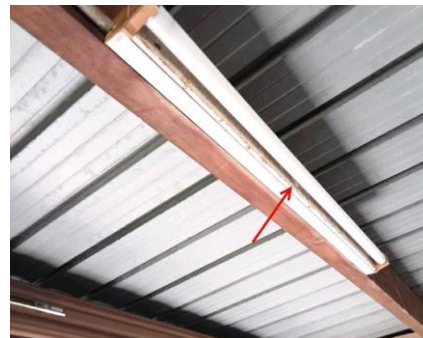
Photo No: 201207-103626  
Result: PCB - Presumed Positive  
Location-Level: Interior - Ground Floor  
Room-Location: Garage, single tube fluorescent light  
Feature-Material: Capacitor

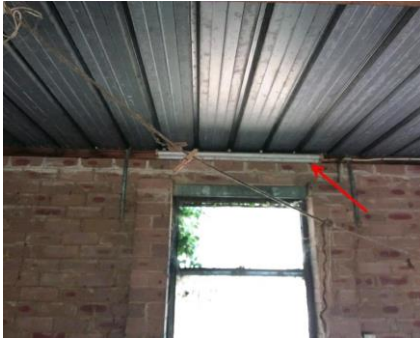
Photo No: 201207-102820  
Result: PCB - Presumed Positive  
Location-Level: Interior - Ground Floor  
Room-Location: Garage, single tube fluorescent light  
Feature-Material: Capacitor

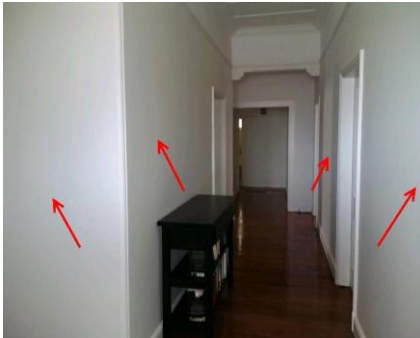
Photo No: 200928-102642  
Result: Asbestos - Negative  
Location-Level: Interior - Ground Floor  
Room-Location: Division walls Next to front entrance - internal walls  
Feature-Material: Brick

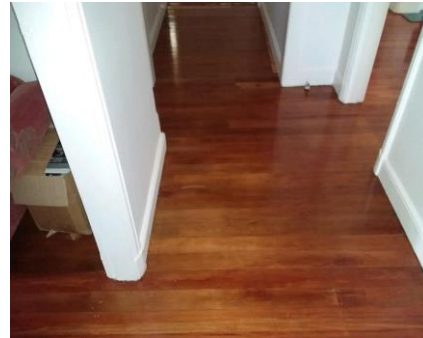
Photo No: 200928-104125  
Result: Asbestos - Negative  
Location-Level: Interior - Ground Floor  
Room-Location: Bedrooms, corridor, living room, dining room and kitchen- flooring  
Feature-Material: Timber

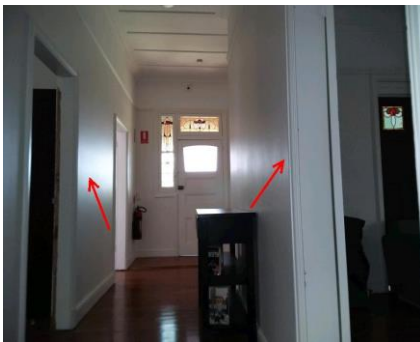
Photo No: 200928-104435  
Result: Asbestos - Negative  
Location-Level: Interior - Ground Floor  
Room-Location: Bedrooms, living room and corridor - internal walls  
Feature-Material: Brick

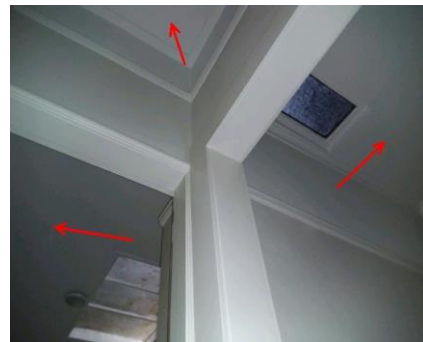
Photo No: 200928-112521  
Result: Asbestos - Negative  
Location-Level: Interior - Ground Floor  
Room-Location: Bedrooms, living room & dining room - ceilings  
Feature-Material: Plasterboard

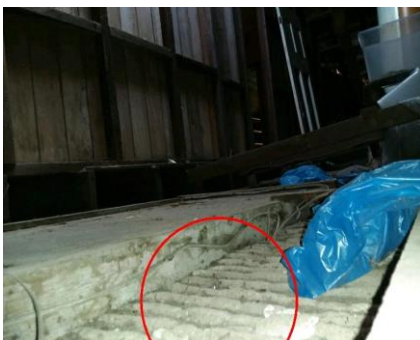
Photo No: 200928-112812  
Result: Asbestos - Negative  
Location-Level: Interior - Ground Floor  
Room-Location: GF ceiling cavity and 1st floor - dust and debris  
Feature-Material: Dust and debris

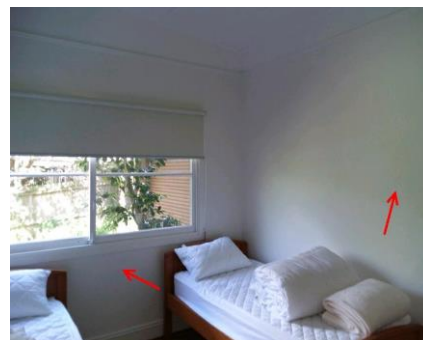
Photo No: 200928-114301  
Result: Asbestos - Presumed Negative  
Location-Level: Interior - Ground Floor  
Room-Location: Room: Narrabri - south and west walls  
Feature-Material: Plasterboard

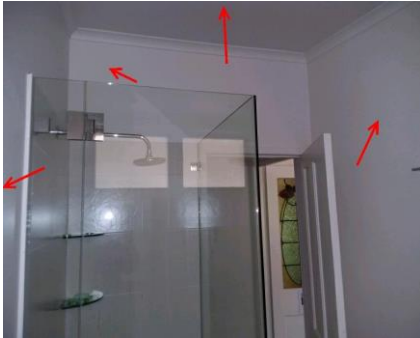
Photo No: 200928-114932  
Result: Asbestos - Negative  
Location-Level: Interior - Ground Floor  
Room-Location: Bathroom - internal walls and ceiling  
Feature-Material: Plasterboard

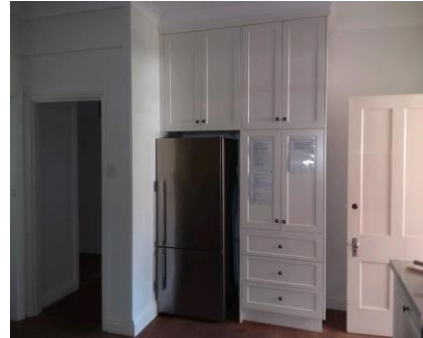
Photo No: 200928-115150  
Result: Asbestos - Presumed Negative  
Location-Level: Interior - Ground Floor  
Room-Location: Kitchen - southern wall and ceiling  
Feature-Material: Plasterboard

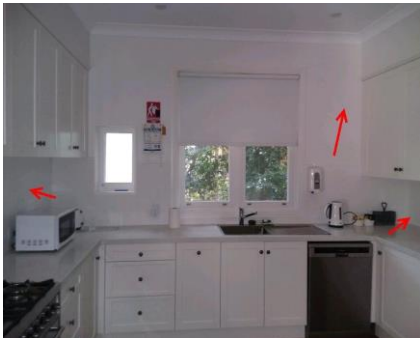
Photo No: 200928-115234  
Result: Asbestos - Negative  
Location-Level: Interior - Ground Floor  
Room-Location: Kitchen - eastern, western and northern walls  
Feature-Material: Brick

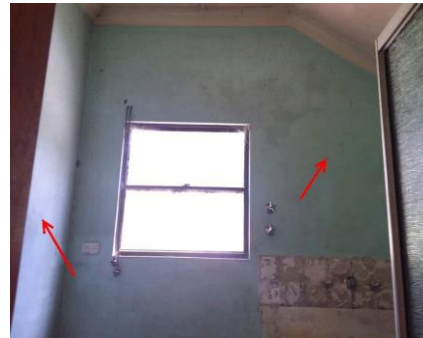
Photo No: 200928-121902  
Result: Lead in Paint - Negative  
Location-Level: Exterior - Ground Floor  
Room-Location: Bathroom - internal walls  
Feature-Material: Lower colour paint system

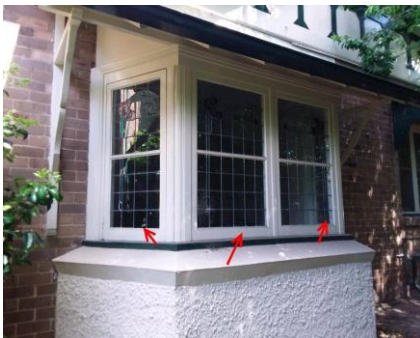
Photo No: 200928-123512  
Result: Asbestos - Negative  
Location-Level: Exterior - Ground Floor  
Room-Location: All elevation of the house - window frame sealant  
Feature-Material: Mastic-like materi

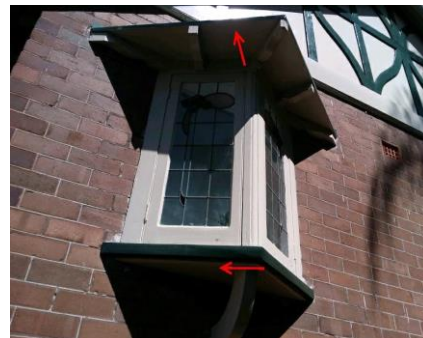
Photo No: 200928-123914  
Result: Asbestos - Negative  
Location-Level: Exterior - Ground Floor  
Room-Location: Northern elevation of the house - infill panels to window  
Feature-Material: FC sheeting

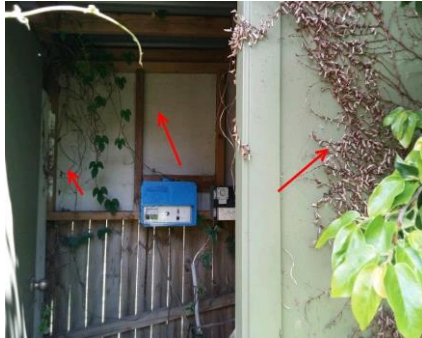
Photo No: 200928-124326  
Result: Asbestos - Negative  
Location-Level: Interior and Exterior - Ground Floor  
Room-Location: All elevation of shed - walls  
Feature-Material: FC sheeting

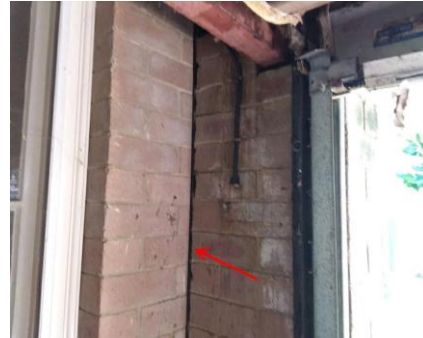
Photo No: 201207-103132  
Result: Asbestos - Negative  
Location-Level: Interior - Ground Floor  
Room-Location: Garage, expansion joints  
Feature-Material: Bitumenous material
