# Tree Assessment Report

Armidale Secondary College

Redevelopment SSD 9095

Date of Report 27<sup>th</sup> June 2018

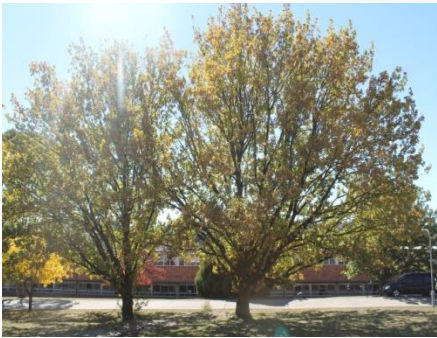
| Tree No. | Location | Scientific & Common Name | Height (m) | Crown spread (m) | DBH (cm) | Condition of Tree<br>(Health & Structure)<br>(Defect & Measurements)<br><br>Retention Value | Basal Flare (cm) | SRZ (m)<br>Radius | TPZ (M)<br>Radius | TULE & Retention Value | OBSERVATIONS<br>RECOMMENDATIONS |
|---|---|---|---|---|---|---|---|---|---|---|---|
| 7 | Not affected | Quercus robur,<br>English Oak | 12 | 12 | 50 | Mature, Good Condition, Minor Dead Wood, Significant tree | 60 | | | A2 High | Tree Indicated for Removal Tree Removal / Retain Plan |
| 8 | Not affected | Quercus robur,<br>English Oak | 12 | 12 | 50 | Mature, Good Condition, Minor Dead Wood, Significant Tree | 62 | | | A2 High | Tree Indicated for Removal Tree Removal / Retain Plan |

**TREE 7-8** Quercus robur, Semi Mature x 2

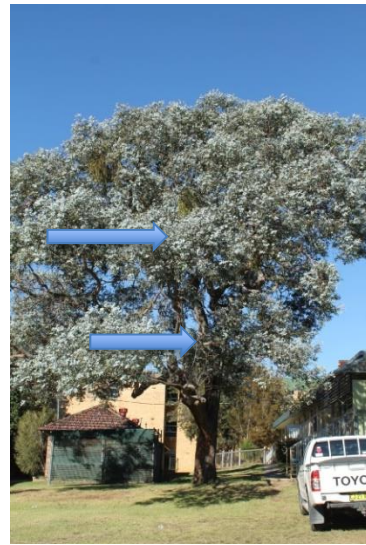
| 47 | Not affected | Eucalyptus cinerea, Argyle Apple | 14 | 16 | 90 | Mature, Good Condition, Physical Damage at 12m. Significant Tree | 110 | | | D2<br>Medium | EARLY WORKS REMOVAL |

**TREE 47** Significant Tree Several Fail sites

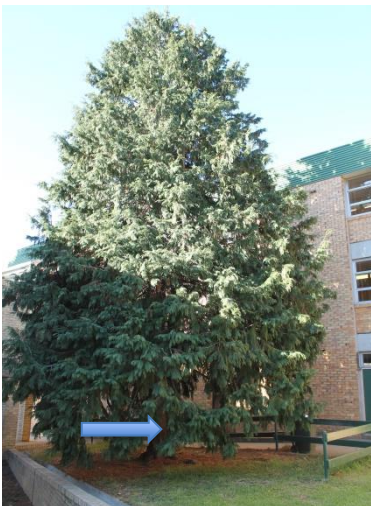
| 49 | Other – Path | Cuspressus spp spp. | 10 | 14 | 30x3 | Mature, Good Condition but Poor Development/Habit, Physical Damage at Union Base | 75 | | | D3<br>C4<br>Low | EARLY WORKS REMOVAL |

**TREE 49** Split base

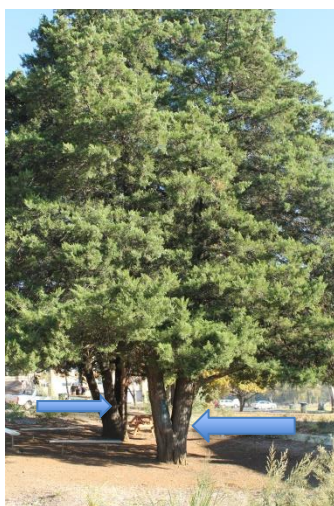
| 100 | Not affected | Cuspressus spp | 12 | 12 | 40/40<br>50/30 | Mature, Physical Damage at Base | 100 | | | C4<br>Low | Tree Indicated for Removal Tree Removal / Retain Plan . Structural defect at base |
| 101 | Not affected | Cuspressus spp | 10 | 12 | 40/40 | Mature, Physical Damage at Base | 90 | | | D3<br>C4<br>Low | Tree Indicated for Removal Tree Removal / Retain Plan.<br><br>Structural defect at base |

**TREE 100 & 101** Union separation

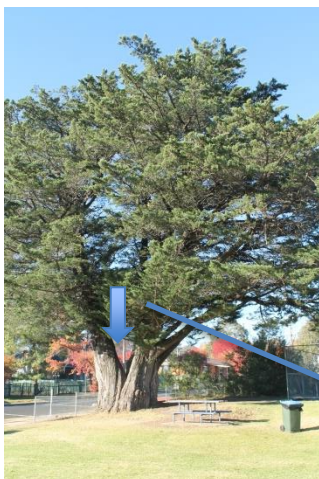
| 105 | Other – Path | Cuspressus spp | 19 | 16 | 280 | Mature, 3x main leader fracture at base east | 306 | | | D2 High | Fractured at base monitor @ 6 month intervals Retain |

**Tree 105** fracture at union
