Wyoming One Slope Stability Analysis

Wyoming One Slope Stability Analysis Tomingley Gold Operations Pty Ltd

AMC Project 121045
10 November 2021

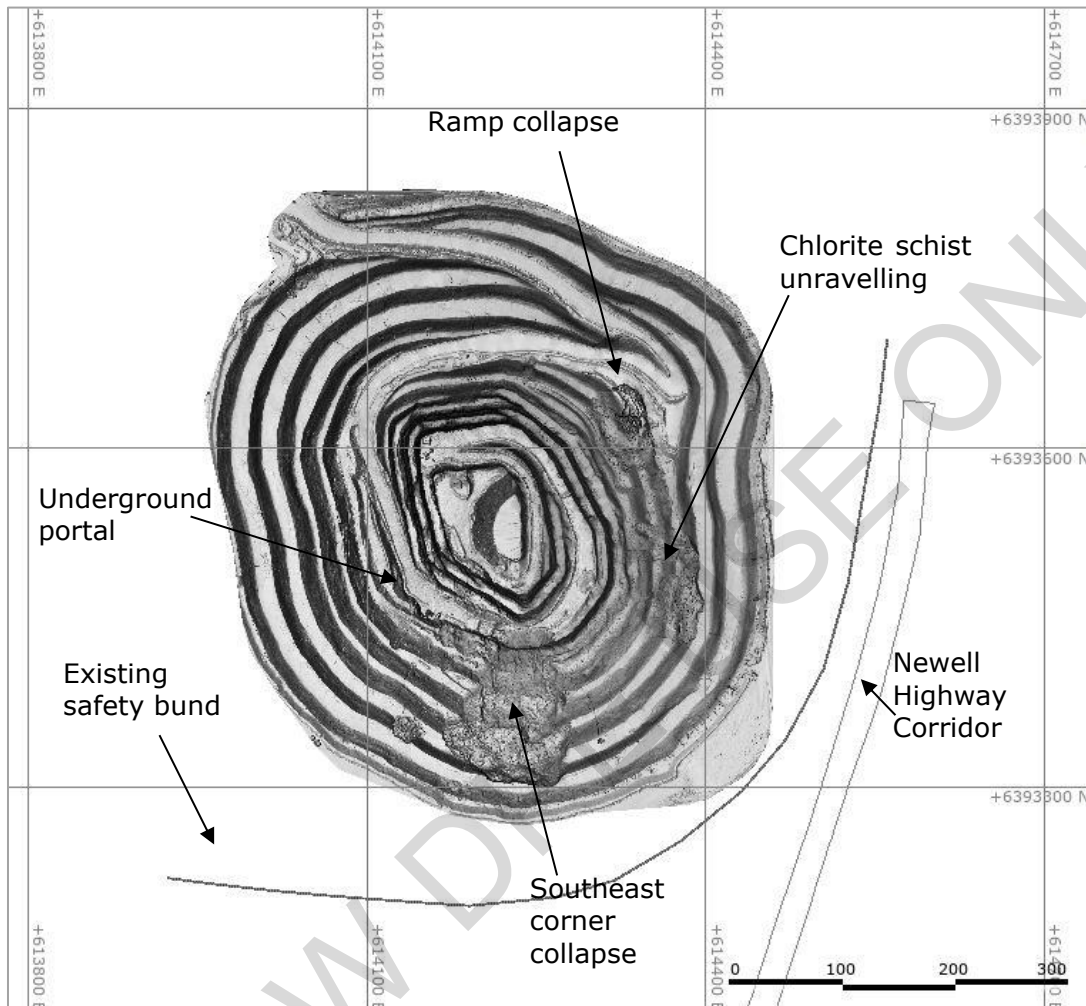
Figure 3.1 Geotechnical areas of concern within the WY1 pit

- **Southeast collapse** involving multi-bench collapse of the saprolite and weathered rock between 240 mRL to 195 mRL that was experiencing ongoing unravelling and rock fall.
- **Chlorite schist unravelling** where minor rockfalls were occurring from the saprolite and weathered rock horizons on the east wall between 240 mRL and 195 mRL.
- **Ramp collapse** involving ongoing movement of the saprolite beneath the switchback at the multi-bench scale.

Both the southeast collapse and the chlorite schist unravelling have the potential to promote large scale instability that could impact the location of the long-term pit crest.

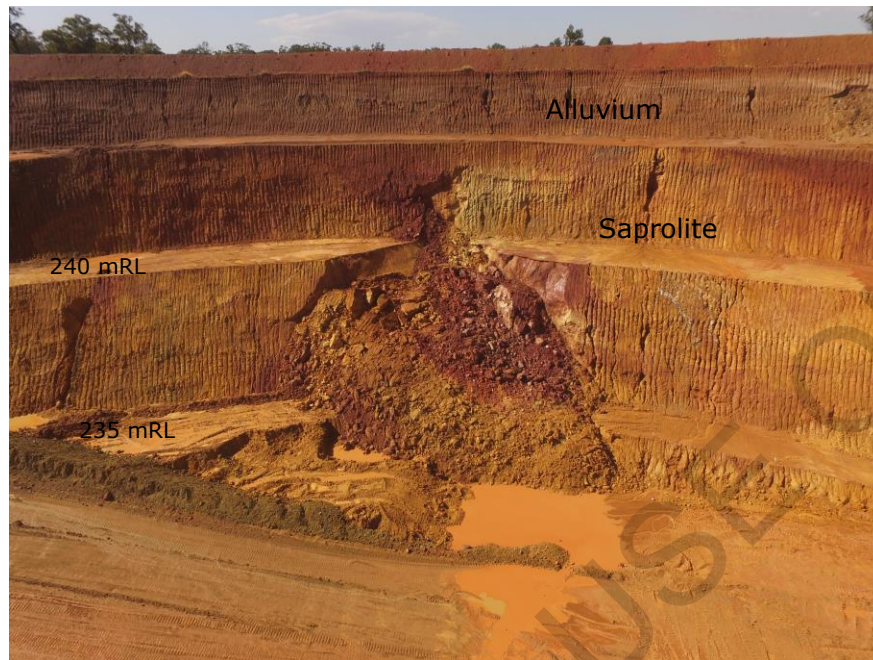
Figure 3.2 Initial collapse of the saprolite in the southeast corner of WY1

Initial collapse in the southeast corner occurred within the saprolite immediately beneath the alluvium in about December 2016. Figure 3.2 shows the initial collapse in the saprolite materials and Figure 3.3 shows the current condition of the southeast corner. Since December 2016, there has been progressive collapse of, the saprolite towards the west, the alluvium in the bench above and the weathered rock in the bench below.

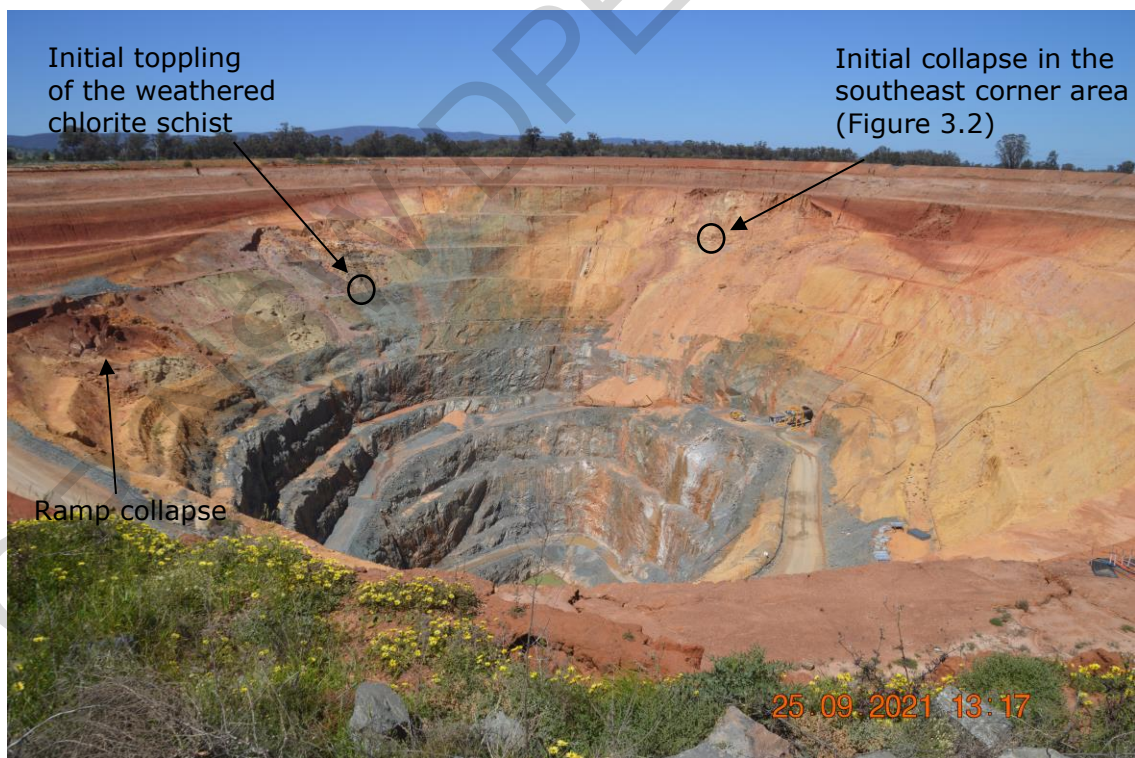
Figure 3.3 Current condition of the southeast corner and the chlorite schist in WY1

Figure 3.3 shows the current condition of the east wall in the area designated as chlorite schist unravelling.

The initial collapse in this area, which occurred in about July 2017, was of the weathered rock at an RL of about 231 m. The collapse mechanism was likely to be toppling style within the chlorite schist unit that has pervasive sub-vertical foliation dipping into the wall. Further toppling of the weathered schist promoted the collapse of the saprolite above and laterally towards the north.

The unravelling of the weathered rock and collapse of the saprolite appears to be shallow structure and material strength related rather than a deep-seated instability. The main instability occurs over a lateral length of about 100 m and vertically over two benches (40 m). TGO has not noticed any cracking or movement behind the east wall pit crest that would indicate a large-scale instability was occurring.

TGO has indicated that soil and rock falls from this area are infrequent, and this is consistent with a lack of collapsed material evident on the berms below and on the main ramp. A key contributor to the ongoing instability of this area is rainfall and surface water flow over the slope.

This area is anticipated to deteriorate over the long-term and is likely to encroach on the alluvium.

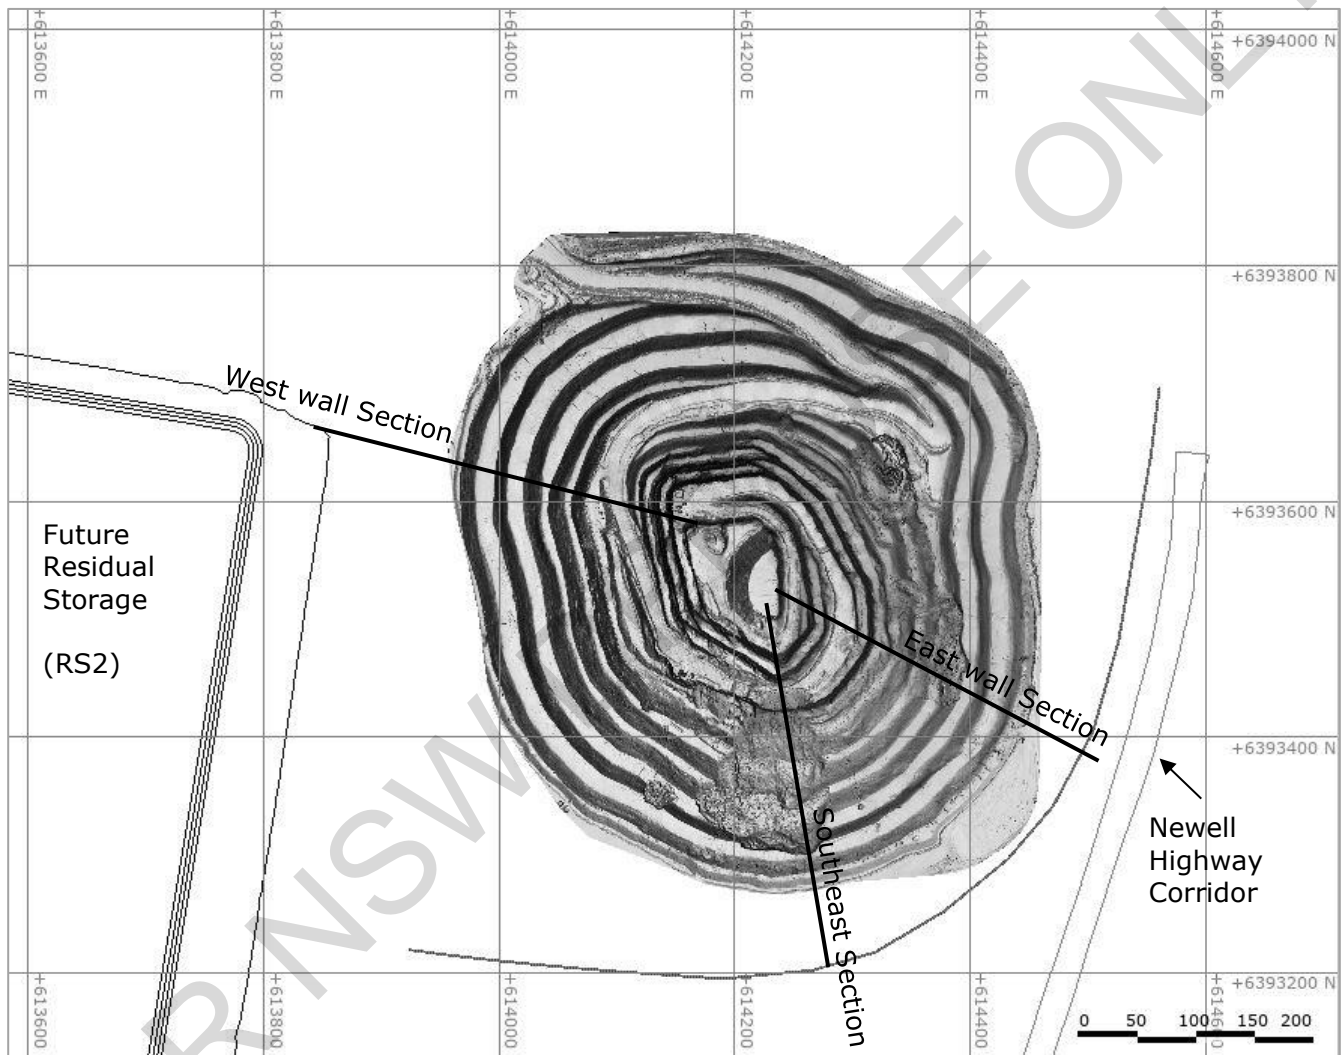
Figure 6.1 Plan showing location of analyses

The East wall and West wall section locations were analysed as failure in these wall areas could impact the re-aligned Newell Highway corridor and the RS2 respectively (Figure 6.1). The Southeast Section was analysed as due its current condition, this slope has the potential to experience a significant rock mass style failure in the long-term.

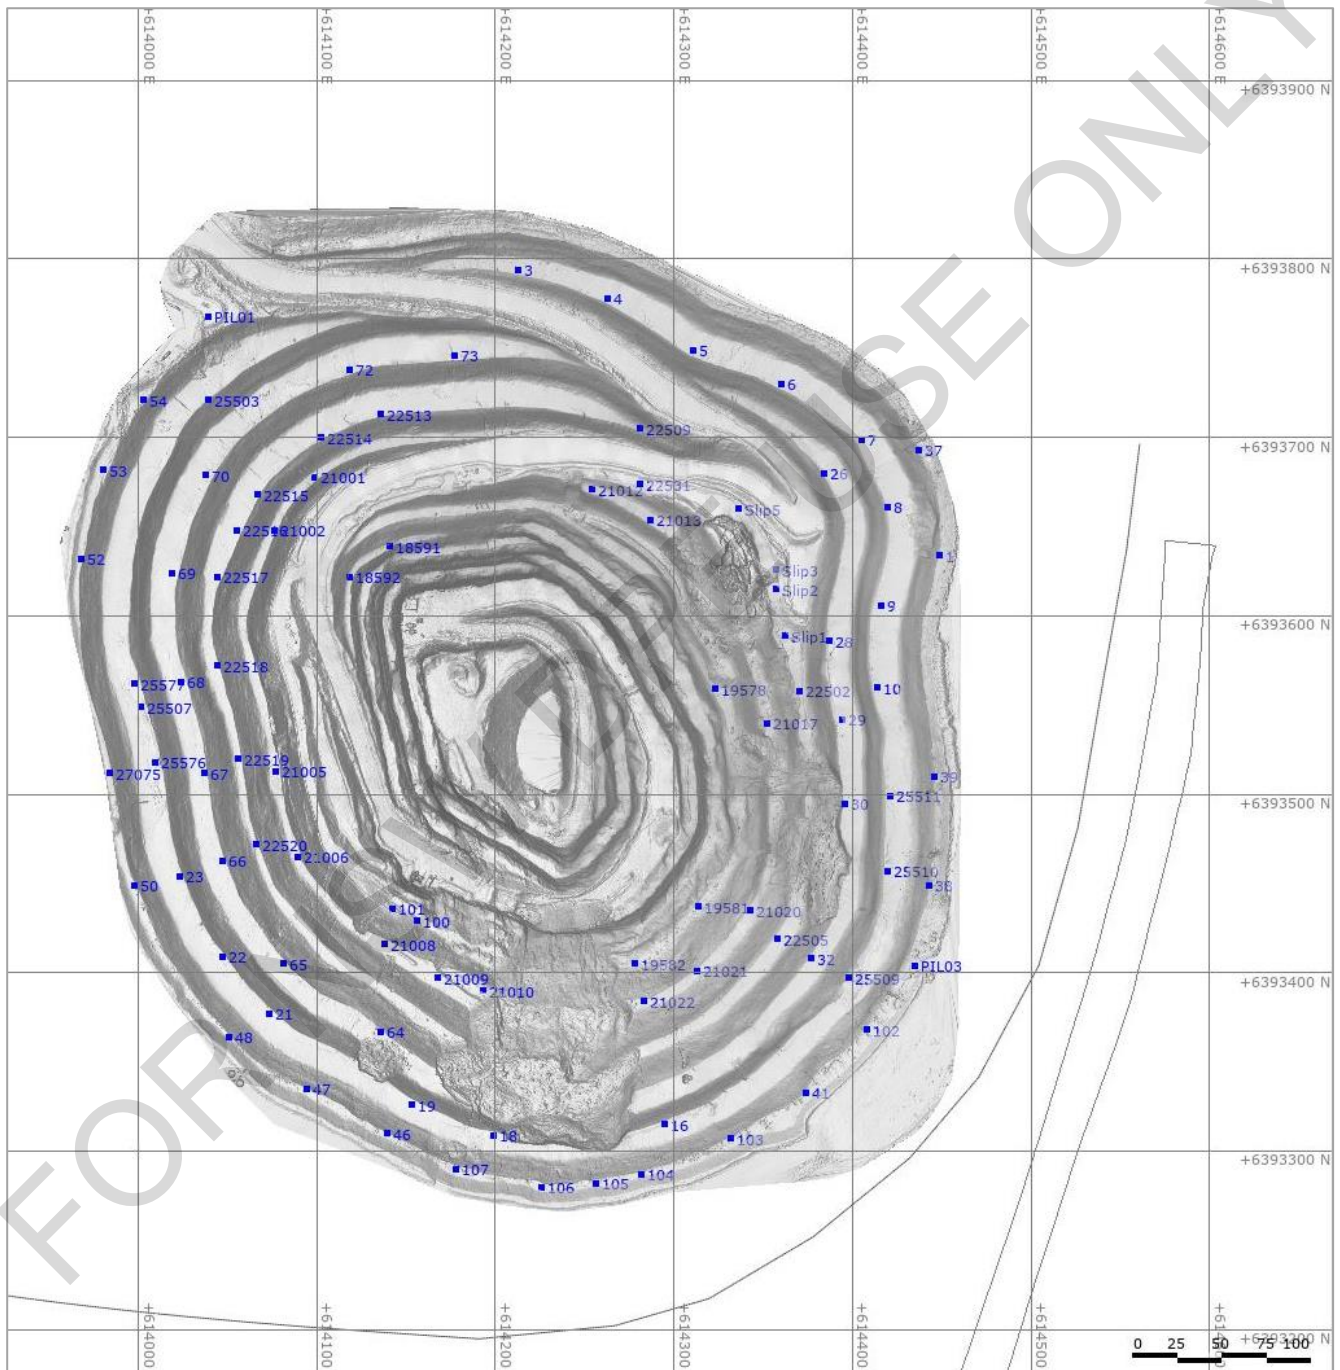
Figure A1 Plan showing the location of prisms in WY1.

- Prisms 106, 107 and 19 are located on the slope above the southeast collapse.
- Prisms 21006, 22518, 22519, 66, 67 and 68 are located on the west wall and have previously indicated some movement.
- Prisms 25509, 25510 and 25511 are located on the east wall above the chlorite schist unravelling area.

Most prisms showed a total movement of less than 160 mm over the past two years. The available prism data does not indicate acceleration or significant wall movements that are concerning from an overall wall stability aspect. TGO has indicated that the minor increase in displacement on the 21 April 2021 was likely to be due to atmospheric and not prism movement.

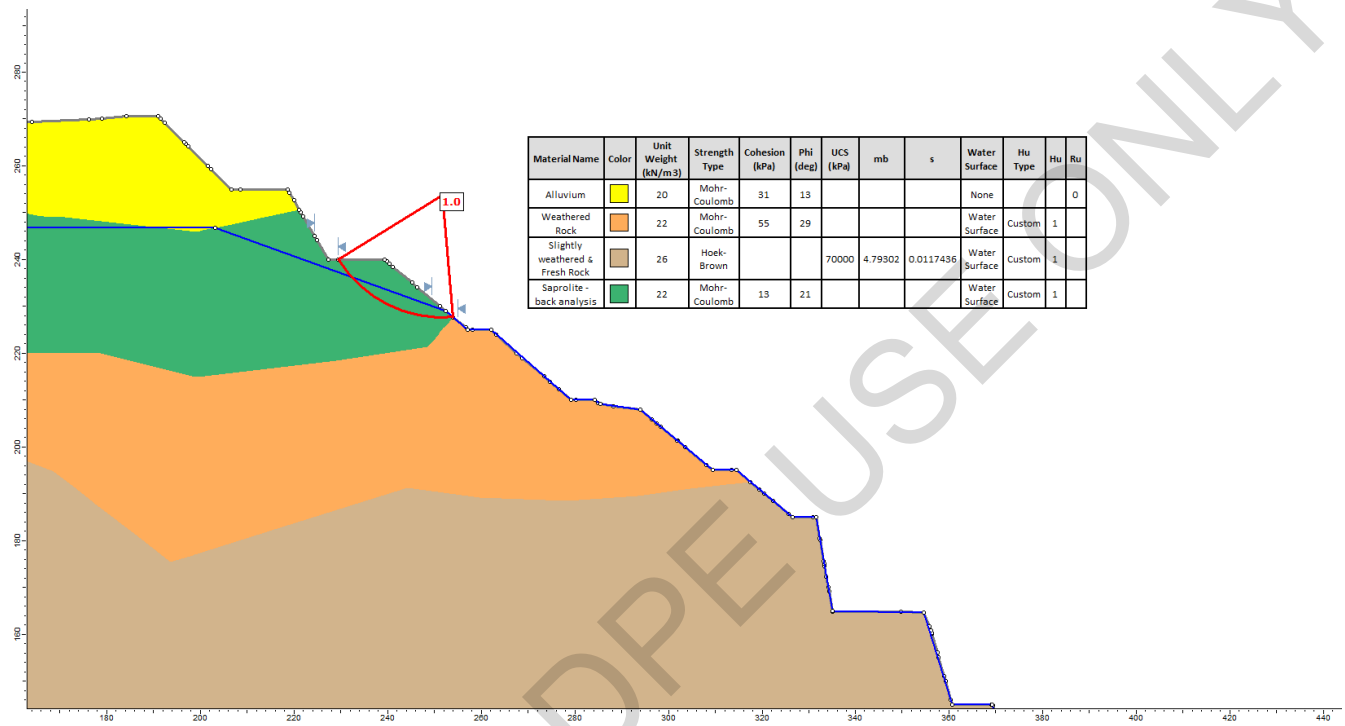
Figure B1 WY1 southeast corner results of back analysis

The result of the back analysis is provided in Appendix B. The back analysed strength parameters for the saprolite material were assessed based on a Factor of Safety (FOS) of 1.0.

- $c' = 13 \text{ kPa}$ and $\phi' = 21^\circ$.

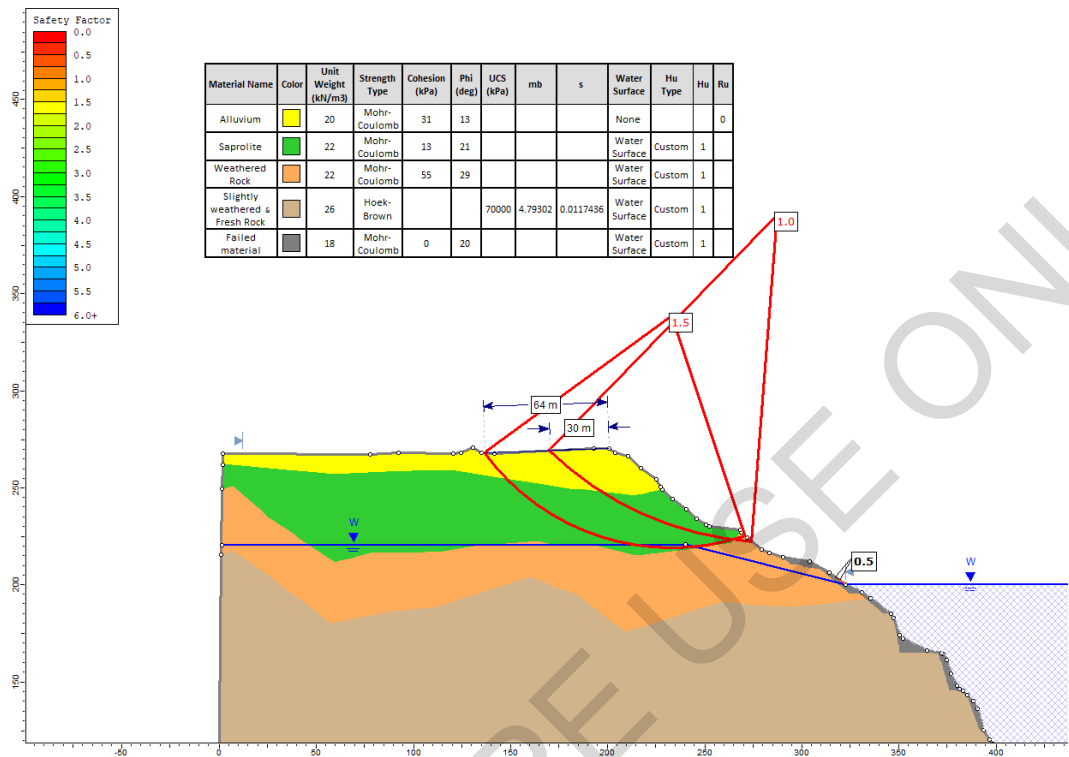
Figure C1 SLIDE analysis results for WY1 southeast corner

The result of slope stability analysis for the southeast corner has indicated a FOS of 1.0 for a circular failure path through the alluvium and saprolite. This suggests that the stability of the alluvium and saprolite is marginal and that there is a potential for further collapse of these materials in the short-term rather than in the long-term. The potential for collapse is increased after rainfall events. If not already done, TGO need to implement appropriate exclusions and management procedures to reduce the safety risks relating to further failure of the southeast slope.

Slope remediation could be required for the southeast wall area to remain as part of the current approved final landform. The most effective option to improve wall stability and reduce the potential for rock mass style failure in the southeast corner will be to flatten the slope through the alluvium and saprolite.

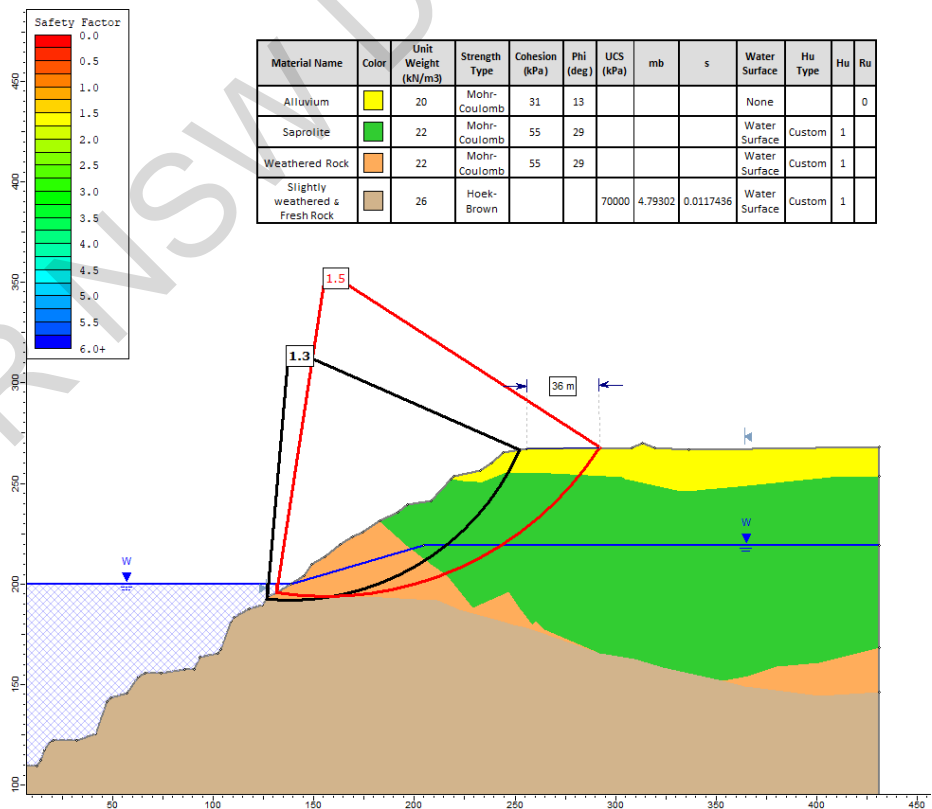
Figure C2 SLIDE analysis results for WY1 east wall

Slope stability analyses completed on these three wall areas suggests that a rock mass style failure mechanism through the alluvium and saprolite could occur, and potential long-term crest cut-back could be up to 23 m for the west wall, 36 m for the east wall and 64 m for the southeast wall.
