### Flat fibre cement sheet – S69

## MAIN HOSPITAL

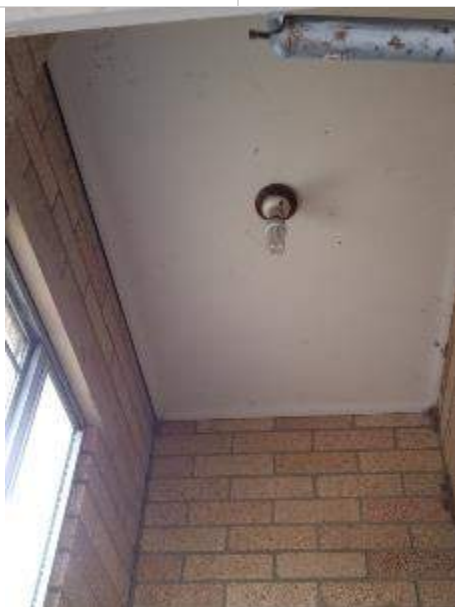
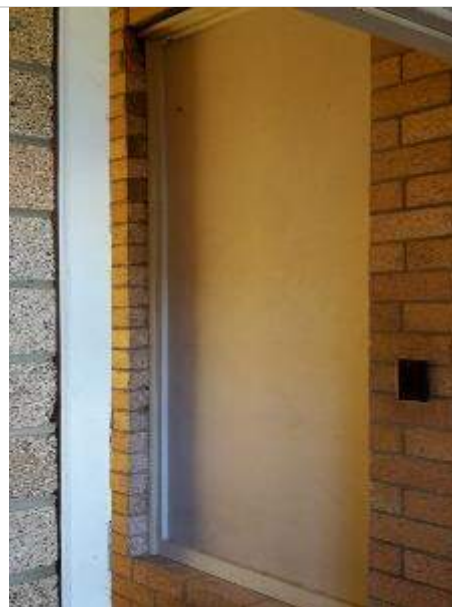
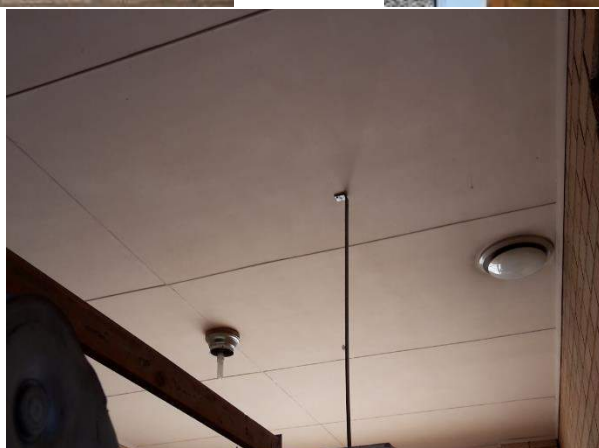
| <b>Location:</b> | Internal, ceiling lining to external toilet, rear room to garage and garage, and panel covering doorway to residence |
| <b>Material Type:</b> | Flat asbestos fibre cement sheet |
| <b>Condition:</b> | Generally intact |
| <b>Risk Assessment / Recommendation:</b> | Low risk, leave and maintain in current condition |

| <b>Reinspection / Removal Date:</b> | Remove prior to refurbishment / demolition works or reinspect in 5 years |

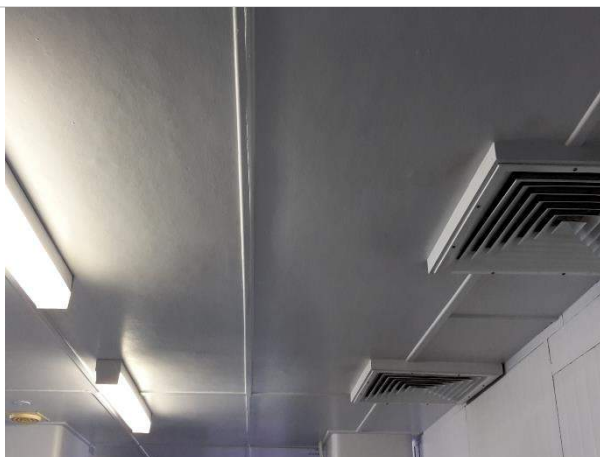
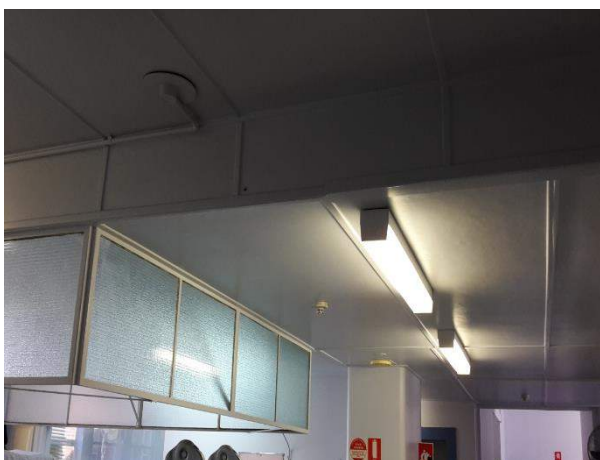
## Flat fibre cement sheet – S70

| <b>Location:</b> | Internal, ground floor, kitchen, bulkhead and ceiling lining |
| <b>Material Type:</b> | Flat asbestos fibre cement sheet |
| <b>Condition:</b> | Generally intact |
| <b>Risk Assessment / Recommendation:</b> | Low risk, leave and maintain in current condition |

| <b>Reinspection / Removal Date:</b> | Remove prior to refurbishment / demolition works or reinspect in 5 years |

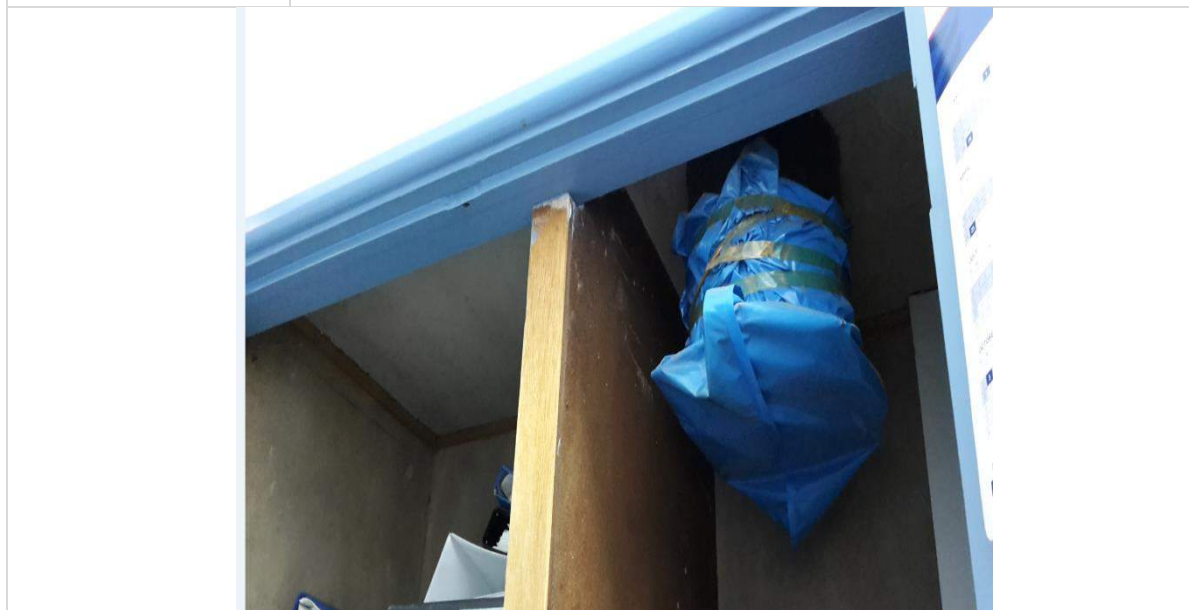
## Flat fibre cement sheet – S71

| <b>Location:</b> | Internal, ground floor, kitchen, office cupboard ceiling lining |
| <b>Material Type:</b> | Flat asbestos fibre cement sheet |
| <b>Condition:</b> | Generally intact |
| <b>Risk Assessment / Recommendation:</b> | Low risk, leave and maintain in current condition |

| <b>Reinspection / Removal Date:</b> | Remove prior to refurbishment / demolition works or reinspect in 5 years |

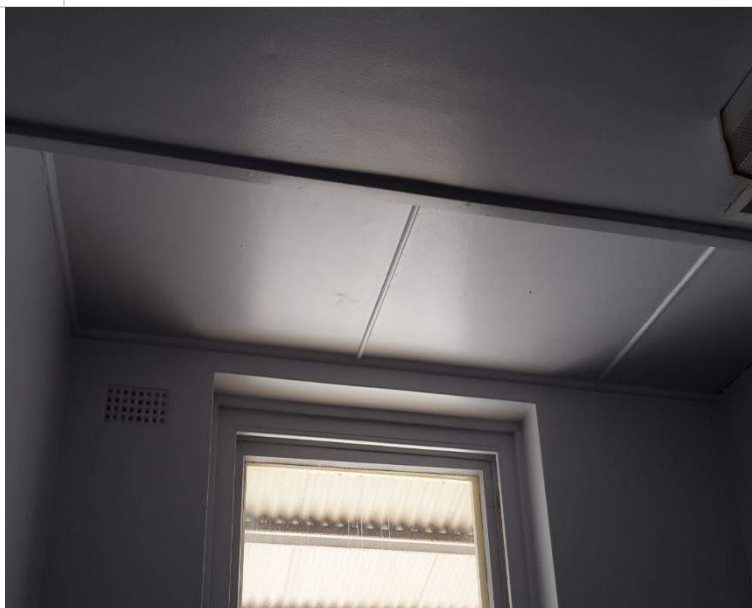
## Flat fibre cement sheet – S73

| <b>Location:</b> | Internal, ground floor, toilets outside kitchen, ceiling lining |
| <b>Material Type:</b> | Flat asbestos fibre cement sheet |
| <b>Condition:</b> | Generally intact |
| <b>Risk Assessment / Recommendation:</b> | Low risk, leave and maintain in current condition |

| <b>Reinspection / Removal Date:</b> | Remove prior to refurbishment / demolition works or reinspect in 5 years |

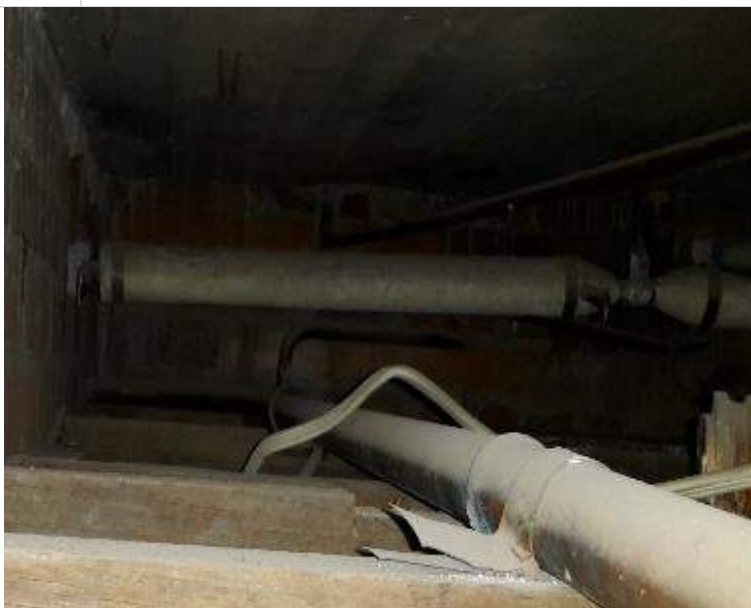
**Wrapped asbestos lagging on pipework – Similar to S07**

| <b>Location:</b> | Internal, ground floor ceiling space above toilets outside kitchen |
| <b>Material Type:</b> | Wrapped asbestos lagging on pipework |
| <b>Condition:</b> | Generally intact |
| <b>Risk Assessment / Recommendation:</b> | High risk, material should be removed as soon as reasonably practicable. Access to this area is generally restricted (via ladder only). Although in a good condition, the wrapping could easily be penetrated. |

| <b>Reinspection / Removal Date:</b> | Remove material as soon as reasonably practicable and prior to refurbishment and/or demolition works |

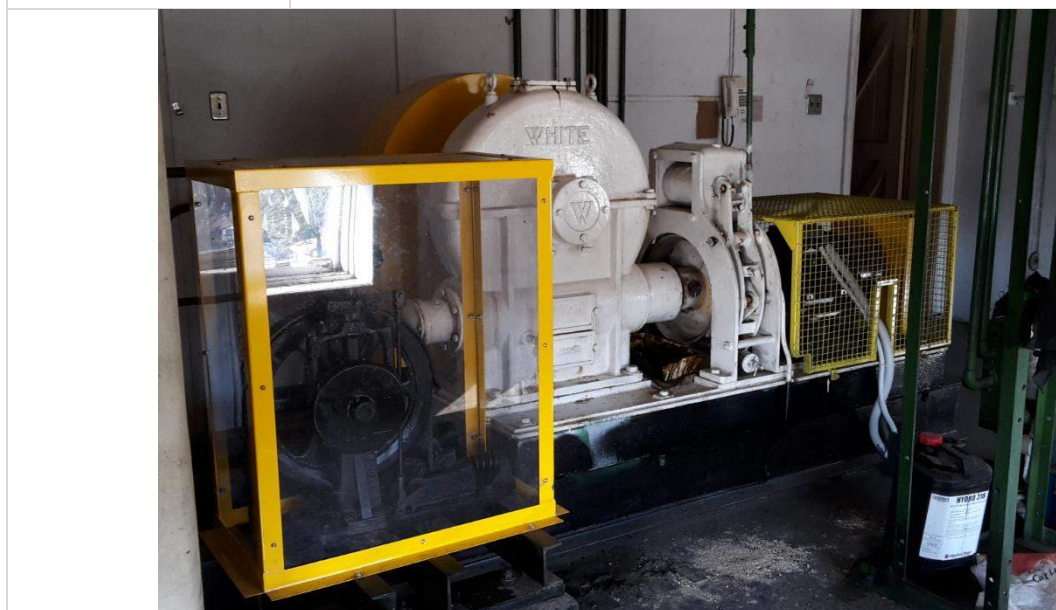
**Lift brake equipment including brake shoes – Not sampled (electrical hazard)**

| <b>Location:</b> | Internal, Level 4 lift motor room |
| <b>Material Type:</b> | Lift equipment including brake shoes |
| <b>Condition:</b> | Generally intact |
| <b>Risk Assessment / Recommendation:</b> | Low risk, leave and maintain in current condition |

| <b>Reinspection / Removal Date:</b> | Remove prior to refurbishment / demolition works or reinspect in 5 years |

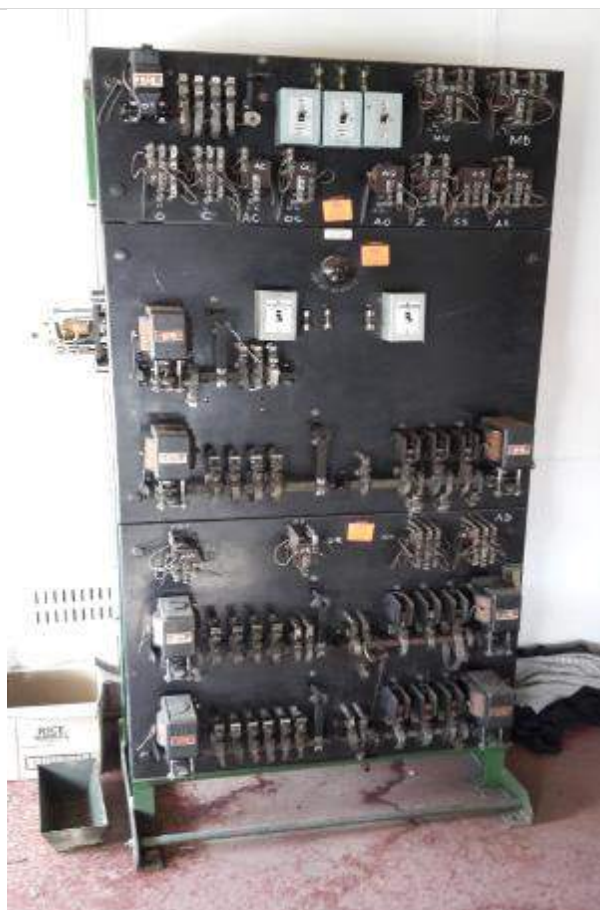
**Asbestos electrical backing board – S74**

| <b>Location:</b> | Internal, Level 4 lift motor room |
| <b>Material Type:</b> | Asbestos electrical backing board |
| <b>Condition:</b> | Generally intact |
| <b>Risk Assessment / Recommendation:</b> | Low risk, leave and maintain in current condition |

| <b>Reinspection / Removal Date:</b> | Remove prior to refurbishment / demolition works or reinspect in 5 years |

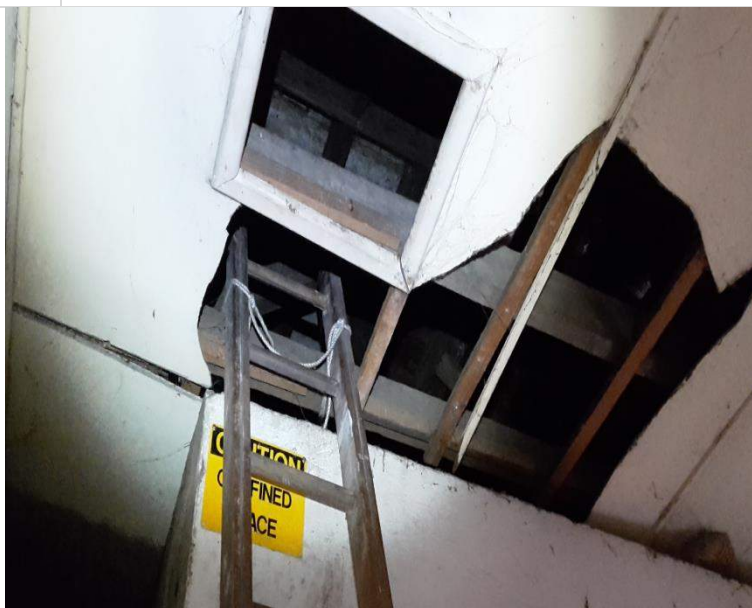
## Flat fibre cement sheet – S75

| <b>Location:</b> | Internal, Level 4, stairwell and above water tank, ceiling lining |
| <b>Material Type:</b> | Flat asbestos fibre cement sheet |
| <b>Condition:</b> | Generally intact |
| <b>Risk Assessment / Recommendation:</b> | Moderate risk, remove as soon as reasonably practicable. Large areas of broken sheet with exposed edges. |

| <b>Reinspection / Removal Date:</b> | Remove prior to refurbishment / demolition works or reinspect in 12 months |

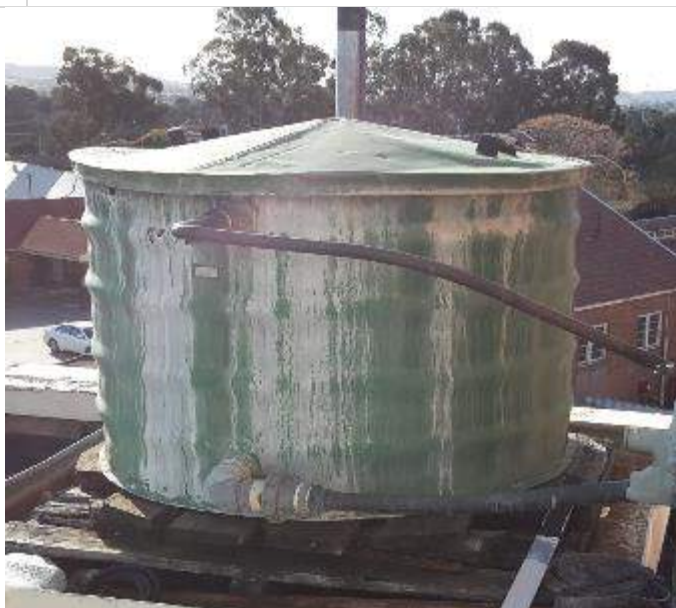
**Water tank insulation – Not sampled (sealed unit)**

| <b>Location:</b> | External, Level 3 balcony off plant room |
| <b>Material Type:</b> | Water tank insulation |
| <b>Condition:</b> | Generally contained |
| <b>Risk Assessment / Recommendation:</b> | Low risk, leave and maintain in current condition |

| <b>Reinspection / Removal Date:</b> | Remove prior to refurbishment / demolition works or reinspect in 5 years |

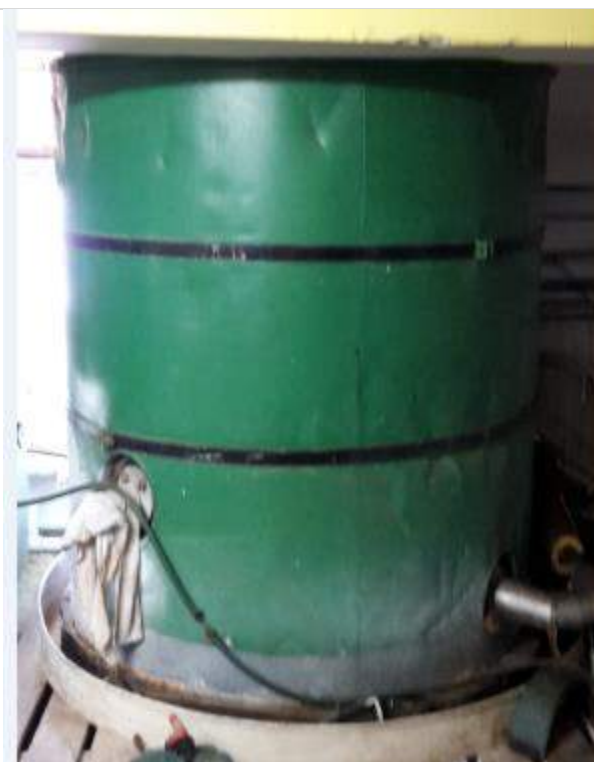
**Water tank insulation – Not sampled (sealed unit)**

| <b>Location:</b> | Internal, Level 3 plant room |
| <b>Material Type:</b> | Water tank insulation |
| <b>Condition:</b> | Generally contained |
| <b>Risk Assessment / Recommendation:</b> | Low risk, leave and maintain in current condition |

| <b>Reinspection / Removal Date:</b> | Remove prior to refurbishment / demolition works or reinspect in 5 years |

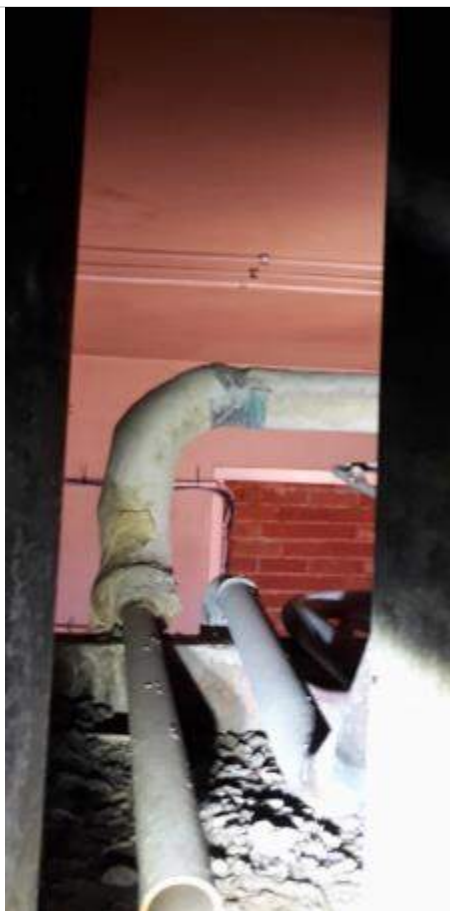
**Wrapped asbestos lagging on pipework – Similar to S07**

| <b>Location:</b> | Internal, Level 2, Services duct looking through to theatre sterilised water plant room |
| <b>Material Type:</b> | Wrapped asbestos lagging on pipework |
| <b>Condition:</b> | Generally intact |
| <b>Risk Assessment / Recommendation:</b> | High risk, material should be removed as soon as reasonably practicable. Access to the services ducts is generally restricted (locked). Although in a good condition, the wrapping could easily be penetrated. |

| <b>Reinspection / Removal Date:</b> | Remove material as soon as reasonably practicable and prior to refurbishment and/or demolition works |

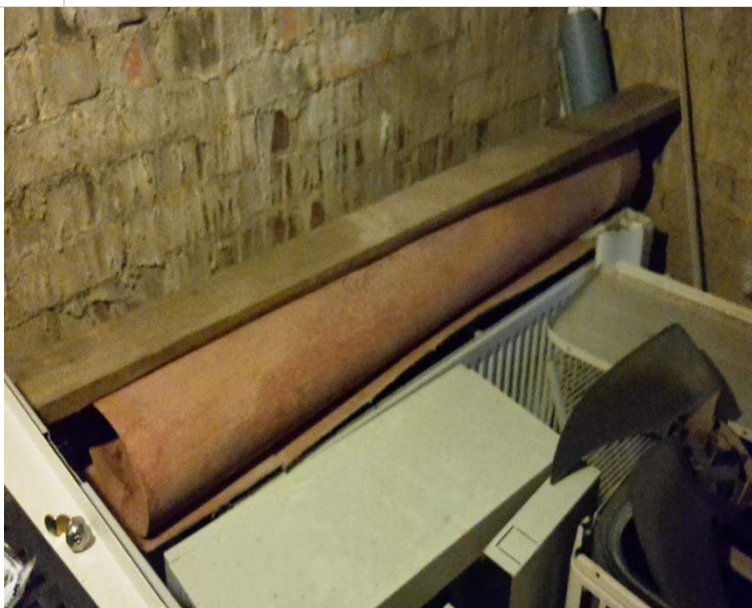
## Stored Material – S80

| <b>Location:</b> | Internal, Basement stored material |
| <b>Material Type:</b> | Gasket |
| <b>Condition:</b> | Generally intact |
| <b>Risk Assessment / Recommendation:</b> | Low risk, leave and maintain in current condition |

| <b>Reinspection / Removal Date:</b> | Remove prior to refurbishment / demolition works or reinspect in 5 years |

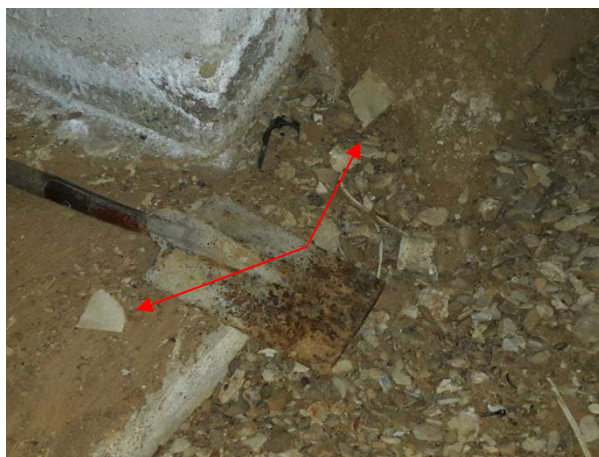
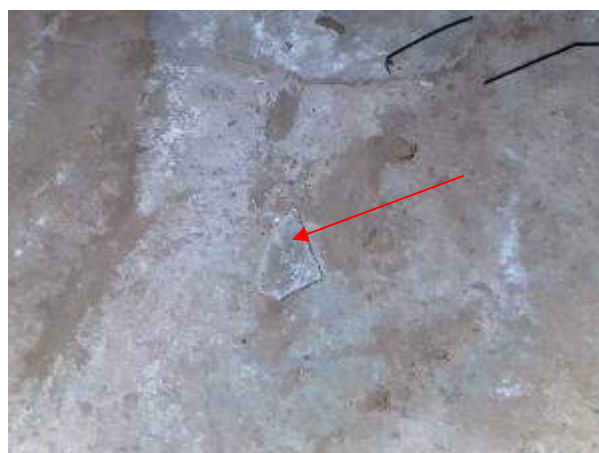
**Debris (fibre cement sheet) – S82**

| <b>Location:</b> | Internal, Basement, debris on ground |
| <b>Material Type:</b> | Debris (fibre cement sheet) |
| <b>Condition:</b> | Deteriorated with exposed unsealed edges |
| <b>Risk Assessment / Recommendation:</b> | Moderate risk, remove as soon as reasonably practicable |

| <b>Reinspection / Removal Date:</b> | Remove prior to refurbishment / demolition works or reinspect in 12 months |

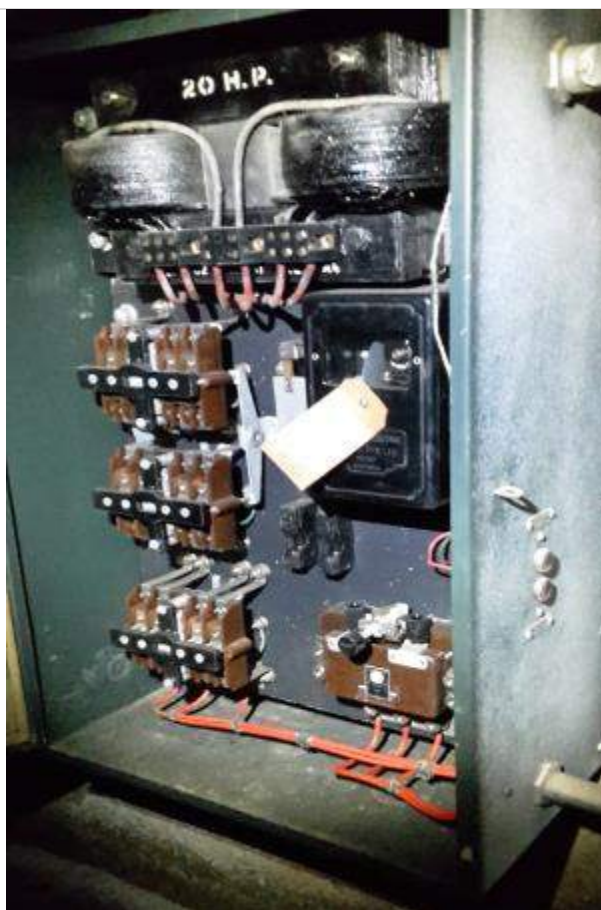
**Asbestos electrical backing board – S83**

| <b>Location:</b> | Internal, Basement, southern end of corridor |
| <b>Material Type:</b> | Asbestos electrical backing board |
| <b>Condition:</b> | Generally intact |
| <b>Risk Assessment / Recommendation:</b> | Low risk, leave and maintain in current condition |

| <b>Reinspection / Removal Date:</b> | Remove prior to refurbishment / demolition works or reinspect in 5 years |

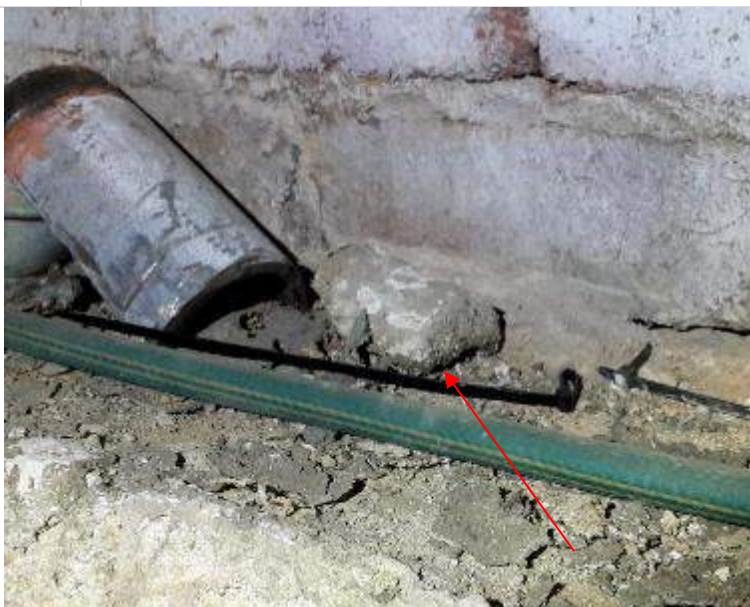
## Lagging debris – S84

| <b>Location:</b> | Internal, basement debris on ground western corridor |
| <b>Material Type:</b> | Wrapped asbestos lagging on pipework |
| <b>Condition:</b> | Generally intact |
| <b>Risk Assessment / Recommendation:</b> | High risk, material should be removed as soon as reasonably practicable. Access to this building is restricted (padlocked). Access to this area should be further restricted and there must be no disturbance of the ground surfaces and/or any suspect material to generate fugitive dust. |

| <b>Reinspection / Removal Date:</b> | Remove material as soon as reasonably practicable and prior to refurbishment and/or demolition works |

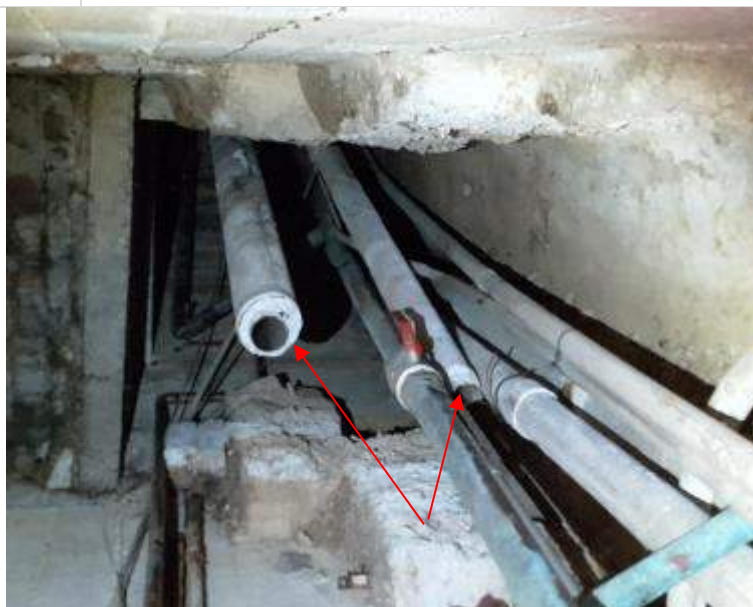
**Wrapped asbestos lagging on pipework – Similar to S07**

| <b>Location:</b> | Basement, plant room across basement and ground floor, pipework extending towards former boilerhouse |
| <b>Material Type:</b> | Wrapped asbestos lagging on pipework |
| <b>Condition:</b> | Generally intact |
| <b>Risk Assessment / Recommendation:</b> | High risk, material should be removed as soon as reasonably practicable. Access to this room is restricted (padlocked). The ends of the wrapping do not appear to be sealed. |

| <b>Reinspection / Removal Date:</b> | Remove material as soon as reasonably practicable and prior to refurbishment and/or demolition works |

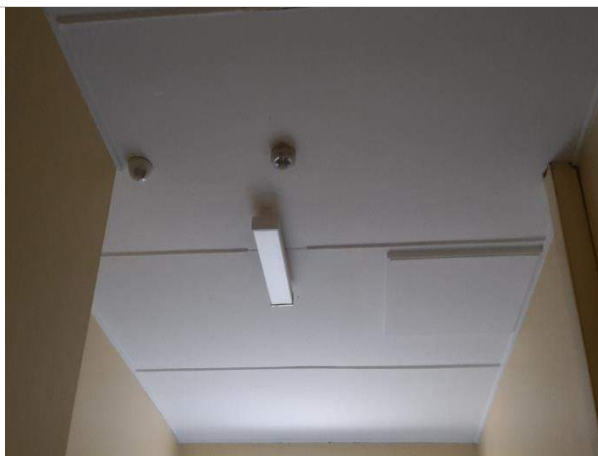
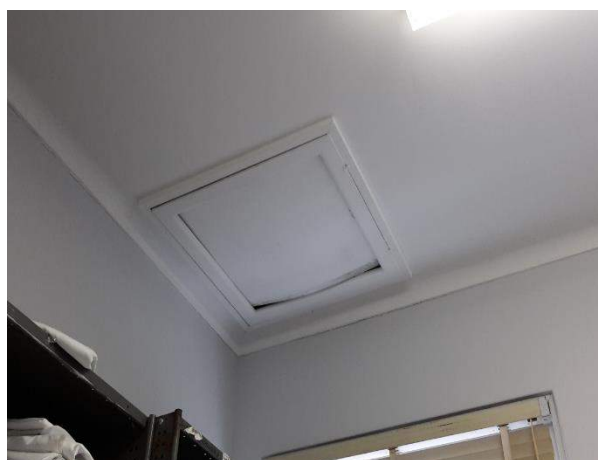
## Flat fibre cement sheet – S90

| <b>Location:</b> | Internal, ceiling linings to west facing rooms including toilets, former bathroom and adjacent rooms |
| <b>Material Type:</b> | Flat asbestos fibre cement sheet |
| <b>Condition:</b> | Generally intact |
| <b>Risk Assessment / Recommendation:</b> | Low risk, leave and maintain in current condition |

| <b>Reinspection / Removal Date:</b> | Remove prior to refurbishment / demolition works or reinspect in 5 years |

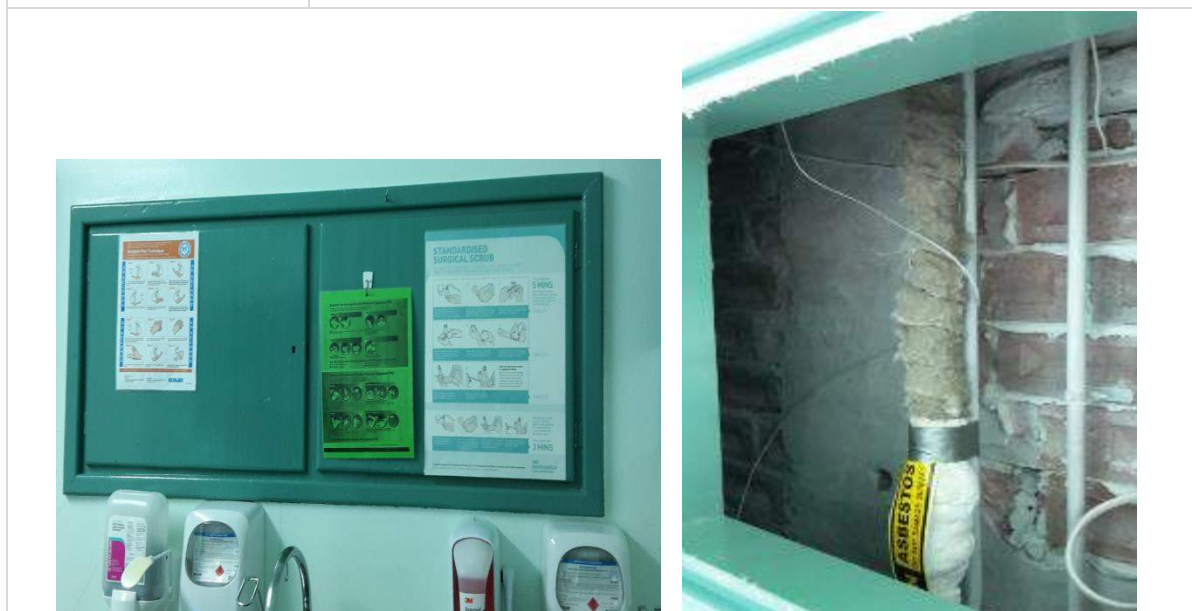
## Wrapped asbestos lagging on pipework – Similar to S07

| <b>Location:</b> | Internal, First floor cupboard in scrub room above sink (indicative of lagged pipework in service ducts throughout building) |
| <b>Material Type:</b> | Wrapped asbestos lagging on pipework |
| <b>Condition:</b> | Generally intact |
| <b>Risk Assessment / Recommendation:</b> | High risk, material should be removed as soon as reasonably practicable. Access to this cupboard and the ceiling space is generally restricted (padlocked and/or via ladder). Although in a good condition, the wrapping could easily be penetrated. |

| <b>Reinspection / Removal Date:</b> | Remove material as soon as reasonably practicable and prior to refurbishment and/or demolition works |

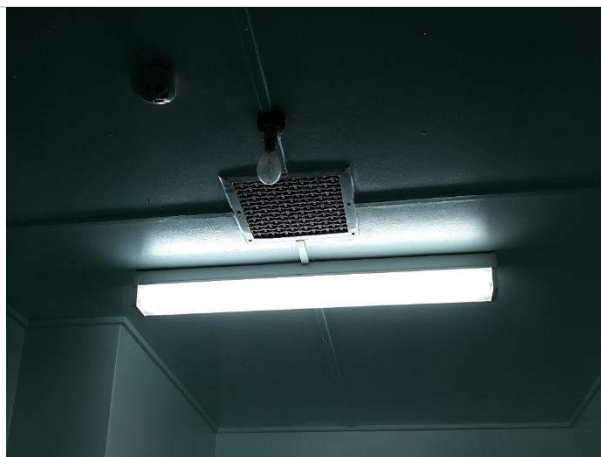
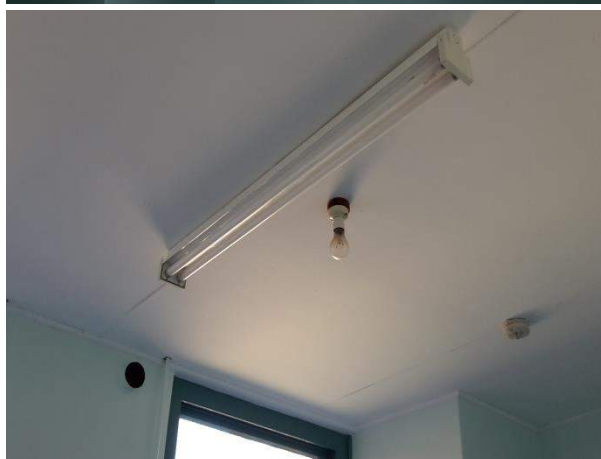
**Flat fibre cement sheet – Not sampled (sterile area)**

| <b>Location:</b> | Internal, first floor, scrub room and wash room, ceiling lining |
| <b>Material Type:</b> | Flat asbestos fibre cement sheet |
| <b>Condition:</b> | Generally intact |
| <b>Risk Assessment / Recommendation:</b> | Low risk, leave and maintain in current condition |

| <b>Reinspection / Removal Date:</b> | Remove prior to refurbishment / demolition works or reinspect in 5 years |

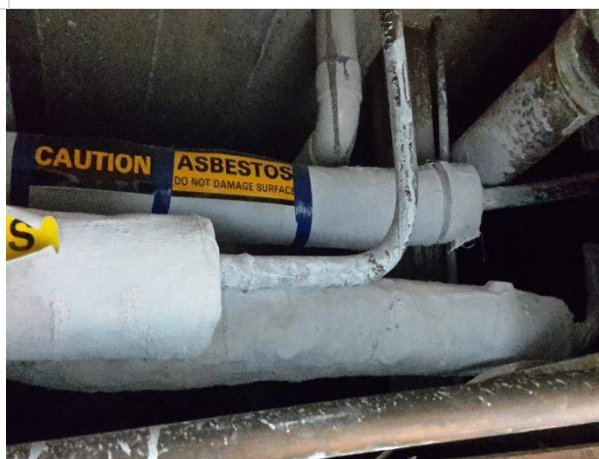
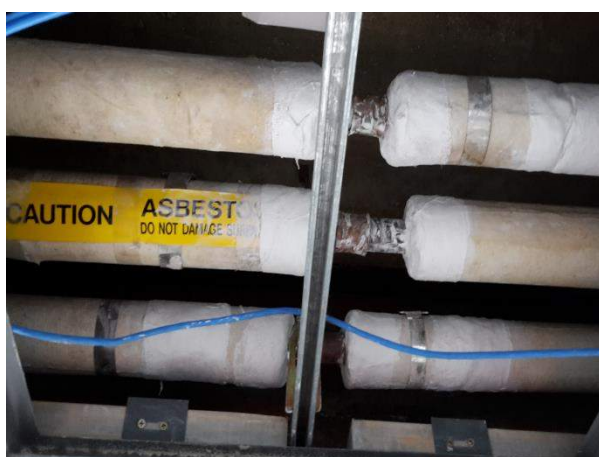
**Wrapped asbestos lagging on pipework – Similar to S07**

| <b>Location:</b> | Internal, first floor ceiling space, pipework |
| <b>Material Type:</b> | Wrapped asbestos lagging on pipework |
| <b>Condition:</b> | Generally intact |
| <b>Risk Assessment / Recommendation:</b> | High risk, material should be removed as soon as reasonably practicable. Access to this area is generally restricted (via ladder). Although the wrapped appears to be in good condition, it could be easily penetrated. |

| <b>Reinspection / Removal Date:</b> | Remove material as soon as reasonably practicable and prior to refurbishment and/or demolition works |

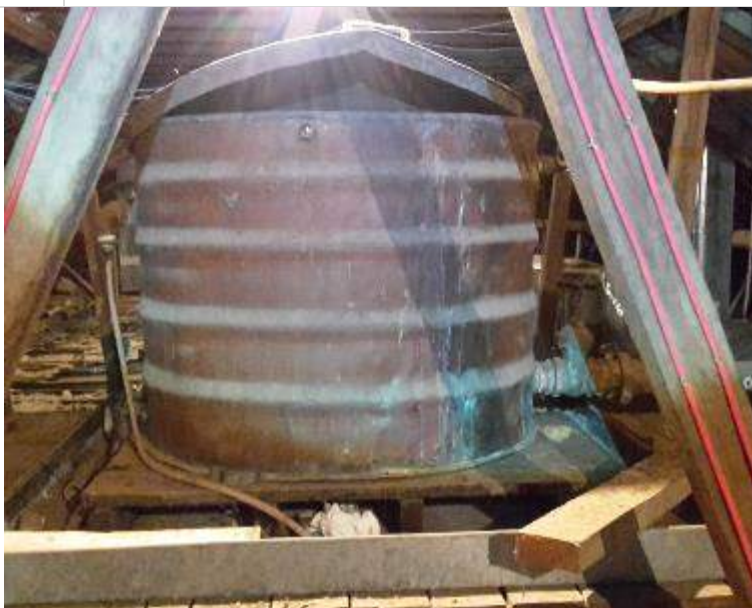
**Water tank insulation – Not sampled (access restriction)**

| <b>Location:</b> | Internal, first floor ceiling space over theatres, water tank |
| <b>Material Type:</b> | Water tank insulation |
| <b>Condition:</b> | Generally contained |
| <b>Risk Assessment / Recommendation:</b> | Low risk, leave and maintain in current condition |

| <b>Reinspection / Removal Date:</b> | Remove prior to refurbishment / demolition works or reinspect in 5 years |

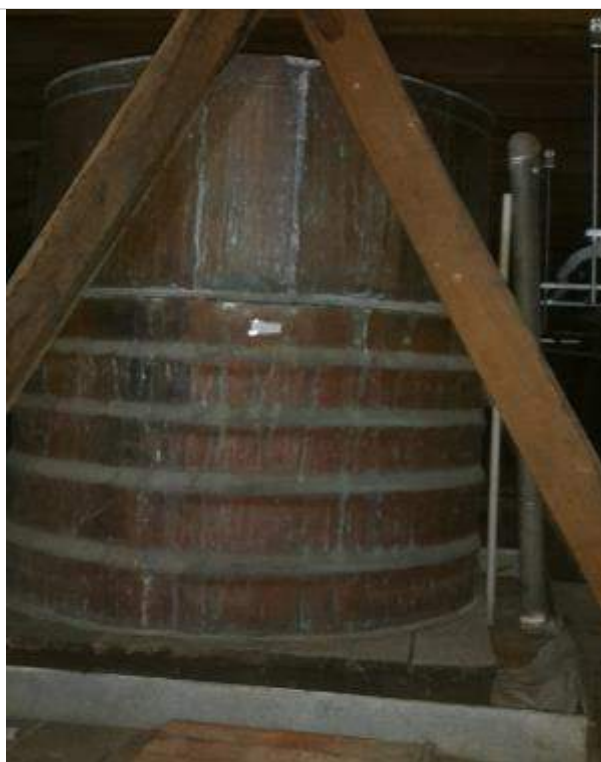
**Water tank insulation – Not sampled (access restriction)**

| <b>Location:</b> | Internal, second floor ceiling space northern end of building, water tank |
| <b>Material Type:</b> | Water tank insulation |
| <b>Condition:</b> | Generally contained |
| <b>Risk Assessment / Recommendation:</b> | Low risk, leave and maintain in current condition |

| <b>Reinspection / Removal Date:</b> | Remove prior to refurbishment / demolition works or reinspect in 5 years |

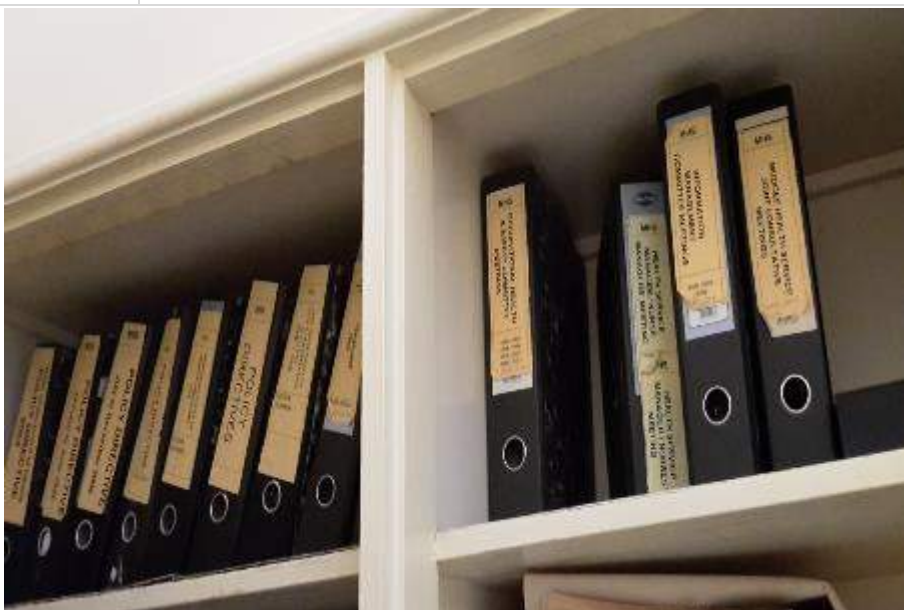
## Flat fibre cement sheet – S94

| <b>Location:</b> | Level 2, Room #223 cupboard lining |
| <b>Material Type:</b> | Flat asbestos fibre cement sheet |
| <b>Condition:</b> | Generally intact |
| <b>Risk Assessment / Recommendation:</b> | Low risk, leave and maintain in current condition |

| <b>Reinspection / Removal Date:</b> | Remove prior to refurbishment / demolition works or reinspect in 5 years |

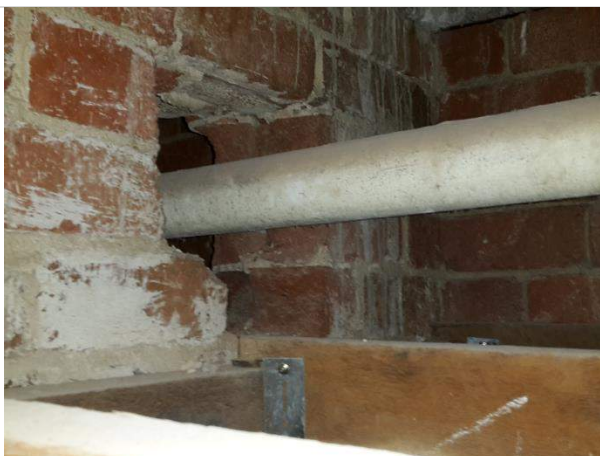
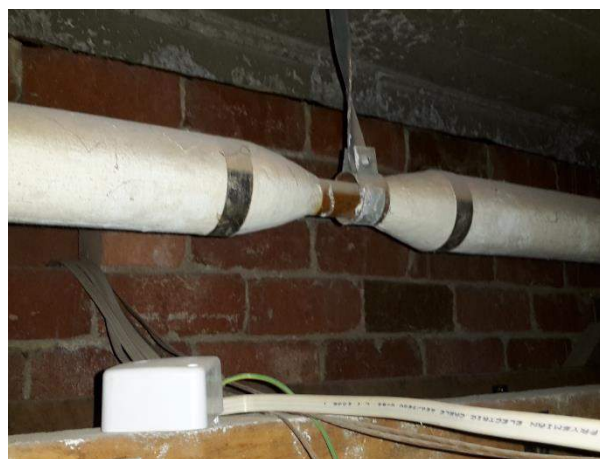
**Wrapped asbestos lagging on pipework – Similar to S07**

| <b>Location:</b> | Internal, Ground floor ceiling space |
| <b>Material Type:</b> | Wrapped asbestos lagging on pipework |
| <b>Condition:</b> | Generally intact |
| <b>Risk Assessment / Recommendation:</b> | High risk, material should be removed as soon as reasonably practicable. Access to this cupboard and the ceiling space is generally restricted (padlocked and/or via ladder). Although in a good condition, the wrapping could easily be penetrated. |

| <b>Reinspection / Removal Date:</b> | Remove material as soon as reasonably practicable and prior to refurbishment and/or demolition works |

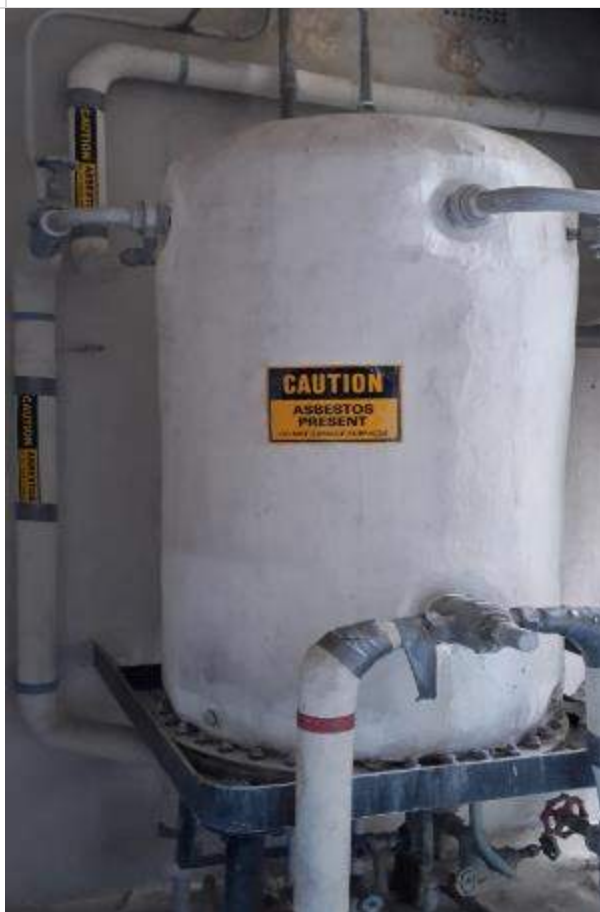
**Lagged water tank – Similar to S07**

| <b>Location:</b> | Internal, Level 2, theatre sterilised water plant room, water tank and associated pipework |
| <b>Material Type:</b> | Lagging |
| <b>Condition:</b> | Generally intact |
| <b>Risk Assessment / Recommendation:</b> | High risk, material should be removed as soon as reasonably practicable. Access to this cupboard and the ceiling space is generally restricted (padlocked and/or via ladder). Although in a good condition, the wrapping could easily be penetrated. |

| <b>Reinspection / Removal Date:</b> | Remove material as soon as reasonably practicable and prior to refurbishment and/or demolition works |

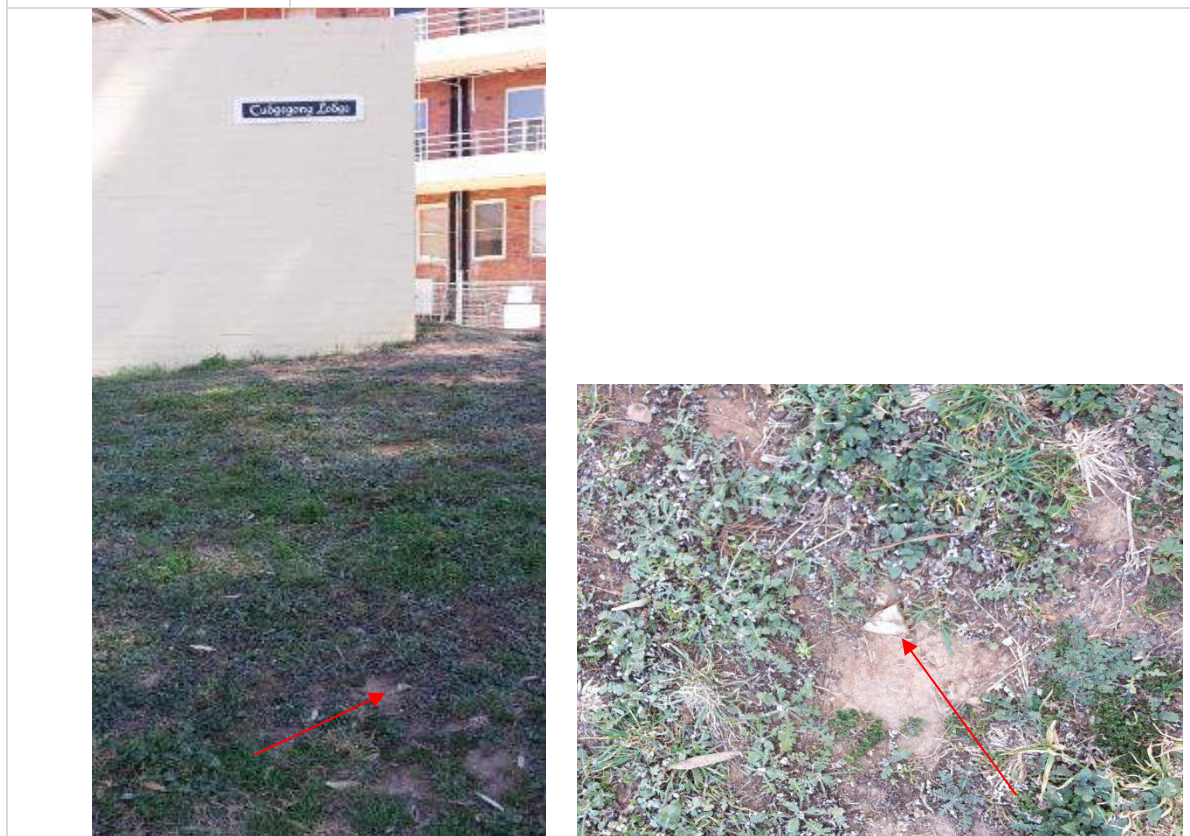
## Debris fibre cement – S95

| <b>Location:</b> | External hospital grounds between main hospital / workshop / training centre |
| <b>Material Type:</b> | Debris - asbestos fibre cement |
| <b>Condition:</b> | Generally intact |
| <b>Risk Assessment / Recommendation:</b> | Moderate risk, remove as soon as reasonably practicable. The fragment identified was obtained as the sample. Considering the findings of the survey it is likely that additional fragments would be identified on the ground surface and or following heavy rainfall. A walkover inspection of the hospital grounds should be undertaken to visually inspect the site surface for any further evidence of asbestos containing materials. |

| <b>Reinspection / Removal Date:</b> | Undertake inspection of ground surface as soon as reasonably practicable and reinspect every 12 months. |
