| Mudgee District Hospital, Meares Street, Mudgee, NSW<br>Hazardous Building Materials Register - September 2017 | | | | | | | | | |

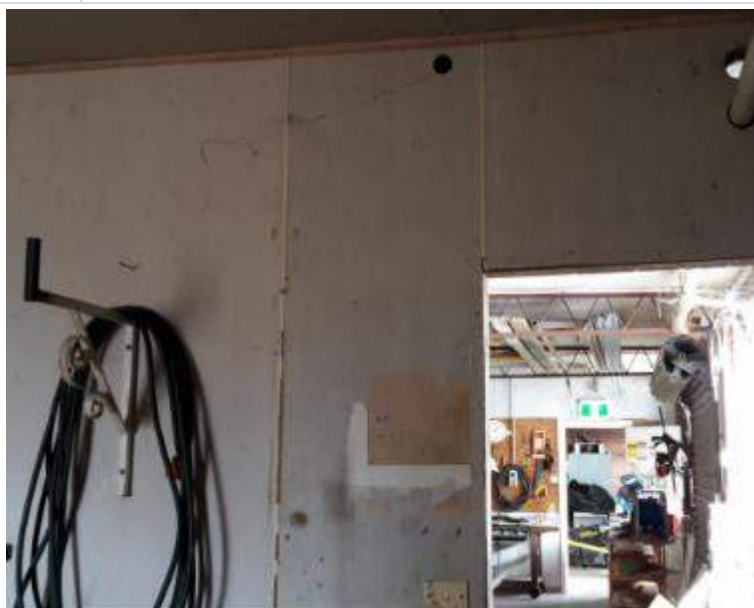
| <b>Condition:</b> | Generally intact |
| <b>Risk Assessment / Recommendation:</b> | Low risk, leave and maintain in current condition |

| <b>Reinspection / Removal Date:</b> | Remove prior to refurbishment / demolition works or reinspect in 5 years |

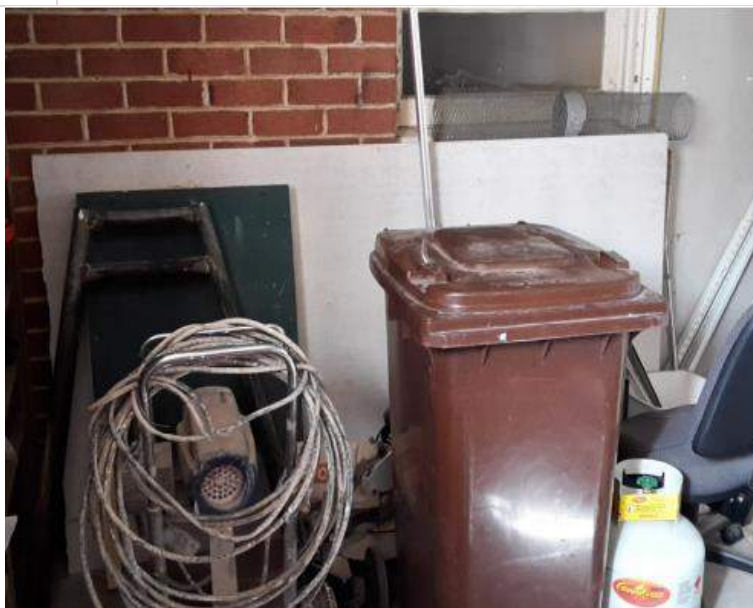
## FLAT FIBRE CEMENT SHEET – S03

| <b>Condition:</b> | Generally intact |
| <b>Risk Assessment / Recommendation:</b> | Low risk, leave and maintain in current condition |

| <b>Reinspection / Removal Date:</b> | Remove prior to refurbishment / demolition works or reinspect in 5 years |

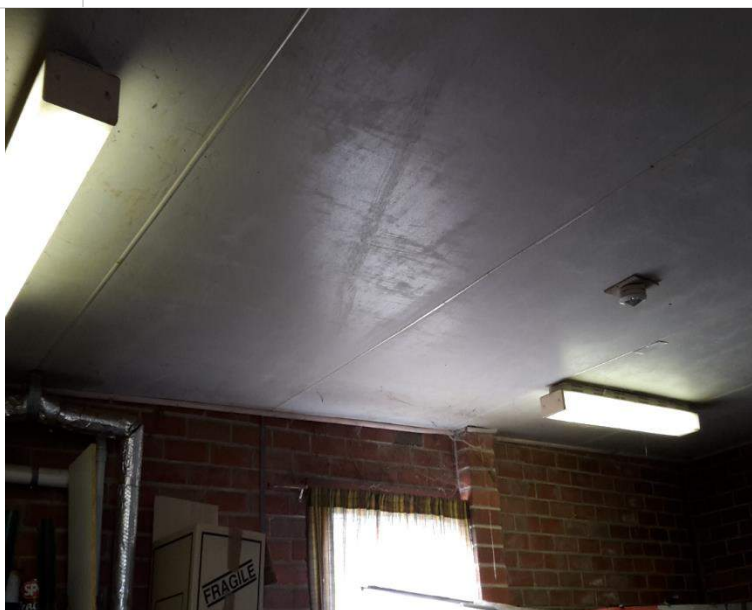
## FLAT FIBRE CEMENT SHEET – S04

| <b>Condition:</b> | Generally intact |
| <b>Risk Assessment / Recommendation:</b> | Low risk, leave and maintain in current condition |

| <b>Reinspection / Removal Date:</b> | Remove prior to refurbishment / demolition works or reinspect in 5 years |

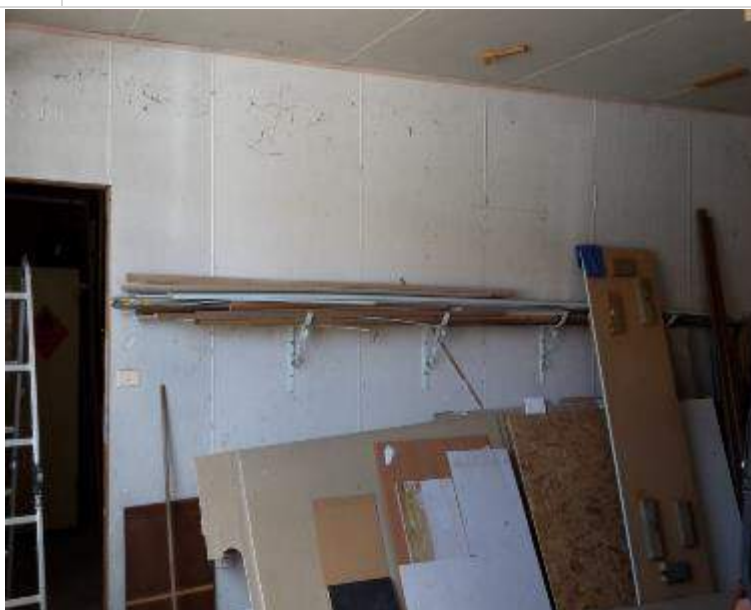
**FLAT FIBRE CEMENT SHEET – S05**

| <b>Condition:</b> | Generally intact |
| <b>Risk Assessment / Recommendation:</b> | Low risk, leave and maintain in current condition |

| <b>Reinspection / Removal Date:</b> | Remove prior to refurbishment / demolition works or reinspect in 5 years |

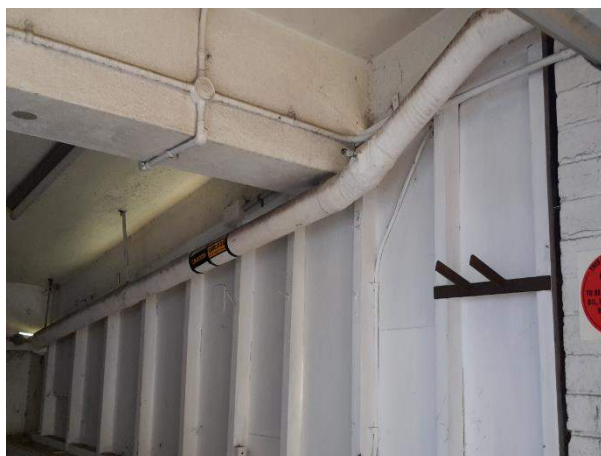
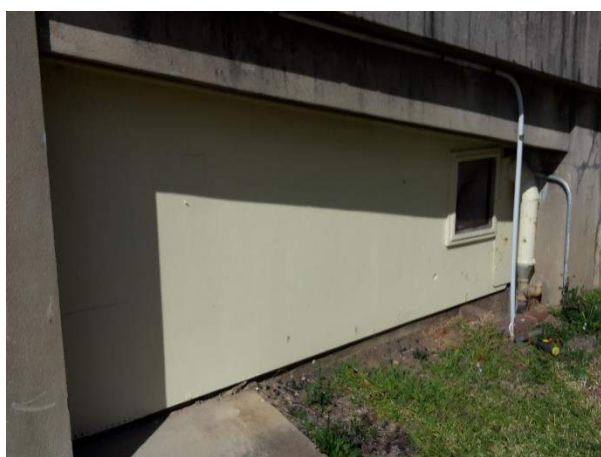
## FLAT FIBRE CEMENT SHEET – S06

| <b>Condition:</b> | Generally intact |
| <b>Risk Assessment / Recommendation:</b> | Low risk, leave and maintain in current condition |

| <b>Reinspection / Removal Date:</b> | Remove prior to refurbishment / demolition works or reinspect in 5 years |
