PRE-DEMOLITION HAZARDOUS BUILDING MATERIALS ASSESSMENT

Manager's Residence, French Forest Bushland Cemetery

85 Byron Road and 63 Ingleburn Road, Leppington NSW

5 NOVEMBER 2020

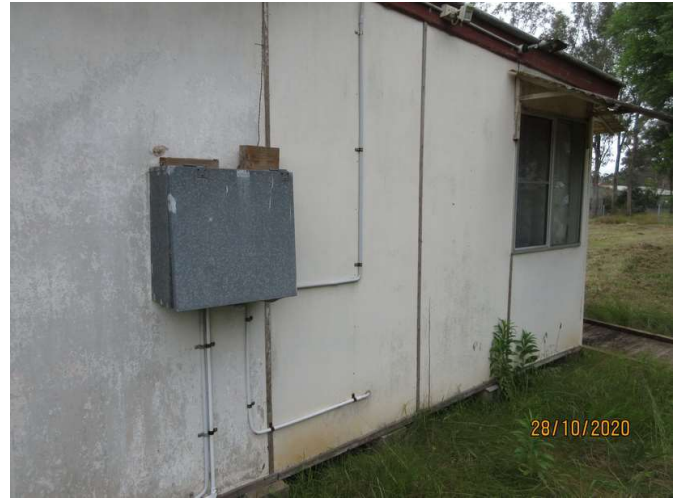
Item	Area / Level / Room / Location	Feature	Description	Hazmet Type	Sample No.	Result	Friability	Susceptibility	Condition	Risk Level	Estimated Extent	Recommendations	Priority	Review if Remains	Photo
Part A: Register of Asbestos															
Area 1 - Farm Residential Compound															
External Areas															
1	Front residential house	Building envelopes	Fibro sheet walls (double skinned) constructed as building envelopes to the house	Asbestos	820045-01	Positive	Non-Friable		Poor	Medium	150+sqm	To be removed by a licensed asbestos removalist with clearance certificate issued by a LAA	P4		1-01
2	Front house	triangle gable wall to eastern elevation (front)	Cement board	Asbestos	similar to 820045-01	Presumed Positive	Non-Friable		Fair	Medium	10sqm	To be removed by a licensed asbestos removalist with clearance certificate issued by a LAA	P4		1-01
3	Southern elevation	Power switch box	black backing panel in switch box and potential switches	Asbestos	N/A	Presumed Positive	Non-Friable		Fair	Low	1 sqm	To be removed by a licensed asbestos removalist with clearance certificate issued by a LAA	P4		1-02

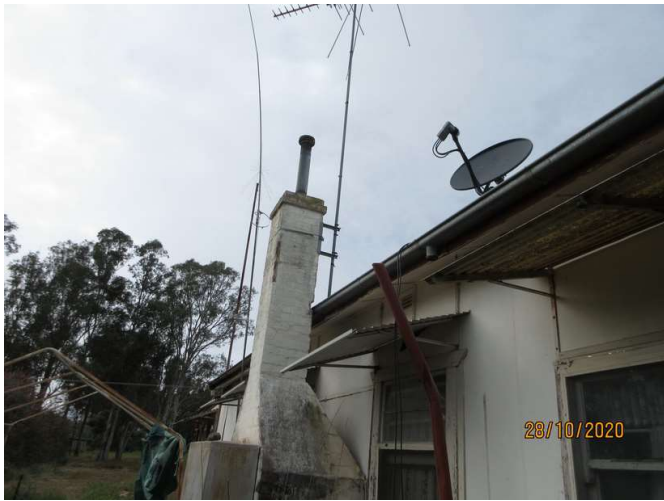
4	Roof Eave line	Soffit board	Fiber cement sheets	Asbestos	N/A	Presumed Positive	Non-Friable		Fair	Medium	15+sqm	To be removed by a licensed asbestos removalist with clearance certificate issued by a LAA	P4		1-03
5	Sub-floor space	Loose cement board	Fiber cement sheets	Asbestos	N/A	Presumed Positive	Non-Friable		Poor	Medium	5+sqm	Search the entire sub-floor space for any stored cement sheet; To be removed by a licensed asbestos removalist with clearance certificate issued by a LAA	P4		1-04, 1-05, 1-06
6	Sub-floor space	Under laundry	Waste water discharge pipe	Asbestos	Similar to 820045-03	Presumed Positive	Non-Friable		Fair	Low	2m	To be removed by a licensed asbestos removalist with clearance certificate issued by a LAA	P4		1-07
7	North and western external areas adjacent to the house	Rubbish piles	Loose fibre cement boards and pipe	Asbestos	820045-03	Positive	Non-Friable		Poor	Medium		To be removed by a licensed asbestos removalist with clearance certificate issued by a LAA ; All associated fibre cement debris nearby to be treated as ACM and removed together	P4		1-08, 1-09, 1-10

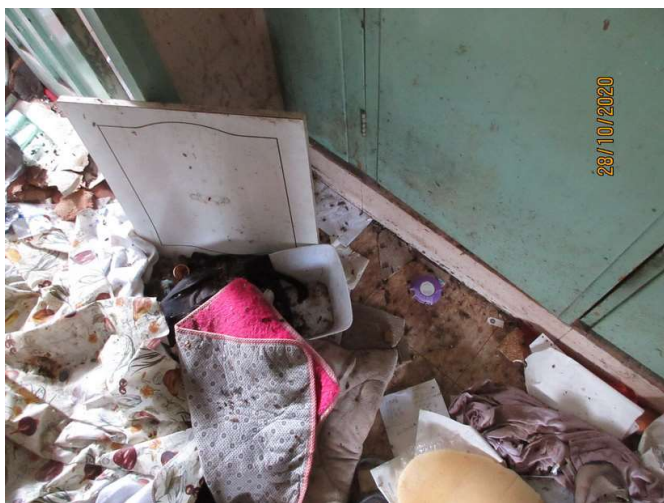
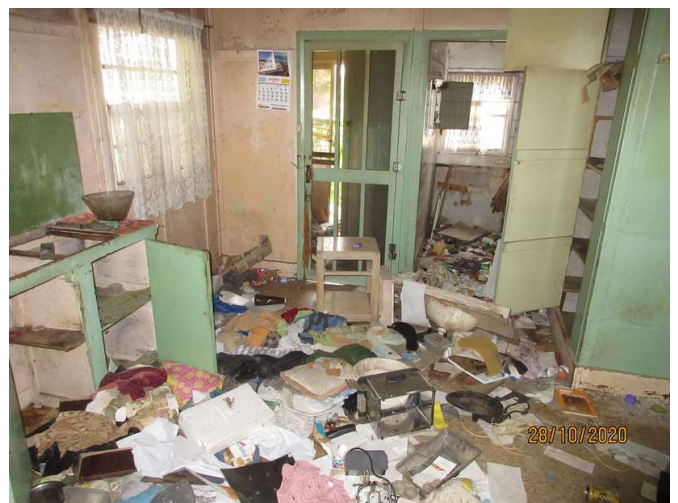
8	Timber windows	Window putty	Window putty	Asbestos	820045-14	Negative	Non-Friable		Poor	Low		No asbestos control measures required when remove this item			1-35, 1-36
Internal Rooms of the Front House															
9	Loose rubbish	Throughout internal area	Potential contamination of loose fill asbestos	Asbestos	N/A	Positive	Friable	High	Poor	High		Considering possible Friable contamination to all floor areas, all items be removed by a Class A licensed asbestos removalist with clearance certificate issued by a LAA	P1		1-11, 1-12

The engagement of a well trained Class A asbestos removalist is required to remove the identified asbestos containing materials, together with the rubbish within the internal area of Area 1 main house, which is considered to have been contaminated with asbestos due to the highly damaged Mr. Fluffy loose fill fire proof in the fireplace in the lounge room.

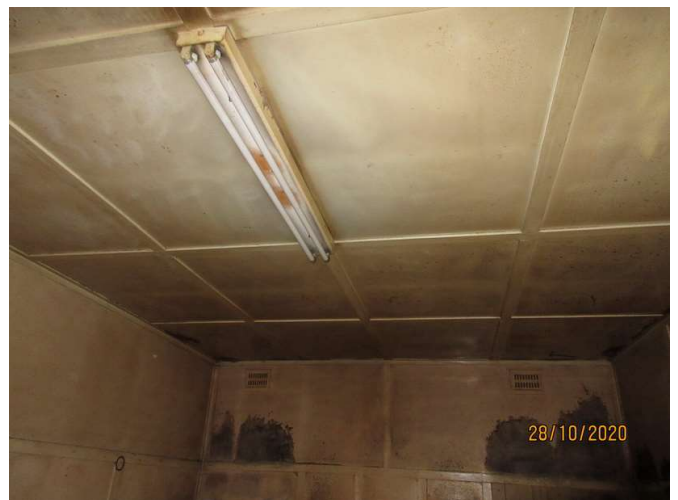
Item	Area / Level / Room / Location	Feature	Description	Hazmet Type	Sample No.	Result	Friability	Susceptibility	Condition	Risk Level	Estimated Extent	Recommendations	Priority	Review if Remains	Photo
10	Laundry	Internal wall lining	Fiber cement sheets	Asbestos	820045-02	Positive	Non-Friable		Poor	Medium	5+sqm	To be removed by a licensed asbestos removalist with clearance certificate issued by a LAA			1-13
11	Laundry and kitchen	Flooring	Vinyl floor tiles	Asbestos	820045-04	Positive	Non-Friable	—	Fair			Considering possible Friable contamination to all floor areas, item be removed by a Class A licensed asbestos removalist with clearance certificate issued by a LAA			1-14, 1-15
12	Laundry and kitchen	Ceiling	Cement board ceiling with evident damages	Asbestos	820045-06, 820045-07	Positive	Non-Friable	—	Poor	Medium	20+sqm	To be removed by a licensed asbestos removalist with clearance certificate issued by a LAA			1-16

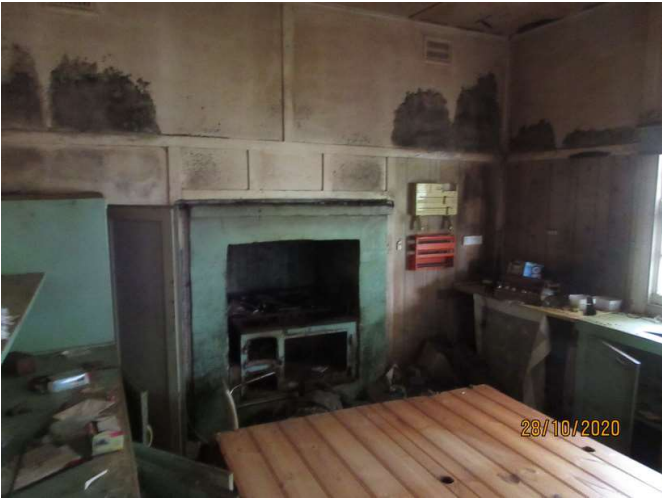
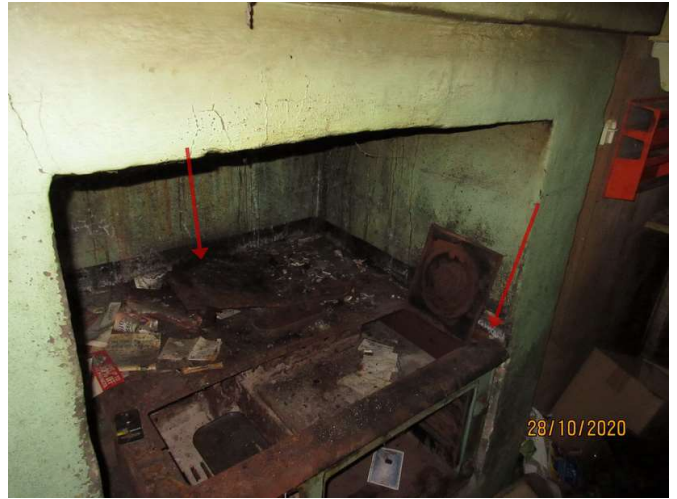
13	Bathroom next to laundry	ceiling and wall board	Fiber cement sheets	Asbestos	similar to those in the kitchen	Positive	Non-Friable		Poor	Medium	10+sqm	To be removed by a licensed asbestos removalist with clearance certificate issued by a LAA			1-17
14	Kitchen floor	Floor area next to door to lounge room	Floor dust wipe	Asbestos	820045-08	Positive	Friable		Poor	High	20+sqm	To be removed together with all loose rubbishes by a Class A licensed asbestos removalist with clearance certificate issued by a LAA	P1		1-18
15	Kitchen	Damaged wood fire oven	Potential presence of loose fill fire stop concealed behind the oven	Asbestos	N/A	Presumed Positive	Friable		Poor	High	1 item	If positively identified, immediately contact a LAA for a further investigation. Item to be removed together with all loose rubbishes by a Class A licensed asbestos removalist with clearance certificate issued by a LAA	P1		1-19, 1-20

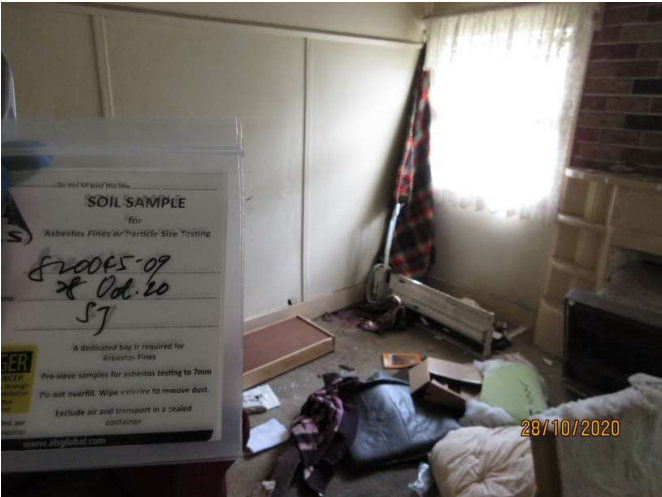
16	Lounge room	Internal wall lining	Fiber cement sheets	Asbestos	820045-09	Positive	Non-Friable		Poor	Medium	20+sqm	To be removed by a licensed asbestos removalist with clearance certificate issued by a LAA	P4		1-21
17	Lounge room	Electrical heater installed in old fire place	Loose fill insulation	Asbestos	820045-10	Positive	Friable	High	Poor	High	1 item	To be removed by a licensed asbestos removalist with clearance certificate issued by a LAA Internal sides of the old fire place to be clean in conjunction with the Class A removal works	P1		1-22 to 1-24
18	Lounge room	Ceiling	Fiber cement sheets	Asbestos	similar to 820045-09	Presumed Positive	Non-Friable		Fair	Medium	15+sqm	To be removed by a licensed asbestos removalist with clearance certificate issued by a LAA	P4		1-25
19	Hall way	ceiling and wall board	Fiber cement sheets	Asbestos	similar to 820045-09	Presumed Positive	Non-Friable		Fair	Medium	15+sqm	To be removed by a licensed asbestos removalist with clearance certificate issued by a LAA	P4		1-26

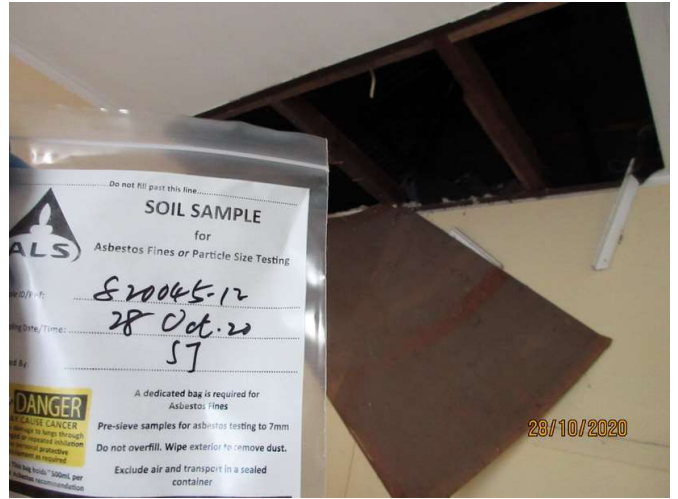
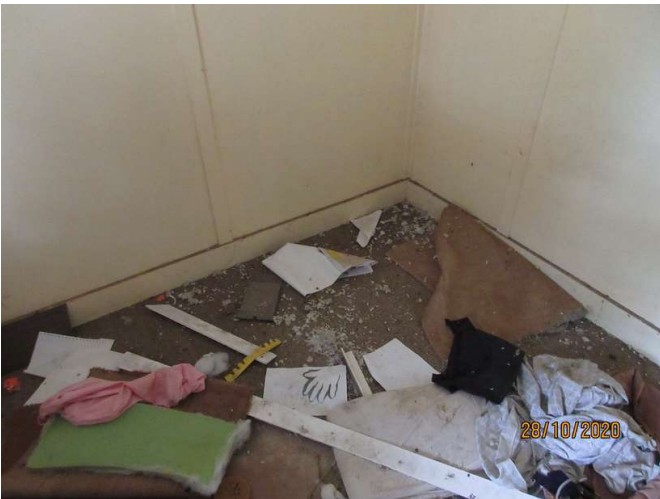
Item	Area / Level / Room / Location	Feature	Description	Hazmet Type	Sample No.	Result	Friability	Susceptibility	Condition	Risk Level	Estimated Extent	Recommendations	Priority	Review if Remains	Photo
21	Bedroom (blue)	ceiling	Fiber cement sheets	Asbestos	similar to 820045-09	Presumed Positive	Non-Friable		Fair	Medium	10sqm	To be removed by a licensed asbestos removalist with clearance certificate issued by a LAA	P4		1-30
22	Lounge room	Carpet underlay	Bituminous sheet insulation	Asbestos	820045-11	Negative	Non-Friable		Fair	—		No asbestos containing sheet but contamination of loose fill asbestos to the carpet must be considered			1-31
23	Roof space	Damaged ceiling access in yellow bed room	loose insulation clumps from damaged water tank	Asbestos	820045-12	Negative	Friable		Poor	—	5+sqm	No asbestos containing sheet but contamination of loose fill asbestos to the carpet must be considered			1-32, 1-33

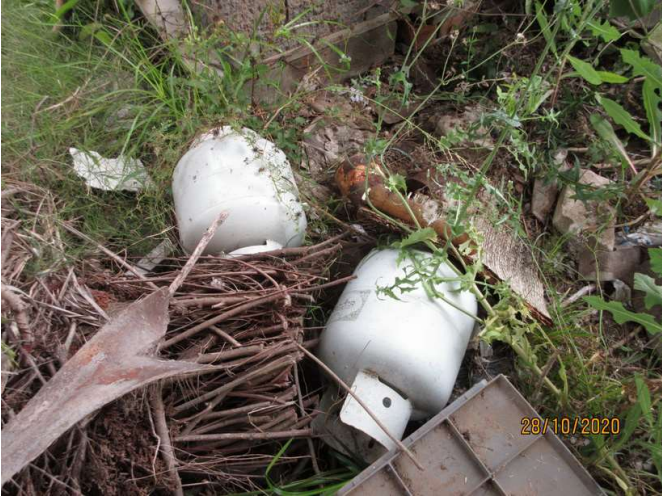
Part D: Ozone Depleted Refrigerants															
41	Rear residential House (Area 2)	Main lounge room in the middle	Wall mount TECO split air conditioning	Ozone-Depleting	R22	Positive		High	Poor	Medium	about 3-4 kg	The compressor could be installed on the roof Refrigerant to be extract by a licensed electrician prior to the removal for a safe disposal	P2		1-59, 1-60
Part E: Other Hazmat (Toxic, Flammable Liquide, Corrosives Chemicals)															
42	Area-1 main house	BBQ stall at rear awning	Two 9L gas cylinders	Other	Possible flammable gas containing	Presumed Positive	—	Low	Fair	Low		To be carefully collected for a safe disposal	—		1-61

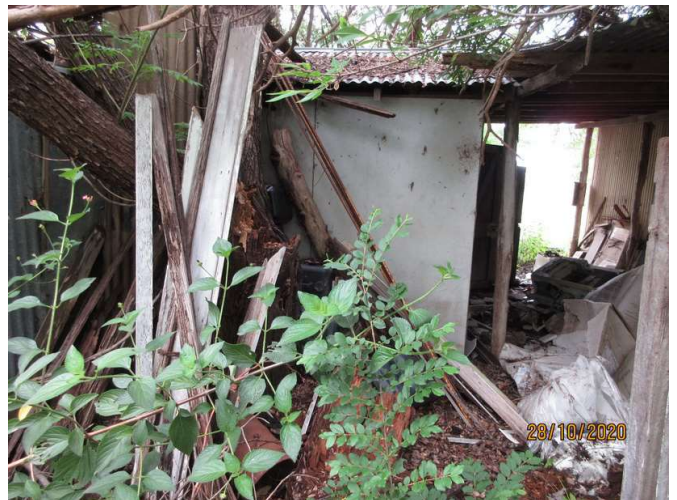
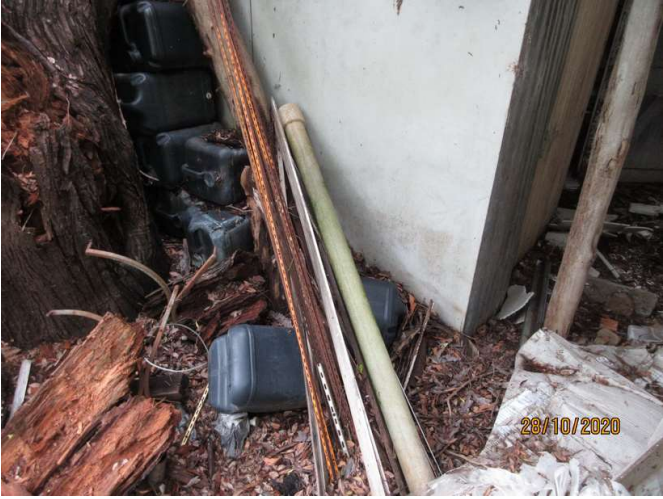
More than 15 black plastic containers were observed stacked against the back of rear workshop at Area 1. Unknown liquid contents were noted. No labels were evident on these containers. Given the property was an agricultural land use, the containers could contain or were used for pesticides or farming chemicals. Further investigation is required prior to a safe disposal.

Item	Area / Level / Room / Location	Feature	Description	Hazmet Type	Sample No.	Result	Friability	Susceptibility	Condition	Risk Level	Estimated Extent	Recommendations	Priority	Review if Remains	Photo
43	Area-1 main house	Internal rooms	Loose syringe and needles, Loose cans and glass bottles	Other	Potential bio-hazard	Presumed Positive	—	High	Poor	High		Loose cans and glass bottles could also be used for suspected drug abuse; All suspected bio-hazard contaminated items to be carefully collected for a safe disposal	P1		1-62 to 1-65
44	Area 1- Metal farm shed	Black containers behind the shed	Unknown liquid substance contained	Toxic	Potential chemical hazard	Presumed Positive	—	High	Fair	High		Further investigation to be carried out	P1		1-66, 1-67
