Amity College

Pre-Construction Dilapidation Assessment

63 Ingleburn Road & 85 Byron Road,
Leppington, NSW

P1806493JR03V01
December 2020

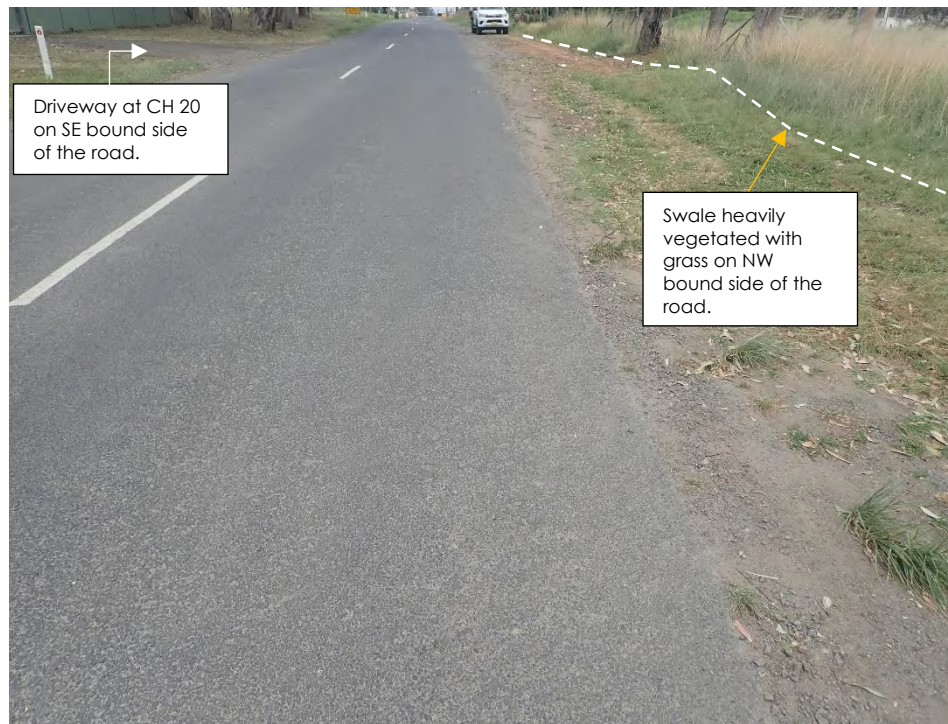
Photo 1: Looking southwest from CH 0 m to CH 40 m.

Chainage (approx.)	Comments	Photo No.
0 m – 20 m	No damage observed in the pavement.	Refer to Photo 1
	Unsealed driveway at CH 20 m on SE bound side of the road.	
	Swale heavily vegetated with grass on NW bound side of the road	
20 m – 40 m	No damages observed.	
40 m – 60 m	Shoulder deterioration of the pavement observed.	Refer to Photo 2
	Barbed wire fence on NW bound side of the road.	
	Existing utility pole at the CH 55 m on the NW bound side of the road.	Refer to Photo 3
	Repaired asphalt layer joints observed on SE bound side of the road.	Refer to Photo 4
60 m – 80 m	Existing site entrance at CH 60 m on NW side of the road.	Refer to Photo 5
80 m – 100 m	Asphalt repair joints at SE bound side of the road.	Refer to Photo 6
	Shoulder deterioration at NW bound side of the road.	
	Swale heavily vegetated with grass on NW bound side of the road	
100 m – 120 m	Asphalt repair joint cracks in central part of the pavement.	Refer to Photo 7

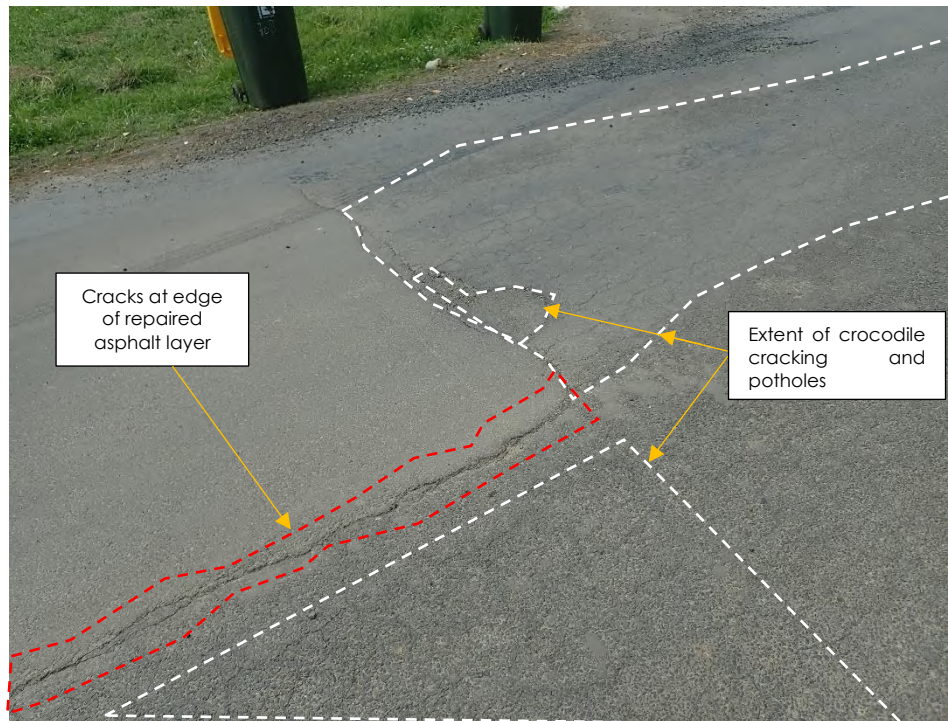
Photo 8: Looking southwest from CH 105 m.

Driveway at CH 110 m on SE bound side of the road.	
	Potholes, crocodile cracking and asphalt repair joint cracks at SE bound side of the road.	Refer to Photo 8
	Shoulder degradation and crocodile cracking on SE bound side of the road.	Refer to Photo 9 and Photo 10
	Swale heavily vegetated with grass on NW bound side of the road	Refer to Photo 11
120 m – 140 m	Existing utility pole at the CH 122 m on the NW bound side of the road.	Refer to Photo 12

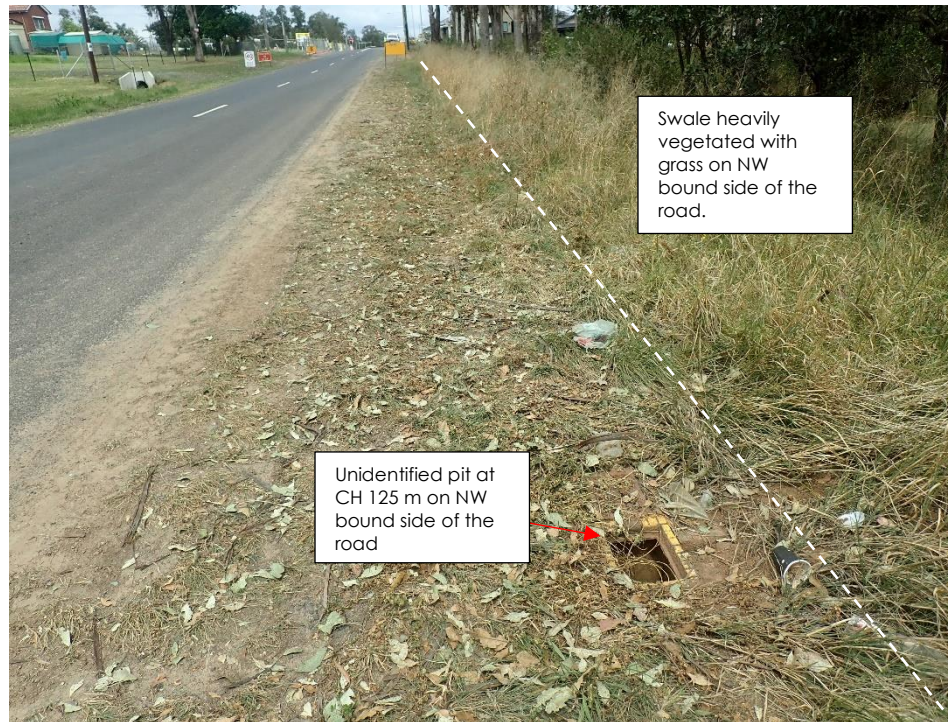
Photo 13: Looking southwest from CH 122 m to CH180 m.

Chainage (approx.)	Comments	Photo No.
	Unidentified pit at CH 125 m on NW bound side of the road.	Refer to Photo 13
	Swale heavily vegetated with grass on NW bound side of the road	
140 m – 160 m	No damage observed.	Refer to Photo 13
160 m – 180 m	Driveway at CH 180 m on SE bound side of the road	Refer to Photo 14
	Stormwater outlet in a poor condition on SE bound side of the road at CH 180 m.	
	Clogging of the table drains on SE bound side of the road from approximately CH 178 m to CH 160 m.	Refer to Photo 15
180 m – 200 m	Traffic sign boards on NW bound side of the road.	Refer to Photo 16
	Wheel marks, ruts and grass and trees covered areas on the NW bound side of the road.	Refer to Photo 16 and Photo 17
200 m – 220m	No damage observed.	Refer to Photo 17
220 m – 240 m	Shoulder deterioration on the NW bound side of the road.	Refer to Photo 18
	Existing utility poles observed at CH 225 m on the NW bound side of the road.	Refer to Photo 18

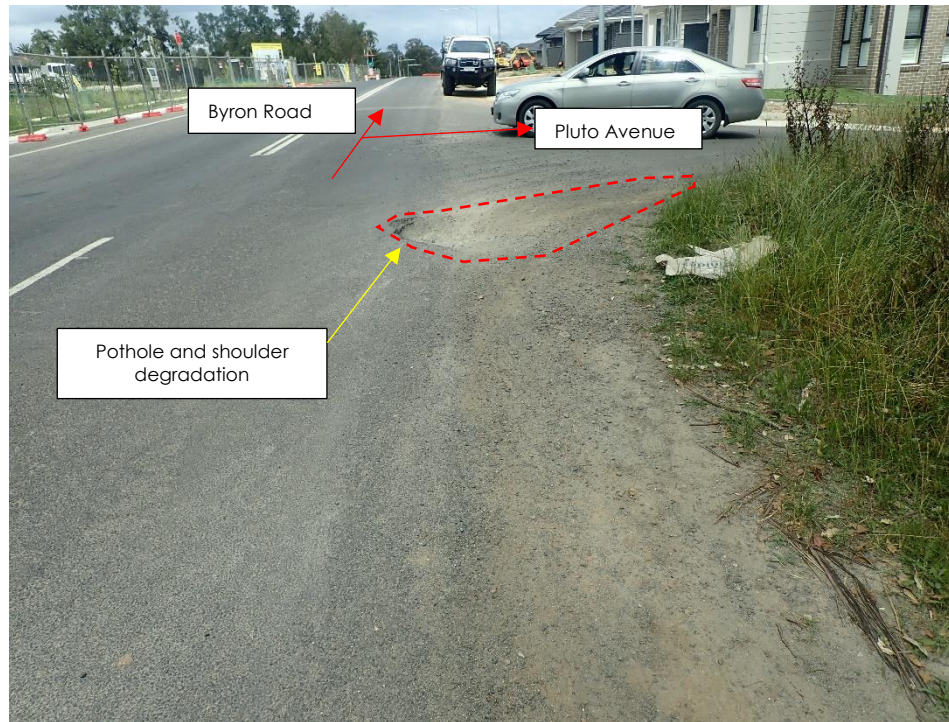
Photo 19: Looking southwest from CH 230 m.

Pothole and shoulder degradation at the corner of the intersection of Byron Road and Pluto Avenue	Refer to Photo 19
	Crocodile cracking observed at SE bound side of the road at CH 237 m.	Refer to Photo 20
	Temporary site entrance through damaged barbed wire fence at the corner of intersection of Byron Road and Pluto Avenue.	Refer to Photo 21
240 m – 260 m	No damage observed.	Refer to Photo 22
260 m – 280 m	No damage observed.	Refer to Photo 22
280 m – 300 m	No damage observed.	Refer to Photo 22
300 m – 320m	No damage observed.	Refer to Photo 23
320 m – 340 m	No damage observed.	Refer to Photo 23
340 m – 360 m	No damage observed.	Refer to Photo 24
360 m – 380 m	No damage observed.	Refer to Photo 24
380 m – 400 m	No damage observed.	Refer to Photo 24
