96-104 Carlingford Road, Epping NSW 2121

Epping West Public School

DILAPIDATION REPORT

7<sup>th</sup> September 2021

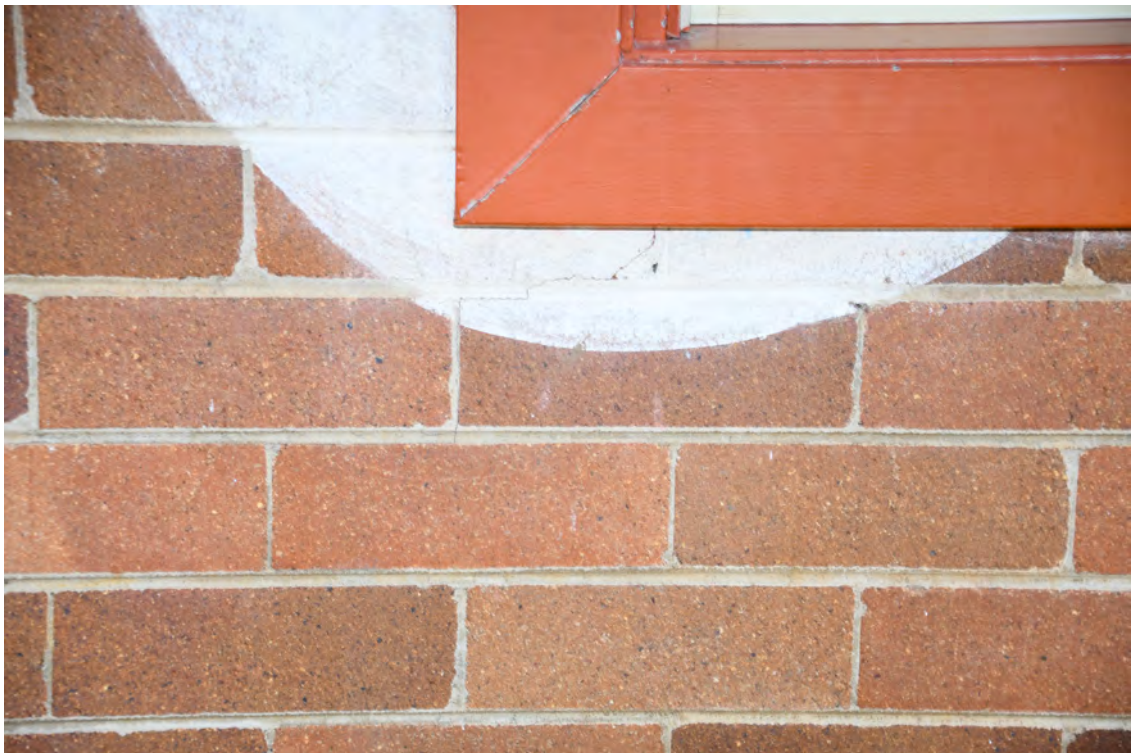
PRO\_0008.jpg

Block H. Northern elevation. Heading east. Cracked mortar bed.

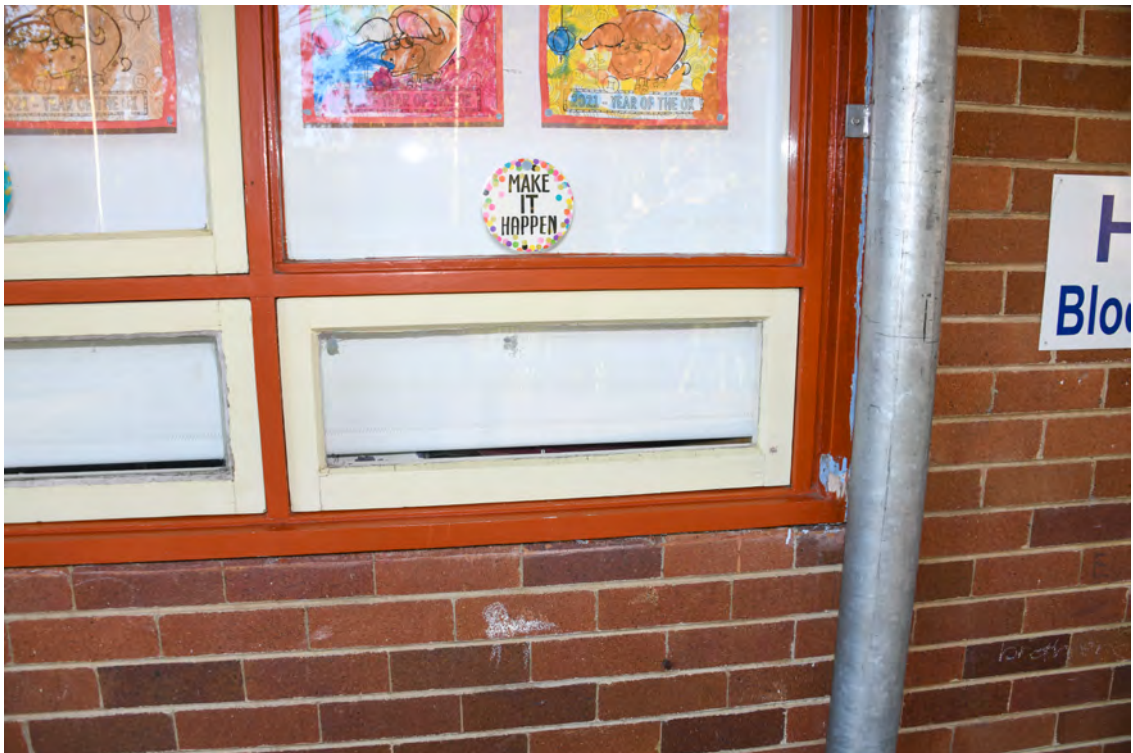
PRO\_0020.jpg

Block H. Northern elevation. Western end. Cracked glazing.

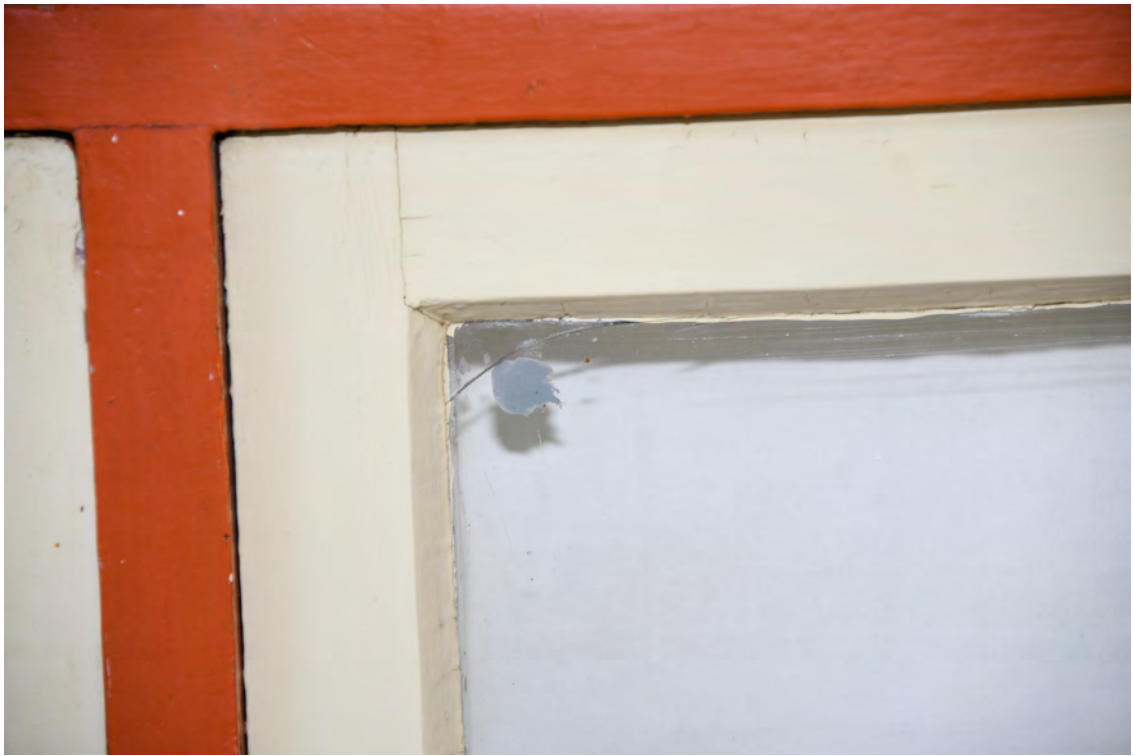
PRO\_0021.jpg

Block H. Northern elevation. Western end. Cracked glazing.

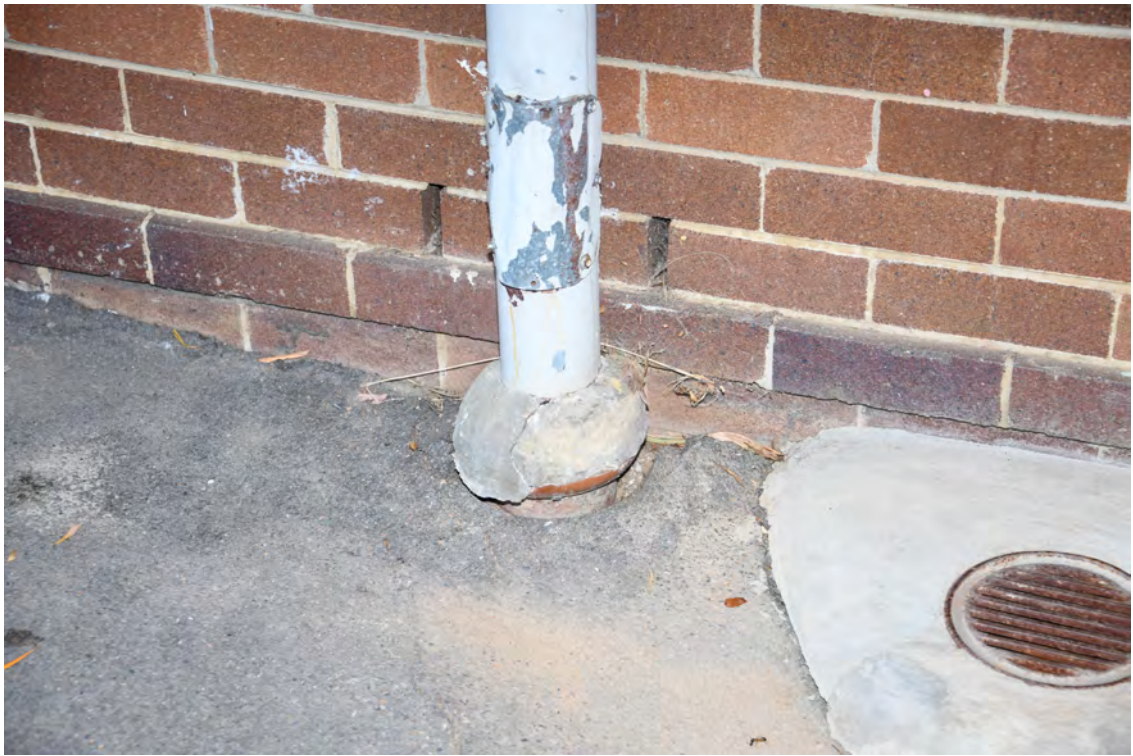
PRO\_0031.jpg

Block H. Northern elevation. Eastern end. Cracked surround to the base of the downpipe.

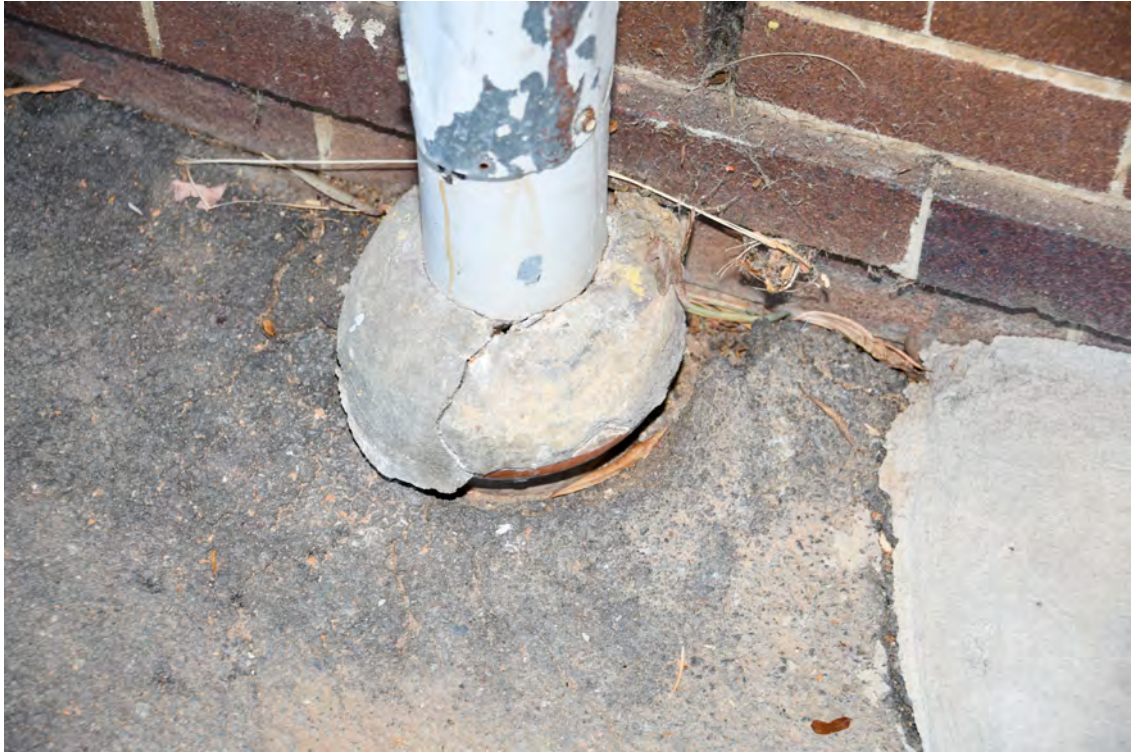
PRO\_0033.jpg

Block H. Northern elevation. Eastern end. Cracked surround to the base of the downpipe.

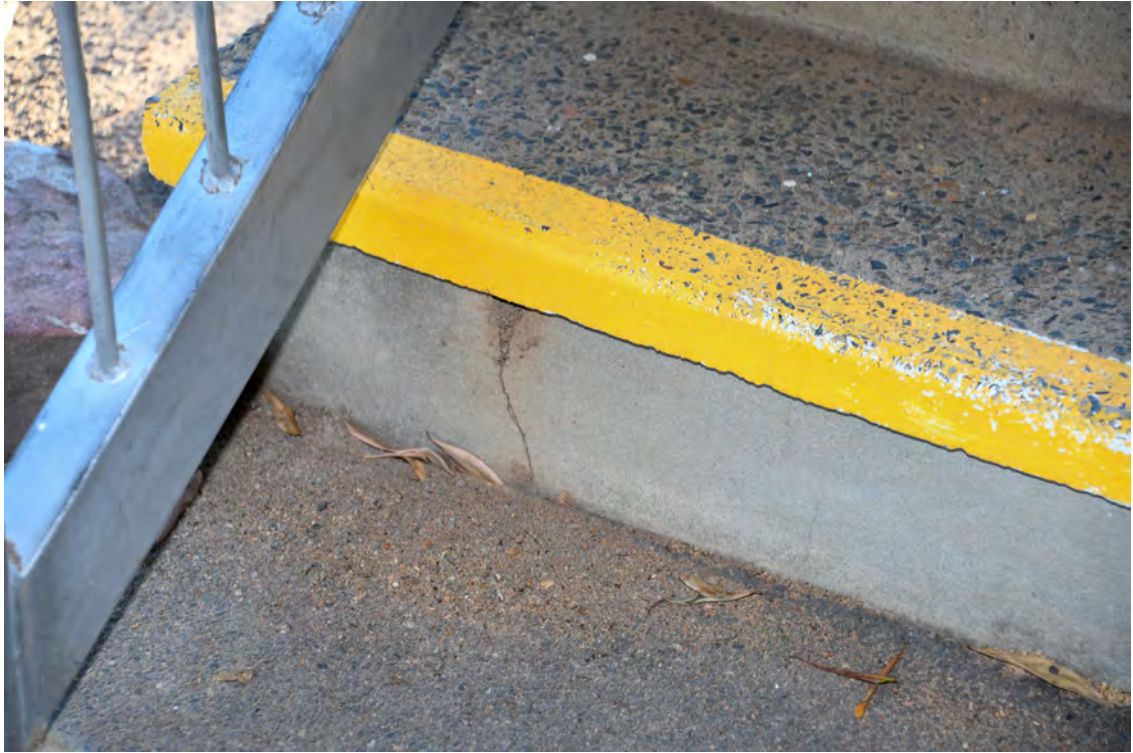
PRO\_0037.jpg

Block H. Northern elevation. Eastern entry. Cracked rendered finish to the stair tread.

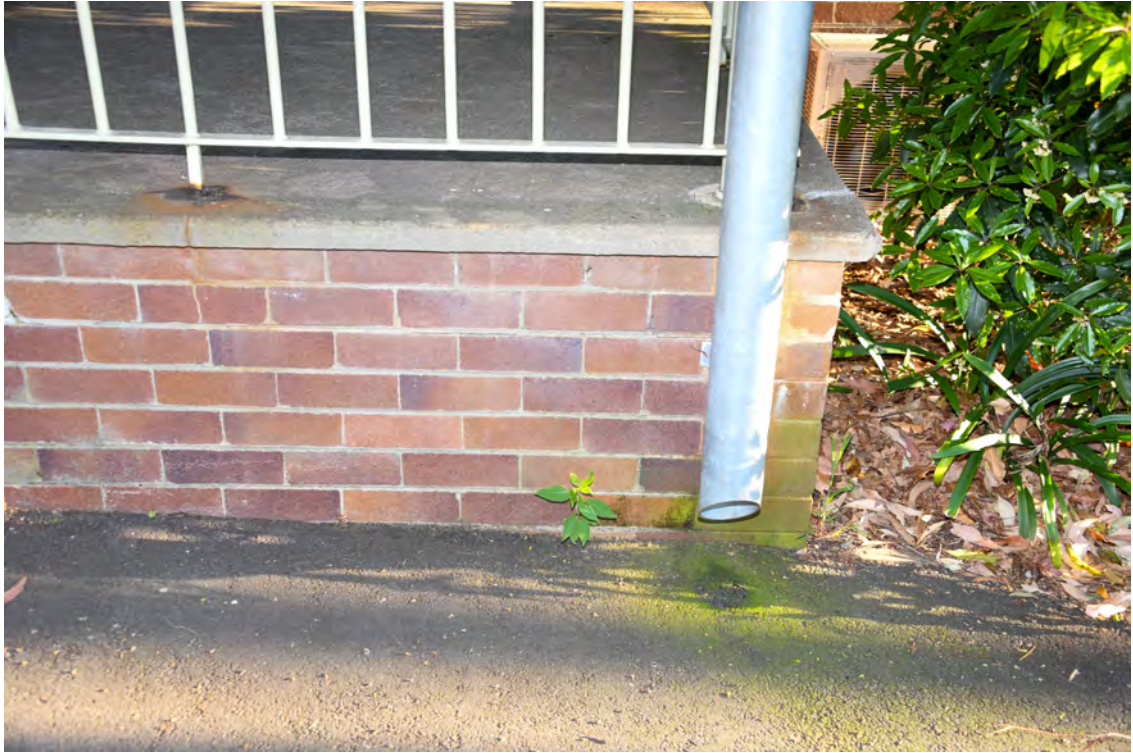
PRO\_0053.jpg

Block H. Southern elevation fronting Carlingford Road. Heading west. Eastern building entry. Cracked mortar beds.

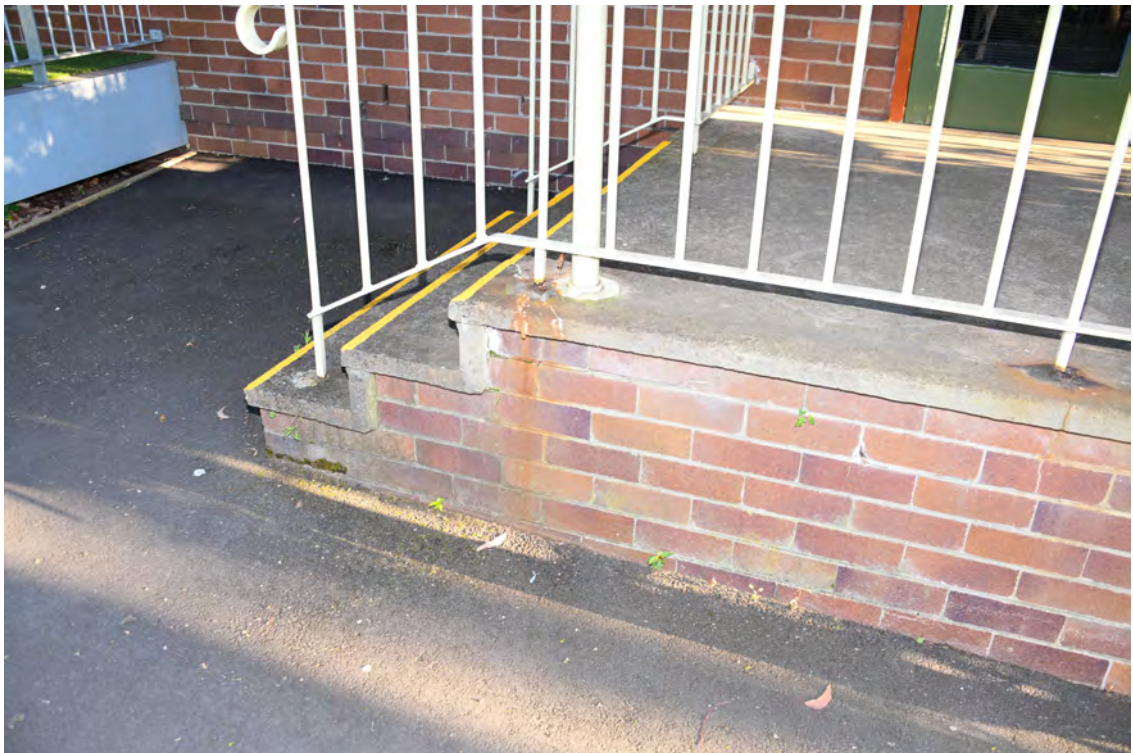
PRO\_0054.jpg

Block H. Southern elevation fronting Carlingford Road. Heading west. Eastern building entry. Cracked concrete landing.

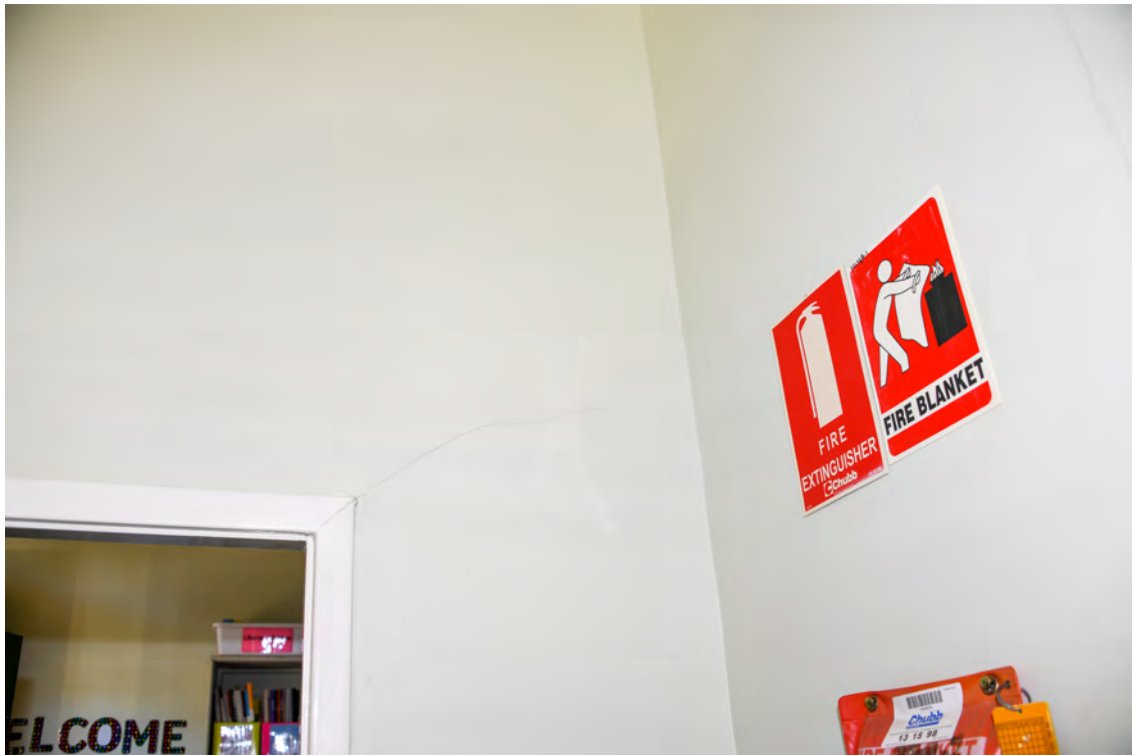
PRO\_0478.jpg

Block H. Interior. Eastern end. Foyer. Eastern face. Crack stemming out from the doorway.

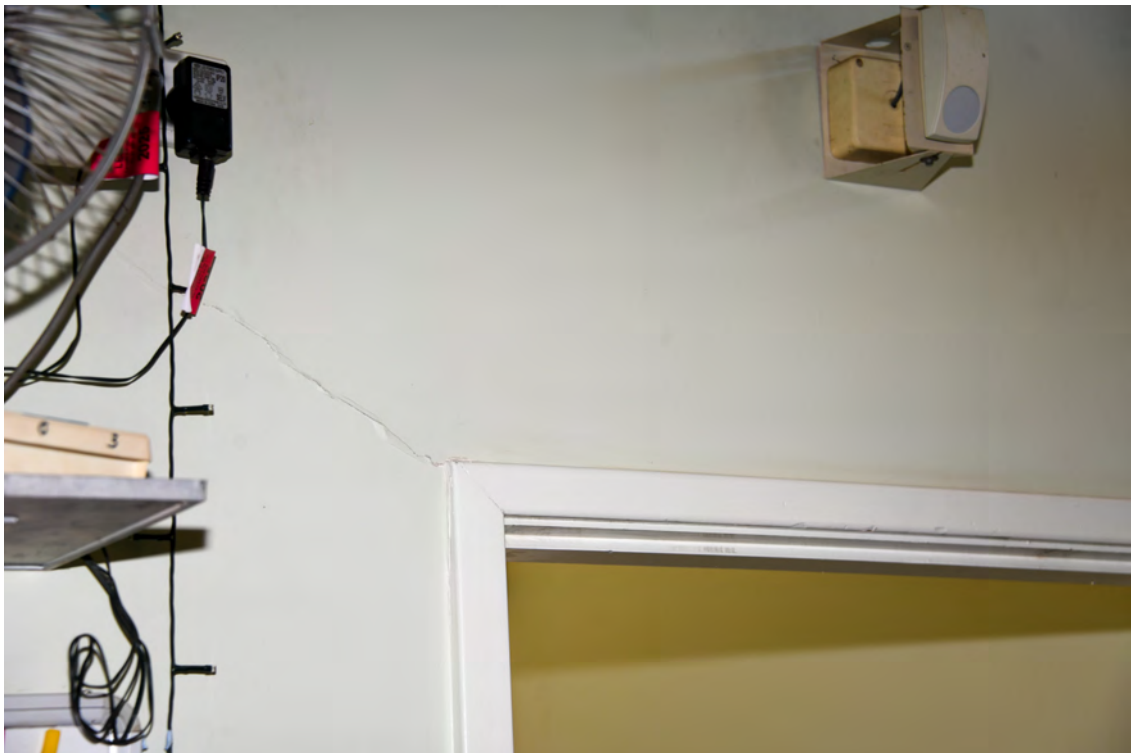
PRO\_0491.jpg

Block H. Interior. Eastern room. Room K6F. Western face. Cracked cladding.

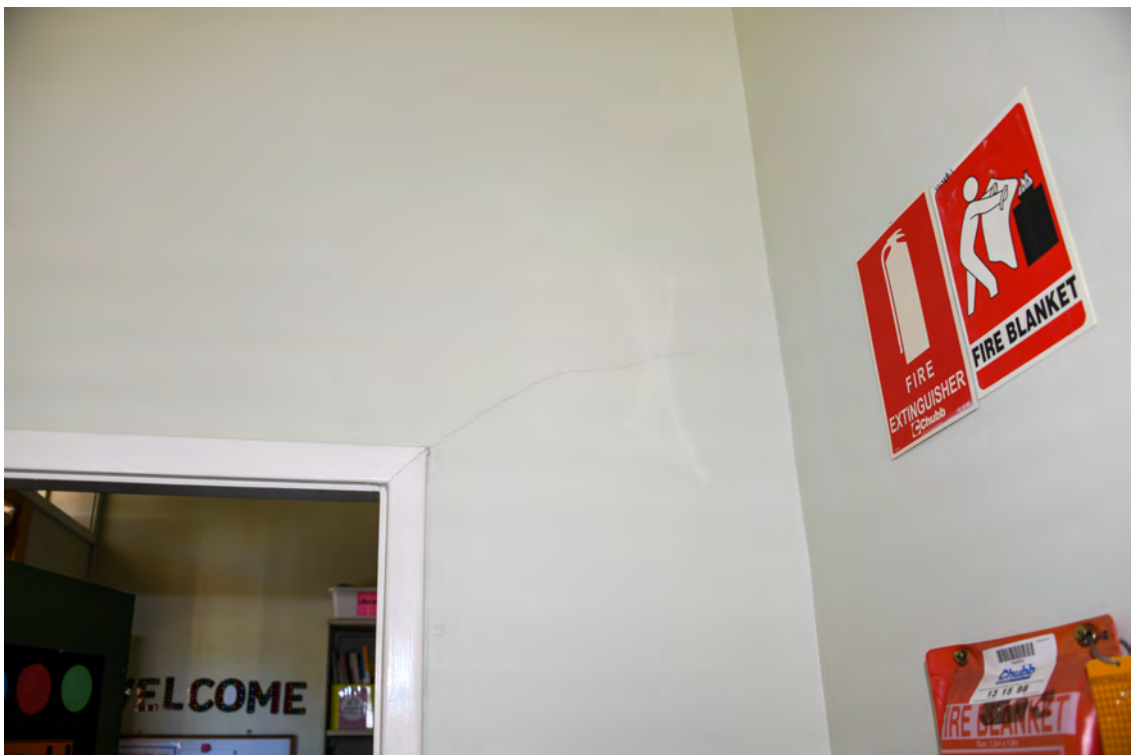
PRO\_0499.jpg

Block H. Interior. Eastern end. Foyer. Eastern face. Cracked wall cladding.

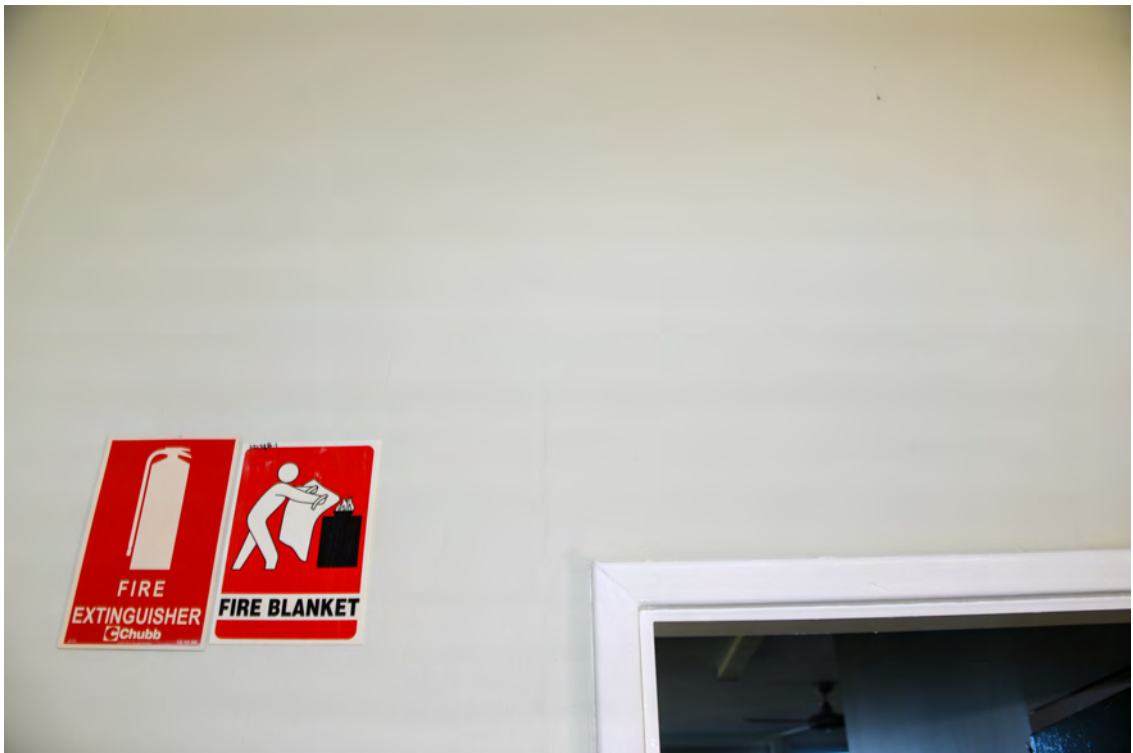
PRO\_0501.jpg

Block H. Interior. Eastern end. Foyer. Eastern end of the southern face. Cracked wall cladding.

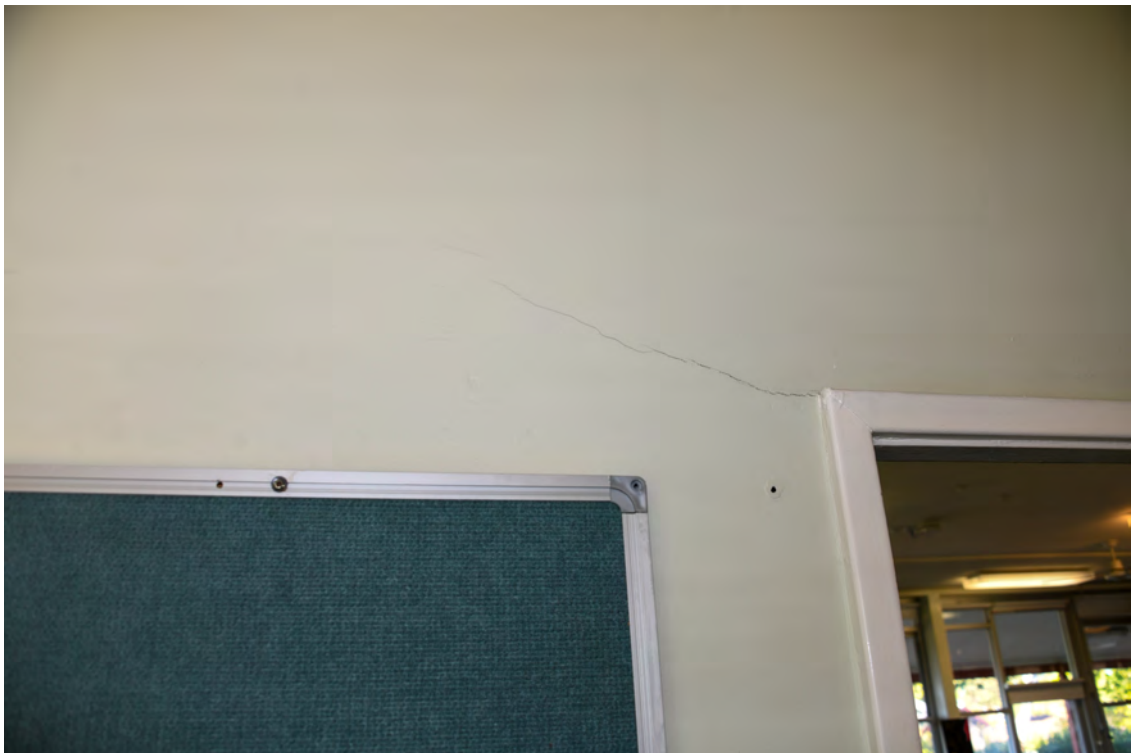
PRO\_0503.jpg

Block H. Interior. Eastern end. Foyer. Southern face. Western end. Cracked cladding stemming out from the doorway.

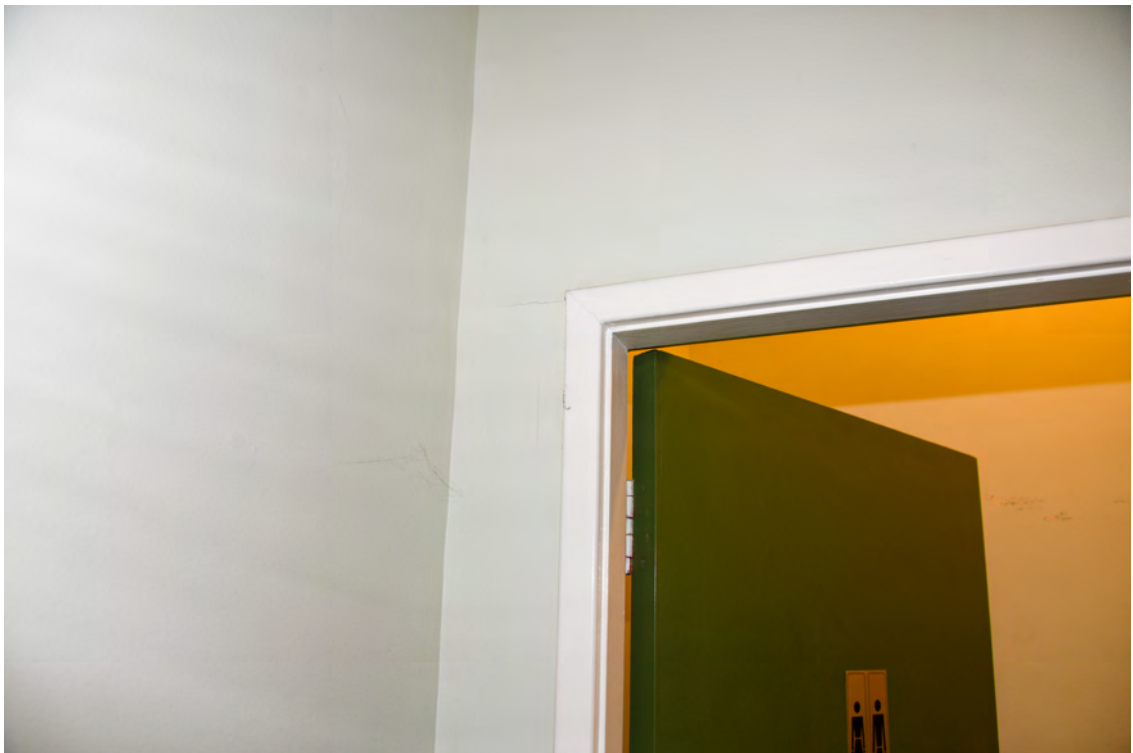
PRO\_0505.jpg

Block H. Interior. Eastern end. Foyer. Western face. Cracked cladding stemming out from the doorway.

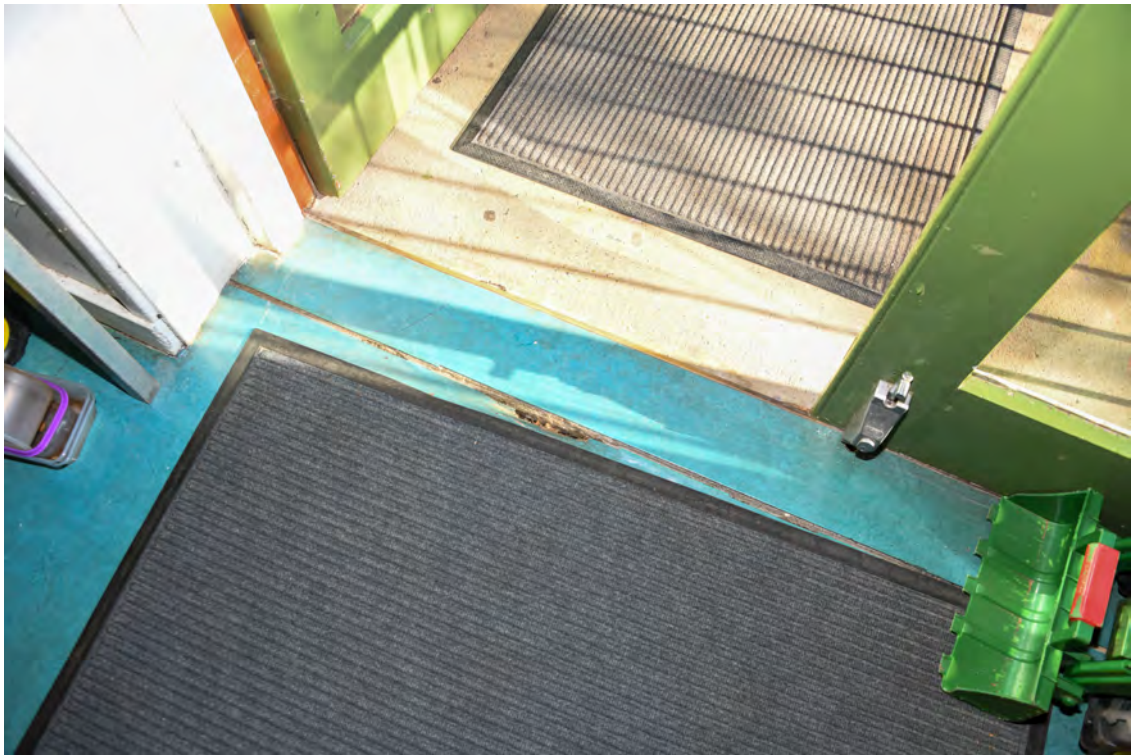
PRO\_0510.jpg

Block H. Interior. Eastern end. Foyer. Northern side of the flooring. Damaged sub flooring.

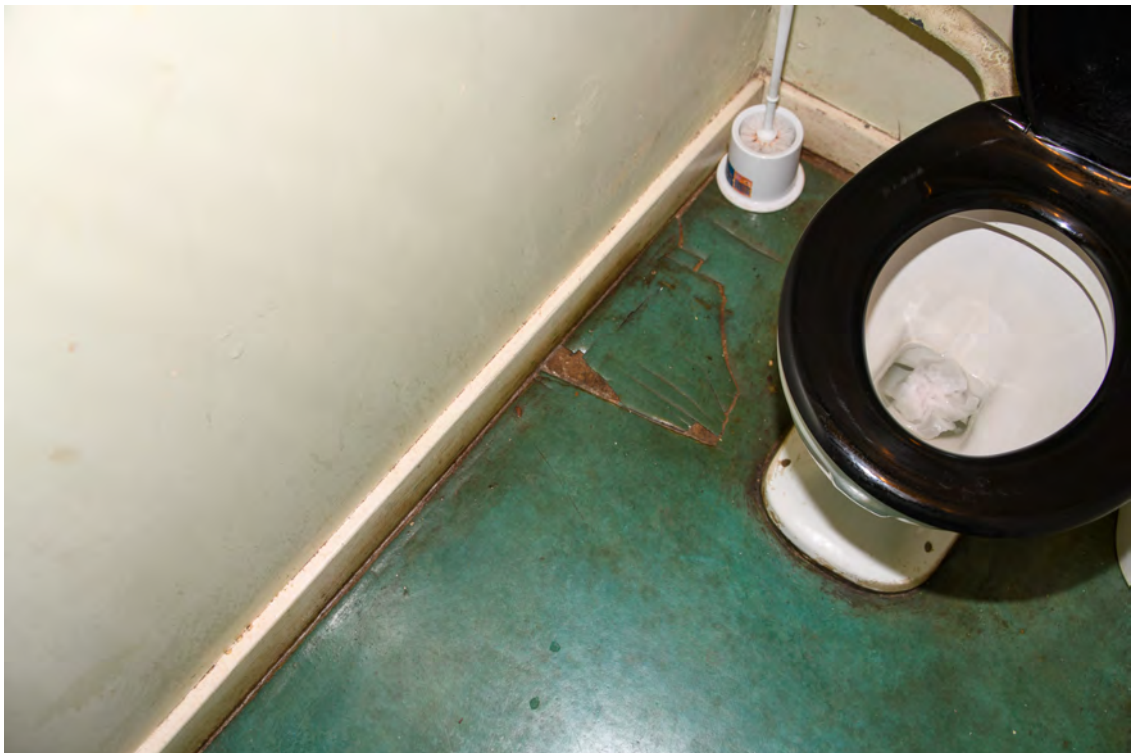
PRO\_0515.jpg

Block H. Interior. Eastern end. Foyer. Amenities. Damaged flooring.

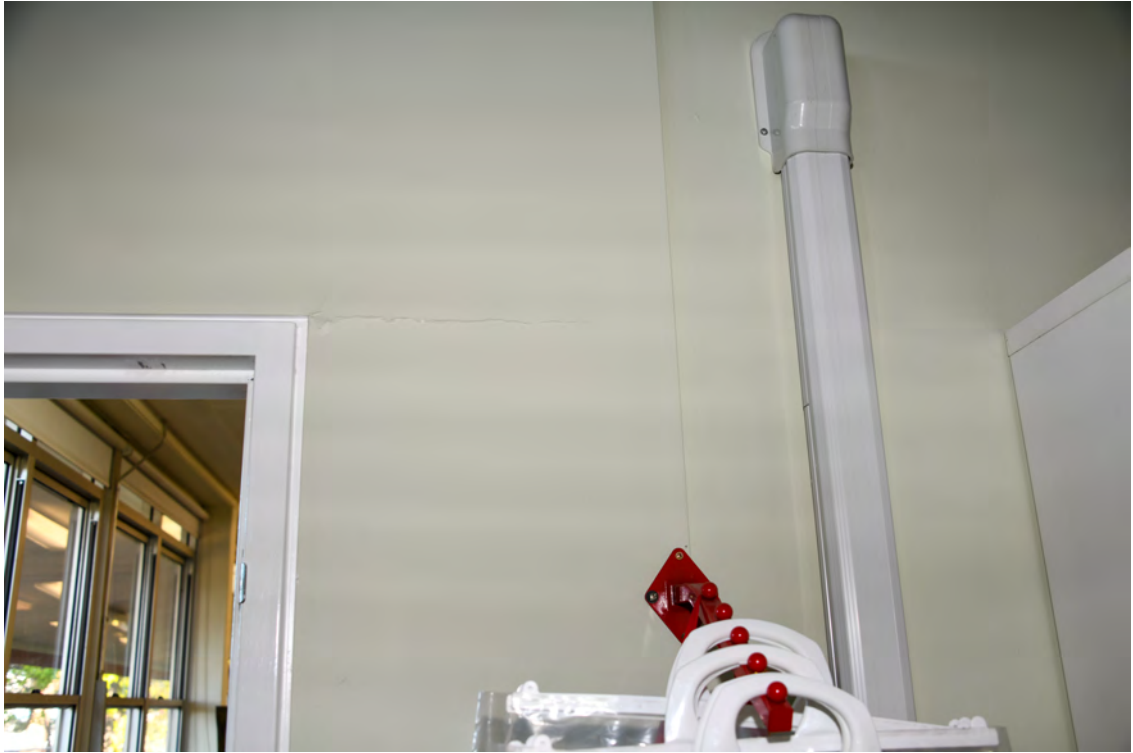
PRO\_0544.jpg

Block H. Interior. Staff room. Western face. Cracked wall cladding.

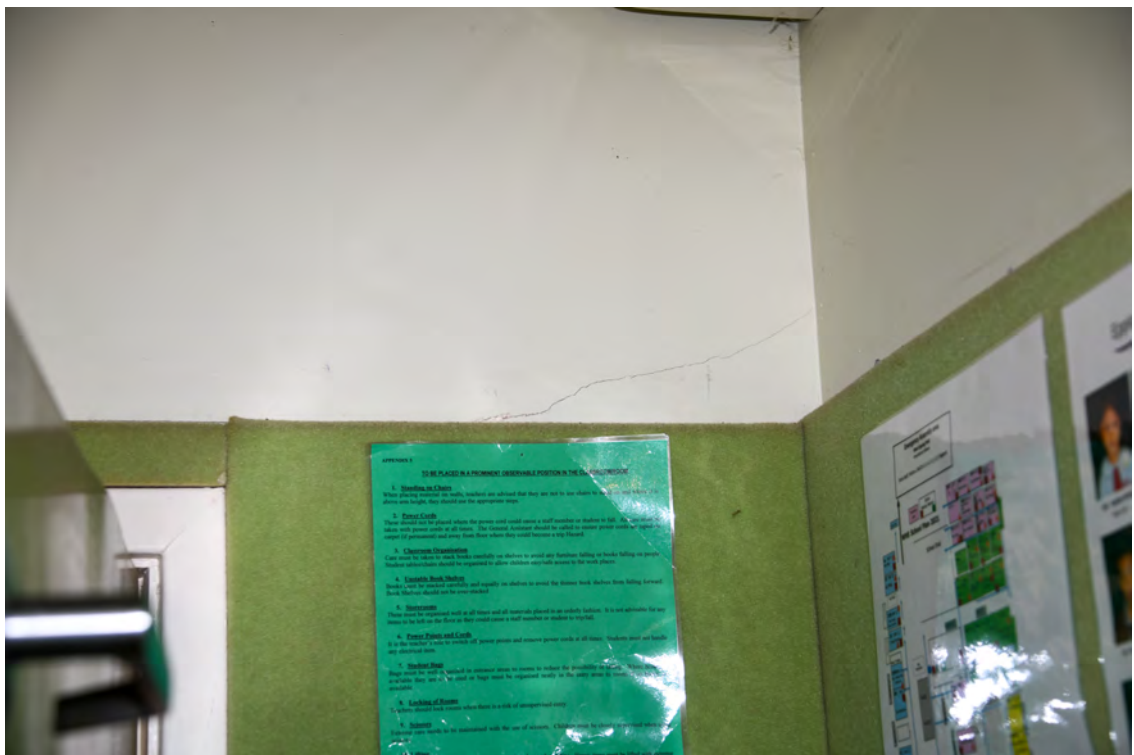
PRO\_0561.jpg

Block H. Interior. Room HR0031. North-eastern corner. Cracked wall.

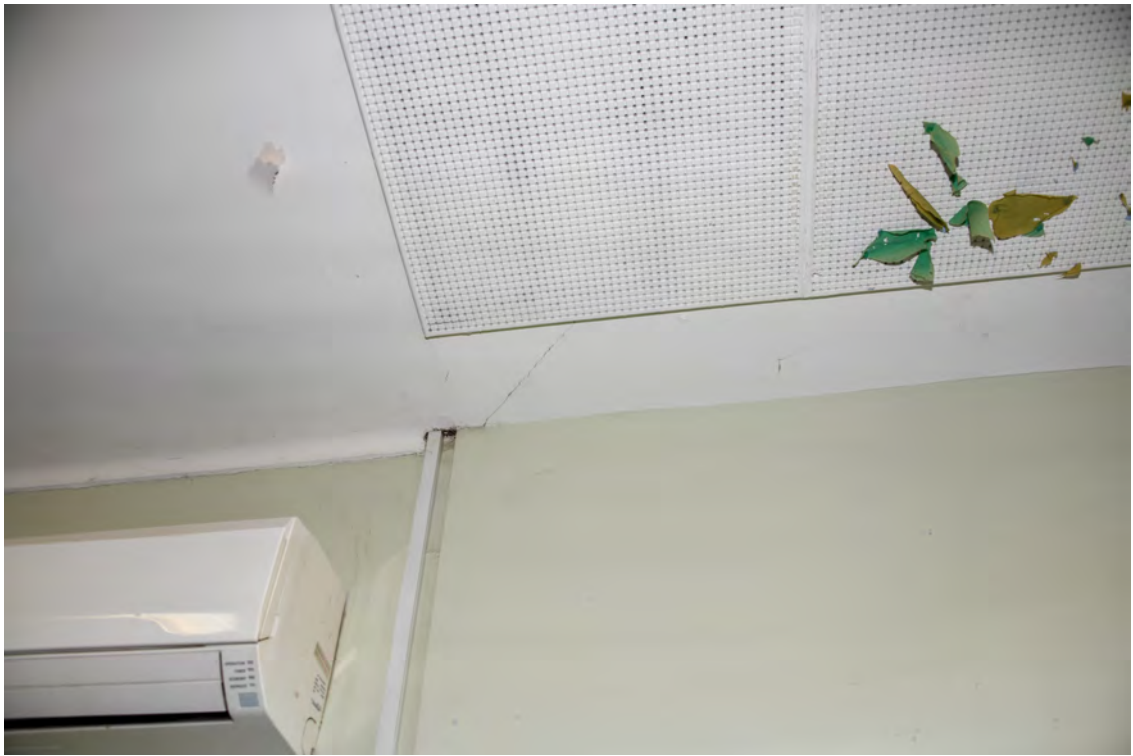
PRO\_0568.jpg

Block H. Interior. Room HR0031. Eastern face. Ceiling. Crack.

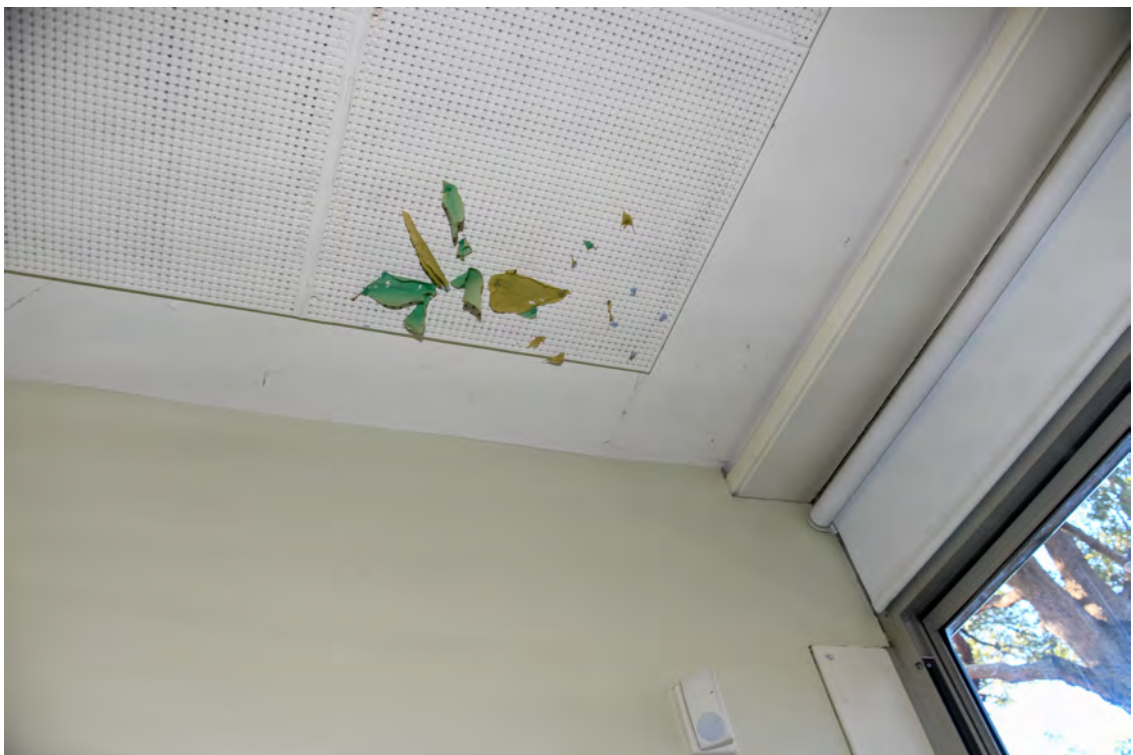
PRO\_0569.jpg

Block H. Interior. Room HR0031. South-eastern corner. Ceiling. Crack.

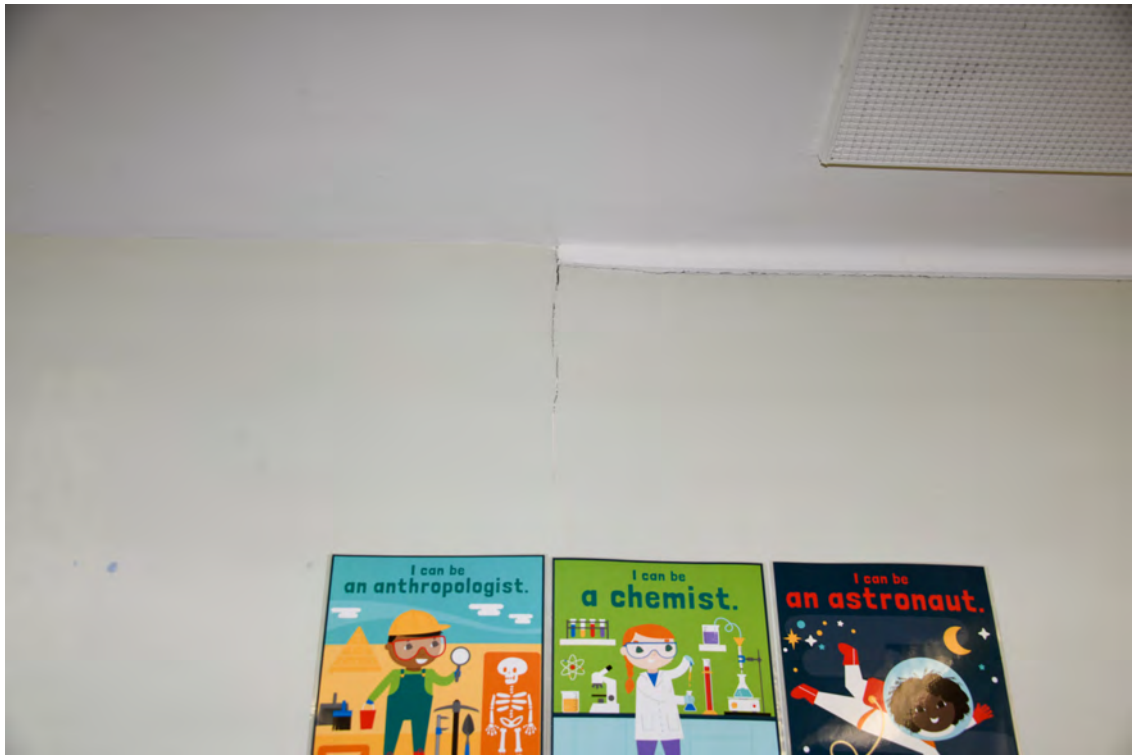
PRO\_0610.jpg

Block H. Interior. Room HR0027. Western face. Crack.

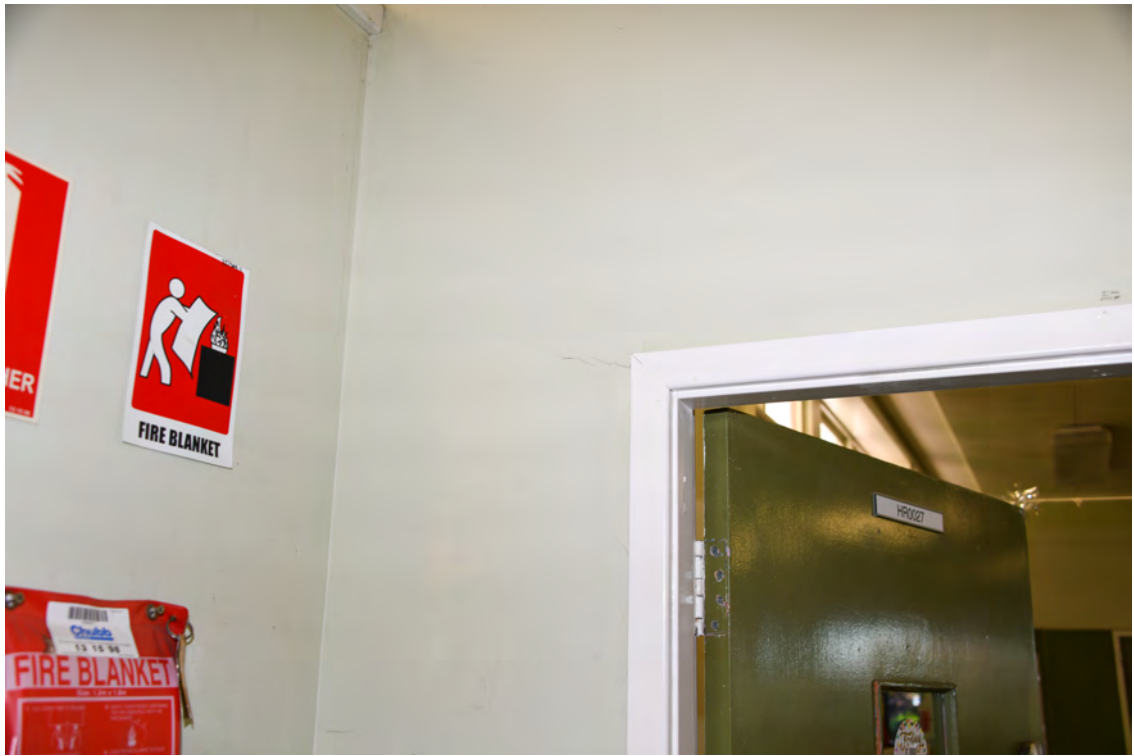
PRO\_0626.jpg

Block H. Interior. Foyer outside Room HR0027. Eastern face. Cracked wall cladding.

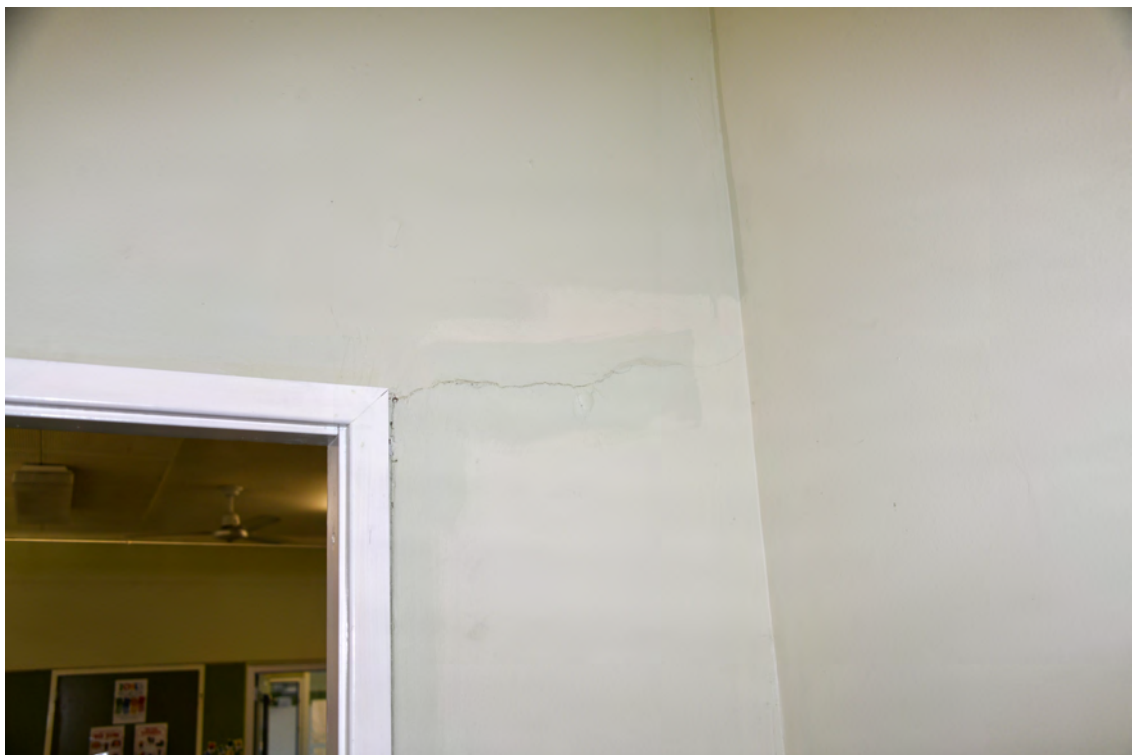
PRO\_0627.jpg

Block H. Interior. Foyer outside Room HR0027. Eastern face. Cracked wall cladding.

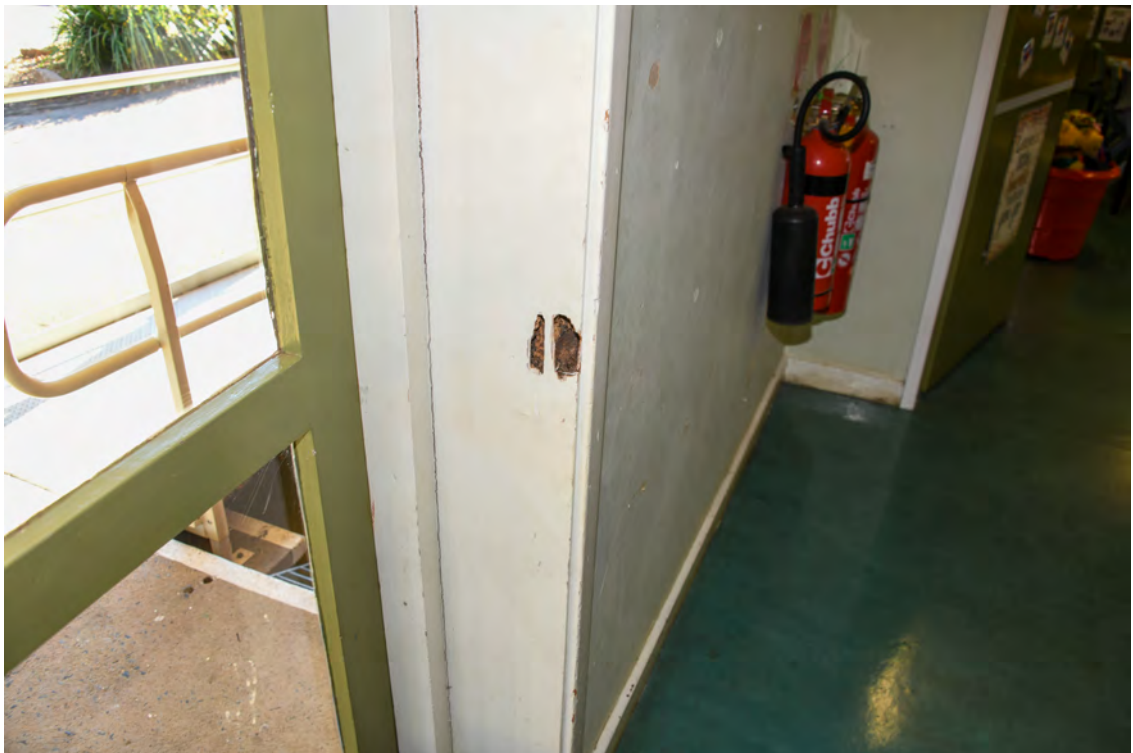
PRO\_0637.jpg

Block H. Interior. Foyer. Northern face. Eastern reveal to the doorway. Rot.

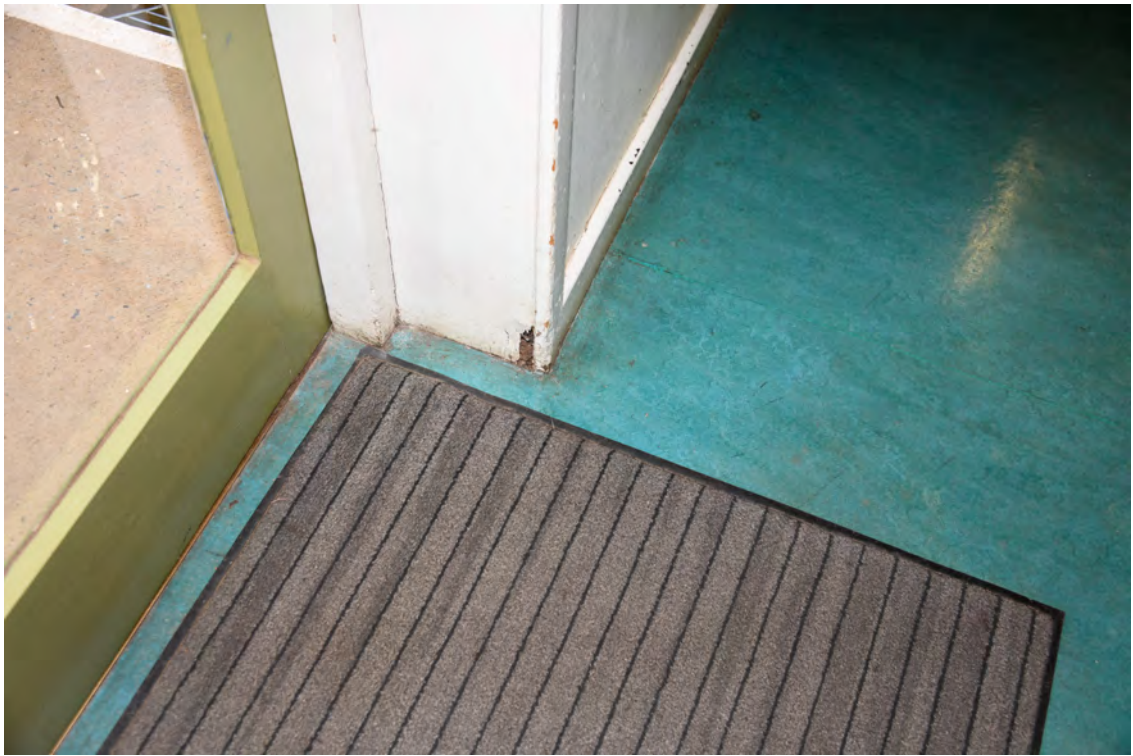
PRO\_0638.jpg

Block H. Interior. Foyer. Northern face. Eastern reveal to the doorway. Rot.

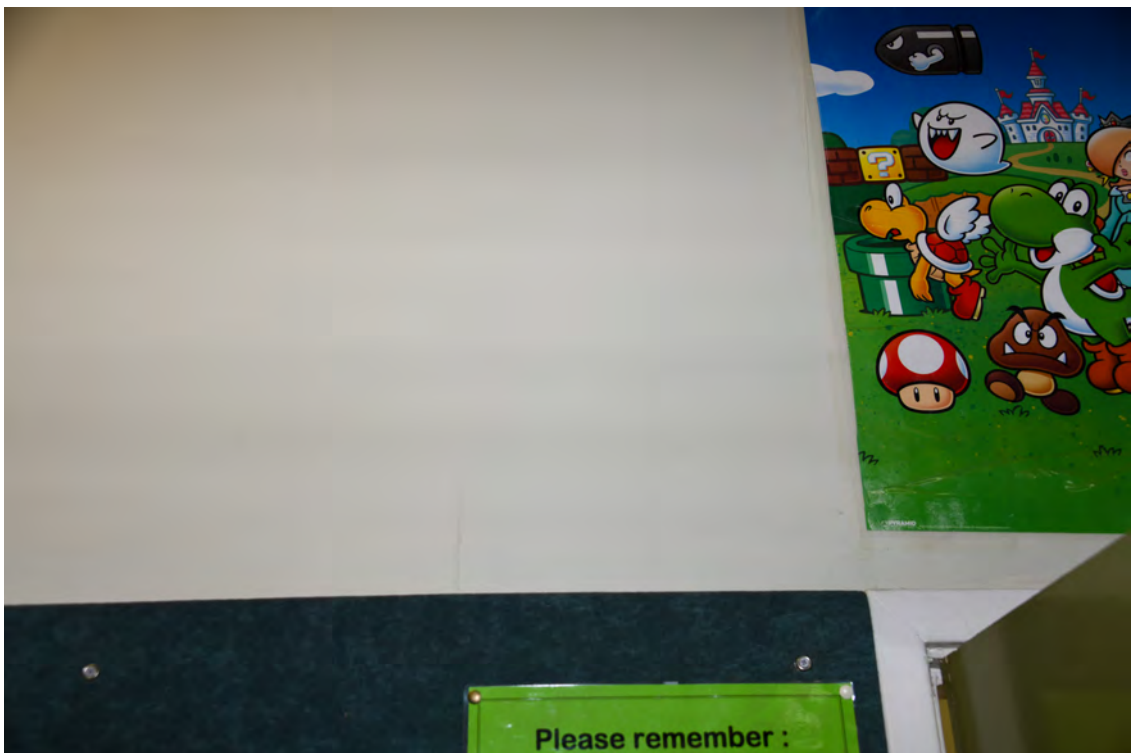
PRO\_0643.jpg

Block H. Interior. Computer room. Northern face. Vertical crack in the wall cladding.
