96-104 Carlingford Road, Epping NSW 2121

Epping West Public School

DILAPIDATION REPORT

7<sup>th</sup> September 2021

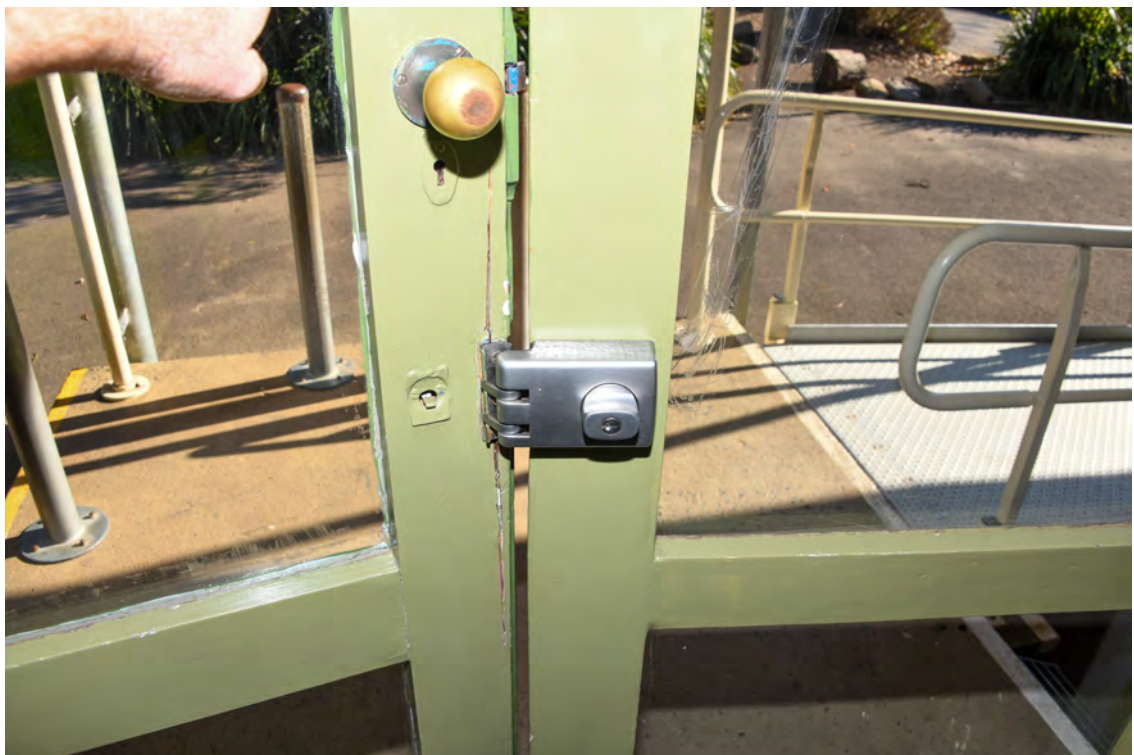
PRO\_0661.jpg

Block H. Interior. Foyer. Damage to the western exit door.

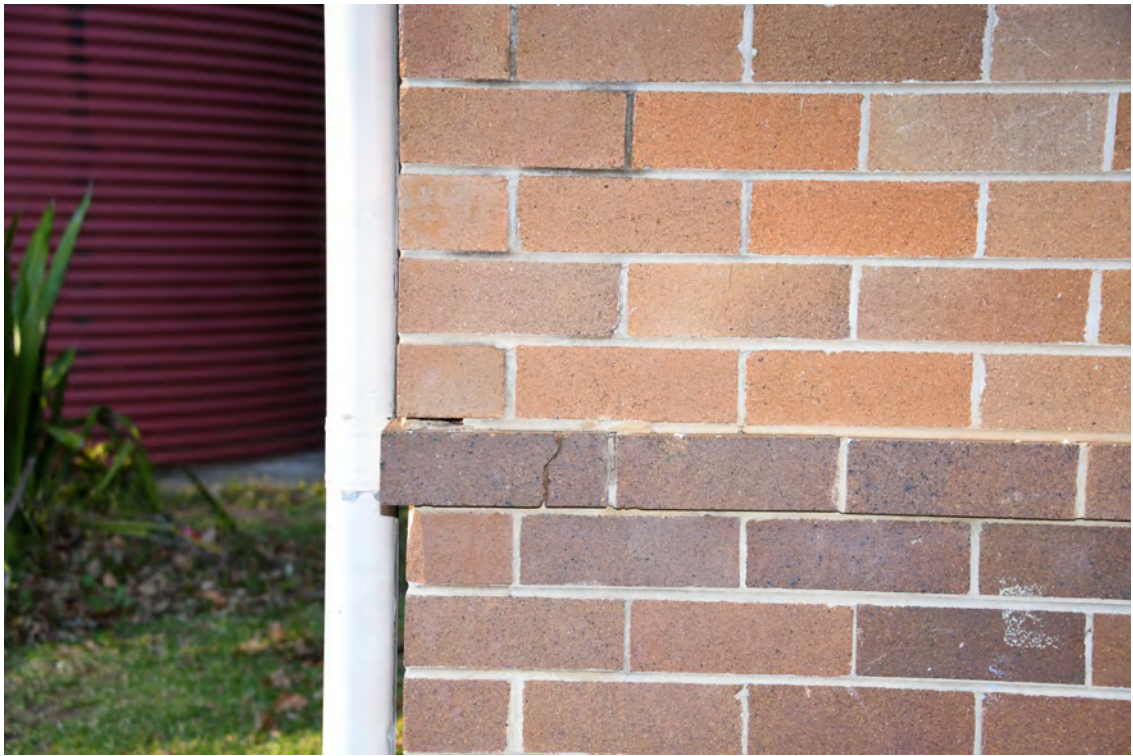
PRO\_0070.jpg

Block F. Northern elevation. Eastern end. Cracked brick.

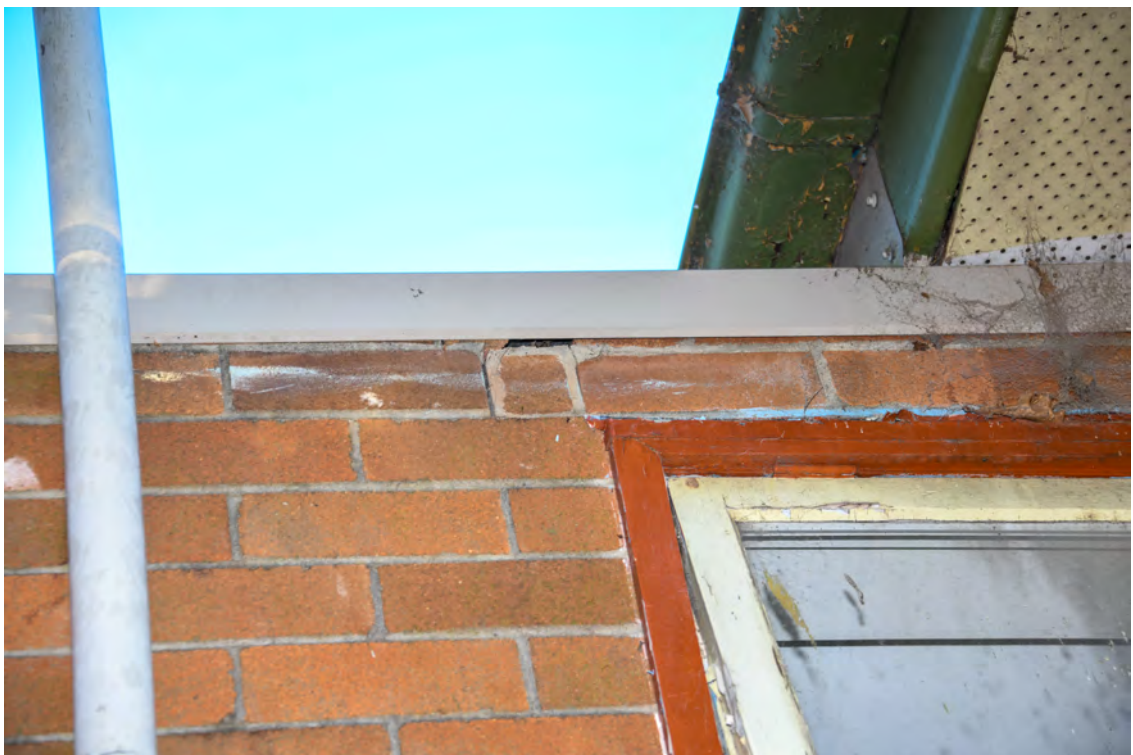
PRO\_0095.jpg

Block F. Eastern elevation. Southern end. Loose brick.

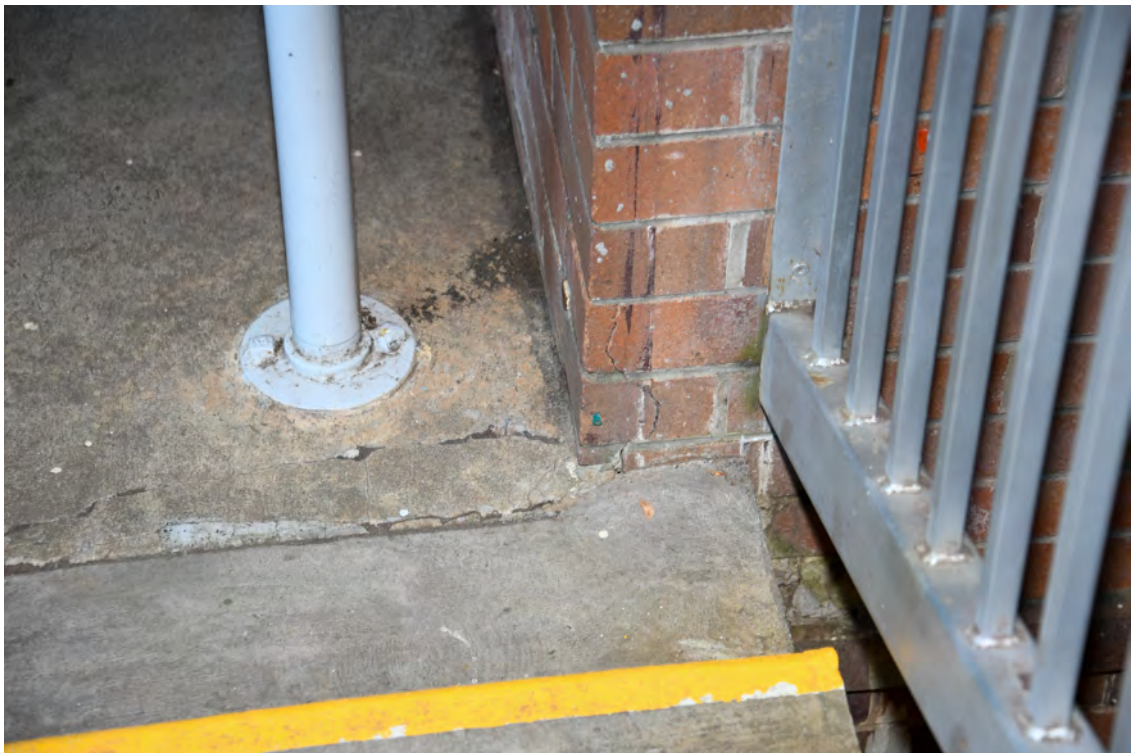
PRO\_0105.jpg

Block F. Southern elevation. Eastern end. Cracked brickwork and concrete paving.

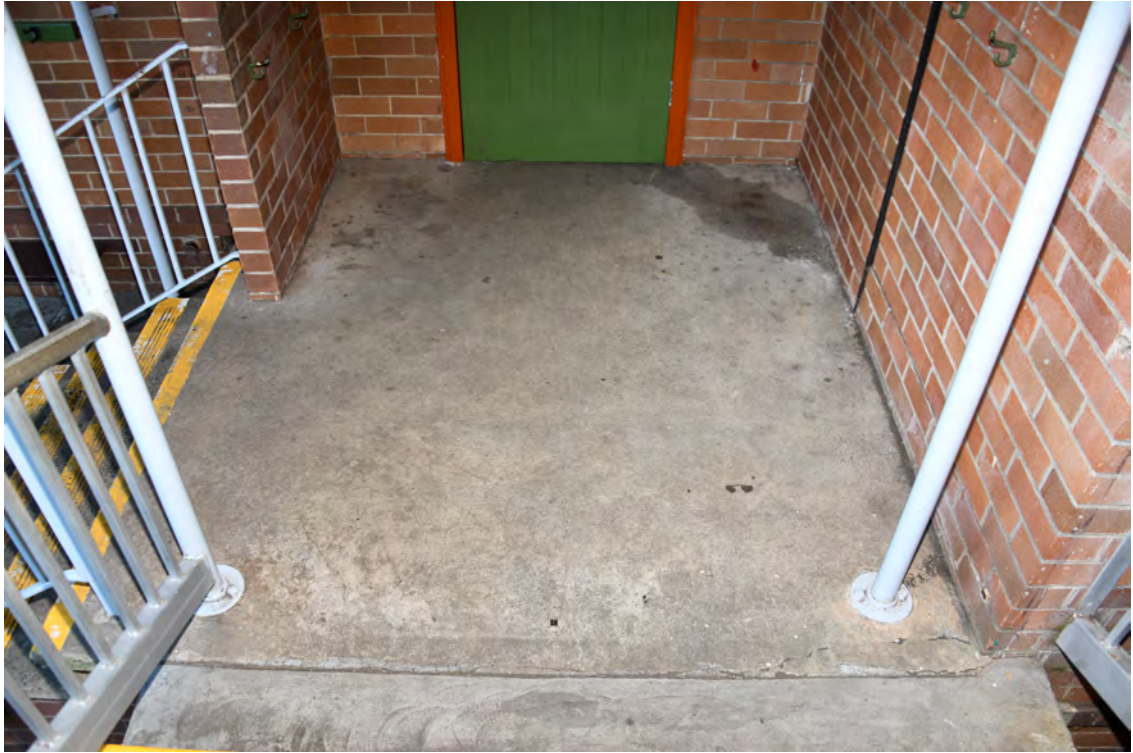
PRO\_0106.jpg

Block F. Southern elevation. Eastern end. Cracked concrete paving.

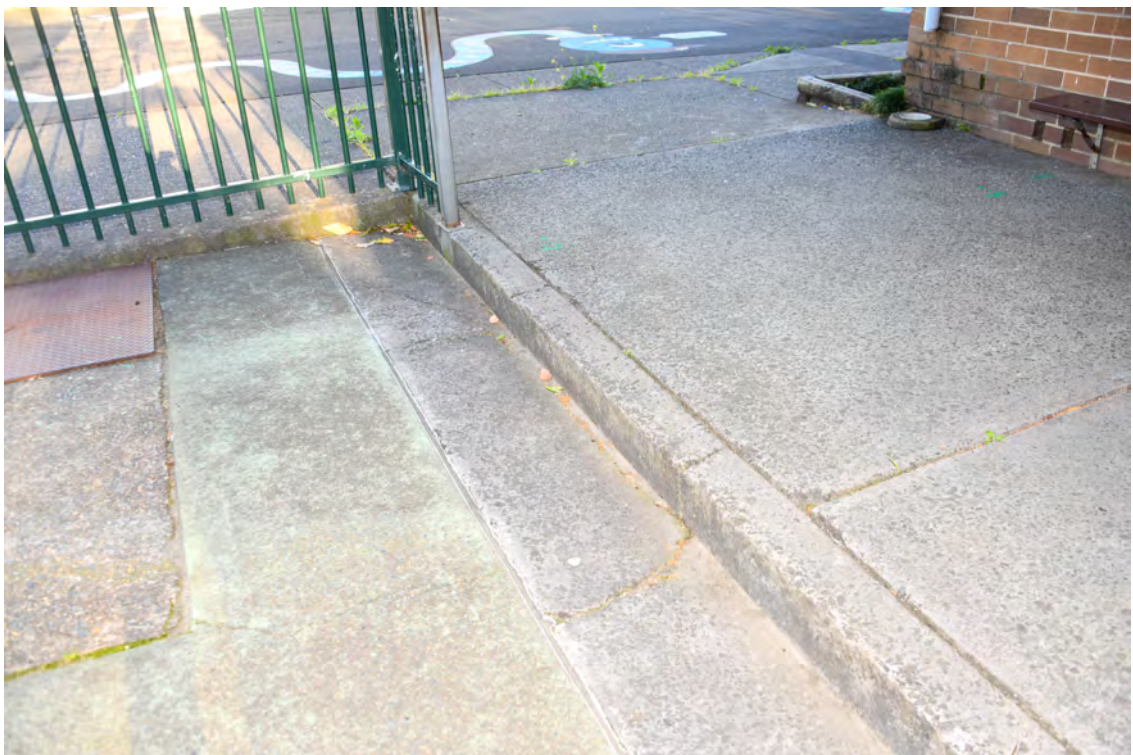
PRO\_0127.jpg

Block F. Southern elevation. Western end. Cracked kerb and gutter.

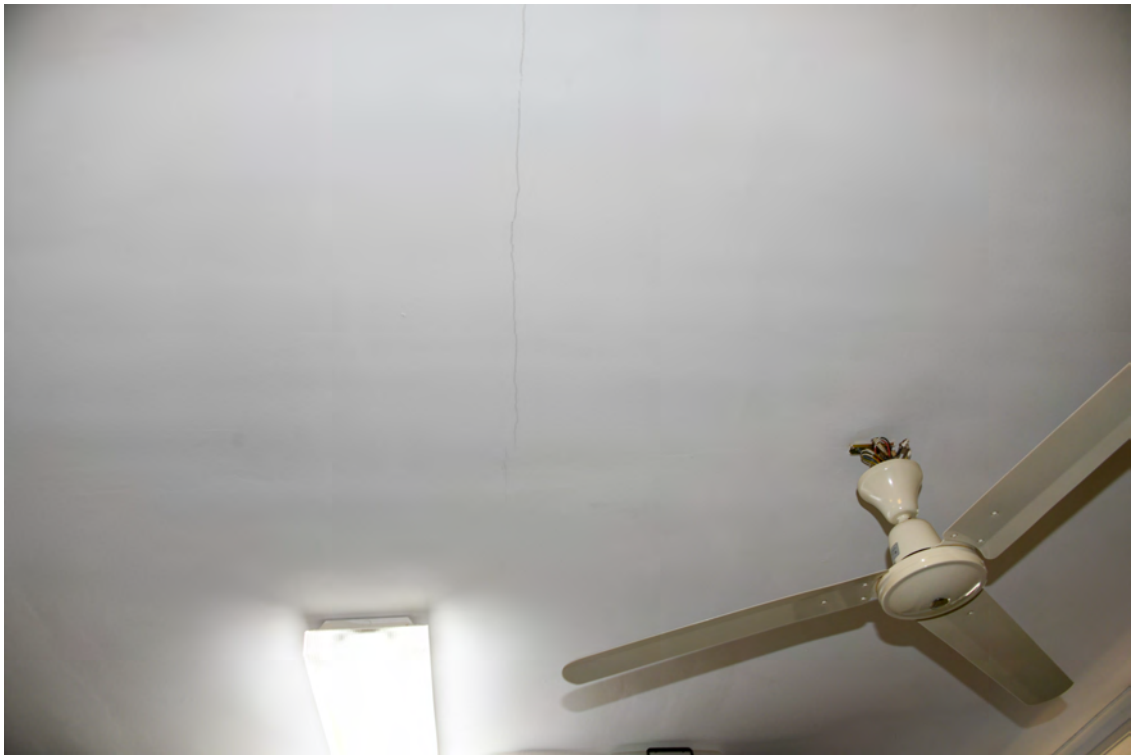
PRO\_0808.jpg

Block F. Interior. Eastern room. Cracked ceiling.

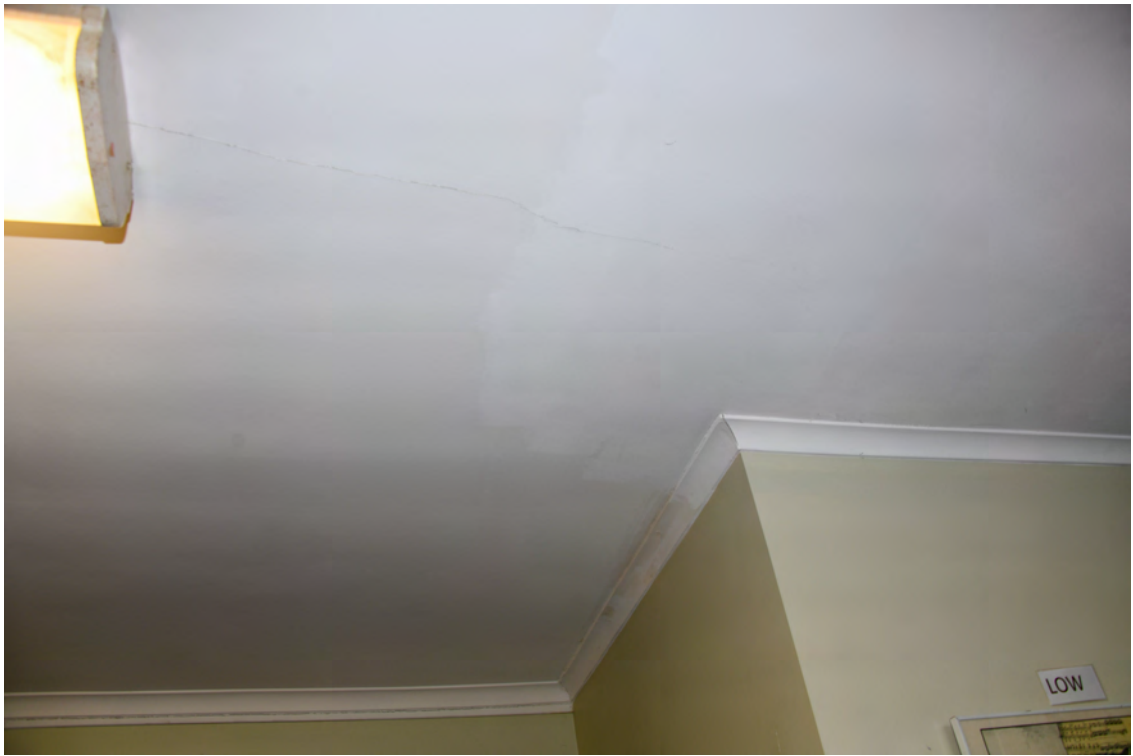
PRO\_0810.jpg

Block F. Interior. Eastern room. Cracked ceiling.

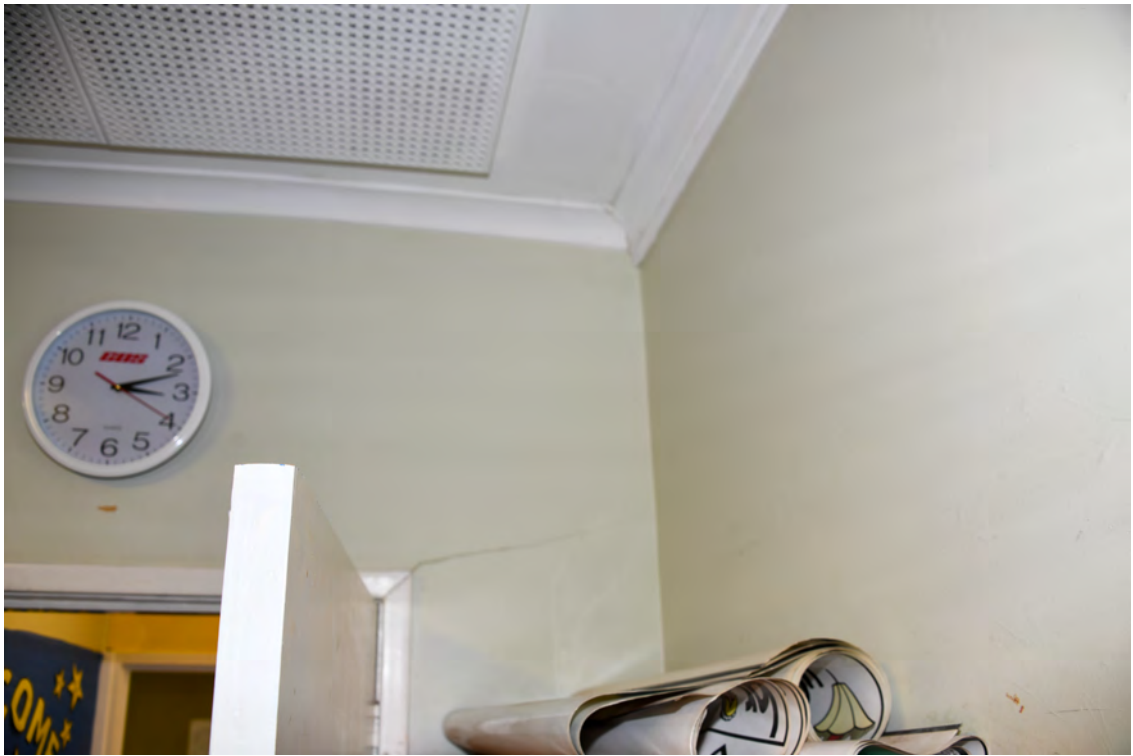
PRO\_0838.jpg

Block F. Interior. Second eastern room (Mrs Wiltshire). Eastern face. Cracked wall cladding.

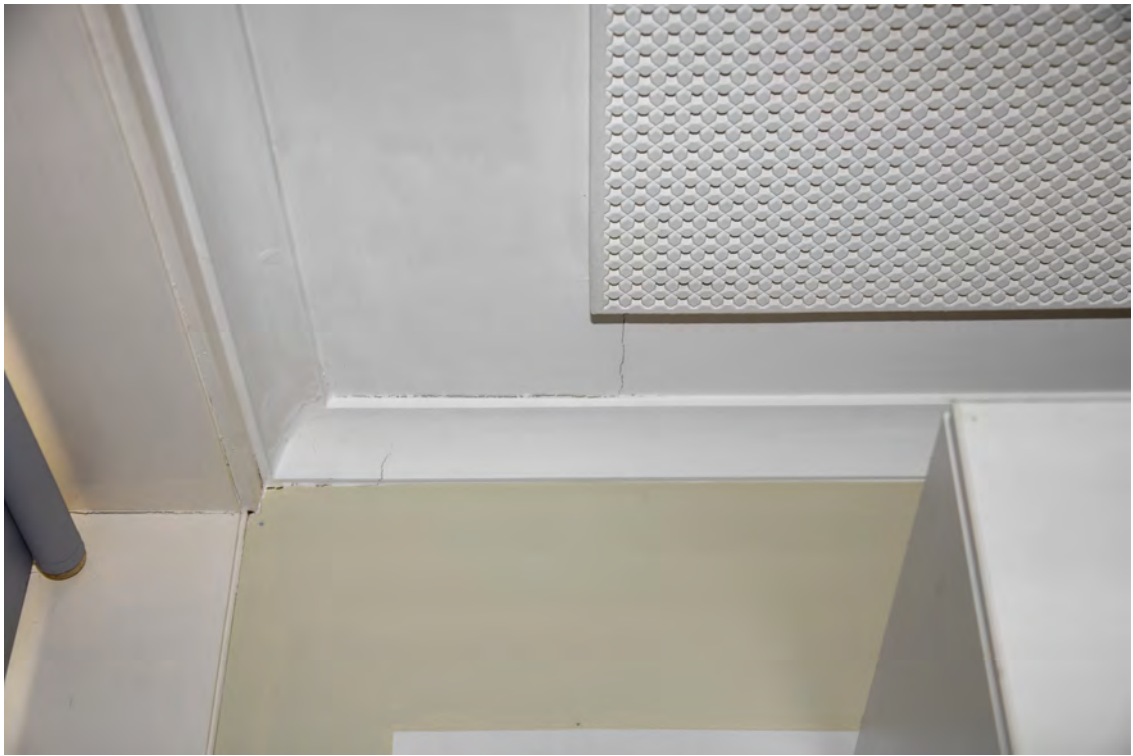
PRO\_0855.jpg

Block F. Interior. Room KA. North-eastern corner of the ceiling. Cracked ceiling.

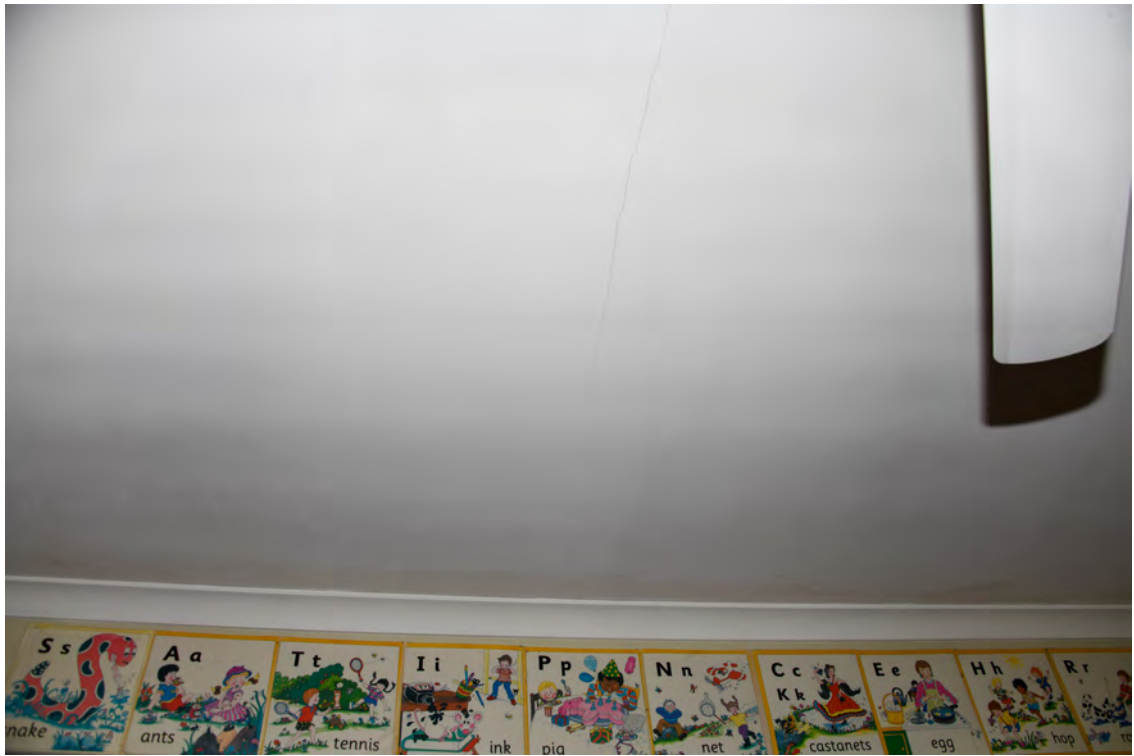
PRO\_0857.jpg

Block F. Interior. Room KA. Eastern side of the ceiling. Cracked ceiling.

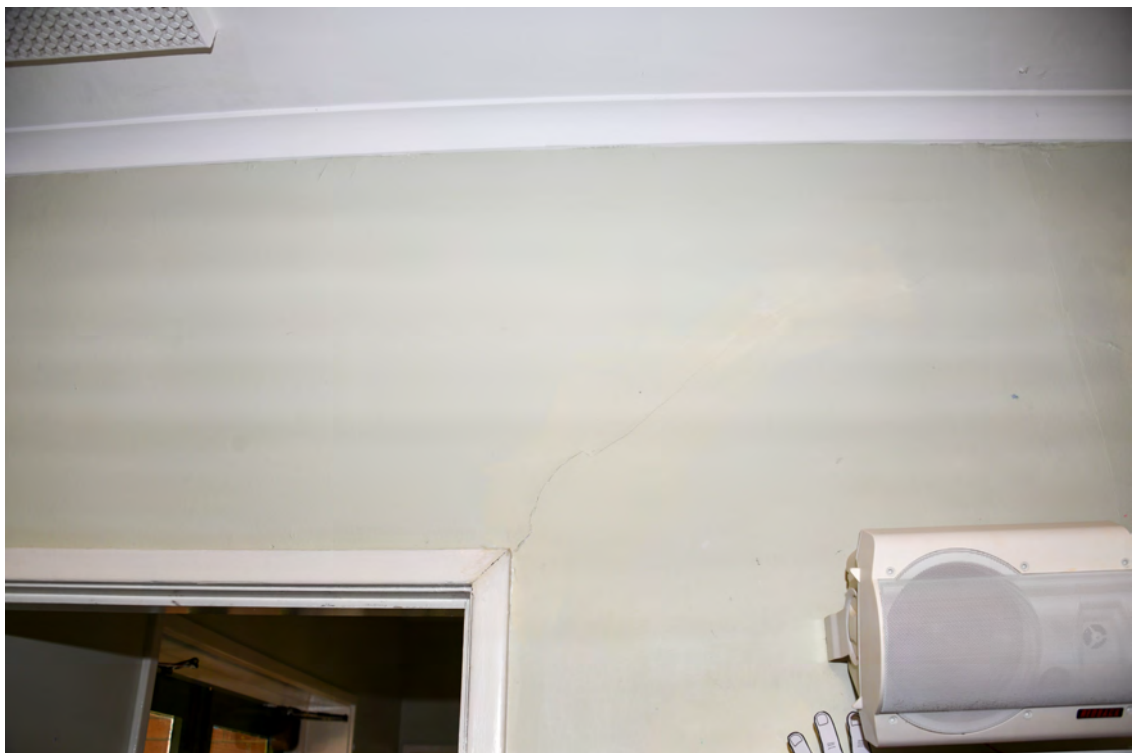
PRO\_0876.jpg

Block F. Interior. Room KG. Western face. Cracked cladding stemming out from the doorway.

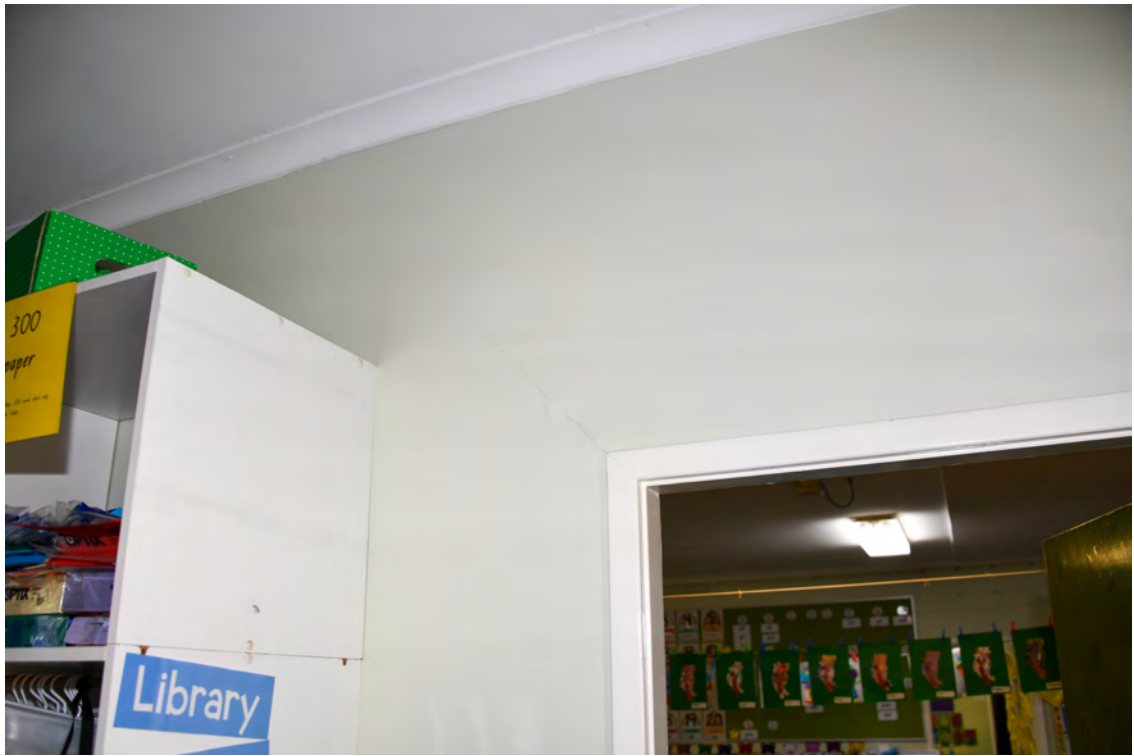
PRO\_0887.jpg

Block F. Interior. Foyer. Eastern face. Cracked wall cladding stemming out from the doorway.

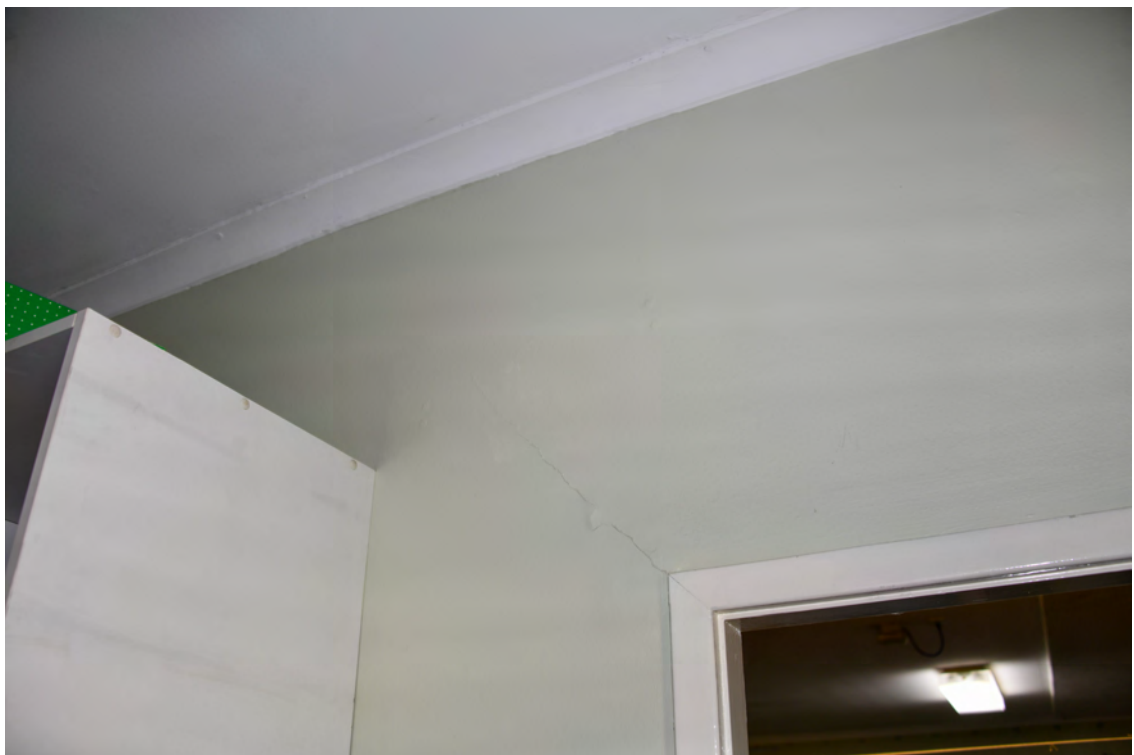
PRO\_0894.jpg

Block F. Interior. Foyer. Western face. Cracked cladding stemming out from the doorway.

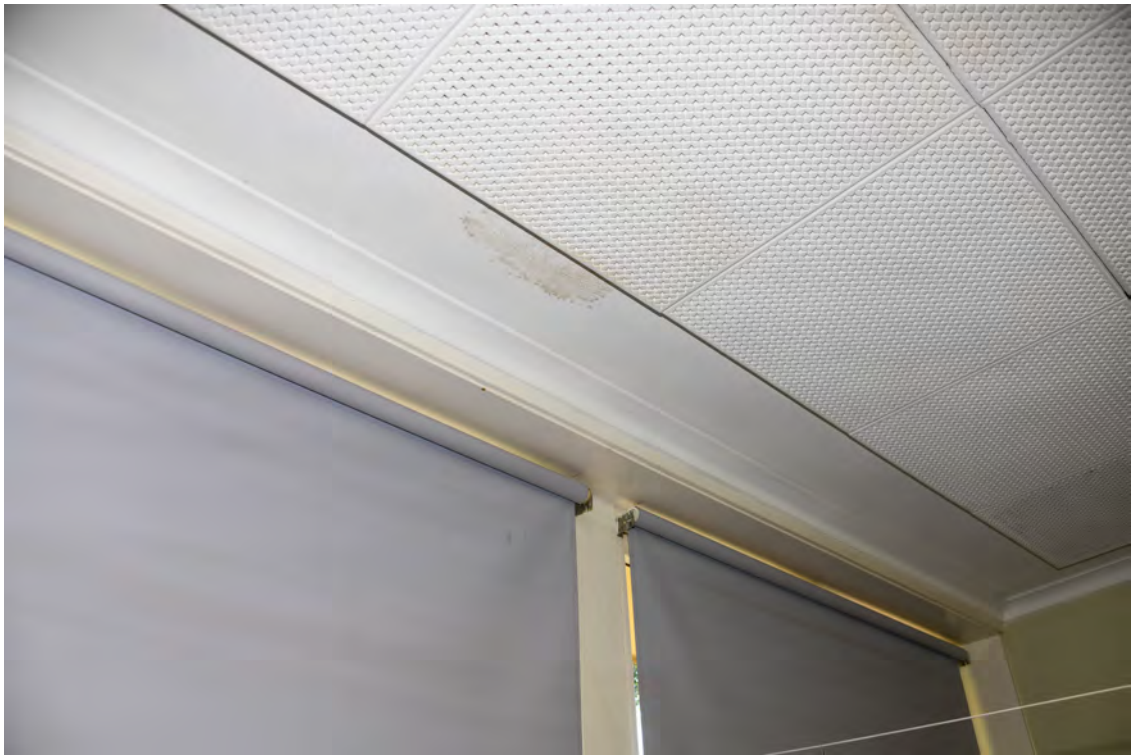
PRO\_0899.jpg

Block F. Interior. Room KH. Northern face. Stain on the ceiling.

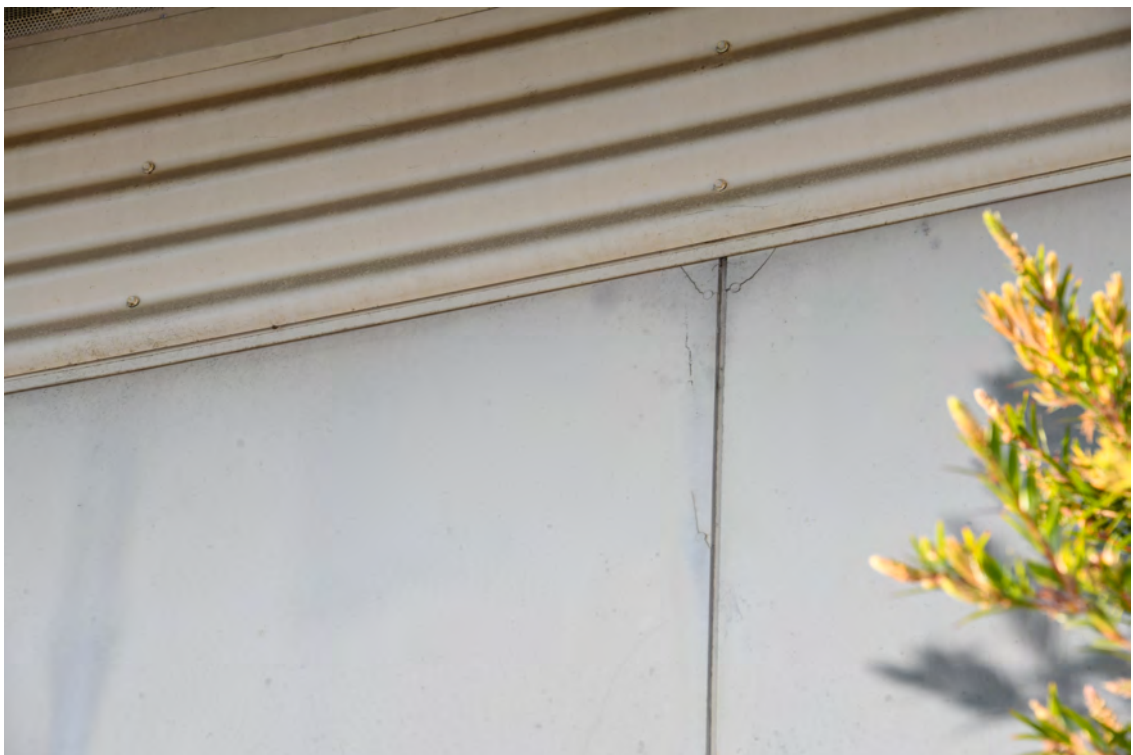
PRO\_0150.jpg

Block I. Northern elevation. Cracked wall cladding.

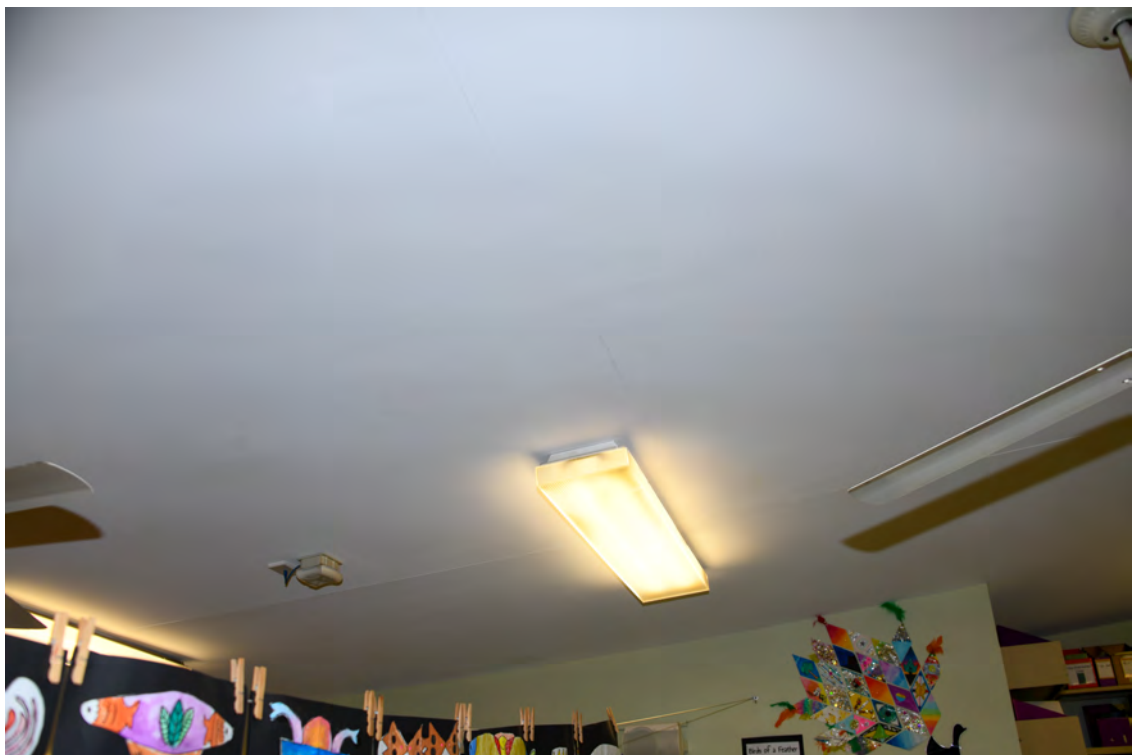
PRO\_0991.jpg

Block I. Eastern room. Ceiling. Cracked lining.

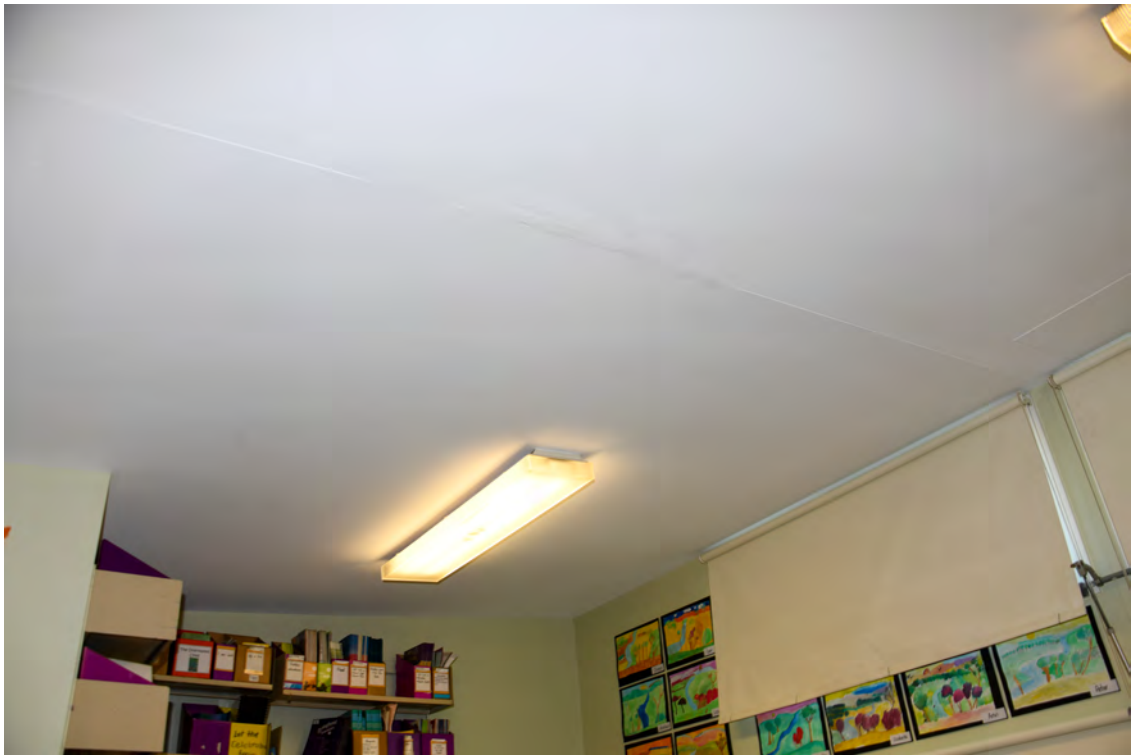
PRO\_0992.jpg

Block I. Eastern room. Ceiling. Water damage.

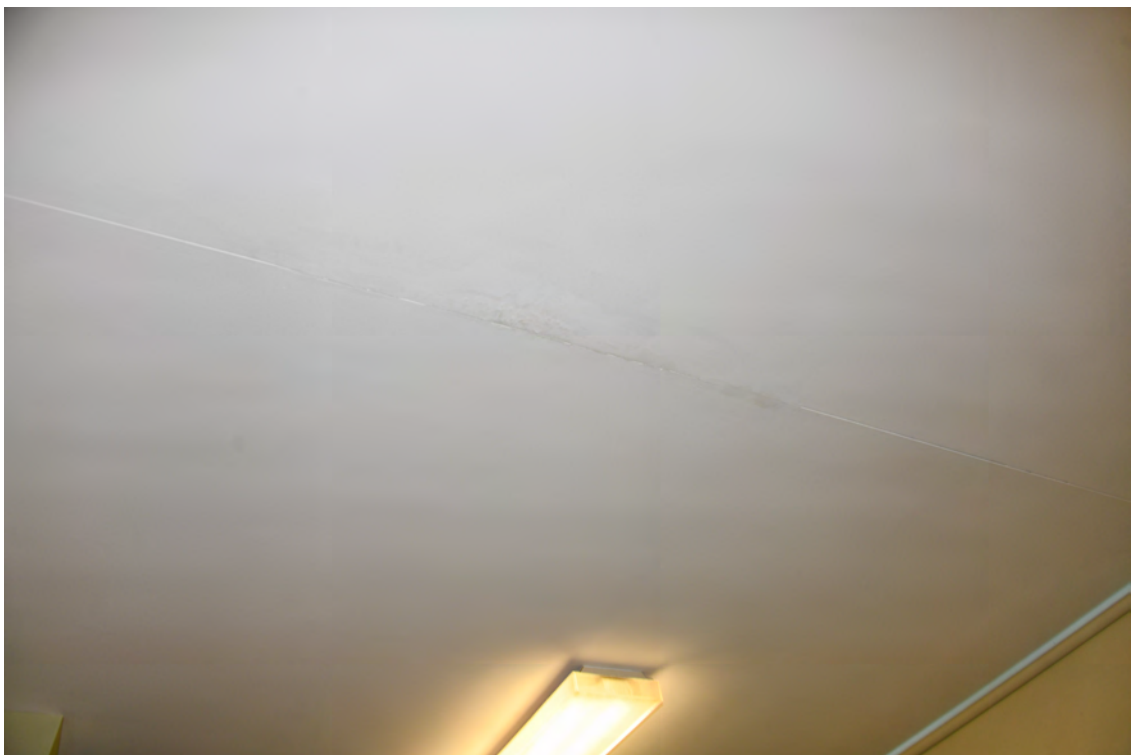
PRO\_0993.jpg

Block I. Eastern room. Ceiling. Water damage.

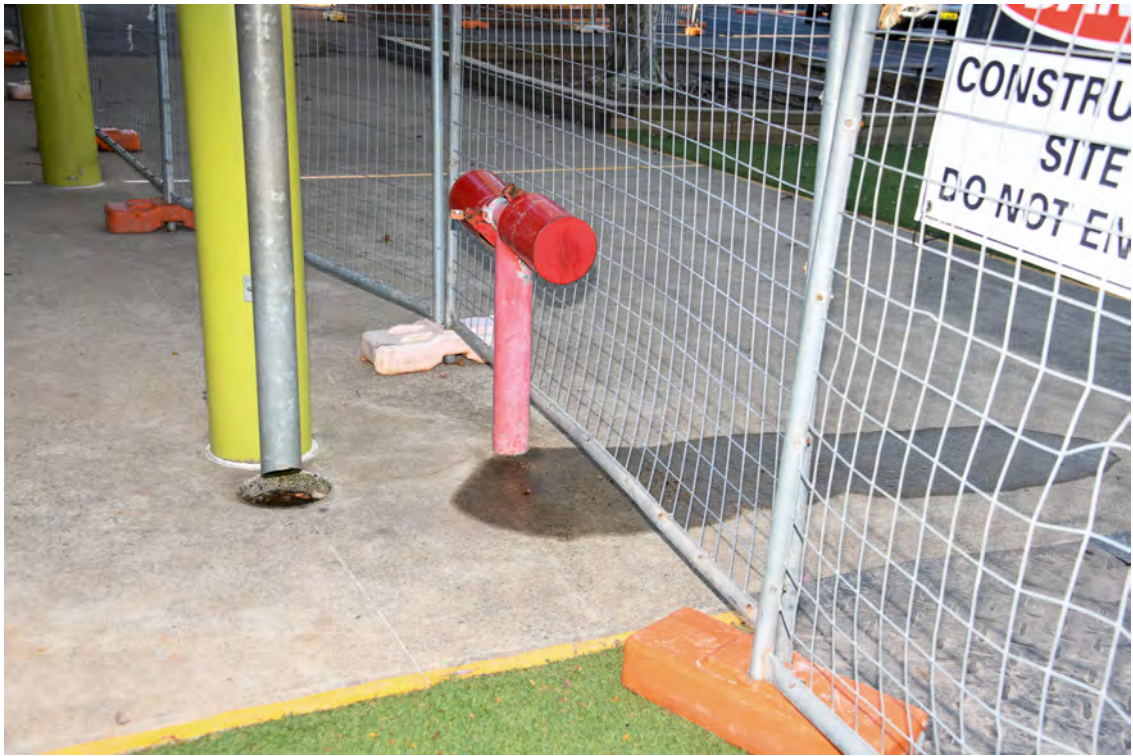
PRO\_0190.jpg

Block M / Hall / The Aurora Centre. Northern elevation. Western end. Leaking hydrant.

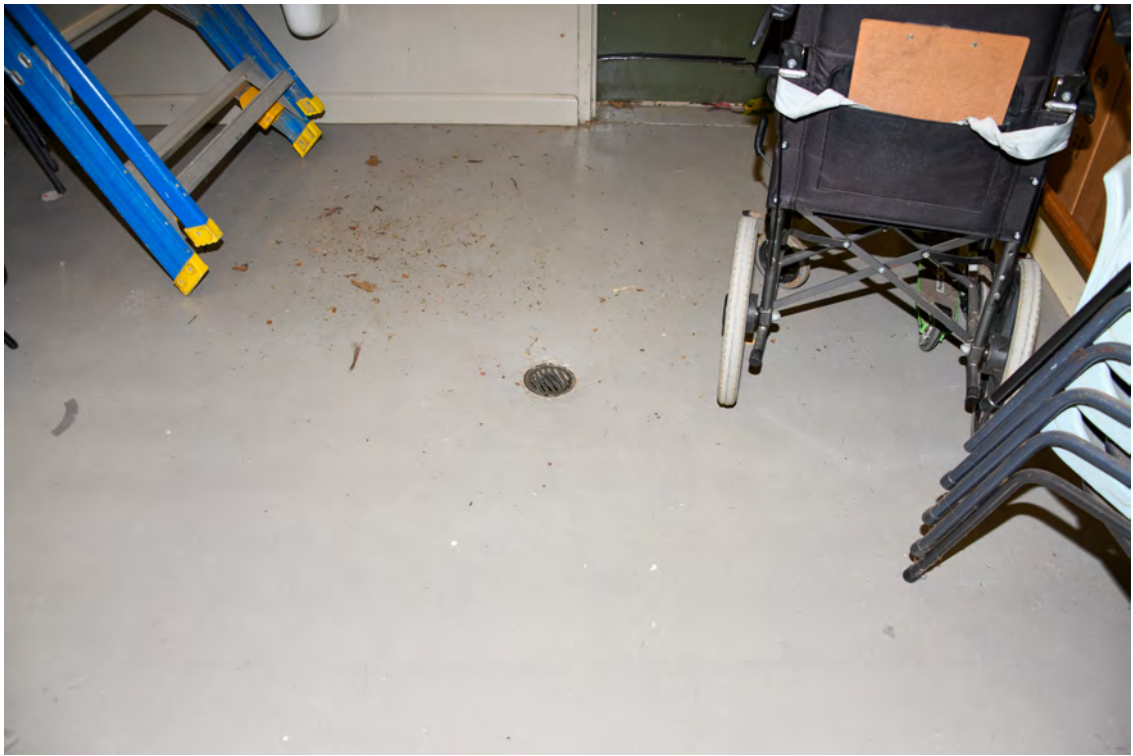
PRO\_0719.jpg

Block M / Hall / The Aurora Centre. Interior. Southern face. Boys Change Room. Flooring. Cracked flooring.

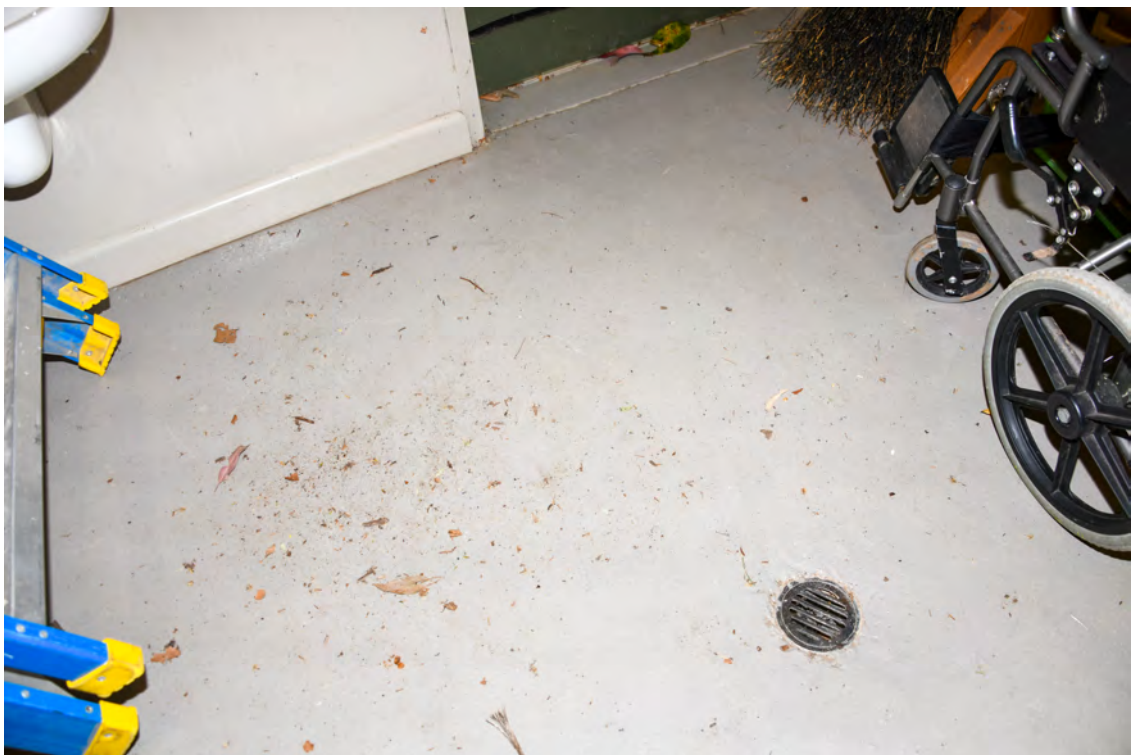
PRO\_0720.jpg

Block M / Hall / The Aurora Centre. Interior. Southern face. Boys Change Room. Flooring. Cracked flooring.

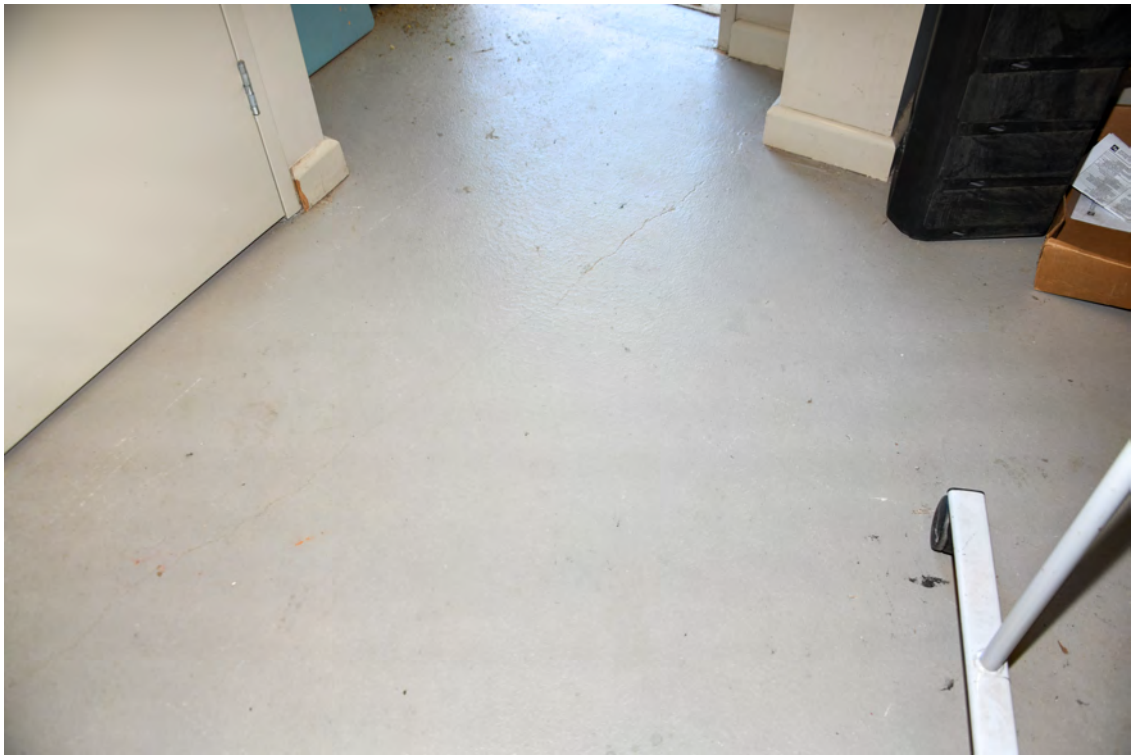
PRO\_0737.jpg

Block M / Hall / The Aurora Centre. Interior. Southern face. Girls Change Room.  
Cracked flooring.

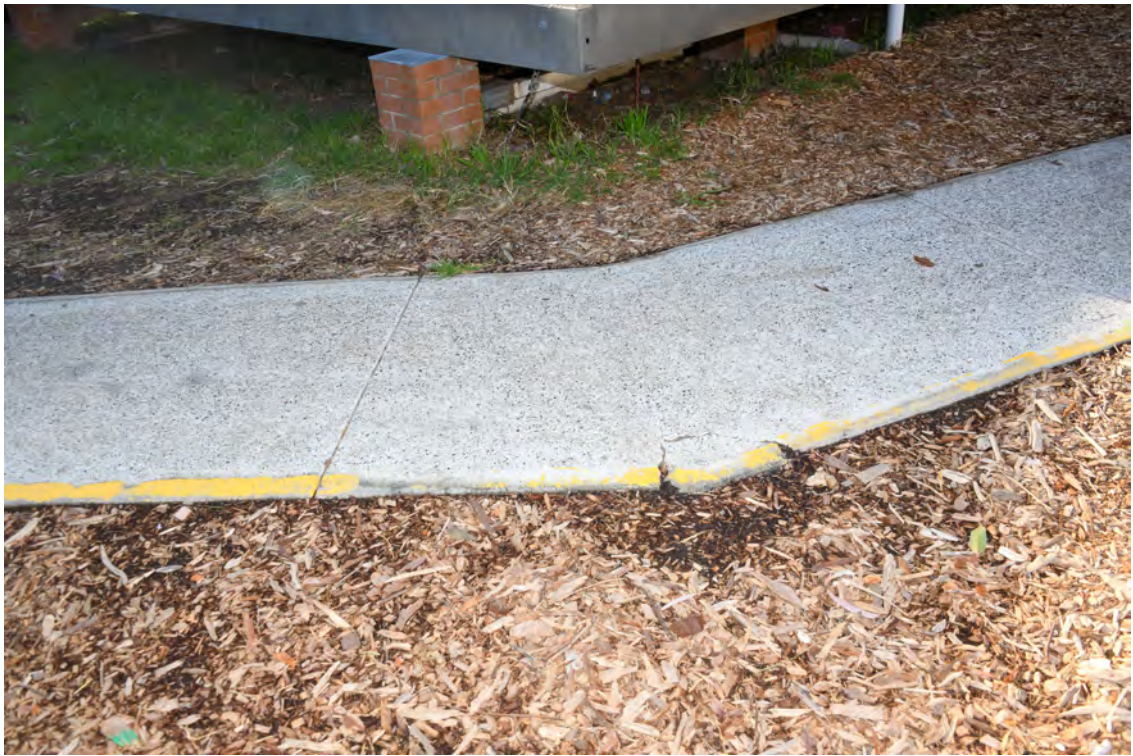
PRO\_0292.jpg

Amenities on the northern side of Block M / Hall / The Aurora Centre. Area on the eastern side of the block. Damaged paving.

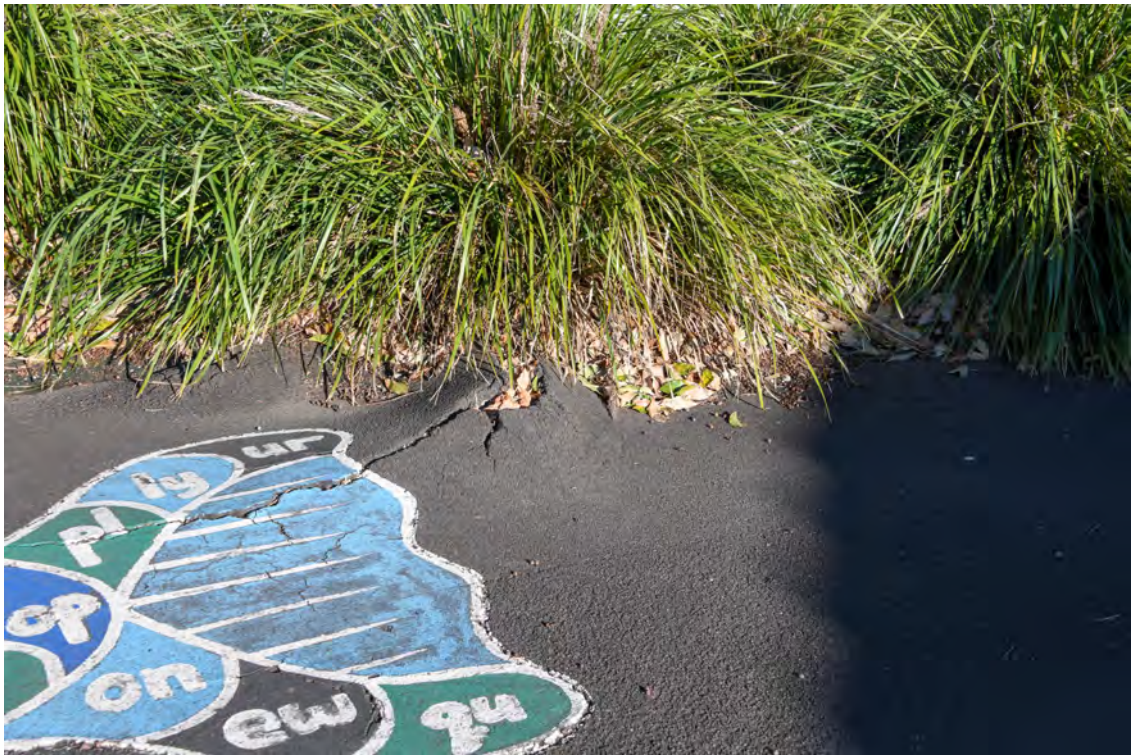
PRO\_0316.jpg

Block D. Eastern elevation. Southern end. Damaged adjacent asphalt paving.

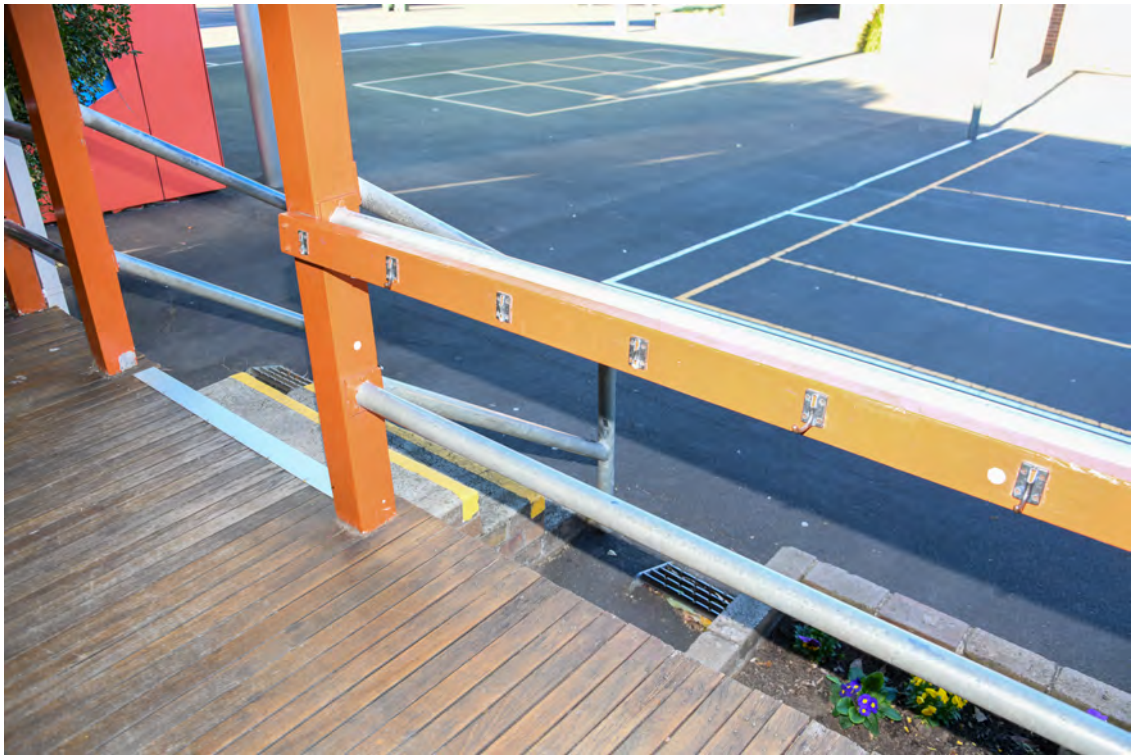
PRO\_0348.jpg

Block D. Western elevation. Southern end. Damaged coat hooks.
