96-104 Carlingford Road, Epping NSW 2121

Epping West Public School

DILAPIDATION REPORT

7<sup>th</sup> September 2021

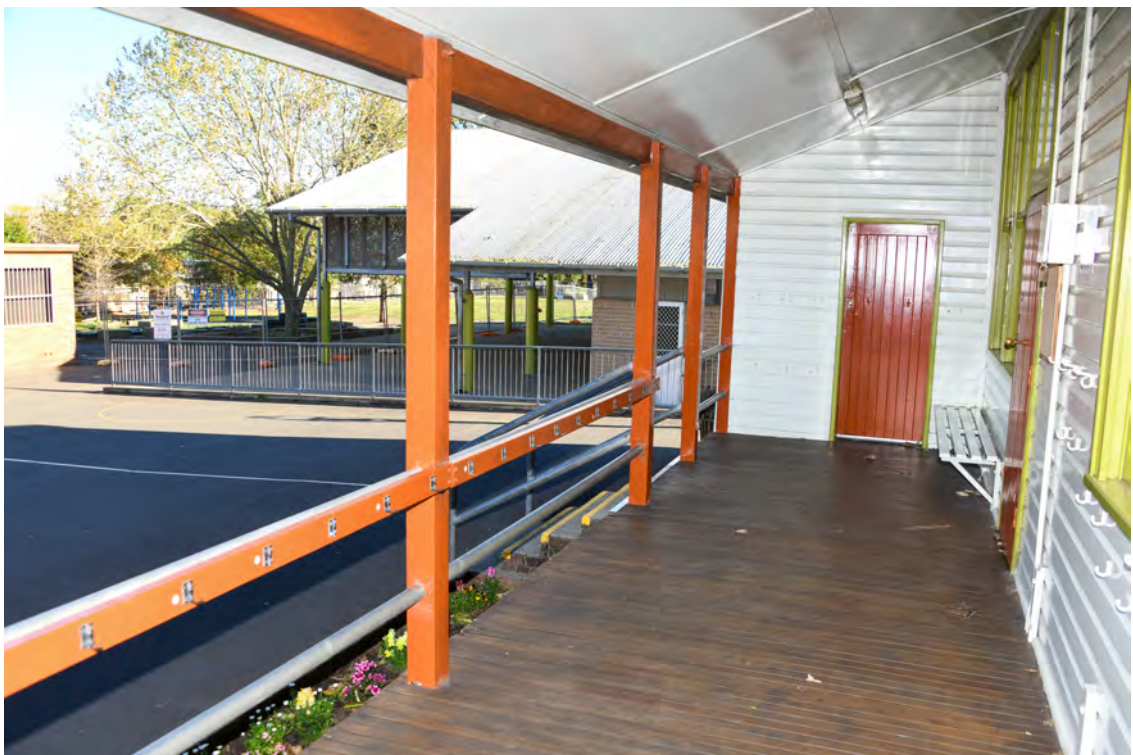
PRO\_0349.jpg

Block D. Western elevation. Damaged coat hooks.

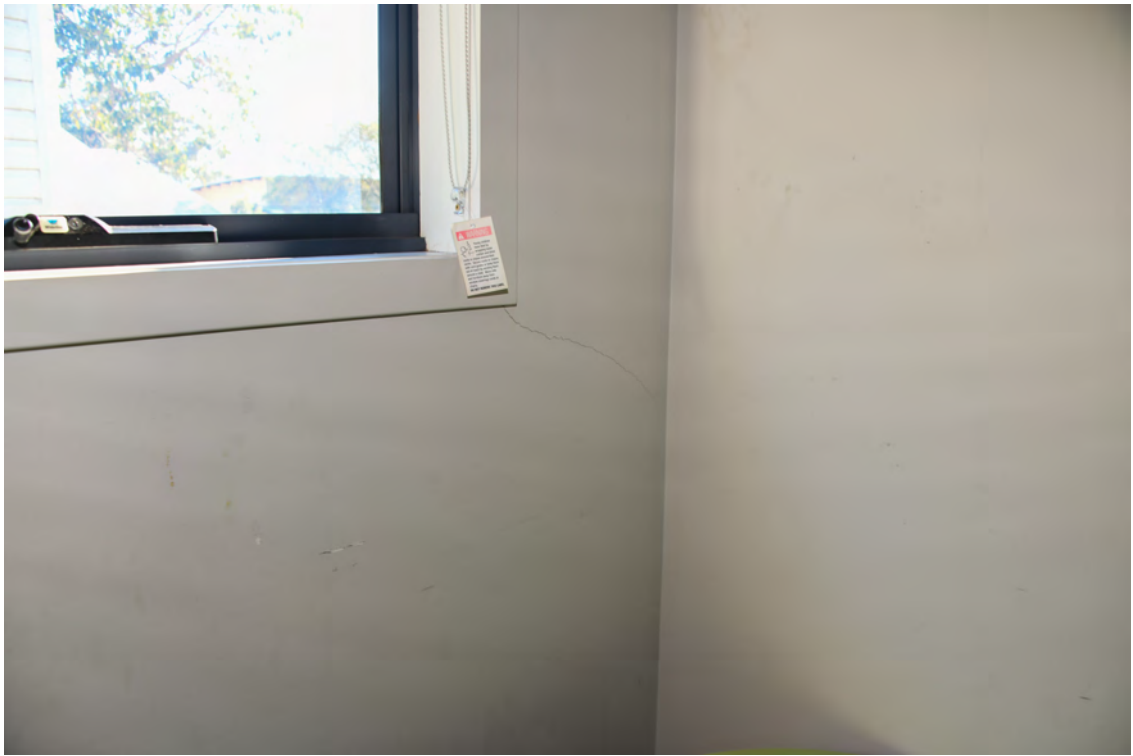
PRO\_0921.jpg

Block R. Interior. Western half. Western face. Crack in the wall lining.

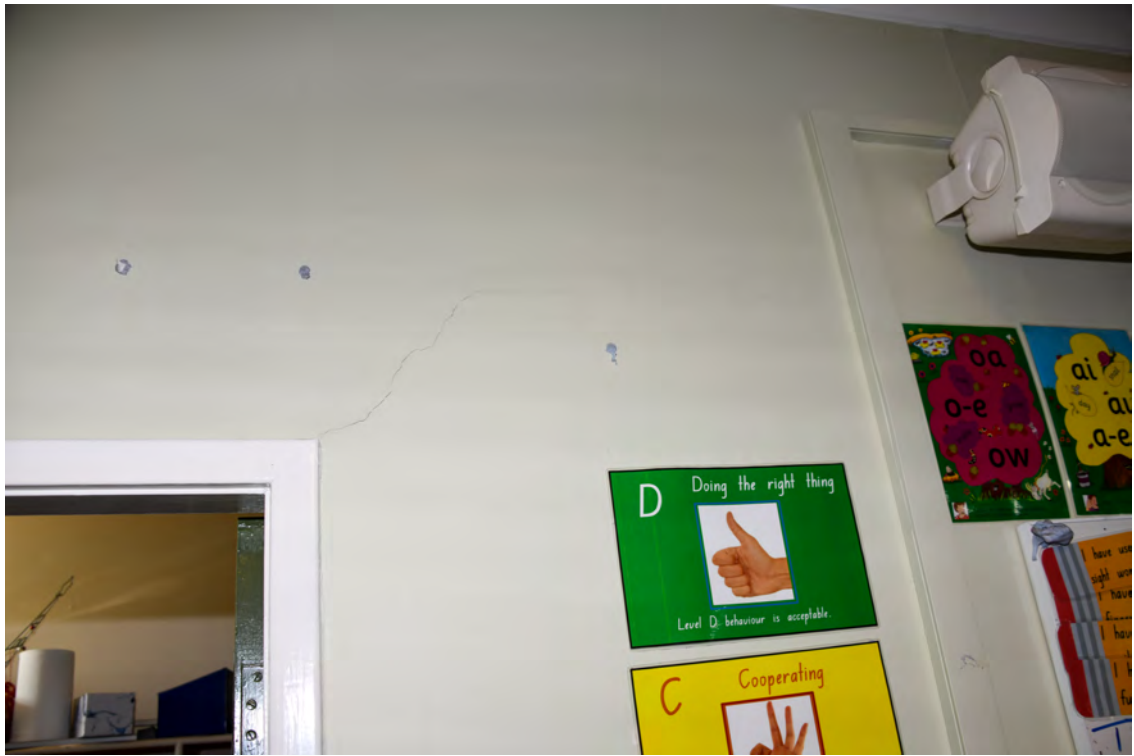
PRO\_0433.jpg

Block A. Room 1G. Southern face. Cracked wall cladding.

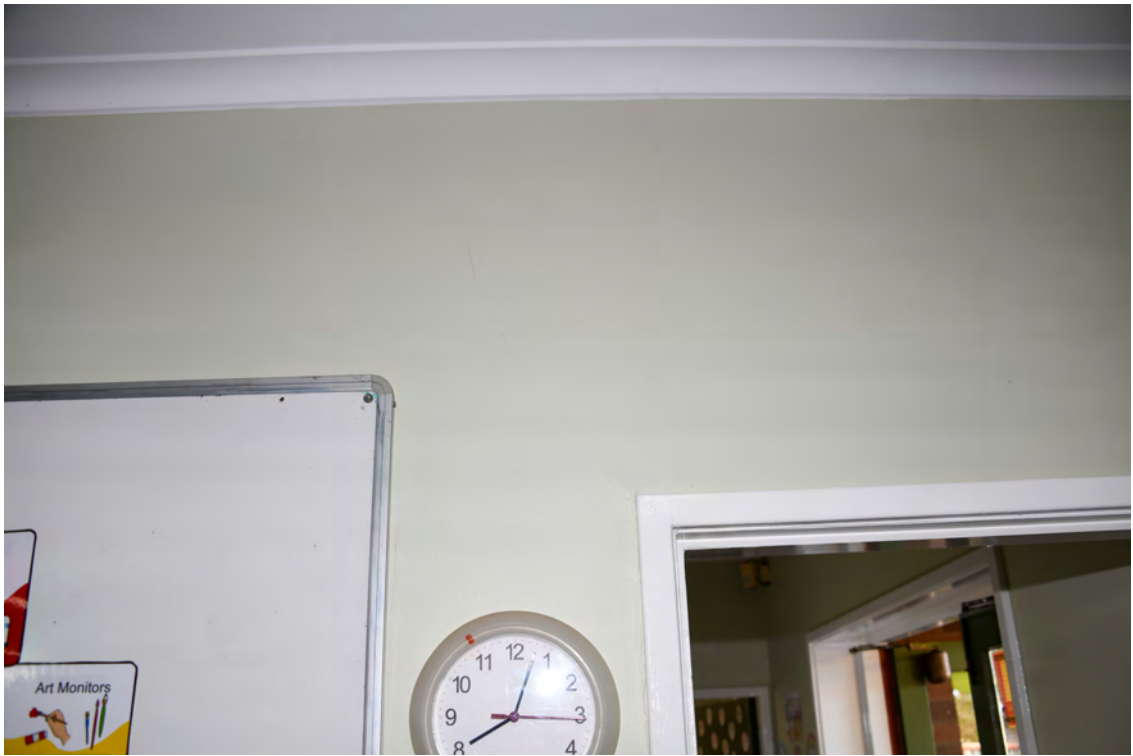
PRO\_0435.jpg

Block A. Room 1G. Southern face. Cracked wall cladding.

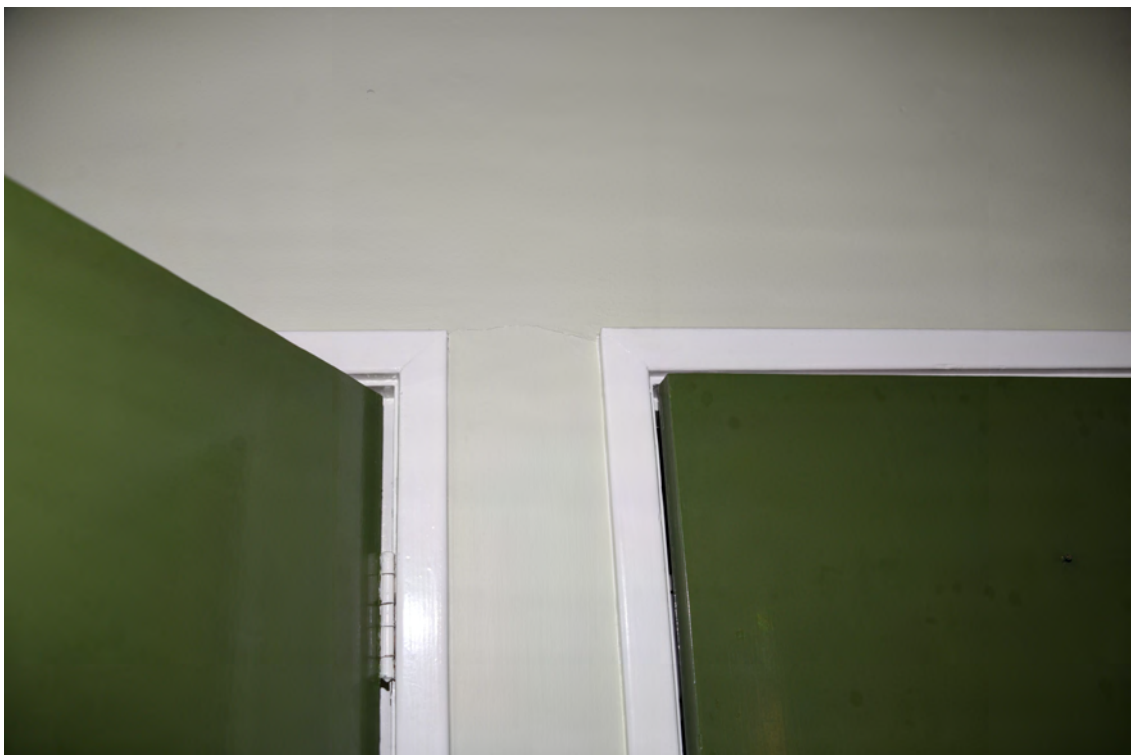
PRO\_0436.jpg

Block A. Room 1G. Southern face. Cracked wall cladding.

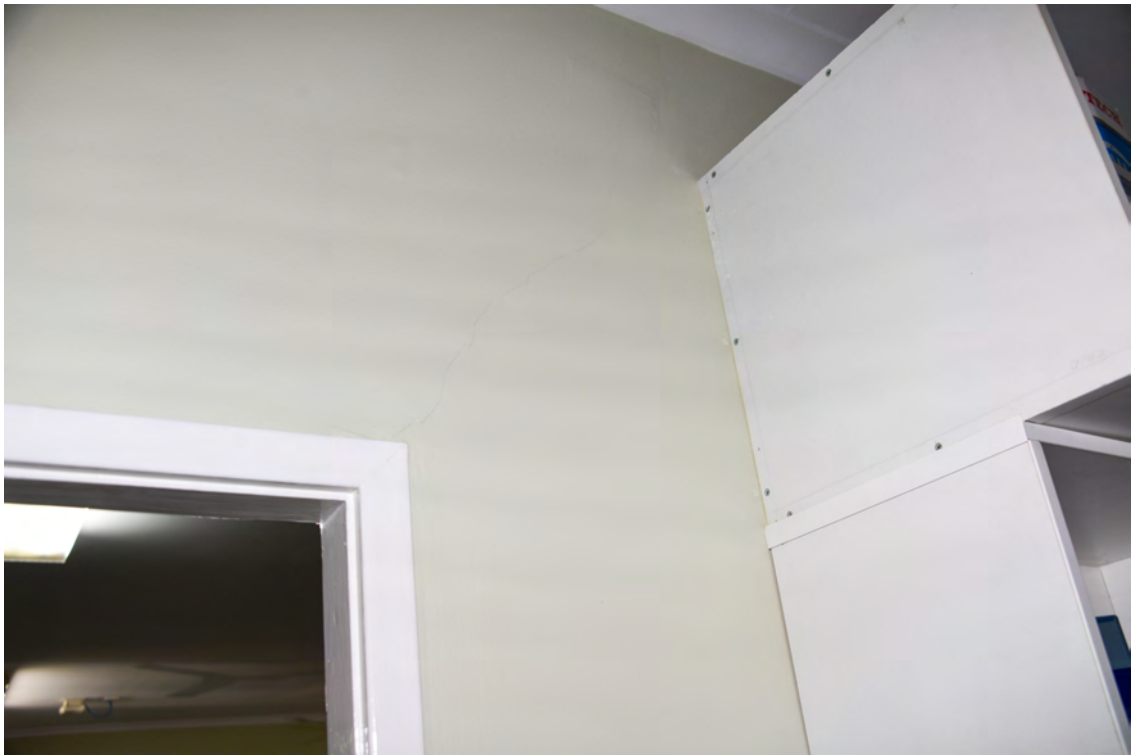
PRO\_0449.jpg

Block A. Building foyer. Northern face. Cracked wall cladding.

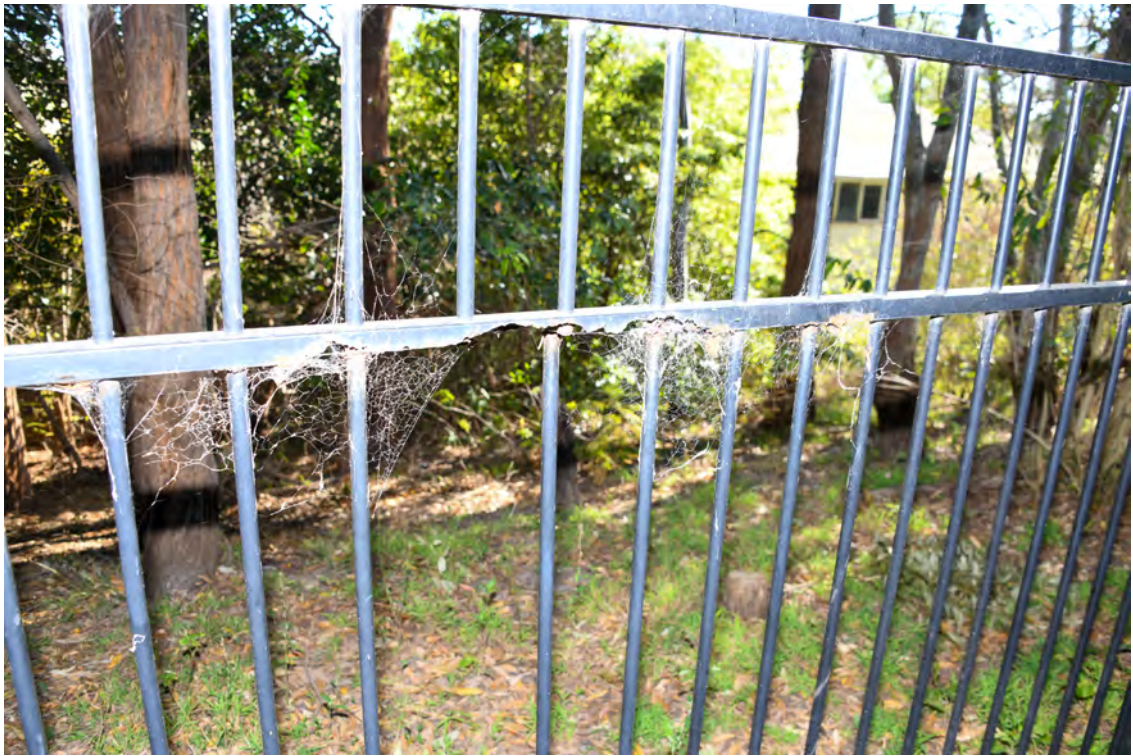
PRO\_1163.jpg

School boundaries. Northern boundary common with the YMCA. Heading west. Rusted and damaged boundary fence.

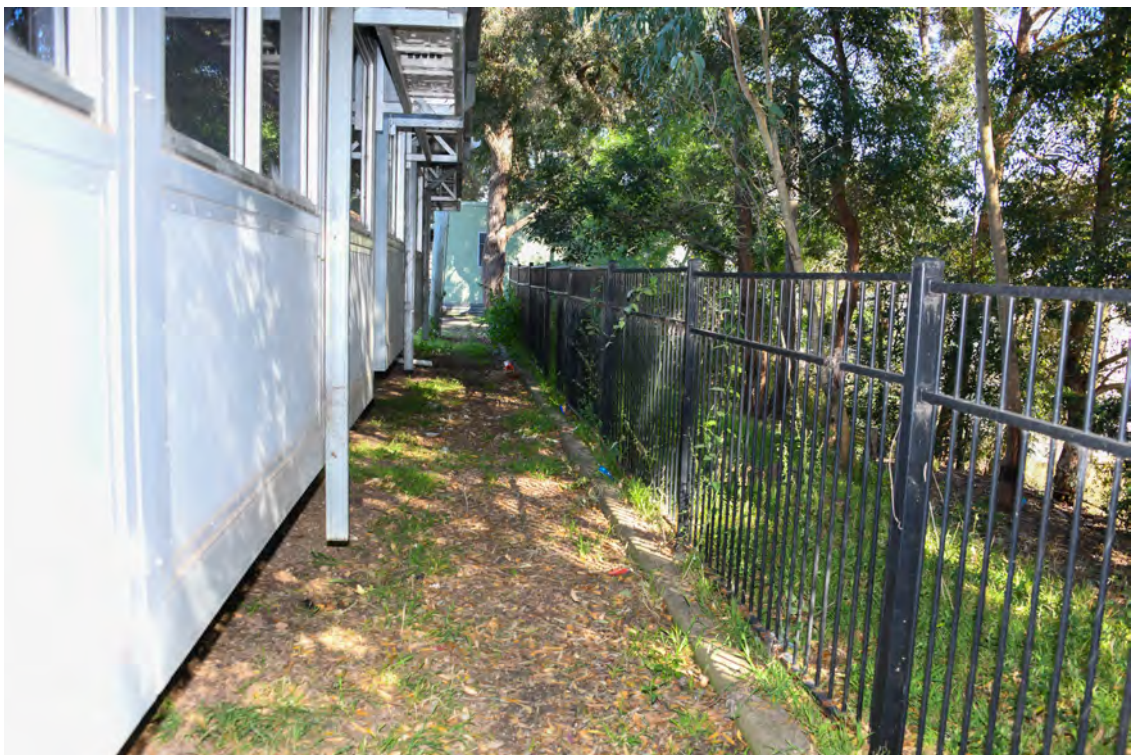
PRO\_1164.jpg

School boundaries. Northern boundary common with the YMCA. Heading west. Rusted and damaged boundary fence.

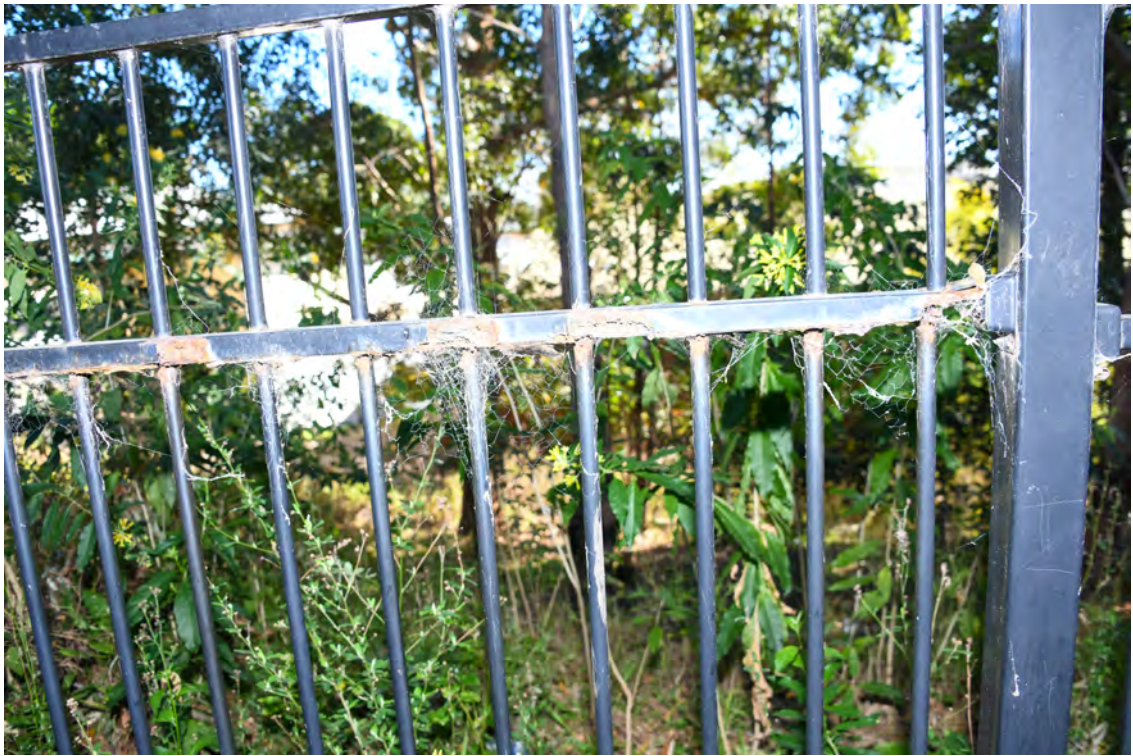
PRO\_1171.jpg

School boundaries. Northern boundary common with the YMCA. Heading west. Rusty and damaged boundary fence.
