Re: Request for Secretary Discretion – Wollar Solar Farm

Road Safety Audit

Stage 7 – Existing Condition

Intersection of Wollar Road (MR208) and Barigan Road,
Wollar

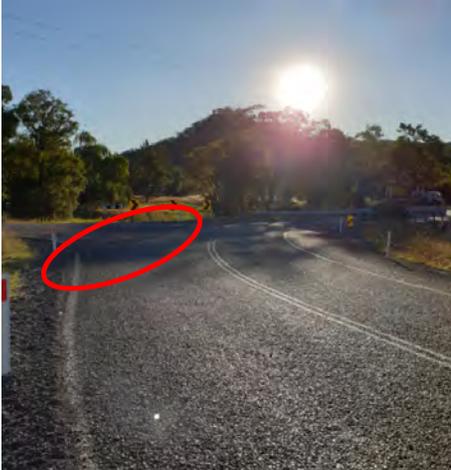
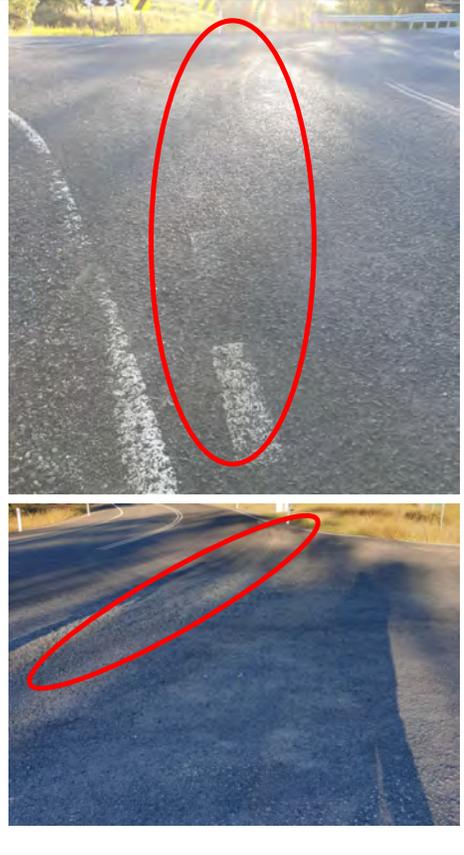
CAR No	Location Category	Description of Risk to Road Safety	Photographs/ Plans / Drawing No	Risk Assessment	Client Response
1.	Intersection of Wollar Road (MR208) and Barigan Road Eastbound / Northbound Delineation And Road alignment and cross section	<p>The auditors observed during the site inspection at the intersection of Wollar Road (MR208) and Barigan Road, there is a combination of the line marking on the outside of horizontal curve that is faded and worn to delineate through vehicles on Wollar Road (MR208), and delineate the give way location for vehicles on Barigan Road.</p> <p>This may increase the likelihood of readability issues for drivers. This may increase the risk of an eastbound vehicle on Wollar Road striking a holding northbound vehicle on Barigan Road (i.e. eastbound vehicles on Wollar Road (MR208) taking a wide vehicle path around the horizontal curve, and holding vehicles on Barigan Road encroaching into the Wollar Road (MR208) through lane.</p>

Improbable	
				Consequence	
				Minor	
				Risk Level	
Low

CAR No	Location Category	Description of Risk to Road Safety	Photographs/ Plans / Drawing No	Risk Assessment	Client Response
		<p>The likelihood of this risk may be increased for eastbound vehicles, during adverse weather conditions (i.e. rain / storm events), at night, during peak traffic periods and at times of the day due to sun glare.</p> <p>This may increase the risk of vehicle crashes and result in injury to occupants of a vehicle/s.</p>

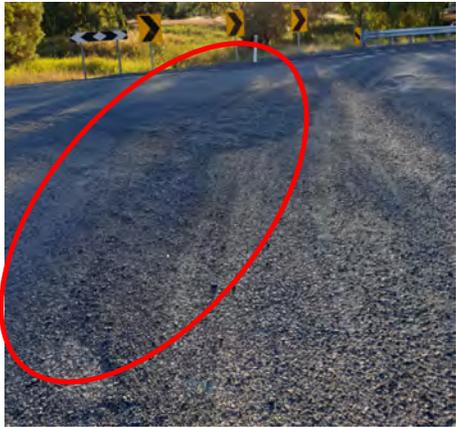
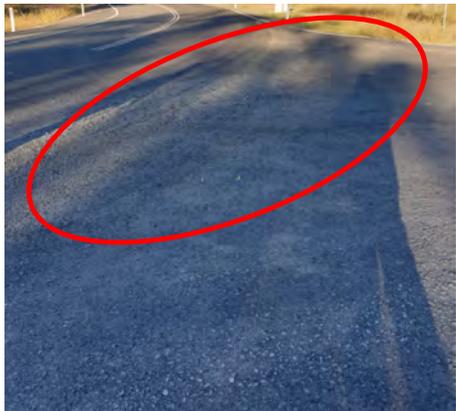
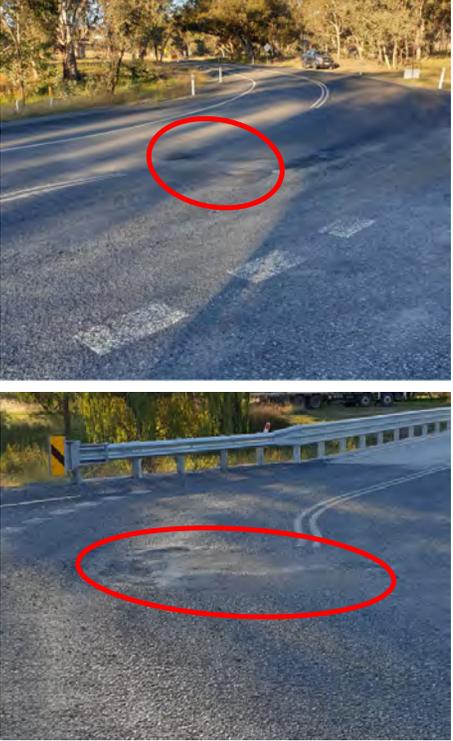
CAR No	Location Category	Description of Risk to Road Safety	Photographs/ Plans / Drawing No	Risk Assessment	Client Response						
2.	<p>Intersection of Wollar Road (MR208) and Barigan Road</p> <p>Eastbound / Westbound / Northbound</p> <p>Road pavement</p>	<p>During the site inspection, the auditors observed a combination of the outer edge of the westbound carriageway, particularly within the intersection at Barigan Road, contained a build-up of loose gravel within the road carriageway as well as a pothole within the westbound through lane on Wollar Road (MR208). This combination may reduce traction of the vehicle to the road surface and increase the risk of a vehicle becoming errant. This may be increased for westbound through vehicles and eastbound vehicles turning right from Wollar Road (MR208) into Barigan Road. The likelihood of this issue may increase during adverse weather conditions (i.e. rain). This may increase the risk of an errant vehicle to strike a vehicle holding at the intersection on Barigan Road (i.e. at the give way line), and / or objects within the clear zone. This may result in injury to occupants of a vehicle/s.</p>

Likeli-hood	Occasional	Consequence	Minor	Risk Level	Medium	
Likeli-hood											
Occasional											
Consequence											
Minor											
Risk Level											
Medium

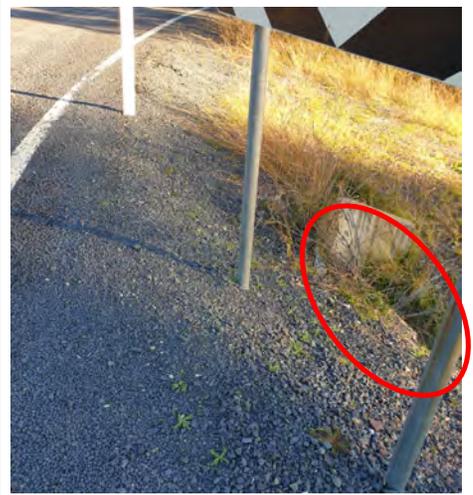
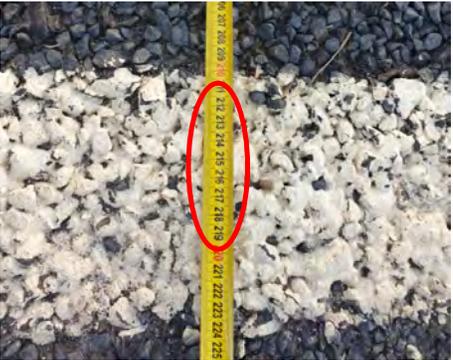
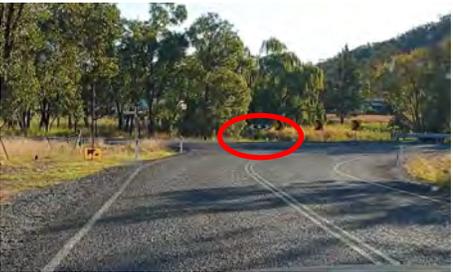
CAR No	Location Category	Description of Risk to Road Safety	Photographs/ Plans / Drawing No	Risk Assessment	Client Response						
3.	<p data-bbox="233 443 411 597">Intersection of Wollar Road (MR208) and Barigan Road</p> <p data-bbox="233 686 411 743">Westbound / Northbound</p> <p data-bbox="233 833 411 889">Roadside hazard</p>	<p data-bbox="428 443 951 808">Within the westbound verge of the intersection of Wollar Road (MR208) and Barigan Road, there is a culvert headwall located within the clear zone. An errant westbound vehicle on Wollar Road (MR208) or an errant northbound vehicle on Barigan Road at this location may have a reduced ability to regain control of their vehicle and strike the culvert headwall. The likelihood of this issue may increase during adverse weather conditions (i.e. rain). This may lead to rapid deceleration of a vehicle result in injury to occupants of a vehicle/s.</p>

Likeli-hood	Improbable	Consequence	Serious	Risk Level	Medium	
Likeli-hood											
Improbable											
Consequence											
Serious											
Risk Level											
Medium

CAR No	Location Category	Description of Risk to Road Safety	Photographs/ Plans / Drawing No	Risk Assessment	Client Response
			<p data-bbox="968 451 1421 509">Distance between edge of travel lane and culvert headwall (2.15m)</p>

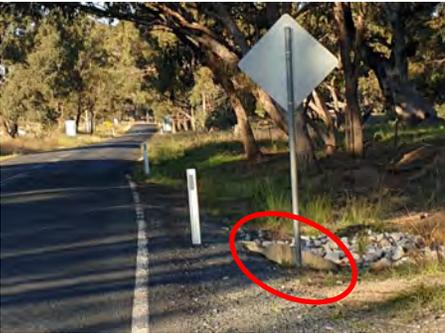
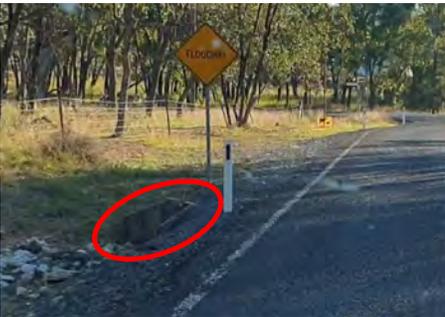
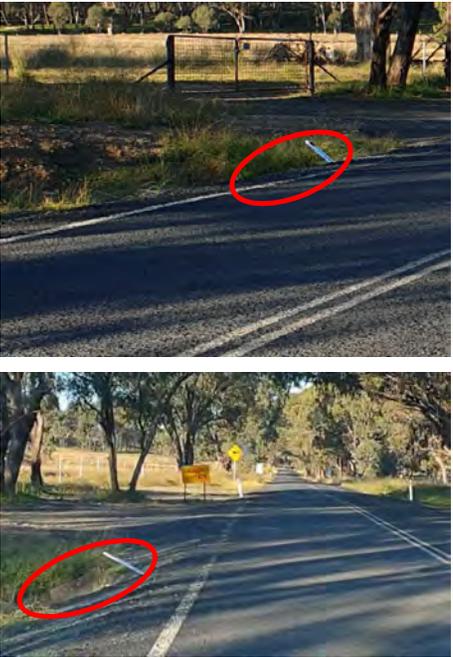
CAR No	Location Category	Description of Risk to Road Safety	Photographs/ Plans / Drawing No	Risk Assessment	Client Response						
4.	<p>Wollar Road (MR208)</p> <p>50m East of Intersection of Wollar Road (MR208) and Barigan Road</p> <p>Westbound / Eastbound</p> <p>Roadside hazard</p>	<p>Within the eastbound and westbound verge, approximately 50m east of the intersection of Wollar Road (MR208) and Barigan Road, there are culvert headwalls located within the clear zone. An errant vehicle at this location may have a reduced ability to regain control of their vehicle and strike the culvert headwall. The likelihood of this issue may increase during adverse weather conditions (i.e. rain). This may lead to rapid deceleration of a vehicle result in injury to occupants of a vehicle/s.</p> <p>Note – These culvert headwalls are located along a straight length of road alignment.</p>

Likeli-hood	Improbable	Consequence	Serious	Risk Level	Medium	
Likeli-hood											
Improbable											
Consequence											
Serious											
Risk Level											
Medium

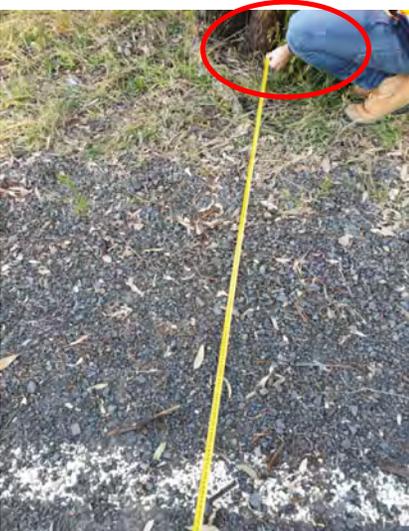
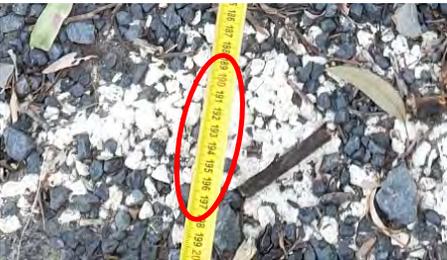
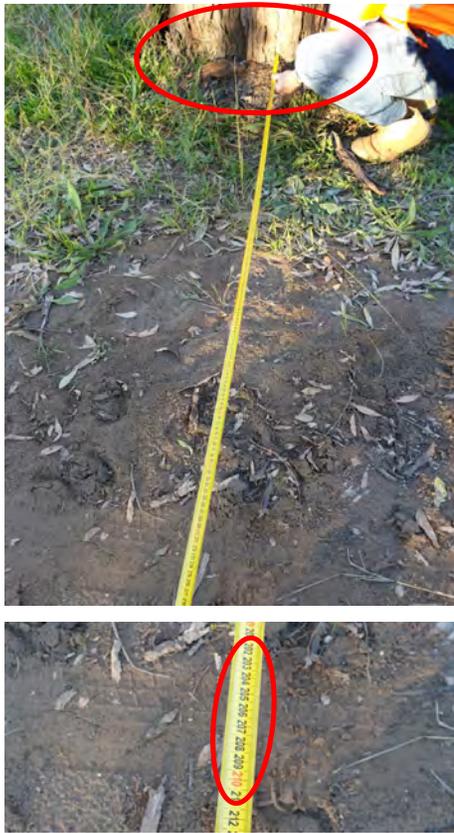
CAR No	Location Category	Description of Risk to Road Safety	Photographs/ Plans / Drawing No	Risk Assessment	Client Response						
5.	<p data-bbox="237 440 401 532">Wollar Road (MR208) and Barigan Road</p> <p data-bbox="237 621 401 743">Eastbound / Westbound / Northbound / Southbound</p> <p data-bbox="237 833 401 889">Roadside hazards</p>	<p data-bbox="432 431 951 776">The auditors observed within the audit subject location on Wollar Road (MR208) and Barigan Road, several trees with trunks in excess of 100mm diameter, located within the clear zone. Errant vehicles at these locations may have a reduced ability to regain control of their vehicle and strike the large trees. The likelihood of this issue may increase during adverse weather conditions (i.e. rain) and / or night. This may lead to rapid deceleration of a vehicle result in injury to occupants of a vehicle/s.</p>

Likeli-hood	Improbable	Consequence	Serious	Risk Level	Medium	
Likeli-hood											
Improbable											
Consequence											
Serious											
Risk Level											
Medium

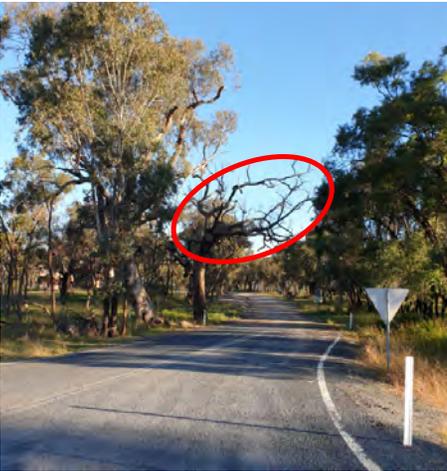
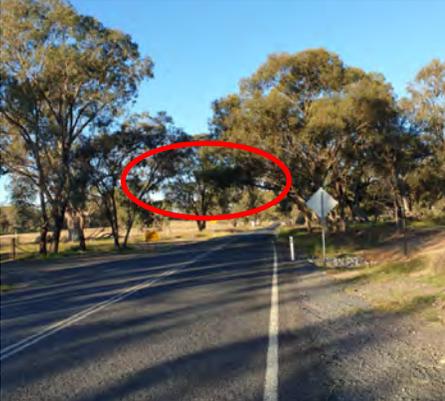
CAR No	Location Category	Description of Risk to Road Safety	Photographs/ Plans / Drawing No	Risk Assessment	Client Response
6.	<p>Wollar Road (MR208) and Barigan Road</p> <p>Eastbound / Westbound / Northbound / Southbound</p> <p>Roadside Hazard</p>	<p>The auditors observed on Wollar Road (MR208) and Barigan Road, several trees with overhanging branches.</p> <p>These overhanging branches may cause an obstruction, and be struck by oncoming oversize (high) vehicles.</p> <p>If work is undertaken in the future within the root zone of the trees (i.e. pavement work), this may impact within the roots of the trees. If the root zone of the tree is impacted, this may increase the risk of the tree to die back and/or drop branches. This may strike an oncoming vehicle and cause severe damage to a vehicle, and / or rapid deceleration of a vehicle. This may cause serious injury to occupants of a vehicle.</p>

<p>Likeli-hood</p> <p>Improbable</p> <p>Consequence</p> <p>Serious</p> <p>Risk Level</p> <p>Medium</p>

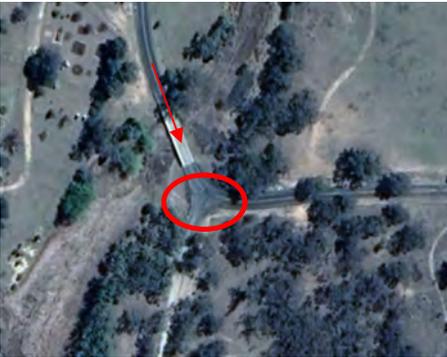
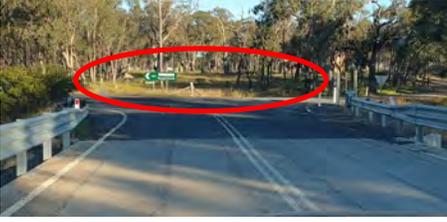
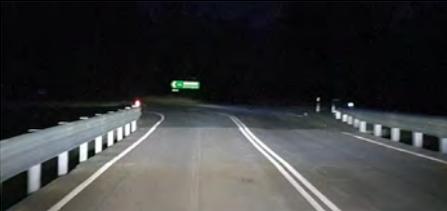
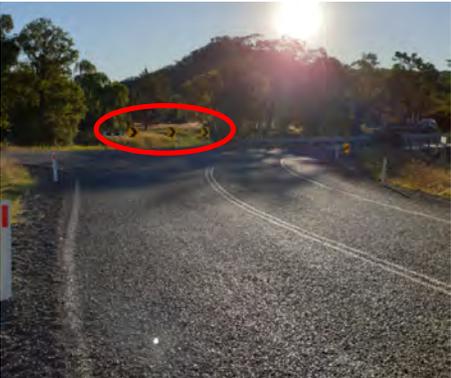
CAR No	Location Category	Description of Risk to Road Safety	Photographs/ Plans / Drawing No	Risk Assessment	Client Response						
7.	<p data-bbox="233 440 415 597">Intersection of Wollar Road (MR208) and Barigan Road</p> <p data-bbox="233 683 390 743">Eastbound / Westbound</p> <p data-bbox="233 829 365 954">Road alignment and cross section</p>	<p data-bbox="428 435 953 1068">On Wollar Road (MR208), the horizontal curve appears tight to suit the 50km/h sign posted speed limit. During the site inspection, the auditors observed that the westbound alignment approaching the bridge provides chevron alignment marker signs (CAMS) however, for the eastbound alignment, it was identified there are no CAMS present to provide sufficient delineation through this area, with only an intersection directional sign evident. This in combination with a lack of delineation (i.e. faded line marking, few guideposts and no RRPM's) may lead to an approaching eastbound vehicle not observing the change in direction of the road alignment. The likelihood of this risk may increase at night and / or during adverse weather conditions. This may lead to a vehicle becoming errant and striking objects within the clear zone, or striking an oncoming westbound vehicle. This may lead to serious injury to occupants of a vehicle/s.</p>

Likeli-hood	Improbable	Consequence	Minor	Risk Level	Low	
Likeli-hood											
Improbable											
Consequence											
Minor											
Risk Level											
Low

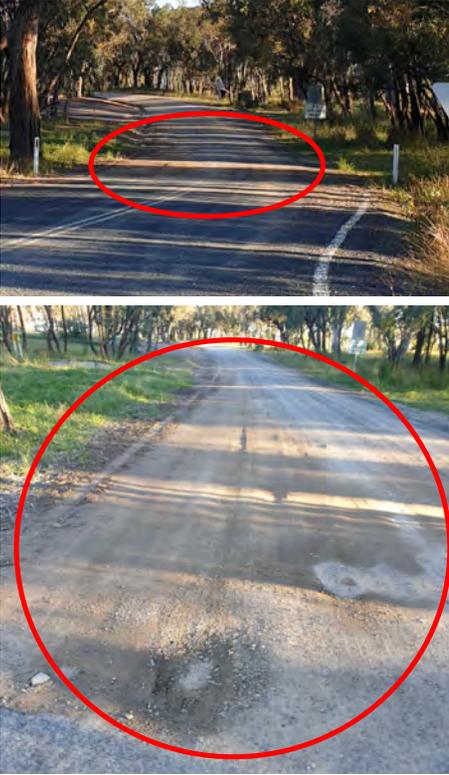
No findings were allocated "intolerable" rating and only finding #8 was allocated "high risk" rating. Finding #8 is that Barigan Road is an unsealed road, with narrow lane widths and no shoulder. The narrow carriageway poses a risk for drivers passing heavy vehicles and the unsealed pavement surface increases the risk of vehicles becoming errant.

CAR No	Location Category	Description of Risk to Road Safety	Photographs/ Plans / Drawing No	Risk Assessment	Client Response						
8.	Barigan Road Northbound / Southbound Road alignment and cross section And Road pavement	<p>Barigan Road is an unsealed road, with narrow lane widths and no shoulder. Additionally, the auditors did not observe a sign posted speed limit along Barigan Road within the vicinity of the intersection with Wollar Road (MR208) – Note 50km/h sign posted speed limit northbound approaching the intersection with Wollar Road (MR208). Narrow carriageway widths may create lane position issues for passing drivers, in particular heavy vehicles accessing Barigan Road. Vehicles may not have sufficient space to pull over into the verge to allow a passing heavy vehicle in some locations. Additionally, the unsealed pavement surface may increase the risk of vehicles becoming errant. The likelihood of these risks may increase during adverse weather conditions, at night, an during peak traffic periods. This may result in vehicle crashes and result in serious injury to occupants of a vehicle/s.</p> <p>Note – Barigan Road was not signposted with a speed limit within the vicinity of the</p>

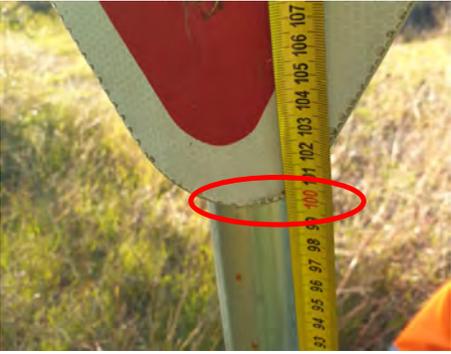
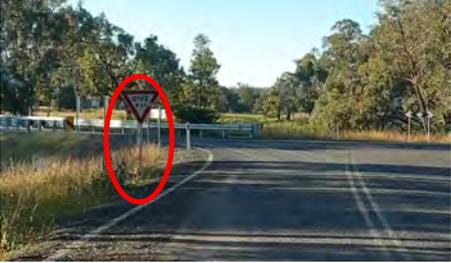
Item	Location Category	Description of Observation	Photographs/ Plans / Drawing No	Client Response
1.	<p>Barigan Road, approaching the intersection of Wollar Road (MR208)</p> <p>Northbound</p> <p>Traffic signs</p>	<p>The auditors observed the Give Way sign on Barigan Road, approaching the intersection with Wollar Road (MR208) appears low.</p> <p>Refer AS1742.2, C2.3.4 Height rural – notes “the height of the sign should not normally be installed less than 1.5m above the nearest edge of the travelled way”.</p> <p>The auditors observed the sign has been placed 1m above the nearest edge of the road carriageway.</p>

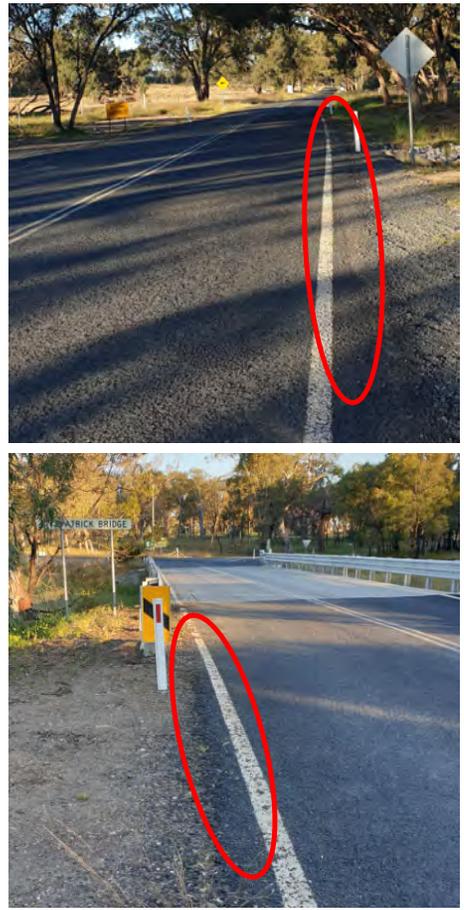
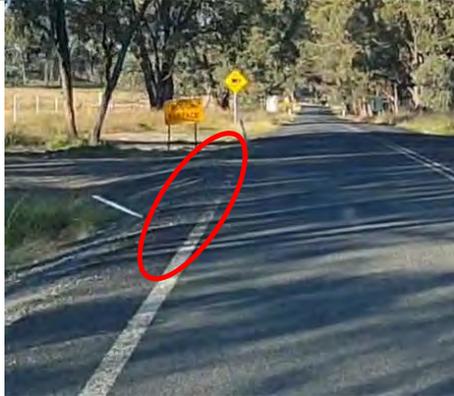
<p>2.</p>	<p>Intersection of Wollar Road (MR208) and Barigan Road</p> <p>Eastbound / Westbound</p> <p>Road alignment and cross section</p> <p>And Cyclist infrastructure</p>	<p>Along Wollar Road (MR208) between the western site extents (north of the bridge) and 65m east of the intersection with Barigan Road, the auditors observed a narrow shoulder (0.5m). Along Wollar Road (MR208) between 65m east of the intersection with Barigan Road and east to the site extents, the auditors observed a no shoulder along the edge of the travel lane. This narrow shoulder width does not provide sufficient room for an on-road cyclist to be passed by a vehicle in the same travel direction.</p> <p>Note – The auditors observed the site is a semi-rural environment, on the edge of the town of Wollar, with a low AADT at the site location, and low signposted speed limit (50km/h). This may result in a very low potential demand for on-road cyclists. The auditors did not observe cyclists within the vicinity during the site inspection.</p>

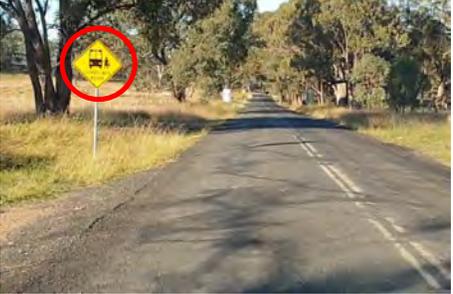
<p>3.</p>	<p>Wollar Road (MR208) and Barigan Road</p> <p>Eastbound / Westbound</p> <p>Road users</p>	<p>On Wollar Road (MR208) and Barigan Road, the auditors observed during the site inspection that there is no existing available space within the road shoulder or verge suitable for a bus to pick up and drop off passengers. This includes storage and access for passengers.</p> <p>Note – The auditors observed the “School bus route” sign located within the eastbound carriageway, approximately 70m east of the intersection of Wollar Road (MR208) and Barigan Road.</p> <p>Note – There are no existing signposted bus stop locations within the audit subject location.</p>

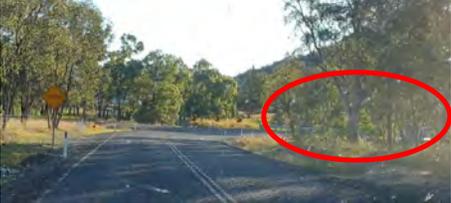
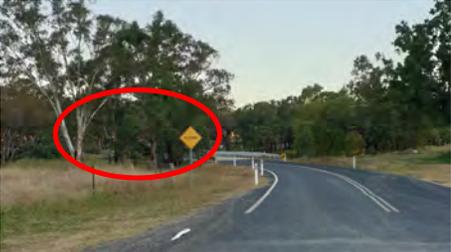
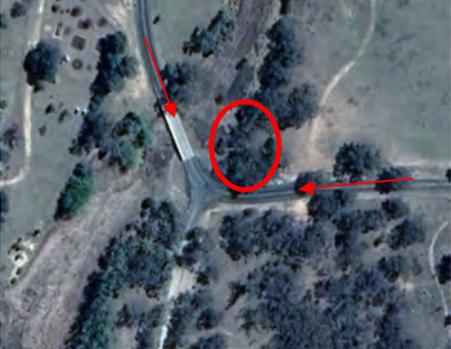
<p>4.</p>	<p>Intersection of Wollar Road (MR208) and Barigan Road</p> <p>Eastbound / Westbound</p> <p>Road alignment and cross section</p> <p>And</p> <p>Road users</p>	<p>The auditors observed during the site inspection the sight lines of drivers on Wollar Road (MR208) in both directions approaching the intersection with Barigan Road, are obscured due to the existing trees on the inside of the horizontal curve. Overside vehicles may approaching the bridge, north of the intersection, may be obscured to the view of oncoming vehicles in both directions. This may lead to approaching vehicles not being able to pass an oversized vehicle on the bridge and / or pull over into a safe location off the road carriageway to allow the oversized vehicle to pass. This may cause driver frustration and / or lead to vehicle damage.</p>	<p>Westbound</p>

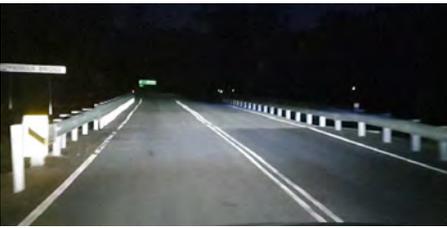
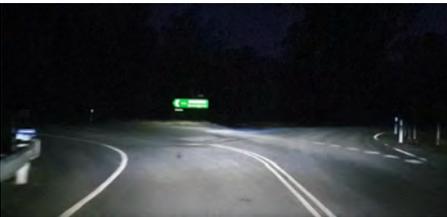
<p>5.</p>	<p>Wollar Road (MR208) and Barigan Road</p> <p>Eastbound / Westbound</p> <p>Delineation</p>	<p>The auditors observed a lack of delineators on the road pavement within the auditable site location (i.e. RRPM's), along with a lack of delineators on top of the bridge safety barriers. This may create readability issues for drivers, particularly approaching the horizontal curve near the intersection of Wollar Road (MR208) and Barigan Road.</p> <p>The auditors observed the location has a combination of a low signposted speed limit (50km/h), is located within the vicinity of the town of Wollar, contains a low AADT, a limited amount of traffic during the audit site inspection.</p>

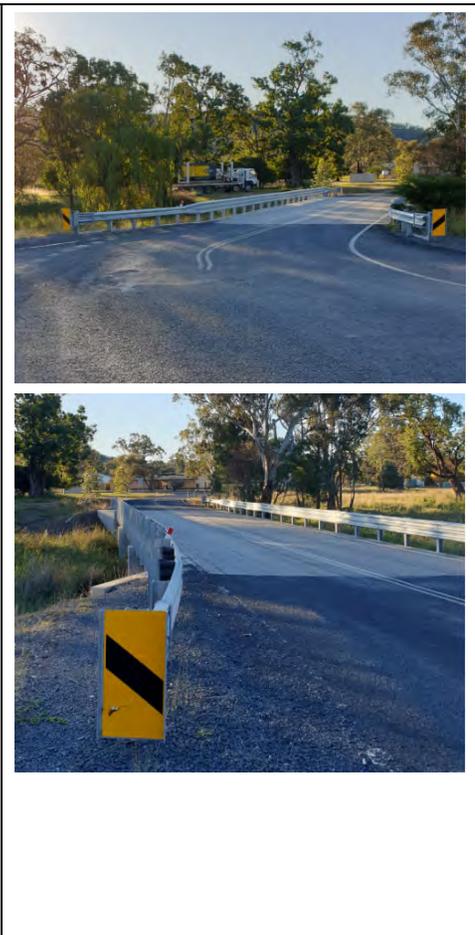
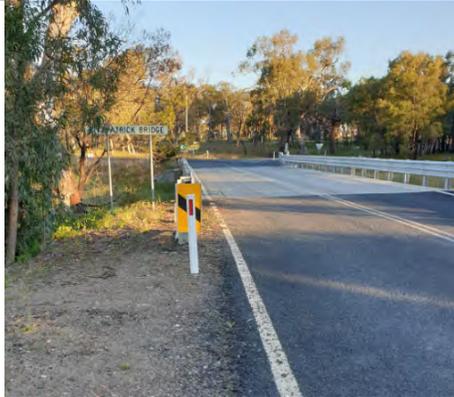
<p>6.</p>	<p>Wollar Road (MR208) at Fitzpatrick Bridge</p> <p>Eastbound / Westbound</p>	<p>Fitzpatrick bridge contains one travel lane in each direction, with guard rail along the edge of the bridge deck.</p> <p>Note – The RMS advice letter (refer supporting documents) mentioned the RSA is to include “An assessment, including a road safety audit, of the existing Wollar Road (MR208) and Barrigan Road intersection. Particularly, an assessment of the current geometry of the intersection, including the narrow single lane bridge in Wollar Road on approach to the intersection, and its ability to safely accommodate increased traffic volumes.”</p> <p>During the site inspection, the auditors observed the Fitzpatrick bridge contained one travel lane in each direction (two lanes), in lieu of the single lane bridge described in the advice letter.</p>

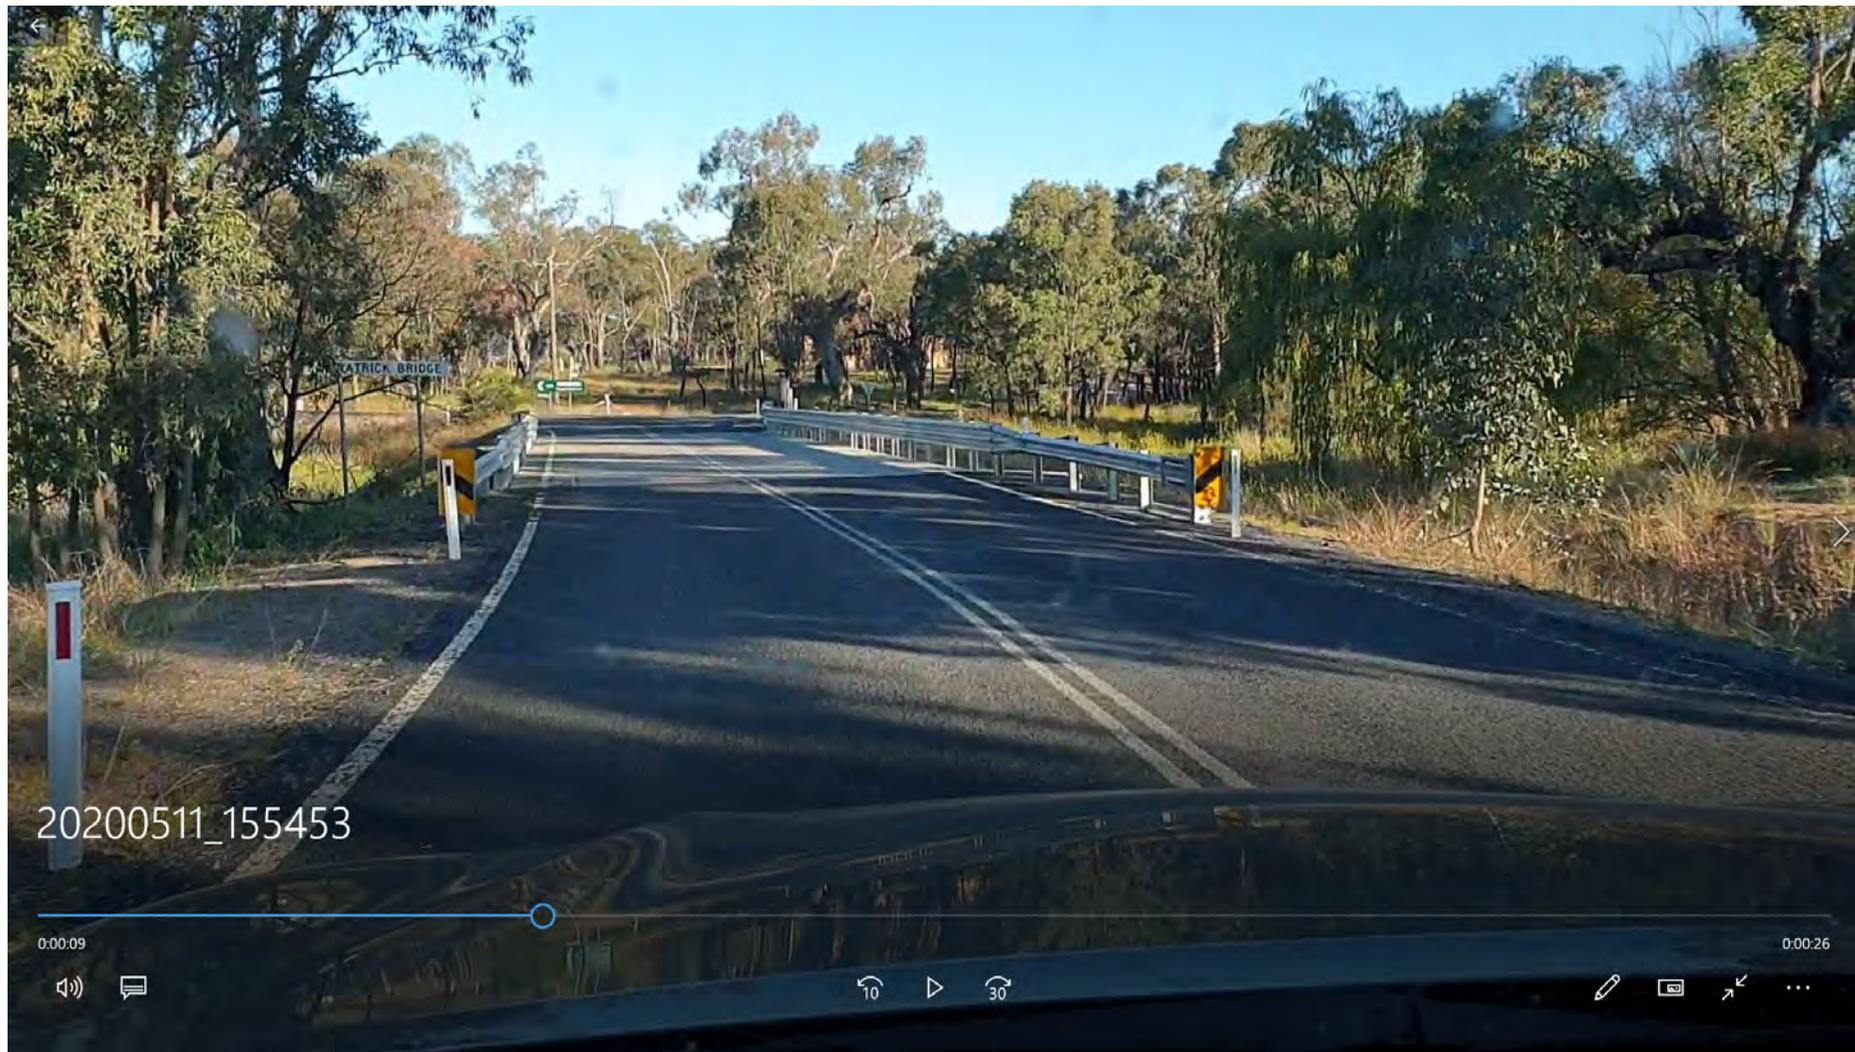
Same aspect as previous photo. Note bridge widened to two lanes with guardrails. Road also much wider with full lane markings. Work completed circa 2017.

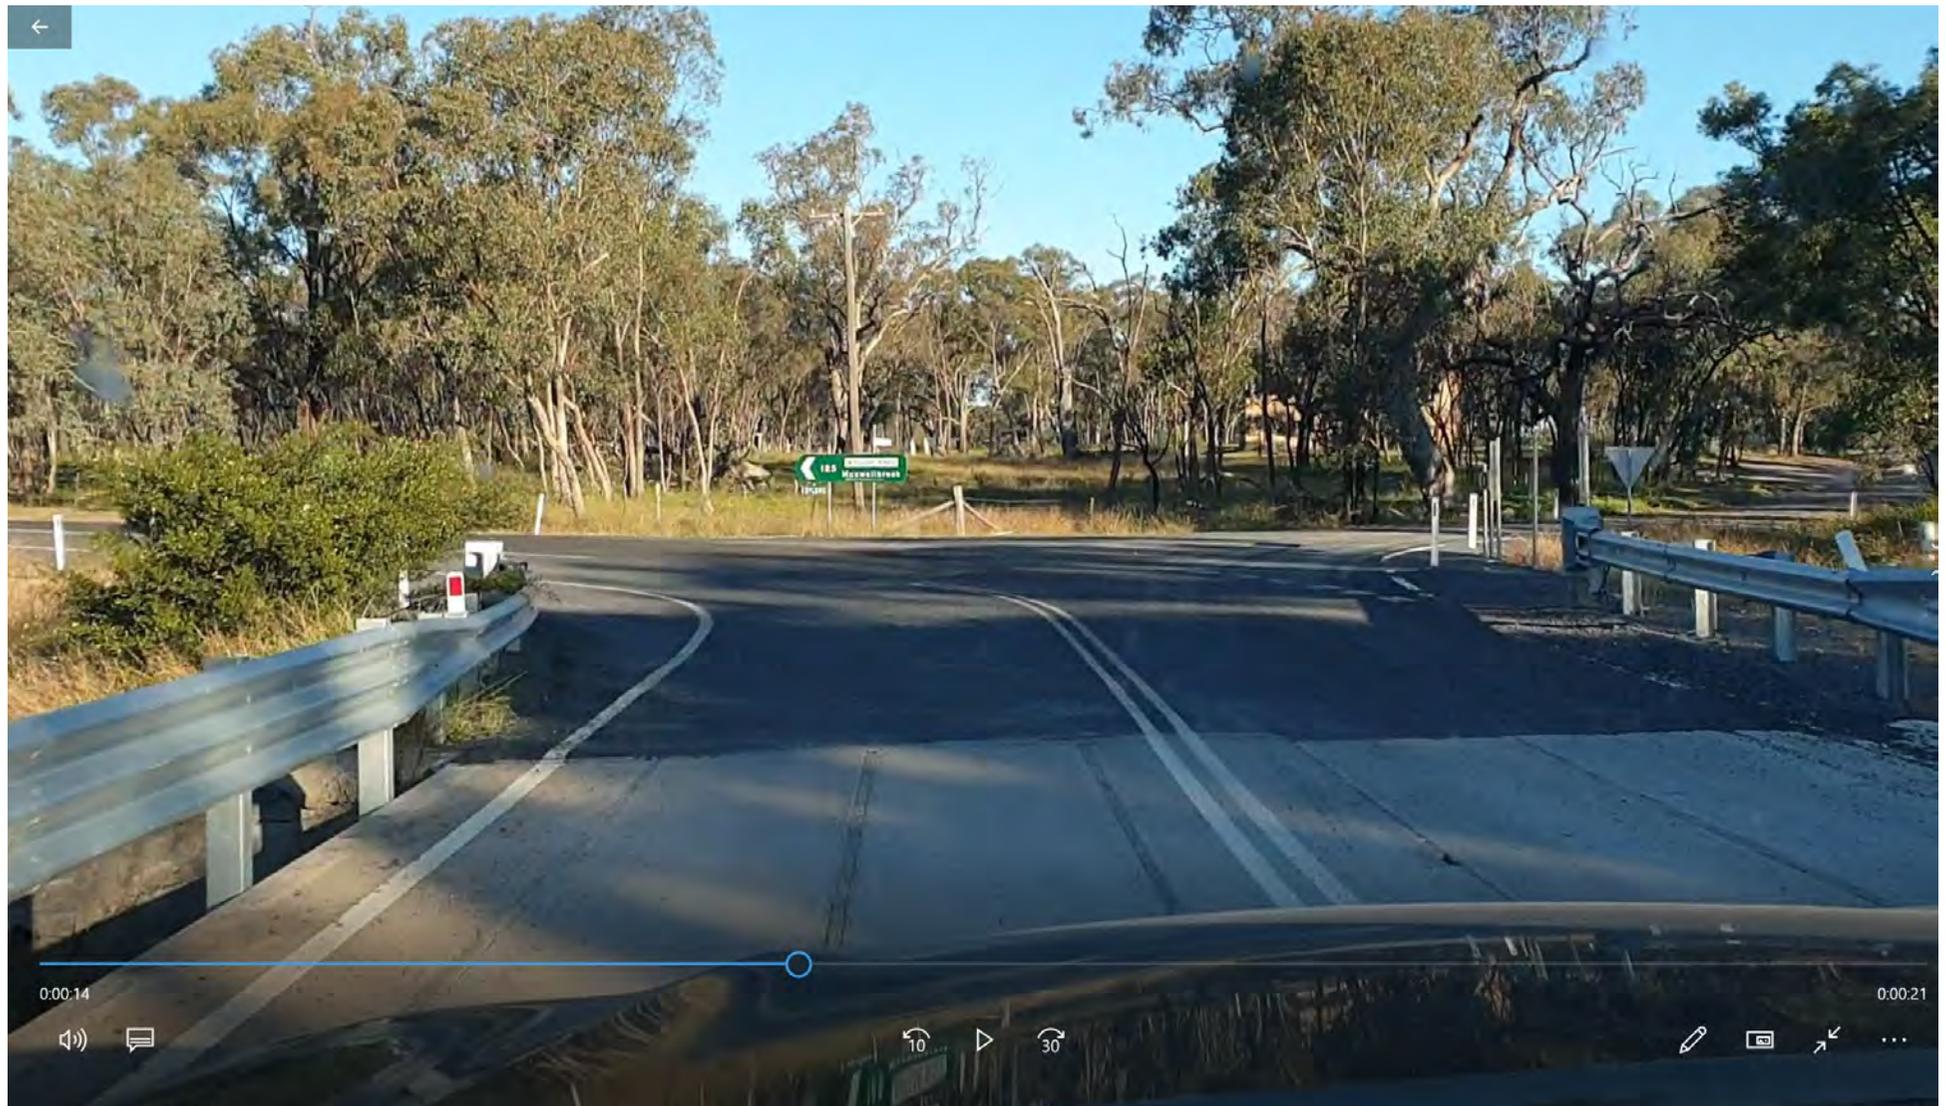
Travelling east on Wollar Rd, away from Wollar village, arriving at Barigan Road intersection (Barigan Road is road on the right of photo). Note substantial difference in condition of intersection
