# TREETALK

Arboricultural Impact Assessment  
Wentworthville Public School  
70 - 100 Fullagar Rd  
Wentworthville

Project No 5230/D2  
February 2019

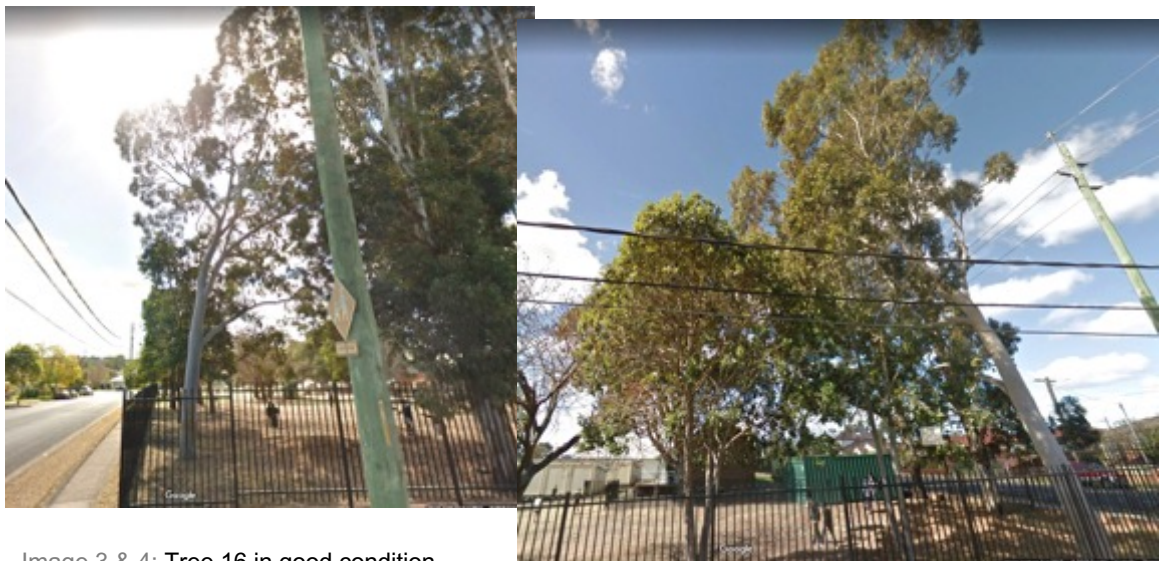
Image 3 & 4: Tree 16 in good condition

Retention of tree 16 would be desirable if possible. It is a healthy tree in *Good* condition with a long future.

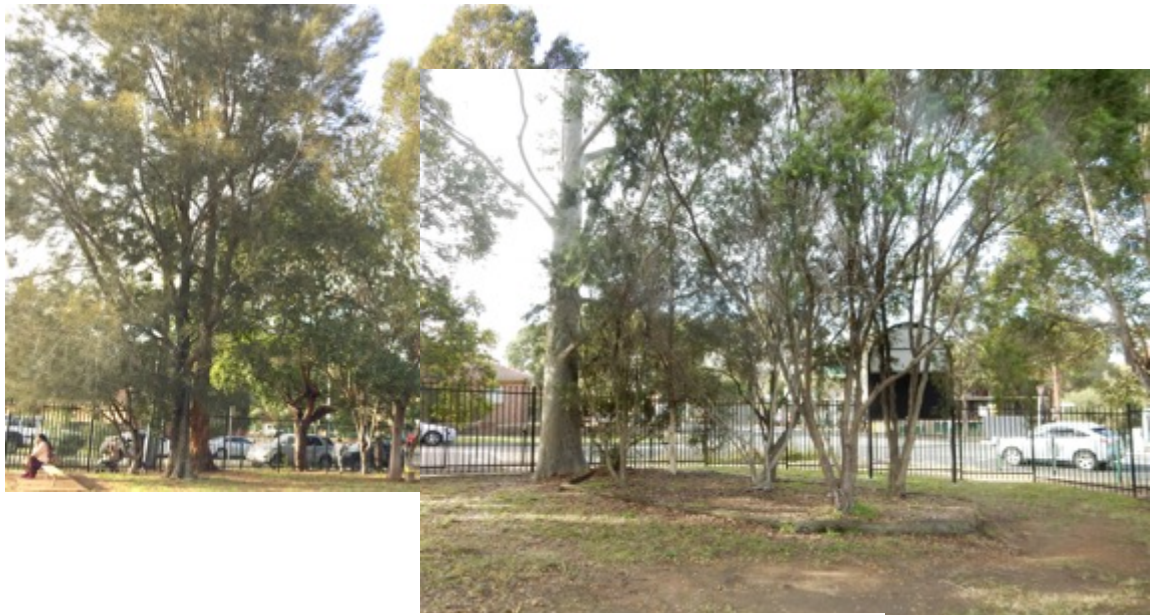
Trees near the corner of Station and Fullagar Street near the school sign, provide a significant canopy and are generally in *Good* health and condition. Understorey planting has been achieved to some degree with Bottle Brushes in garden beds.

Image 5 & 6: Good canopy trees near corner of Fullagar and Station Streets

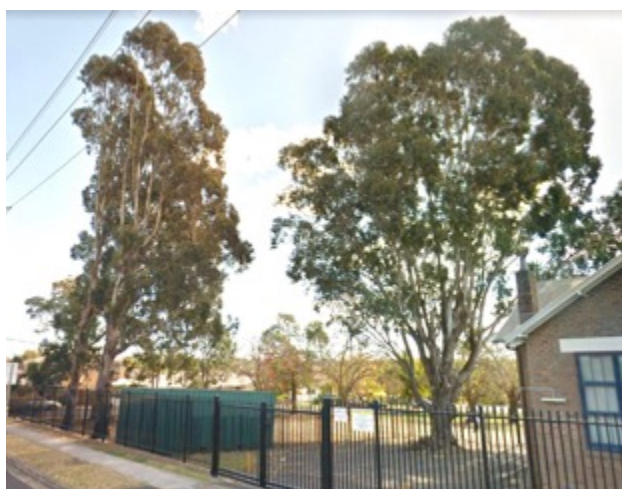
Image 7: Trees in ecologically significant area

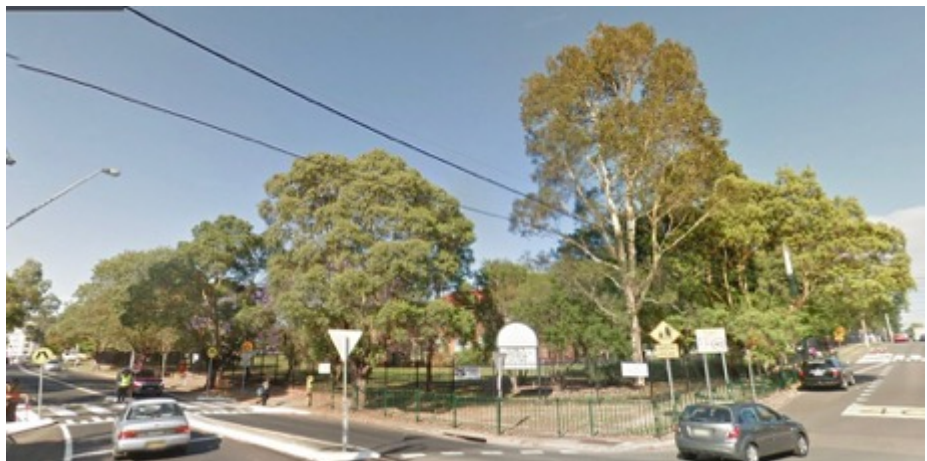
Image 8: Good canopy of trees near corner of Fullagar and Station Street

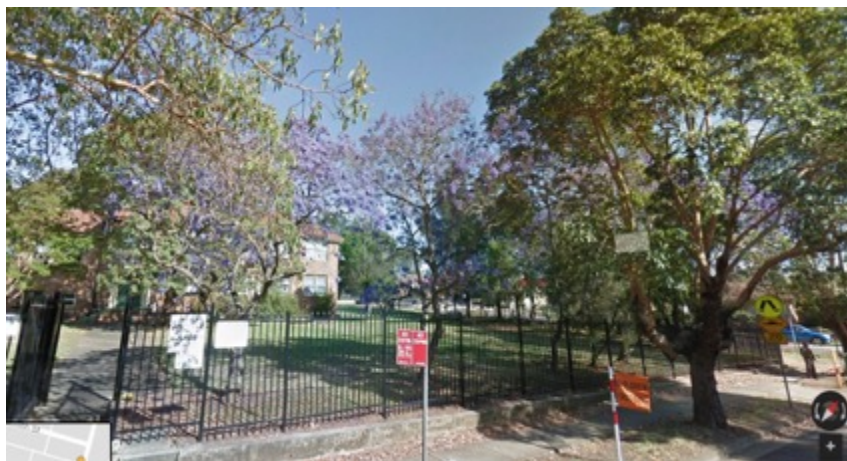
Street trees are all Brush Box species and those along Station Street are well established and in generally good condition. Similarly, a tree on Fullagar Street near Station Street. This tree has been *gully pruned* (see image) and is successfully surrounding wires while providing adequate clearance of power lines.

Image 9: Brush box street trees and Jacarandas near Station street

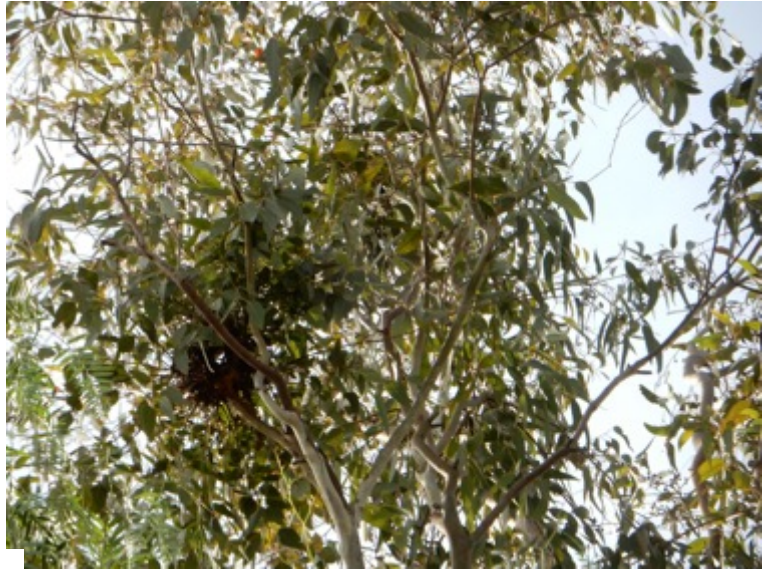
Image 10: Nest in Tree 1

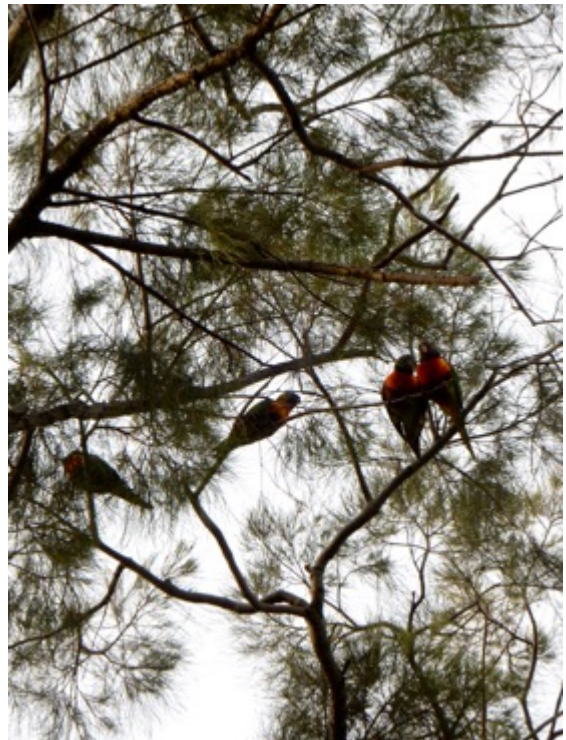
Image 11: Parakeets in Casuarinas along Fullagar Road

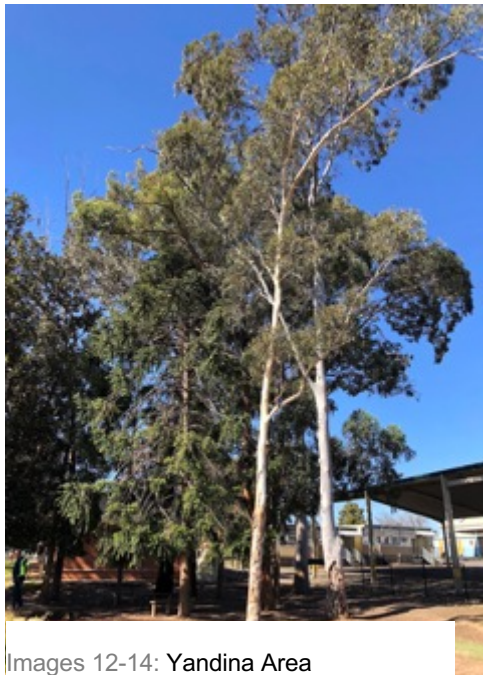
Images 12-14: Yandina Area

An area of note is the Yandina (aboriginal element) near Fullagar Road and west of buildings. This is considered to be of importance to the school community and includes a good selection of native trees and an attractive serpentine timber walkway structure. The trees in this area are closely planted and represent a relatively healthy selection (with some notable exceptions) despite heavy compaction.

Building works and landscaping features are near these trees and specific arboricultural site management will be required.

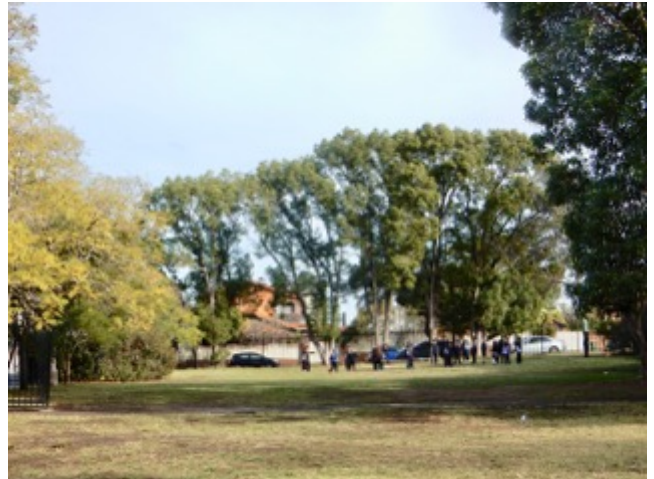
The group of Camphor Laurel (Trees 72 – 76) along the eastern section near Monash Street are in *Fair* health and *Fair* condition and can be retained. However, these trees are unlikely to improve significantly in health. If this becomes a high activity area, they should be managed to remove dead wood. When replaced it should be with a similarly large and significant species such as Brush Box, Casuarina or Allocasuarina or another suitable Cumberland Plain Woodland canopy trees.

Image 15: Camphor Laurels along Monash Street

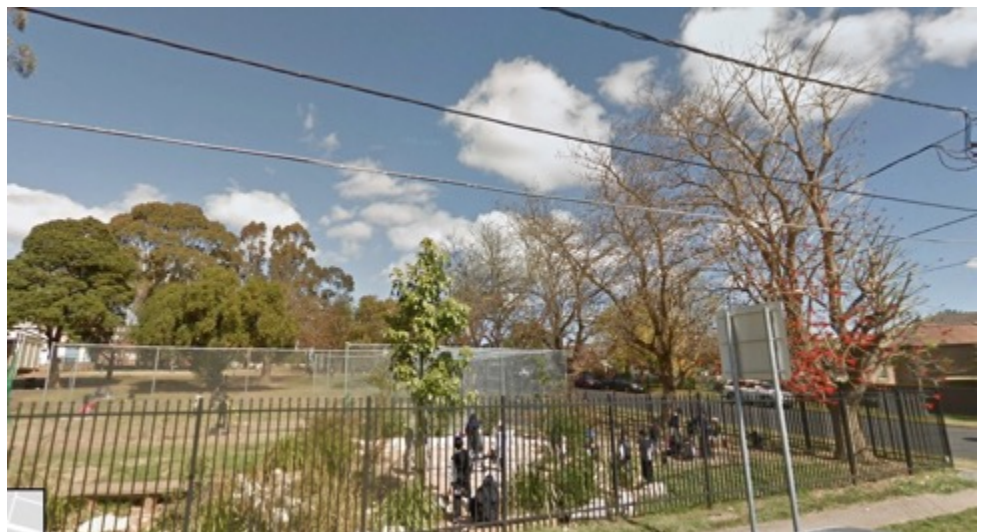
**Coral Trees** are planted along the western boundary near Garfield Street and the southern boundary near Monash Street. These trees, while colourful and generally attractive when vigorous, they are readily affected by decay fungi and lose structural strength as they age.

Although the trees on this site are generally in *Good* health (for *Erythrina* species) These trees should be closely monitored and any deadwood removed immediately.

Image 16: North eastern corner of site

These trees can be readily replaced with some more suitable species (e.g. see Yandina area or consider other colourful species suitable or clay soils).

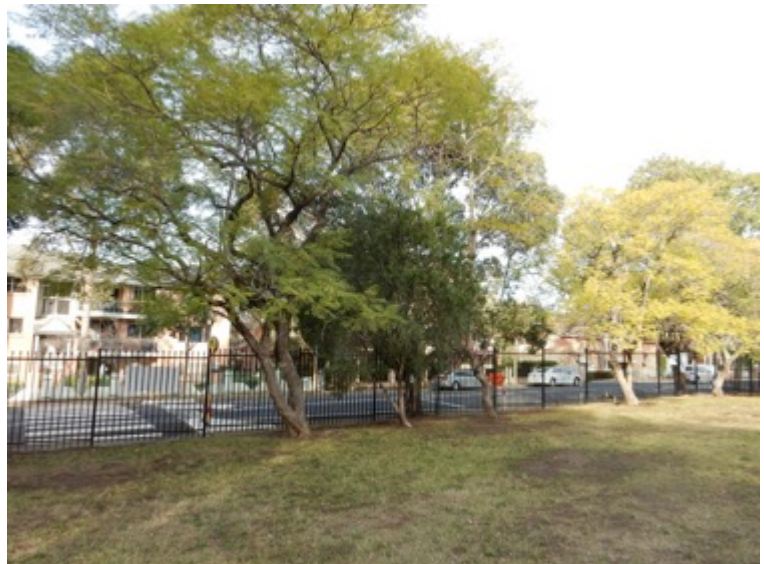
As noted in the assessment of the geotechnical report, the soil along Station Street is

Image 17: Exotics near Station Street

'fill/rubble' and accounts for the poor growth of the trees along the boundary.

I highly recommend that this soil be tested and remediated by an organisation such as SESL (I do not know how long this process takes) to improve the soil for the existing trees (e.g. Jacarandas which will not be replaced) and for the health of further planting.

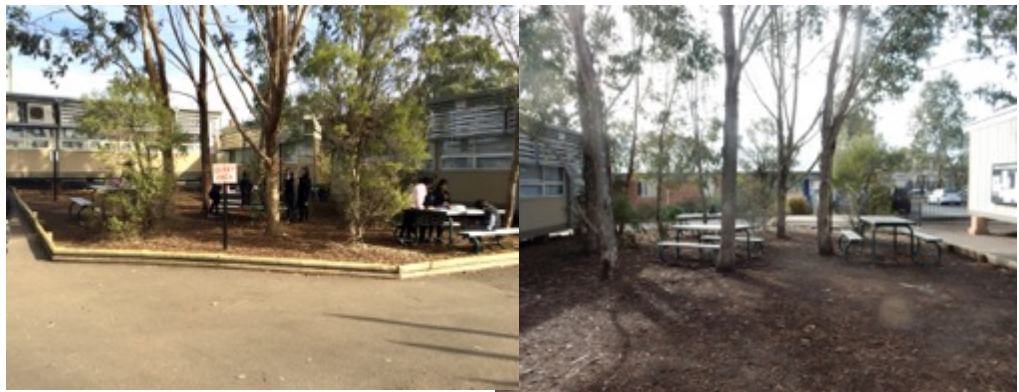
Images 19 & 20: Locally endemic trees in *quiet area* of ecological significance.  
Maintenance of mulch will be beneficial

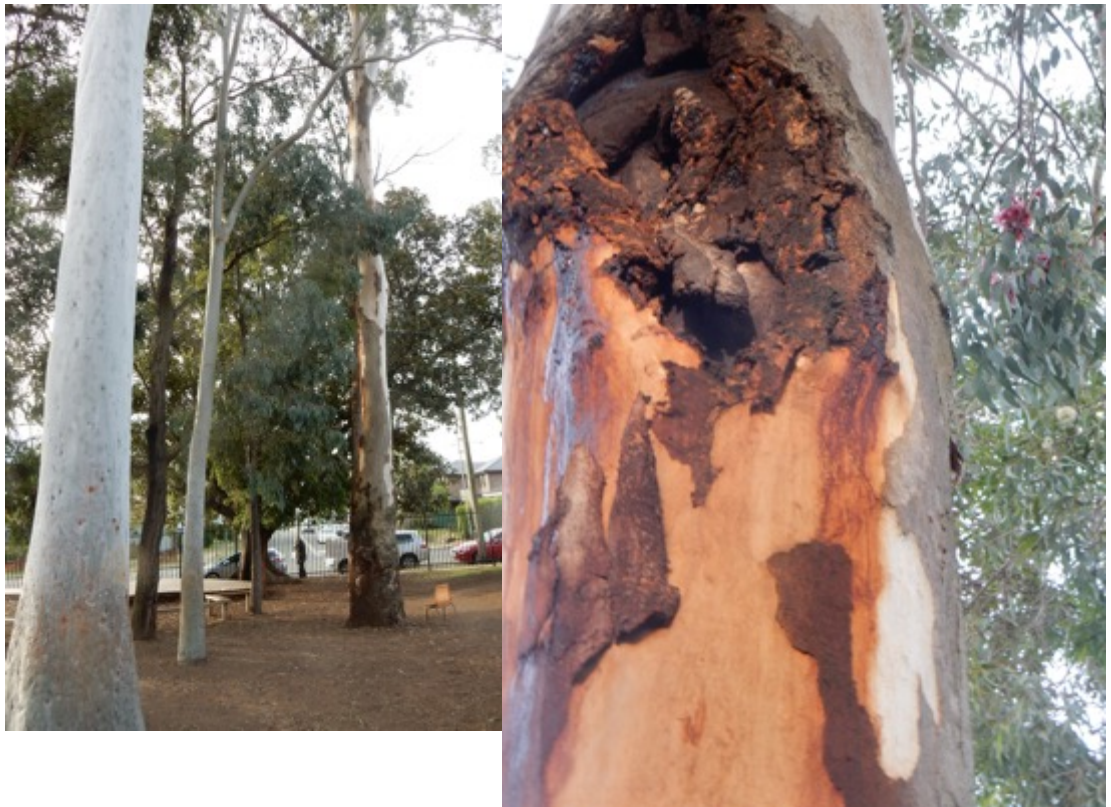
HT1 is a *Eucalyptus punctata* (Grey Gum) Tree 34 in the TT table, in the *Yandina* area where the canopy of many trees is beneficial for birds and other fauna. Many birds were observed within the canopy of these trees most of which are to be retained and protected.

As this is a high usage area, the larger dead trees must be managed for risk which will require the removal of two tall Tallowwoods (Trees 30 and 31) with high percentages of deadwood and limited futures.

Images 21 & 22: Tree 34 (Tree HT1) in the Yandina area

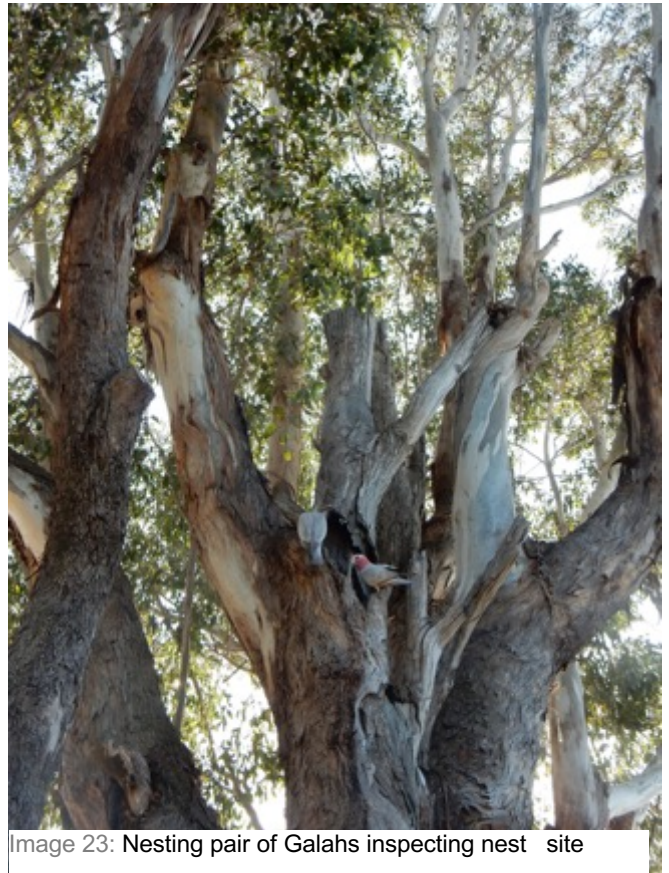
This deadwood is an ideal habitat. Nesting pairs of Galahs were observed (see Image 23).

As the tree will now be in a high usage area, it was climbed to assess structural strength of dead central branches and found to be in *Good Condition*. It is contained within the central section of the tree and is not adversely impacting upon the tree's structural strength.

Image 23: Nesting pair of Galahs inspecting nest site

Habitat pruning is advised when the young birds have moved on. Some careful pruning of older wood will limit chances of dead wood falling.

Some careful pruning is advised to minimise risk while retaining habitat benefits, see Pruning section.

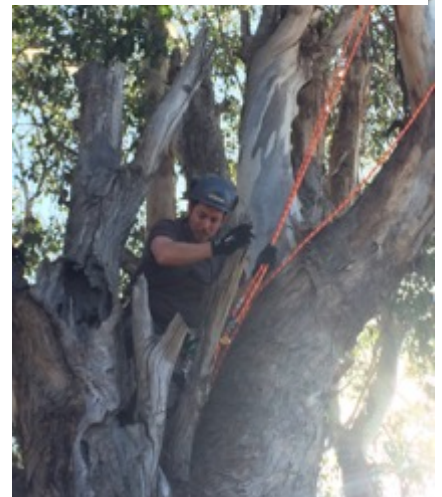
Image 24: Arborist inspecting habitat tree wood for management

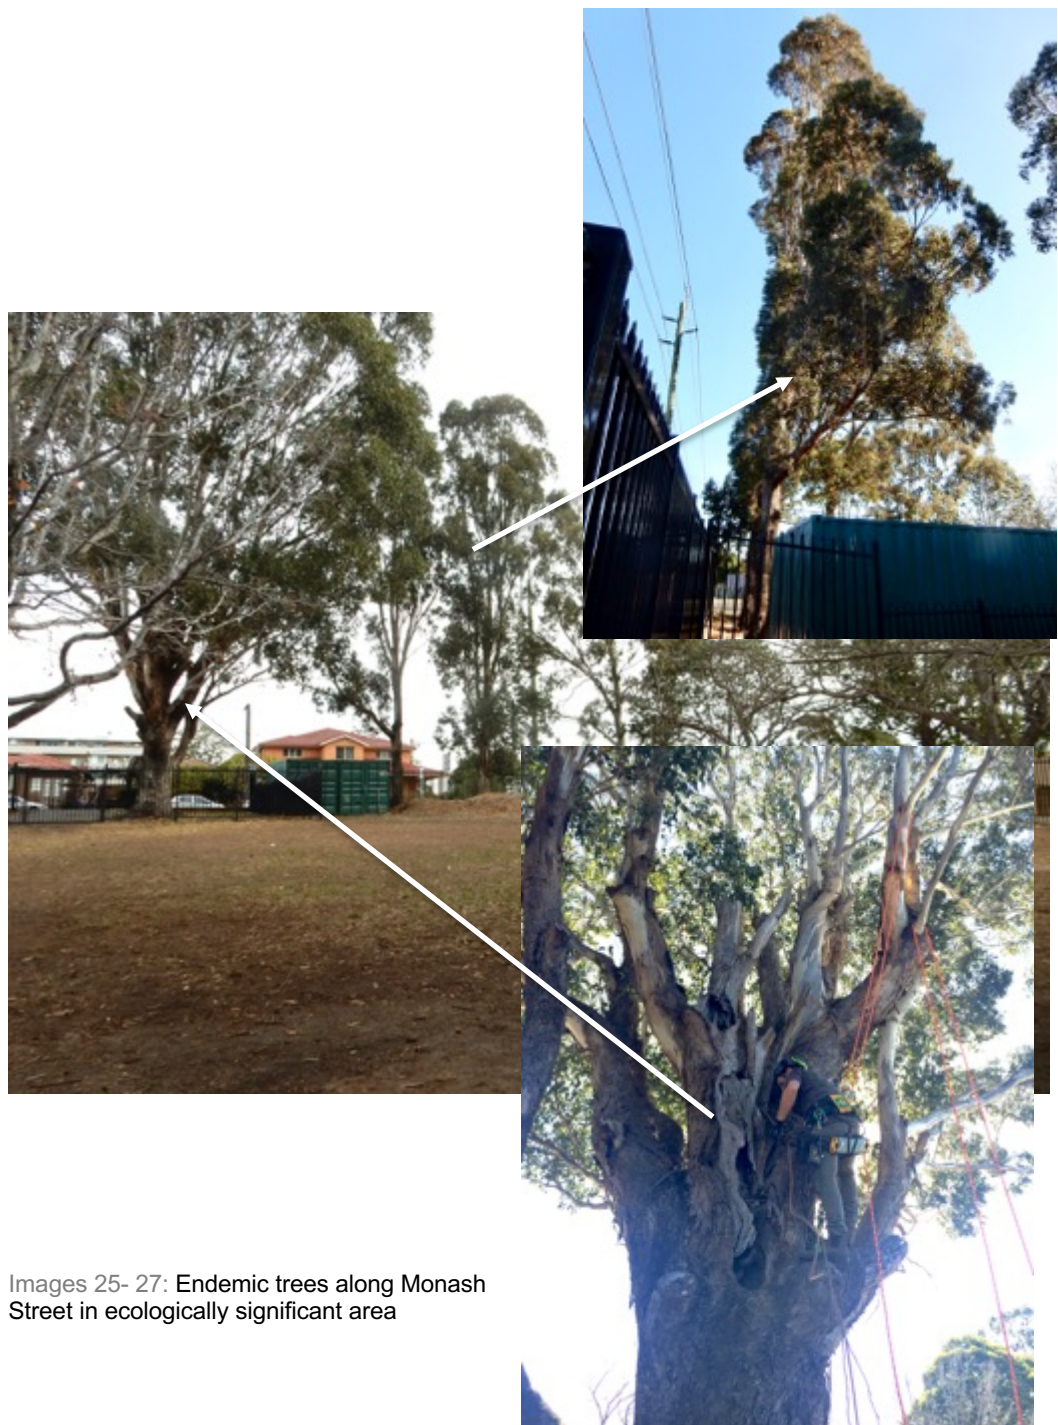
Habitat Trees 13 – 16 in ecologically sensitive area.

Images 25- 27: Endemic trees along Monash Street in ecologically significant area

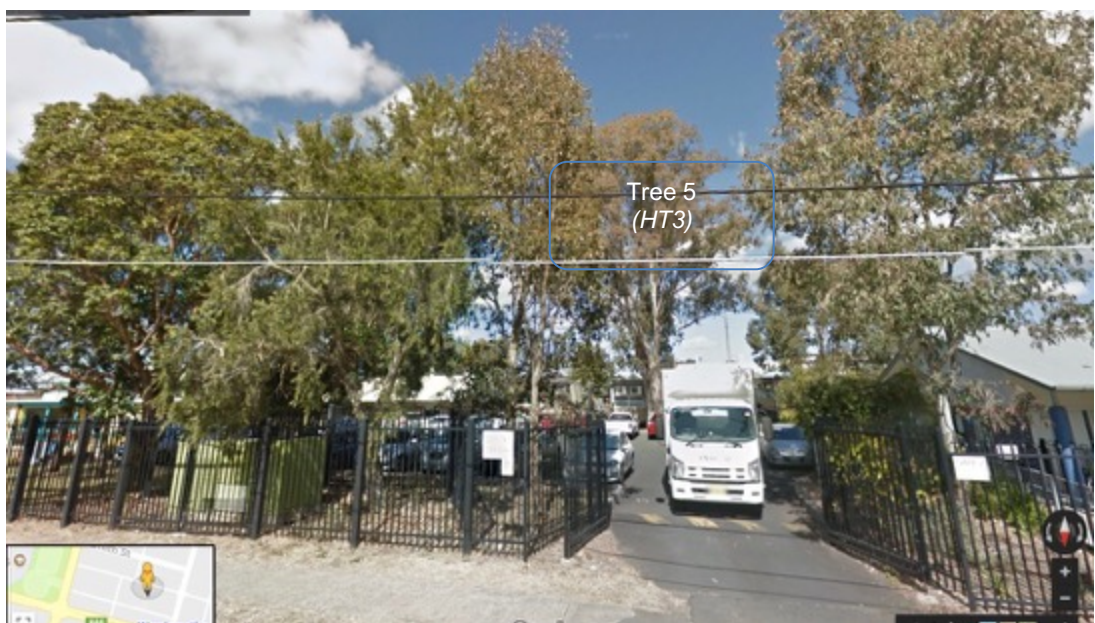
HT3 a *Eucalyptus tereticornis* (Forest Red Gum) Tree 5 in the TT schedule, near the car parking area. It is a locally endemic tree and appears to have been present prior to the school establishment (as noted evident in 1943 - See NSW6maps Image 2).

The tree canopy also has an unknown history which is also evident in the canopy which does not display normal branch development. Its complex branching may indicate topping (an undesirable practice) at some distant stage -- or extensive storm damage.

It is difficult to perform a definitive risk assessment. Knowledge of past works on this tree would be very useful in understanding its future.

Image 28: Tree 5 (*Habitat Tree HT3*) and younger endemic trees near entrance from Fullagar Street

A further assessment could be undertaken to further understand the possible risks involved. However, at this stage there are no indicators from the ground that would lead to immediate concerns. Work proposed in this area will impact on this tree, and its removal is planned.

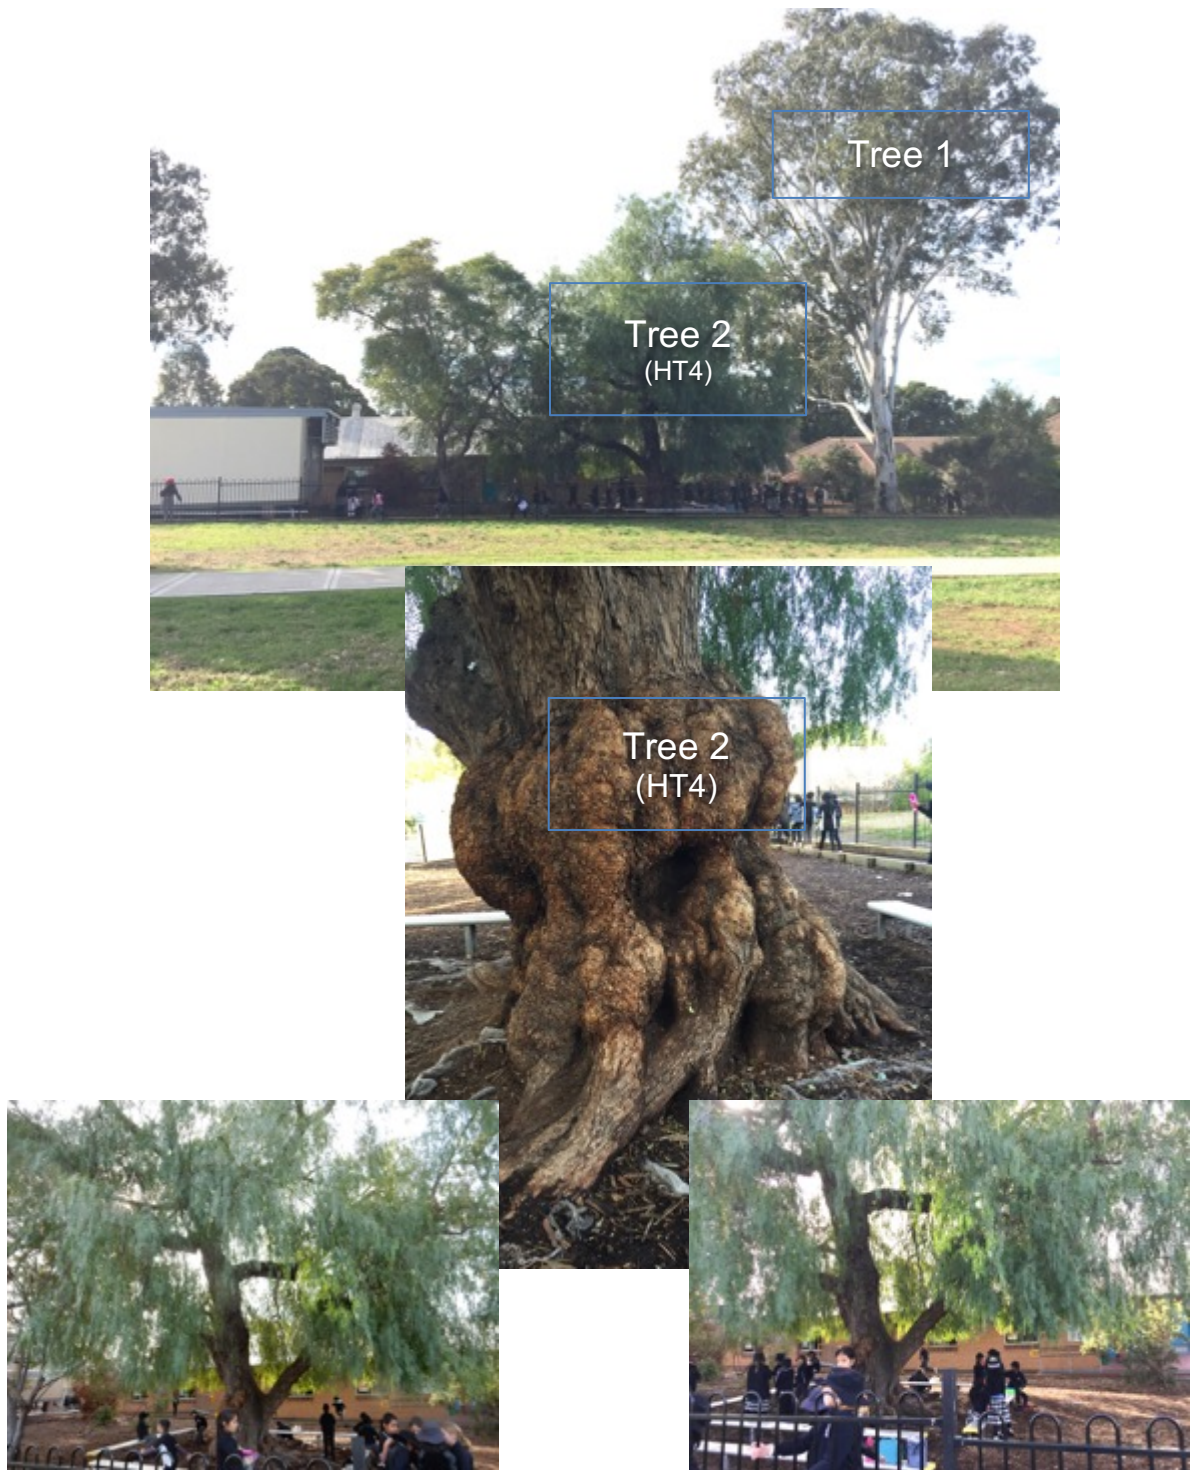
HT4 is an exotic *Schinus molle* var. *areira* (Pepper Tree) Tree 2 in the TT schedule, in the central area. This aesthetically pleasing specimen and environment with many children congregating under during inspections (see images below). Its retention and protection is planned and works are unlikely to impact on this tree. A nest was observed in the adjacent Tree 1

Images 29 - 32: Tree 2 Habitat Tree (HT4) Pepper tree in central area.

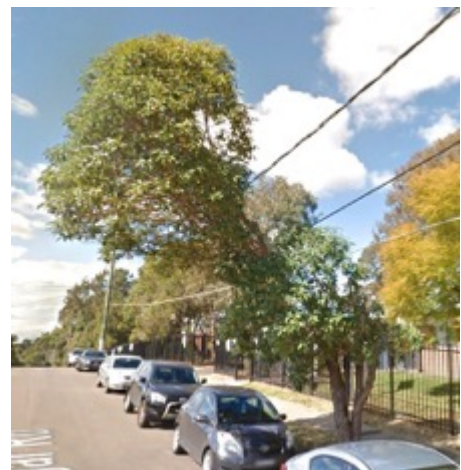
This tree is outside the site and has a limited future, *Short ULE*. A request to Council for its removal and replacement is advise (see adjacent image).

Image 33: Tree A  
Poorly lopped under wires - limited future.
