## Asbestos Remediation Clearance Certificate

Client: The Trades Team  
Contact: Michael Soliman  
Unit 29/105A Vanessa Street  
Kingsgrove NSW 2208  
Project number: 2259070A

Site: 5141 – Kyeemagh Infants School – Corner Jacobson Ave and Beehag St, Kyeemagh NSW 2216  
Specific work area(s)/room(s): Grassy area, at the corner of the school play field and the day care building, to Jacobson Ave.

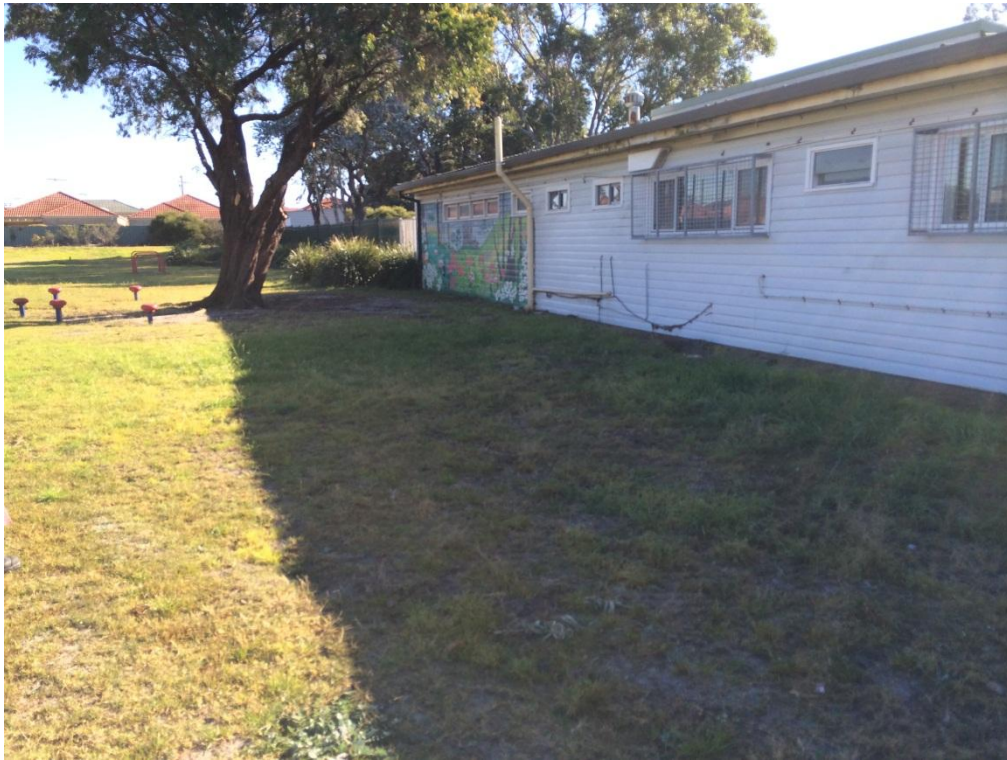
**Photograph 1:** work area facing tree, towards the back end of the day care building.

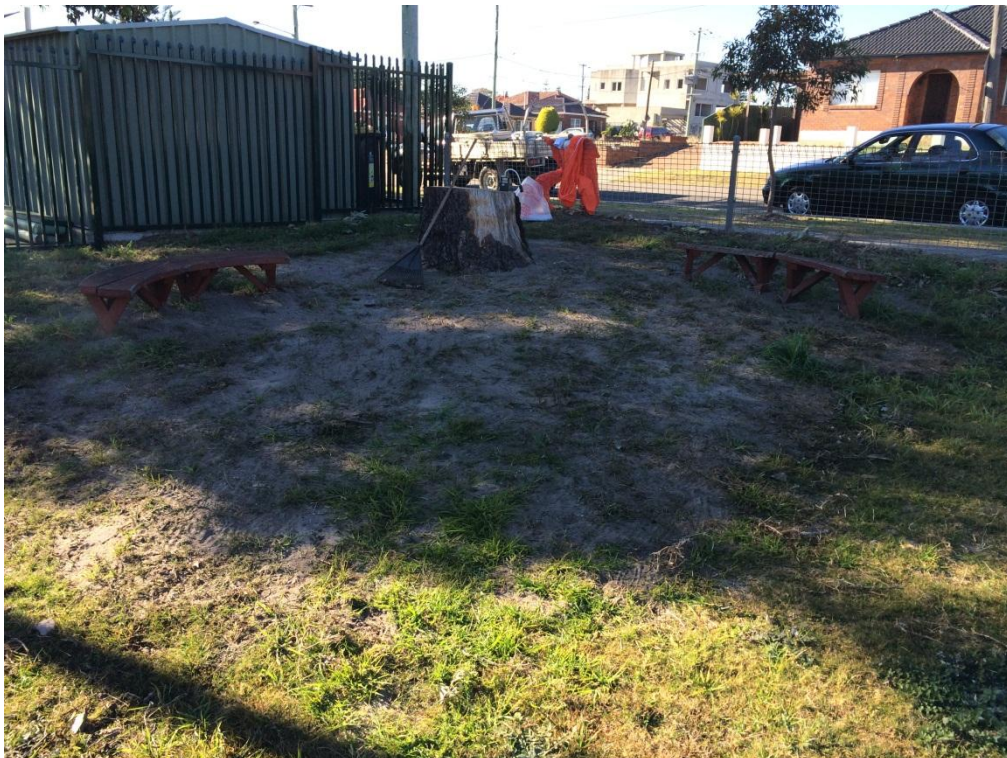
**Photograph 2:** work area to Jacobson Ave.
