# Dilapidation Report Pre-Construction

## Bonshaw Solar Farm Development

Bonshaw Solar Farm Road Dilapidation Survey

9/09/2025

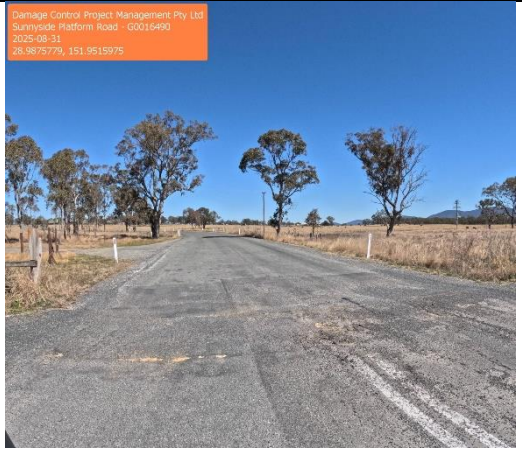
| Defect ID | Start CH | End CH | Defect Type (and side of road) | Image |
|---|---|---|---|---|
| 1 | 00003 | 00003 | Seal failure (right)<br><br>Potholes (both) | A photograph of a gravel road with visible seal failure and potholes on the right side. An orange information box in the top left corner contains the following text: "Damage Control Project Management Pty Ltd", "Sunnyside Platform Road - 00016490", "2025-08-31", and "28.9875776, 151.9515975". |

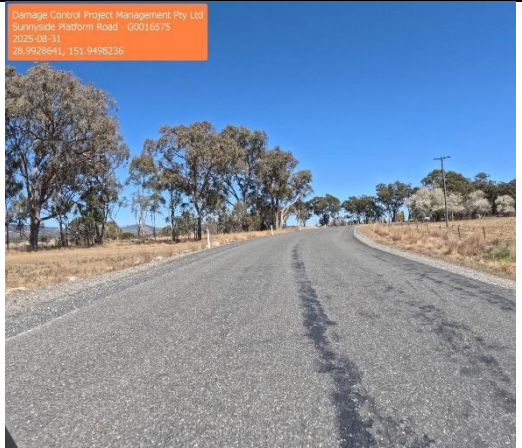
| Defect ID | Start CH | End CH | Defect Type (and side of road) | Image |
|---|---|---|---|---|
| 2 | 00600 | 00689 | Seal – flushing (right) | A photograph of a gravel road showing seal flushing on the right side. An orange information box in the top left corner contains the following text: "Damage Control Project Management Pty Ltd", "Sunnyside Platform Road - 00016575", "2025-08-31", and "28.9926641, 151.9498236". |

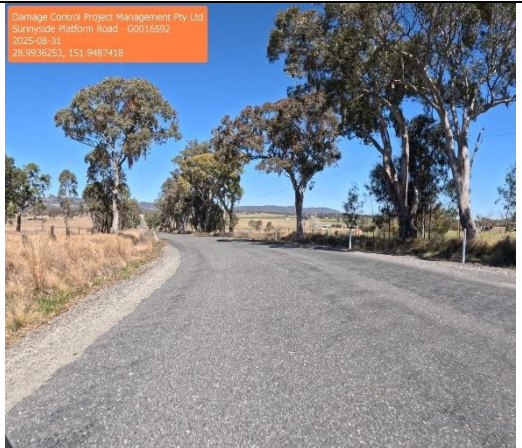
| Defect ID | Start CH | End CH | Defect Type (and side of road) | Image |
|---|---|---|---|---|
| 3 | 00800 | 00825 | Edge break (left) | A photograph of a gravel road showing an edge break on the left side. An orange information box in the top left corner contains the following text: "Damage Control Project Management Pty Ltd", "Sunnyside Platform Road - 00016592", "2025-08-31", and "28.9906263, 151.9487418". |

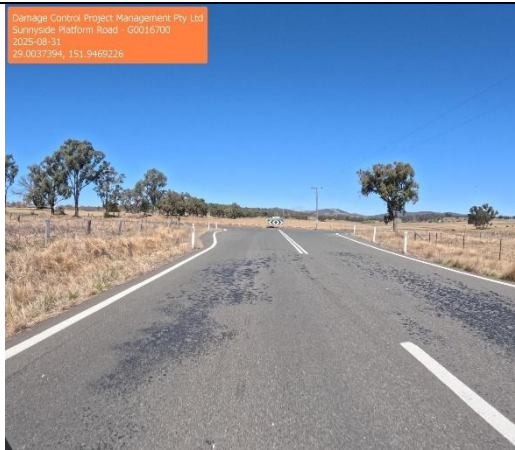
| 4 | 01950 | 01950 | Asphalt cold overlay – flushing (both) | |

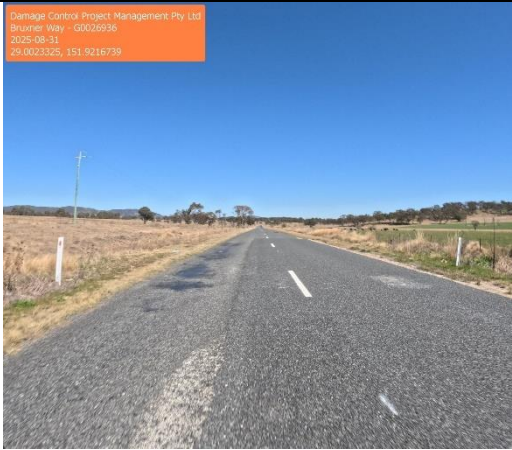
| 7 | 8039 | 8139 | <p>Pavement failure (both)</p> <p>Cracking (right)</p> <p>Seal – flushing (left)</p> | <p>Damage Control Project Management Pty Ltd<br/>Bruner Way - G0026936<br/>2025-08-31<br/>29.0021325, 151.9216739</p> |

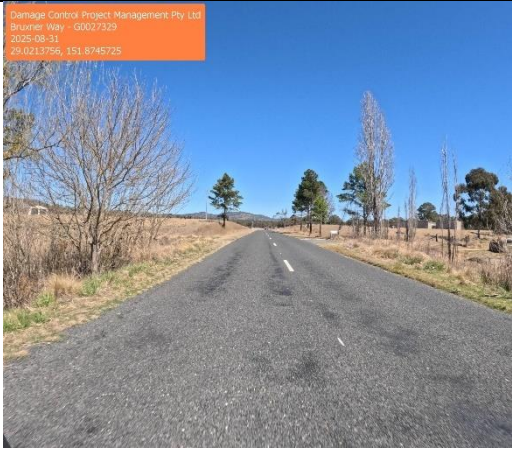
| 8 | 13349 | 13379 | Seal – flushing (left) | <p>Damage Control Project Management Pty Ltd<br/>Bruner Way - G0027329<br/>2025-08-31<br/>29.0213756, 151.8745725</p> |

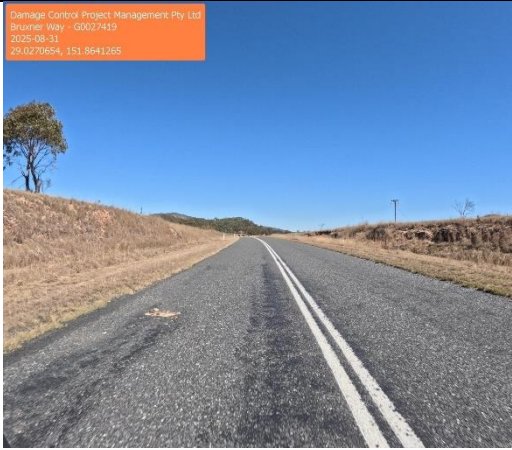
| 9 | 14549 | 14569 | <p>Potholes (left)</p> <p>Seal – flushing (left)</p> | <p>Damage Control Project Management Pty Ltd<br/>Bruner Way - G0027419<br/>2025-08-31<br/>29.0270654, 151.8641265</p> |

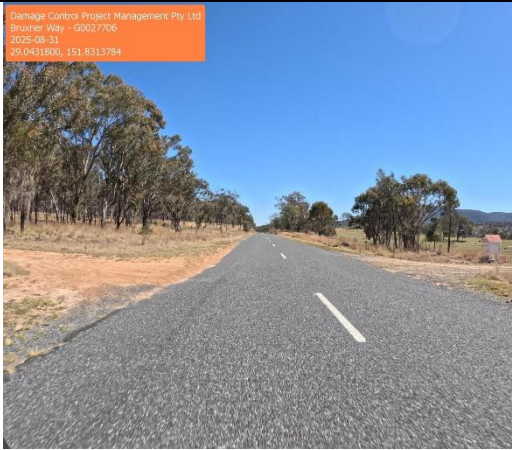
| 13 | 18449 | 18469 | Loose material<br>(left) | <p>Damage Control Project Management Pty Ltd<br/>Brunner Way - G0027706<br/>2025-08-31<br/>29.04281800, 151.8313784</p> |

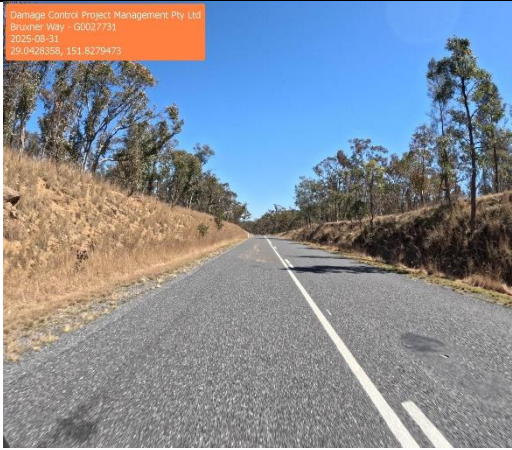
| 14 | 18789 | 18789 | Potholes (right)<br><br>Pavement<br>deformation<br>(right) | <p>Damage Control Project Management Pty Ltd<br/>Brunner Way - G0027731<br/>2025-08-31<br/>29.0428358, 151.8317943</p> |

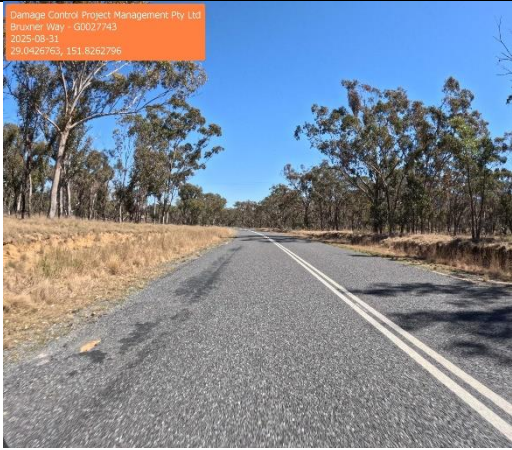
| 15 | 18939 | 18969 | Potholes (left)<br><br>Edge break (left)<br><br>Edge drop (left) | <p>Damage Control Project Management Pty Ltd<br/>Brunner Way - G0027743<br/>2025-08-31<br/>29.0428763, 151.8262796</p> |

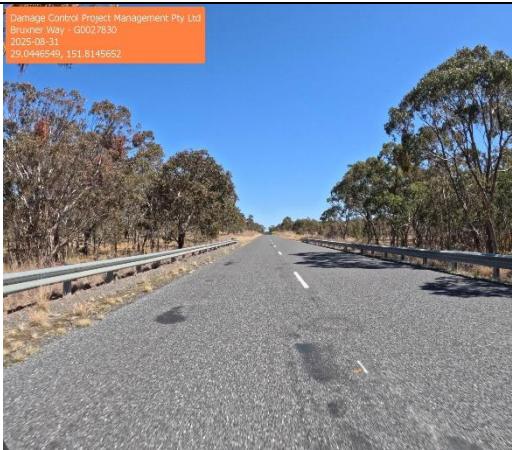
| 16 | 20089 | 20169 | Pavement deformation (left)<br><br>Cracking (left) | <div> <div> Damage Control Project Management Pty Ltd<br/> Braemar Way - G0027830<br/> 2025-08-31<br/> 29.0445540, 151.8145652 </div> </div> |

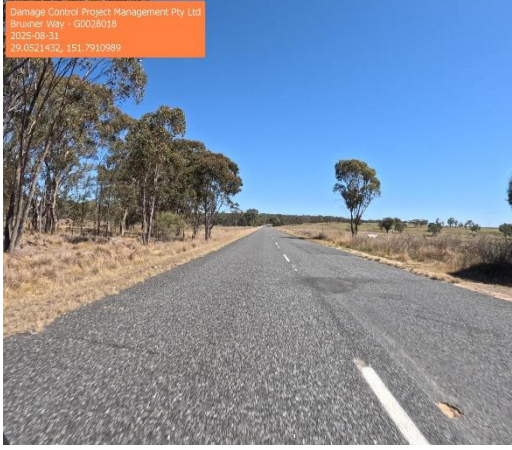
| 17 | 22639 | 22639 | Potholes (right) | <div> <div> Damage Control Project Management Pty Ltd<br/> Braemar Way - G0028018<br/> 2025-08-31<br/> 29.0521432, 151.7910989 </div> </div> |

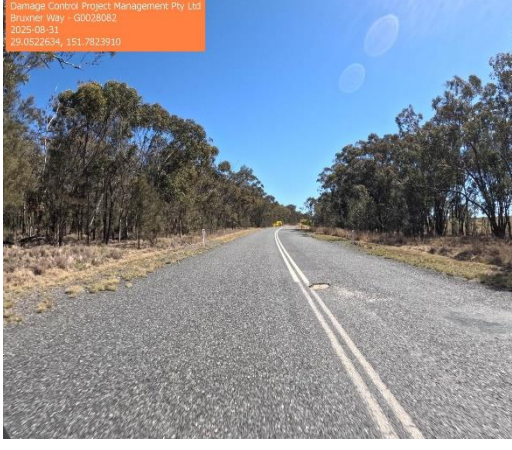
| 18 | 23489 | 23489 | Potholes (right) | <div> <div> Damage Control Project Management Pty Ltd<br/> Braemar Way - G0028062<br/> 2025-08-31<br/> 29.0522634, 151.7823910 </div> </div> |

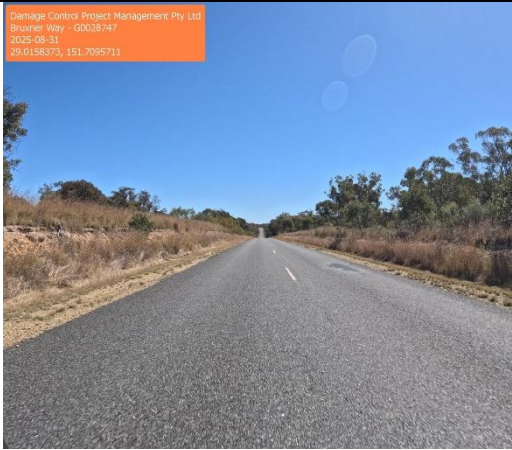
| 25 | 32429 | 32489 | Cracking (right)<br><br>Pavement failure (right) | <p>Damage Control Project Management Pty Ltd<br/>Brunner Way - G0028747<br/>2025-08-31<br/>29.0158373, 151.7095711</p> |

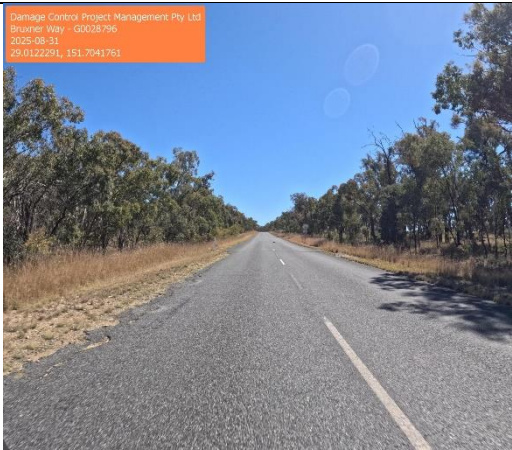
| 26 | 33119 | 33139 | Edge break (left) | <p>Damage Control Project Management Pty Ltd<br/>Brunner Way - G0028796<br/>2025-08-31<br/>29.0122291, 151.7041761</p> |

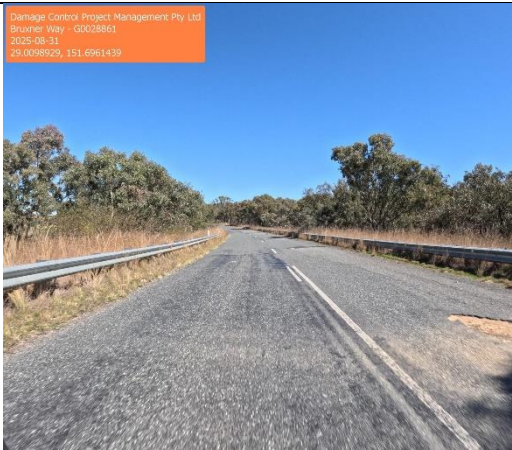
| 27 | 33989 | 34099 | Potholes (right) | <p>Damage Control Project Management Pty Ltd<br/>Brunner Way - G0028801<br/>2025-08-31<br/>29.0098929, 151.6961439</p> |

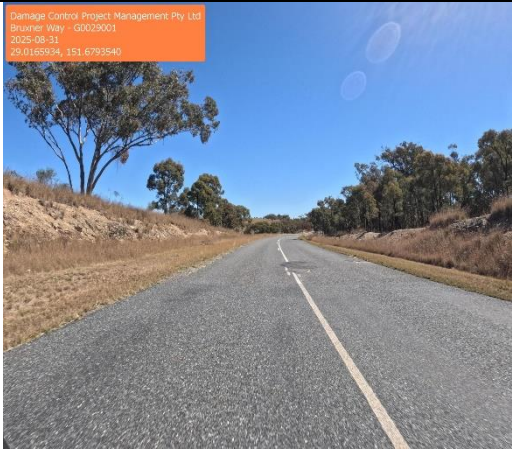
| 31 | 35879 | 35889 | Pavement failures (right) | <div> <div> Damage Control Project Management Pty Ltd<br/> Braemar Way - G0029001<br/> 2025-08-31<br/> 29.0125934, 151.6793540 </div> </div> |

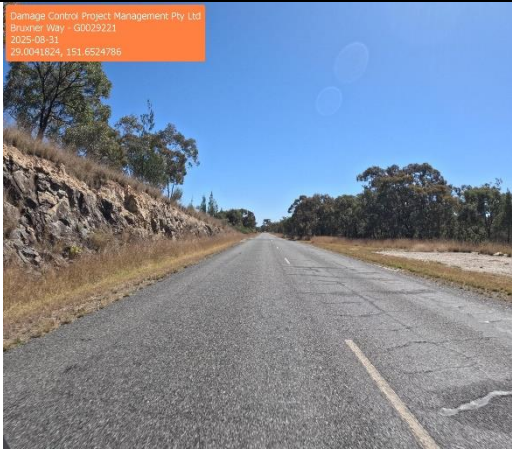
| 37 | 38849 | 38899 | Cracking – block (right) | <p>Damage Control Project Management Pty Ltd<br/>Brunner Way - G0029221<br/>2025-08-31<br/>29.0041824, 151.6524786</p> |

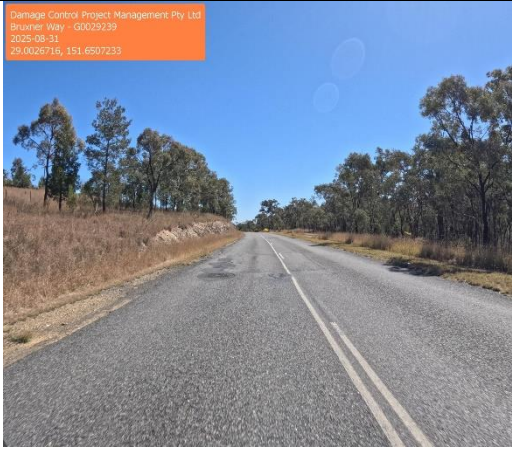
| 38 | 39109 | 39189 | Pavement failure (both) | <p>Damage Control Project Management Pty Ltd<br/>Brunner Way - G0029239<br/>2025-08-31<br/>29.0028716, 151.6507233</p> |

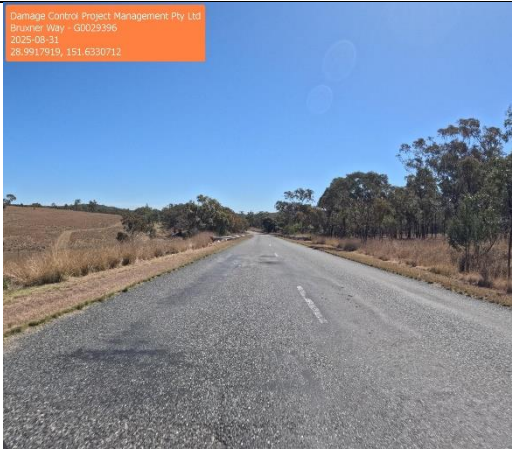
| 39 | 41229 | 41289 | Pavement failure (both) | <p>Damage Control Project Management Pty Ltd<br/>Brunner Way - G0029396<br/>2025-08-31<br/>28.9917919, 151.630712</p> |

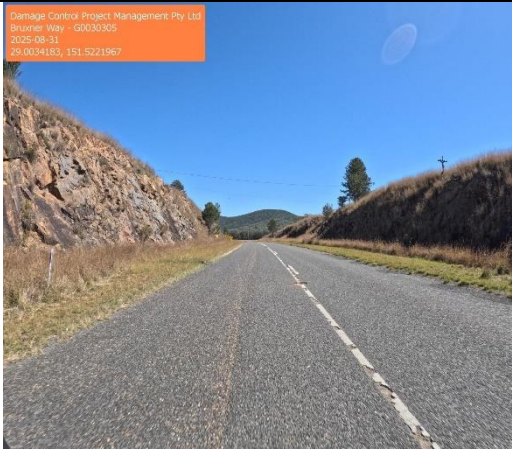
| 46 | 53509 | 56459 | Potholes (both)<br><br>Seal stripping<br>(centre) | <p>Damage Control Project Management Pty Ltd<br/>Bruner Way - G0030305<br/>2025-08-31<br/>29.0034083, 151.5221967</p> |

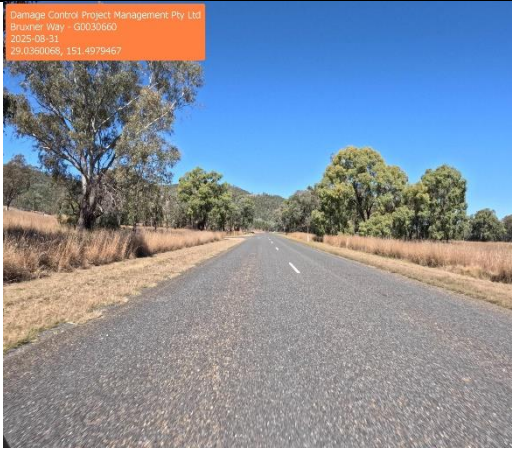
| 47 | 58289 | 58389 | Edge break (left) | <p>Damage Control Project Management Pty Ltd<br/>Bruner Way - G0030660<br/>2025-08-31<br/>29.0360068, 151.4975967</p> |

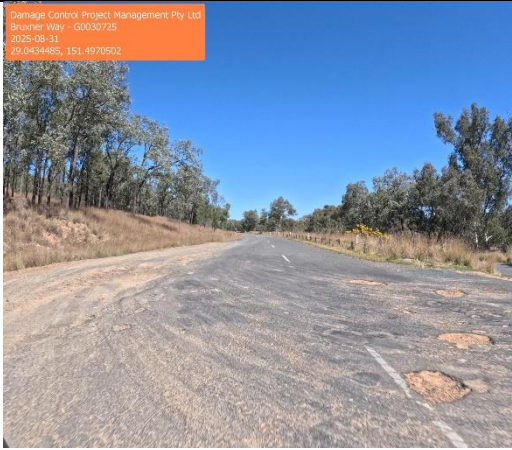
| 48 | 59389 | 59439 | Potholes (both)<br><br>Edge break (left)<br><br>Loose material<br>(both) | <p>Damage Control Project Management Pty Ltd<br/>Bruner Way - G0030725<br/>2025-08-31<br/>29.0434485, 151.4970502</p> |

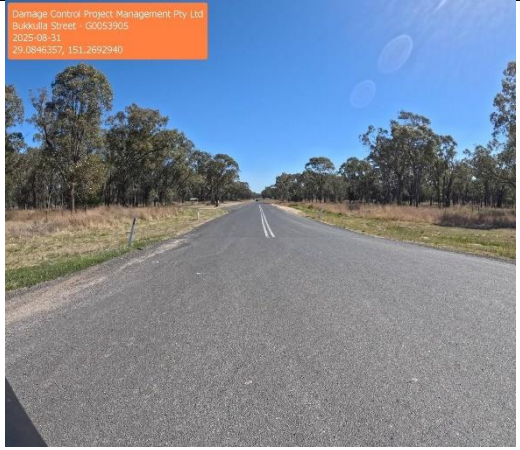
| Defect ID | Start CH | End CH | Defect Type (and side of road) | Image |
|---|---|---|---|---|
| 1 | 00000 | 00020 | Edge break (left) | |

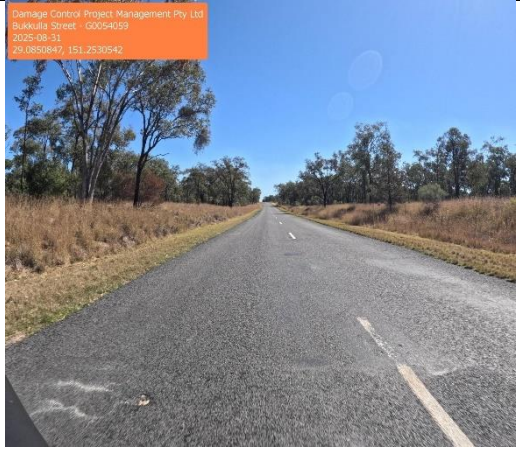
| Defect ID | Start CH | End CH | Defect Type (and side of road) | Image |
|---|---|---|---|---|
| 2 | 1590 | 1590 | Potholes (left)<br>Cracking (both) | |

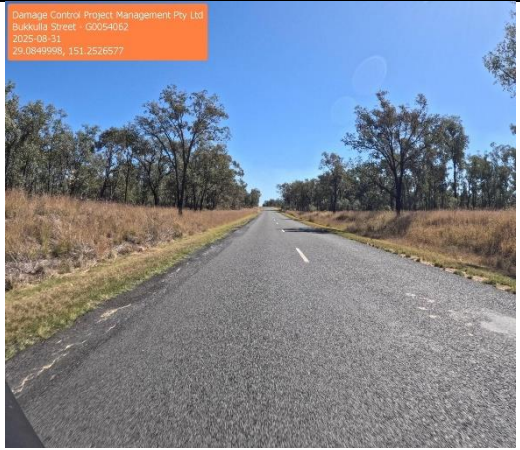
| Defect ID | Start CH | End CH | Defect Type (and side of road) | Image |
|---|---|---|---|---|
| 3 | 1590 | 1680 | Pavement failure (left)<br>Edge break (left) | |

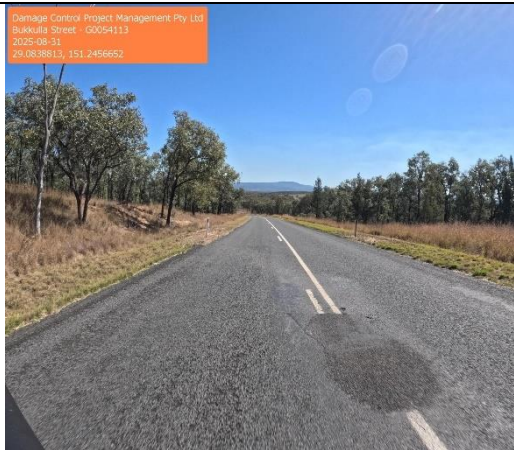
| 4 | 2330 | 2340 | Pavement failure<br>(centre) | <p>Damage Control Project Management Pty Ltd<br/>Bukkalla Street - G0054113<br/>2025-08-31<br/>29.0838813, 151.2456652</p> |

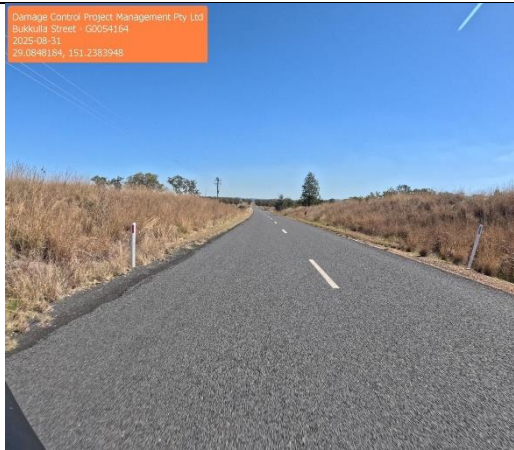
| 5 | 3000 | 3100 | Edge drop (right) | <p>Damage Control Project Management Pty Ltd<br/>Bukkalla Street - G00541164<br/>2025-08-31<br/>29.0848184, 151.2383948</p> |

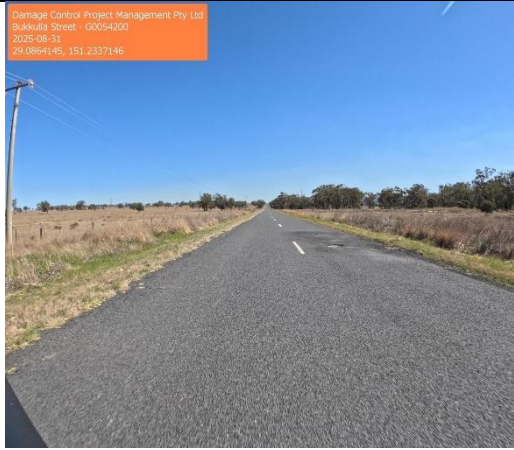
| 6 | 3530 | 3550 | Potholes (right)<br><br>Pavement<br>failures (right) | <p>Damage Control Project Management Pty Ltd<br/>Bukkalla Street - G0054200<br/>2025-08-31<br/>29.0864145, 151.2337146</p> |

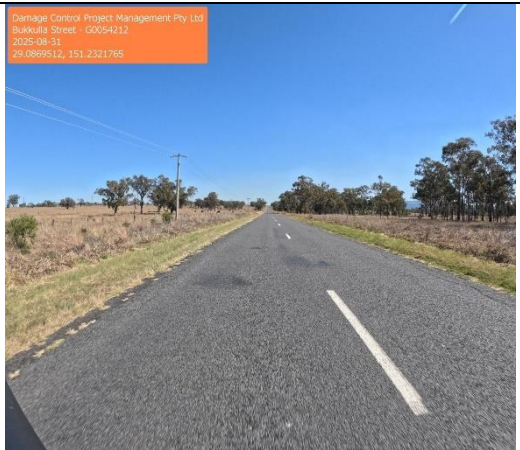
| 7 | 3690 | 3810 | Cracking (right)<br><br>Seal – flushing (left) | <p>Damage Control Project Management Pty Ltd<br/>Bukkalla Street - G0054212<br/>2025-08-31<br/>29.0899512, 151.2321765</p> |

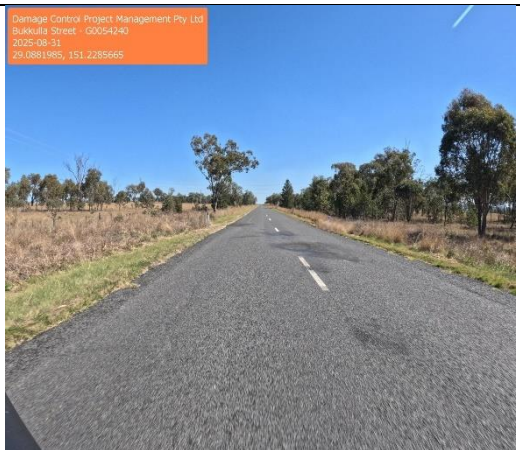
| 8 | 4070 | 4100 | Seal – flushing (both) | <p>Damage Control Project Management Pty Ltd<br/>Bukkalla Street - G0054140<br/>2025-08-31<br/>29.0881985, 151.2285665</p> |

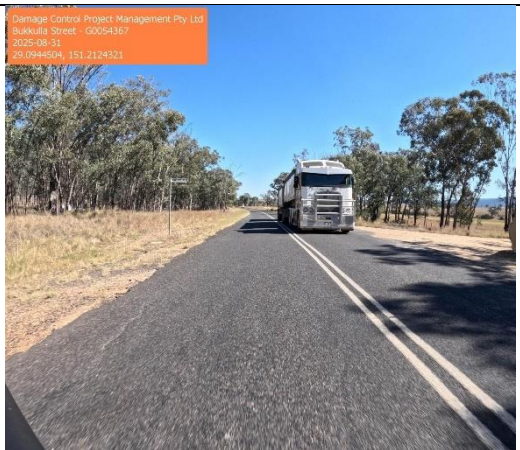
| 9 | 5750 | 5850 | Edge break (left) | <p>Damage Control Project Management Pty Ltd<br/>Bukkalla Street - G0054367<br/>2025-08-31<br/>29.0944504, 151.2124321</p> |

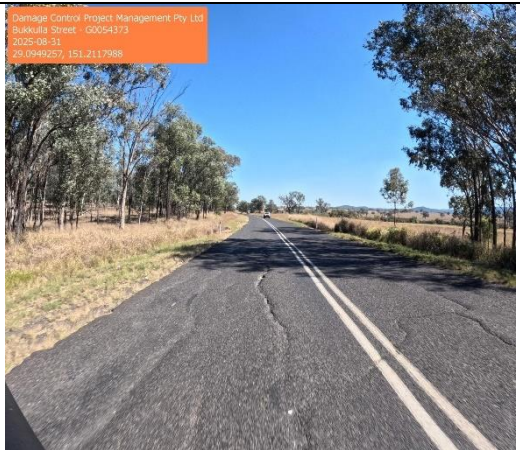
| 10 | 5850 | 6050 | Cracking (both) | |

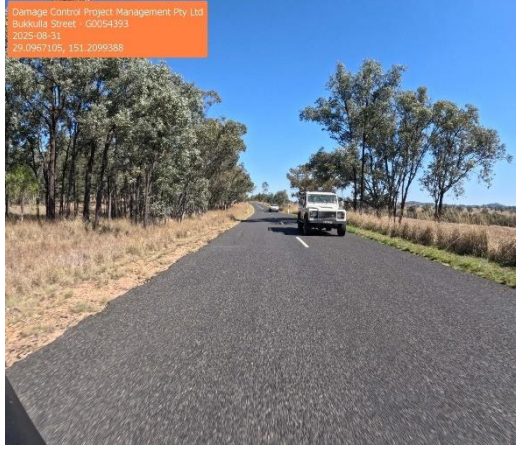
| 11 | 6140 | 6240 | Edge break (left) | |

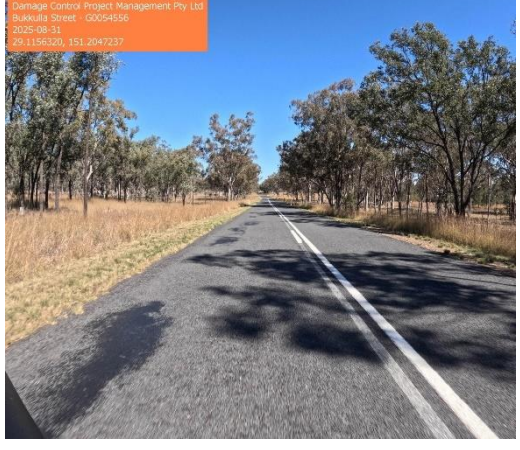
| 12 | 8300 | 8400 | Seal – flushing (left) | |

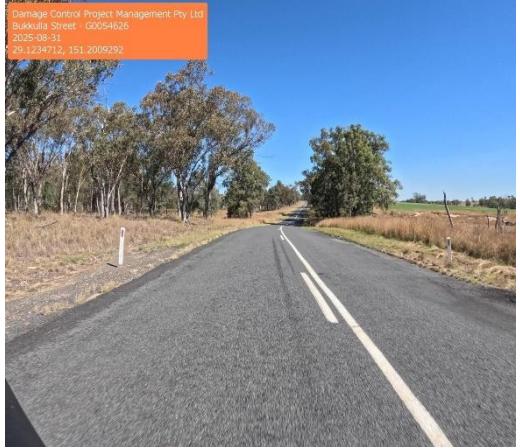
| 13 | 9300 | 9310 | Pavement failure (right) | |

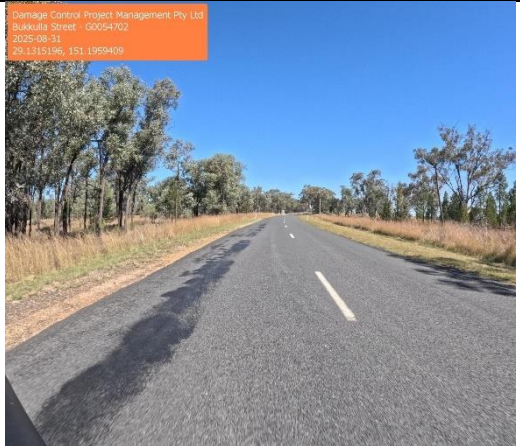
| 14 | 10320 | 10420 | Seal – flushing (left) | |

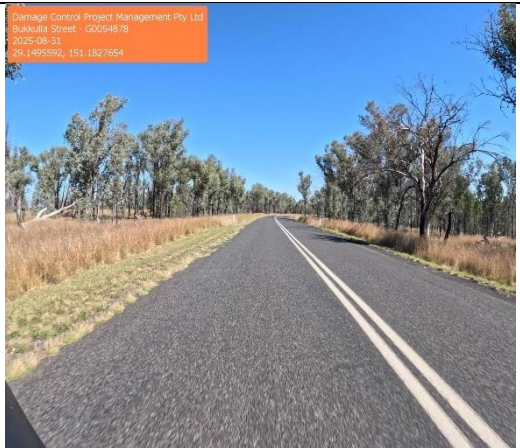
| 15 | 12690 | 12790 | Pavement failure (right) | |

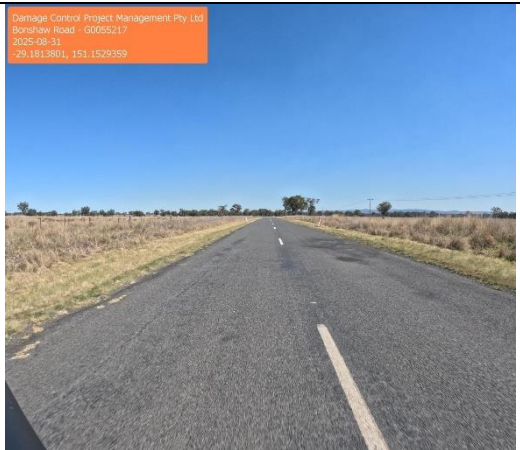
| 19 | 17290 | 17350 | Pavement failure (right)<br><br>Cracking (both) | <p>Damage Control Project Management Pty Ltd<br/>Bonshaw Road - G0055217<br/>2025-08-31<br/>-29.1813801, 151.1529359</p> |

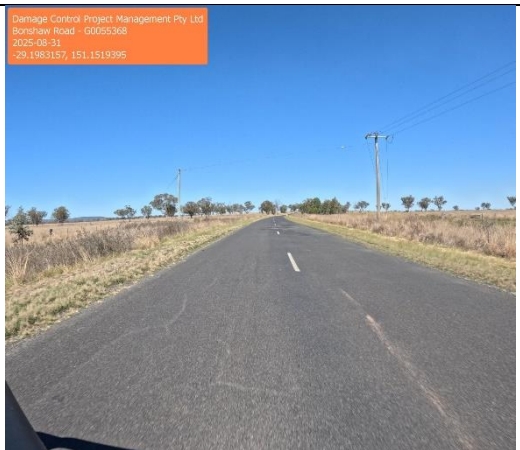
| 20 | 19350 | 19900 | Cracking (both)<br><br>Pavement failure (both) | <p>Damage Control Project Management Pty Ltd<br/>Bonshaw Road - G0055368<br/>2025-08-31<br/>-29.1983157, 151.1519395</p> |

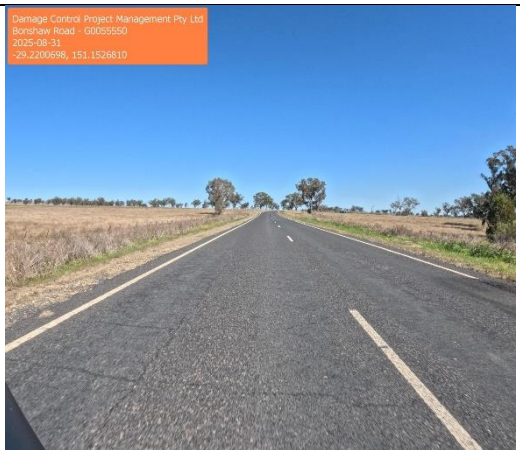
| 21 | 21760 | 21860 | Cracking (both) | <p>Damage Control Project Management Pty Ltd<br/>Bonshaw Road - G0055550<br/>2025-08-31<br/>-29.2200658, 151.1526810</p> |

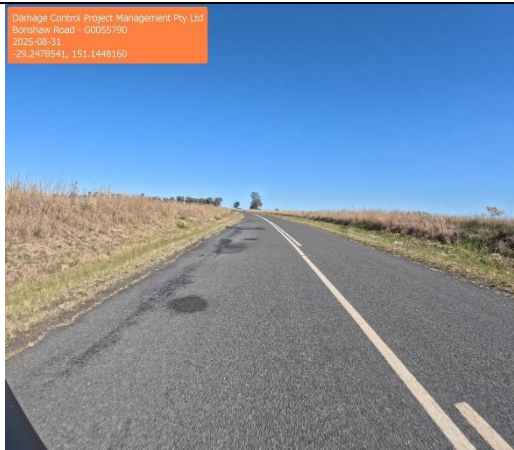
| 22 | 25080 | 25150 | Pavement failure (left) | <p>Damage Control Project Management Pty Ltd<br/>Bonshaw Road - G0055790<br/>2025-08-31<br/>29.2475541, 151.1448160</p> |

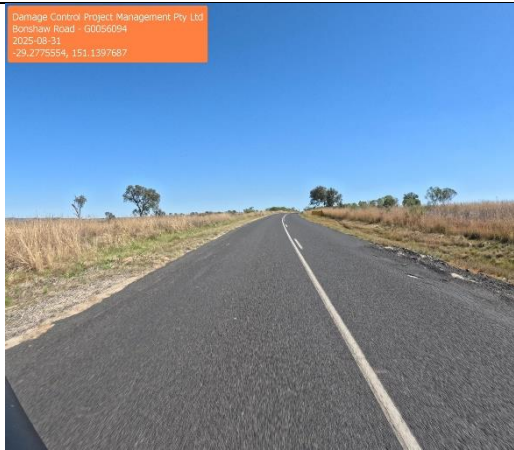
| 23 | 28600 | 29300 | Pavement failure (right) | <p>Damage Control Project Management Pty Ltd<br/>Bonshaw Road - G0056094<br/>2025-08-31<br/>29.2475541, 151.1397687</p> |

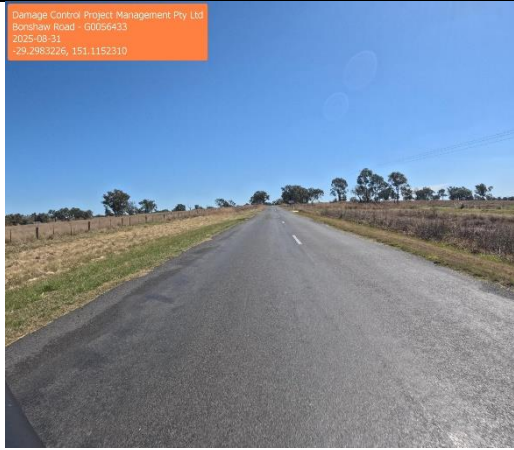
| 24 | 32900 | 34520 | Seal – flushing (both) | <p>Damage Control Project Management Pty Ltd<br/>Bonshaw Road - G0056433<br/>2025-08-31<br/>29.2383226, 151.1152310</p> |

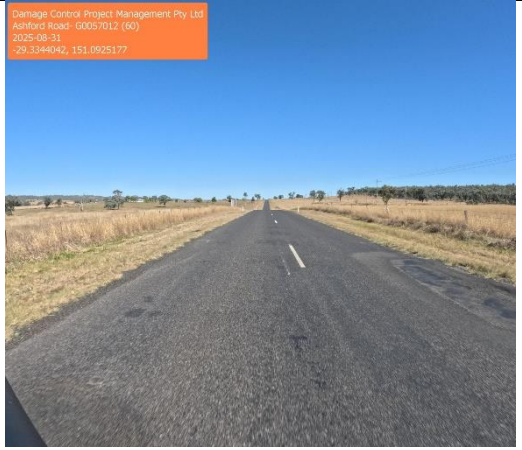
| Defect ID | Start CH | End CH | Defect Type (and side of road) | Image |
|---|---|---|---|---|
| 1 | 770 | 780 | Pavement failure (right) | |

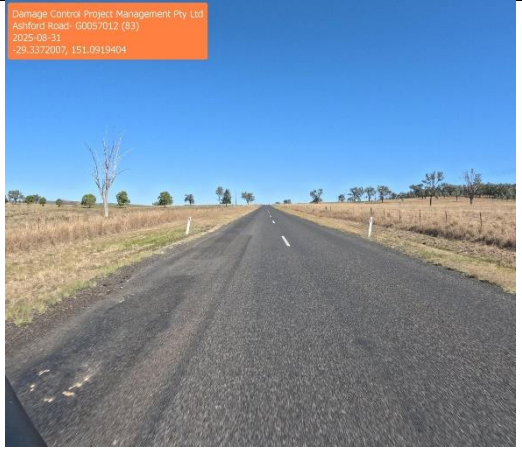
| Defect ID | Start CH | End CH | Defect Type (and side of road) | Image |
|---|---|---|---|---|
| 2 | 1000 | 1100 | Pavement failure (left) | |

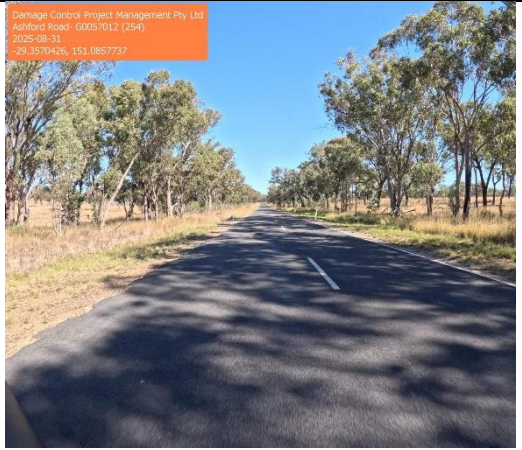
| Defect ID | Start CH | End CH | Defect Type (and side of road) | Image |
|---|---|---|---|---|
| 3 | 3000 | 4000 | Edge break (left) | |

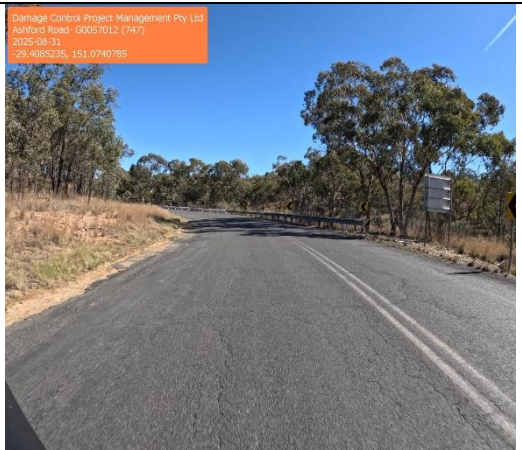
| 4 | 9500 | 13020 | Cracking (both)<br><br>Edge break (left)<br><br>Pavement failure (left) | <div> <div> Damage Control Project Management Pty Ltd<br/> Ashford Road - G0057012 (747)<br/> 2025-08-31<br/> 29 4965235, 151 0240785 </div> </div> |

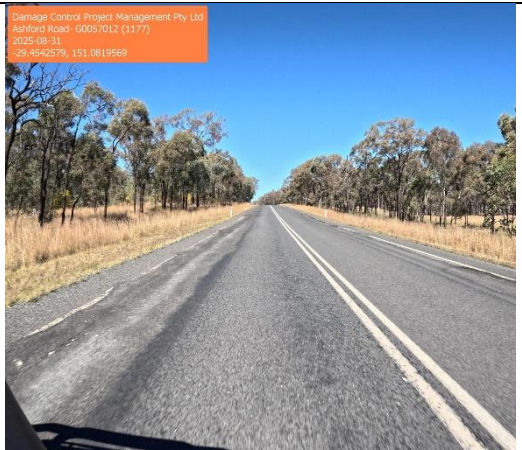
| 5 | 15280 | 15500 | Pavement failure (both) | <div> <div> Damage Control Project Management Pty Ltd<br/> Ashford Road - G0057012 (1177)<br/> 2025-08-31<br/> 29 4965235, 151 0819569 </div> </div> |

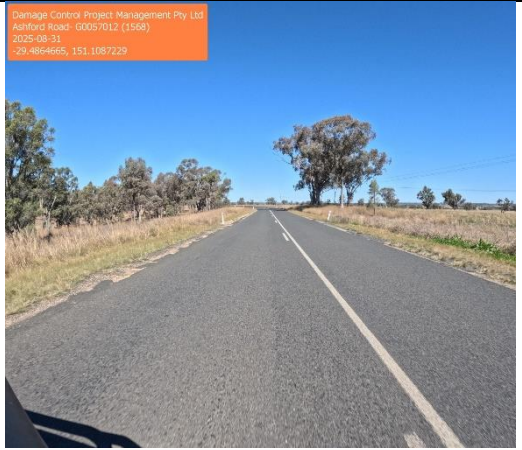
| 6 | 20500 | 21500 | Edge break (left) | <div> <div> Damage Control Project Management Pty Ltd<br/> Ashford Road - G0057012 (1568)<br/> 2025-08-31<br/> 29 4964665, 151 1087229 </div> </div> |

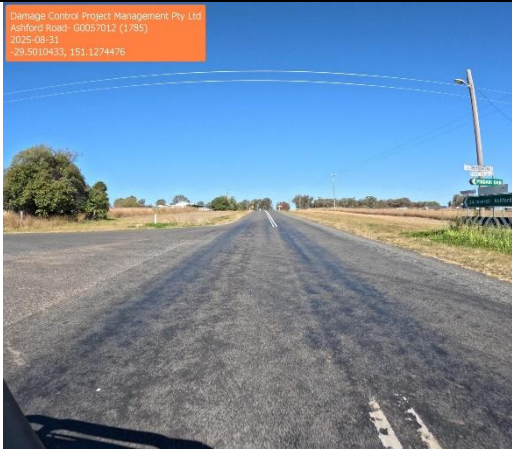
| 7 | 23000 | 23500 | Seal – flushing<br>(both) | |

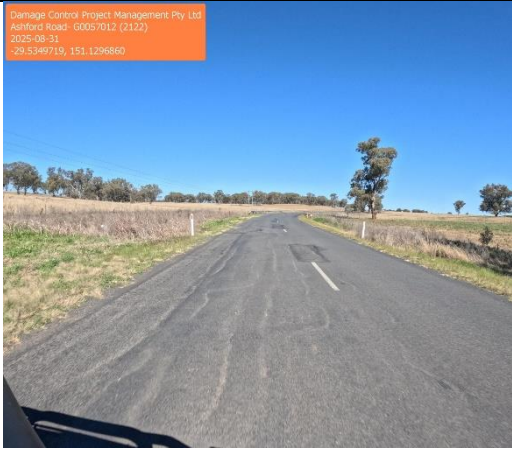
| 8 | 26000 | 32000 | Cracking (both)<br><br>Pavement<br>failures (left) | |

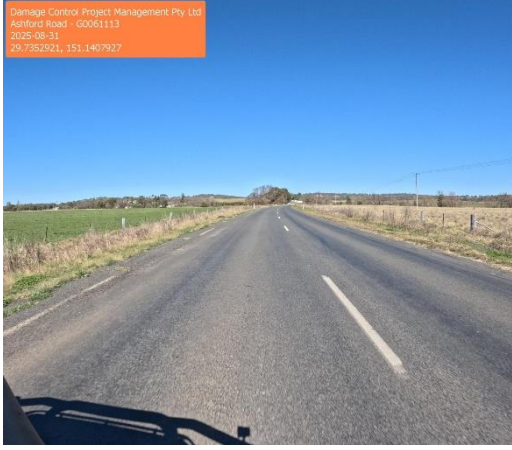
| 9 | 48600 | 49500 | Pavement<br>failures (both)<br><br>Seal – flushing<br>(both) | |

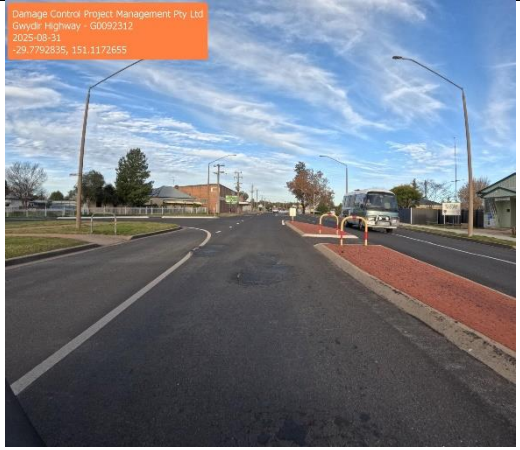
| Defect ID | Start CH | End CH | Defect Type (and side of road) | Image |
|---|---|---|---|---|
| 1 | 900 | 910 | Pavement failure (left) | |

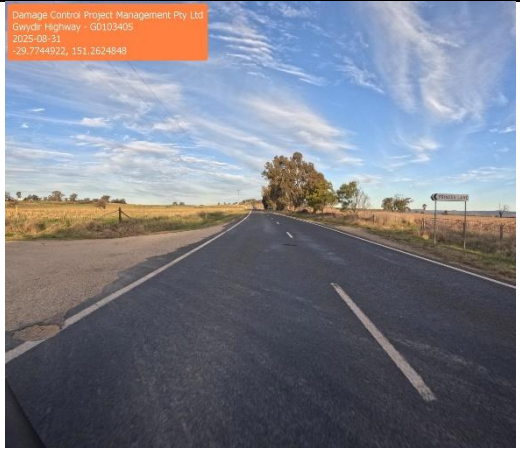
| Defect ID | Start CH | End CH | Defect Type (and side of road) | Image |
|---|---|---|---|---|
| 2 | 14270 | 14320 | Potholes (left)<br><br>Loose material (left)<br><br>Edge break (left) | |

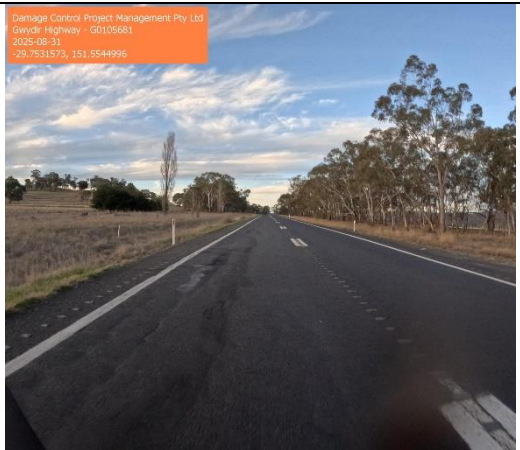
| 3 | 45900 | 46000 | Pavement failures (left) | <p>Damage Control Project Management Pty Ltd<br/>Gwydir Highway - G0105681<br/>2025-08-31<br/>29-7531573, 151-5544995</p> |

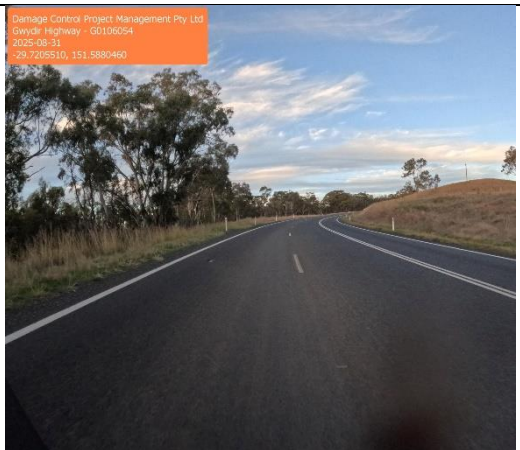
| 4 | 50960 | 50960 | Pothole (left) | <p>Damage Control Project Management Pty Ltd<br/>Gwydir Highway - G0106054<br/>2025-08-31<br/>29-7209510, 151-5890460</p> |

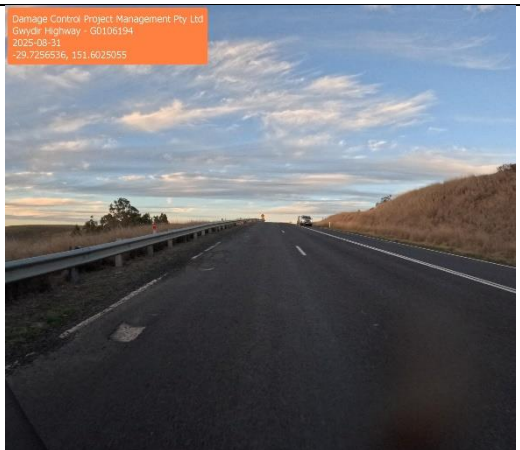
| 5 | 52700 | 52800 | Potholes (left)<br><br>Pavement failures (left) | <p>Damage Control Project Management Pty Ltd<br/>Gwydir Highway - G0106194<br/>2025-08-31<br/>29-7256536, 151-6025055</p> |

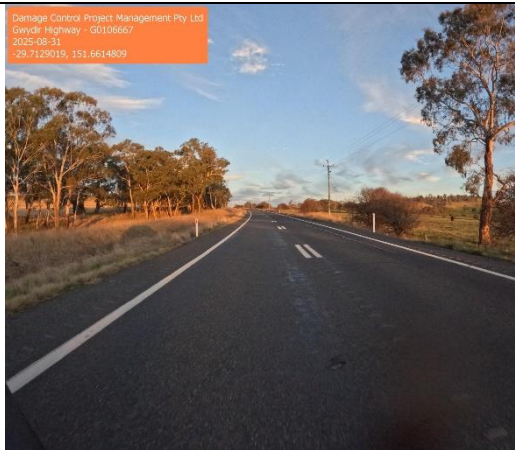
| 6 | 59050 | 59050 | Pothole (left) | <p>Damage Control Project Management Pty Ltd<br/>Gwydir Highway - G0106667<br/>2025-08-31<br/>-29.7129019, 151.6614809</p> |

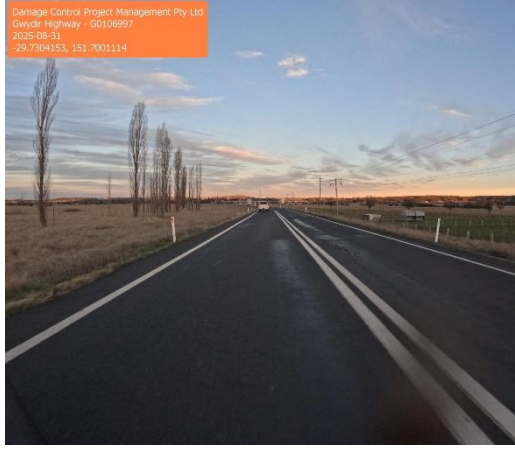
| 7 | 63300 | 63350 | Potholes (right)<br><br>Pavement failures (right) | <p>Damage Control Project Management Pty Ltd<br/>Gwydir Highway - G0106997<br/>2025-08-31<br/>-29.7304153, 151.7001114</p> |

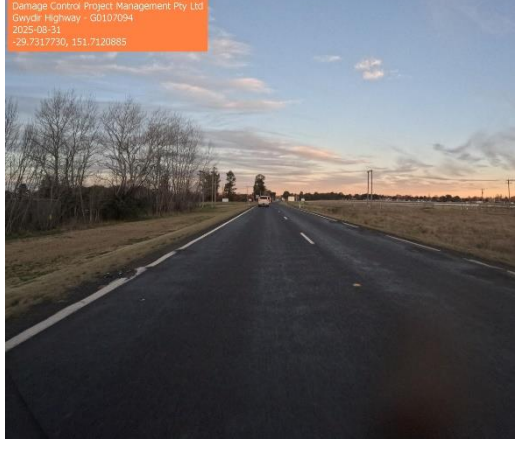
| 8 | 64470 | 65110 | Potholes (both)<br><br>Pavement failures (both) | <p>Damage Control Project Management Pty Ltd<br/>Gwydir Highway - G0107094<br/>2025-08-31<br/>-29.7317730, 151.7120885</p> |

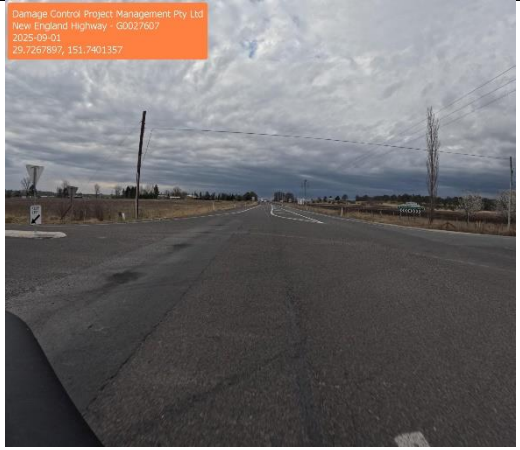
| Defect ID | Start CH | End CH | Defect Type (and side of road) | Image |
|---|---|---|---|---|
| 1 | 990 | 1030 | Cracking (left) | |

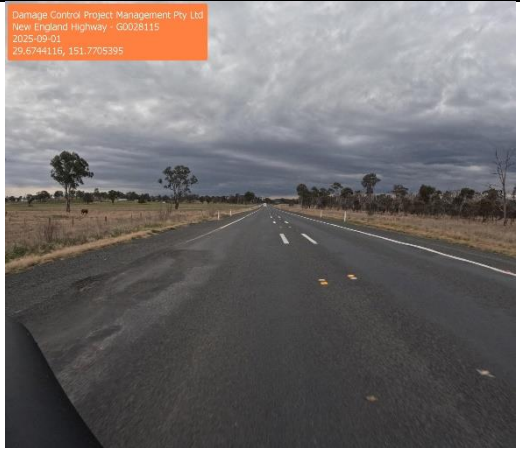
| Defect ID | Start CH | End CH | Defect Type (and side of road) | Image |
|---|---|---|---|---|
| 2 | 7800 | 7850 | Pavement failure (left)<br><br>Cracking (left) | |

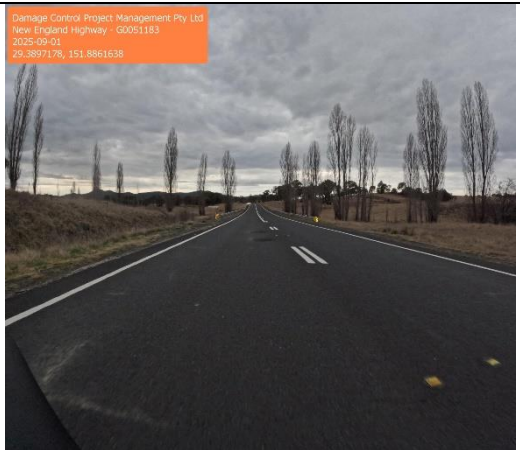
| 12 | 47230 | 48230 | Cracking (left) | <p>Damage Control Project Management Pty Ltd<br/>New England Highway - G0051183<br/>2025-09-01<br/>29.3897176, 151.8861638</p> |

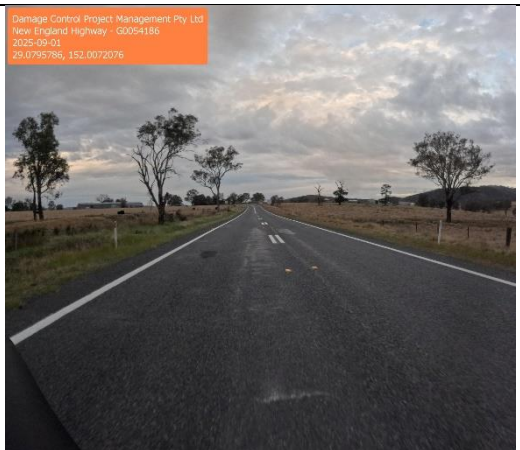
| 13 | 88470 | 88520 | Cracking (left)<br><br>Seal – flushing (left)<br><br>Pavement failures (right) | <p>Damage Control Project Management Pty Ltd<br/>New England Highway - G0054186<br/>2025-09-01<br/>29.0795786, 152.0072076</p> |

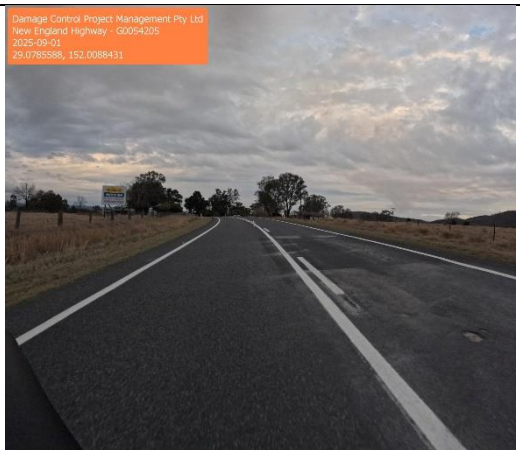
| 14 | 88660 | 88660 | Potholes (right) | <p>Damage Control Project Management Pty Ltd<br/>New England Highway - G0054205<br/>2025-09-01<br/>29.0785588, 152.0088431</p> |

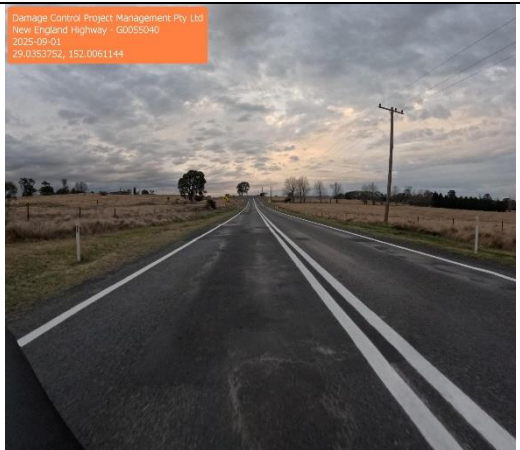
| 15 | 94840 | 94890 | Cracking (both) | <p>Damage Control Project Management Pty Ltd<br/>New England Highway - G0055040<br/>2025-09-01<br/>29.0253752, 152.0061144</p> |

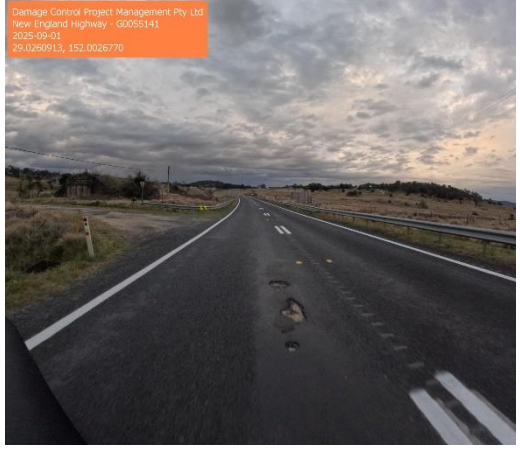
| 16 | 95950 | 95950 | Potholes (left) | <p>Damage Control Project Management Pty Ltd<br/>New England Highway - G0055141<br/>2025-09-01<br/>29.0250913, 152.0026770</p> |

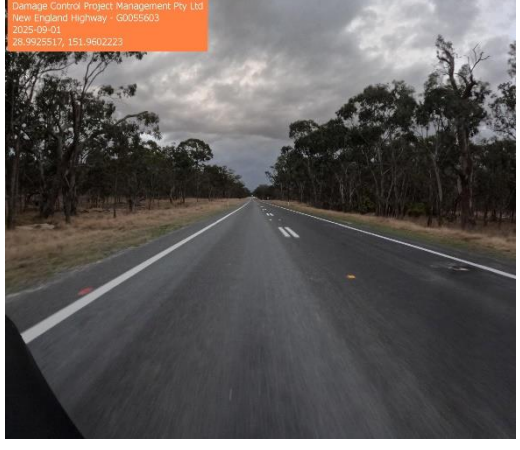
| 17 | 101690 | 102240 | Potholes (both) | <p>Damage Control Project Management Pty Ltd<br/>New England Highway - G0055603<br/>2025-09-01<br/>28.9925517, 151.9602223</p> |
