JBS&G Hazardous Material Assessment Report

Pells Sullivan Meynink
Hazardous Building Materials Survey

Chatswood High School
24 Centennial Avenue, Chatswood, NSW

Pells Sullivan Meynink
Hazardous Building Materials Survey
Chatswood High School
24 Centennial Avenue, Chatswood, NSW
15 March 2019
55579/120,669 (Rev 0)
JBS&G

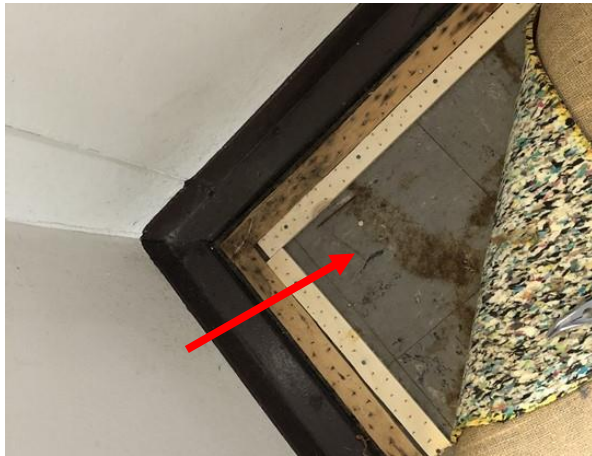
Photo 1: Building A, asbestos containing grey vinyl floor tiles to Room R1001

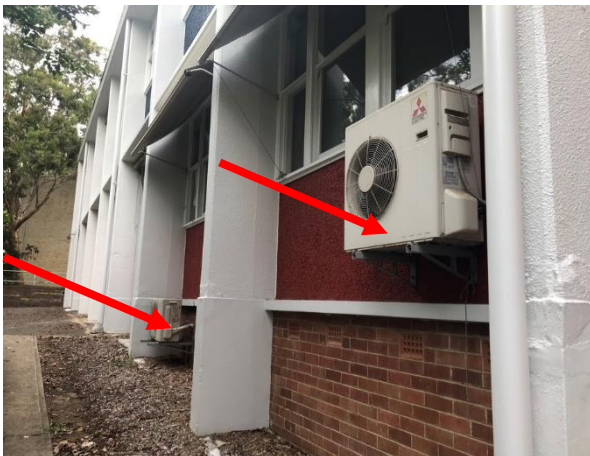
Photo 10: Building A, suspected internal SMF insulation to air conditioning units

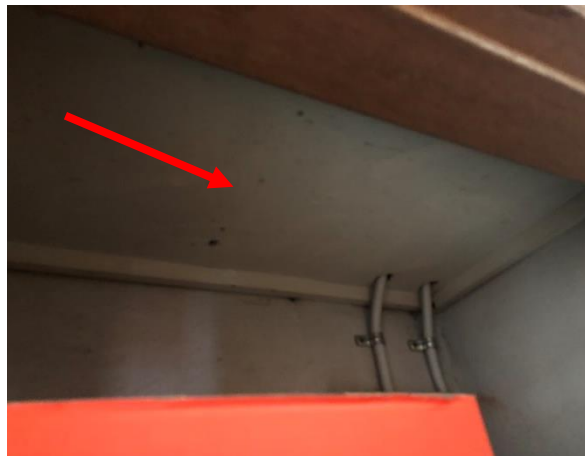
Photo 11: Building B, asbestos containing fibre cement sheeting to ceiling of Room R0008

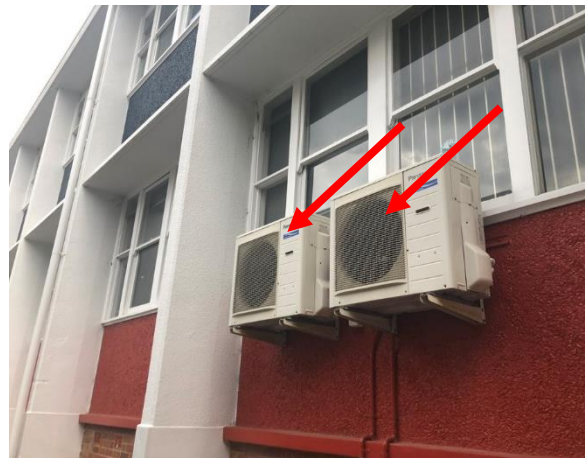
Photo 41: Building F, suspected SMF internal insulation to air conditioning units

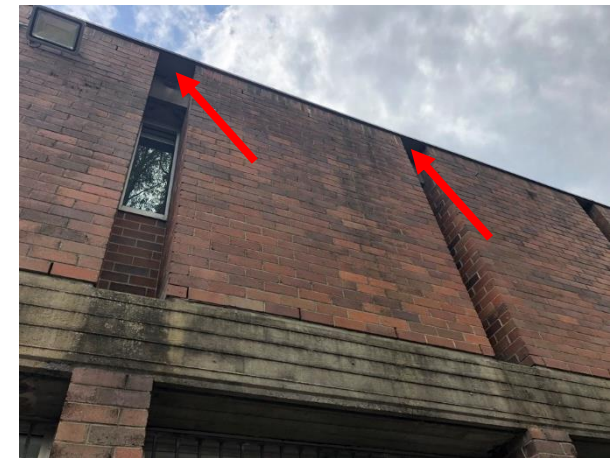
Photo 42: Building H, suspected asbestos containing fibre cement sheeting to eaves above windows

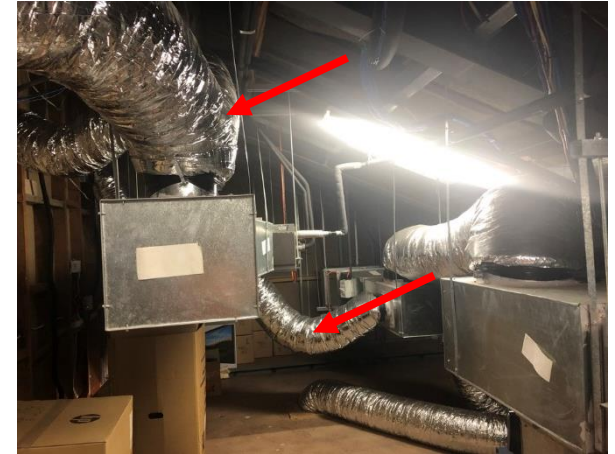
Photo 45: Building H, suspected SMF insulation to air conditioning ducting

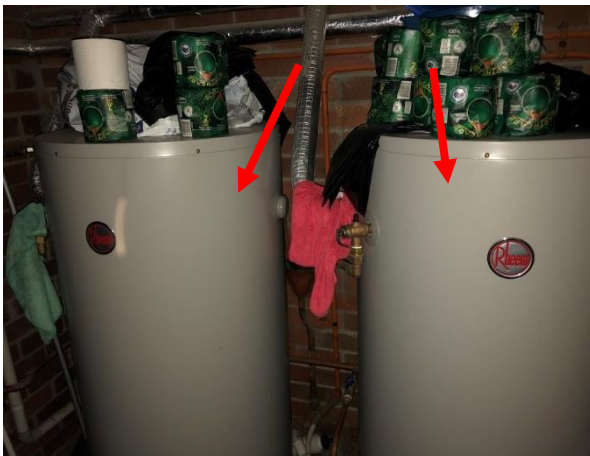
Photo 46: Building H, suspected SMF insulation core to hot water systems in Room R0002

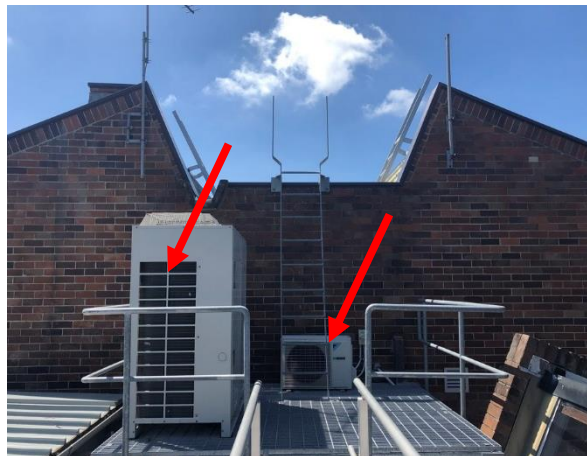
Photo 47: Building H, suspected SMF internal insulation to air conditioning units

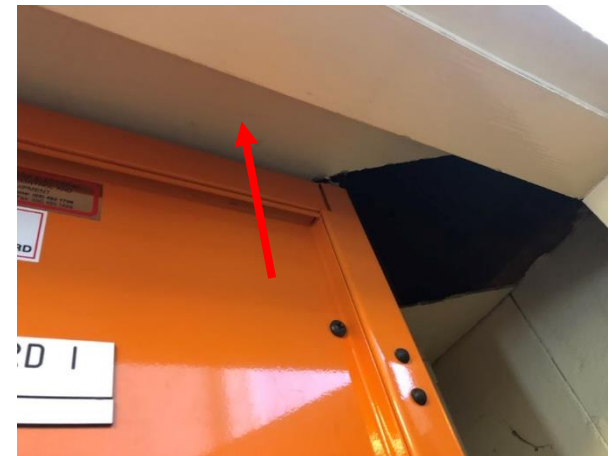
Photo 48: Building I, asbestos containing fibre cement sheet ceiling to Room R0007

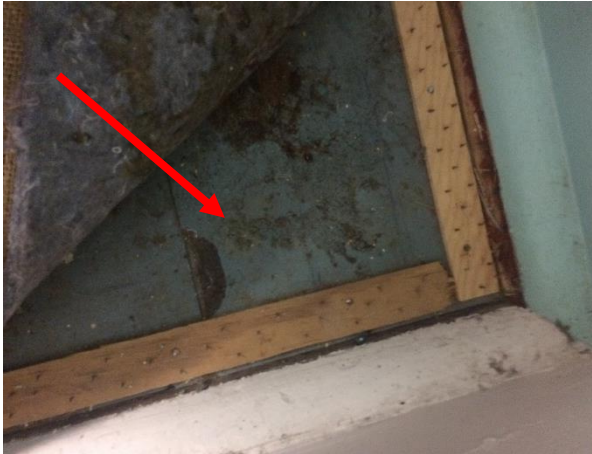
Photo 1: Building A, asbestos containing green vinyl floor tiles to Room R0001

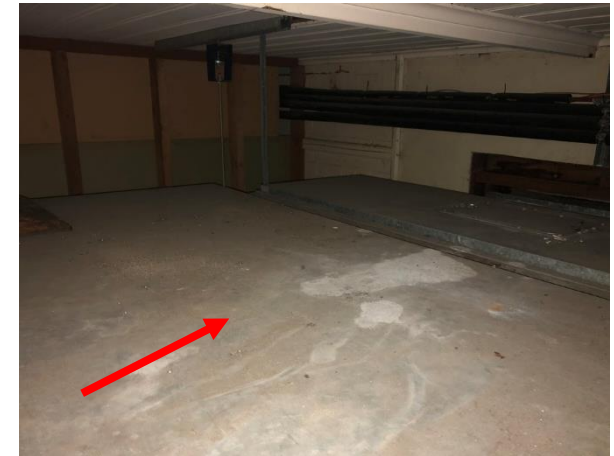
Photo 15: Building A, lead containing dust to air conditioning loft in Room R0031

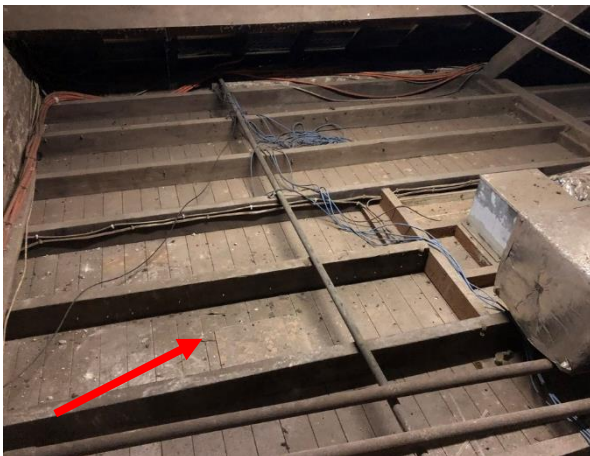
Photo 16: Building A, lead containing dust within roof void

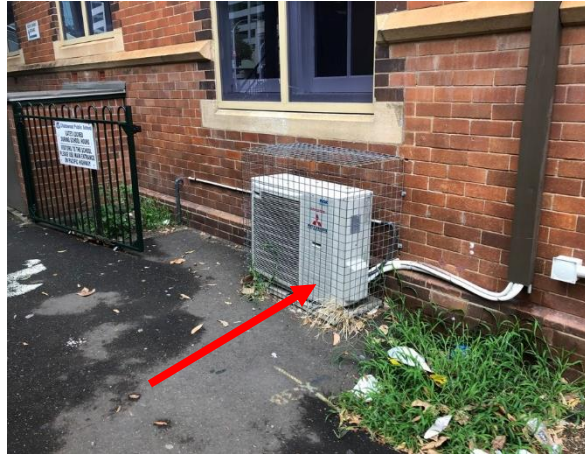
Photo 20: Building A, suspected internal SMF insulation to air conditioning units

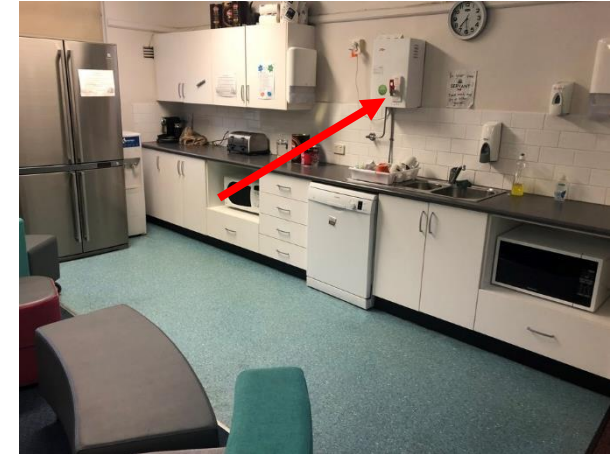
Photo 21: Building A, suspected SMF insulation core to instant hot water system in Room R0001

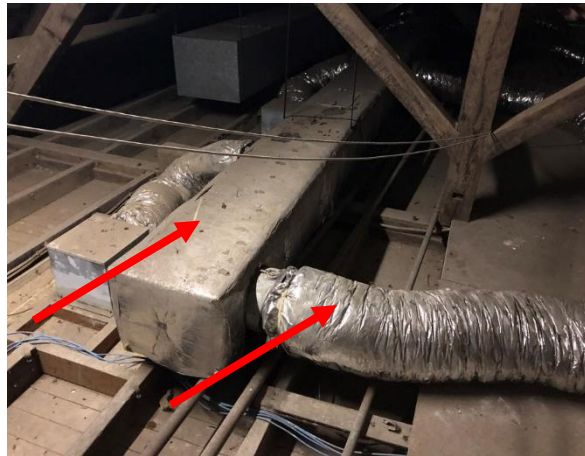
Photo 23: Building A, suspected SMF insulation lagging to air conditioning ducting

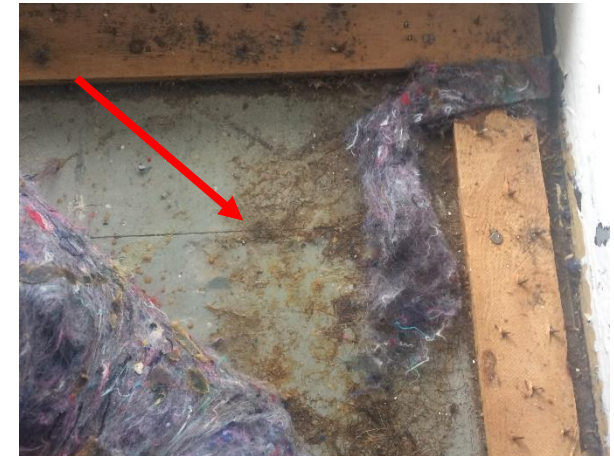
Photo 24: Building B, asbestos containing green vinyl floor tiles to Room R0003

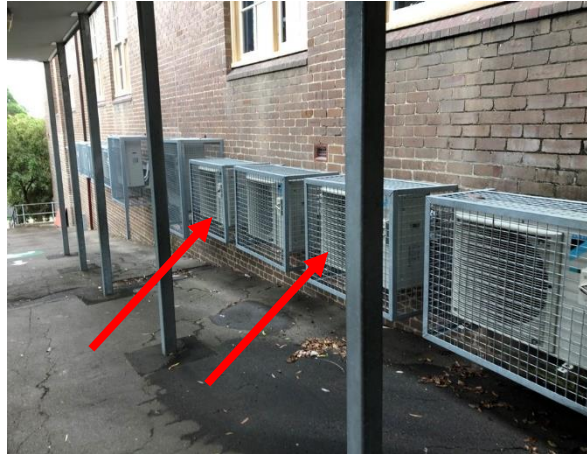
Photo 32: Building B, suspected internal SMF insulation to air conditioning units

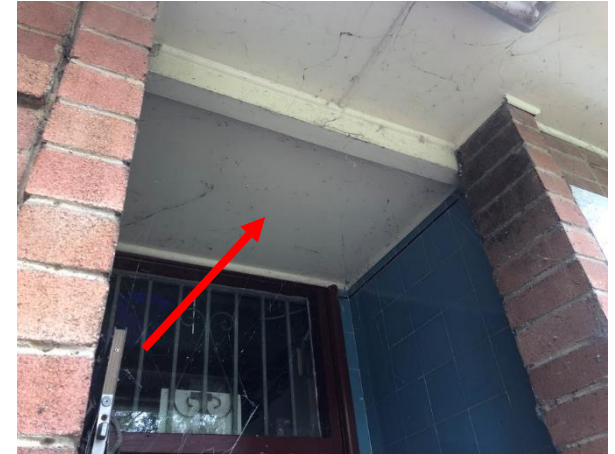
Photo 33: Building C, asbestos containing fibre cement sheeting to Room R0001 ceiling (external soffit)
