# ENVIRONMENTAL REPRESENTATIVE SITE INSPECTION REPORT

From:	Carl Vincent <a href="mailto:carl.vincent@ersed.com.au">carl.vincent@ersed.com.au</a>	Date:	11/05/21	DATE OF INSPECTION	11/05/21
To:	Naiem Teghlobi <a href="mailto:Naiem.Teghlobi@frasersproperty.com.au">Naiem.Teghlobi@frasersproperty.com.au</a>	Construction Activities: <ul style="list-style-type: none"> <li>• Improvement to entrance area.</li> <li>• Management and sorting of demolition and other waste</li> <li>• Limited clearing/stripping along the southern project boundary</li> <li>• Commencement of construction for the main SW sediment basin.</li> <li>• Demolition of 2 dwellings – NW corner</li> <li>• General earthworks central/eastern area covered by PESCP</li> </ul>		Weather Conditions	Cloudy / Rainy
CC:				Rainfall previous 24hrs	<10mm
Project	SSD 9522: Kemps Creek Warehouse, Logistics and Industrial Facilities Hub (THE YARDS)			Rainfall forecast next 24hrs	>10mm
Attendees	<del>Maria Divis (DPIE)</del> Lachlan Paton – AWJ Tim Culmone – AWJ Naiem Teghlobi – Frasers			<a href="http://www.bom.gov.au/jsp/ncc/cdio/weatherData/av?p_nccObsCode=136&amp;p_display_type=dailyDataFile&amp;p_startYear=&amp;p_c=&amp;p_stn_num=0670

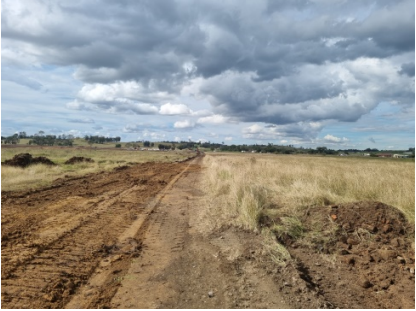
2.

HIGH	<p>The side of the access track southern boundary has been cleared of topsoil.</p> <p>It was indicated that the surveyor has been on site and confirmed the boundary however the <b>boundary identification as required by Condition B39 was not in place at the time of inspection.</b></p> <p>Please provide documented confirmation, from the surveyor, of the location of the boundary and identification had been installed and or communicated per the requirement of B39.</p> <p>Please confirm that no clearing or ground disturbance has occurred outside the approved project boundaries.</p> <p>Note that ground disturbance outside the approved project boundary may indicate a non-compliance with Condition of Consent A2.</p>	13/05/21

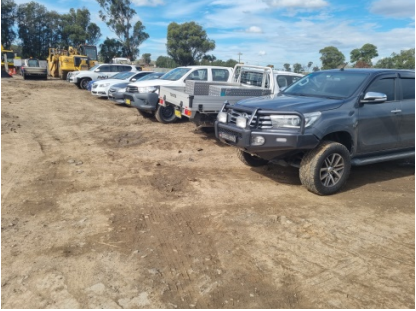
5.	Temp Car park

LOW	<p>The informal car parking area adjacent to the entrance is irregular and churned.</p> <p>In wet conditions this surface will retain water and exacerbate mud being transferred to HVs and LVs that use this area.</p> <p>The surface should be levelled and rolled to reduce tracking of mud from the site.</p> <p>It may be required to import a more stable surface material</p>	16/05/21

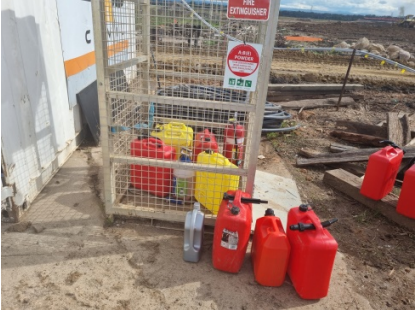
6.	Fuel Storage

HIGH	<p>Jerry cans are observed out of bunded areas.</p> <p>Manage fuels in accordance with the provisions of the CEMP.</p>	12/05/21

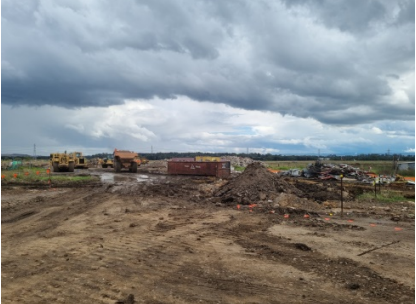
7.	Waste sorting/ handling area

OBSERVATION	<p>Sediment fence has been installed around the lower portion of the handling area.</p> <p>It was communicated that the contractor is still sorting and separating material. This will then be removed from the site.</p>	NA

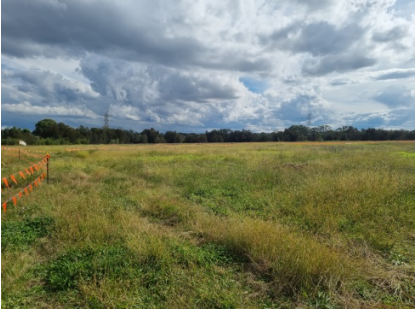
8.	West of main basin

OBSERVATION	<p>The application of Condition. B39 (provided below) in this area was discussed. It was indicated that the actual project boundary is further west of the limit of these current works. Flagging and sediment fence has been provided to indicate the extent of works being undertaken as part of this contract.</p> <p><i>B39. Prior to the commencement of construction, the Applicant must install appropriate boundary identification to be maintained throughout the construction period.</i></p> <p>It was indicated that confirmation that the project boundary has been confirmed with the applicant and documentation of this will be provided.</p>	NA

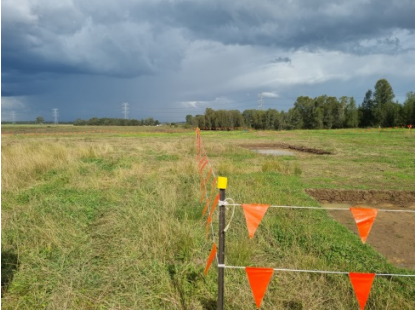
9.	SW corner

OBSERVATION	<p>Flagging has been maintained to protect archaeological investigation areas.</p>	NA	
10.	South of main basin

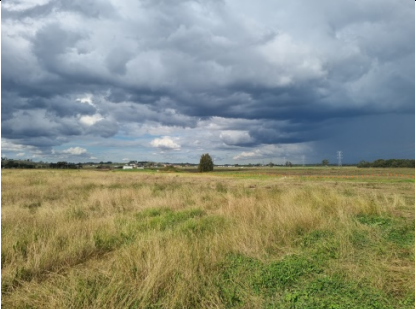
OBSERVATION	<p>It was discussed that a substation diversion will be required to ensure the works from the Microsoft Pad are directed to the new basin.</p>	NA

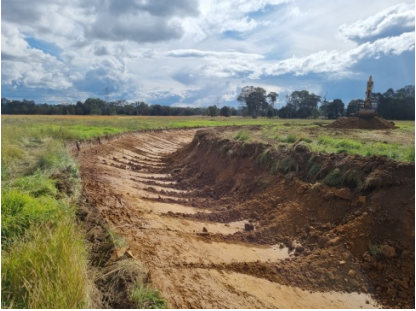
11.	Main basin works

OBSERVATION	<p>The top of cut batter for the new main basin is being constructed. It was indicated that a topsoil berm will be used to confirm the extent of the works and provide sediment control</p> <p>Any low points will need to be stabilised.</p> <p>See previous request for a marked up PESCP for these works.</p> <p>Interpretation of Condition B24 was discussed. The contractor indicated that they may wish to construct a smaller basin only to the extent required to accommodate the Microsoft lot works.</p> <p>Non -Compliance with this condition will only be removed once the sediment control (size/volume) indicated on the approved ESCPs within the CEMP have been constructed and confirmed by survey.</p>	NA

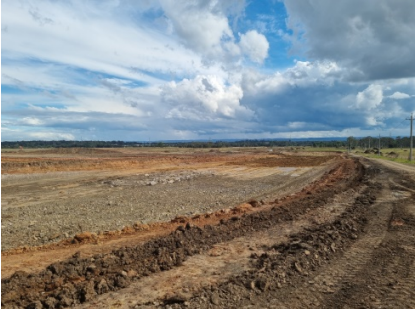
12.	New earth works area

OBSERVATION	<p>The ESC arrangement for this area was confirmed to still be in accordance with the PESCP.</p> <p>The borrow pit area has been increased and extended to incorporate the site of the previous farm dam greatly increasing the available storage of site water in this area if required</p>	NA

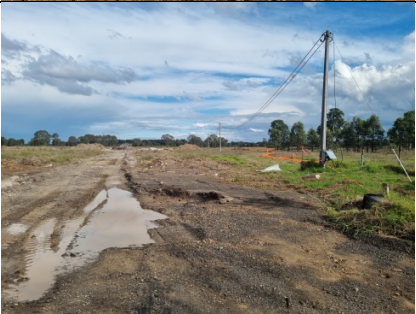
13.	Access track to house demolition

OBSERVATION	<p>the access track to the house demolition site has been improved slightly</p> <p>Sediment fence is in place along the lower side.</p>	NA	
14.	Dewatering line from farm dam

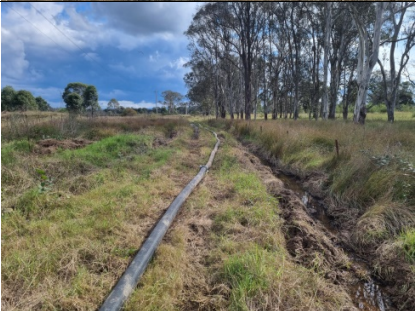
OBSERVATION	A long lay-flat has been provided along the fence line. This lay flat is taking water from the farm dam which is being partially emptied prior to final confirmation/clearance by the ecologist.	NA

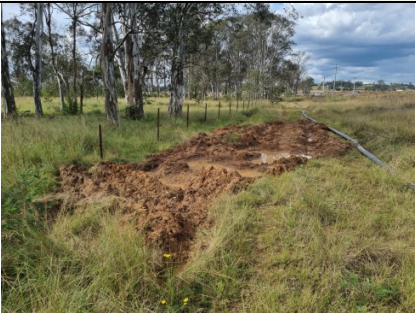
15.	Dewatering line from farm dam

LOW	<p>Localised ground disturbance is observed through this area.</p> <p>Please confirm what this disturbance is associated with/why it occurred.</p>	16/05/21

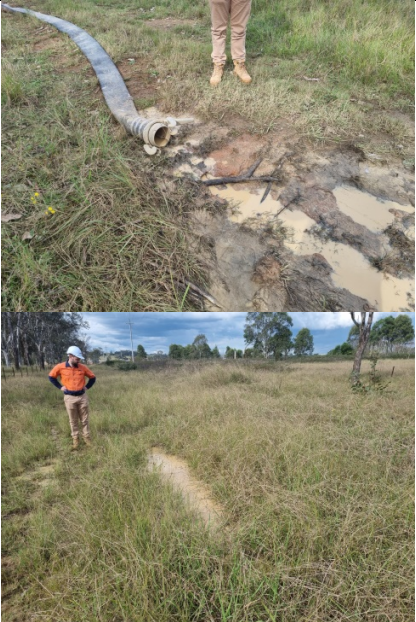
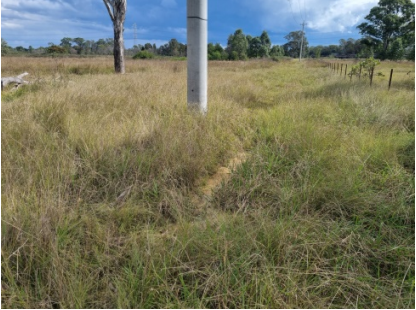
16.	Outlet from dewatering

- 1.8 Dewatering of one of the main farm dams has occurred. Turbid water was confirmed as being pumped and discharged further into the project area proximate to the northern boundary. It was not confirmed if this muddy water has moved off site or to drainage structures leading off site. Further investigation is requested.

OBSERVATION HIGH	<p>Muddy water has been discharged from the lay flat.</p> <p>This muddy water could be seen extending over 100m below the end of the lay-flat indicating that the muddy water ran for some time.</p> <p>This is a non-conformance with the SMP/ESCPs and CEMP.</p> <p>This has potential to evidence of Non-compliance with several conditions of consent including but limited to B25 and C3. (c). Note that a non-compliance with Condition B25 may also constitute an incident to be reported to the DPIE and also EPA.</p> <p>Please investigate this dewatering and provide:</p> <ul style="list-style-type: none"> <li>• Documentation / dewatering authorisations prepared in accordance the SMP/CEMP including water testing confirming WQ criteria</li> <li>• An approximation of the volume of water which was pumped from the dam.</li> <li>• Information on time at which the pumping commenced and was ceased.</li> <li>• Confirmation as to why it was ceased – i.e. when was it observed that muddy water.</li> <li>• Extent of flow or spread of this water and</li> </ul>	13/05/21

<p>where this water did exit the project boundary or meet with drainage lines which exit the project boundary.</p> <ul style="list-style-type: none"> <li>Any interaction of water flow from the dewatering that passed into proximity of the WNSW Pipeline Corridor – this information will be relevant in determining if notification is required to WNSW under Condition B42.</li> <li>Some notes or justification to why this dewatering location was selected and by whom.</li> </ul>

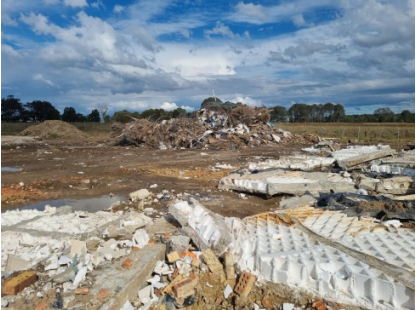
17.	Demolition site

- 1.5 Small quantities of the wind blow polystyrene have been liberated as part of the house demolition – this may create a waste management / housekeeping issue.

OBSERVATION	<p>The house has been partially demolished. The concrete slab has yet to be cleared.</p> <p>Polystyrene has been used within the slab – this has been partially broken up and has been windblown around the local area.</p> <p><b>This waste will need to be cleared as part of completion of demolition. Removal of polystyrene waste and prevention of its windblown spread should be a priority as this is a general requirement of the waste management plan and the CEMP.</b></p>	NA

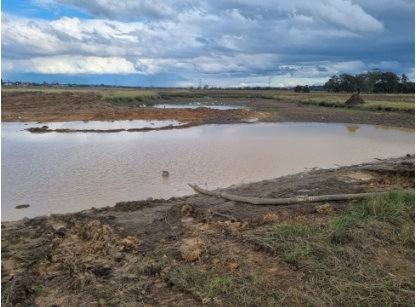
18.	Farm dam – being dewatered

OBSERVATION	<p>The farm dam being dewatered was inspected. It was confirmed by visual inspection that the water within the dam is highly turbid.</p> <p>Options for treatment and further dewatering should be discussed and confirmed with the ecologist.</p>	NA
