## Hazardous Materials Report

University of New England

Bellevue Campus, Armidale NSW

July 2008

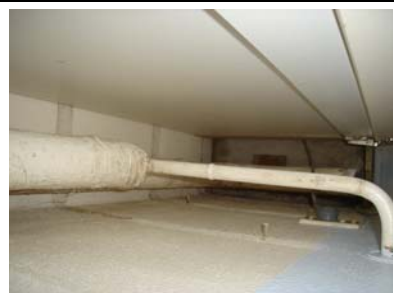
Buildings	Description	Recommendation	Photograph
Earle Page College Block 1 – B032	Level 01, Pipe lagging in Riser Cupboard in Kitchen adjacent to Room 111	Encapsulate the material by an AS-1 licensed contractor as soon as possible

- Engage an AS-1 licensed contractor to encapsulate the pipe lagging within the Kitchen Cupboard Riser adjacent Room 211 within the Earle Page College Block 1 under controlled conditions.
