# Arboricultural Assessment and Management Plan

## 4-18 Doncaster Avenue, Kensington

**Prepared by:** George Palmer

**Dated:** November, 2018

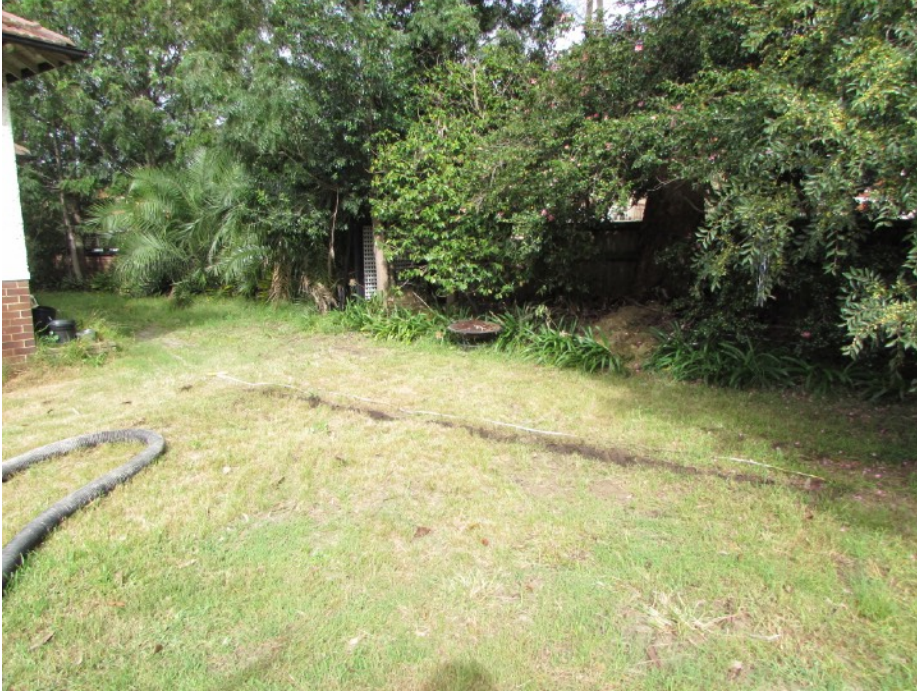
6.4 No structurally significant tree roots were located in the excavation process and this line will form the edge of the proposed construction impact zone.

**Figure 1** Shows the location of excavated trench in relation to the tree and existing building footprint.

7.4 All roots required for pruning or removal should be cut cleanly adjacent to the edge of the proposed construction and covered with hessian to limit the spread of decay and their exposure to the atmosphere.

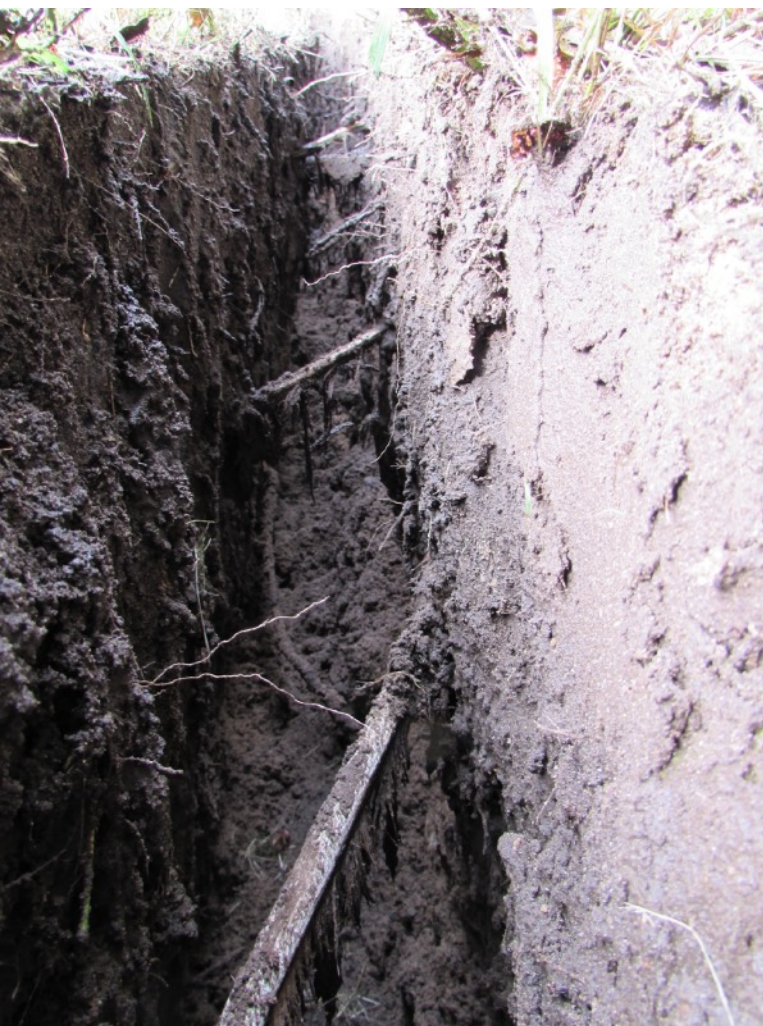
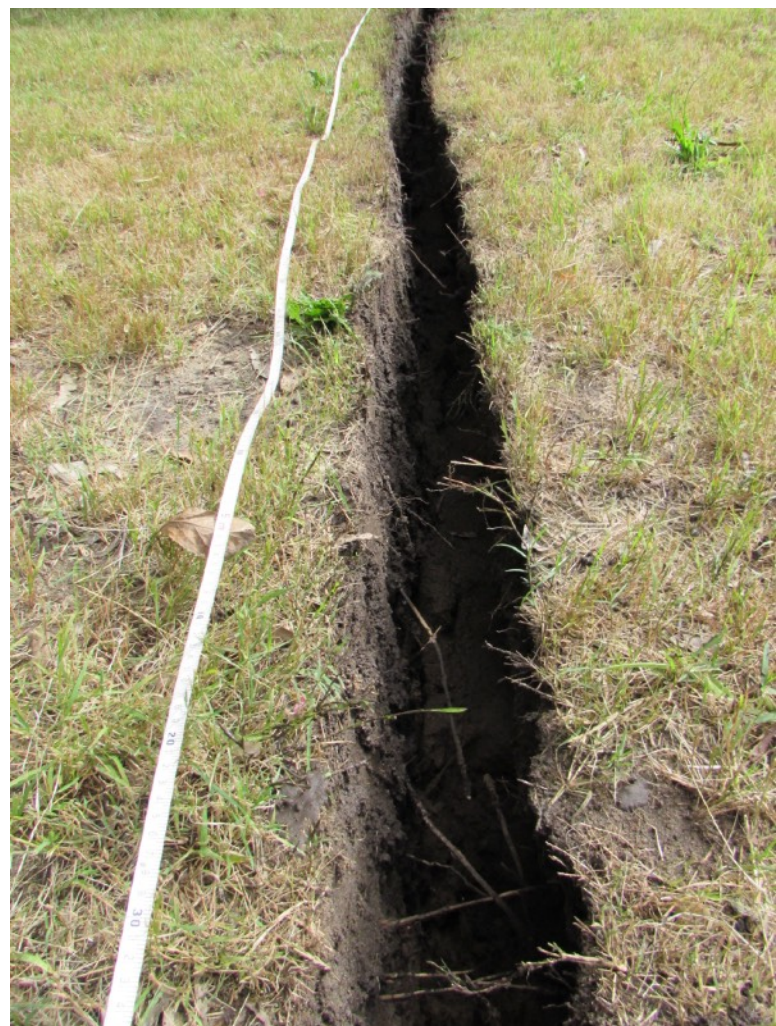
**Figures 2 and 3** Shows the exposed soil profile within the trench.

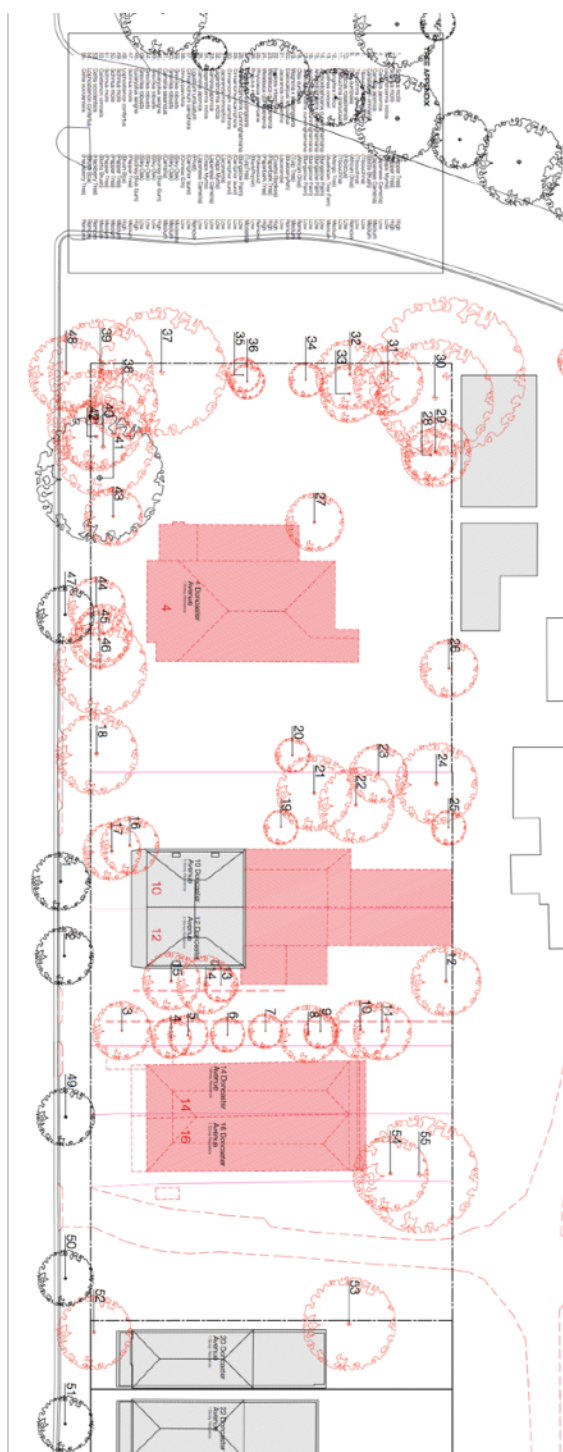
**Figure 4** Shows the existing trees in relation to the residences.
