**PRELIMINARY ENVIRONMENTAL
SITE ASSESSMENT
4 – 18 DONCASTER AVENUE,
KENSINGTON NSW
BLUE SKY COMMERCIAL ASSET
MANAGERS PTY LTD**

6 SEPTEMBER 2018
118090
VERSION 1

**Preliminary Environmental Site Assessment –
4 – 18 Doncaster Avenue, Kensington NSW**

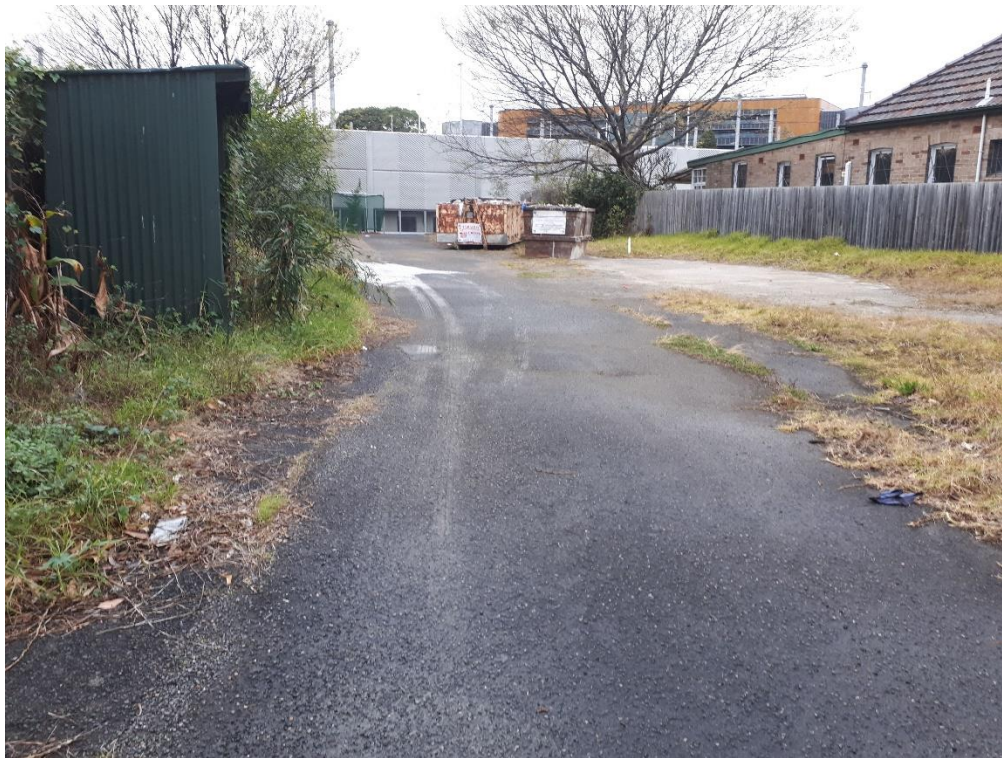
Photo 1

18 Doncaster Ave – Entrance to property being uses for storage

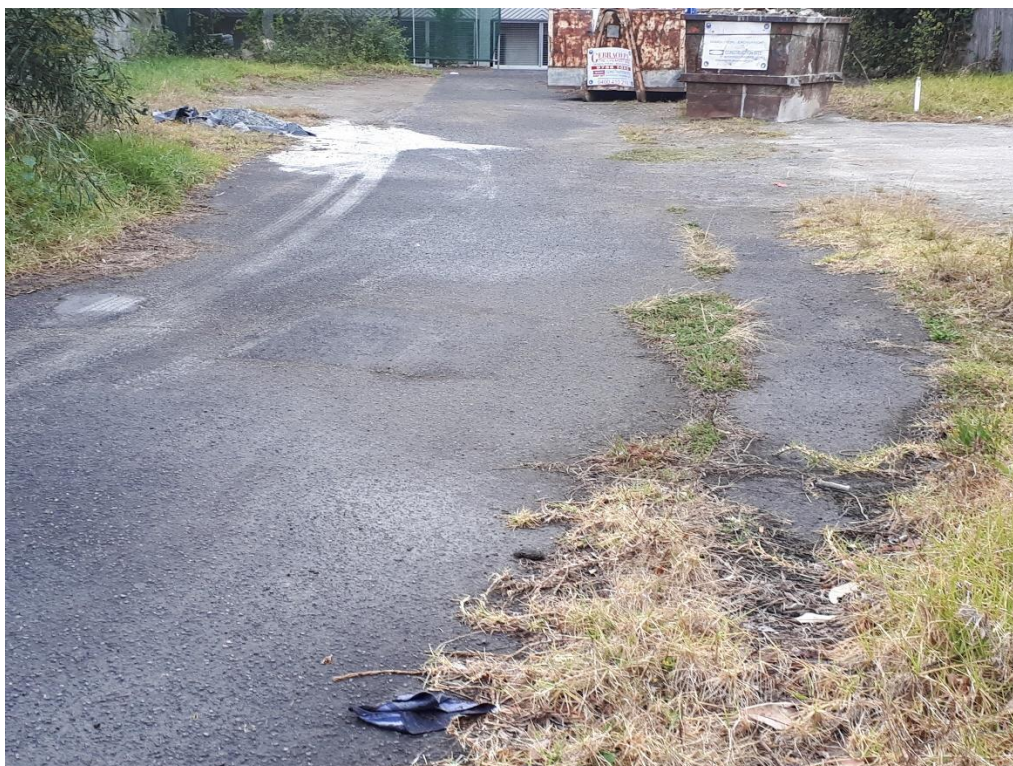
Photo 2

18 Doncaster Ave – Two waste skip bins present

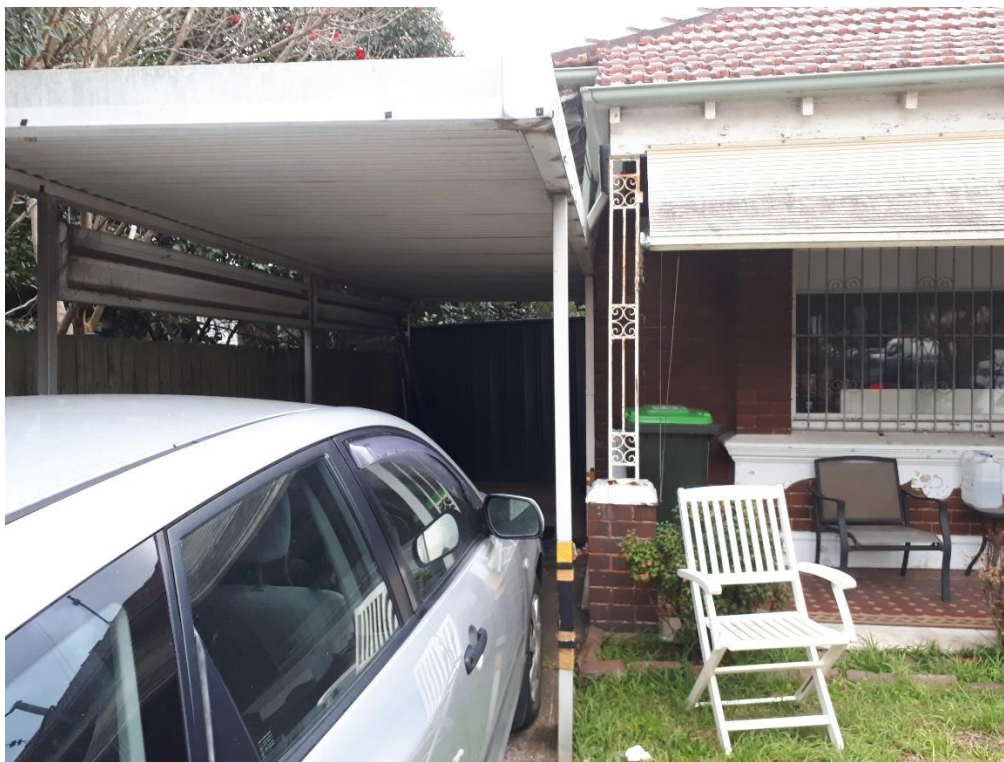
Photo 3

14 Doncaster Ave – front of property

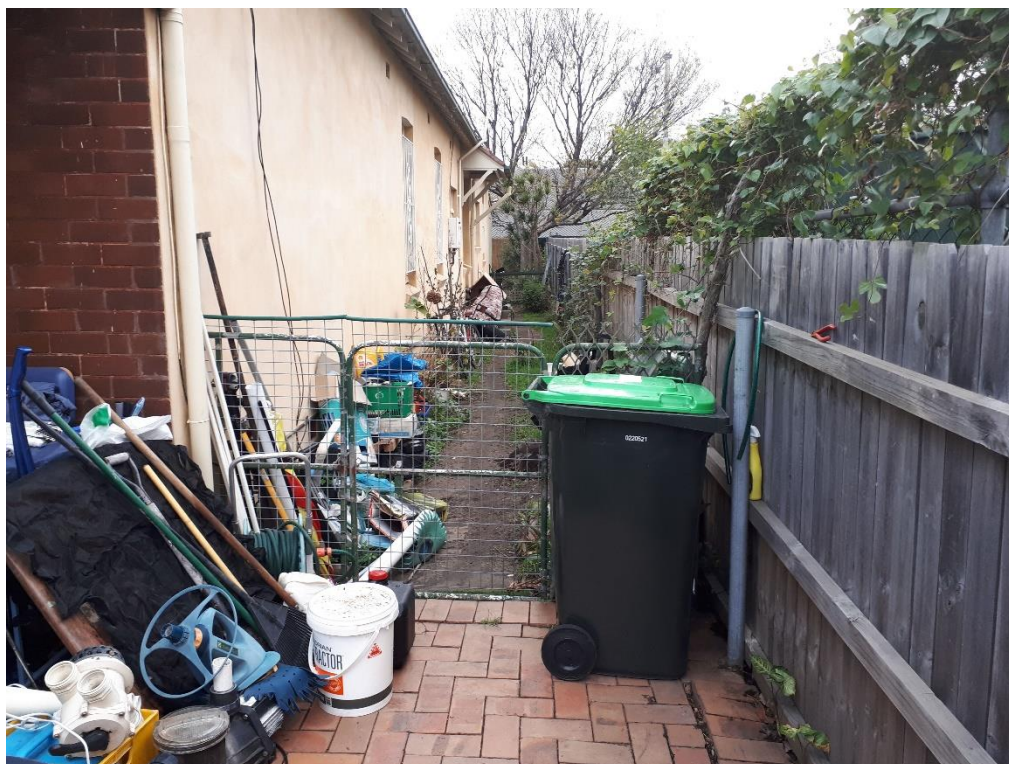
Photo 4

16 Doncaster Ave – southern side of property

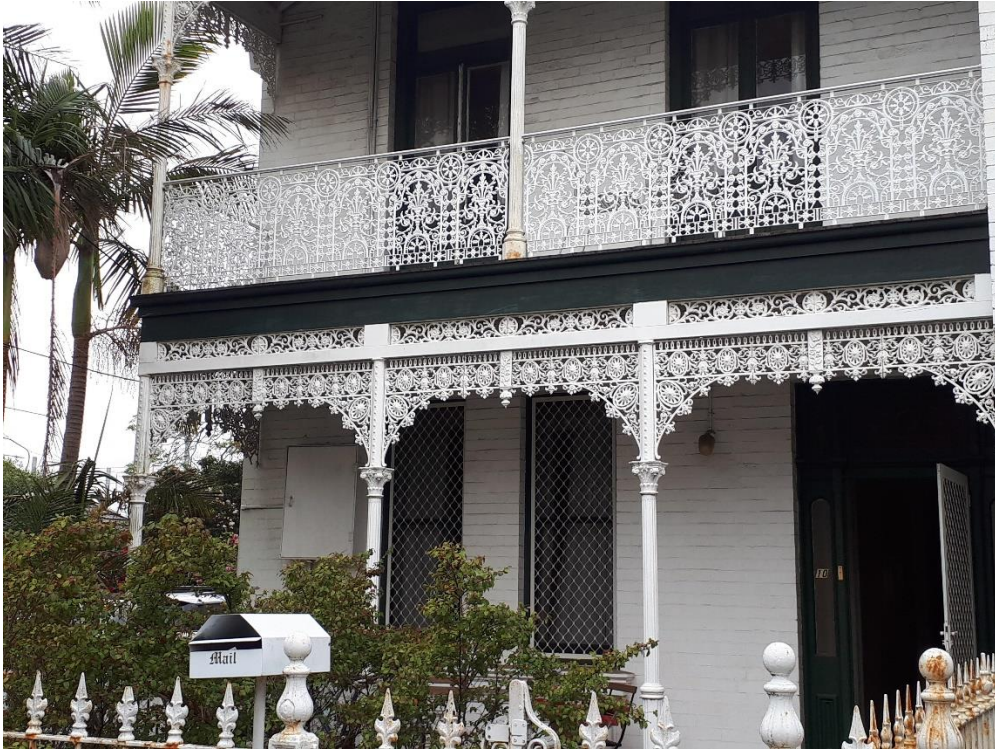
Photo 5

10 Doncaster Ave – front of property

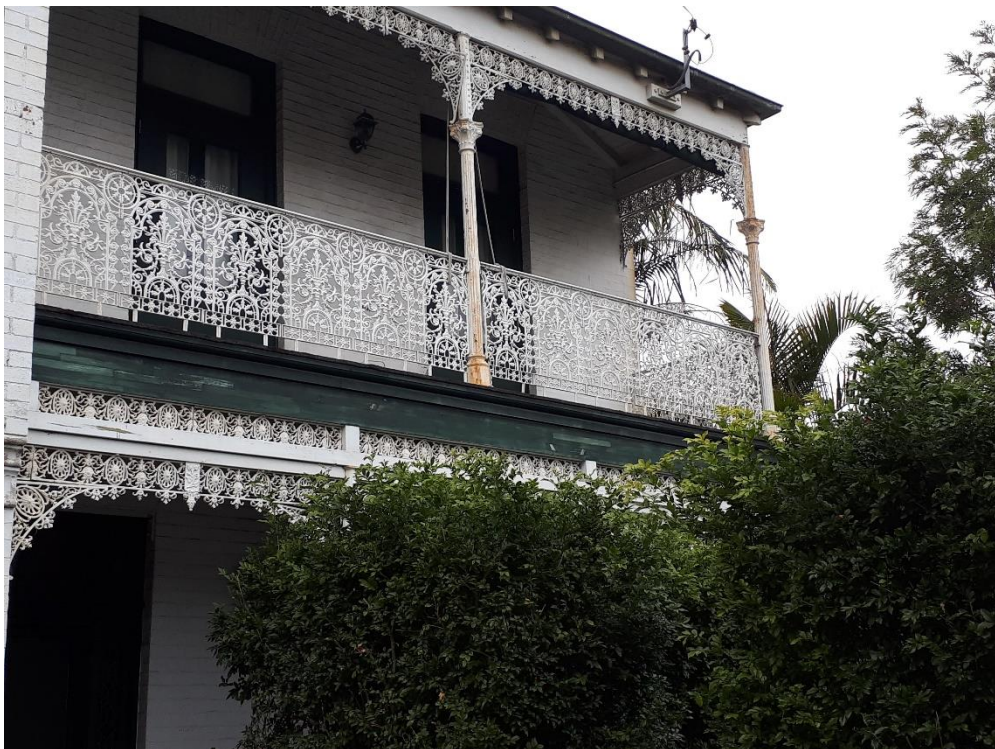
Photo 6

12 Doncaster Ave – front of property

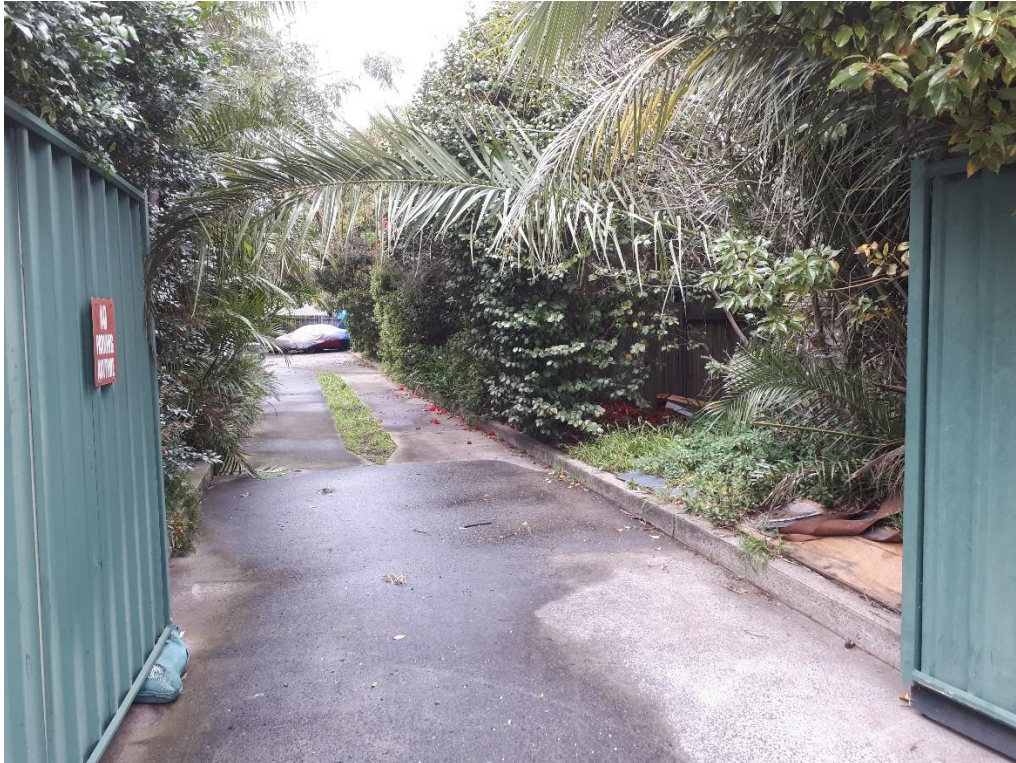
Photo 7

12 Doncaster Ave – adjacent driveway entrance

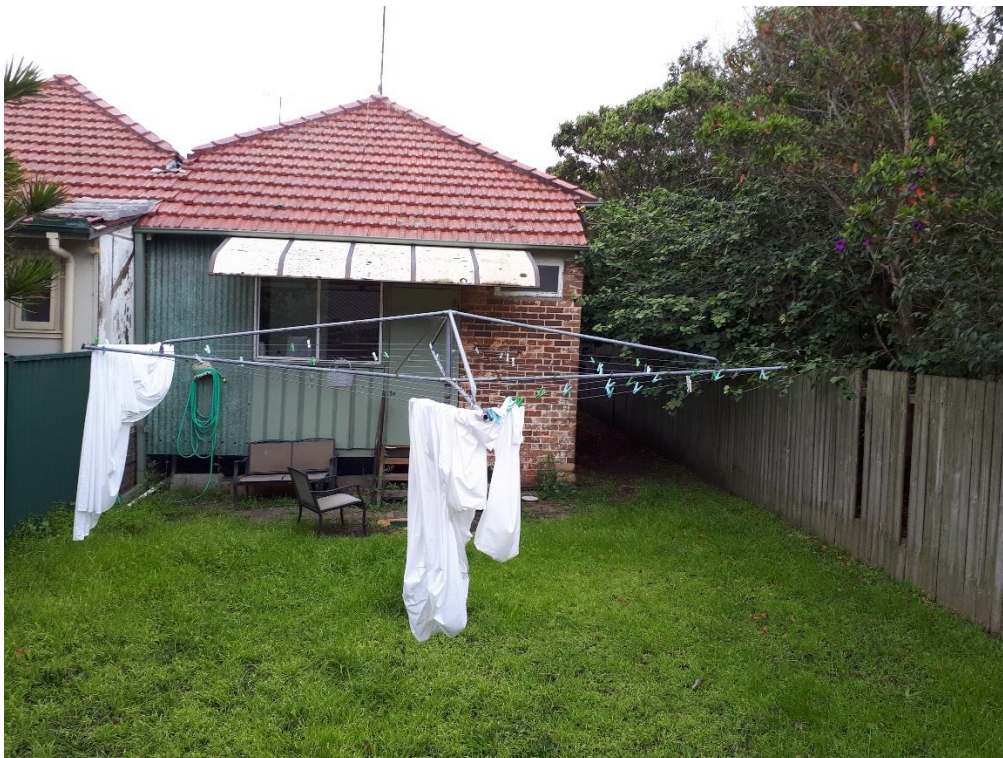
Photo 8

14 Doncaster Ave – rear yard of property

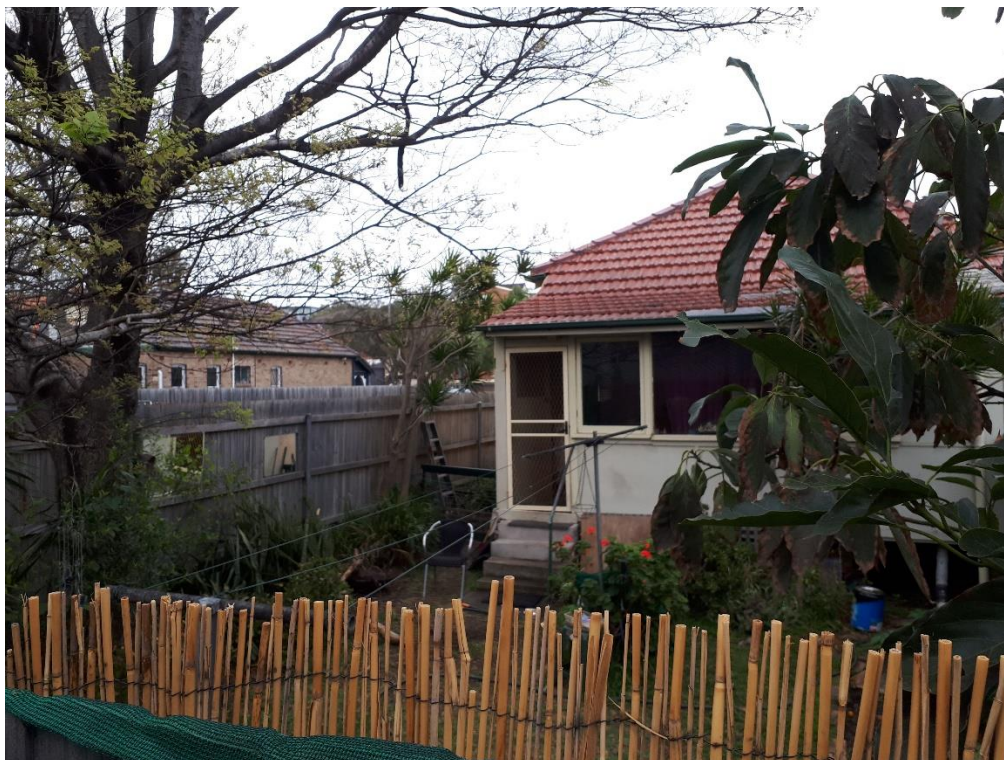
Photo 9

16 Doncaster Ave – rear yard of property

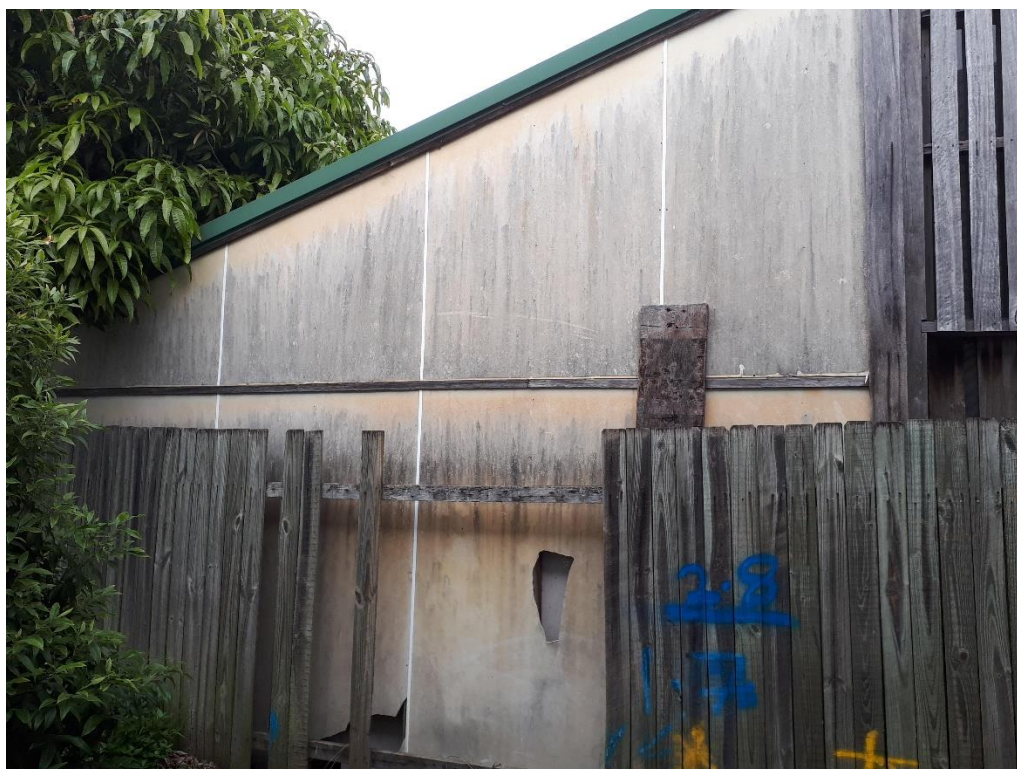
Photo 10

12 Doncaster Ave – fibre-cement shed at rear of property

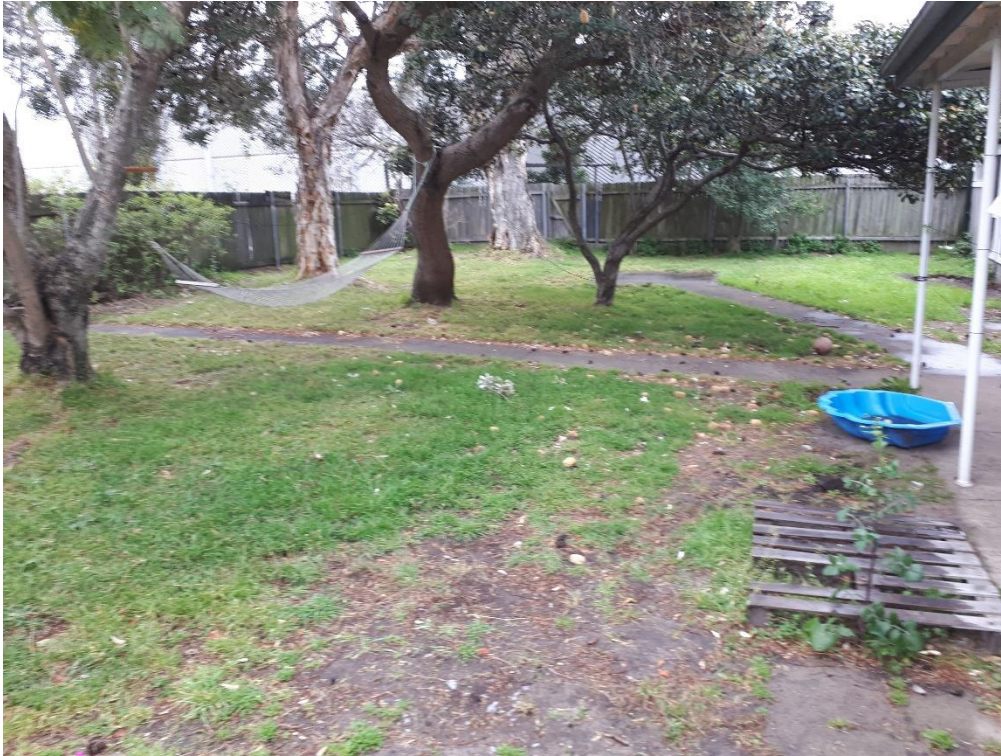
Photo 11

10 Doncaster Ave – rear yard of property

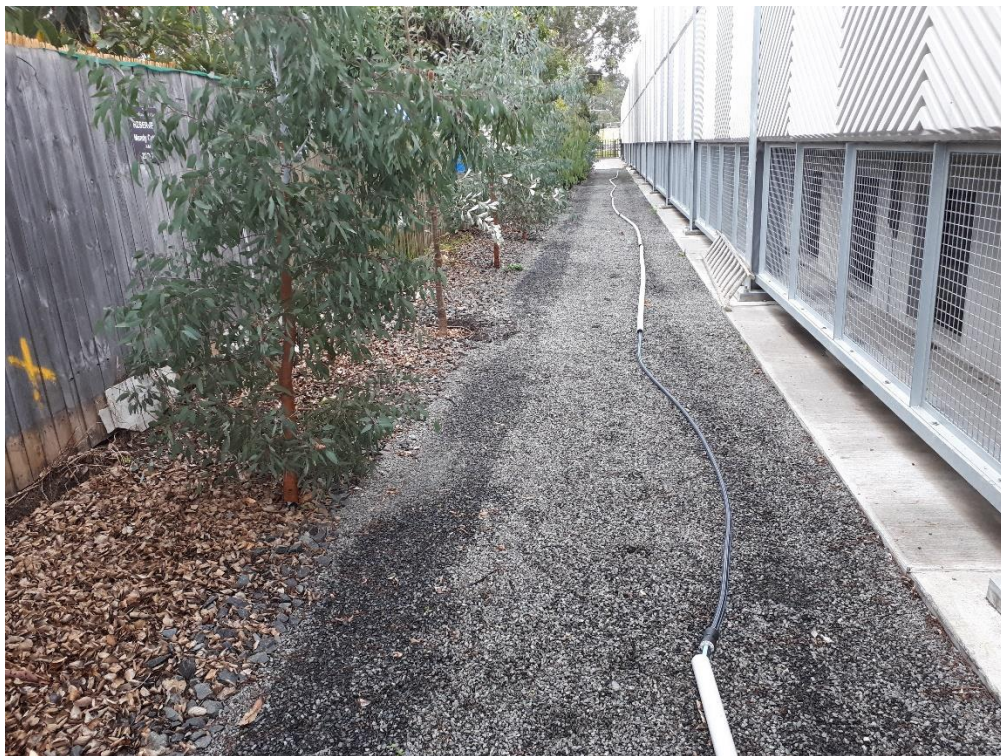
Photo 12

Easement at rear of site. Part of new light rail staging yard.
