**FOUNDATION
EARTH
SCIENCES**

Hazardous Materials Assessment

19-23 Rosalind Street, Cammeray NSW

November 2025

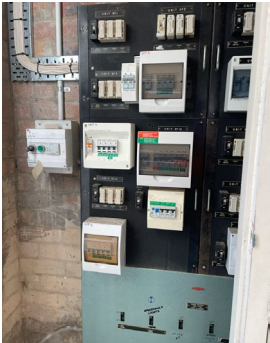
Photo 1

Sample	Location	Surface	Material/ Condition	Result	Priority	Friable/ Non-Friable	Accessibility	Comment	Approx. Qty
NS1	19-23 Rosalind Street, Cammeray NSW	Switch board backing. Auxiliary power boards.	Bituminous panels. Good Condition	All bituminous panels are assumed to contain asbestos.	Medium	Non-Friable	Not accessible	Sample analysis to be undertaken prior to any works commencing in this location	1
NS2	19-23 Rosalind Street, Cammeray NSW	Hot water / AC systems & piping	Insulation. Unknown	Material assessed and SMF expected present within system	Low	N/A	Not accessible without equipment.	Removal under controlled conditions prior to renovation or demolition works	2
NS3	Front Facia Cladding – 19-23 Rosalind Street	External corrugated cladding	Fibrous cement sheeting. Good condition	Material assessed and ACM expected present.	Medium	Non-Friable	Accessible	Removal under controlled conditions prior to renovation or demolition works Destructive sampling is recommended once building is vacant.	Unknown

NS1: Switch board backing.
Auxiliary power boards.

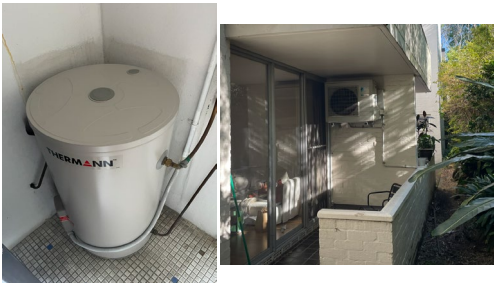
Photo 2

NS2: Hot water / AC systems & piping

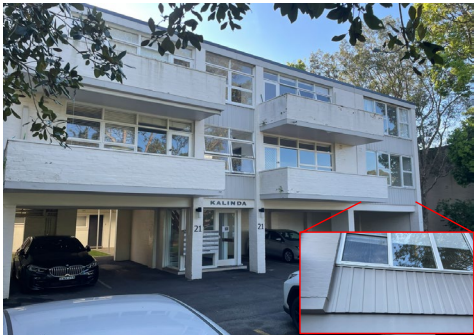
Photo 3

NS3: Front Facia Cladding – All buildings
19-23 Rosalind Street Exterior

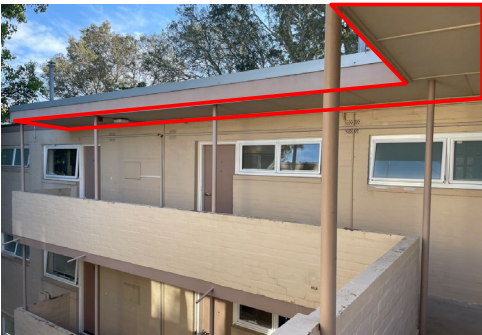
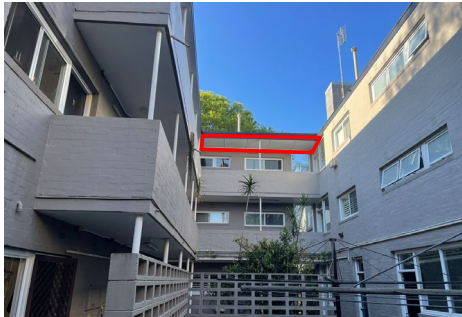
NS4	Top floor awnings – 19-23 Rosalind Street	Panels	Fibrous cement sheeting. Good condition	Material assessed and ACM expected present.	Medium	Non-Friable	Accessible	Removal under controlled conditions prior to renovation or demolition works Destructive sampling is recommended once building is vacant.	Unknown
NS5	Side panels exterior -19-23 Rosalind Street	Corrugated side panels	Fibrous cement sheeting. Good condition	Material assessed and ACM expected present.	Medium	Non-Friable	Accessible	Removal under controlled conditions prior to renovation or demolition works Destructive sampling is recommended once building is vacant.	Unknown

NS4: Top floor awnings – All buildings
19-23 Rosalind Street Panels

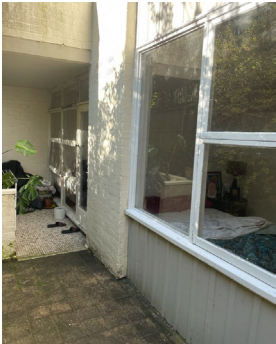
Photo 6

NS5: Side panels exterior -19-23 Rosalind Street.
Trim / side panels
