**Arboricultural Impact Assessment  
Young High School - Main Works 2019 V1**

**1. Introduction.**

This report covers part 2 - Young High Main Works which includes;

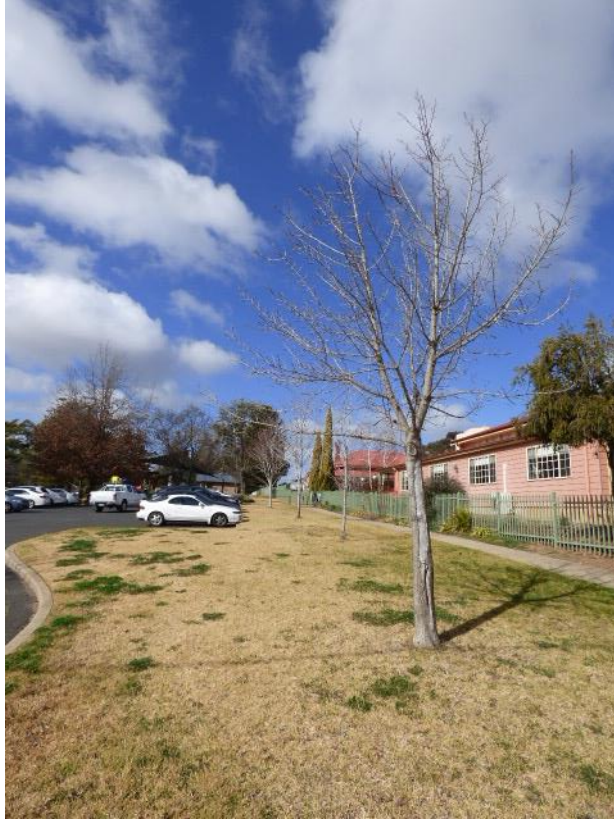
| <b>Table 1 – Trees recommended for removal.</b> | | | |
|---|---|---|---|
| 7 | Canadian Maple - Possibly Acer rubrum | Removal | Modification of car park required - small tree easily replaced in 5 years.<br>Tree in poor condition - will not mature into quality amenity tree |

**Photo 1 – Tree 7 –**  
*Marked for removal -  
Small young tree  
with extensive stem  
damage. Unlikely to  
develop into a quality  
amenity tree.*

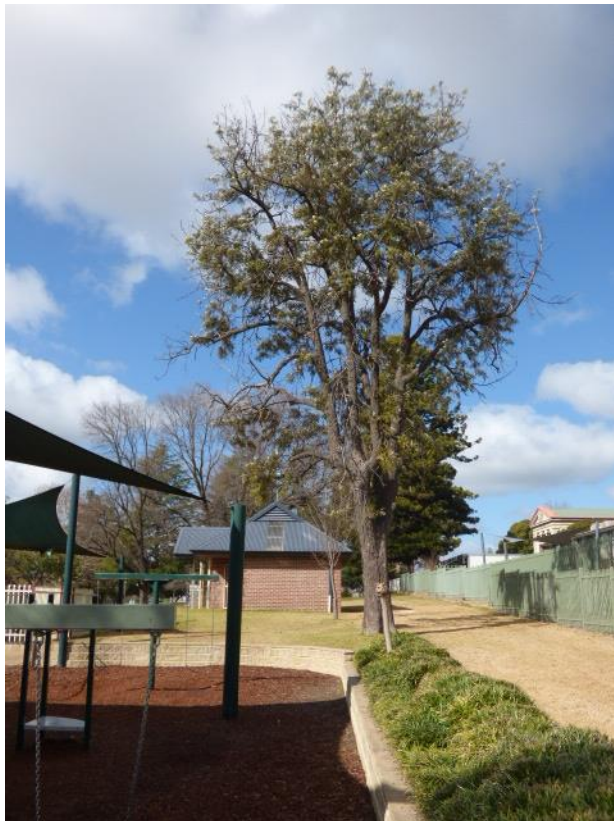
| <b>Table 1 – Trees recommended for removal.</b> | | | |
|---|---|---|---|
| 12 | Grevillea robusta<br>Silky Oak | Removal | Construction of new pathway very close to tree. Tree in poor condition from previous construction impacts. Poor life expectancy - tree in decline |

**Photo 2 – Tree 12**  
*– Marked for removal  
to accommodate new  
pathway. Tree of  
some age, however it  
is in decline due to  
extensive  
development –  
construction of  
retaining wall has  
removed large  
portion of root  
system.*

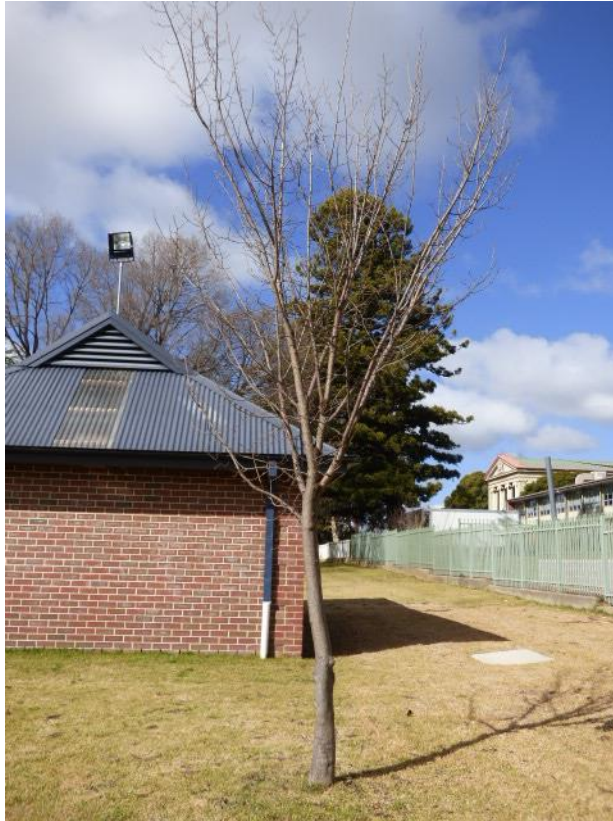
| <b>Table 1 – Trees recommended for removal.</b> | | | |
|---|---|---|---|
| 13 | Ulmus glabra<br>lutescens<br>Golden Elm | Removal | Construction of new pathway very close to tree. Small tree in only fair condition - Pest infestation - Elm Leaf Beetle - poor retention values. Easily replaced in 3 years |

**Photo 3 – Tree 13**  
– *Small Ulmus glabra lutescens*  
Golden Elm - Marked for removal for new pathway – species does not perform well in lower rainfall, and prone to elm leaf beetle and borers.

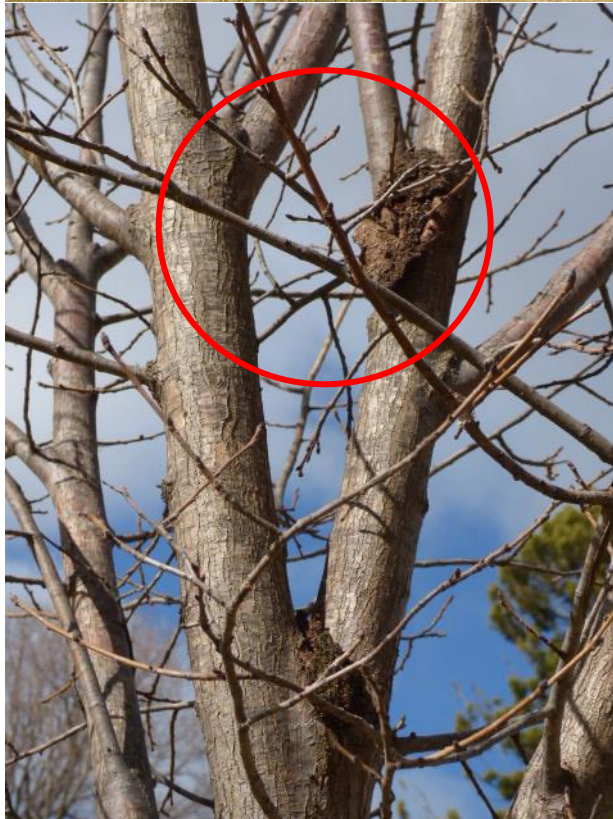
**Photo 4 – Tree 13**  
– Borer infestation circled. Typically will spread through the tree over time and tree will decline.

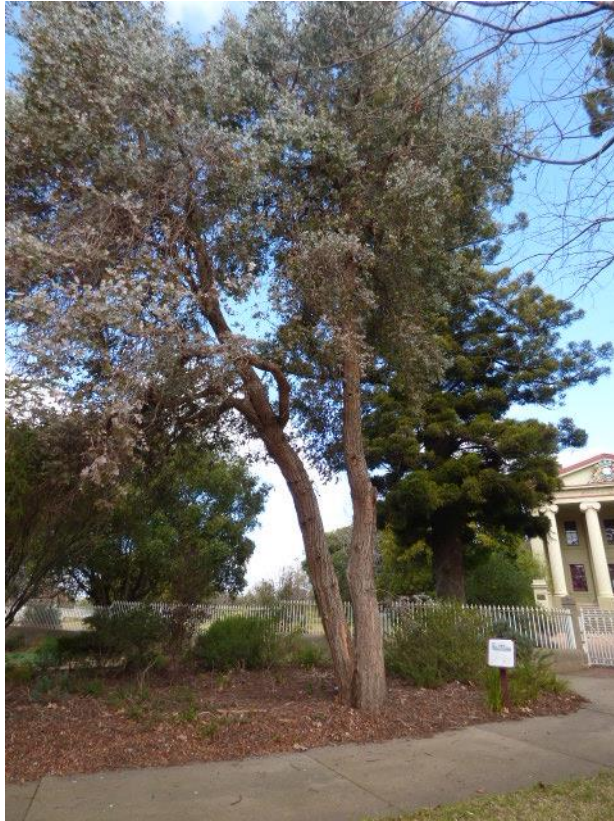
| Table 1 – Trees recommended for removal. | | | |
|---|---|---|---|
| 30 | Eucalyptus cinerea<br>- Argyle Apple | Removal | Identified by Heritage consultant as intrusive planting. Tree also has significant structural fault in stem system - and will be located adjacent to new footpath |

**Photo 5 – Tree 30**  
– *Eucalyptus cinerea*  
– Argyle Apple –  
marked for removal.  
One of number of  
trees identified by  
Heritage Consultant  
as invasive palting.  
Tree also has noted  
stem defect, and  
pathway to be re-  
developed close to  
stem.

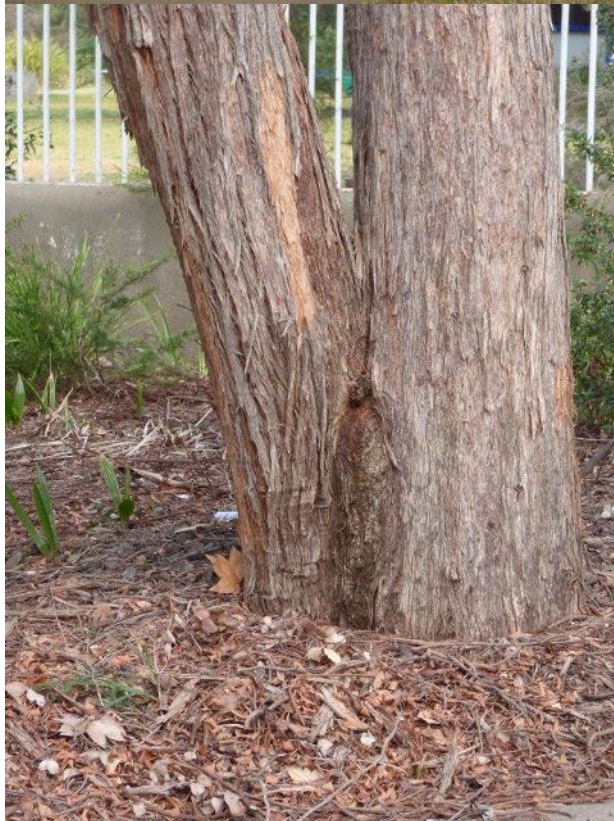
**Photo 6 – Tree 30**  
– close up of  
bifurcation in stem  
system – failure  
likely.

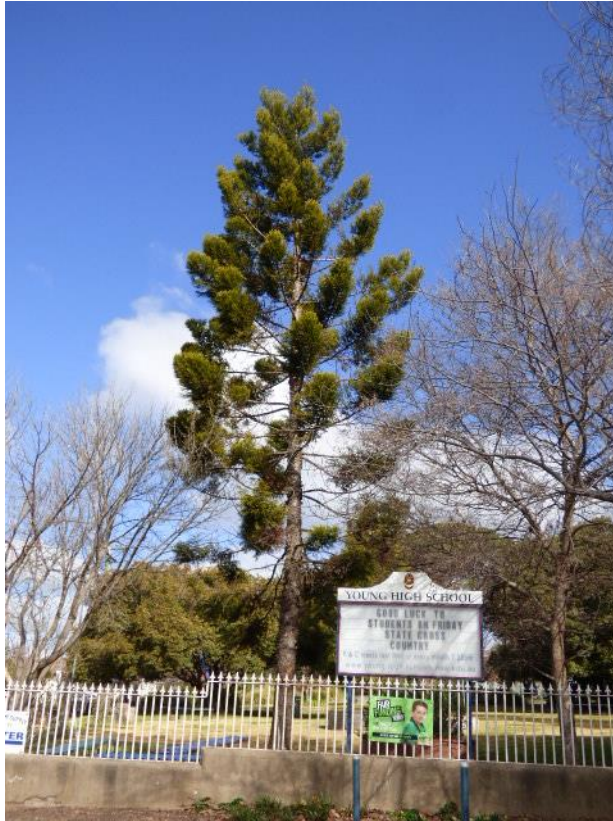
| Table 1 – Trees recommended for removal. | | | |
|---|---|---|---|
| 40 | Araucaria<br>cunninghamii<br>Hoop Pine | Removal | Identified by Heritage consultant as intrusive planting. |

**Photo 7 – Tree 40 -**  
*Araucaria cunninghamii*  
Hoop Pine – young tree - marked for removal a recent planting identified by Heritage consultant as intrusive planting – younger tree that was planted to replace original lost tree – but incorrect location

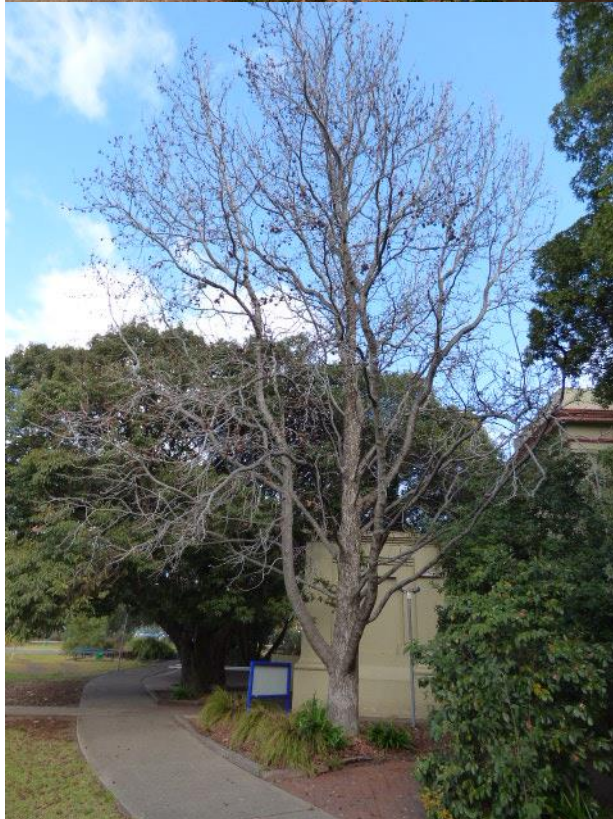
| Table 1 – Trees recommended for removal. | | | |
|---|---|---|---|
| 44 | Liquidambar styraciflua | Removal | Identified by Heritage consultant as intrusive planting. |

**Photo 8 – Tree 44 -**  
*Liquidambar styraciflua* – marked for removal - also identified by Heritage consultant as intrusive planting. (Note in Heritage report the tree is nominated as *Platanus acerfolia*.)

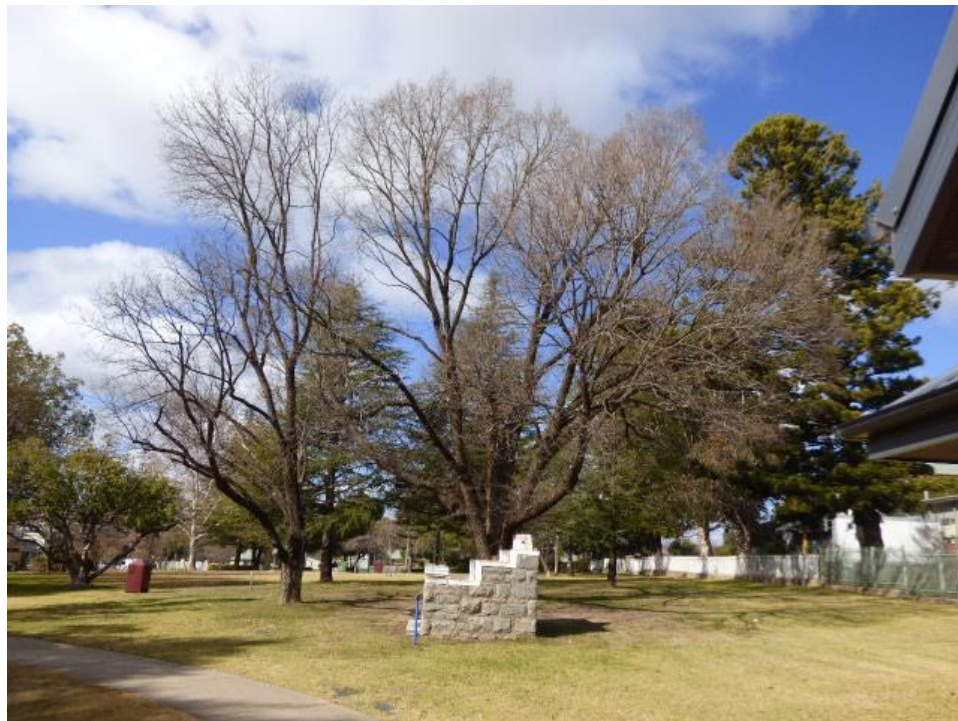
| <b>Table 2 – Summary of Significant Trees and potential Impacts</b> | | | |
|---|---|---|---|
| 15 | <i>Ulmus species</i> (procera)<br>English Elm | Significant Tree - Identified by Heritage Consultant | Works inside TPZ require consultation with project arborist -<br>Proposed Granit pavement should be acceptable - unless excavation is required. Prudent and important to maintain current soil levels |
| 16 | <i>Ulmus species</i> (procera)<br>English Elm | Significant Tree - Identified by Heritage Consultant | Works inside TPZ require consultation with project arborist -<br>Proposed Granit pavement should be acceptable - unless excavation is required. Prudent and important to maintain current soil levels |

**Photo 9 – Trees 15 and 16** *Ulmus species (procera)*  
English Elm – Noted by Heritage Consultant as significant, and larger tree potentially planted by Lord Carrington. Pathway is to be constructed inside the Tree Protection zone – this needs to be considered in relation to the root zone impacts on the trees.

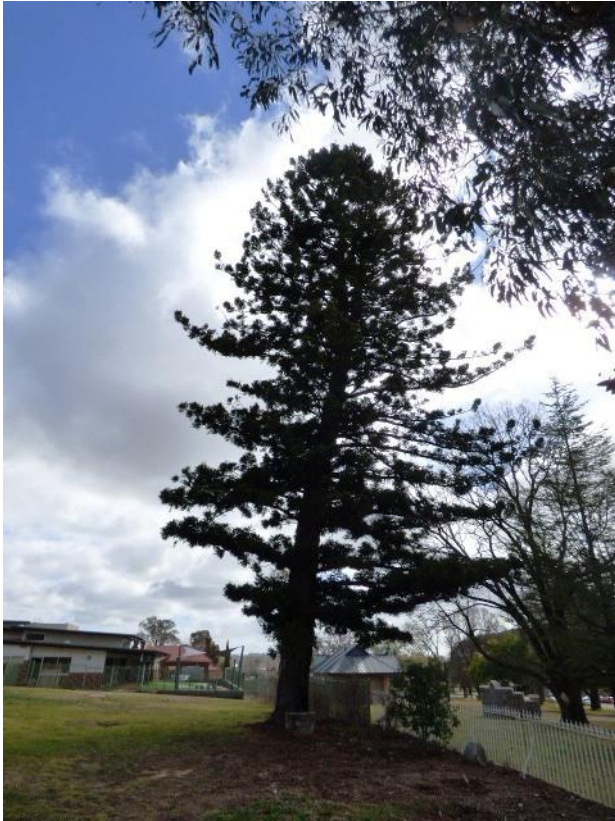
| <b>Table 2 – Summary of Significant Trees and potential Impacts</b> | | | |
|---|---|---|---|
| 33 | <i>Araucaria cunninghamii</i><br>Hoop Pine | Significant Tree - Identified by Heritage Consultant | Major encroachments planned into the TPZ for this tree - this will require careful planning as the tree is in fair condition only. Vigour looks to be declining slightly.<br>Works inside the TPZ for this tree require consultation with Project Arborist. New pathway should respect current soil levels in Carrington Park - excavation well inside TPZ would likely be detrimental - pathways potentially present 25-30% encroachment in addition to encroachments on south side. Consider maintaining current levels and elevating or constructing pathway over current level.<br>Works area also inside TPZ on south side - project arborist will need to be consulted before works commence - also for electrical supply for lighting and irrigation system. Tree will definitely require supplementary watering during development. |

**Photo 10 – Tree 33 –**  
*Araucaria cunninghamii* -  
Hoop Pine Significant tree  
with heritage values. Tree  
protection zone over 13  
meters – tree needs  
consideration for what work  
and how work is conducted.  
Specifically proposed  
footpath to north of tree and  
parallel to current fence.

- Specifically trees 33, 36 & 37 – large Hoop Pines – there is proposal to run lighting along the footpath that traverses the TPZ of all three trees near the structural root zones – **this cannot occur** as general trenching in a line parallel to the footpath. This would equate to TPZ encroachment of 30%, and severing of root systems that currently will extend well past the TPZ and well into Carrington Park.

- Either the electrical line needs to run outside the TPZ's and then come directly to the lights or under bore the whole line and pothole for light installation.
  - If solar power is feasible then consider this option for the individual lights so that no trenching occurs.
- Also Tree 24 and 42 – the electrical supply for lighting will need to be carefully considered as above.

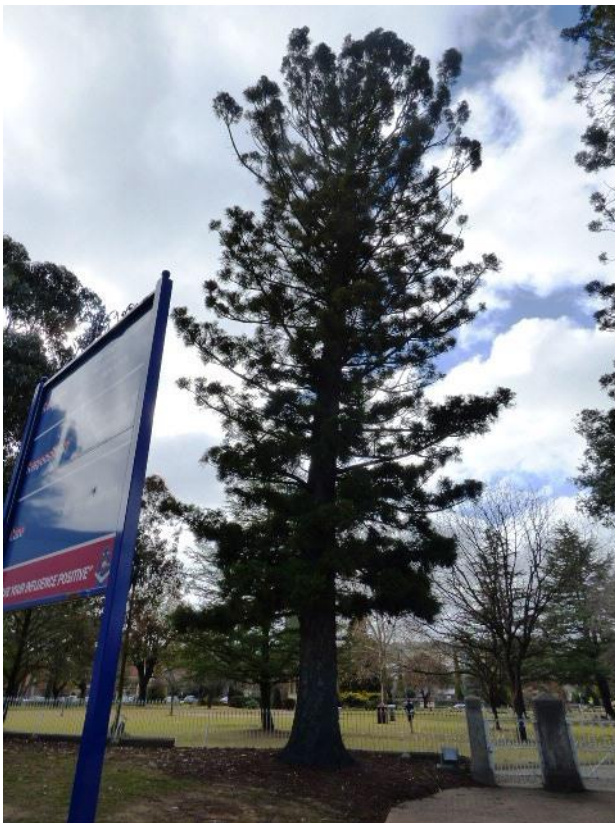
**Photo 11 – Tree 36** *Araucaria*  
*cunninghamii* - Hoop Pine.

| <b>Table 2 – Summary of Significant Trees and potential Impacts</b> | | | |
|---|---|---|---|
| 36 | <i>Araucaria cunninghamii</i><br>Hoop Pine | Significant Tree - Identified by Heritage Consultant | Works inside the TPZ for this tree require consultation with Project Arborist.<br>New pathway should respect current soil levels in Carrington Park - excavation well inside TPZ would likely be detrimental - pathways potentially represent 25-30% encroachment. |

| Table 2 – Summary of Significant Trees and potential Impacts | | | |
|---|---|---|---|
| | | | Works area also inside TPZ on south side - project arborist will need to be consulted before works commence - specifically for electrical supply or any other services. Tree will require supplementary watering during development. |

*Large and significant tree with  
heritage values. Tree protection  
zone 13 meters – tree needs  
consideration for what work and  
how work is conducted.  
Specifically proposed footpath to  
north of tree and parallel to  
current fence.*

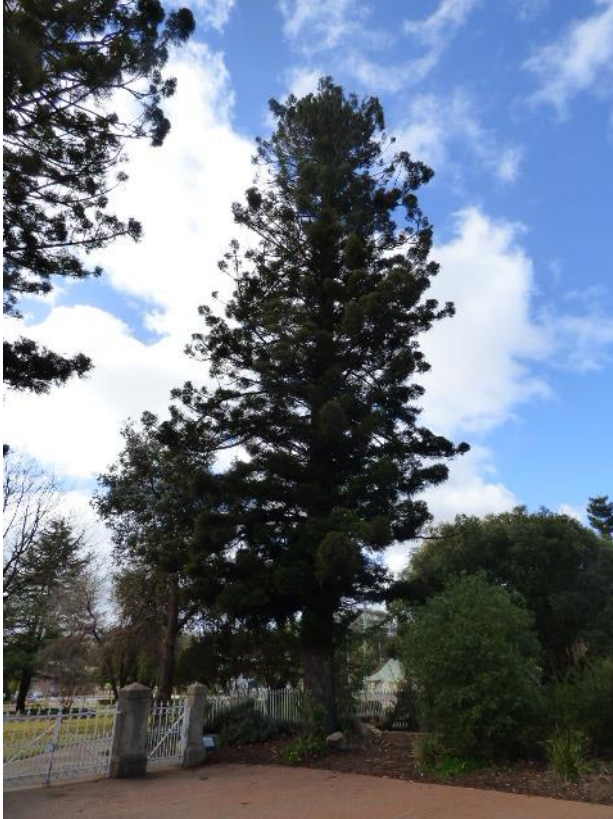
**Photo 12 – Tree 37** *Araucaria cunninghamii* - Hoop Pine.

| Table 2 – Summary of Significant Trees and potential Impacts | | | |
|---|---|---|---|
| 37 | <i>Araucaria cunninghamii</i><br>Hoop Pine | Significant Tree - Identified by Heritage Consultant | Works inside the TPZ for this tree require consultation with Project Arborist. New pathway should respect current soil levels in Carrington Park - excavation well inside TPZ would likely be detrimental - pathways potentially represent 25-30% encroachment. Works area also inside TPZ on south side - project arborist will need to be consulted before works commence - specifically for electrical supply or any other services. Tree will require supplementary watering during development. |

*Large and significant tree with heritage values. Tree protection zone 12 meters – tree needs consideration for what work and how work is conducted. Specifically proposed footpath to north of tree and parallel to current fence.*

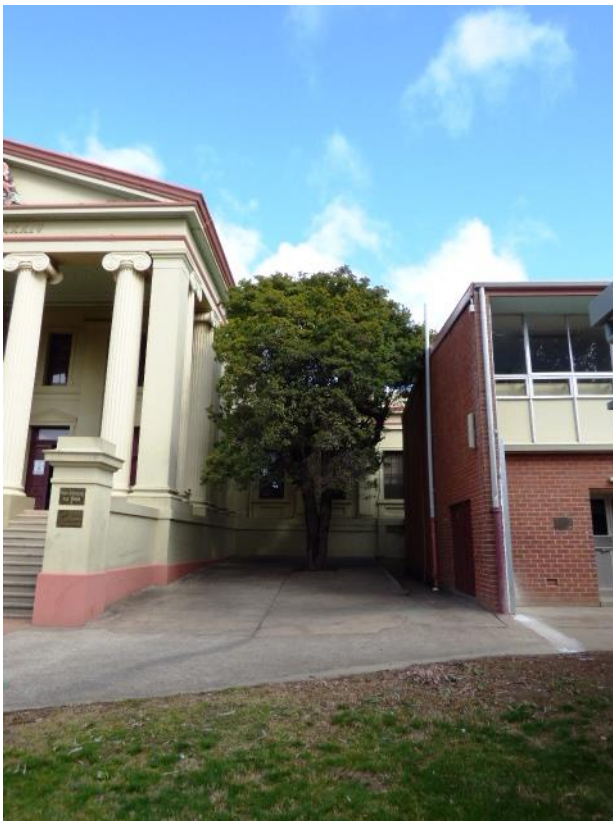
**Photo 13 – Tree 42** - *Arbutus unedo* - Irish Strawberry Tree.

| Table 2 – Summary of Significant Trees and potential Impacts | | | |
|---|---|---|---|
| 42 | <i>Arbutus unedo</i> - Irish Strawberry Tree | Significant Tree - Identified by Heritage Consultant | See also recommendations with regard to Early Works Package - Annexure 2. Works inside the TPZ for this tree require consultation with Project Arborist. Removal of current pavement needs to be conducted by hand work. Any excavation inside TPZ would likely be detrimental to root system. Electrical supply to lighting needs to be considered - no trenching across TPZ. Soil levels need to be maintained at current height. Tree will require supplementary watering during development. |

*Aged and Significant tree with heritage values.*

*Note that the root zone is covered with hard surface, and the tree protection zone theoretically extends into both buildings. Work around the tree will need to be planned – including how the concrete is removed and building BB to right.*

*Once the building BB to right is removed the canopy will be opened up to new and increased wind loadings.*

Tree 42 - Arbutus unedo - Irish Strawberry. Tree 42 is a Significant Tree – heritage values. Potentially the tree stands to gain from the development by an improved root zone, as the concrete coverage will be removed. The tree also needs careful management. Recommendations as below were also provided in Part one of the project – Early works package.

- Requirement for project arborist to meet with demolition organisation and plan demolition with regard to tree.

- Tree root system needs to be considered and viewed at point of demolition. Area around the tree needs to be preserved – root zone and canopy.
  - If bare roots are exposed when concrete is removed then they need to be covered by mulch until landscape construction is undertaken.
- Stem system needs to have bracing system installed to reduce the risk of it failing in a storm event. Tree currently receives full benefit of Block BB from wind loading, this will be removed – stem is in poor condition.
- The projected, or theoretical TPZ goes into the buildings that surround the tree – so effectively the tree root system is already confined in a smaller area than the TPZ. This means the root system that the tree currently has is critical to its ongoing vitality and viability. The current root system integrity must be maintained.

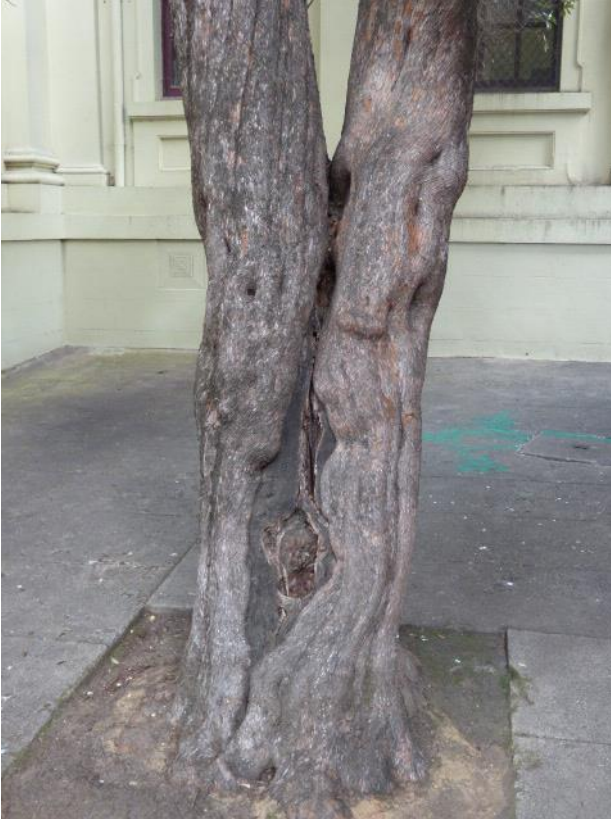
**Photo 14 – Tree 42** - *Arbutus unedo* - Irish Strawberry Tree.

*Close up of stem system – note bifurcation in stem with decay and necrotic zones. Once the building BB is removed the tree will be opened up to wind loading it has not been exposed to for many decades- stem failure is a real possibility of failure under wind loading. A bracing system is recommended to prolong the life of the heritage tree.*

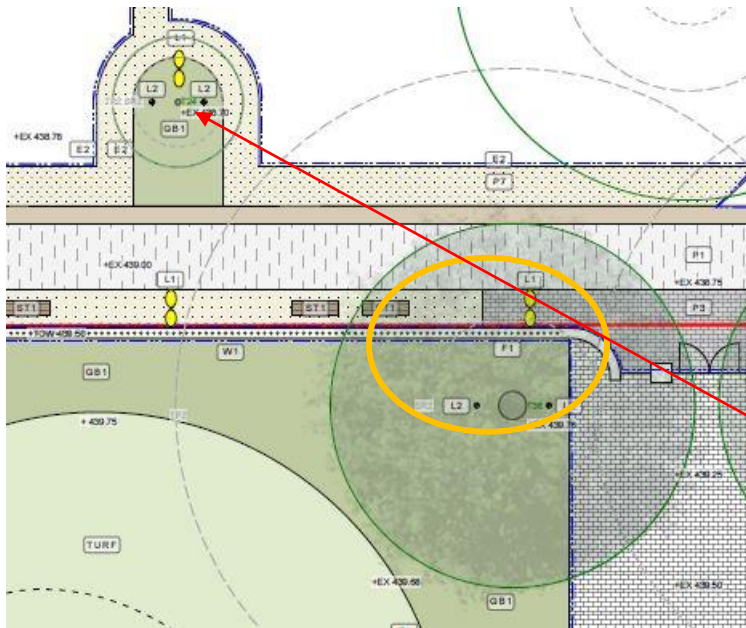
There is proposal for construction of concrete and granite pathways from the Olympic Highway west to the new Library entrance – under the canopy of trees 33, 36 and 37 to the edge of the structural root zone of the trees. The design needs to be such that excavation into the current soil does not occur. The pathway needs to be raised above the current soil level to prevent the severing of root systems. Excavation this close to the stems will not be an acceptable encroachment to the trees. Current root systems will extend well into Carrington Park and well past the TPZ.

Tree 24 – Reconciliation Tree could be effected in similar way.

**Diagram 3 – Extract from Landscape plans – pathway area constructions** to edge of structural root zones of trees 33, 36 & 37 – Orange circle depicts how close to the stem the potential impact could be relative to Tree 36 as example. The design needs to prevent excavation into current soil levels.  
Tree 24 – Reconciliation tree

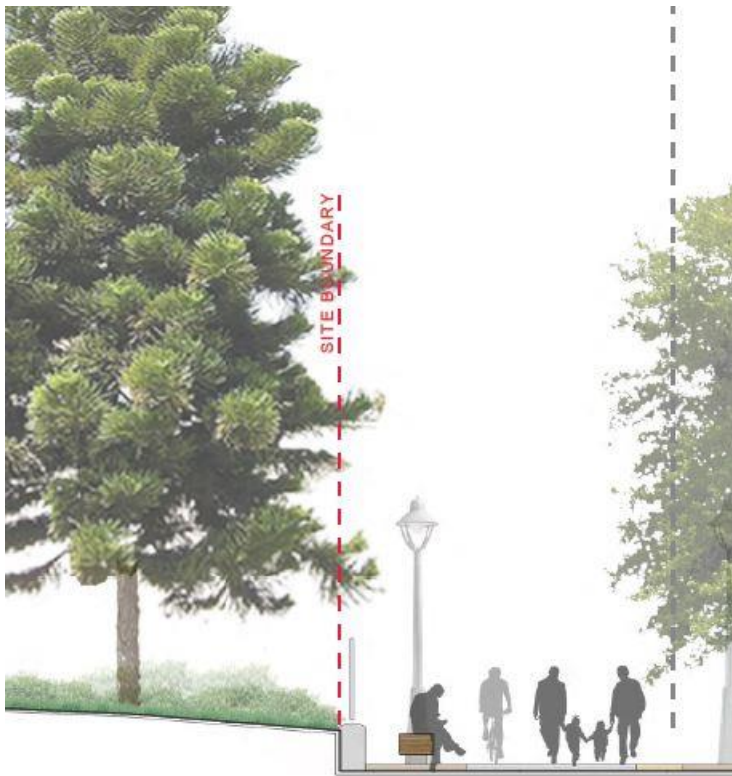
**Diagram 4 –  
Extract from  
Landscape**

Depiction of  
proposed pathway –  
red line of site  
boundary is the  
location of the  
structural root zone  
of trees 33, 36 & 37.

Design and  
construction is  
critical for tree.
