# Arboricultural Impact Assessment

Revision 4

Western Sydney University, Milperra Campus  
NSW, 2214  
2/-/DP129184 + 1/-/DP101147  
Job No. 2400116  
19/03/2026

**Temporal Tree Management Pty Ltd.**

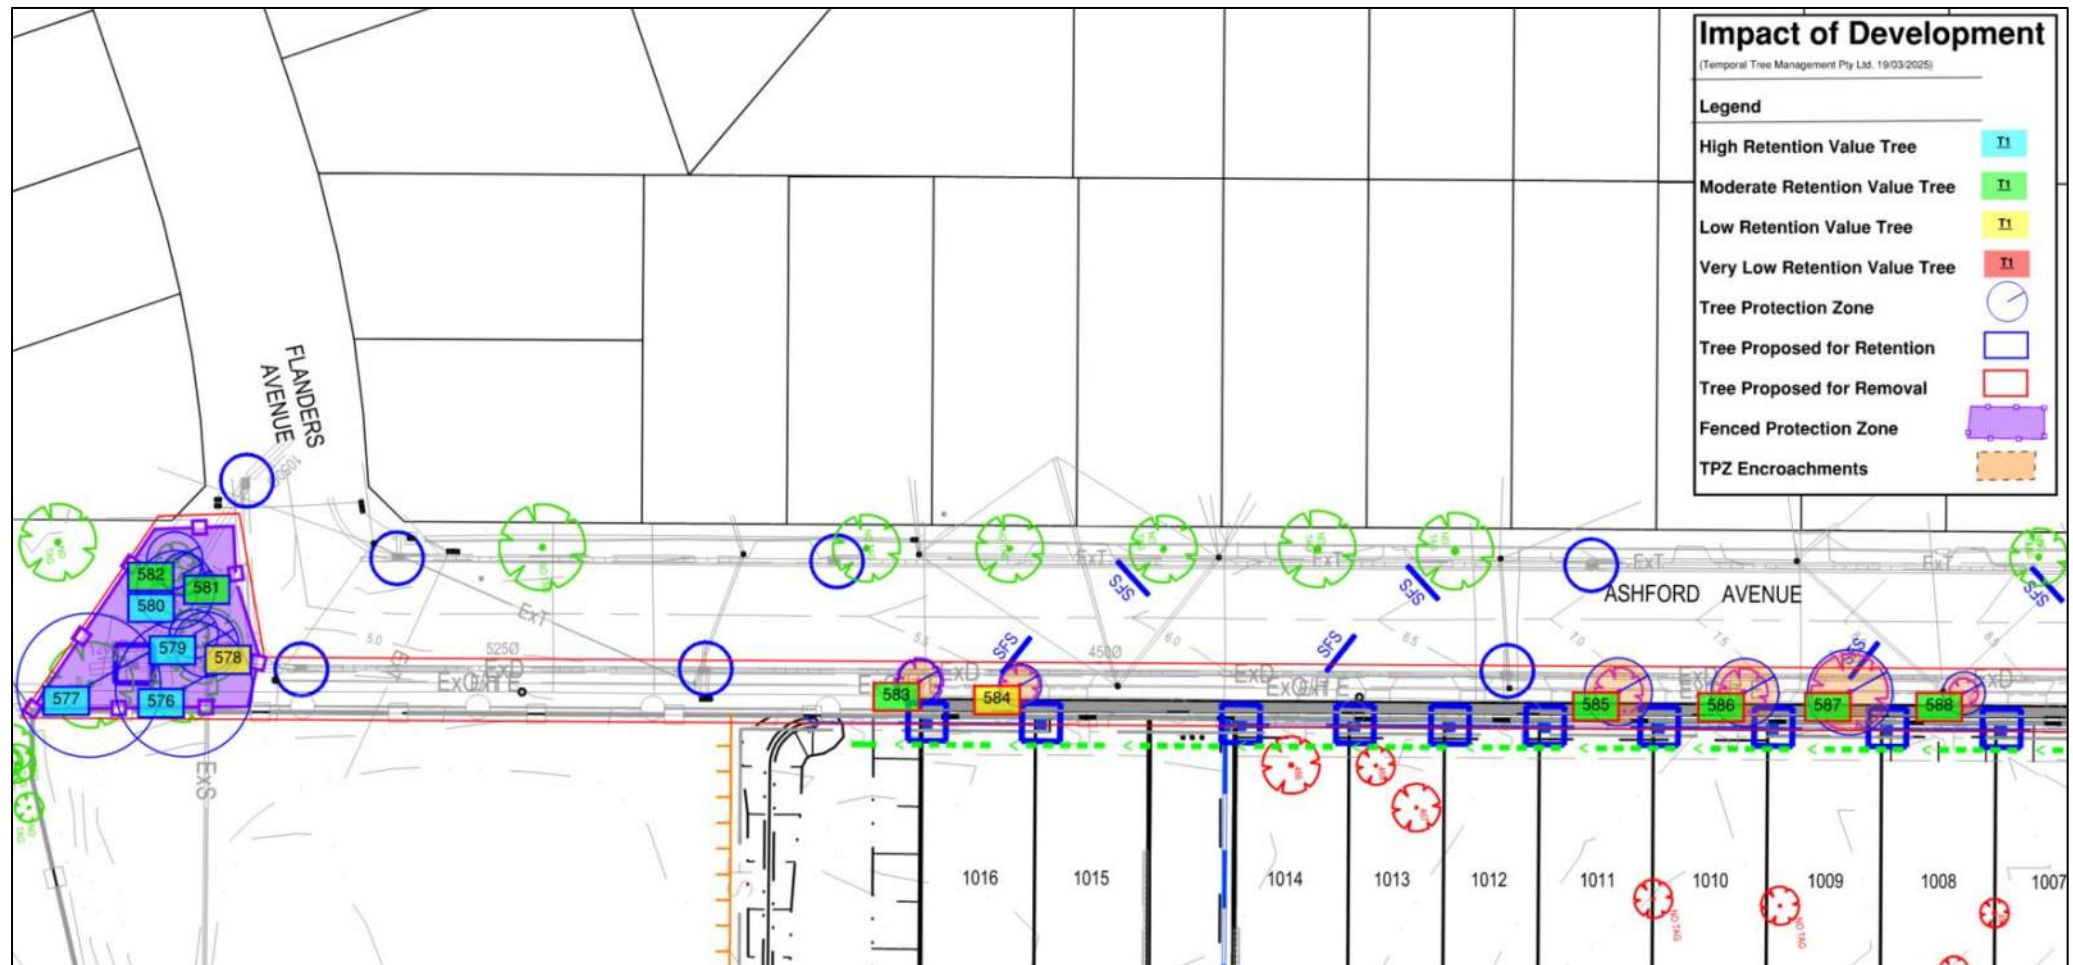
Figure 10. Encroachments and tree protection measures required for Trees 576-588 within southern – central portion of subject site. *Soil and Water Management Plan Overall*, prepared by *Beveridge Williams* (Project No: 2301879, Reference: 303, Revision: H, Drawing No: 401, drawn 19/03/2025). Annotated by Temporal Tree Management Pty Ltd. (19/03/2025). Annotated by Temporal Tree Management Pty Ltd. (20/03/2025).

- Replacement tree planting for Trees 583-596 must be undertaken in accordance with Section 7.1 of this report upon completion of practical works along the eastern Ashford Avenue verge.

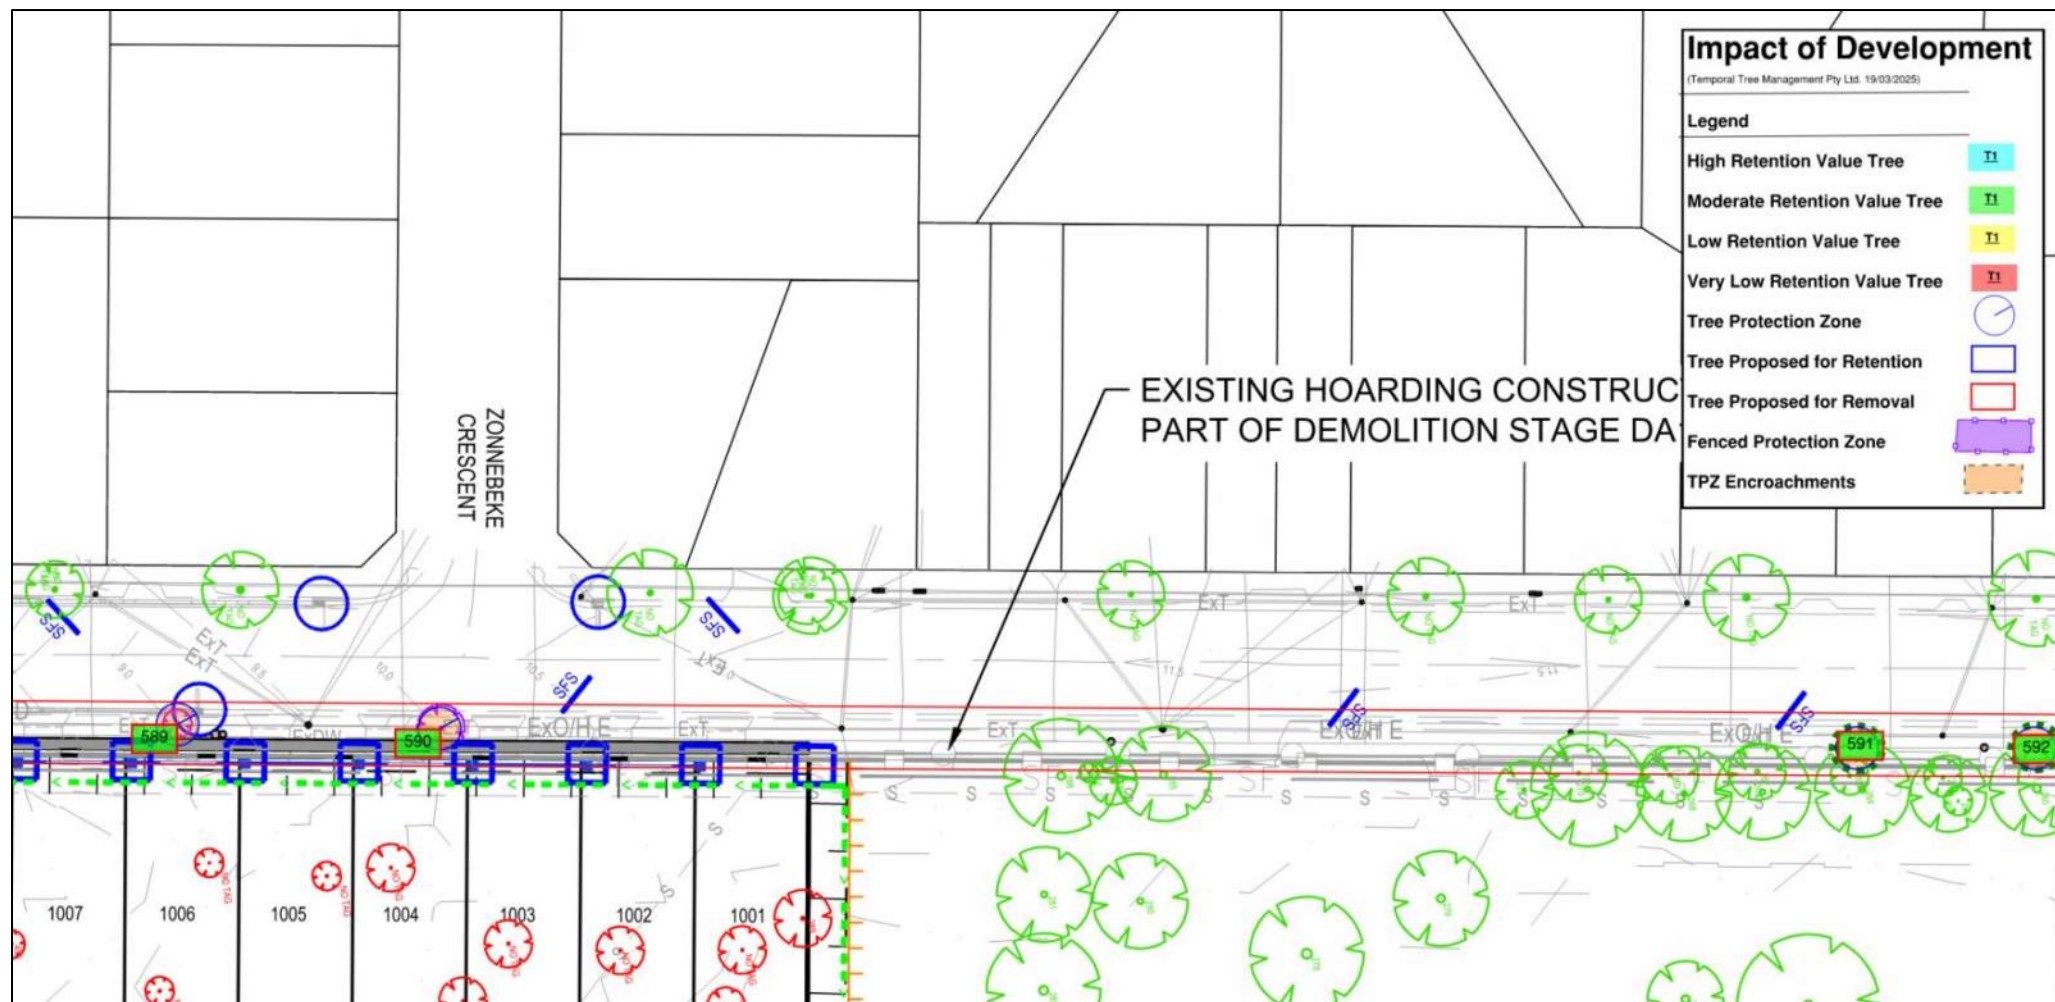
Figure 11. Encroachments and tree protection measures required for Trees 589-592 within central portion of subject site. *Soil and Water Management Plan Overall*, prepared by *Beveridge Williams* (Project No: 2301879, Reference: 303, Revision: H, Drawing No: 401, drawn 19/03/2025). Annotated by Temporal Tree Management Pty Ltd. (19/03/2025). Annotated by Temporal Tree Management Pty Ltd. (20/03/2025).

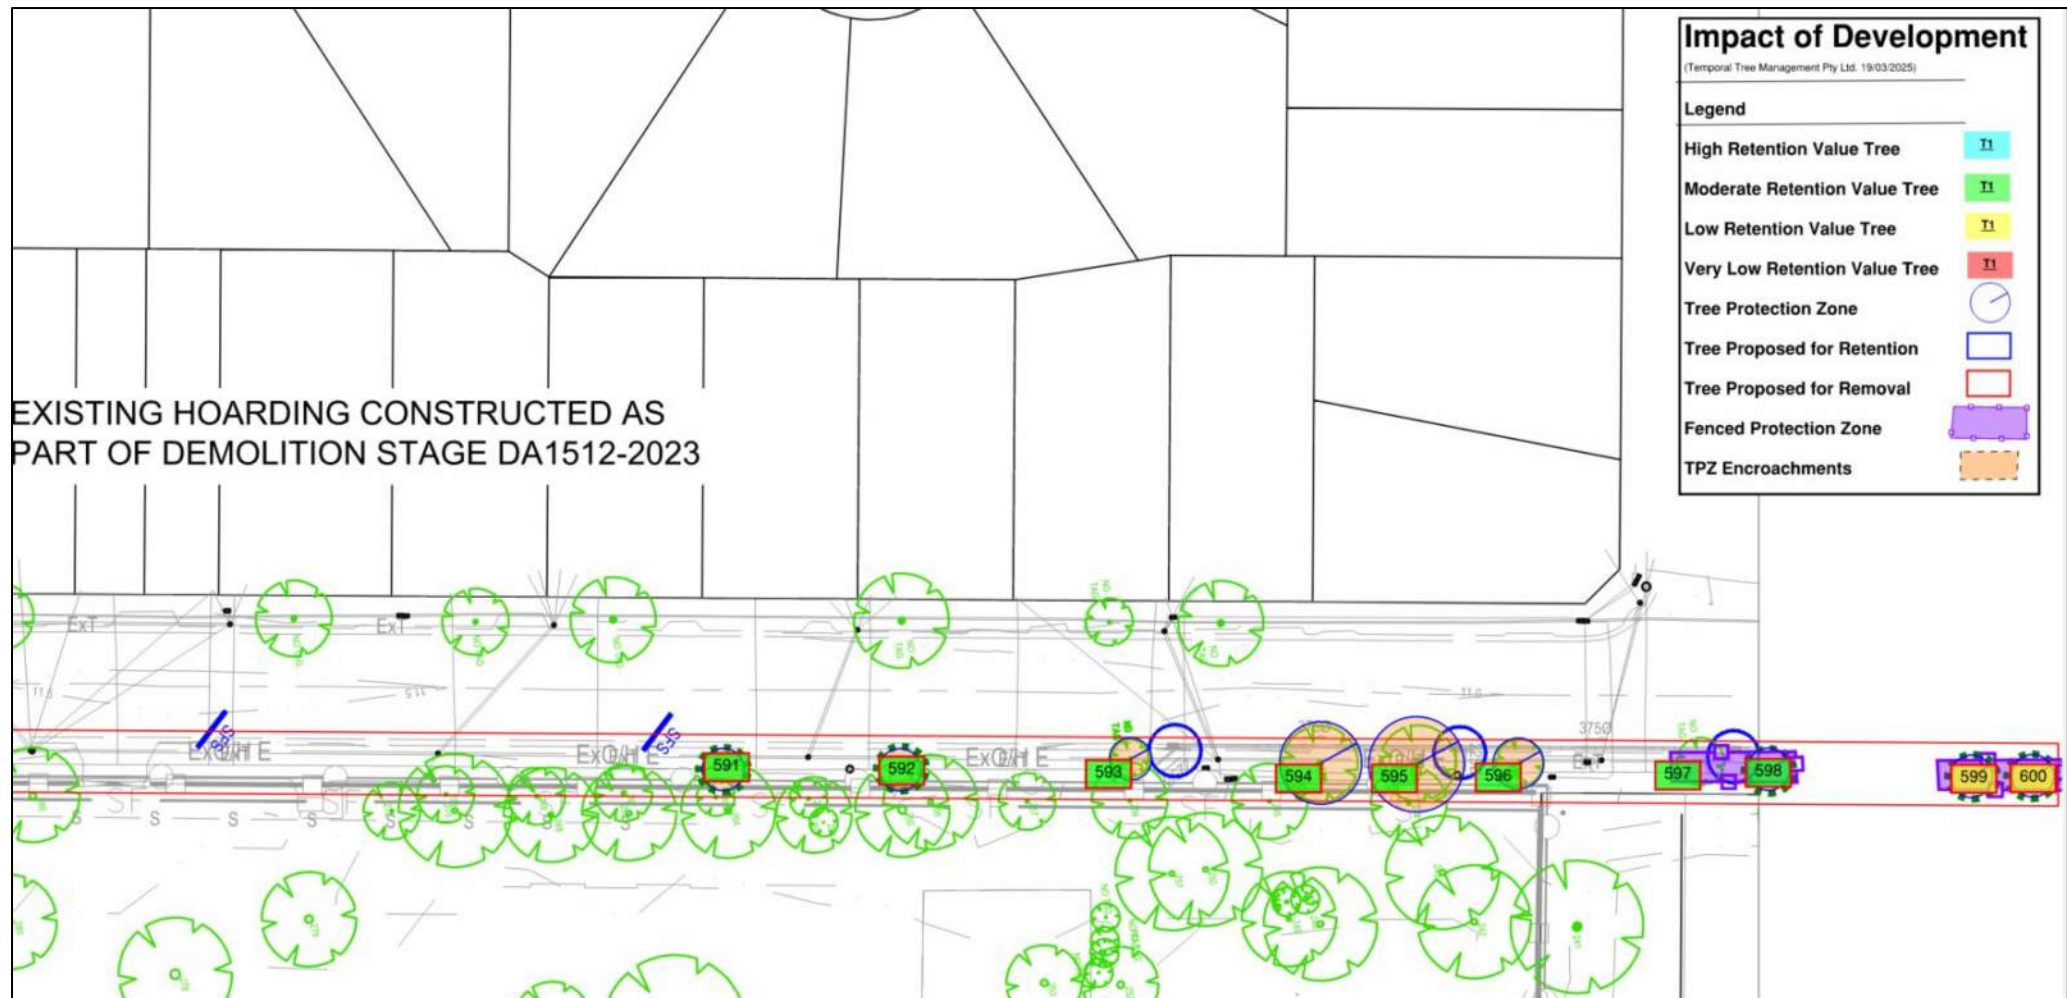
Figure 12. Encroachments and tree protection measures required for Trees 591-600 within northern portion of subject site. *Soil and Water Management Plan Overall*, prepared by *Beveridge Williams* (Project No: 2301879, Reference: 303, Revision: H, Drawing No: 401, drawn 19/03/2025). Annotated by Temporal Tree Management Pty Ltd. (19/03/2025). Annotated by Temporal Tree Management Pty Ltd. (20/03/2025).

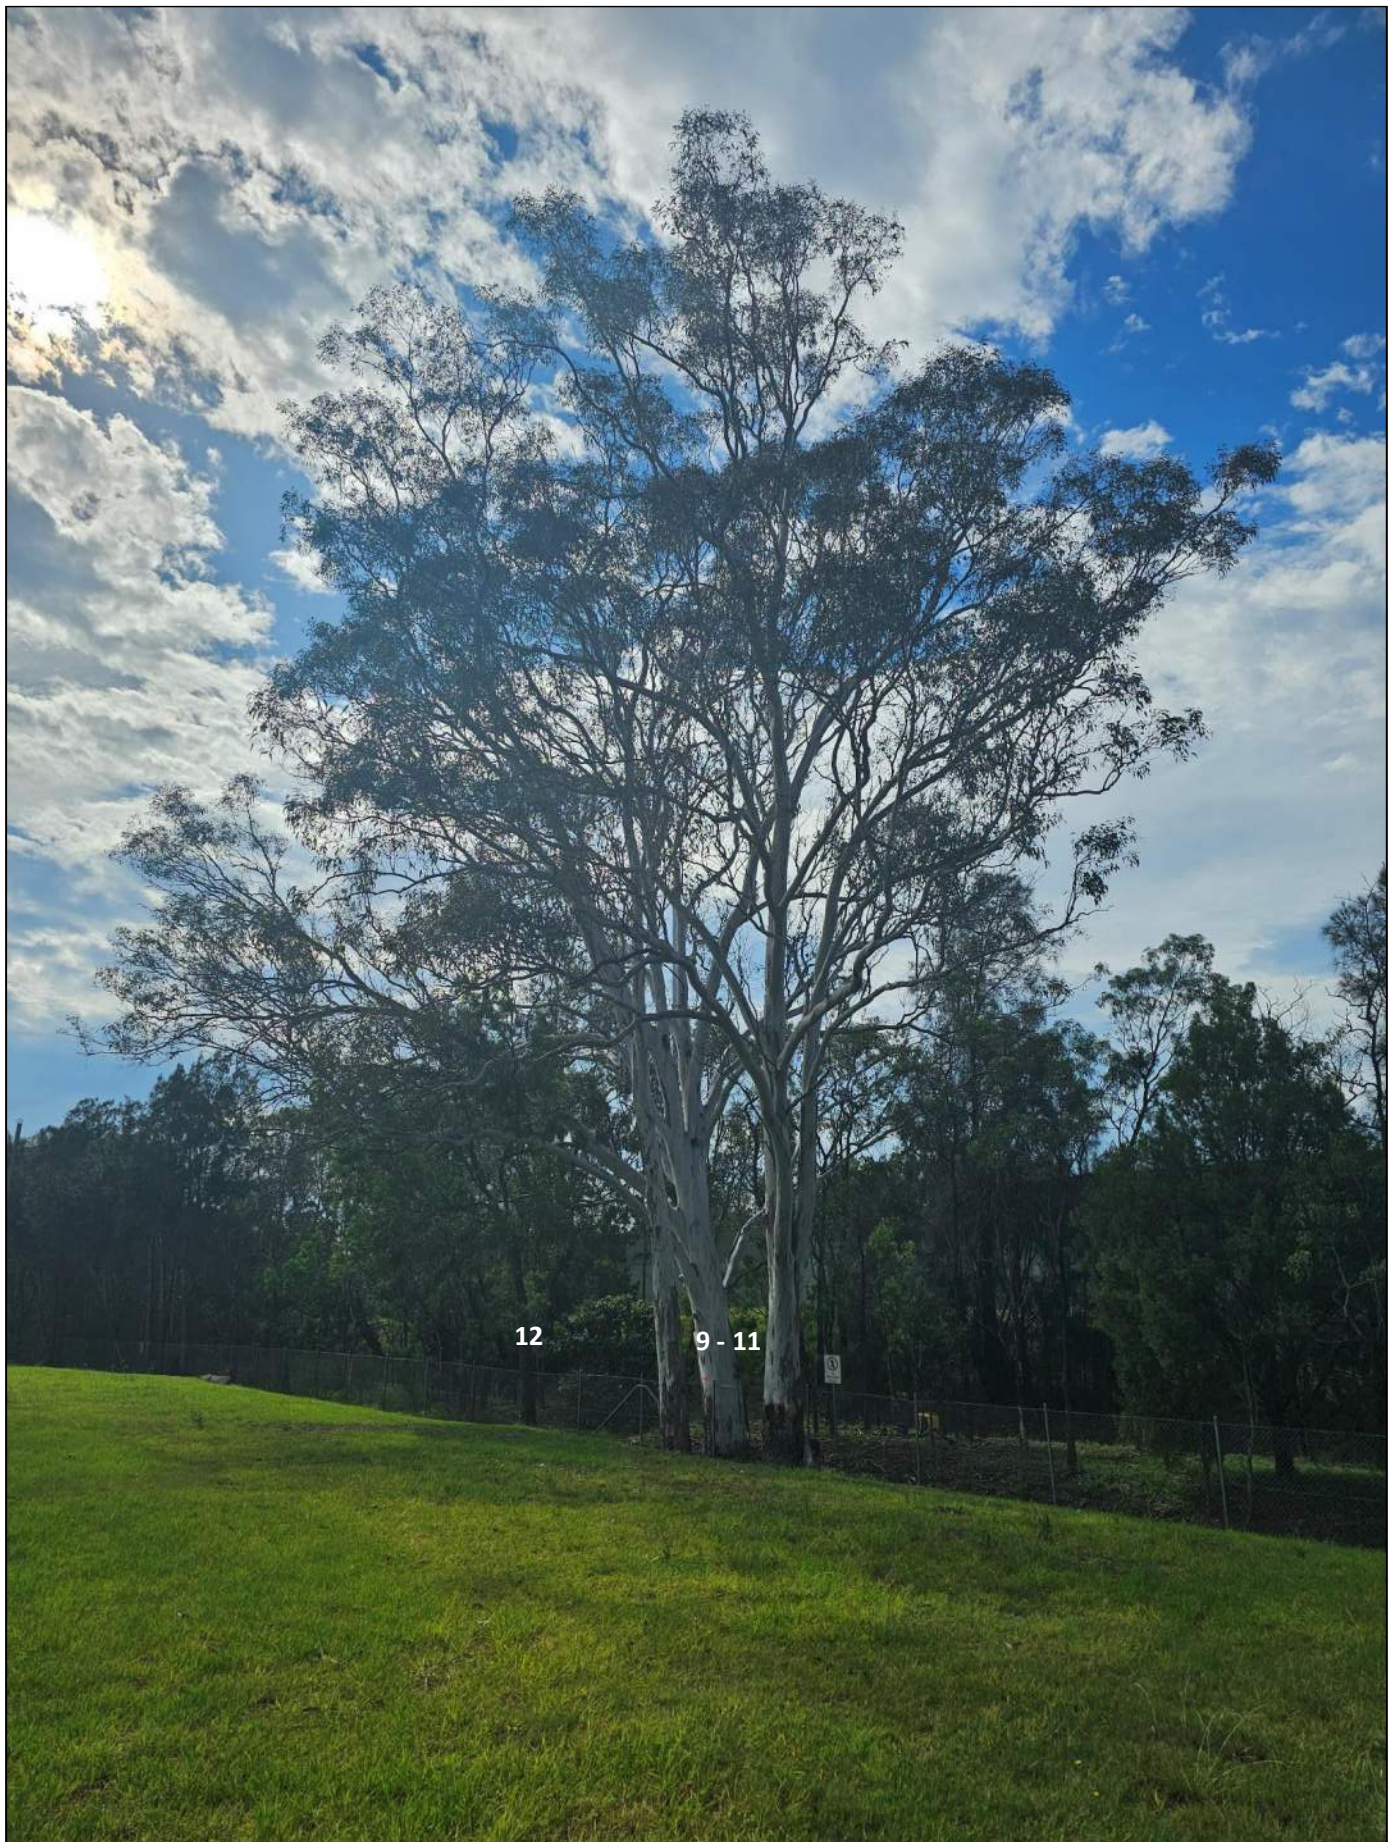
**Figure 4 Trees 9 -11 *Eucalyptus tereticornis* and 12 *Acacia implexa***

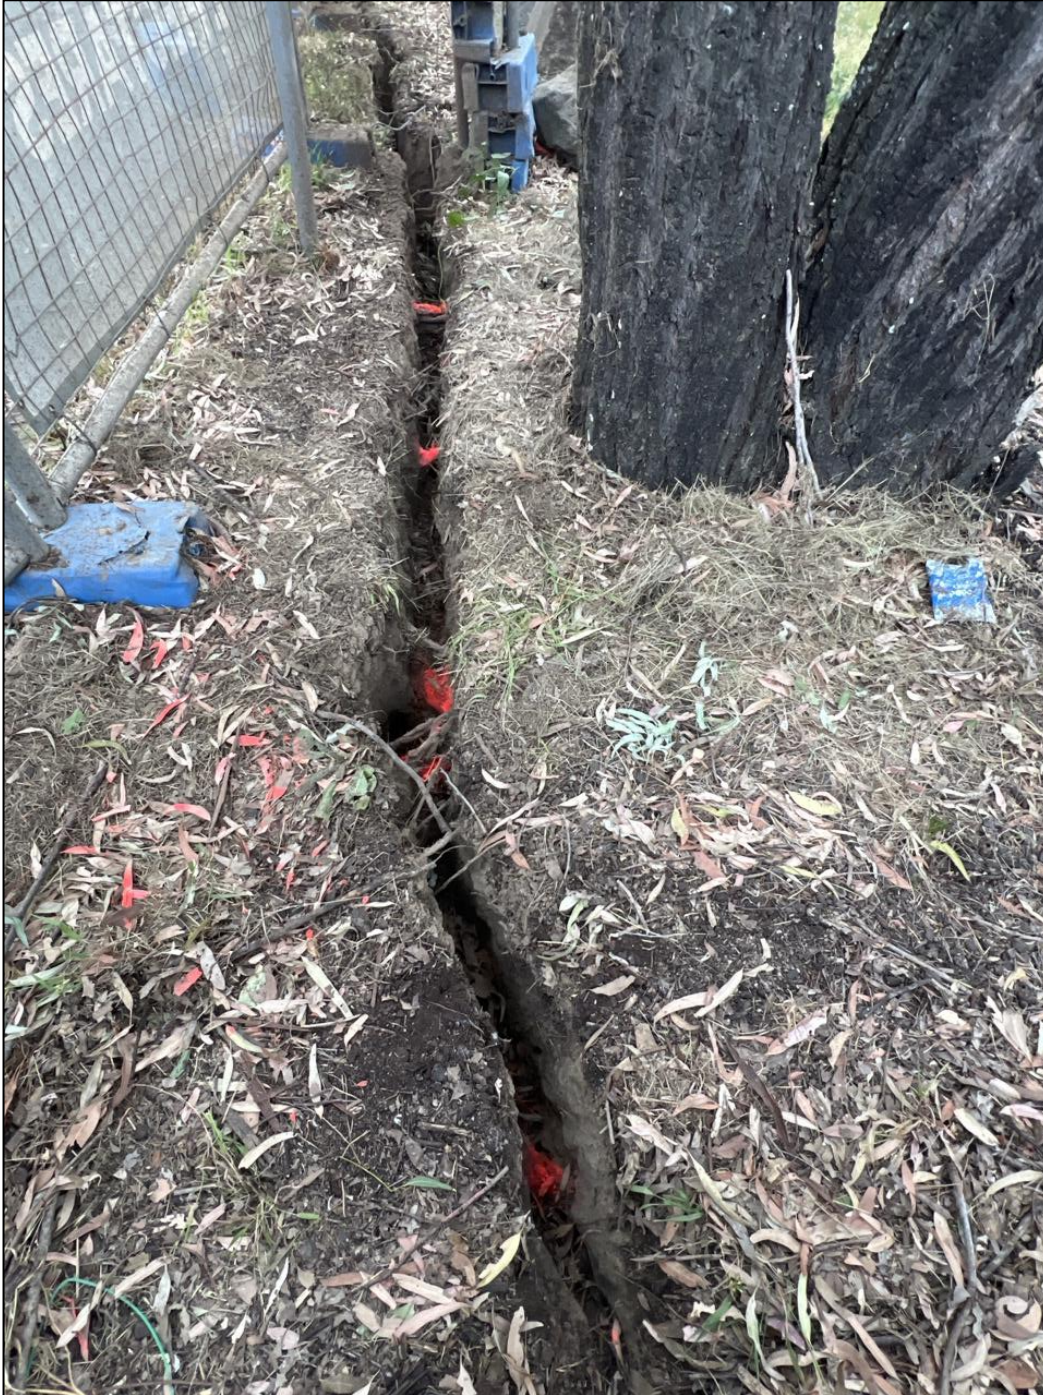
Figure 6. Survey Trench 1 with five Major roots encountered. Image taken from eastern edge of trench.

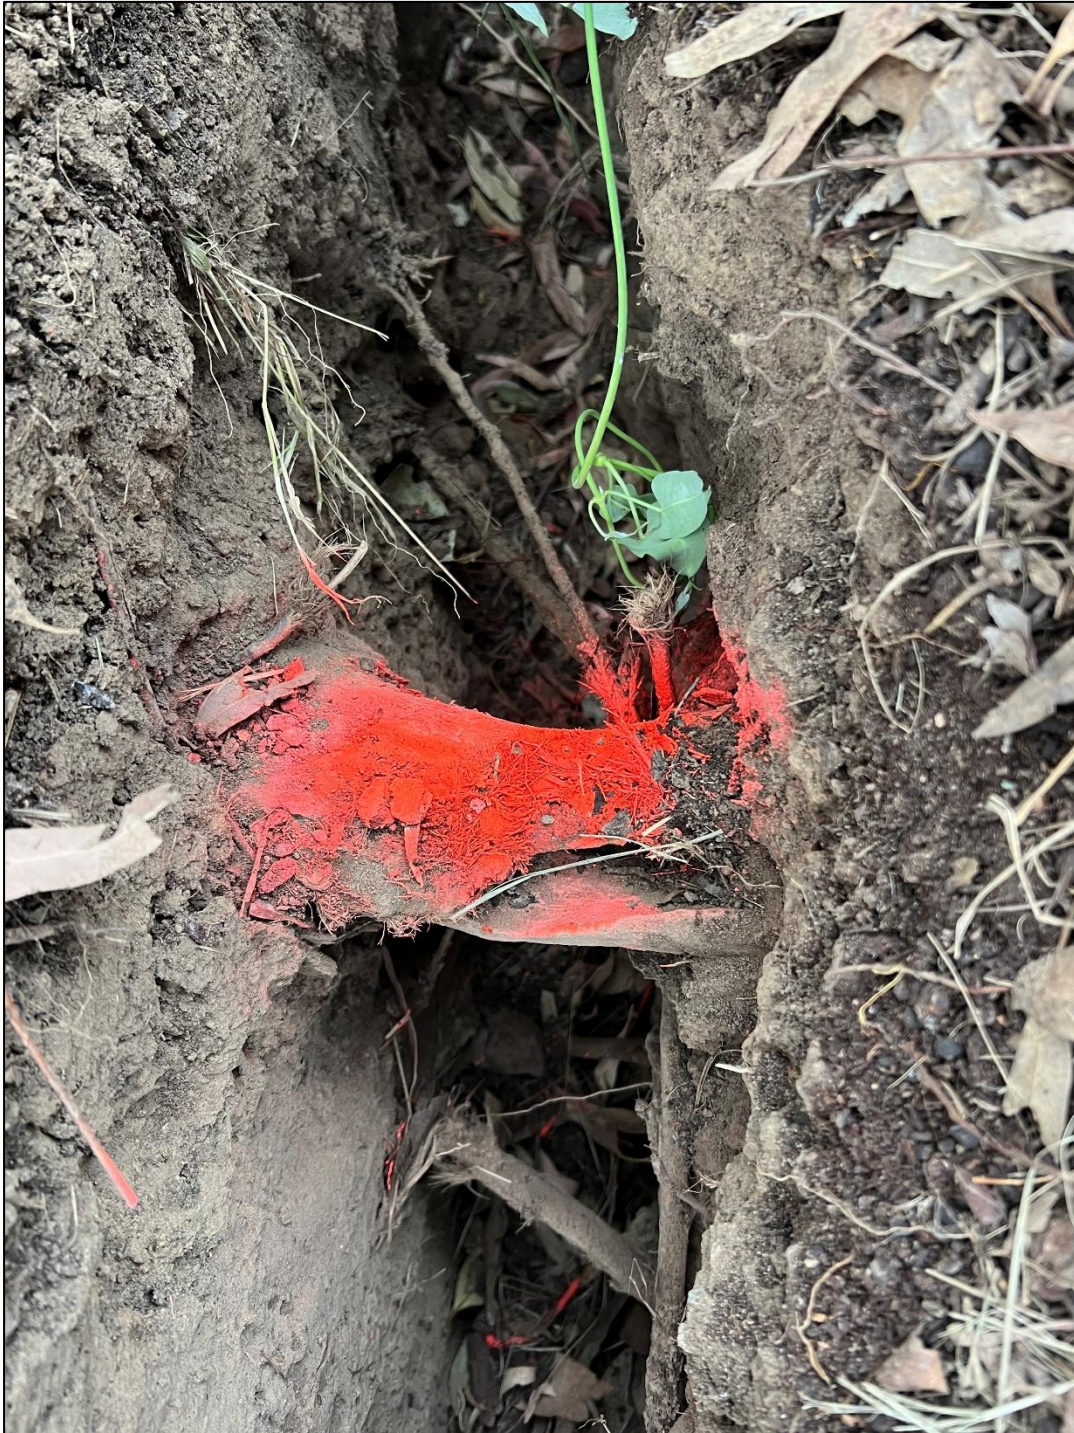
| Root | Distance from Eastern edge of trench (m) | Diameter of root (mm) | Depth of root [mm] | Comments |
|---|---|---|---|---|
| 5 | 5 | 70 | 180 | Major root crossing trench laterally. Originates from Tree 1. Root with tissue necrosis and decay on top side and within central portion of root, suggesting reduced function or root death. Root considered suitable for pruning. |

Figure 9. Root 5 with decay and delamination, suggesting dysfunction or root death.

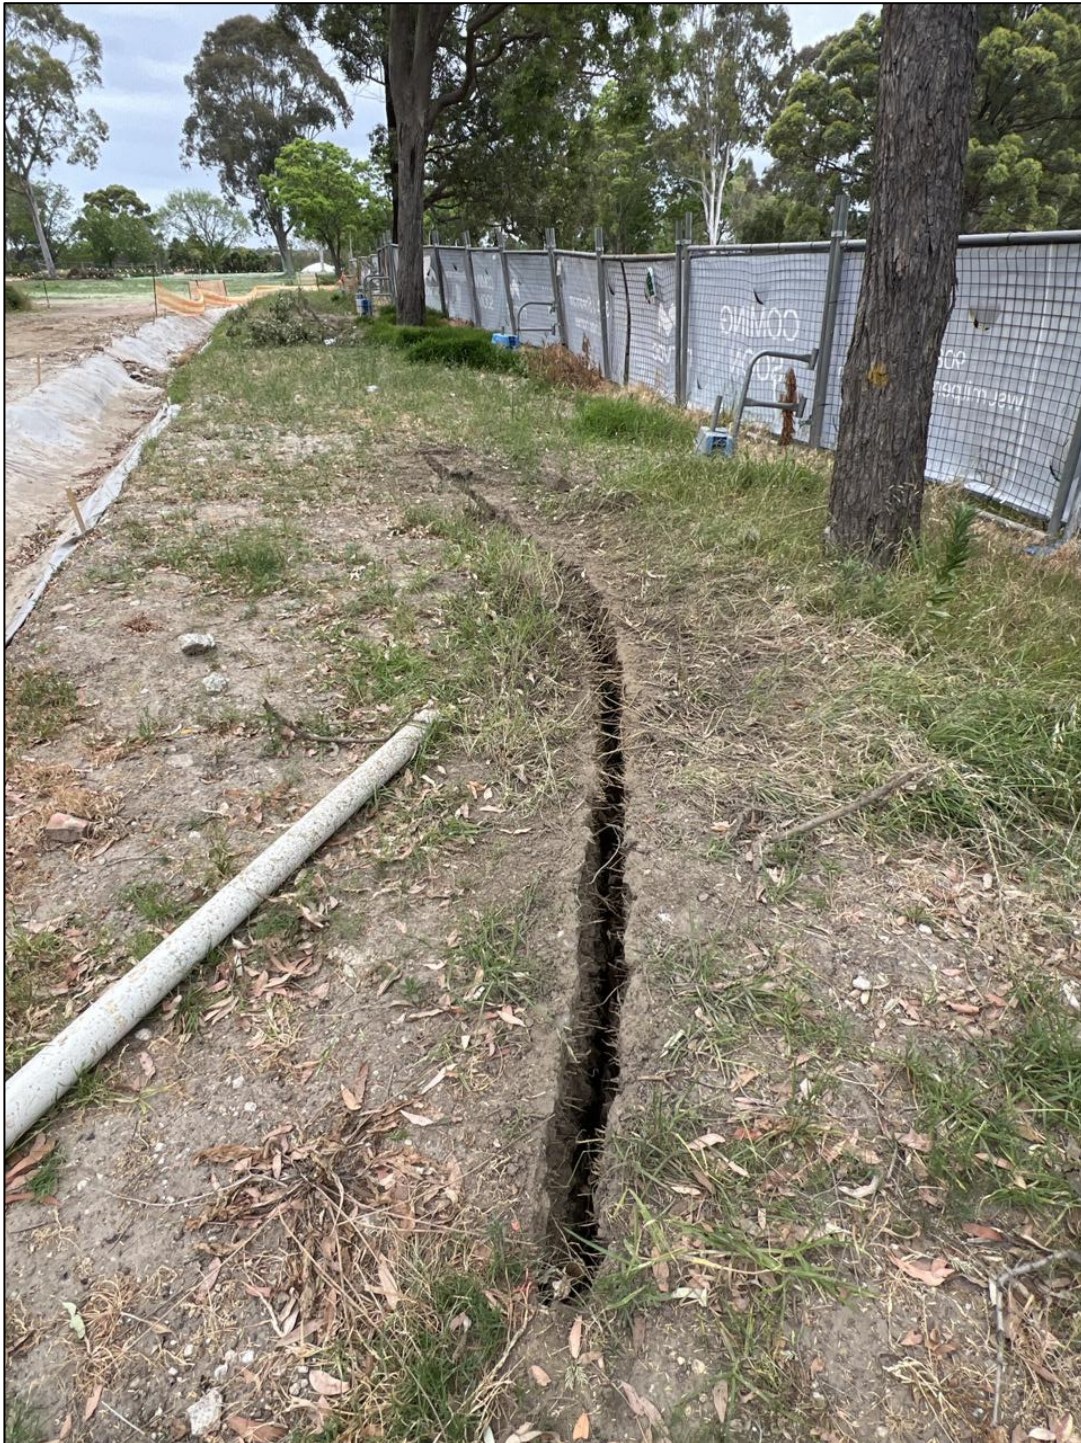
Trench 6 was excavated to a depth of 600 mm along nearest edge of proposed footpath that is within the NRZ of Tree 208. No major or minor roots were encountered in this trench. Heavily compacted clay soils encountered within trench and poor health observed for Tree 208 likely to have underpinned restricted root growth from tree. Proposed pathway can be installed in proposed location in eastern side of tree.

Figure 29. Trench 6 with no major or minor roots encountered. Image taken from northern edge of trench.

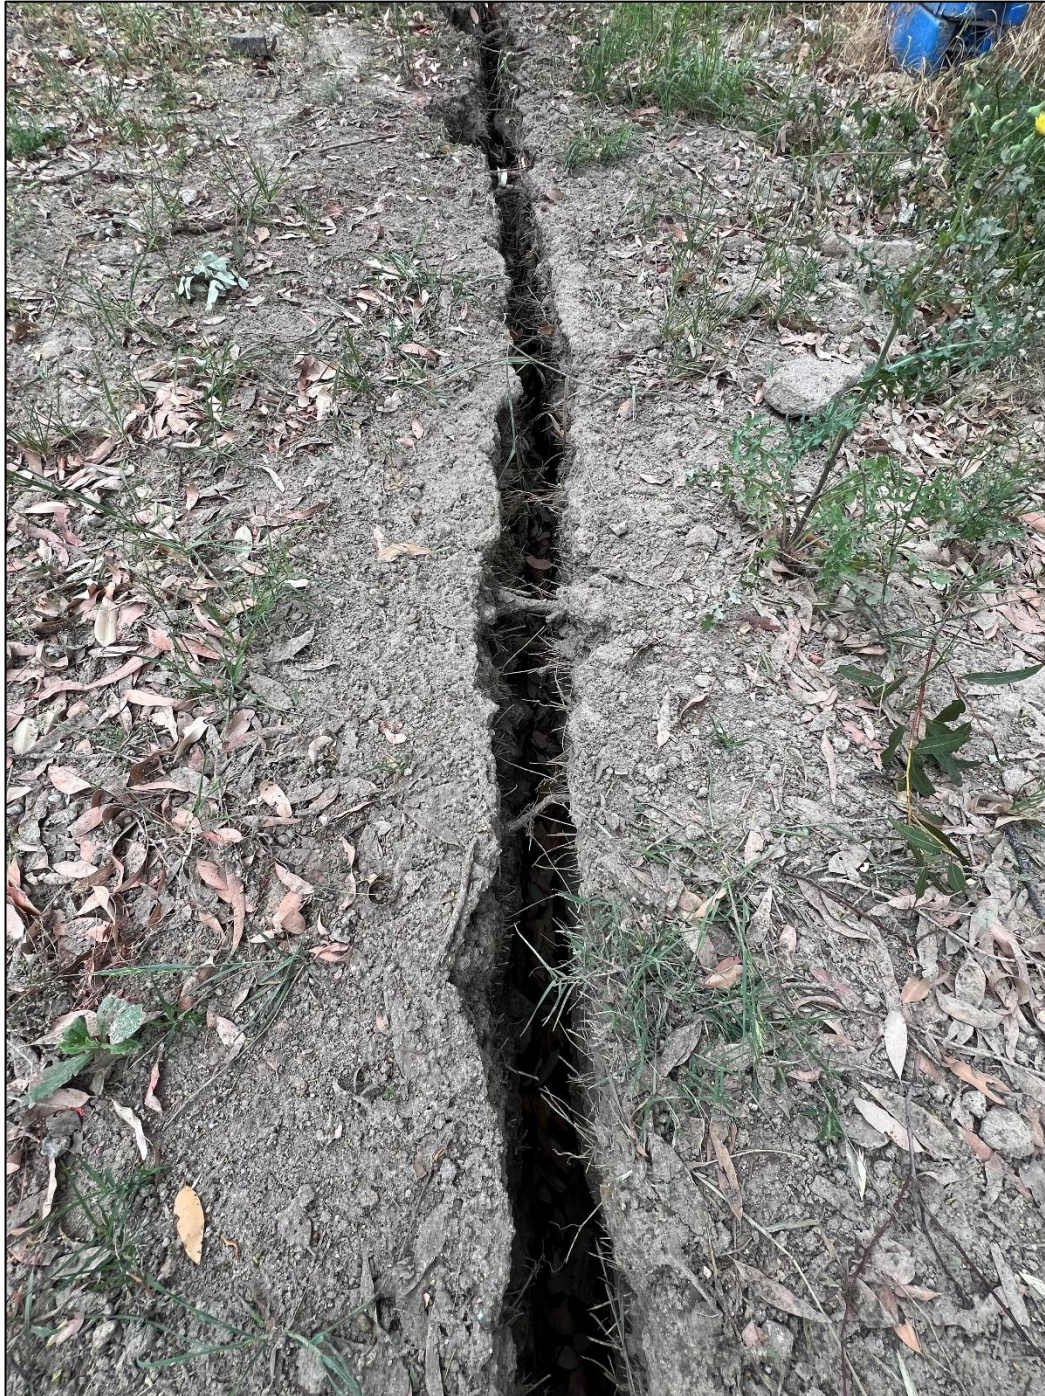
Figure 31. Trench 7 with heavily compact soils and no major roots observed. Minor root growth (14 minor roots) encountered within trench.

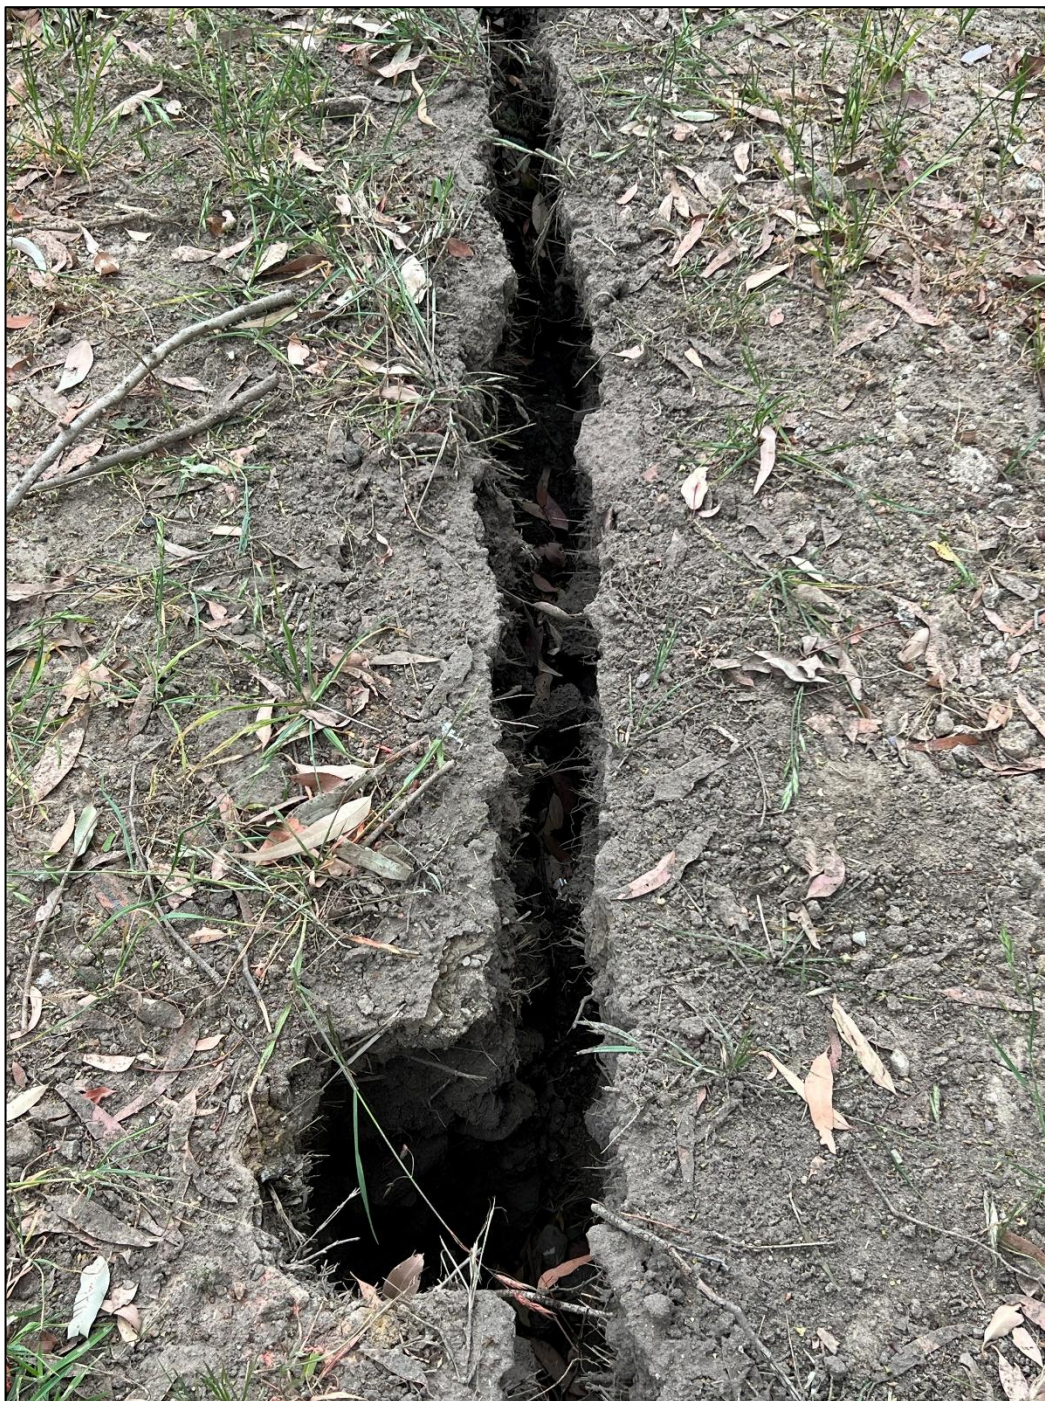
Figure 32. Trench 7 with heavily compact soils and dense rubble at base.

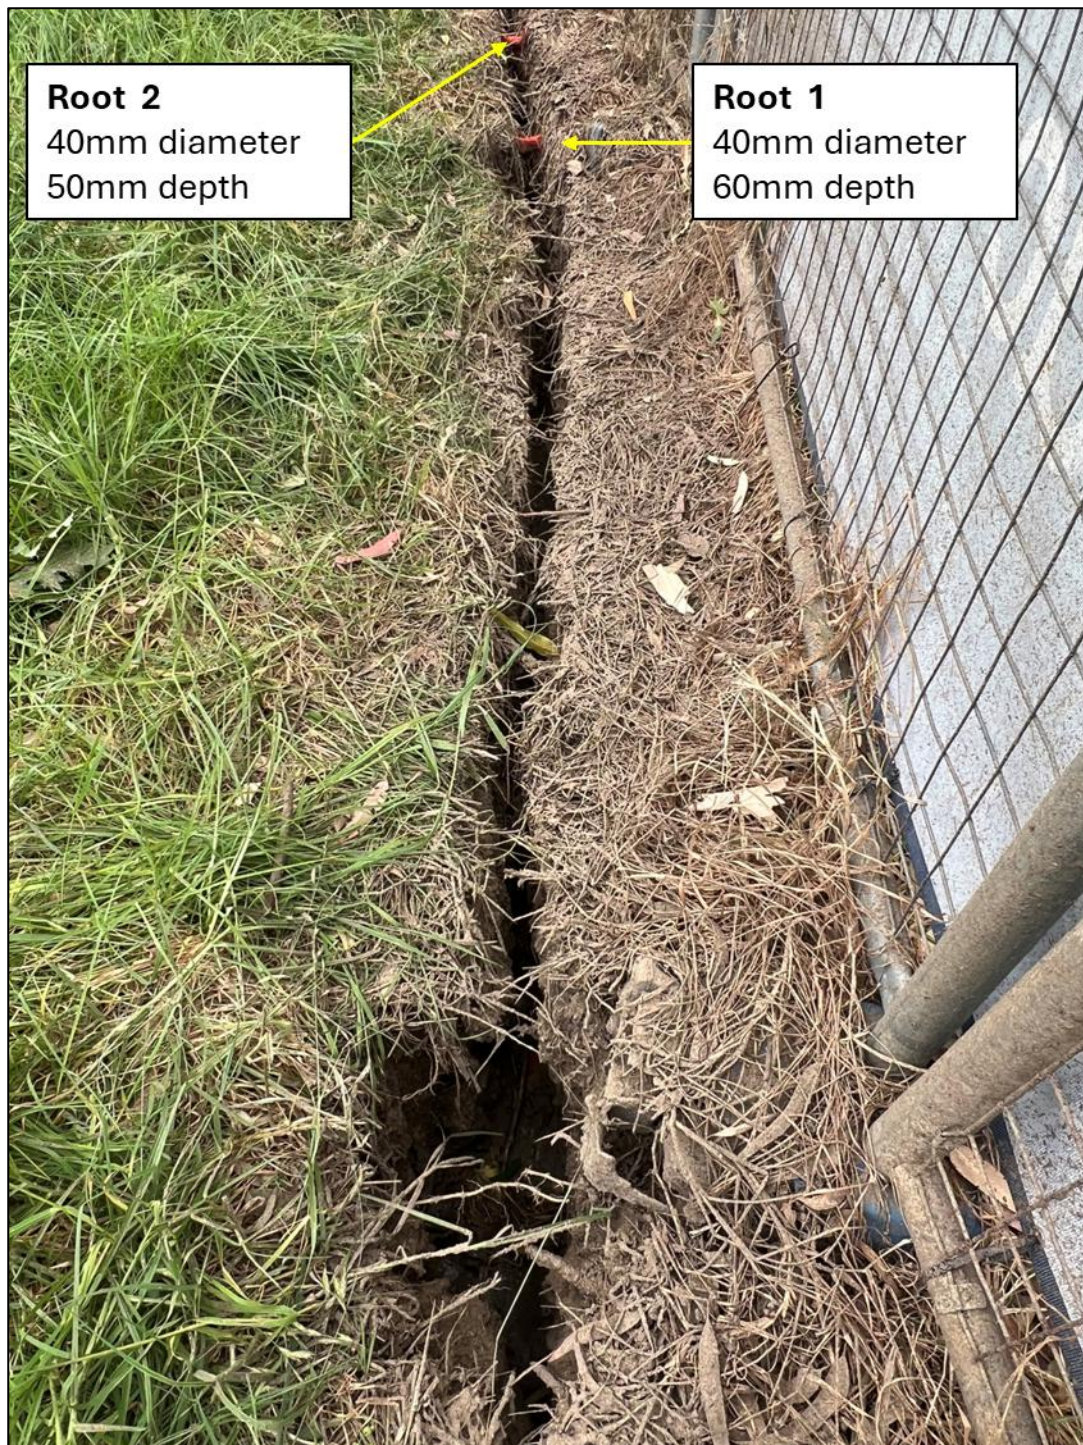
Figure 37. Roots 1 and 2 within central portion of Survey Trench 10. No major roots observed within eastern portion of trench.

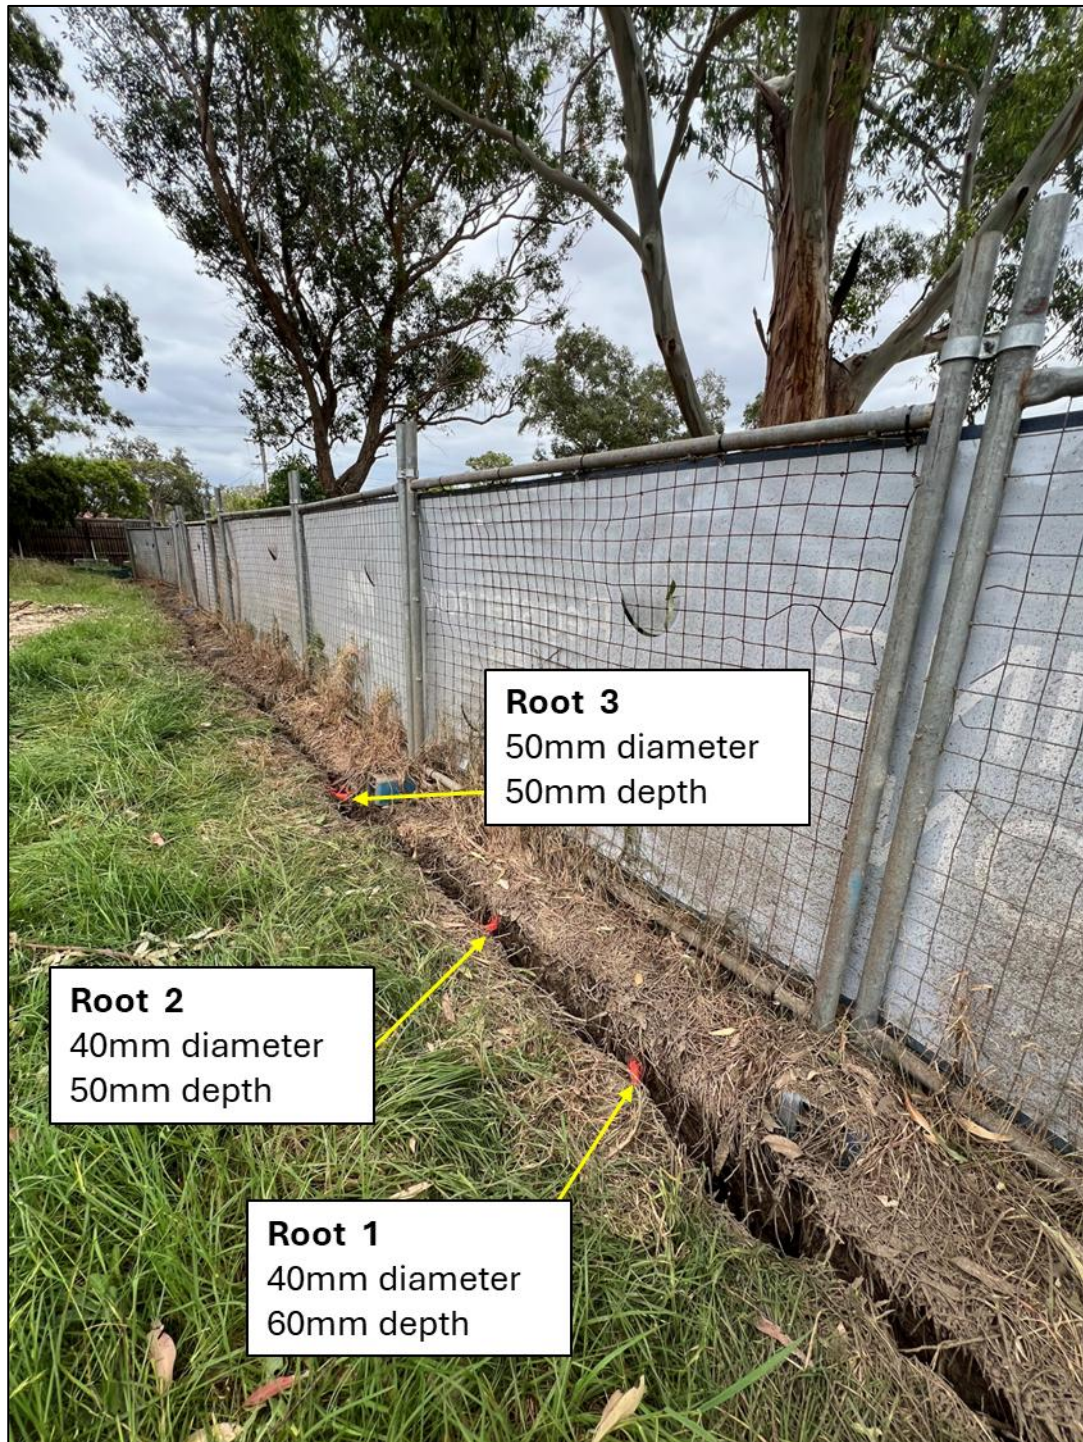
Figure 38. Roots 1, 2 and 3 within central portion of Survey Trench 10 in front of Tree 240.

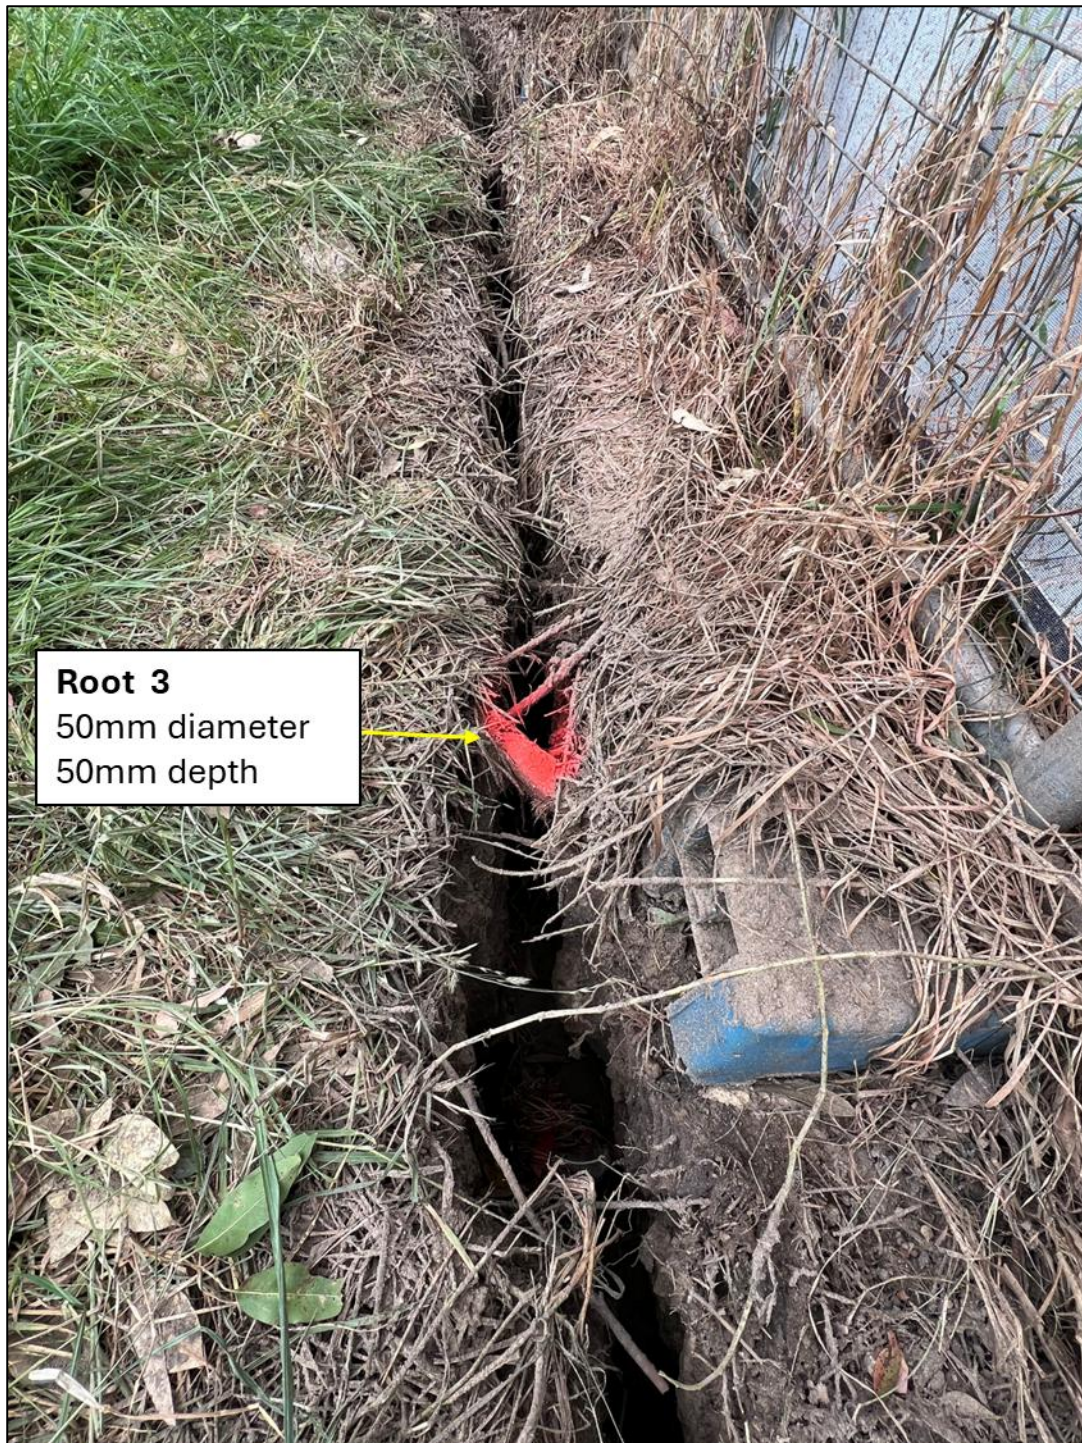
Figure 40. Root 3 within central portion of Survey Trench 10. No major roots observed within western portion of trench.

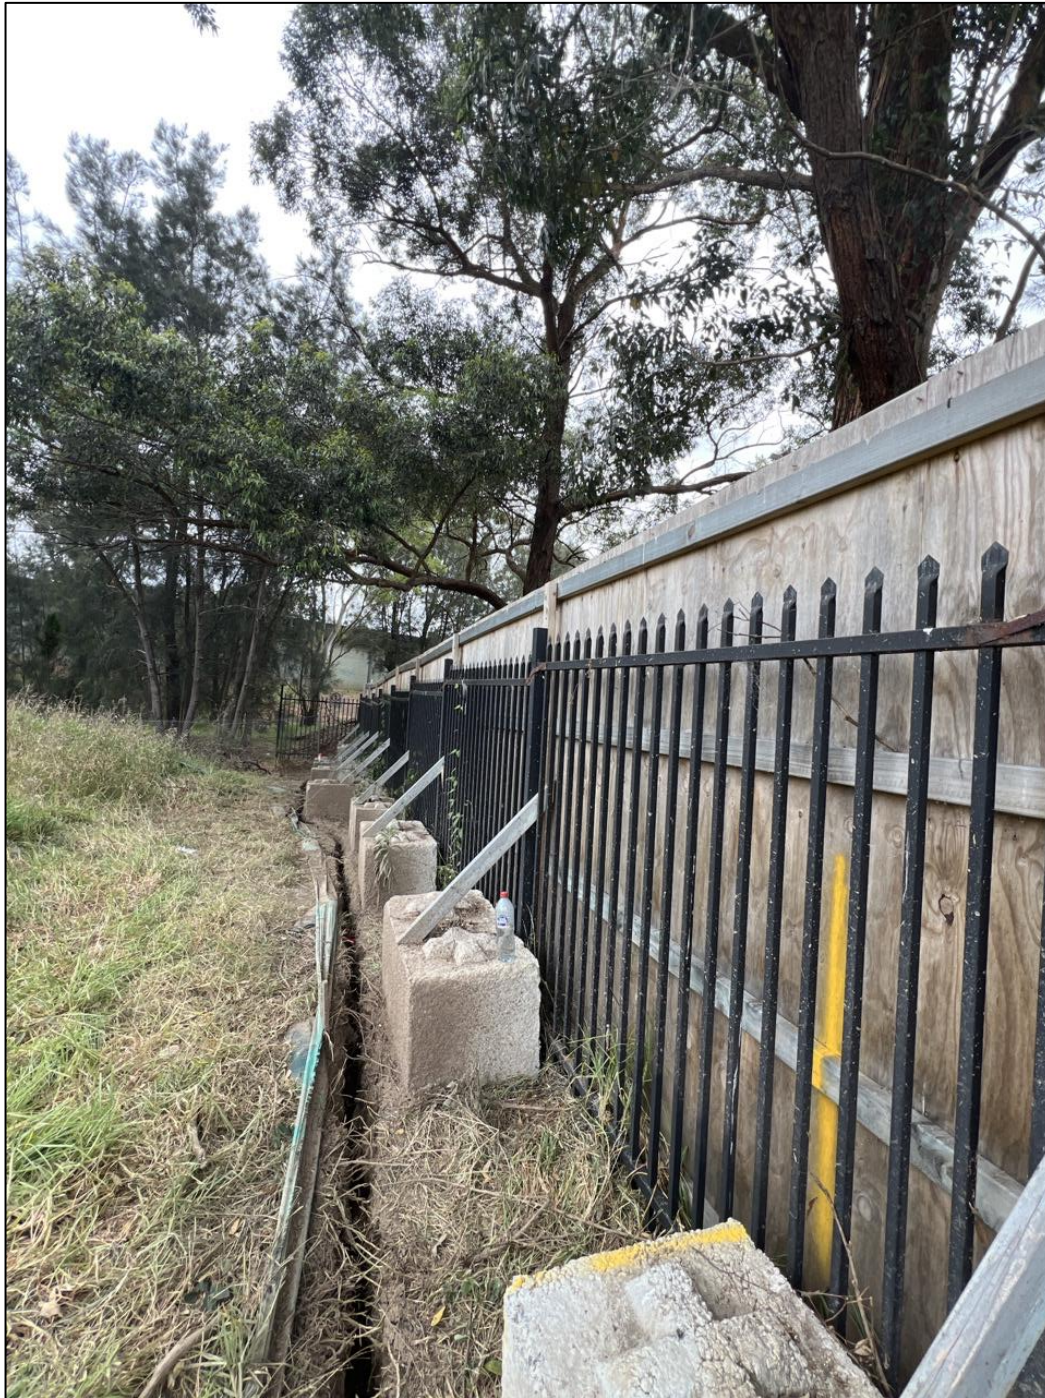
Figure 41. Trench 11 with three major roots encountered. Image taken from eastern edge of trench.
