# Arboricultural Impact Assessment

Revision 4

Western Sydney University, Milperra Campus  
NSW, 2214  
2/-/DP129184 + 1/-/DP101147  
Job No. 2400116  
19/03/2026

**Temporal Tree Management Pty Ltd.**

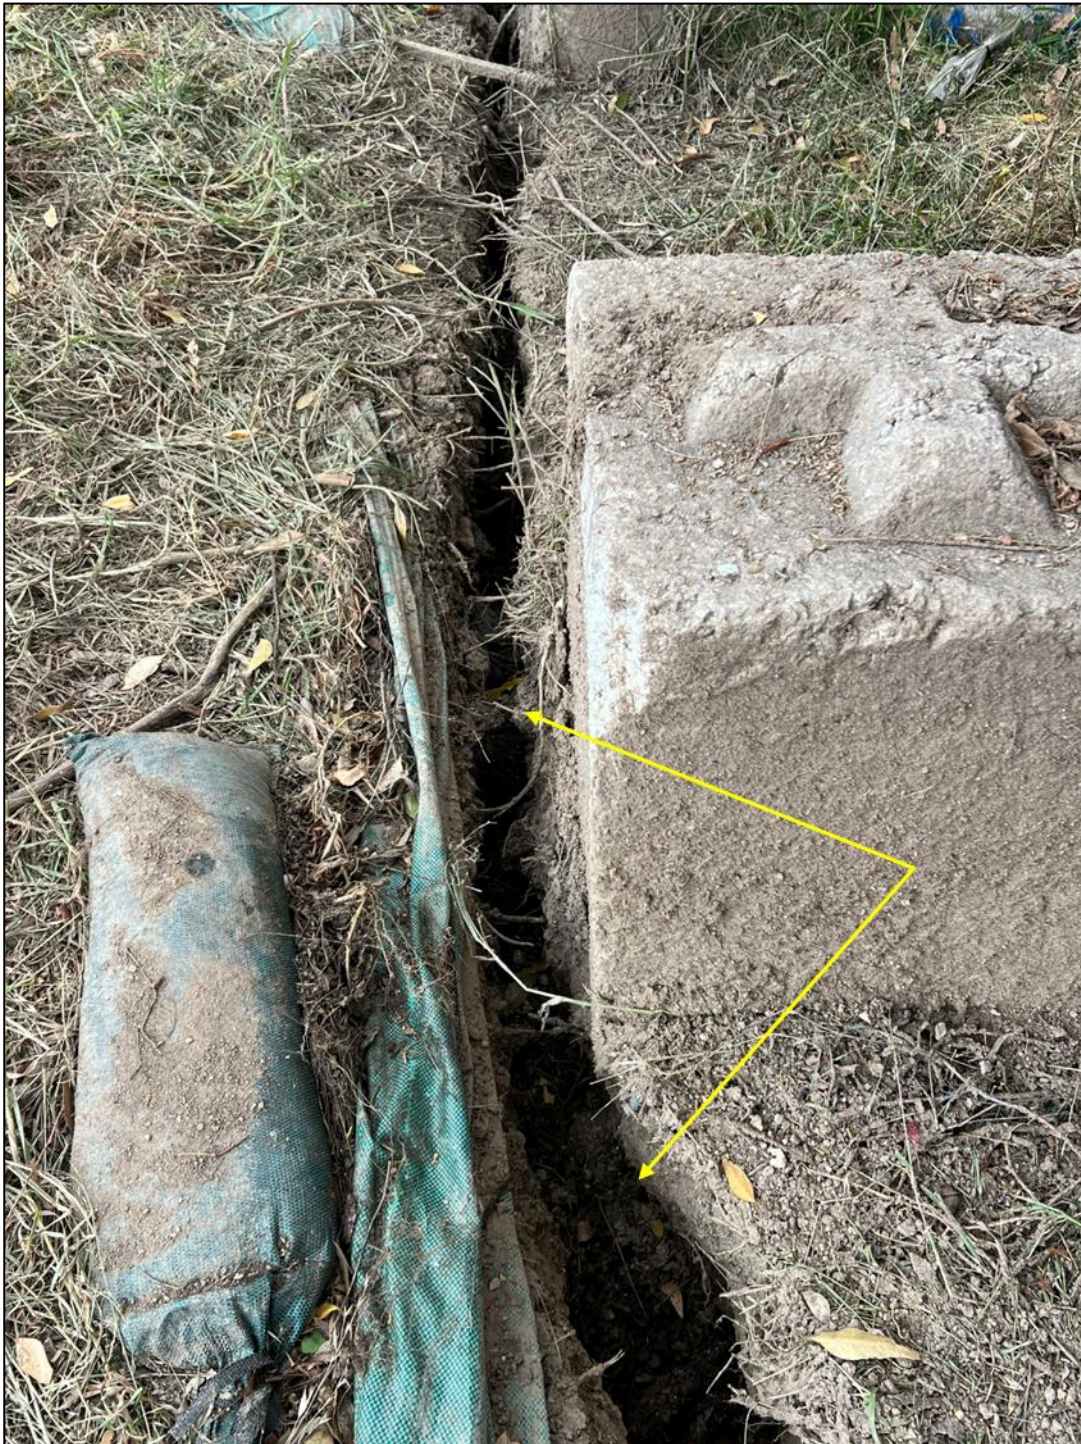
Figure 44. No major roots observed within the southern portion of Survey Trench 11. Heavy clay and a considerable amount of buried rubble were encountered.

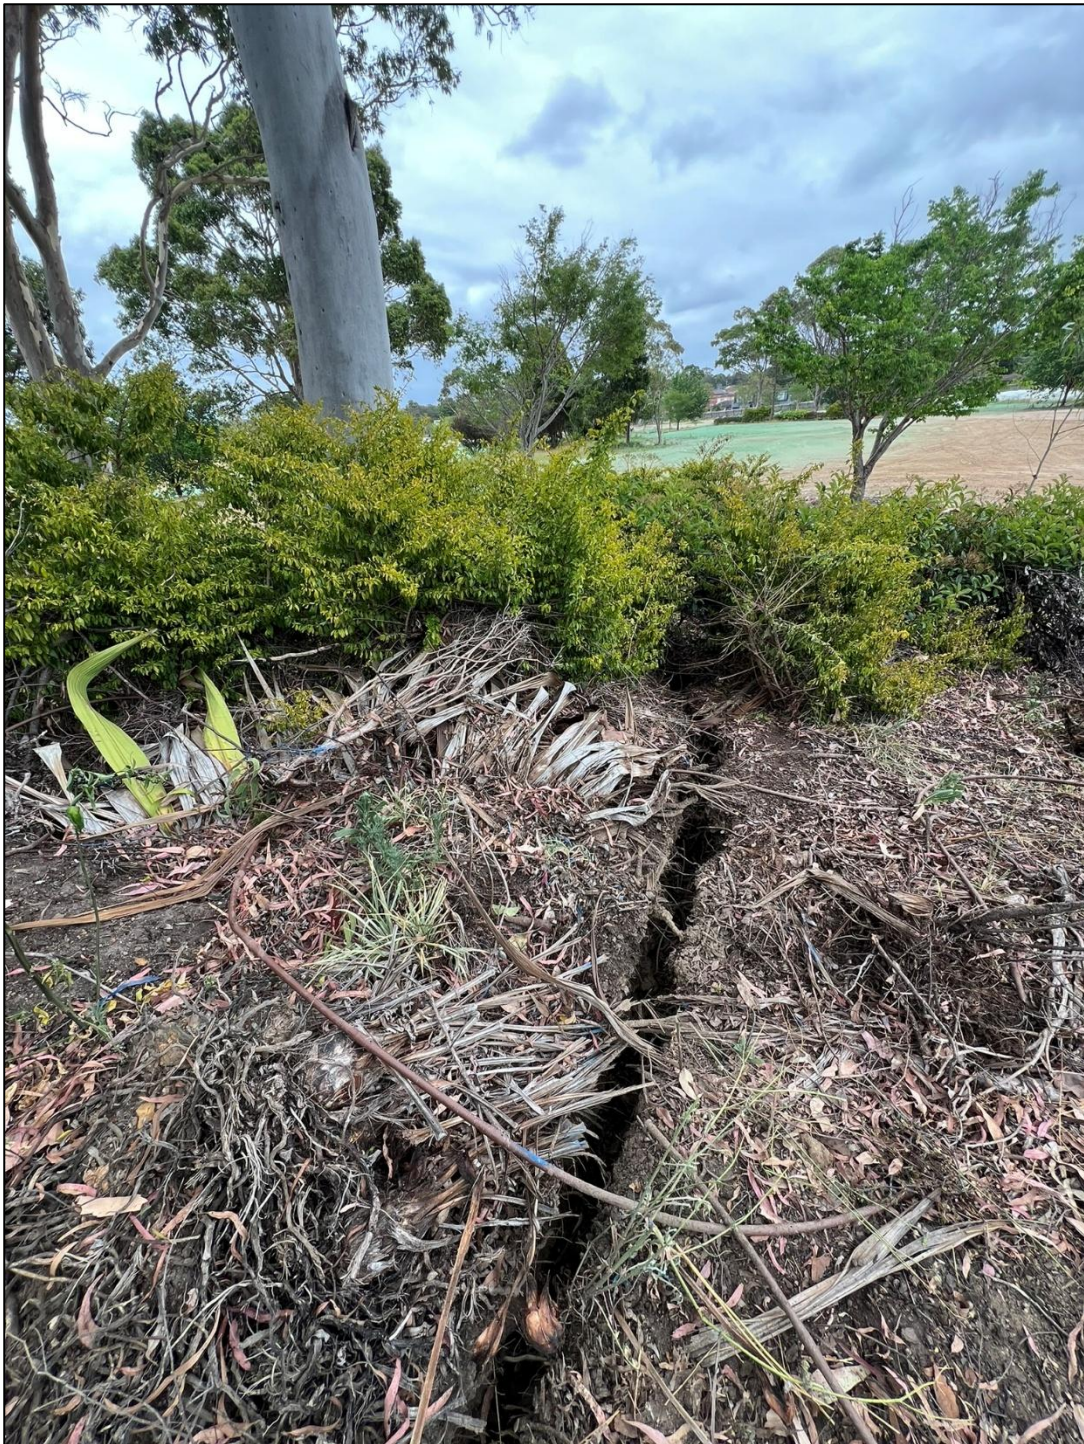
Figure 53. No major roots observed within the central or northern portion of Survey Trench 13.

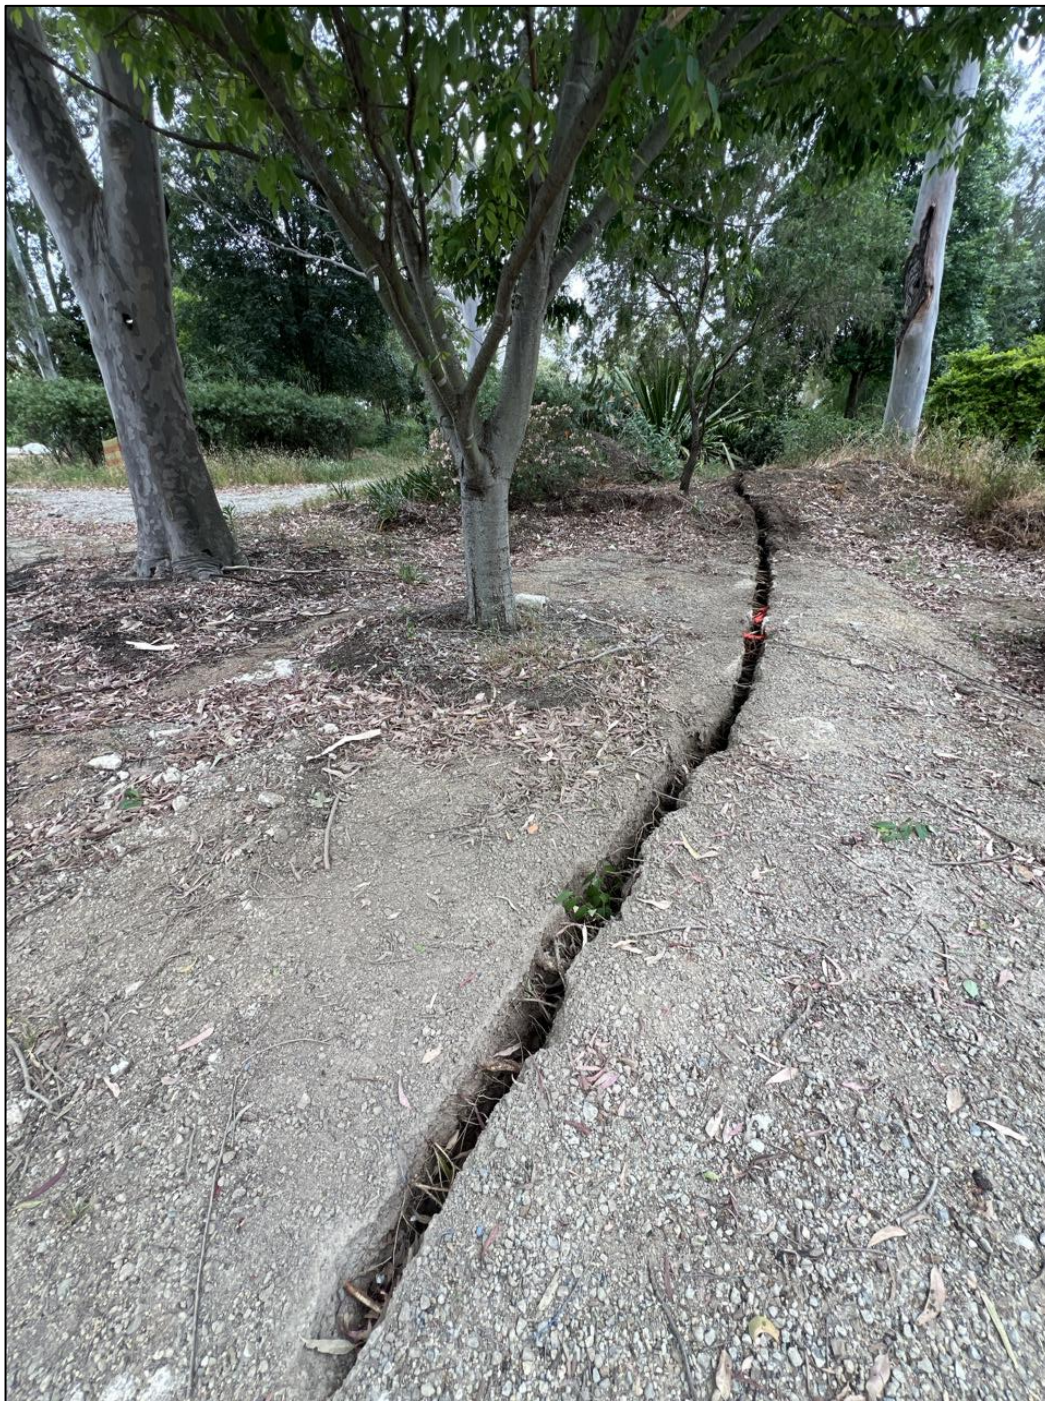
Figure 54. Trench 14 with three major roots encountered. Image taken from western edge of trench.

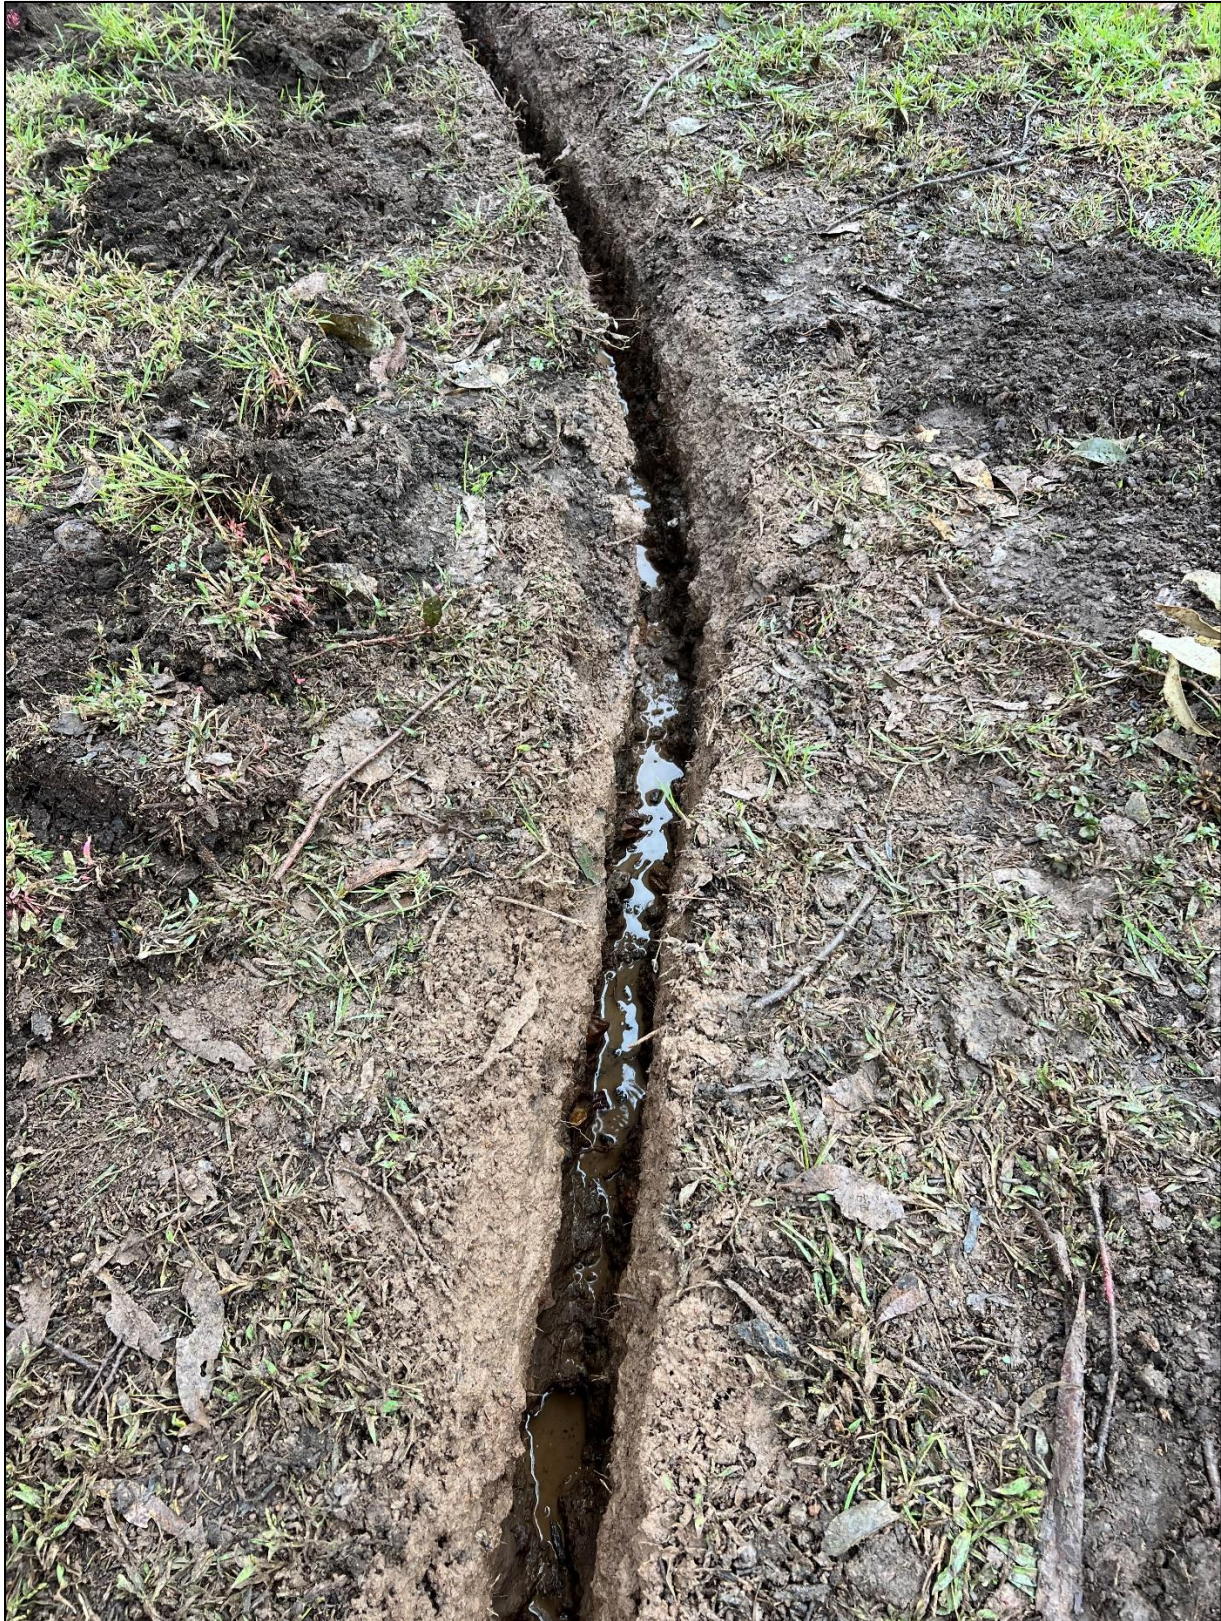
Figure 12. No tree roots observed within the central portion of Survey Trench 1.
