Reference: **3355A**  
18<sup>th</sup> October 2019

## Arborist Addendum

**Re: Royal Hall of Industries**  
**Lot 3, (D.P.861843) and Lot 52 (D.P.1041134)**  
**No. 1 Driver Avenue, MOORE PARK**

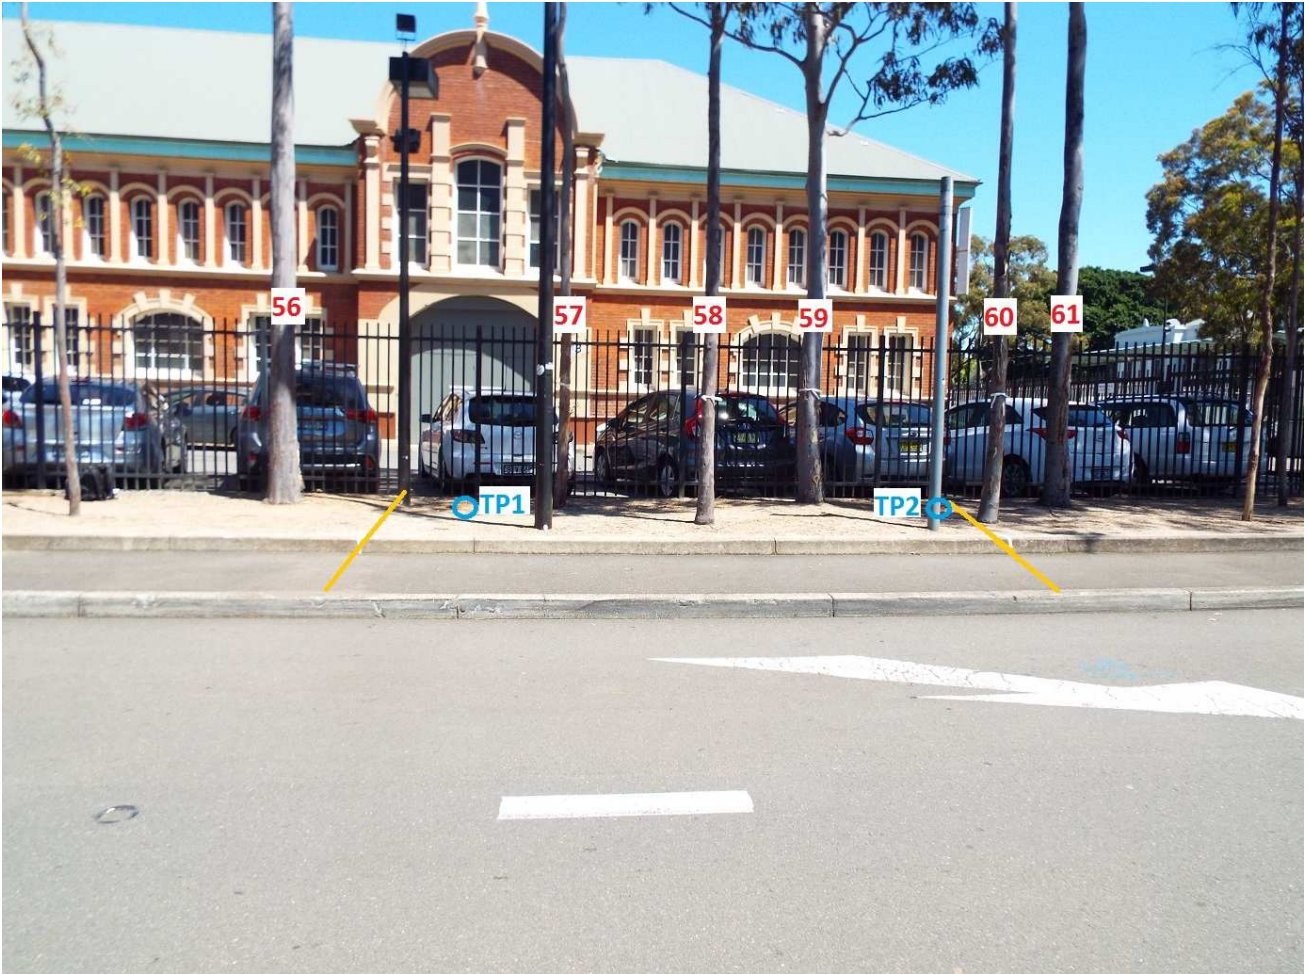
Based on the excavation works proposed for the crossover, two test pits have been excavated in this area (see Photo 1, Appendix E for location, additional photos available on request). The intention is to determine any specific media that had been introduced for the planting and the soil texture/profile to estimate potential root extension and density, therefore impact on trees that contain an encroachment. The test pits have been excavated<sup>6</sup> adjacent to the edge of the proposed crossover and 1000mm from the hob/fence separating the car park. Each test pit was excavated to 400mm depth and approximately 250mm square (across the face). The depth has been based on a combination of the excavation required for the crossover, estimated root depth and limited due to known subsurface utilities (electricity servicing the lamp posts) that occur. The limited assessment of soil depth based on electrical utilities removed the use of a soil probe/profile sampler.

**Soil type/texture:** The soil appears to be consistent with the soil naturally occurring in the area, and this has been based on comparison to soil unearthed in the courtyard adjacent to Lang Road, which was under excavation at the time of assessment and feedback from the contractors regarding the depth and soil unearthed. That is, the area containing these trees does not appear to contain any introduced media and is assumed to extend throughout the adjacent areas. The soil texture has been classed as 'loamy sand'<sup>7</sup>, and is considered to allow normal root extension and a deep root system based on available gas exchange and water percolation, assuming the same soil texture to extend deeper.

**Soil profile;** The soil profile was consistent up to 400mm depth, although a gravel surface including a high concentration of pea gravel compacted into a crust with a mean depth of 60mm occurs over the surface of the planting.

**Root mass;** the root mass is evident within the test pit, although restricted to the soil only and had not migrated into the pea gravel crust. The root density was apparent in the top 150-200mm of soil beneath the crust, although did not provide any root mass greater than 2mm in diameter. The remaining depth, in excess of 250mm below-grade, exhibited larger woody roots up to 35mm in diameter in each test pit. The root density (number of roots) increased with depth.

Based on the results, and within the area of the proposed crossover, the root system is contained to the grade initiating 60mm below the existing grade, where the predominant and larger root system is at 200mm below grade.

**Photo 1; Area of proposed crossover relative to numbered trees No. 56-61. The yellow lines indicate the edge of the proposed crossover. The location of the test pits are indicated by TP1 and TP2. Facing west.**

1. A surface that is flexible and porous with the minimal foundation is utilised, for example *FiltaPave*<sup>TM,20</sup>.

2. The excavation of the crossover is conducted with an air spade, in association with the project arborist. Any significant roots (greater than 20mm in diameter) that conflict with the structure are cleanly cut.

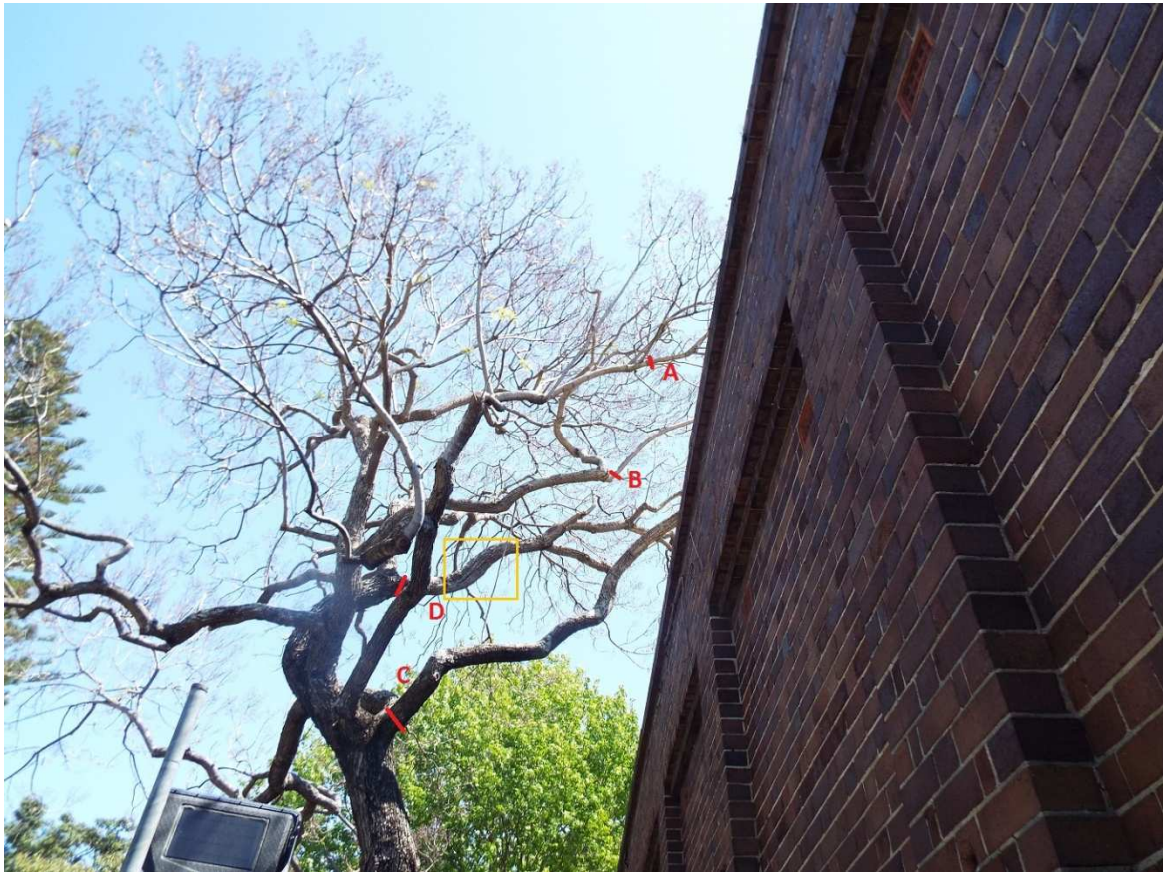
The proportion of pruning has been estimated to consist of 20% of the crown mass and constitute selective pruning (Code S, AS 4373), although potentially also crown lifting (Code S, AS 4373). The pruning will modify the habit, although is not considered to impact the structural dynamics or amenity value based on

views from the streetscape. The pruning is limited to four branches (see Photo 2, Appendix E), although one of these is an epicormic shoot (branch B), and another (branch D) has a structural crack; hazard beam type (see Photo 3, Appendix E) which would likely be removed based on the related risk and target zone of the footpath. The species is widely planted throughout the international urban environment<sup>10,11</sup> and is testament to the species adaptability and resilience. It is documented to be tolerant to pruning<sup>12</sup> and coppicing<sup>13,14</sup> as well referenced to be 'advisable to prune older trees, especially those that function as street trees'<sup>15</sup>. The proportion of pruning is supported by the International Society of Arboriculture<sup>16,17</sup> which nominates no more than 25% of the crown should be removed for any single pruning event. The species is referenced to be tolerant of the pruning and is further supported by the international pruning standard. The pruning will conform to the Australian Standard and is not considered to adversely impact on the amenity value. Part of this pruning is considered necessary to remove existing risks. Condition 17, Section 7.3.2 is required as part of these works.

ID	Tree part	Dia; collar	Length	% of crown mass	Cardinal direction/ degrees	Notes
A	2 <sup>nd</sup> order	30mm	1m	3%	North	-
B	epicormic	40mm	2m	1%	North	Epicormic shoot
C	1 <sup>st</sup> order	120mm	5m	8%	North	-
D	1 <sup>st</sup> order	130mm	5m	8%	North	Hazard beam crack

Photo 2; Tree No. 8; Jacaranda, labelled branches nominated for removal based on the pruning schedule (Appendix D), yellow insert; see Photo 3,. Facing west.

17. The project arborist is required on-site before pruning starts and includes a discussion with the utility arborist to determine the strategy and proportion of pruning to reduce the impact on the trees. The arborist must be in attendance during the pruning and until completion.

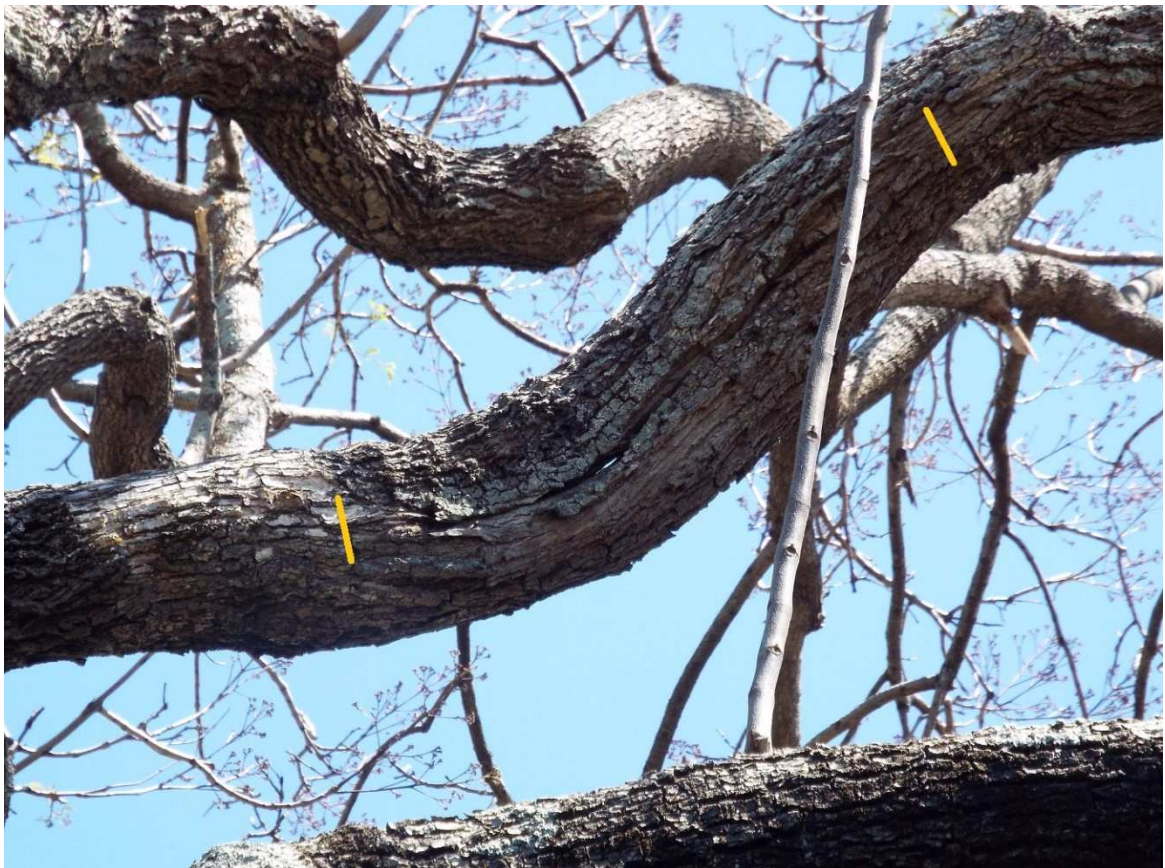
Photo 3; crack within branch labelled D, extremity of the crack illustrated with yellow lines, Facing west.

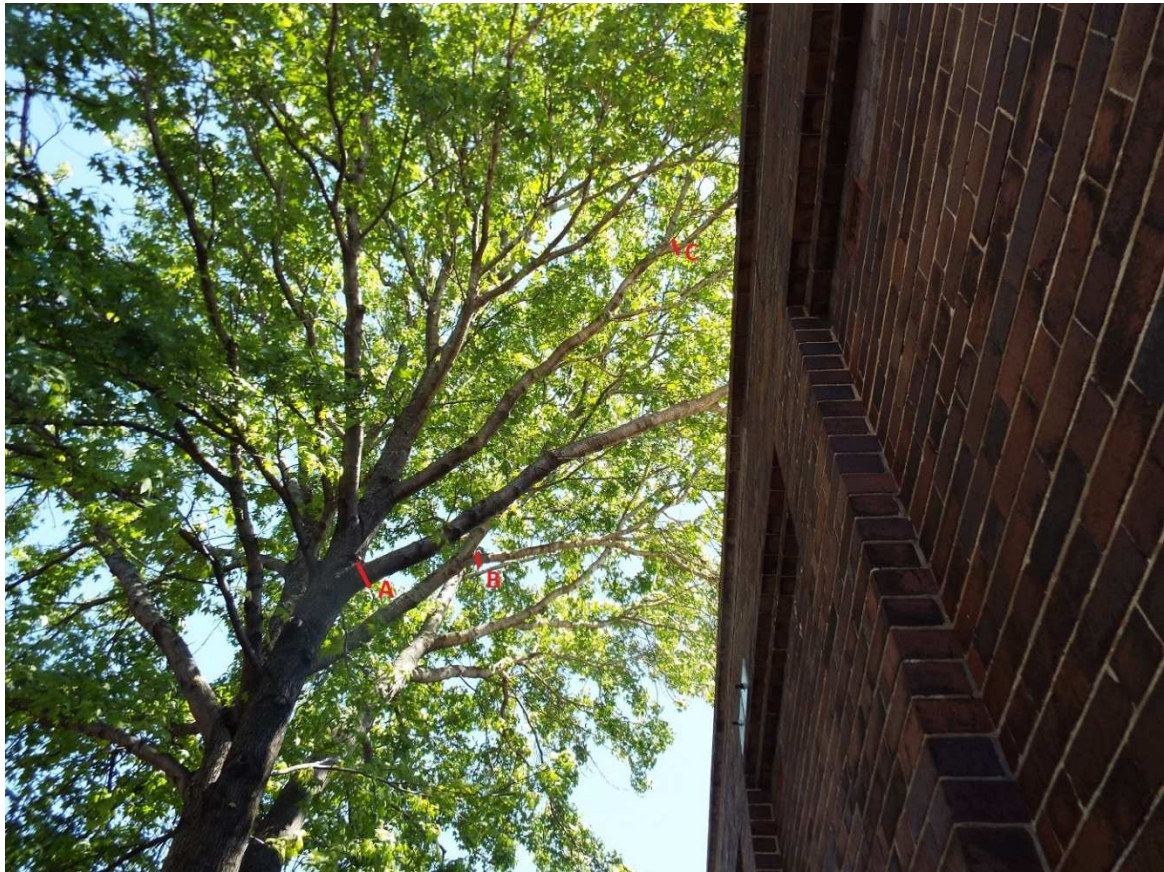
The proportion of pruning has been estimated to consist of 13% of the crown mass and constitute selective pruning (Code S, AS 4373), although potentially also crown lifting (Code S, AS 4373). The pruning will modify the habit, although is not considered to impact the structural dynamics or amenity value based on views from the streetscape. The pruning is limited to two branches (see Photo 4, Appendix E), and selection of twiggy material less than 20mm in diameter. The species is a common tree in the urban environment<sup>11</sup> and is testament to the species adaptability and resilience. The proportion of pruning is not excessive and will conform to the Australian Standard and is not considered to adversely impact on the amenity value. Condition 17, Section 7.3.2 is required as part of these works.

**Photo 4; Tree No. 9, Sweet Gum, labelled branches nominated for removal based on the pruning schedule, Appendix D. Facing west.**
