Royal Hall of Industries - Moore Park

Sydney Swans HQ & Community Centre

<u>Dilapidation</u> <u>Addendum</u> Report - Errol Flynn Blvd

25th August 2021

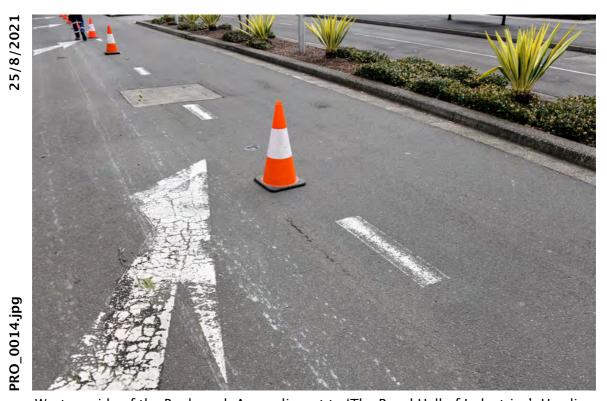
Western side of the Boulevard. Area adjacent to 'The Royal Hall of Industries'. Heading north. Median Strip. Crack in the asphalt road paving.

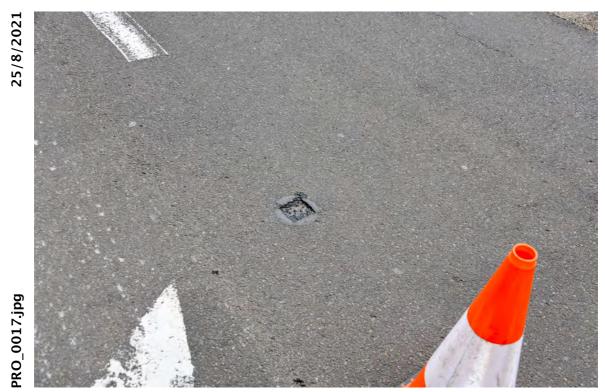
Western side of the Boulevard. Area adjacent to 'The Royal Hall of Industries'. Heading north. Missing reflector.

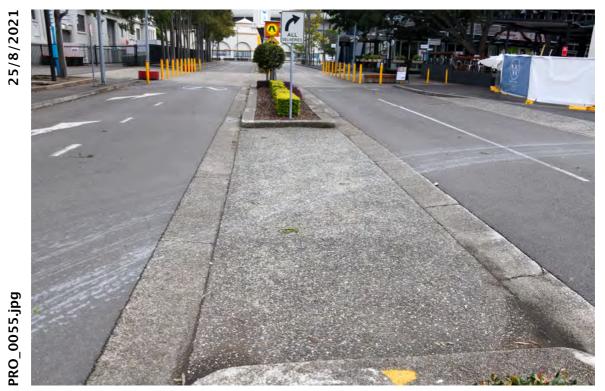
Western side of the Boulevard. Area adjacent to area between 'The Royal Hall of Industries' & 'The Hordern Pavilion'. Heading north. Intersection with Park Road. Gap in the median strip.

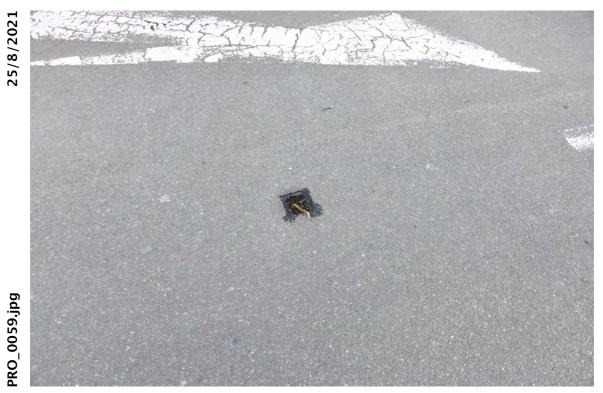
Western side of the Boulevard. Area adjacent to area between 'The Royal Hall of Industries' & 'The Hordern Pavilion'. Heading north. Intersection with Park Road. Missing road reflector.

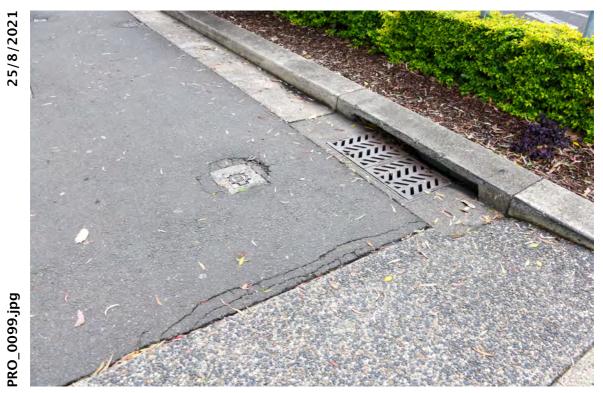
Western side of the Boulevard. Area adjacent to area between 'The Royal Hall of Industries' & 'The Hordern Pavilion'. Heading north. Area of the pedestrian crossing. Facing east. Cracked asphalt paving.

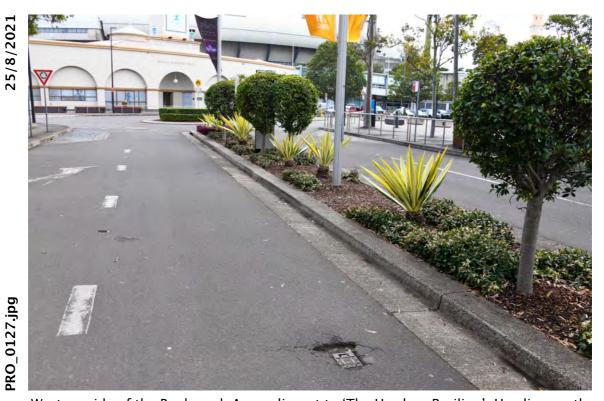
Western side of the Boulevard. Area adjacent to 'The Hordern Pavilion'. Heading north. Damaged paving around the service valve in the road paving.

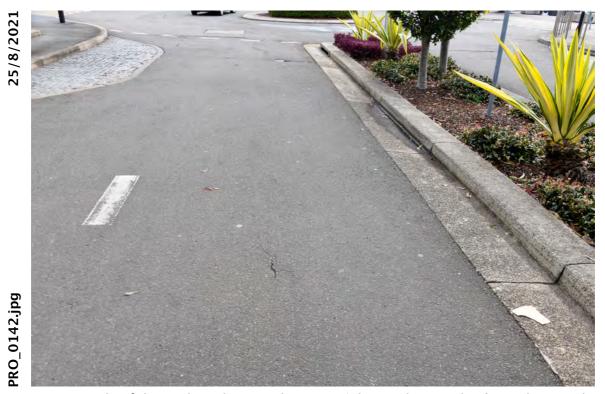
Western side of the Boulevard. Area adjacent to 'The Hordern Pavilion'. Heading north. Cracked paving.

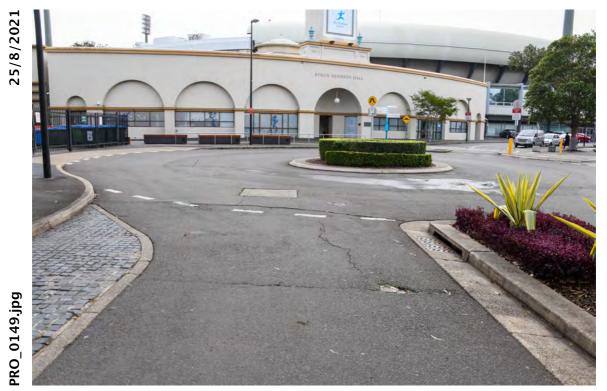
Western side of the Boulevard. Area adjacent to 'The Hordern Pavilion'. Area on the southern side of the roundabout. Cracked road paving.

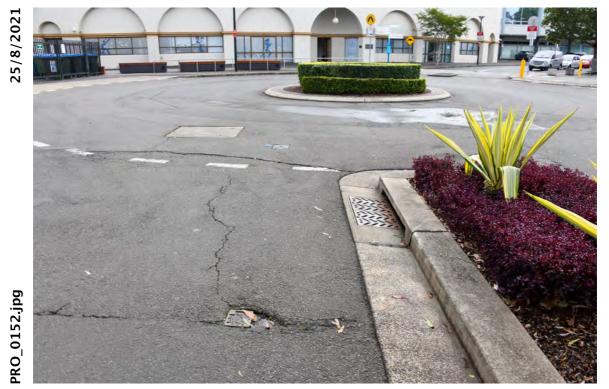
Western side of the Boulevard. Area adjacent to 'The Hordern Pavilion'. Area on the southern side of the roundabout. Damaged road paving.

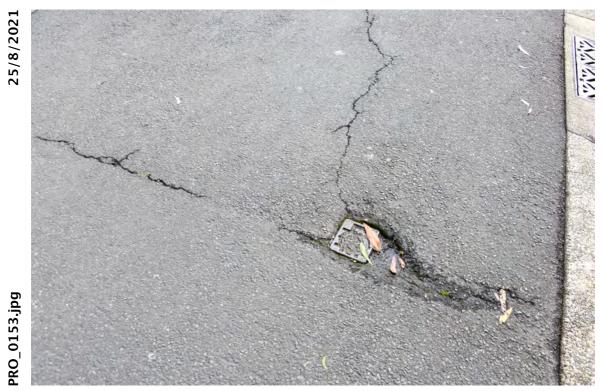
Western side of the Boulevard. Area adjacent to 'The Hordern Pavilion'. Area on the southern side of the roundabout. Damaged road paving.

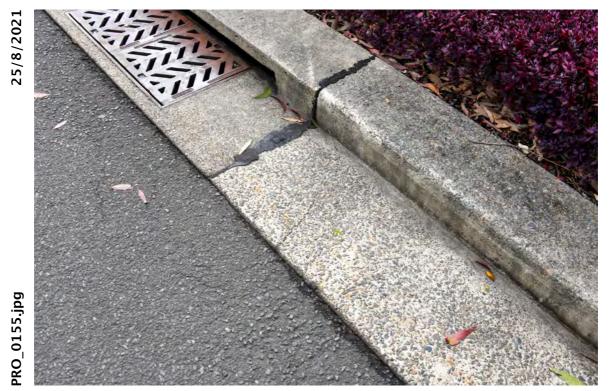
Western side of the Boulevard. Area adjacent to 'The Hordern Pavilion'. Area on the southern side of the roundabout. Cracked median strip gutter.

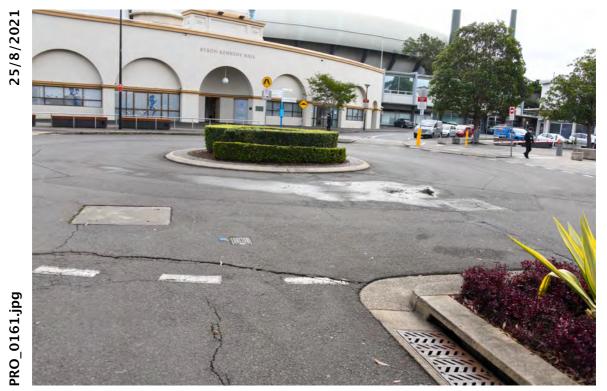
Western side of the Boulevard. Area adjacent to 'The Hordern Pavilion'. Area on the southern side of the roundabout. Cracked road paving.

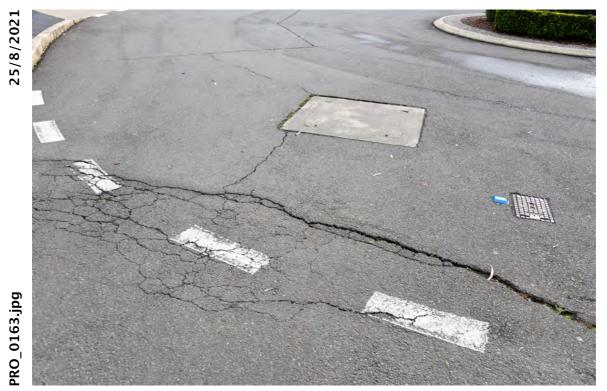
Western side of the Boulevard. Area adjacent to 'The Hordern Pavilion'. Area on the southern side of the roundabout. Cracked road paving.

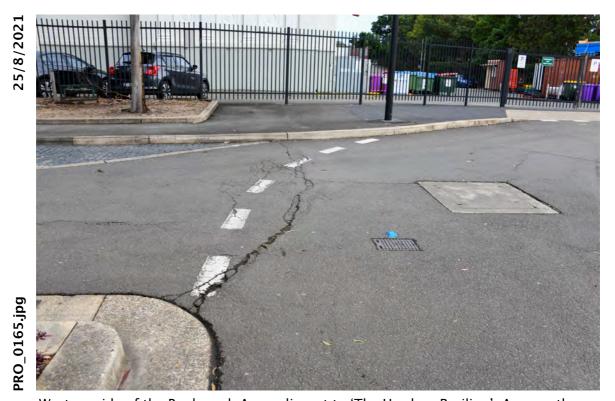
Western side of the Boulevard. Area adjacent to 'The Hordern Pavilion'. Area on the southern side of the roundabout. Facing west. Cracked road paving.

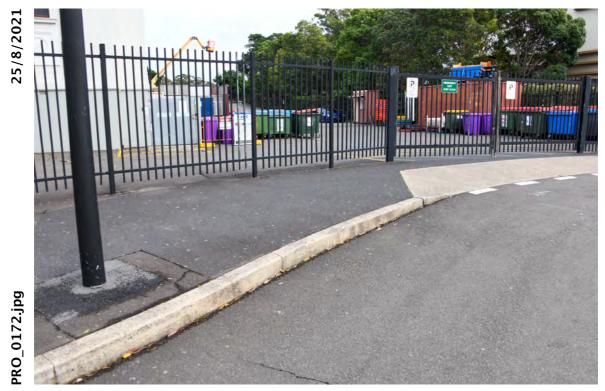
Roundabout at the northern end of the Boulevard. Heading clockwise. South-western side of the roundabout. Cracked kerb.

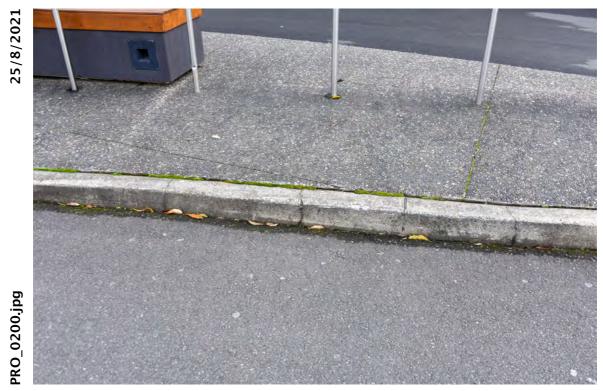
Roundabout at the northern end of the Boulevard. Heading clockwise. Northern side of the roundabout. Cracked kerb.

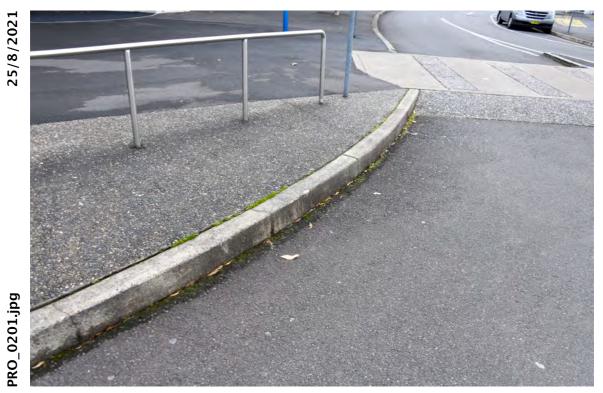
Roundabout at the northern end of the Boulevard. Heading clockwise. Northern side of the roundabout. Intersection with Bent Street. Cracked kerb.

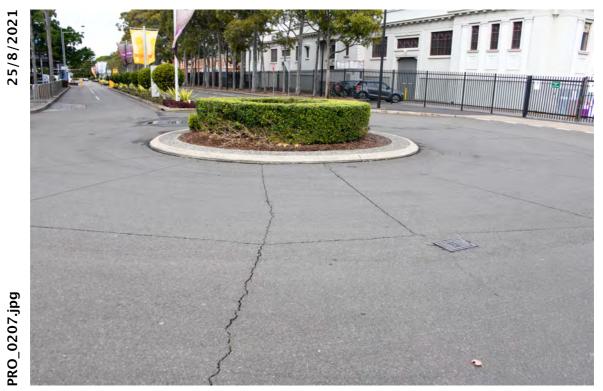
Roundabout at the northern end of the Boulevard. Heading clockwise. Northern side of the roundabout. Intersection with Bent Street. Cracked road paving.

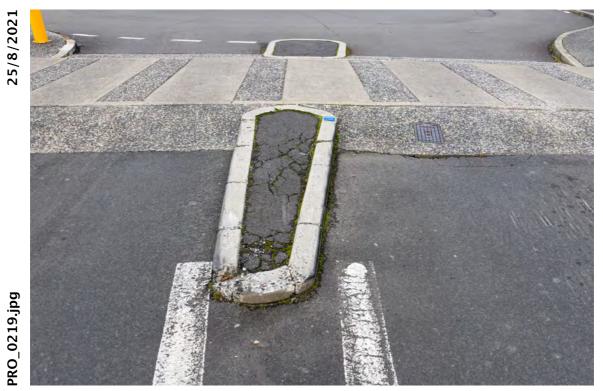
Roundabout at the northern end of the Boulevard. Intersection with Bent Street. Facing south. Damaged median strip.

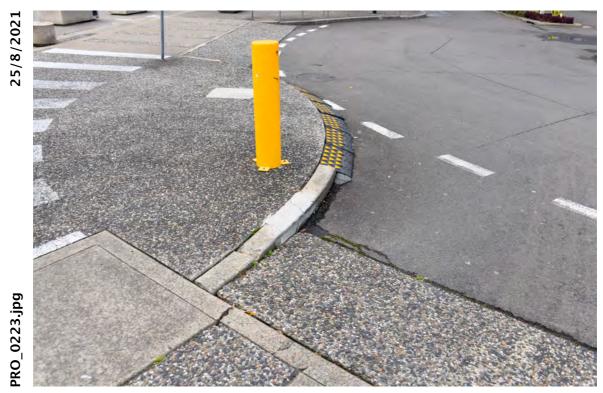
Roundabout at the northern end of the Boulevard. Intersection with Bent Street. Cracked kerb.

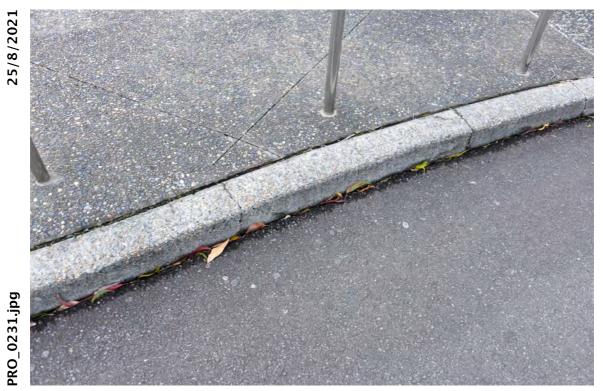
Roundabout at the northern end of the Boulevard. Eastern side of the roundabout. Heading clockwise. Cracked kerb.

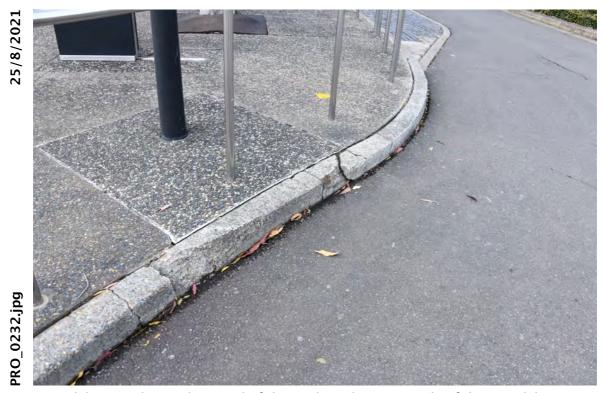
Roundabout at the northern end of the Boulevard. Eastern side of the roundabout. Heading clockwise. Cracked and chipped kerb.

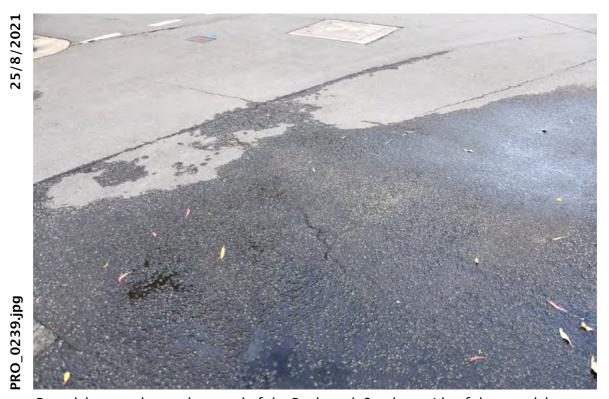
Roundabout at the northern end of the Boulevard. Southern side of the roundabout. Facing west. Cracked road paving.

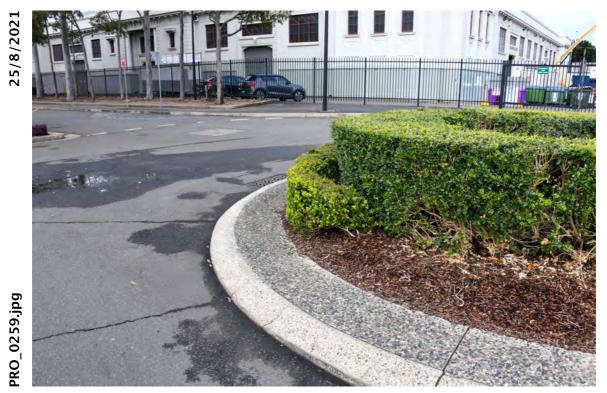
Roundabout at the northern end of the Boulevard. Heading clockwise around the centre of the roundabout. Eastern side. Cracked kerb.

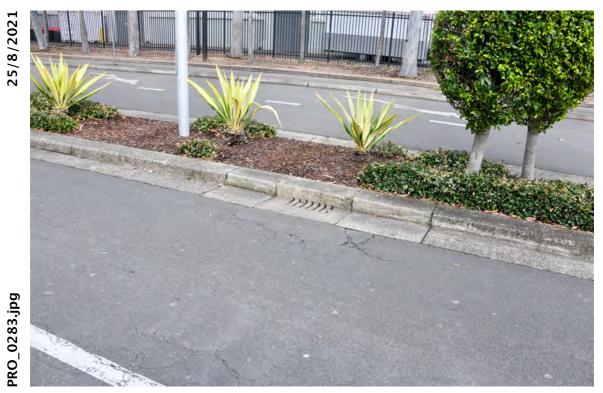
Eastern side of the Boulevard. Area opposite 'The Hordern Pavilion'. Area approaching the intersection with Park Road. Heading south. Cracked paving adjacent to the median strip.

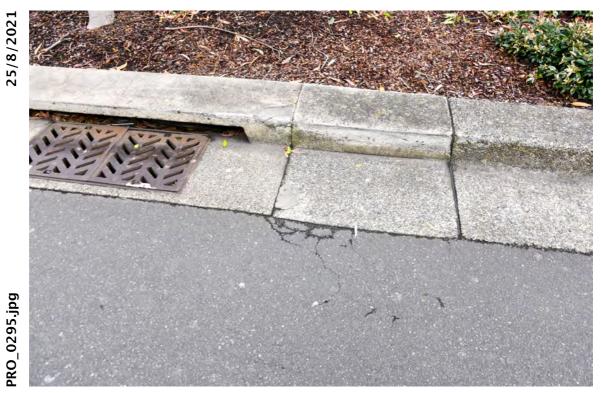
Eastern side of the Boulevard. Area opposite 'The Hordern Pavilion'. Area approaching the intersection with Park Road. Heading south. Storm water drain in the median strip. Cracked adjacent paving.

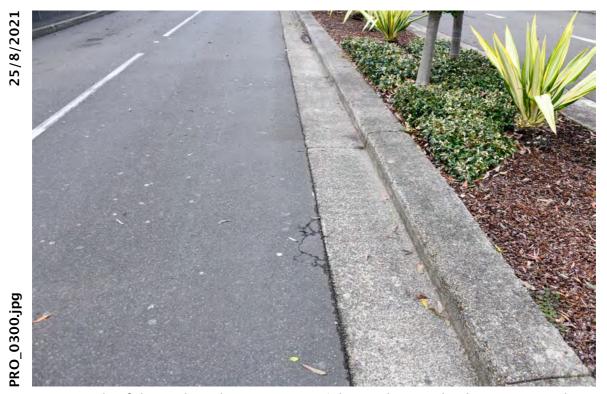
Eastern side of the Boulevard. Area opposite 'The Hordern Pavilion'. Area approaching the intersection with Park Road. Heading south. Cracked paving adjacent to the gutter.

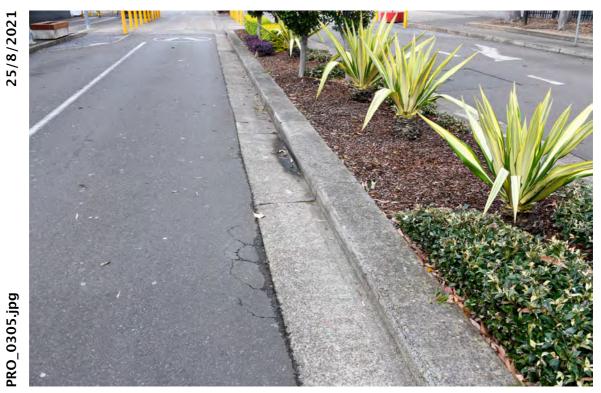
Eastern side of the Boulevard. Area opposite 'The Hordern Pavilion'. Area approaching the intersection with Park Road. Heading south. Cracked paving adjacent to the median strip.

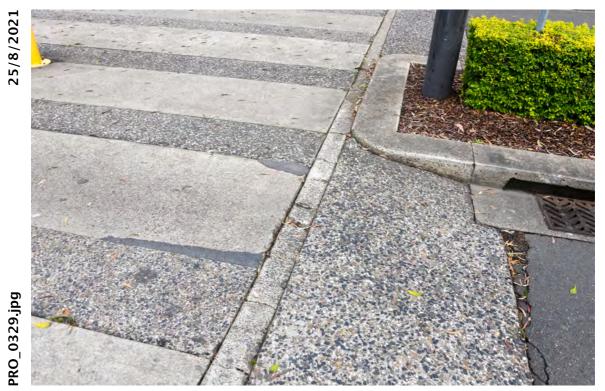
Eastern side of the Boulevard. Area opposite 'The Hordern Pavilion'. Area of the pedestrian crossing. Cracked paving.

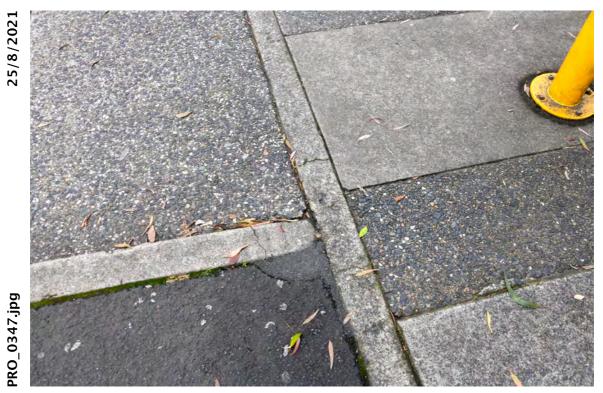
Eastern side of the Boulevard. Area opposite the area between 'The Hordern Pavilion' and 'The Royal Hall of Industries'. Area of the pedestrian crossing. Heading south. Cracked paving.

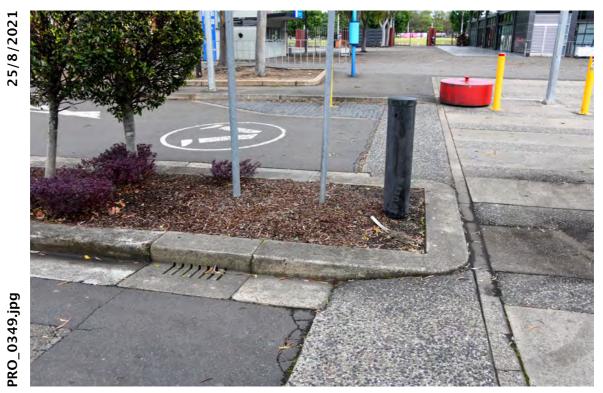
Eastern side of the Boulevard. Area opposite the area between 'The Hordern Pavilion' and 'The Royal Hall of Industries'. Area of the pedestrian crossing. Heading south. Cracked paving.

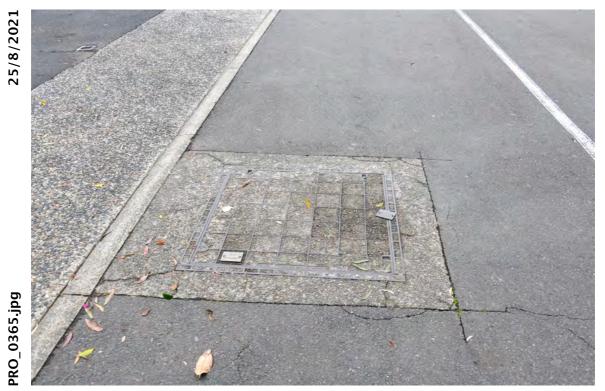
Eastern side of the Boulevard. Area opposite the area between 'The Hordern Pavilion' and 'The Royal Hall of Industries'. Intersection with Park Road. Cracked road paving.

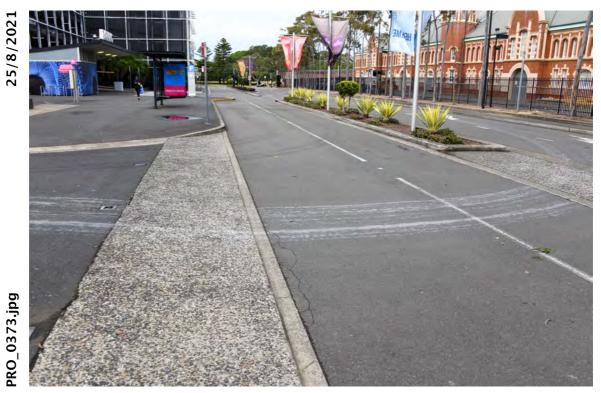
Eastern side of the Boulevard. Area opposite the area between 'The Hordern Pavilion' and 'The Royal Hall of Industries'. Intersection with Park Road. Heading south. Cracked paving.

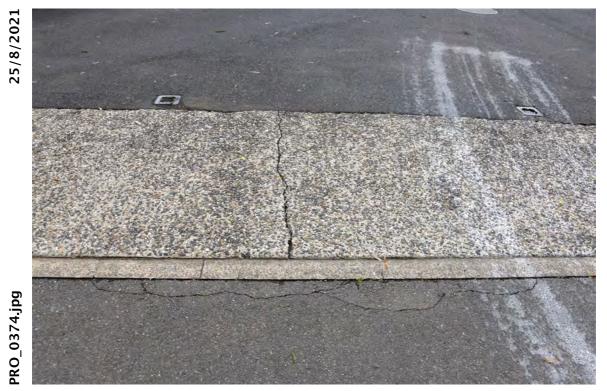
Eastern side of the Boulevard. Area opposite the area between 'The Hordern Pavilion' and 'The Royal Hall of Industries'. Intersection with Park Road. Heading south. Cracked paving.

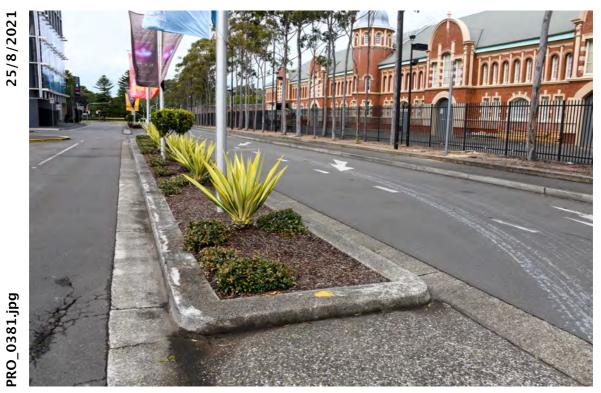
Eastern side of the Boulevard. Area opposite the area between 'The Hordern Pavilion' and 'The Royal Hall of Industries'. Intersection with Park Road. Heading south. Gap in the median strip.

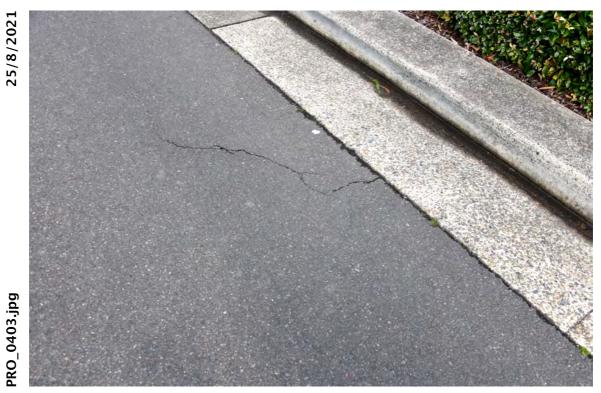
Eastern side of the Boulevard. Area opposite the 'The Royal Hall of Industries'. Area approaching the entry / exit to the 'Wilson Car Park'. Heading south along the median strip. Cracked adjacent paving.

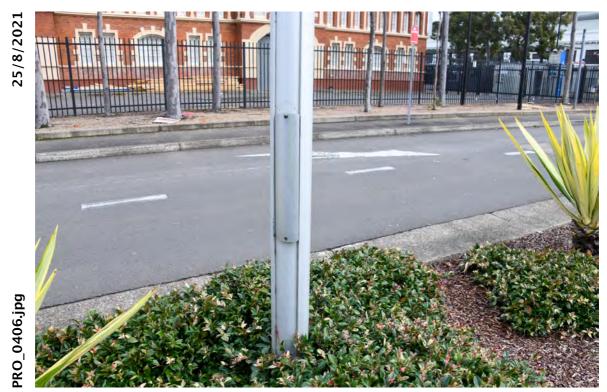
Eastern side of the Boulevard. Area opposite the 'The Royal Hall of Industries'. Area approaching the entry / exit to the 'Wilson Car Park'. Heading south along the median strip. Flagpole. Loose cover plate.
